HISTORIC AND DESIGN REVIEW COMMISSION

June 19, 2019

HDRC CASE NO: 2019-321
ADDRESS: 523 CEDAR ST
LEGAL DESCRIPTION: NCB 2878 BLK 3 LOT 11
ZONING: RM-4, H
CITY COUNCIL DIST.: 1
DISTRICT: King William Historic District
APPLICANT: TREVINO EDUARDO R &
OWNER: TREVINO EDUARDO R &
TYPE OF WORK: Porch Replacement
APPLICATION RECEIVED: May 31, 2019
60-DAY REVIEW: August 18, 2019
CASE MANAGER: Huy Pham

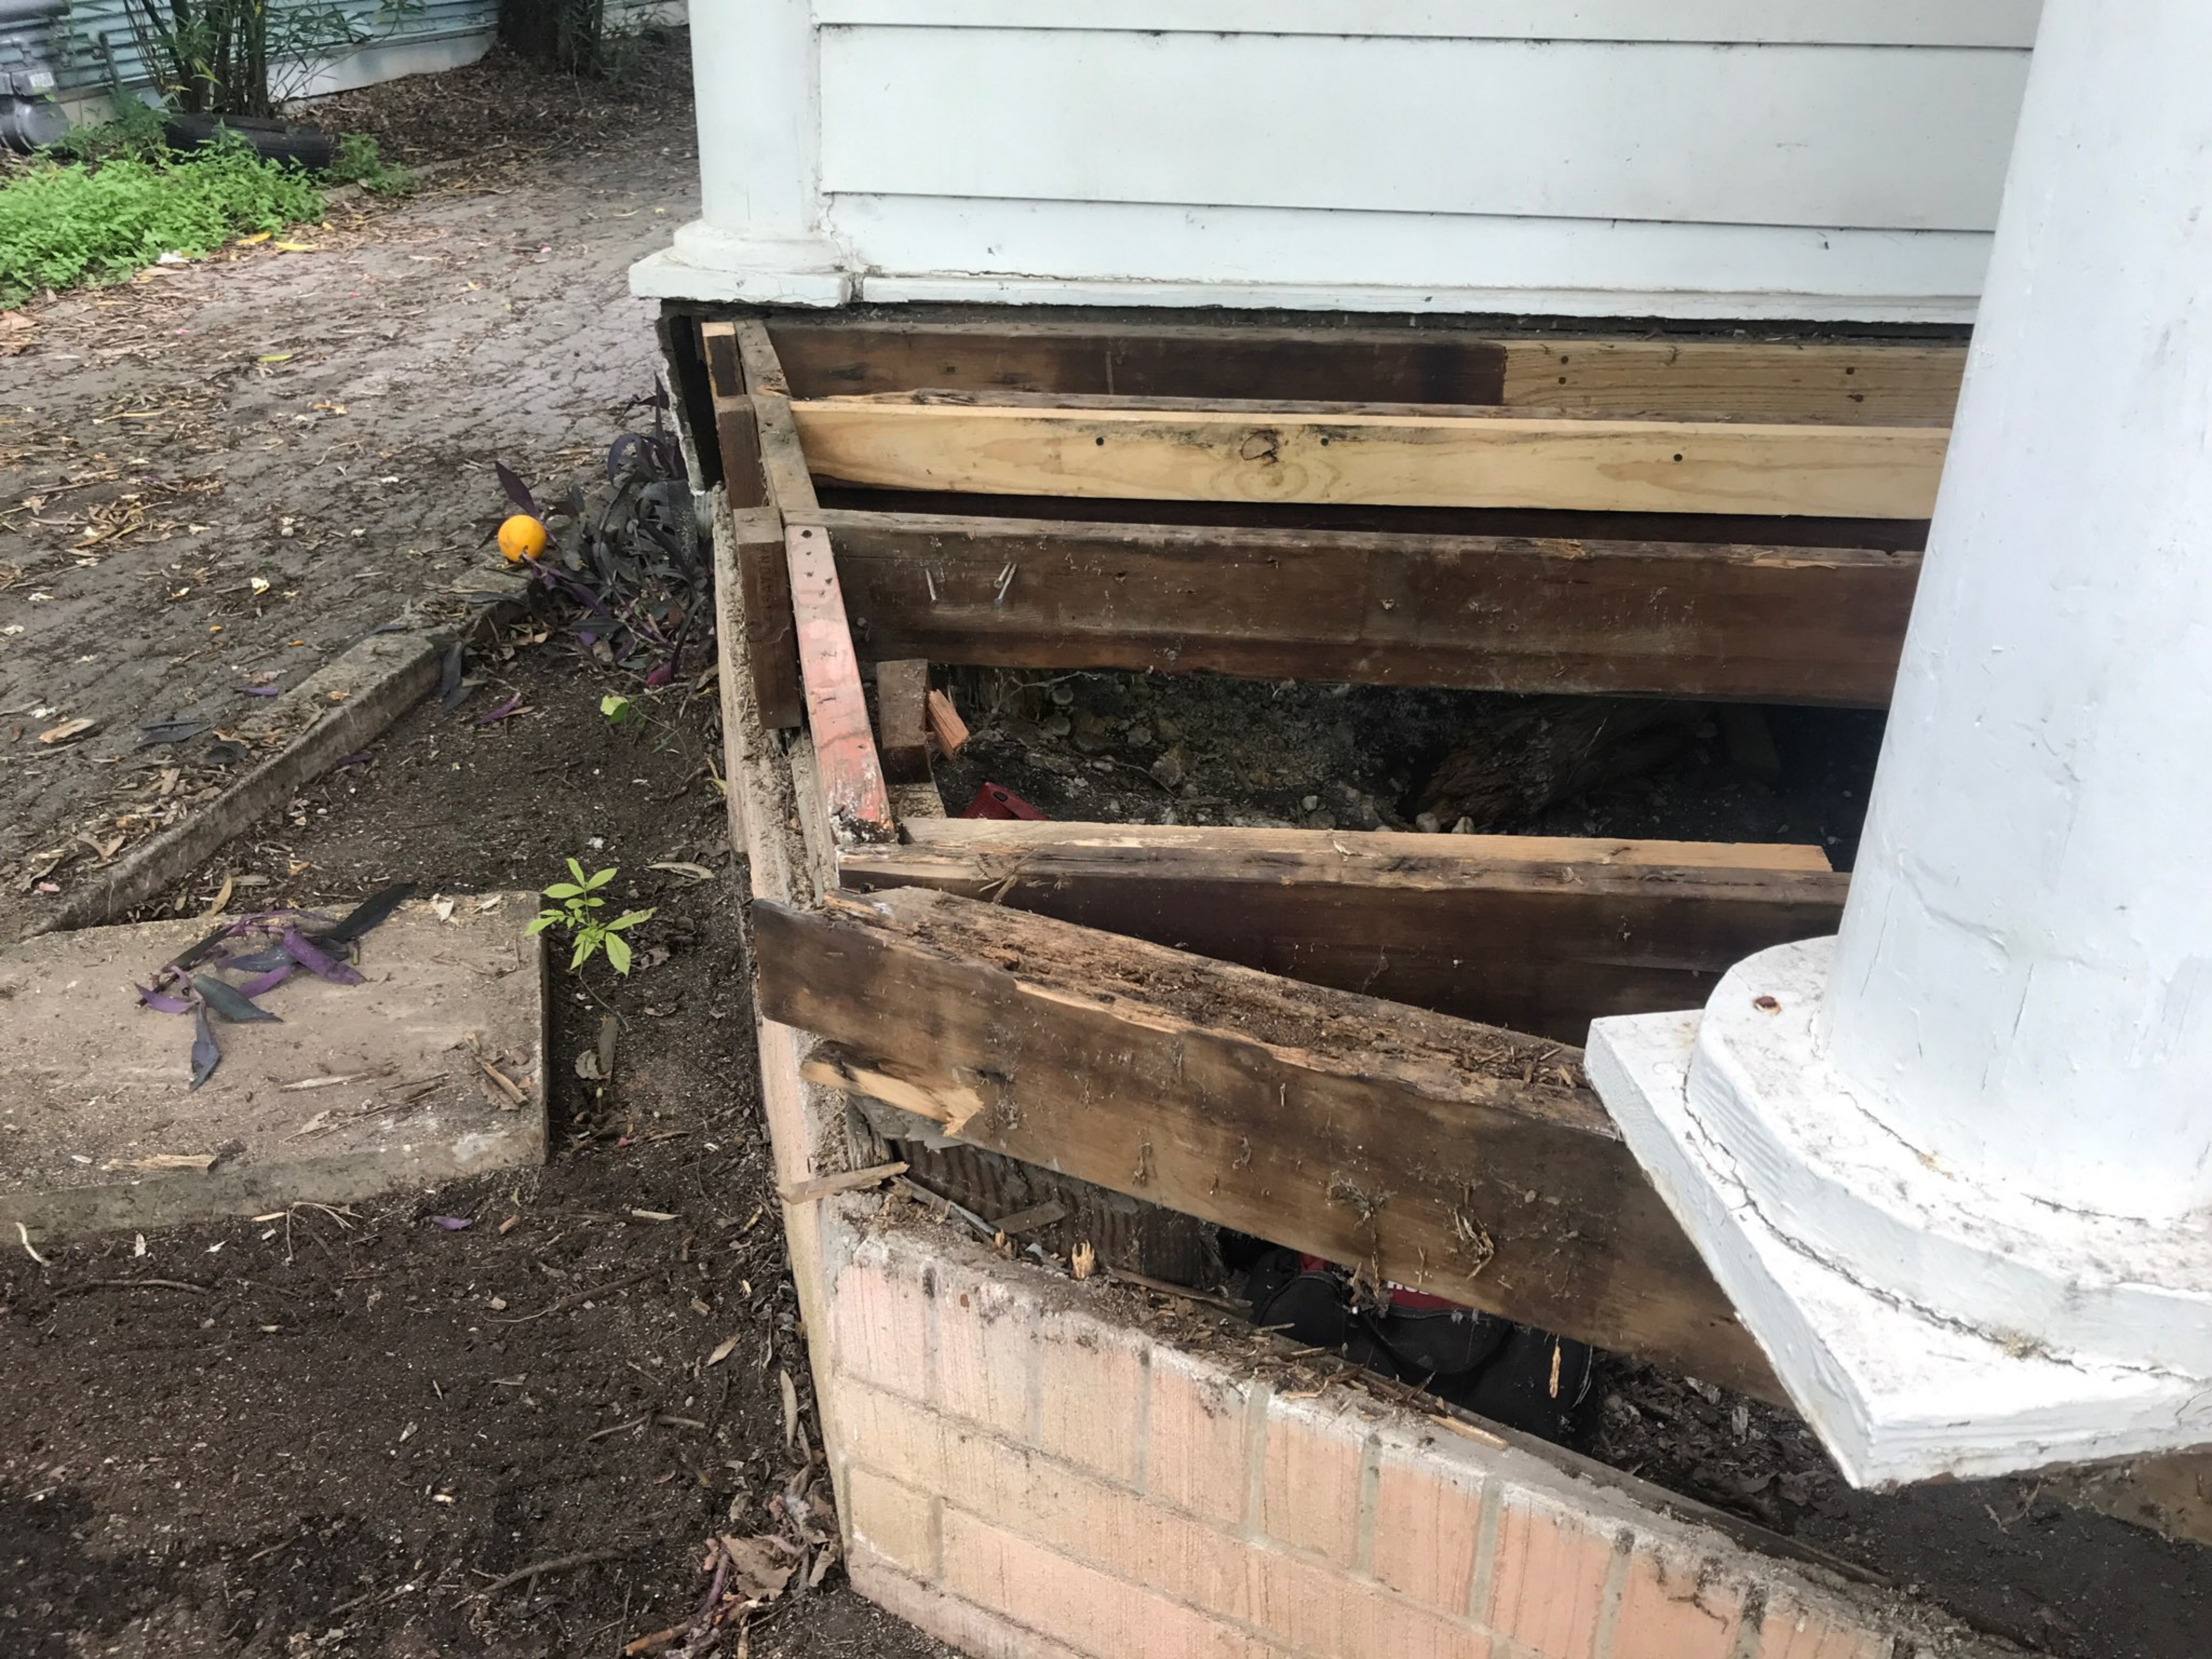
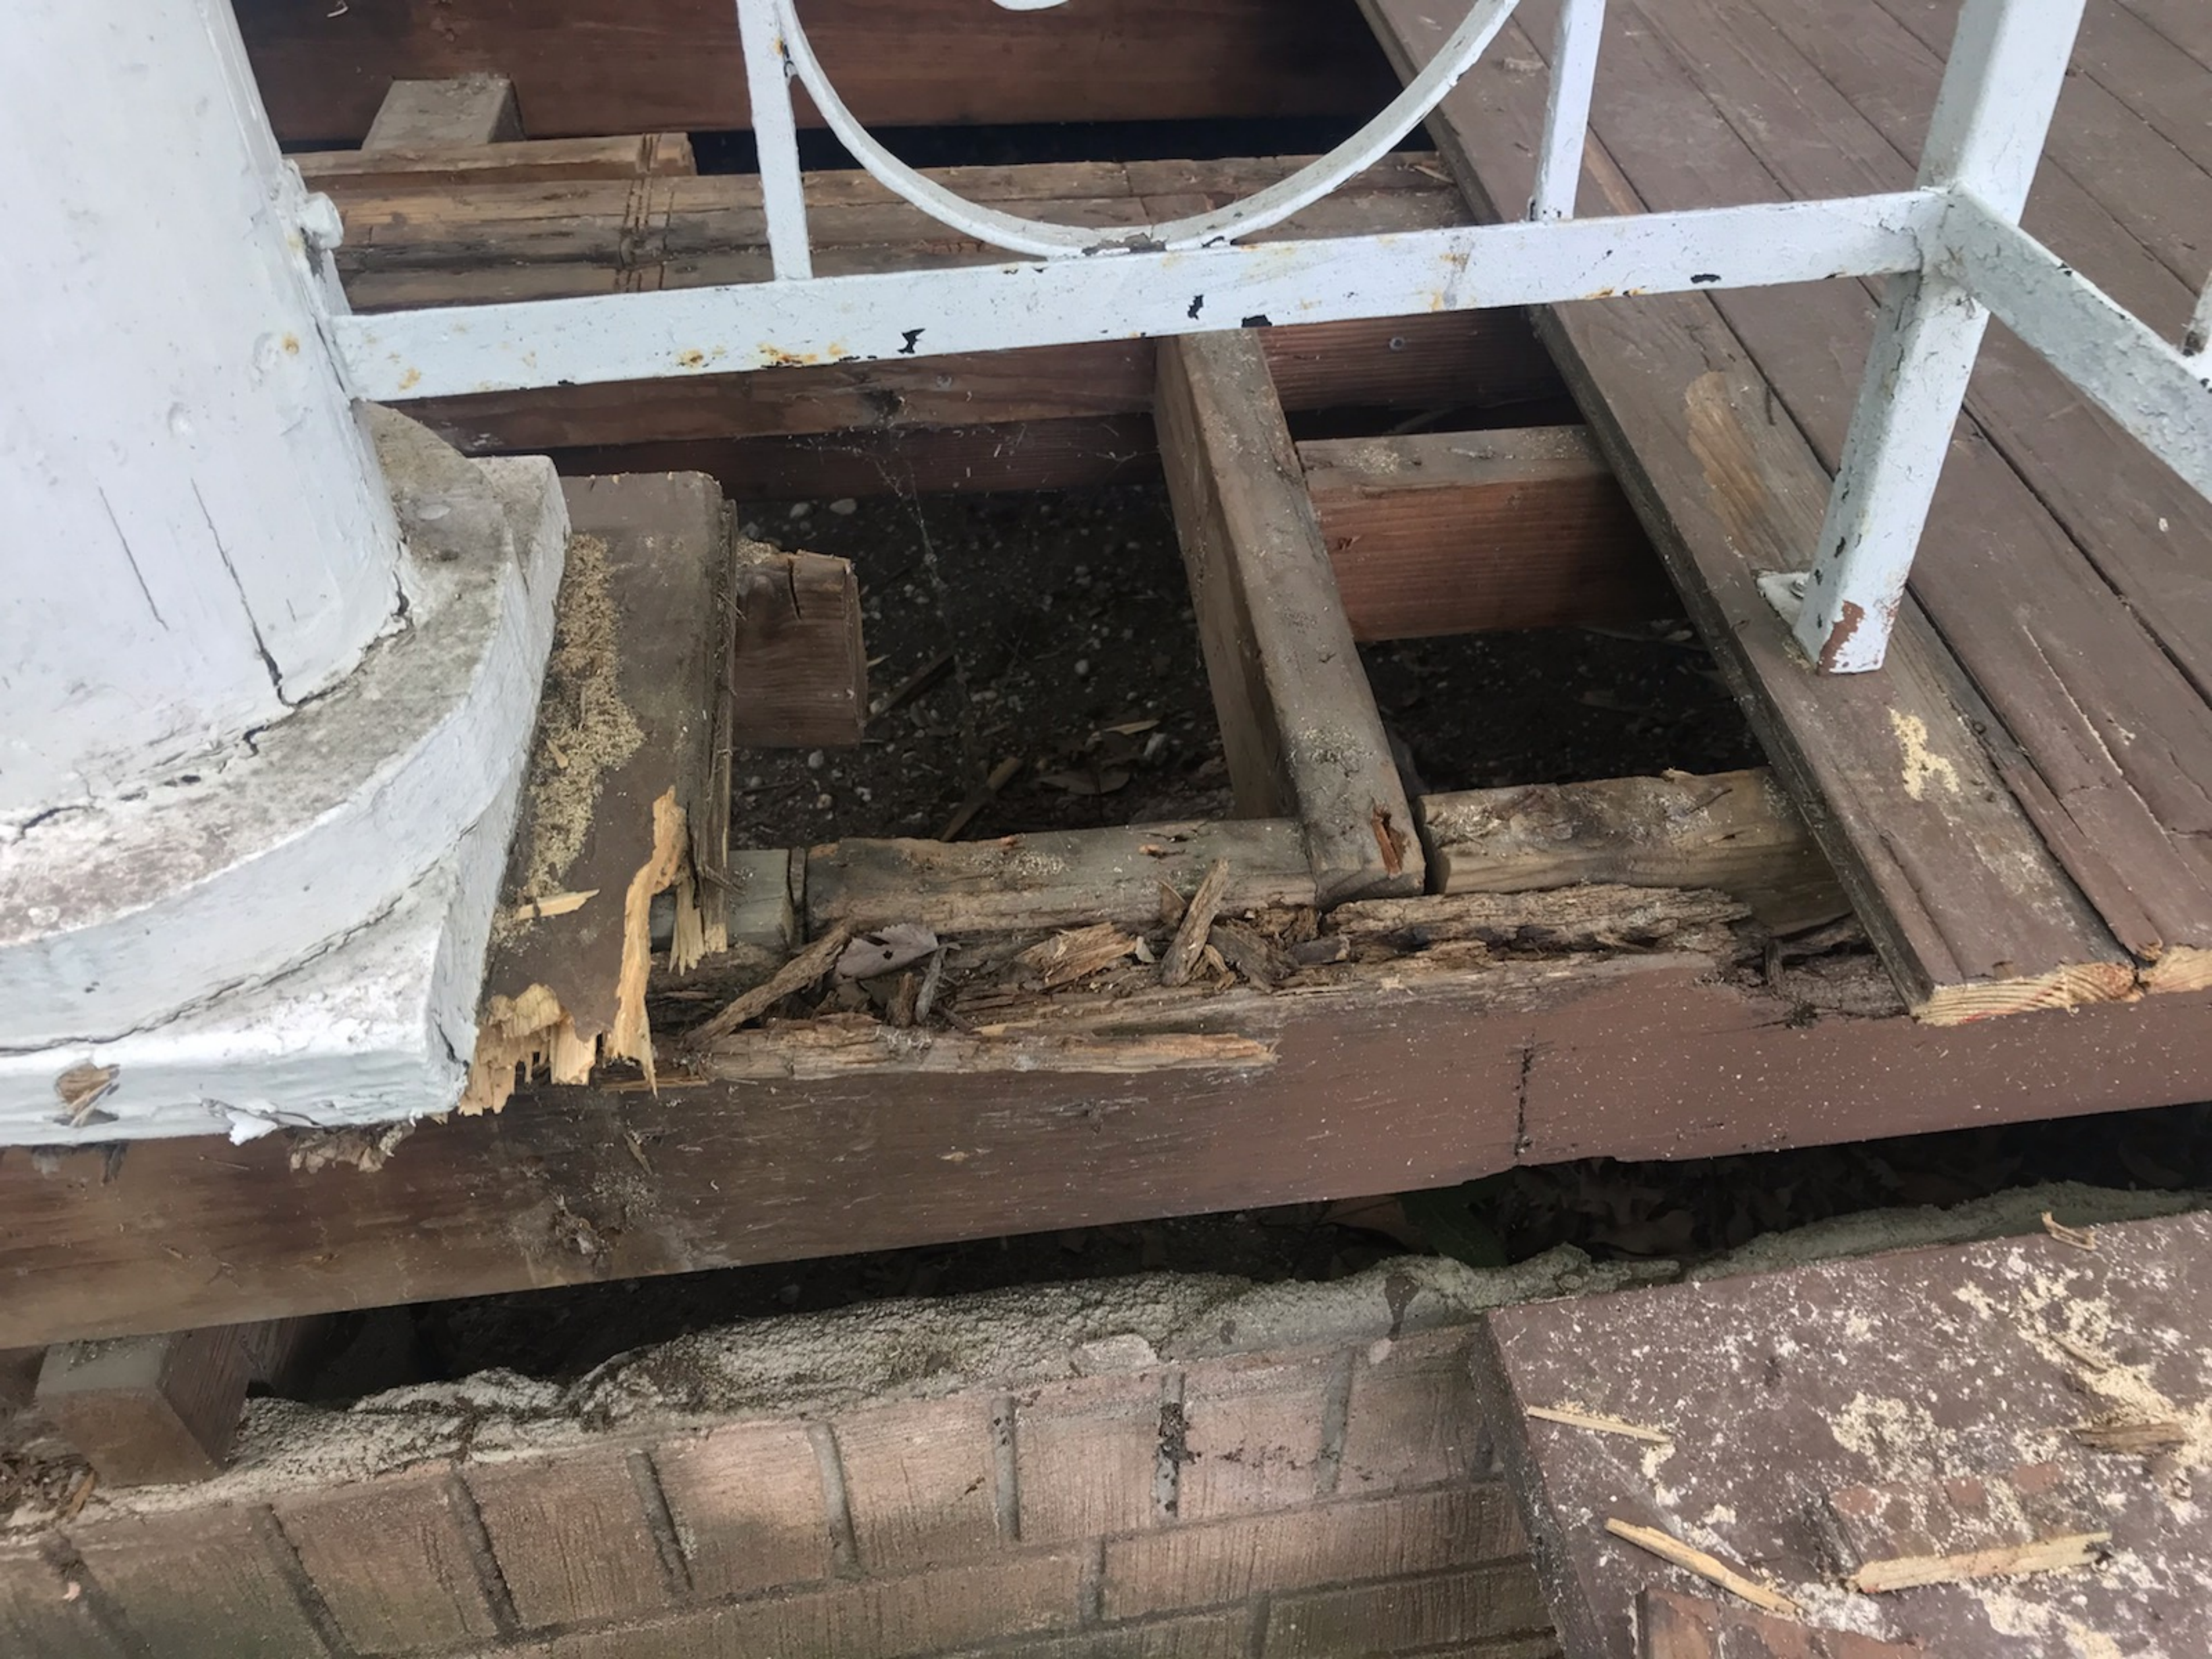
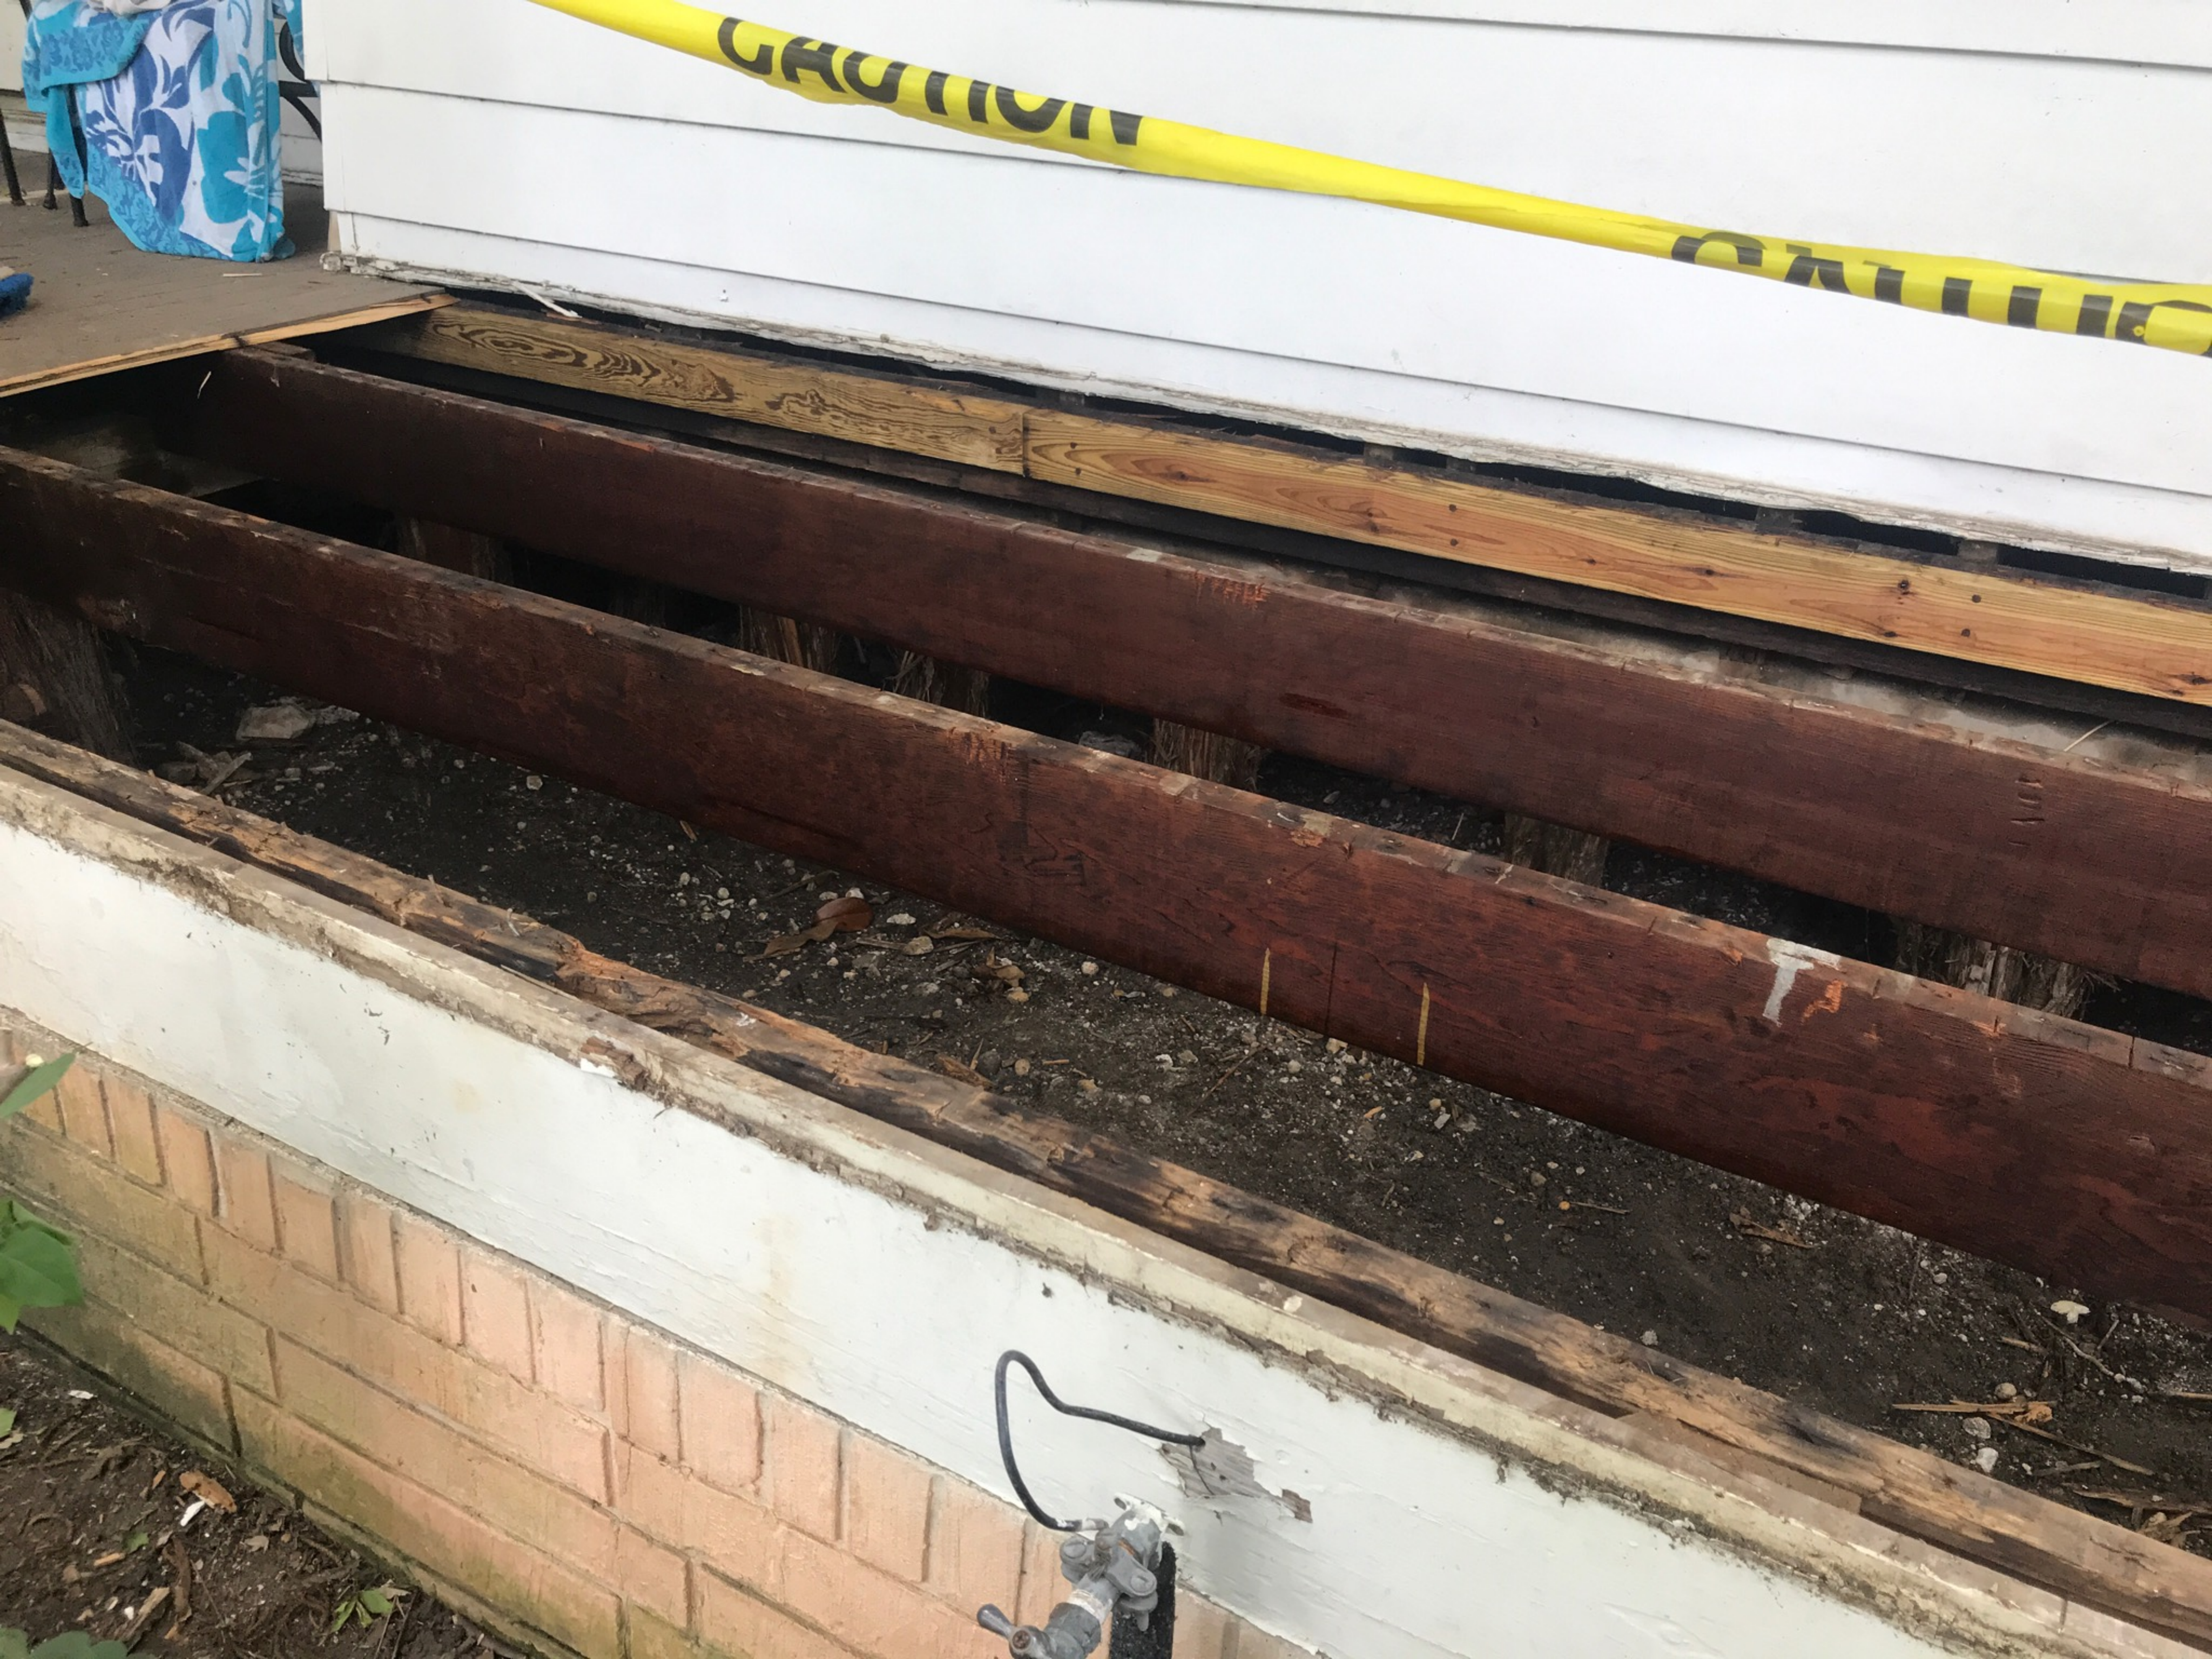
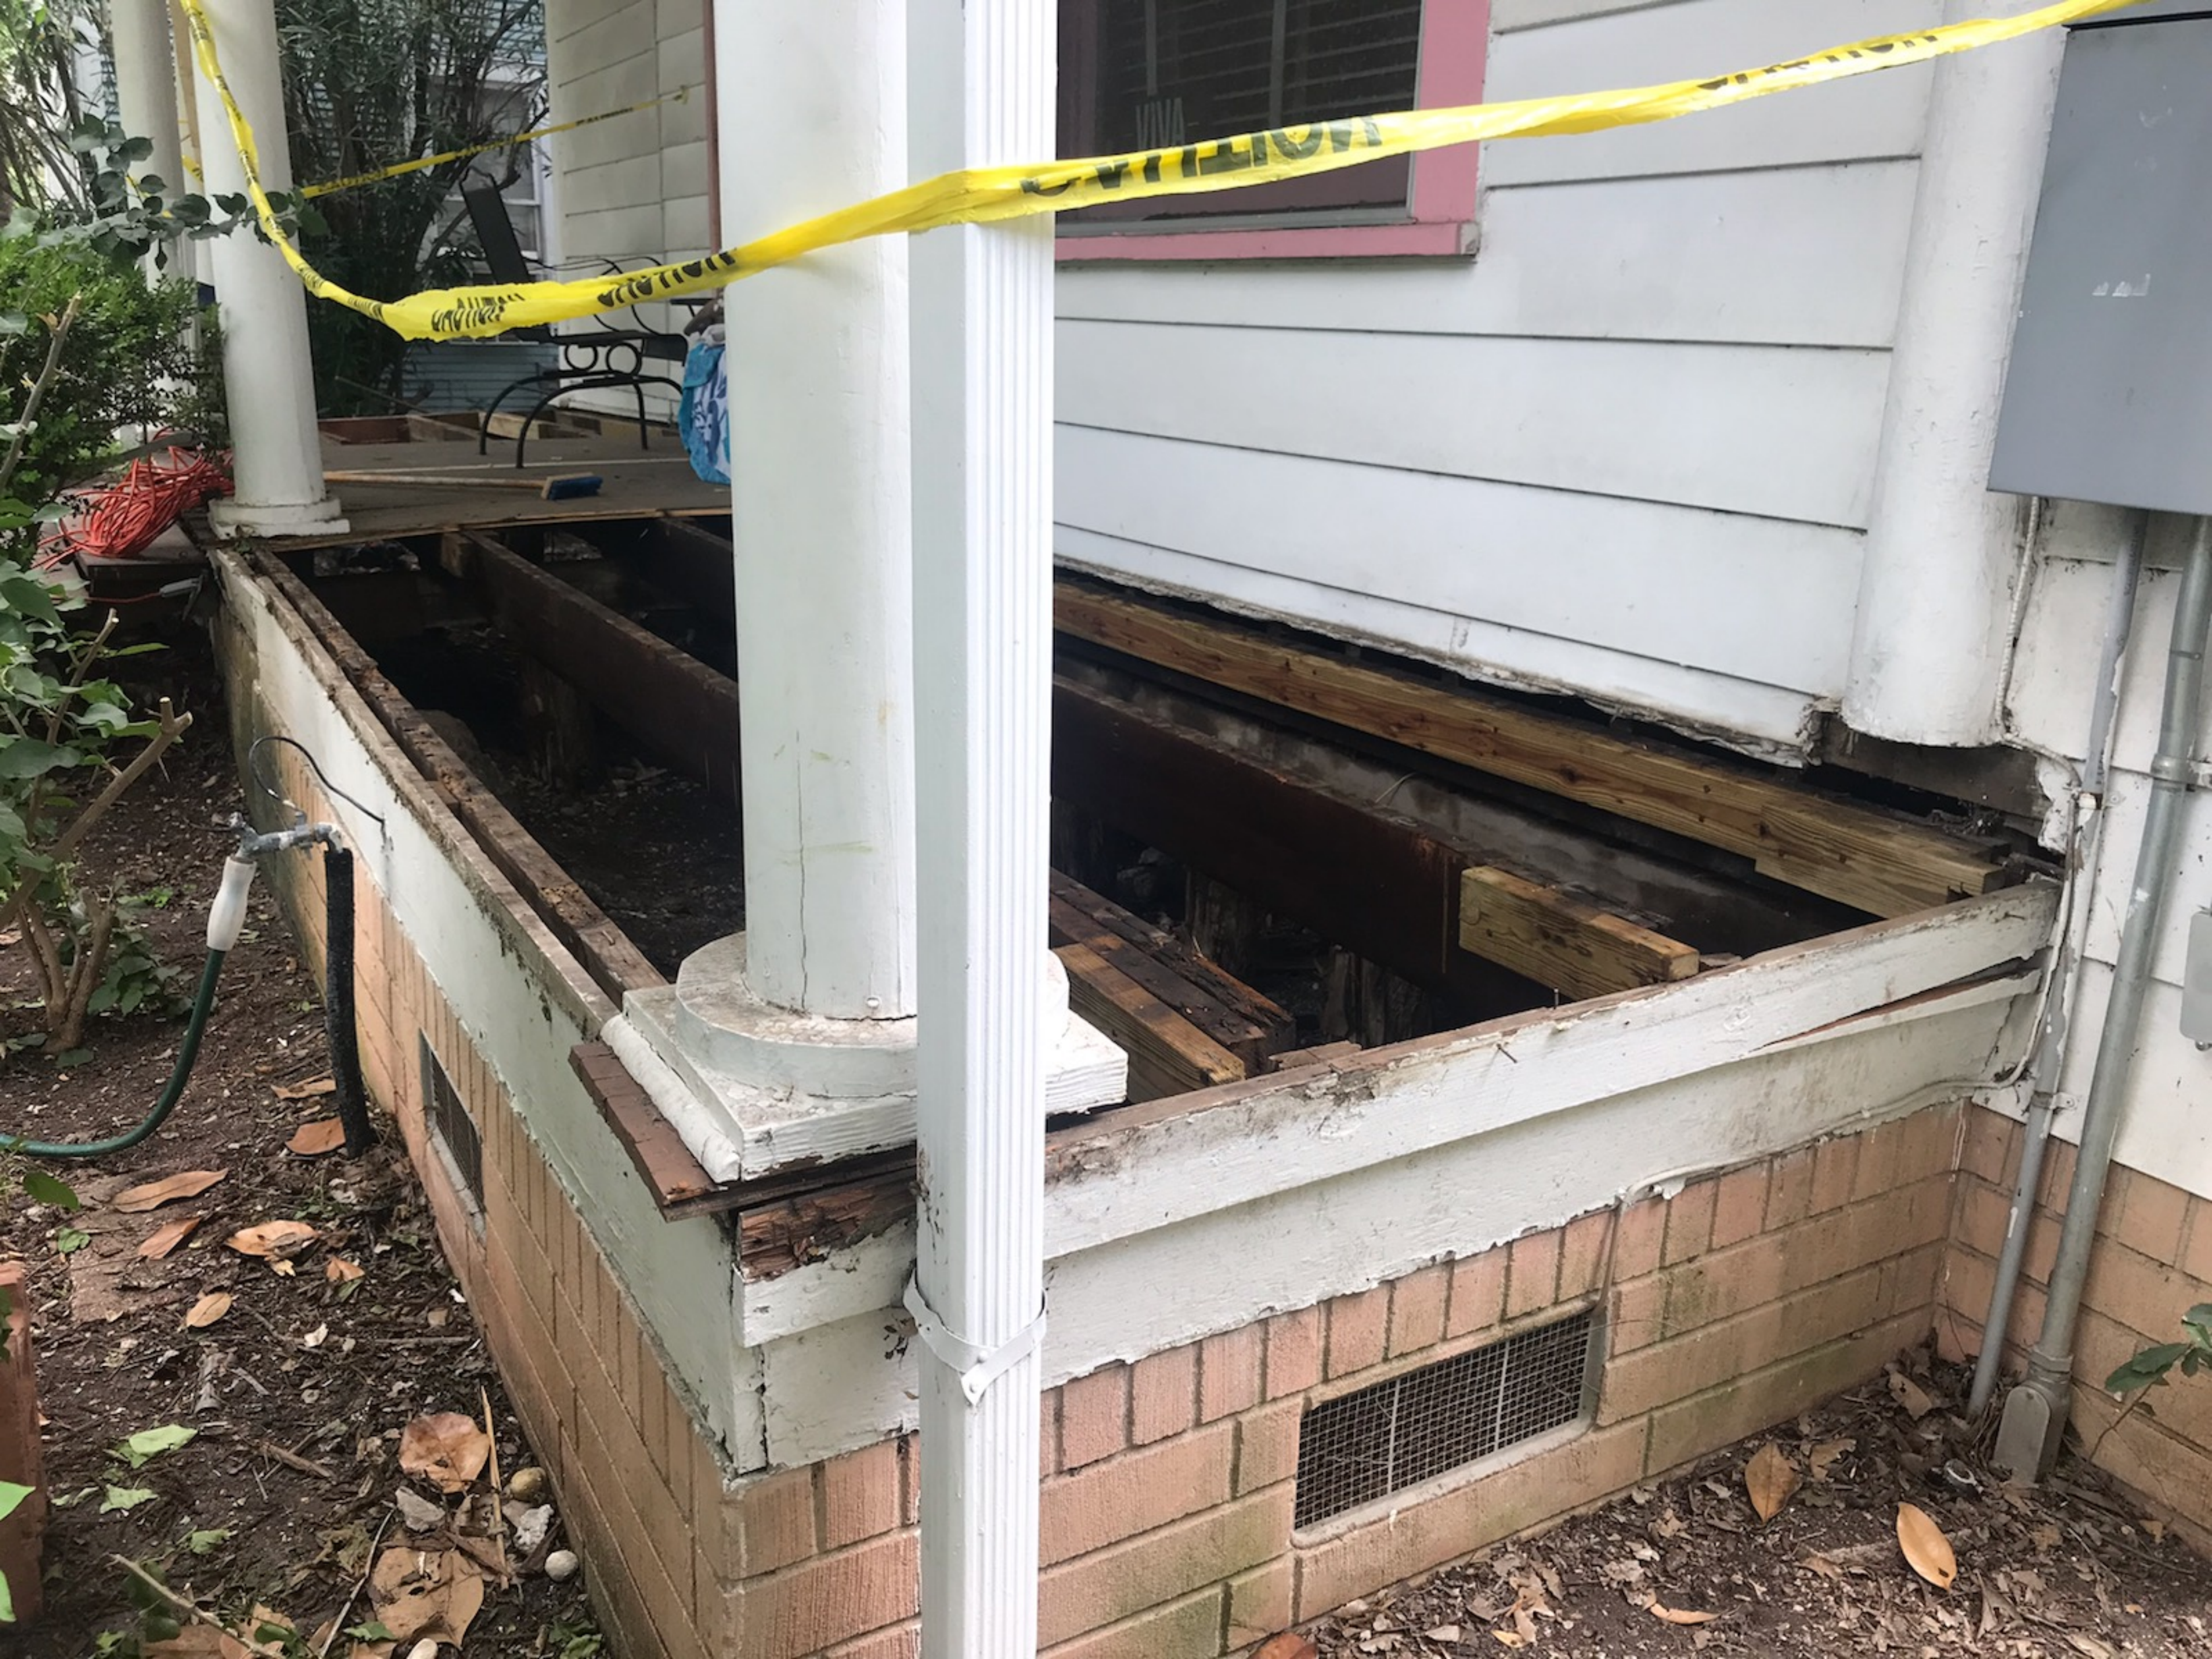
- b. **COMPLIANCE** – On a site visit conducted on May 30, 2019, staff found that the front porch tongue-and-groove decking was replaced with 1x6 boards including the removal of some column capitals. The applicant submitted an application May 31, 2019, to be heard at the next available HDRC hearing.

Staff does not recommend approval based on finding b and c. In-kind replacement of 1x3 tongue-and-groove decking should be installed instead and the column capitals should be restored.

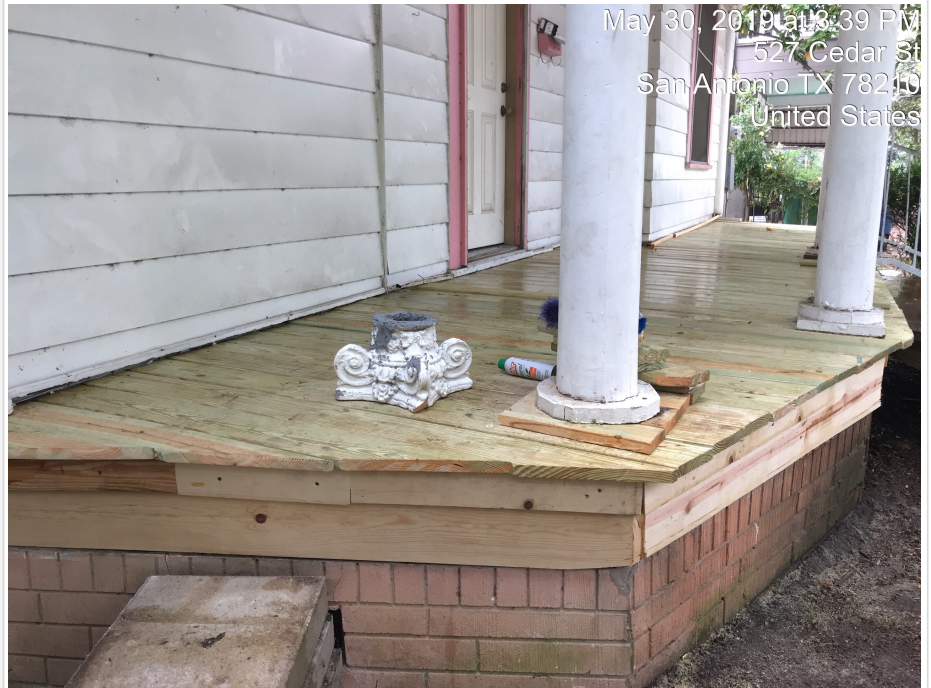
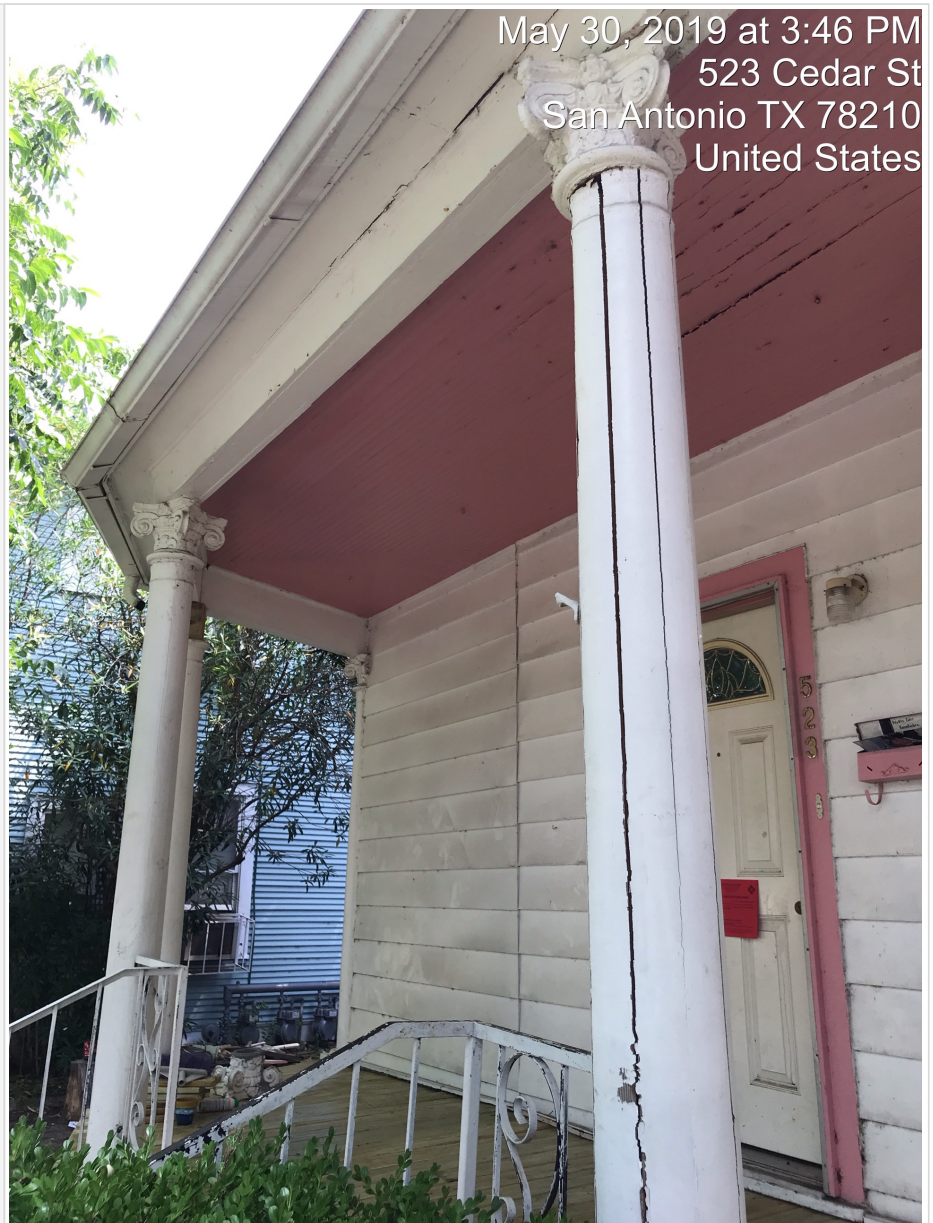
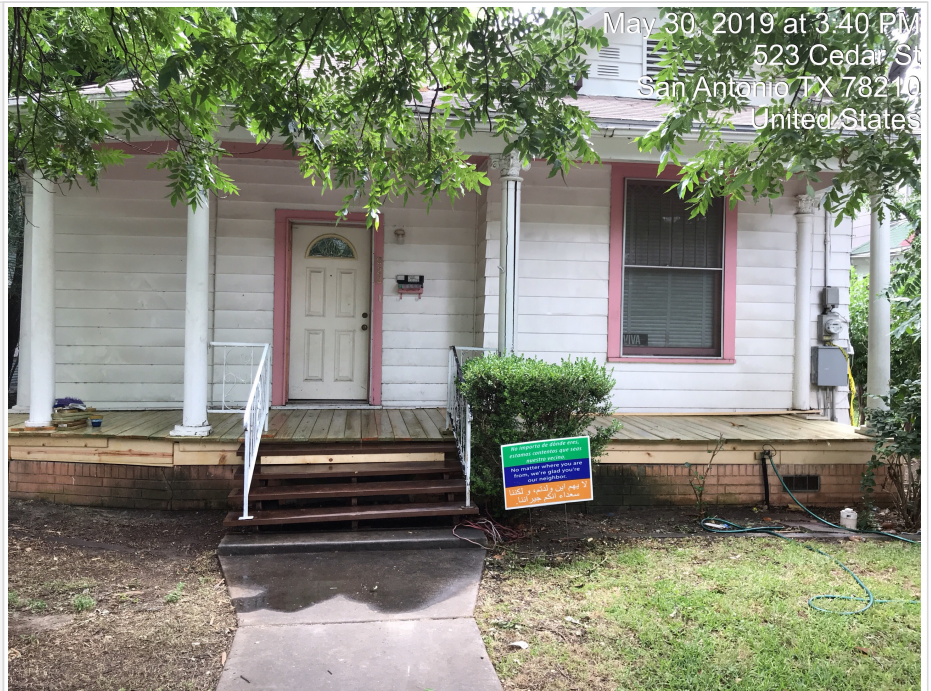
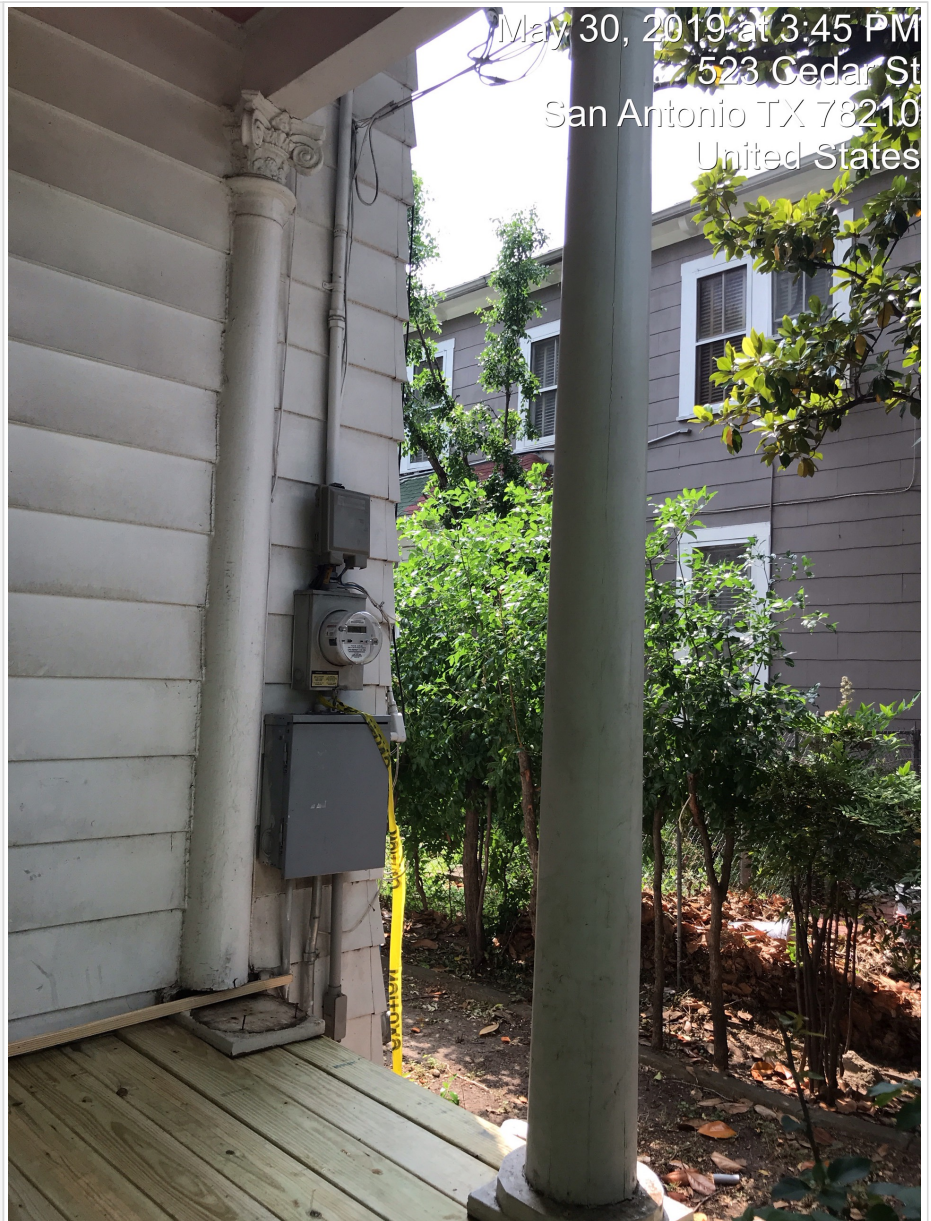
Photographs

Date	05/30/2019
Time	03:40 PM (-5 GMT)
Context	drive-by
Present Staff	Huy Pham, Edward Hall
Present Individuals	Contractor(s)
Types of Work Observed	Exterior Maintenance and Alterations
Amount of Work Completed	Completed
Description of work	Porch decking replacement with 1x6 wood planks. One capital has been removed and visible on site.
Description of interaction	Staff spoke to contractors who were driving away and advise that the owner should review the stop work order.
