HISTORIC AND DESIGN REVIEW COMMISSION

June 19, 2019

HDRC CASE NO: 2019-336
ADDRESS: 405 GILLESPIE
LEGAL DESCRIPTION: NCB 1745 BLK 8 LOT S 51.5 FT OF N 103 FT OF 5 E IRR 7FT OF MID PART OF 5 & 6
ZONING: R-6, H
CITY COUNCIL DIST.: 1
DISTRICT: Tobin Hill Historic District
APPLICANT: Jake Forshpan/FORSHPAN JAKE B & FORSHPAN SHARON K
OWNER: Jake Forshpan/FORSHPAN JAKE B & FORSHPAN SHARON K
TYPE OF WORK: Side porch modifications
APPLICATION RECEIVED: June 03, 2019
60-DAY REVIEW: August 02, 2019
CASE MANAGER: Huy Pham

The applicant is requesting a Certificate of Appropriateness for approval to remove the existing side porch to reconstruct a new enclosed side porch with similar architectural details.

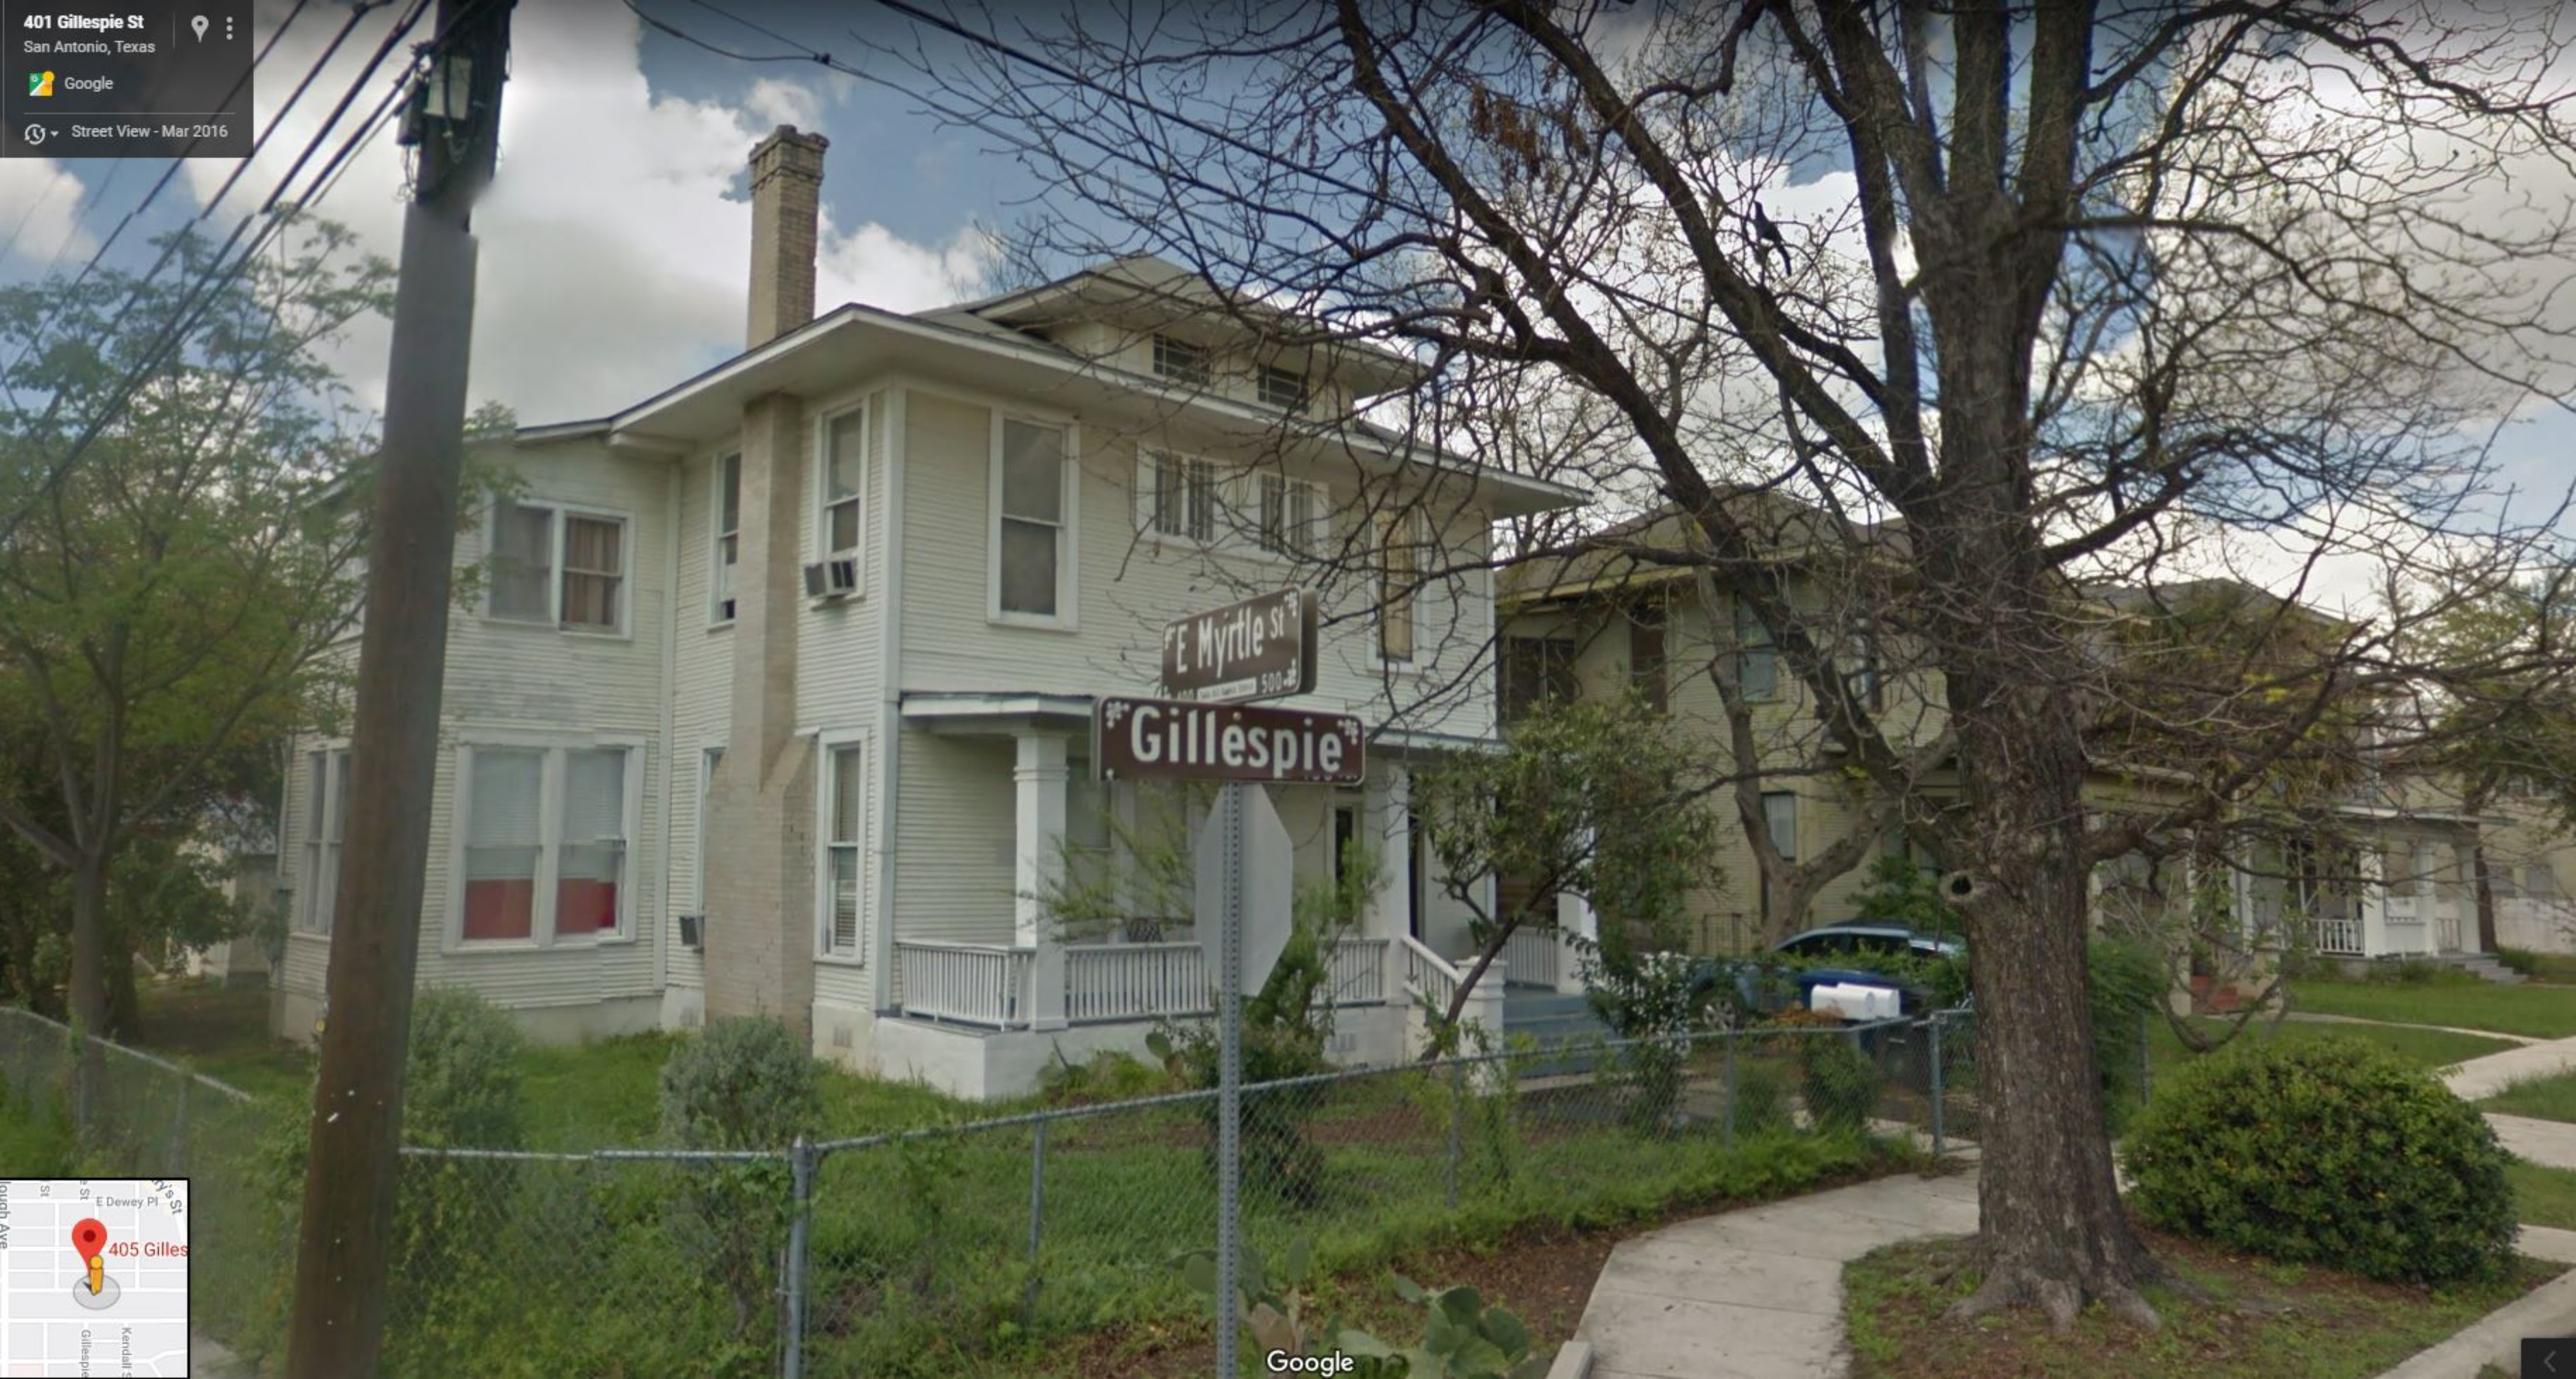
Street View - Mar 2016

- c. **EXISTING PORCH** – The side porch features an open first-floor patio and a second-floor screened balcony or “sleeping porch”. The patio features a concrete slab and two wide Craftsman style columns that match the front porch columns. The balcony footprint is larger than the first-floor porch and features wood board siding and a shed roof. The side porch matches the neighbor’s side porch at 409 Gillespie, except each property’s side porch has columns that match their own front porch.

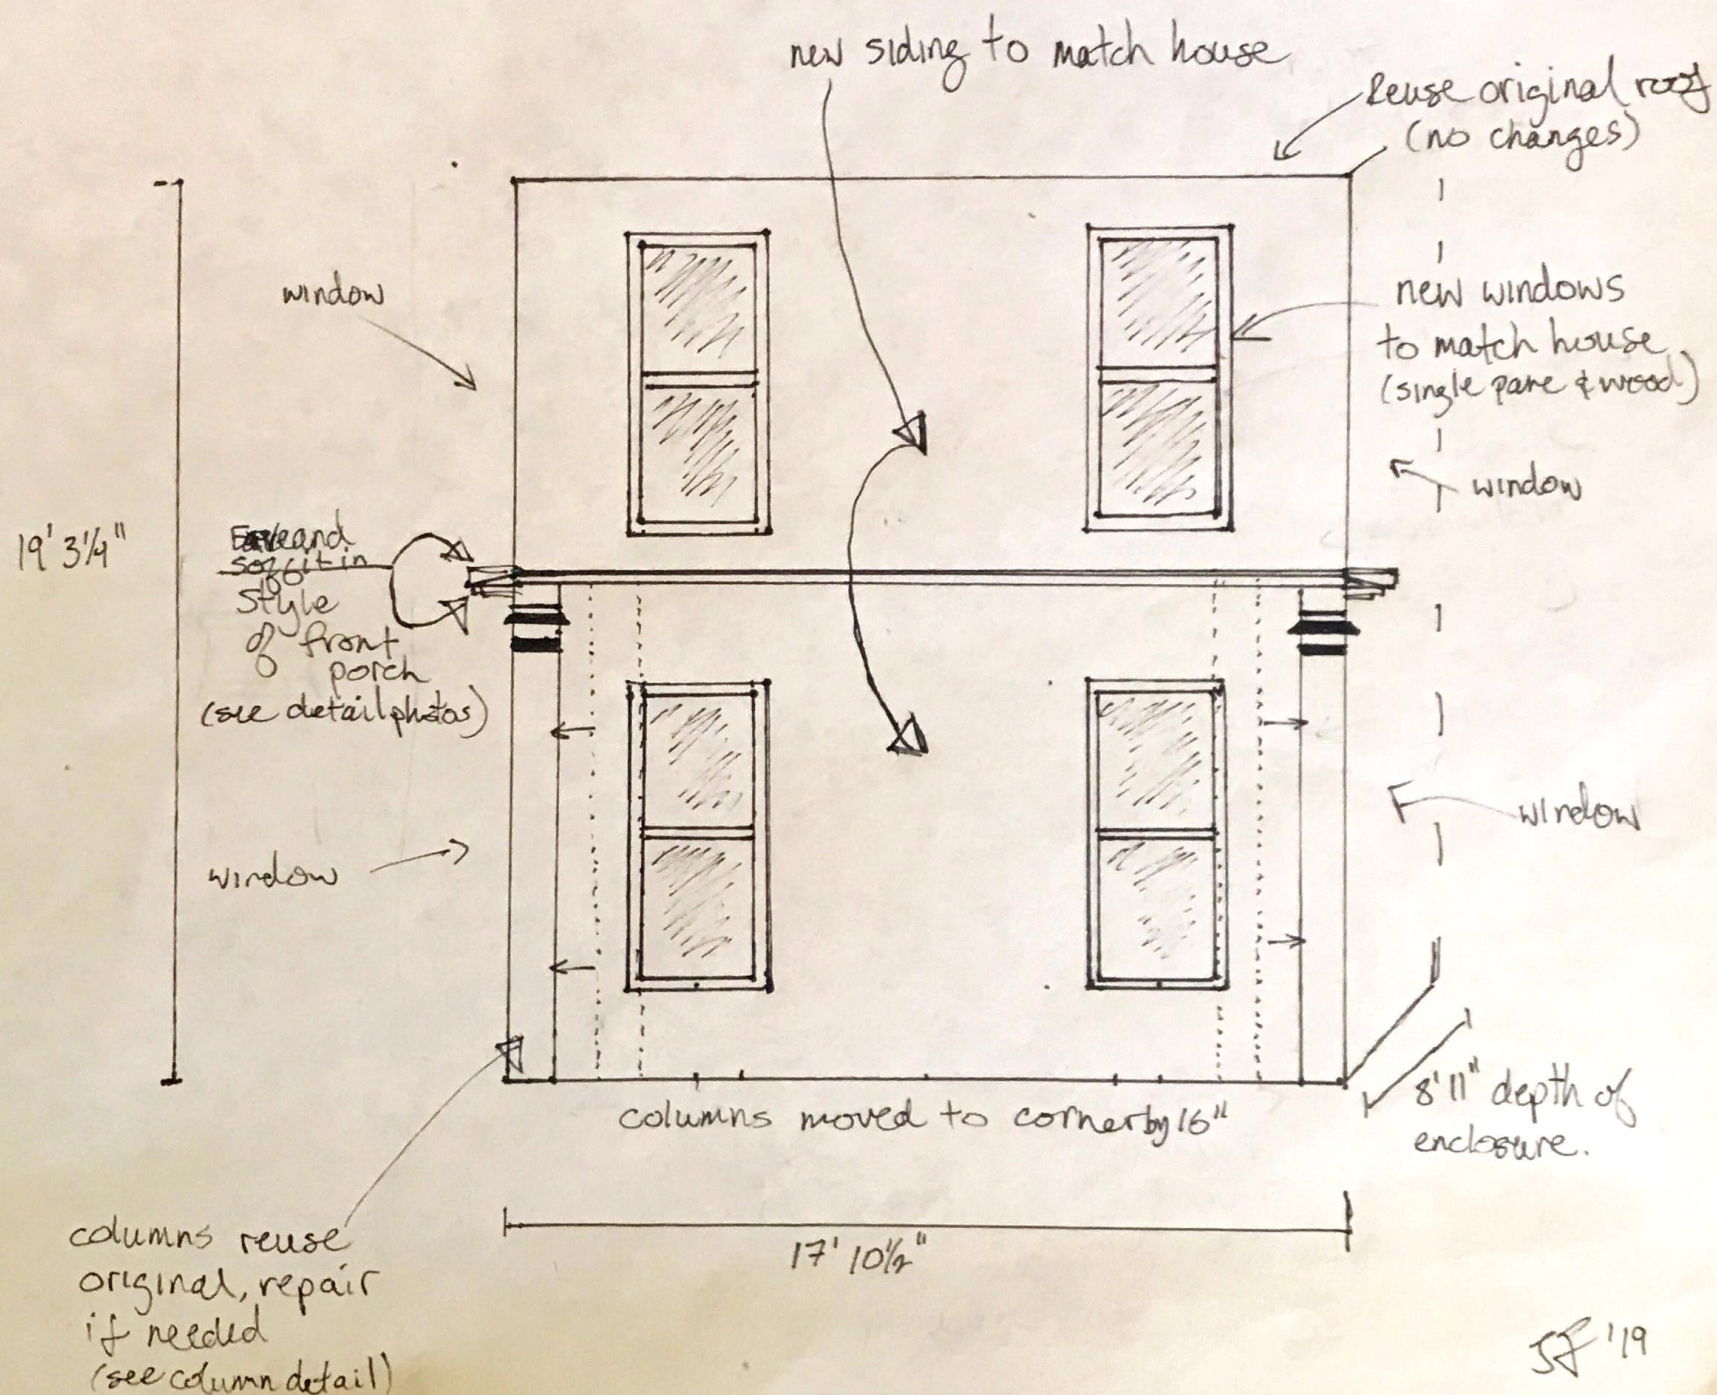
Design elevation

To represent the prior usage as a patio/balcony, the old columns will be refinished/rebuilt and placed at the corners of the first floor. In addition, an eave w/soffit will be added between the first and second floor. In the same style as the front patio eave to maintain the overhang style.

Original columns were set inside the corners of the patio slab. To maintain same footprint as slab and to run a post from the slab all the way up through to the second floor, the columns are proposed to be moved to the outer corners of the patio slab (16") Original columns and details will be used.

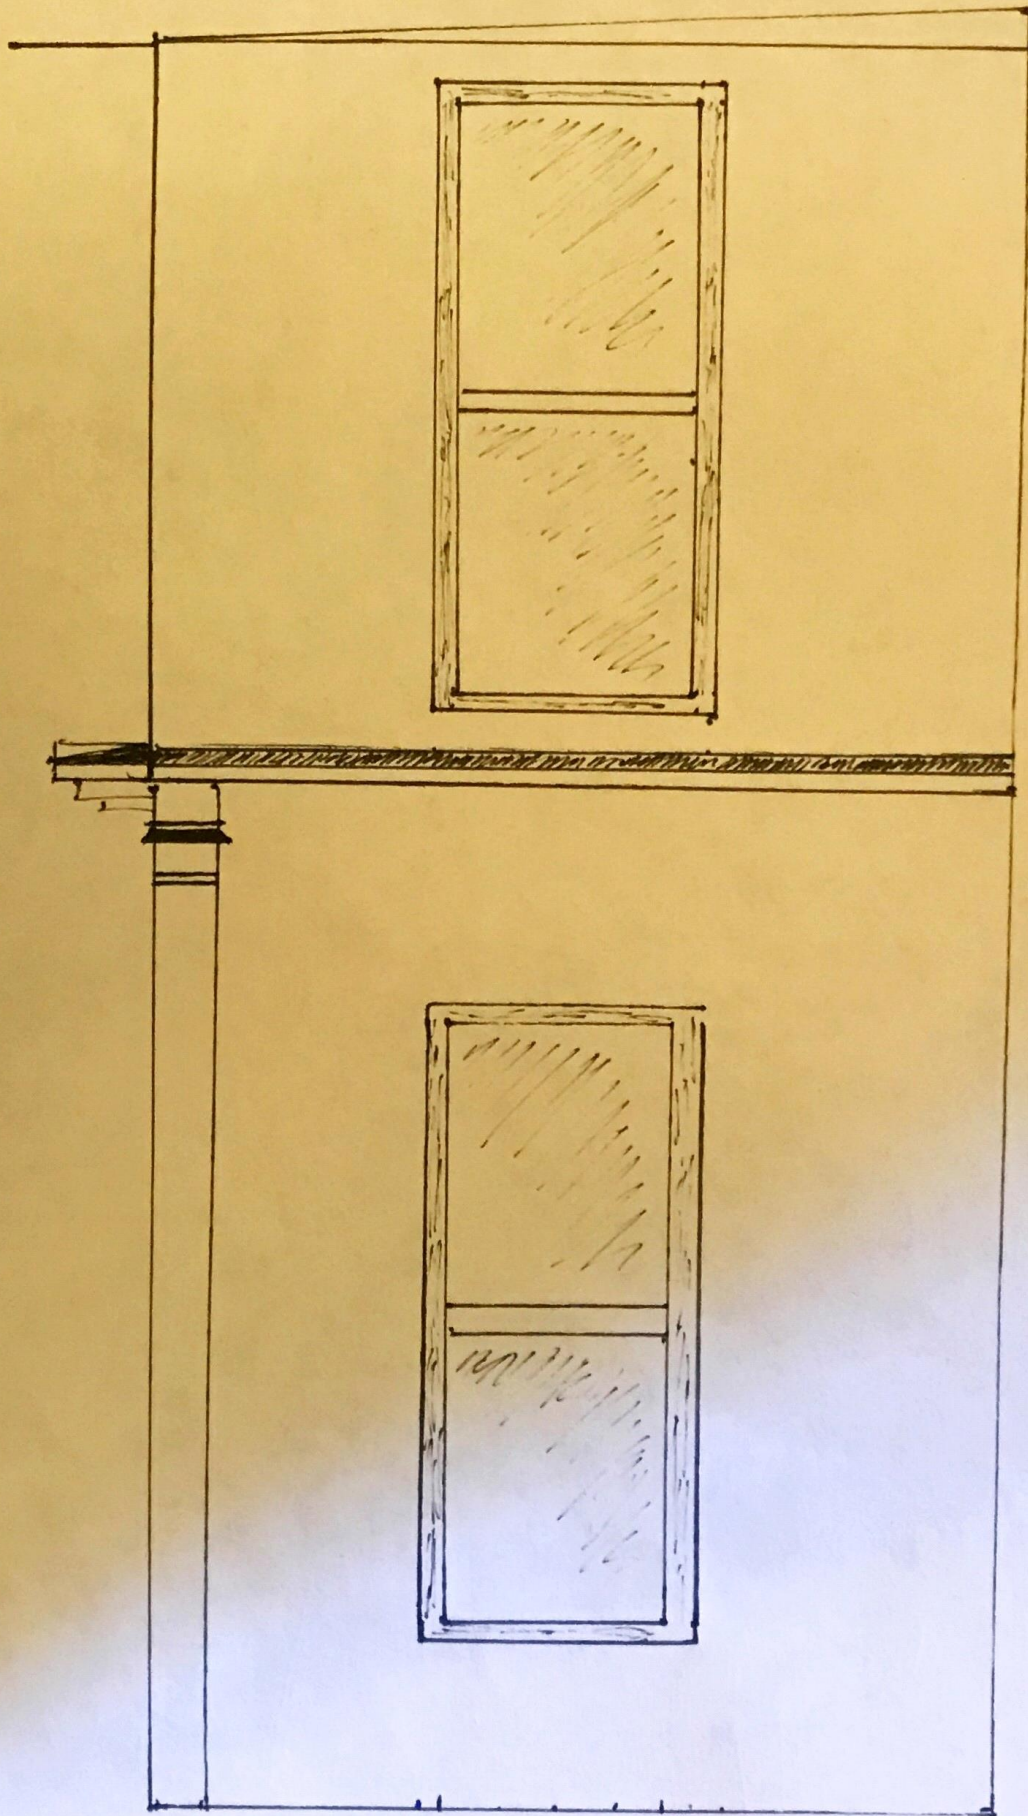
Side elevation

8 (4 top/4 bottom)
single pane wood
windows to match
house (see window
detail)

Siding added to match
house (see siding detail)

eave/soffit added for
overhang (See eave/
soffit detail)

originals collumns moved
to corners (16") post added
inside for structural support
(See collumn detail)

1st floor footprint to
match 2nd floor

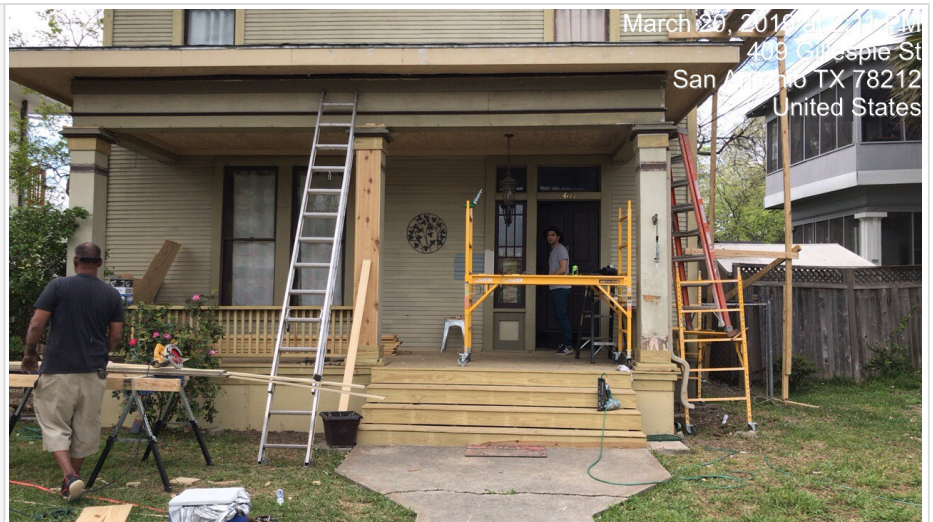
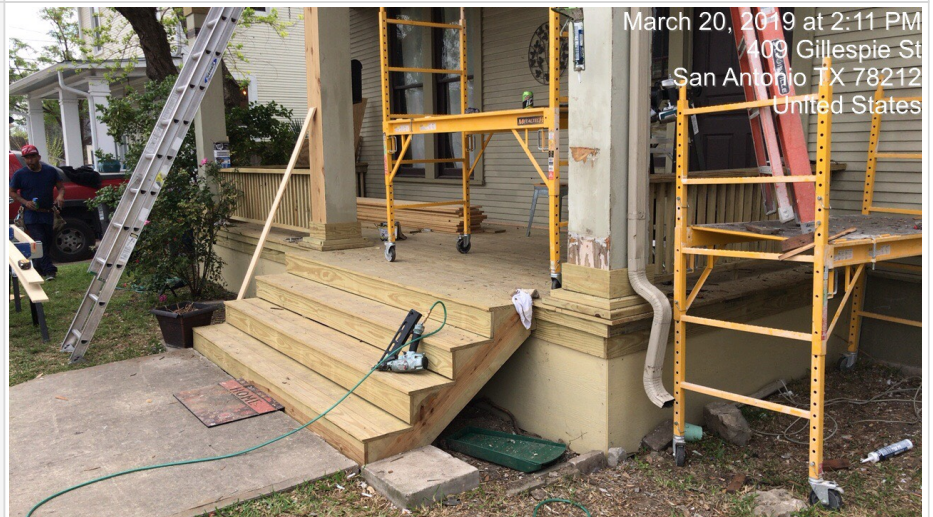
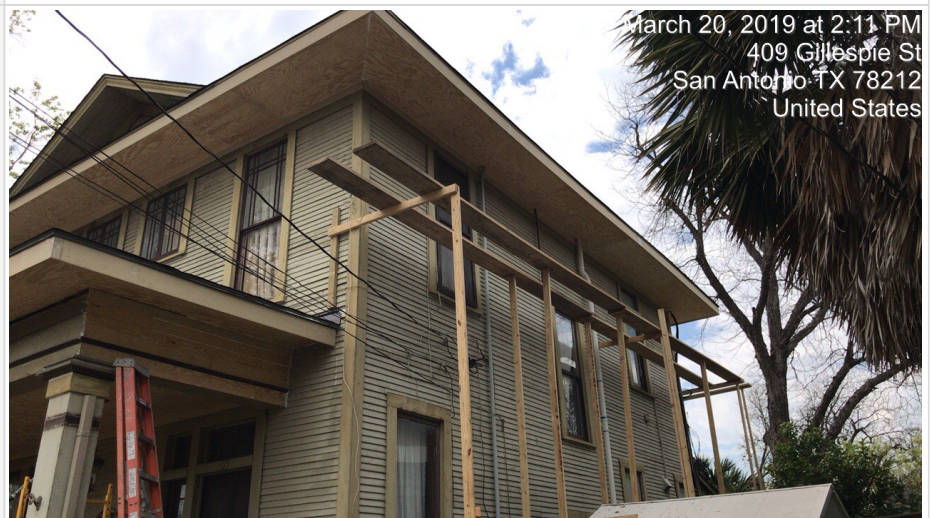
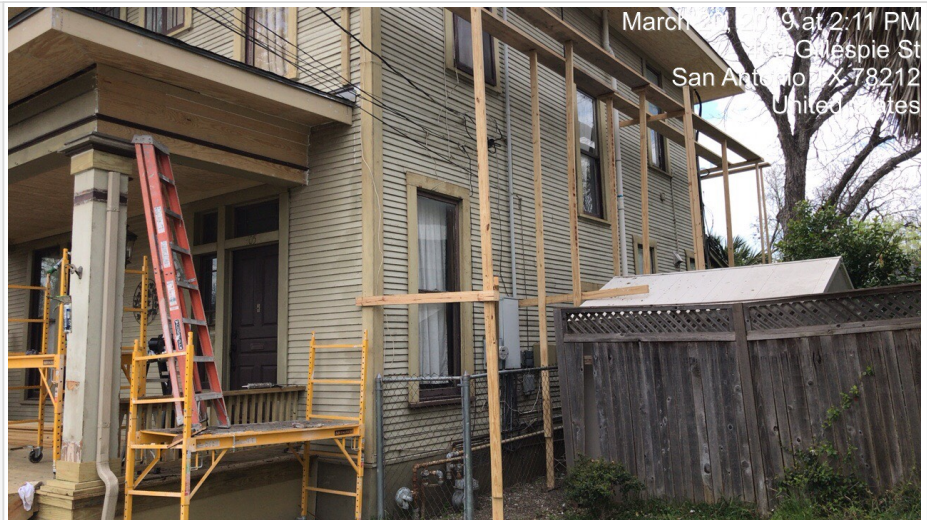
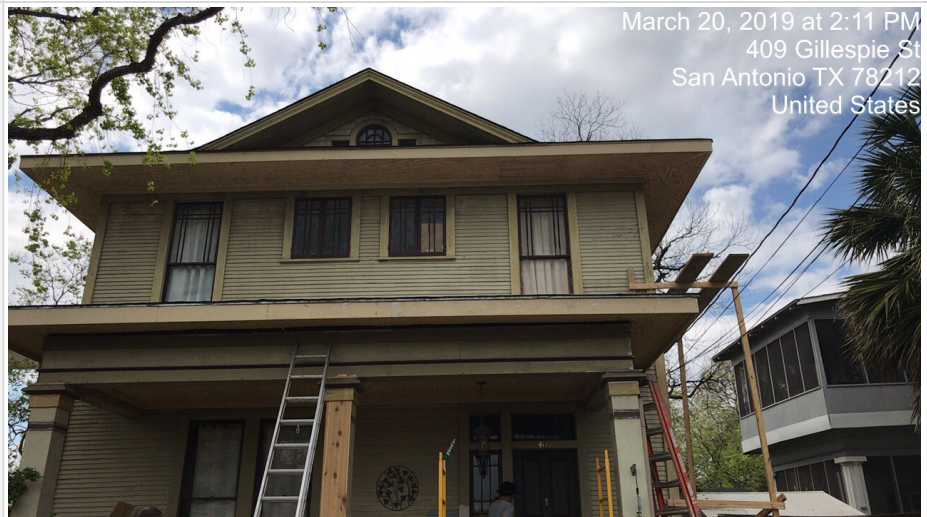
Photographs	  <p>March 20, 2019 at 2:12 PM 405 Gillespie St San Antonio TX 78212 United States</p>
-------------	---

Date	03/20/2019
Time	02:10 PM (-5 GMT)
Context	citizen report
Present Staff	Edward Hall
Present Individuals	Homeowner, Contractor(s)
Types of Work Observed	Exterior Maintenance and Alterations
Amount of Work Completed	75%
Description of work	The scope of work included repair and maintenance with in-kind materials. Areas of work included porch railing repair, column repair, trim repair, window sill repair, and other exterior elements.
Description of interaction	The home owner noted that he would apply for an Admin COA by the morning of Thursday, March 21.

Violation Type	No Certificate of Appropriateness (Code 35-451a)
OHP Action	Spoke with property owner, Spoke with contractor(s), No Action Taken/Photos Only
Other field notes	The work, as best determined, was being done in kind. The contractors were allowed to continue to caulk replaced wood elements. The property owner will apply for an Admin COA by the morning of March 21, 2019.
Will post-work application fee apply?	No
