HISTORIC AND DESIGN REVIEW COMMISSION

HDRC CASE NO: 2019-322

ADDRESS: 648 LEIGH ST

OWNER: DUNN LATASHA
TYPE OF WORK: Window replacement

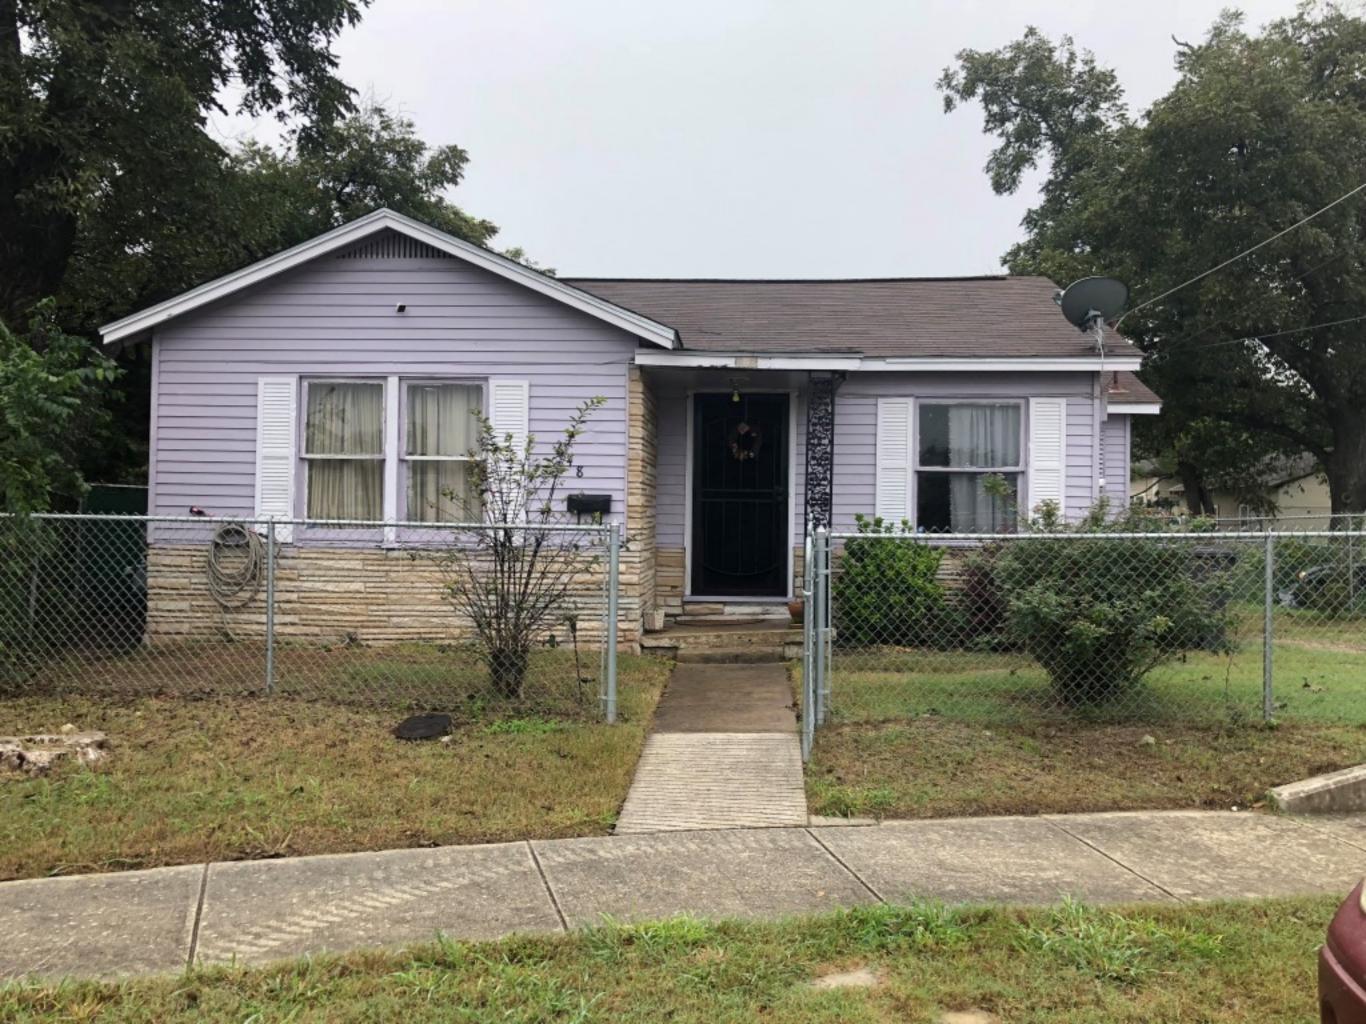
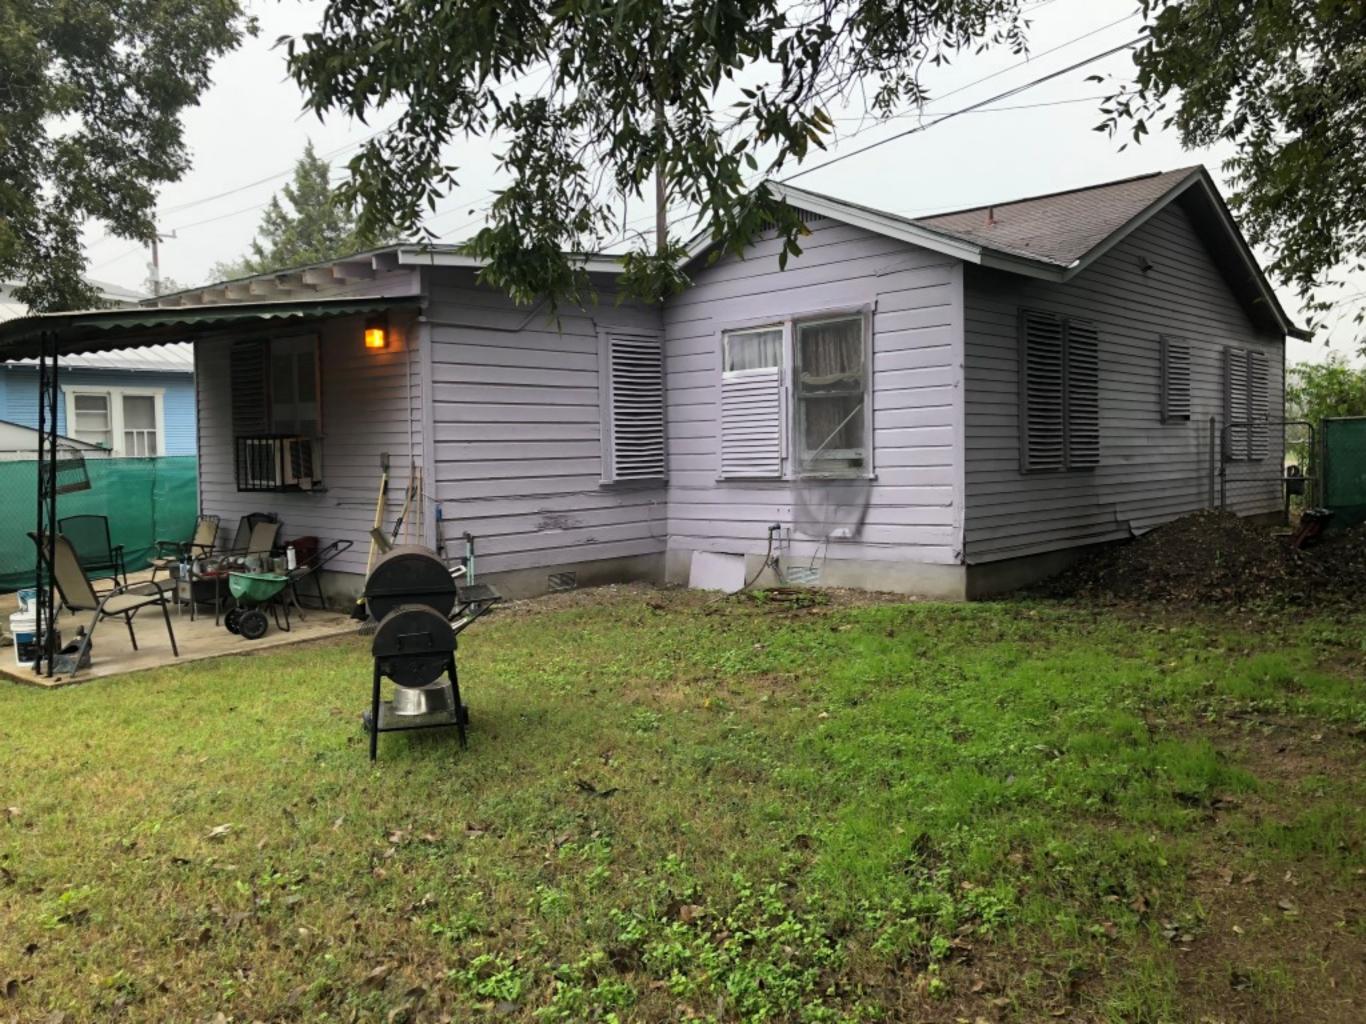
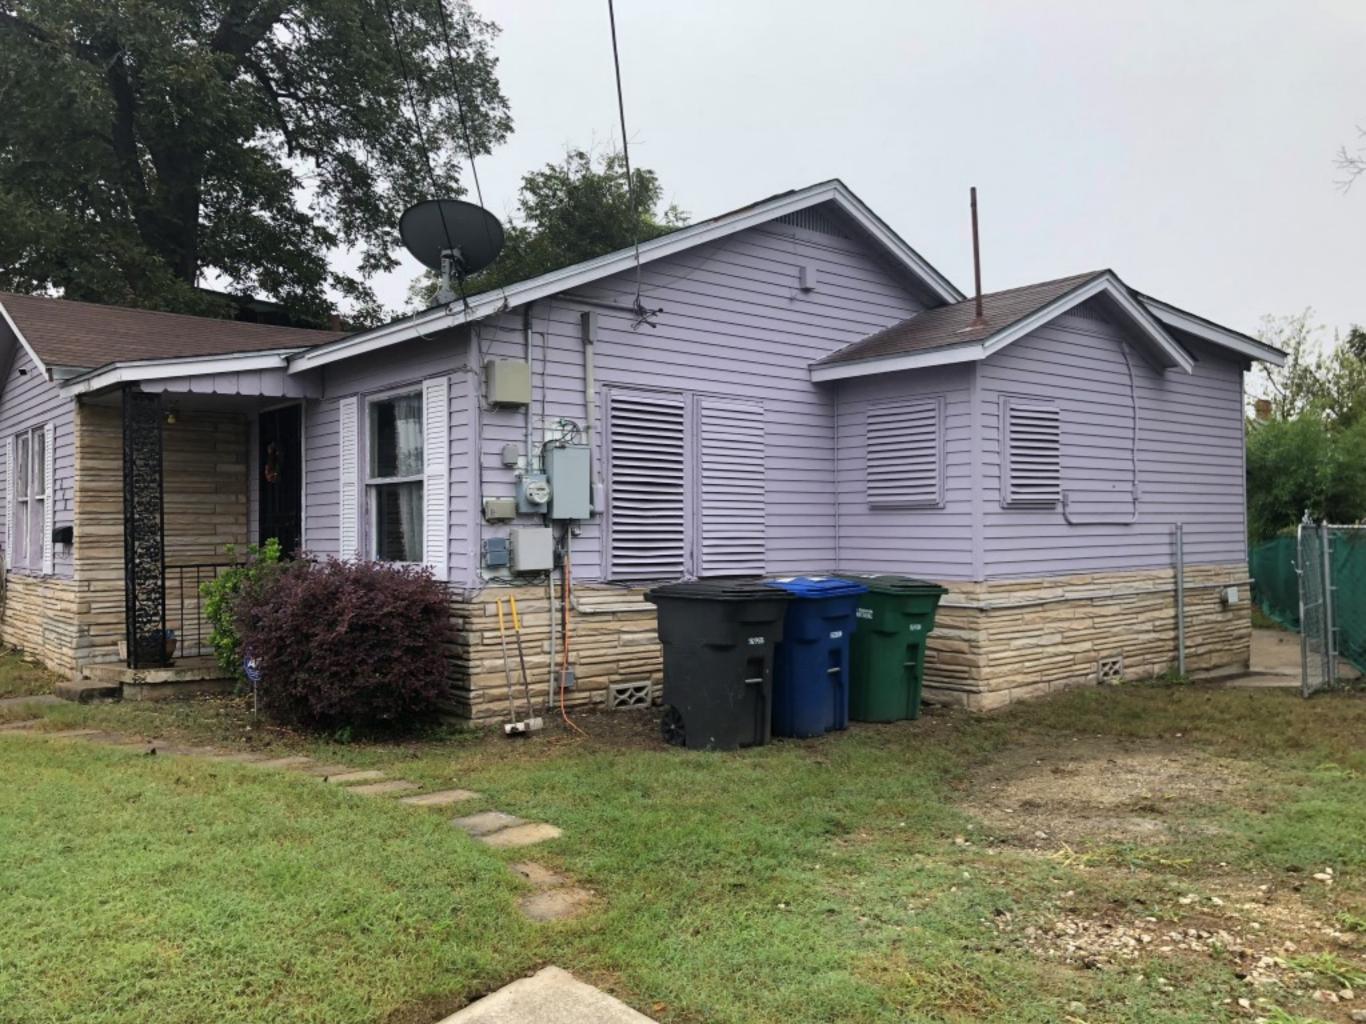
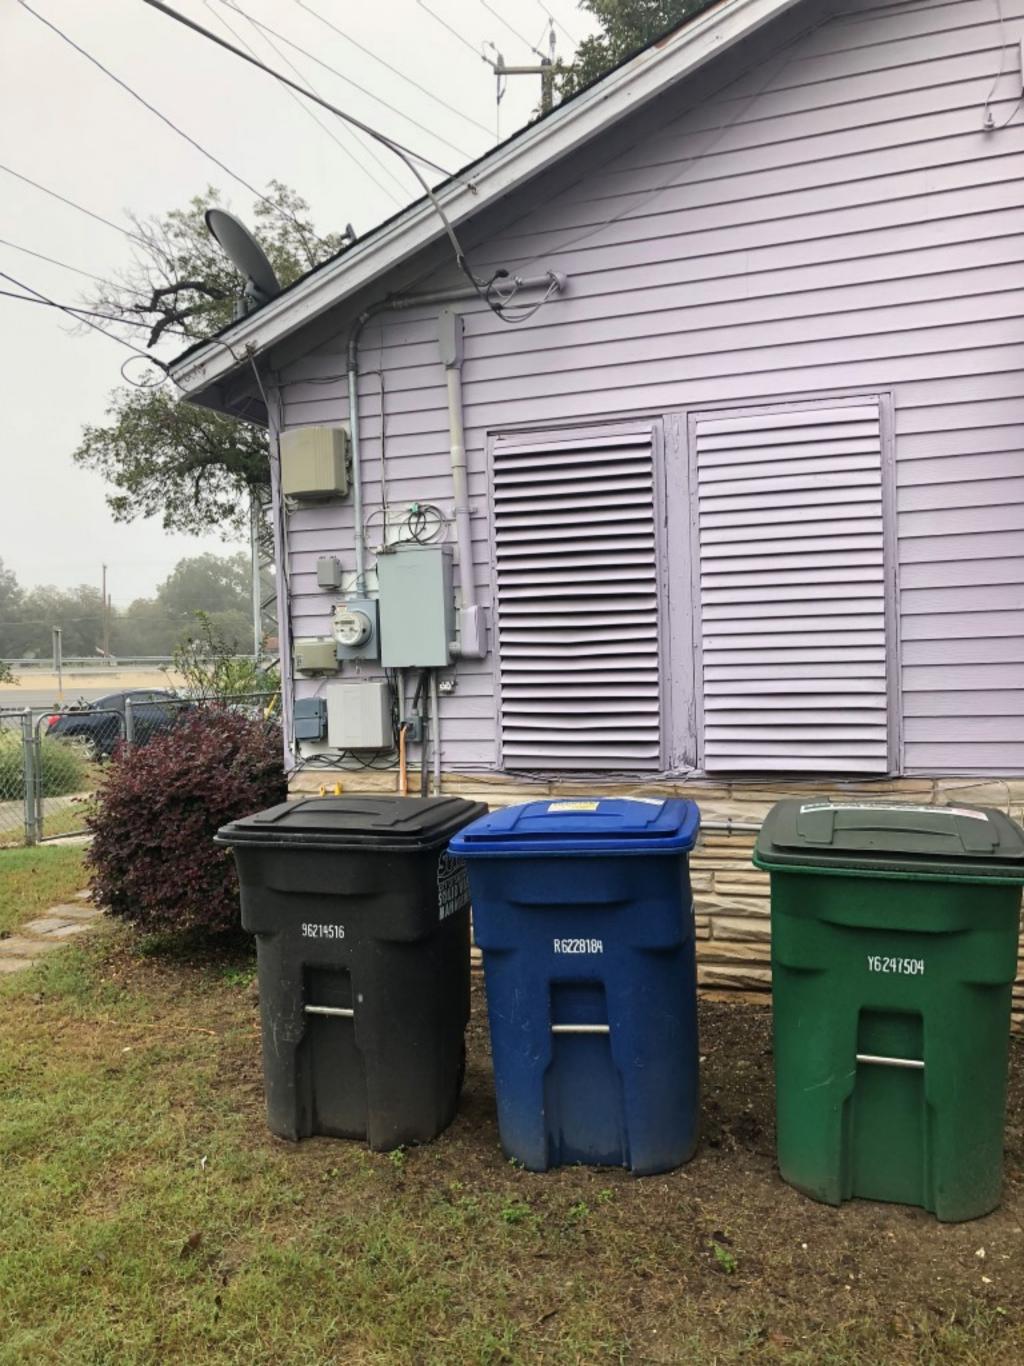
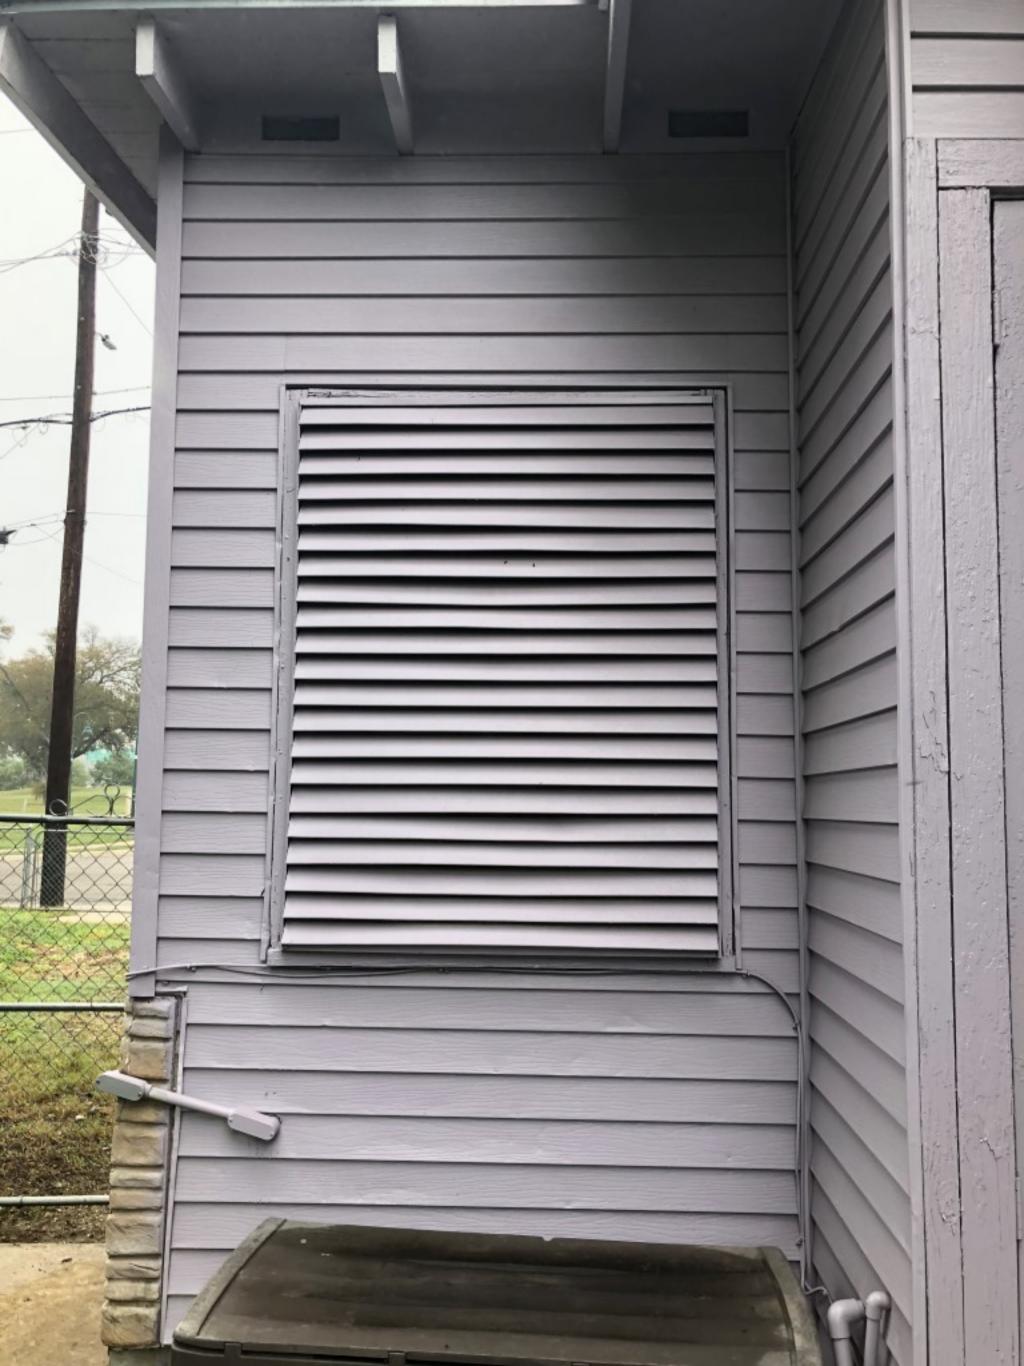
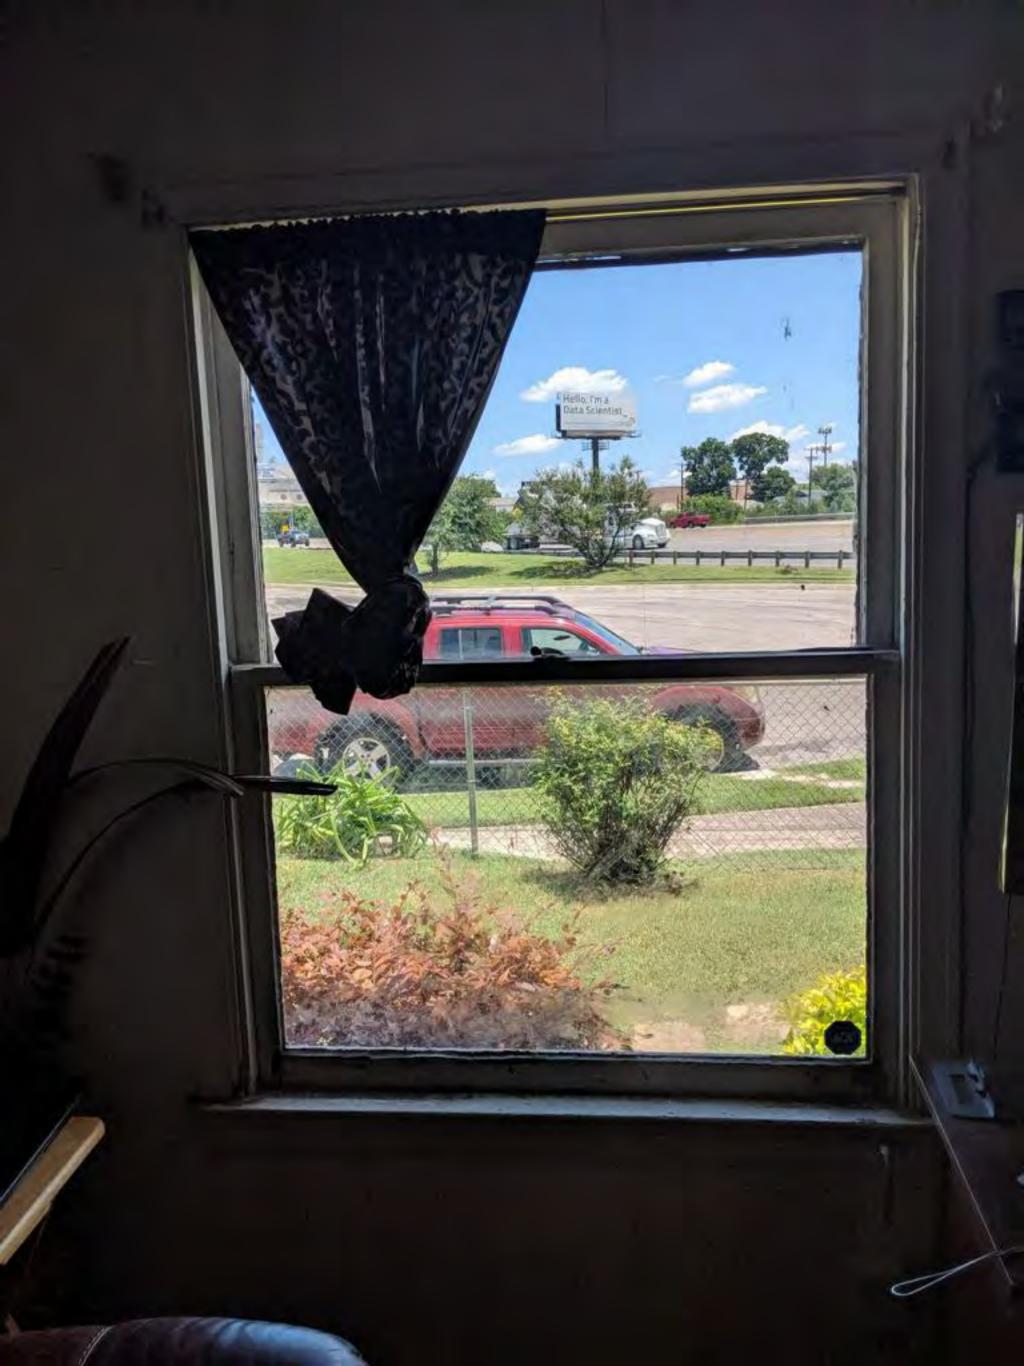
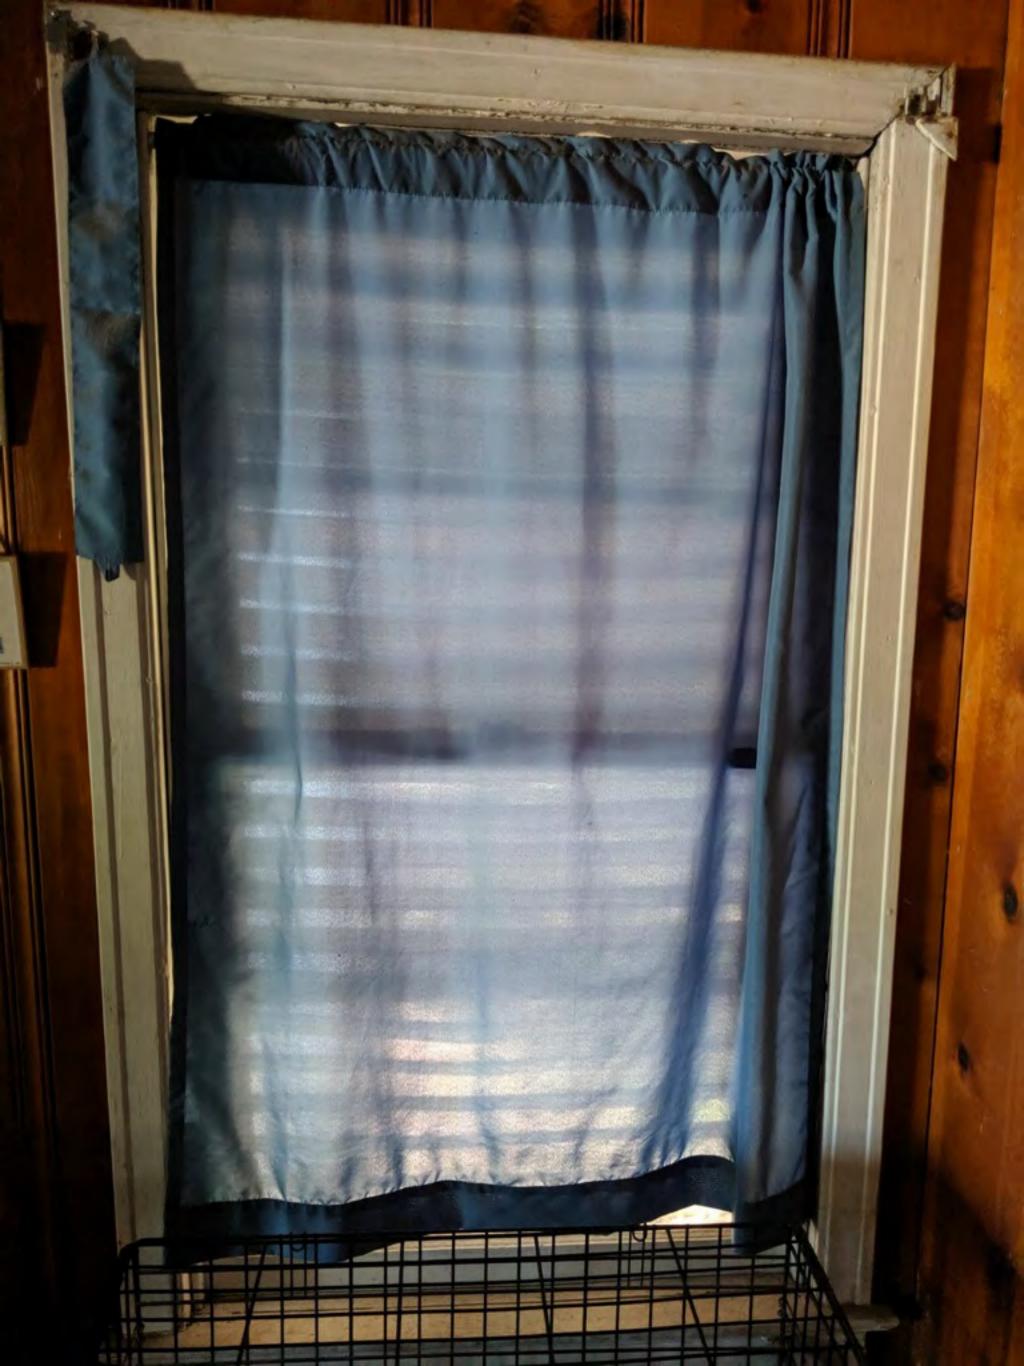
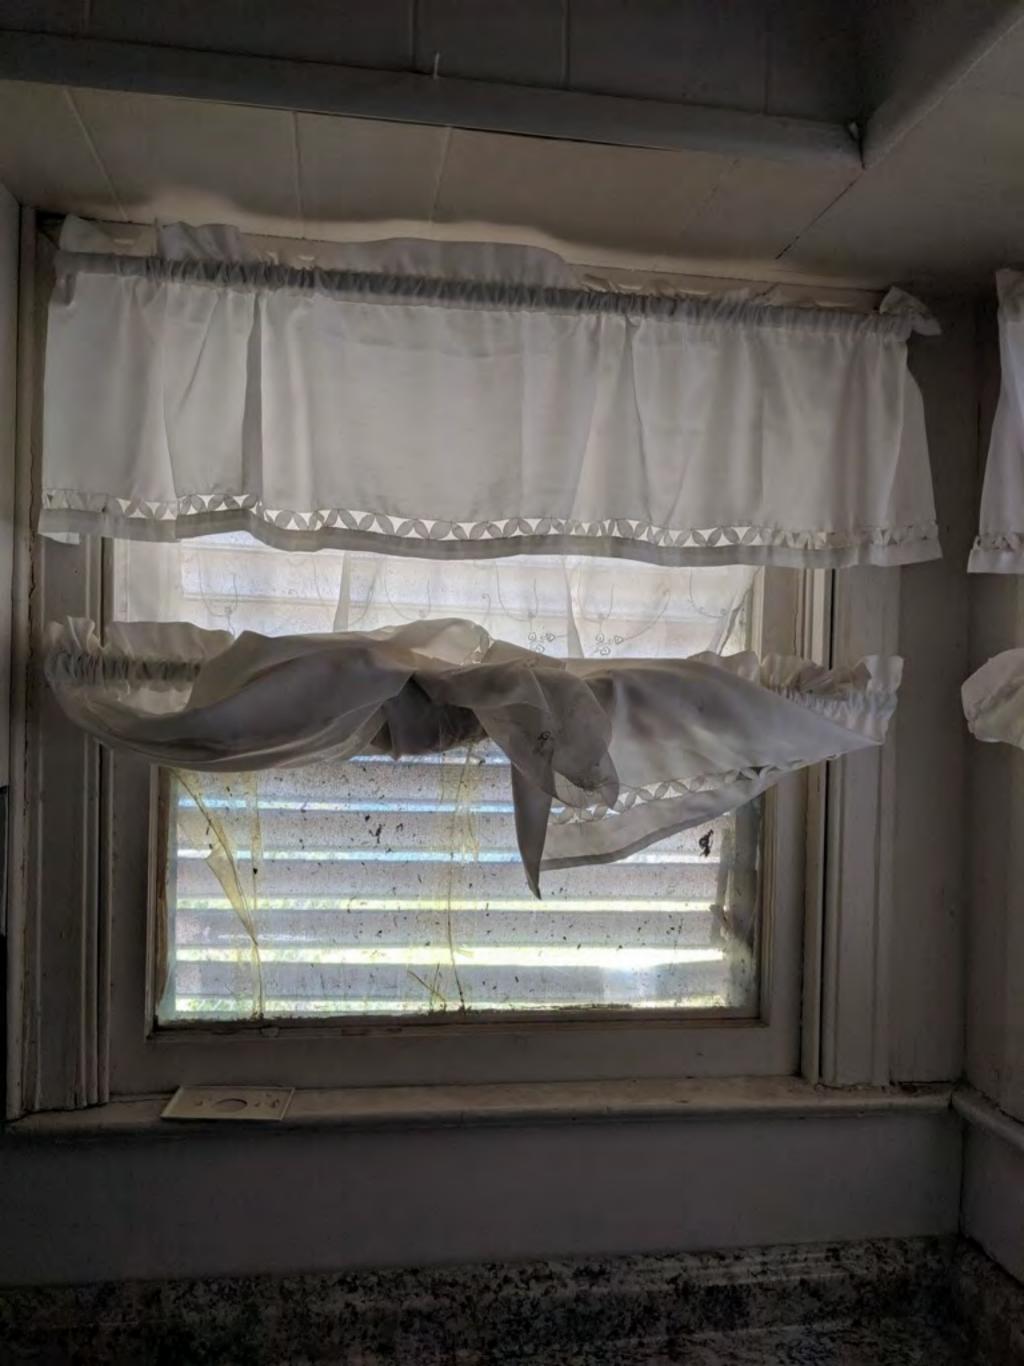
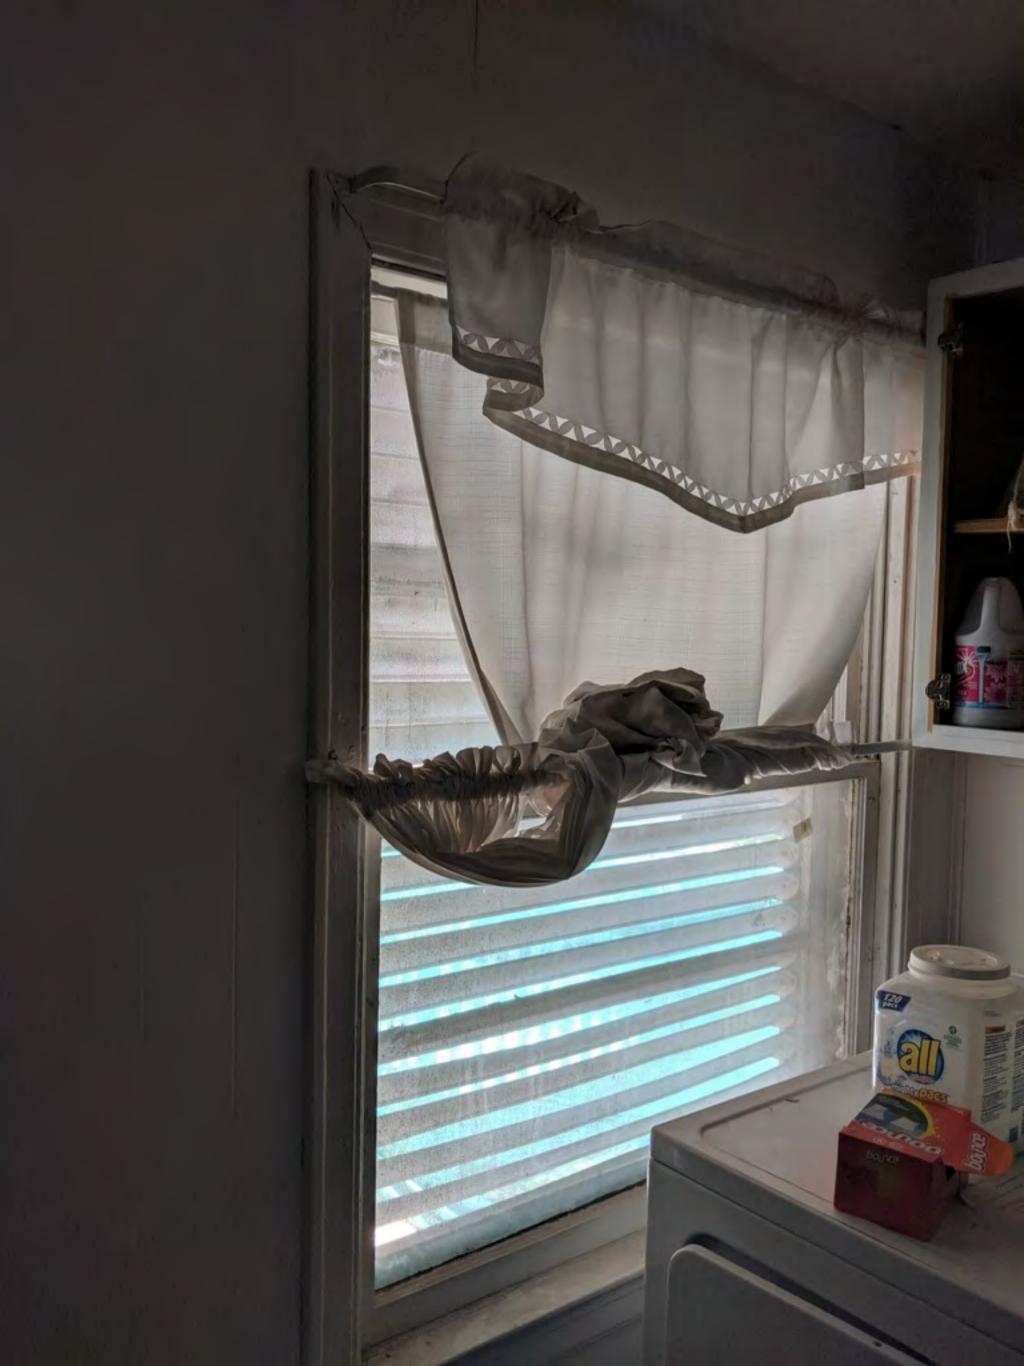
- b. EXISTING WINDOWS: CONDITON The applicant provided several photographs of the existing windows taken from outside the structures. Many of the windows feature exterior wood screens or louvers which have helped protect the window assemblies from ample sun exposure and other environmental factors. The applicant has noted that some of the windows are not operable, have broken or missing pulley cords, and are drafty. Based on the photographic evidence provided, staff finds that the windows are in good condition and are fully repairable.

- d. WINDOW REPLACEMENT According to the Guidelines for Exterior Maintenance and Alterations 6.A.iii., and 6.B.iv., in kind replacement of windows is only appropriate when the original windows are beyond repair. As noted in finding b, staff finds one window to be deteriorated beyond repair, but does not find the rest to be unrepairable. Replacement of any kind is not consistent with the Guidelines.

Staff does not recommend approval of the window replacement based on findings a through d. Staff recommends that the applicant repair the remaining existing wood windows in place. If there are assemblies that are deteriorated beyond repair, the applicant must submit evidence to that effect to staff in the form of an updated window schedule and photographs.
