## HISTORIC AND DESIGN REVIEW COMMISSION

**HDRC CASE NO:** 2019-336  
**ADDRESS:** 405 GILLESPIE  
**LEGAL DESCRIPTION:** NCB 1745 BLK 8 LOT S 51.5 FT OF N 103 FT OF 5 E IRR 7FT OF MID PART OF 5 & 6  
**ZONING:** R-6, H  
**CITY COUNCIL DIST.:** 1  
**DISTRICT:** Tobin Hill Historic District  
**APPLICANT:** Jake Forshpan/FORSHPAN JAKE B & FORSHPAN SHARON K  
**OWNER:** Jake Forshpan/FORSHPAN JAKE B & FORSHPAN SHARON K  
**TYPE OF WORK:** Side porch modifications  
**APPLICATION RECEIVED:** June 03, 2019  
**60-DAY REVIEW:** August 02, 2019  
**CASE MANAGER:** Huy Pham

The applicant is requesting a Certificate of Appropriateness for approval to remove the existing side porch to reconstruct a new enclosed side porch with similar architectural details.

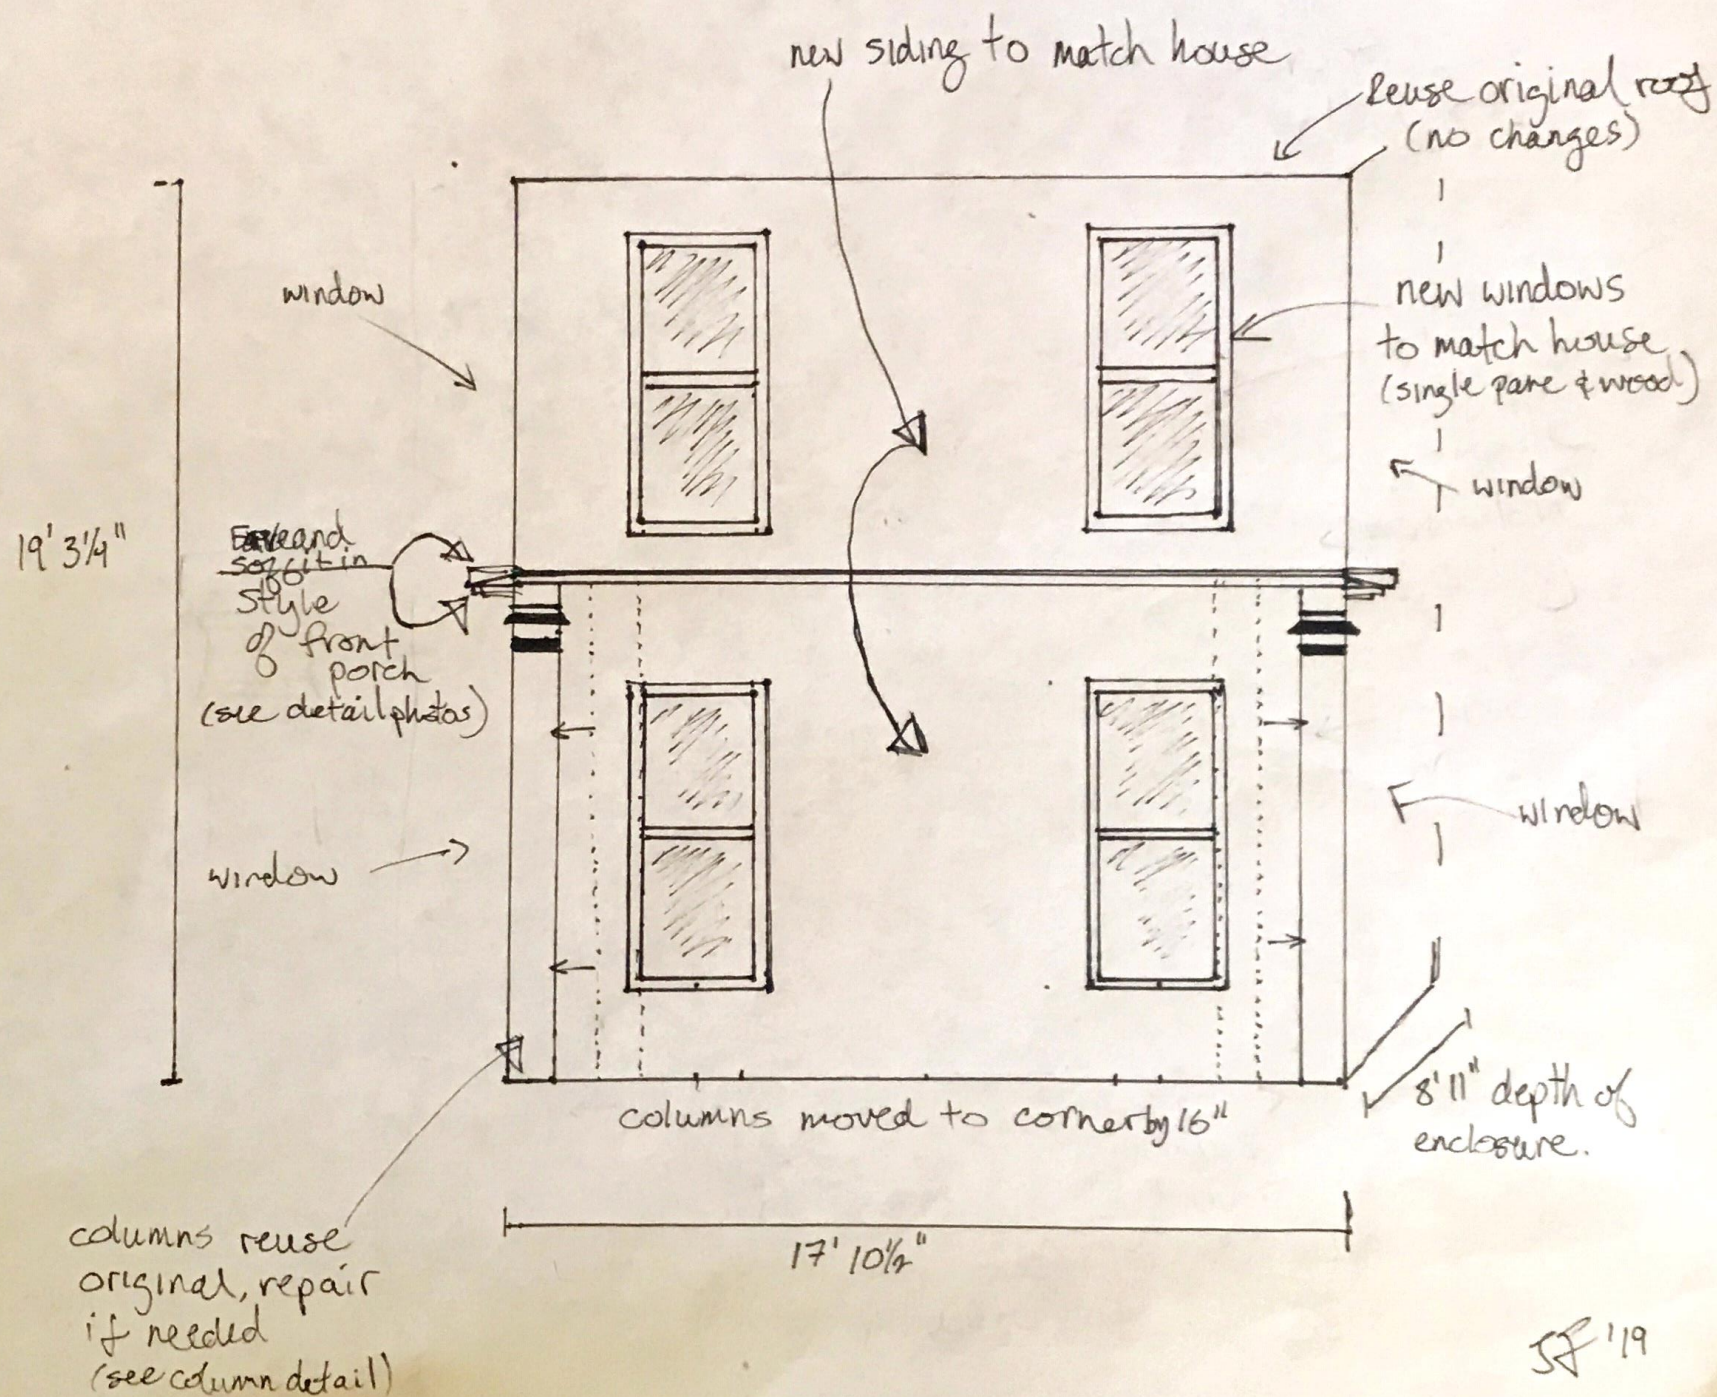
## Design elevation

originals collumns moved  
to corners (16") post added  
inside for structural support  
(See collumn detail)

1st floor footprint to  
match 2nd floor

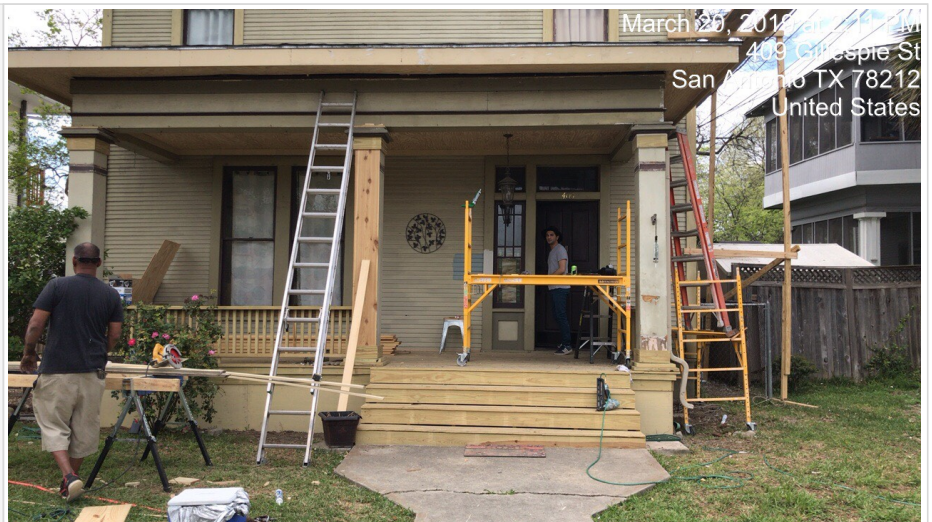
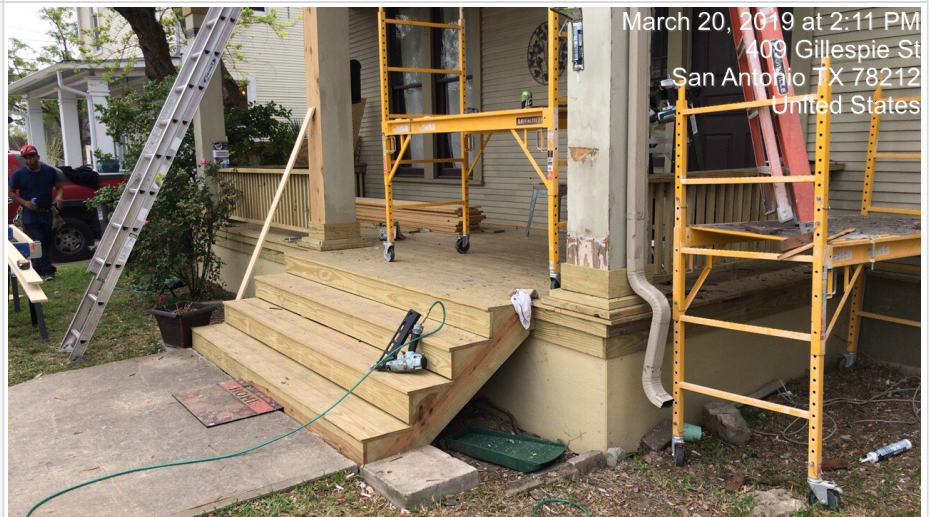
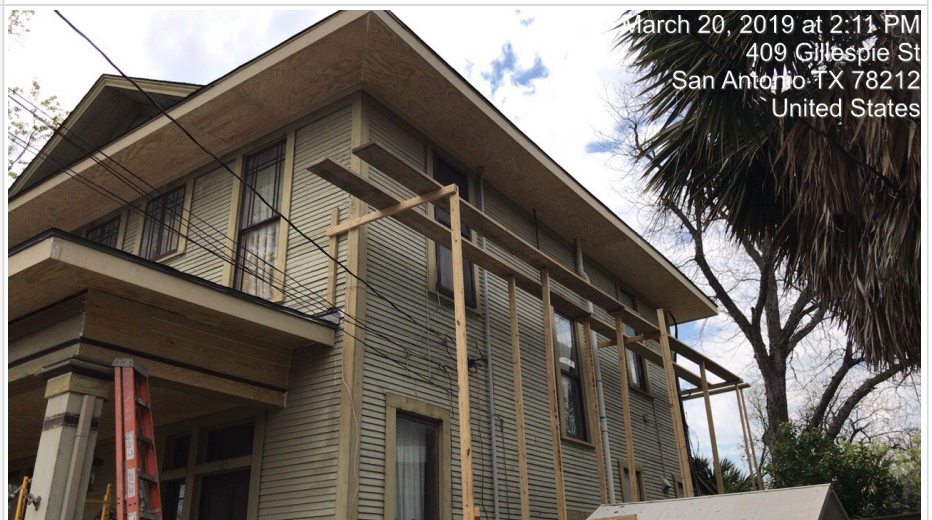
Date	03/20/2019
Time	02:10 PM (-5 GMT)
Context	citizen report
Present Staff	Edward Hall
Present Individuals	Homeowner, Contractor(s)
Types of Work Observed	Exterior Maintenance and Alterations
Amount of Work Completed	75%
Description of work	The scope of work included repair and maintenance with in-kind materials. Areas of work included porch railing repair, column repair, trim repair, window sill repair, and other exterior elements.
Description of interaction	The home owner noted that he would apply for an Admin COA by the morning of Thursday, March 21.

Violation Type	No Certificate of Appropriateness (Code 35-451a)
OHP Action	Spoke with property owner, Spoke with contractor(s), No Action Taken/Photos Only
Other field notes	The work, as best determined, was being done in kind. The contractors were allowed to continue to caulk replaced wood elements. The property owner will apply for an Admin COA by the morning of March 21, 2019.
Will post-work application fee apply?	No
