HISTORIC AND DESIGN REVIEW COMMISSION

July 17, 2019

HDRC CASE NO: 2019-383
ADDRESS: 322 W ELSMERE PLACE
LEGAL DESCRIPTION: NCB 3967 BLK 2 LOT 6
ZONING: R-5,H
CITY COUNCIL DIST.: 1
DISTRICT: Monte Vista Historic District
APPLICANT: Peter B. and Julie A. Nyren
OWNER: Peter B. and Julie A. Nyren
TYPE OF WORK: Historic Tax Certification
APPLICATION RECEIVED: July 03, 2019
60-DAY REVIEW: September 01, 2019
REQUEST:

Tax Certification & Tax Verification for Historic District Home for **322 W Elsmere Pl, San Antonio, TX, 78212**

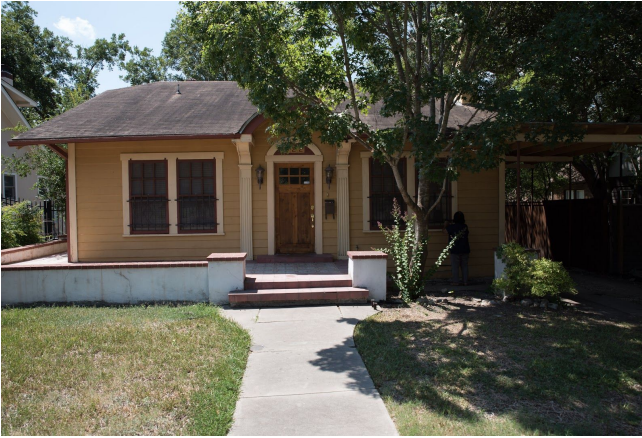
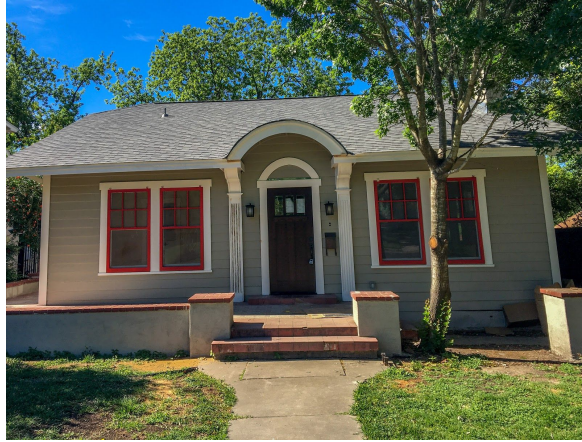
New roof, repairs to rotted eaves, new paint

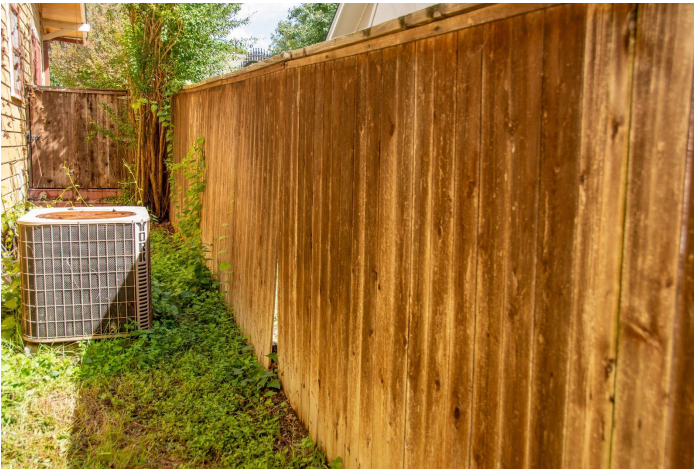
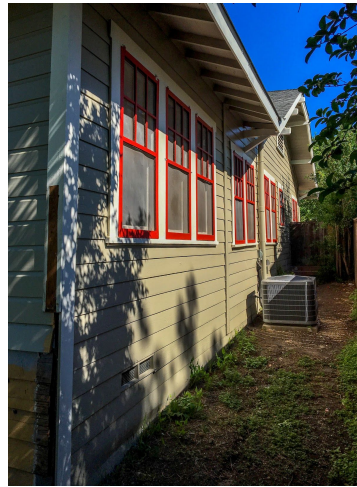
New HVAC system

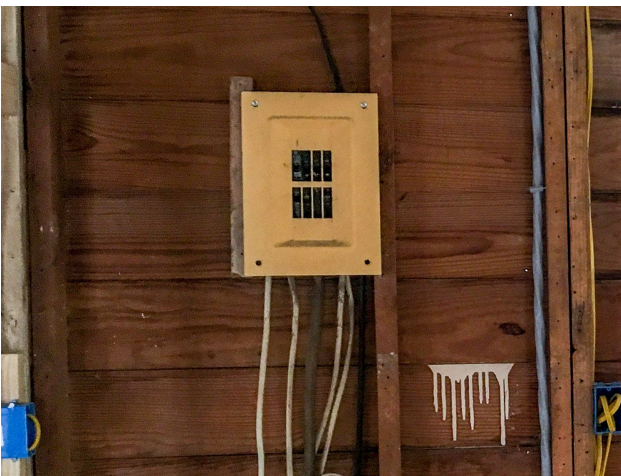
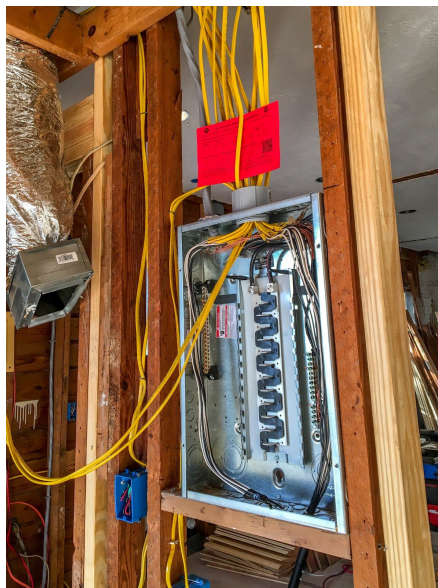
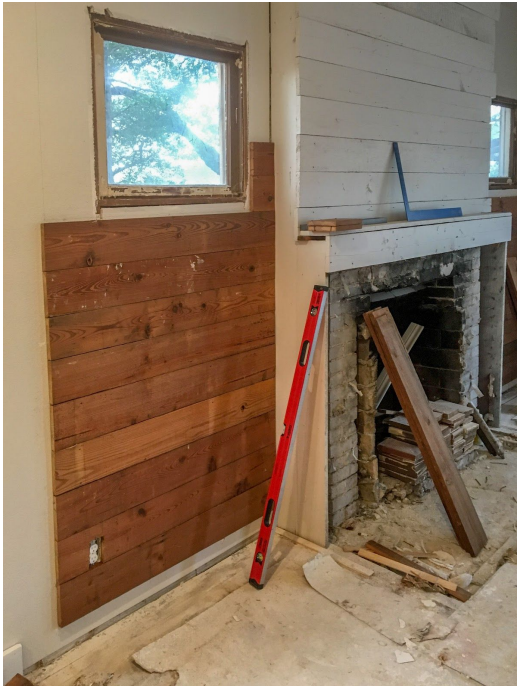
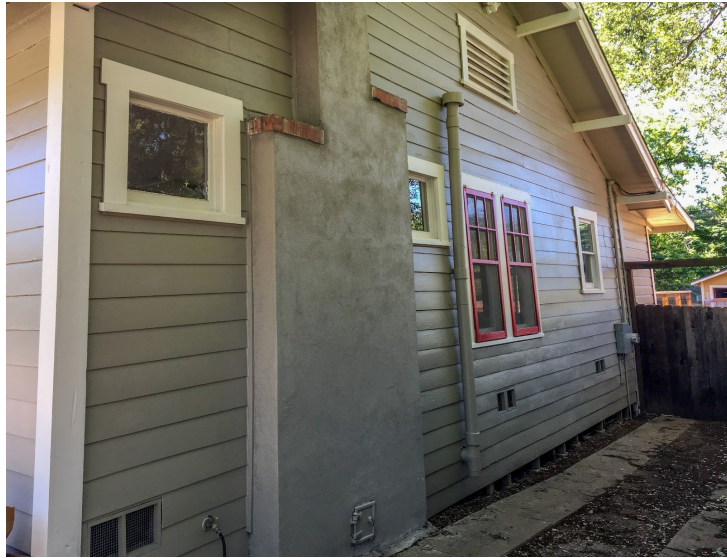
Complete new Electrical System

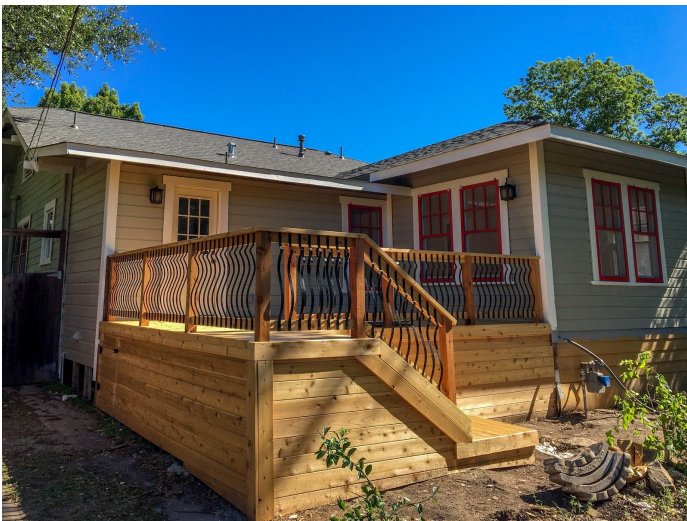
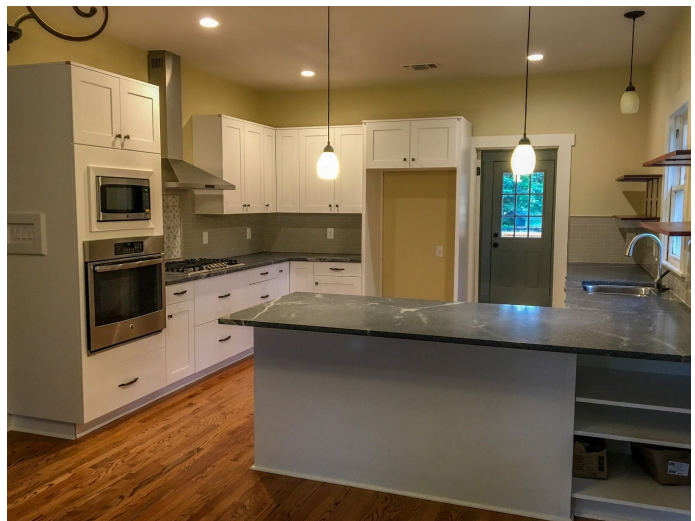
New Deck, all rotted siding replaced, new kitchen and baths
