HISTORIC AND DESIGN REVIEW COMMISSION

July 17, 2019

HDRC CASE NO: 2019-363
ADDRESS: 405 GILLESPIE
LEGAL DESCRIPTION: NCB 1745 BLK 8 LOT S 51.5 FT OF N 103 FT OF 5 E IRR 7FT OF MID PART OF 5 & 6
ZONING: R-6
CITY COUNCIL DIST.: 1
DISTRICT: Tobin Hill Historic District
APPLICANT: Jake Forshpan/FORSHPAN JAKE B & FORSHPAN SHARON K
OWNER: Jake Forshpan/FORSHPAN JAKE B & FORSHPAN SHARON K
TYPE OF WORK: Modifications to side porch
APPLICATION RECEIVED: June 26, 2019
60-DAY REVIEW: August 25, 2019
CASE MANAGER: Huy Pham

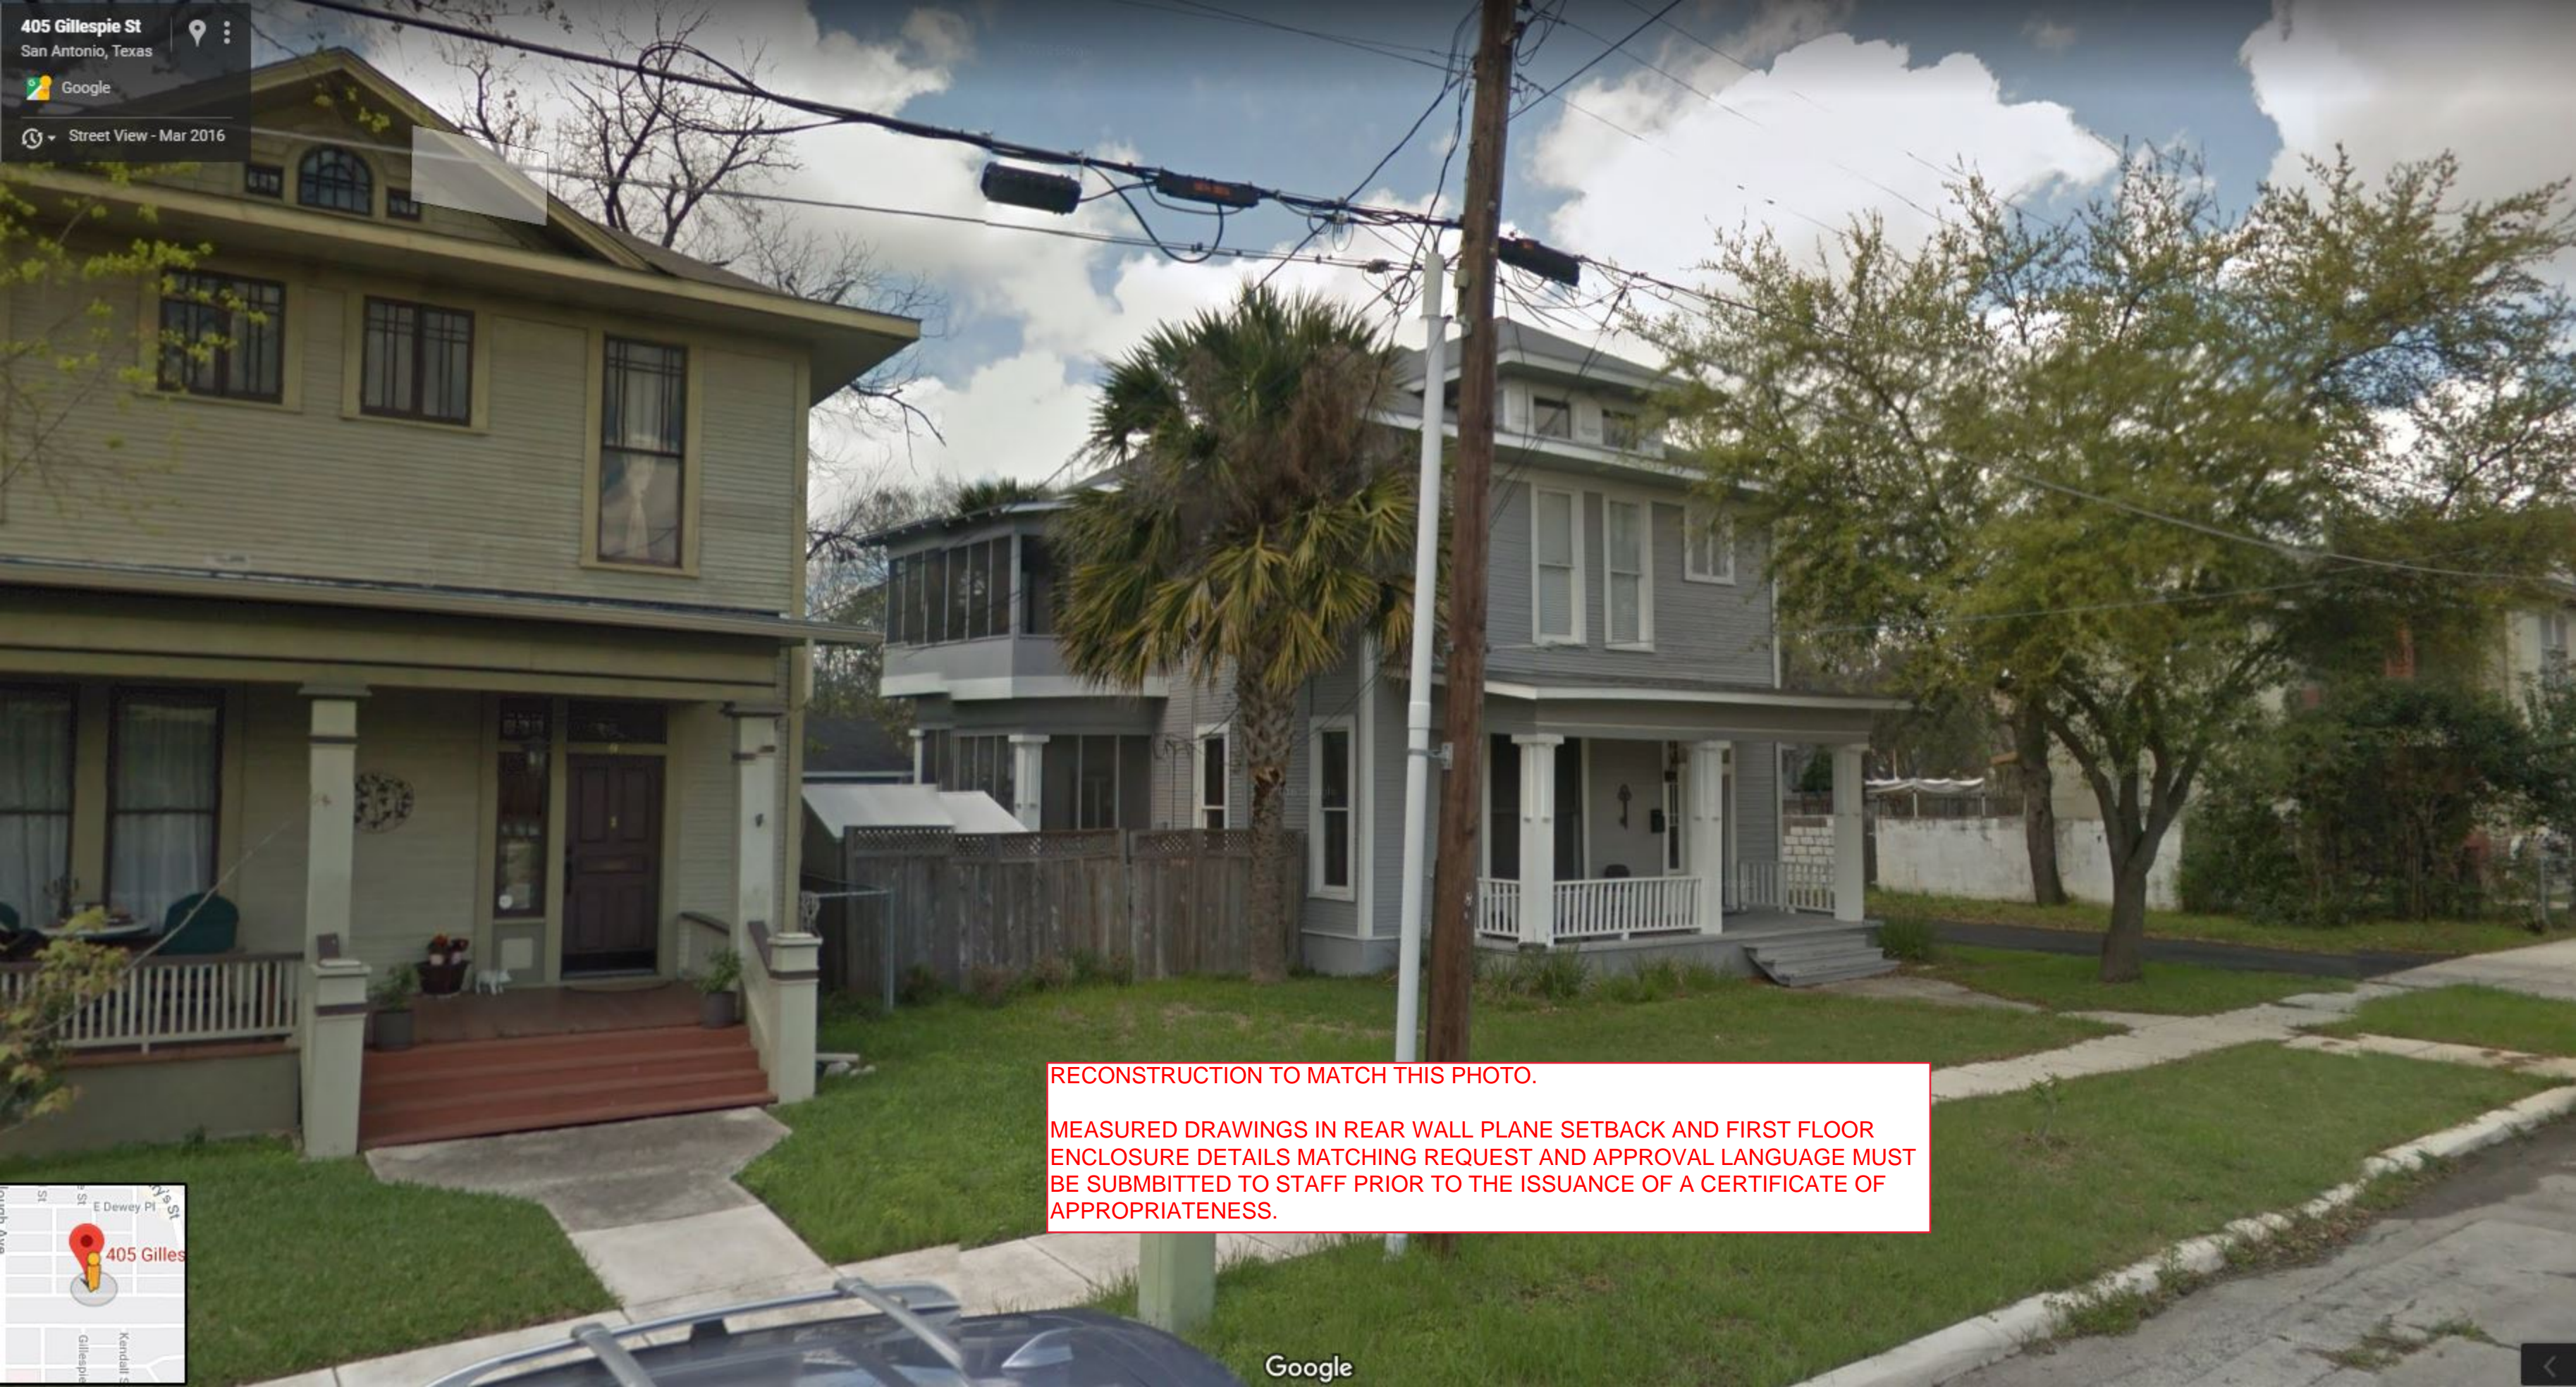
405 Gillespie St
San Antonio, Texas

RECONSTRUCTION TO MATCH THIS PHOTO.

MEASURED DRAWINGS IN REAR WALL PLANE SETBACK AND FIRST FLOOR ENCLOSURE DETAILS MATCHING REQUEST AND APPROVAL LANGUAGE MUST BE SUBMITTED TO STAFF PRIOR TO THE ISSUANCE OF A CERTIFICATE OF APPROPRIATENESS.

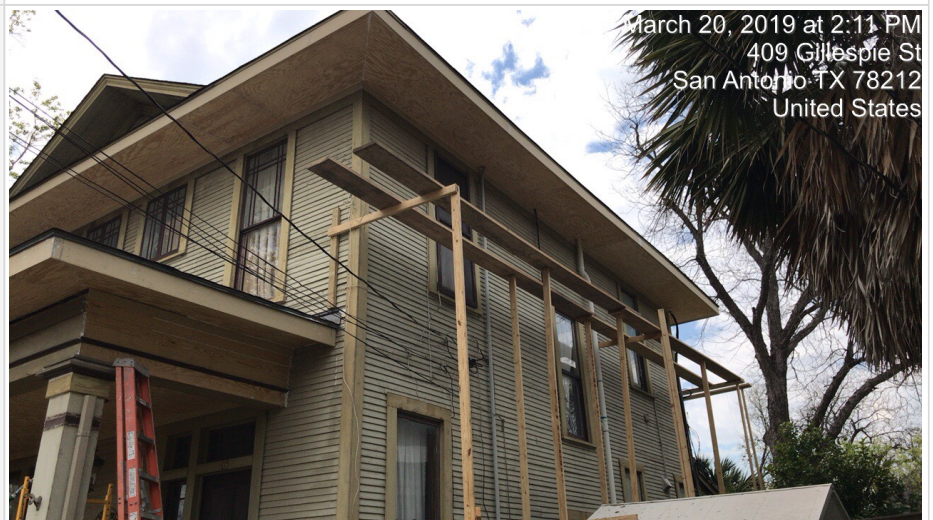
Date	03/20/2019
Time	02:10 PM (-5 GMT)
Context	citizen report
Present Staff	Edward Hall
Present Individuals	Homeowner, Contractor(s)
Types of Work Observed	Exterior Maintenance and Alterations
Amount of Work Completed	75%
Description of work	The scope of work included repair and maintenance with in-kind materials. Areas of work included porch railing repair, column repair, trim repair, window sill repair, and other exterior elements.
Description of interaction	The home owner noted that he would apply for an Admin COA by the morning of Thursday, March 21.

Violation Type	No Certificate of Appropriateness (Code 35-451a)
OHP Action	Spoke with property owner, Spoke with contractor(s), No Action Taken/Photos Only
Other field notes	The work, as best determined, was being done in kind. The contractors were allowed to continue to caulk replaced wood elements. The property owner will apply for an Admin COA by the morning of March 21, 2019.
Will post-work application fee apply?	No
