HISTORIC AND DESIGN REVIEW COMMISSION

July 17, 2019

HDRC CASE NO: 2019-343
ADDRESS: 414 DONALDSON AVE
LEGAL DESCRIPTION: NCB 1932 BLK 39 LOT 26 AND 27
ZONING: R-6,H
CITY COUNCIL DIST.: 7
DISTRICT: Monticello Park Historic District
APPLICANT: KKW Donaldson
OWNER: San Antonio San Antonio/KKW Donaldson
TYPE OF WORK: Window replacement, painting brick, replace siding
APPLICATION RECEIVED: May 22, 2019
60-DAY REVIEW: July 21, 2019
CASE MANAGER: Stephanie Phillips
REQUEST:

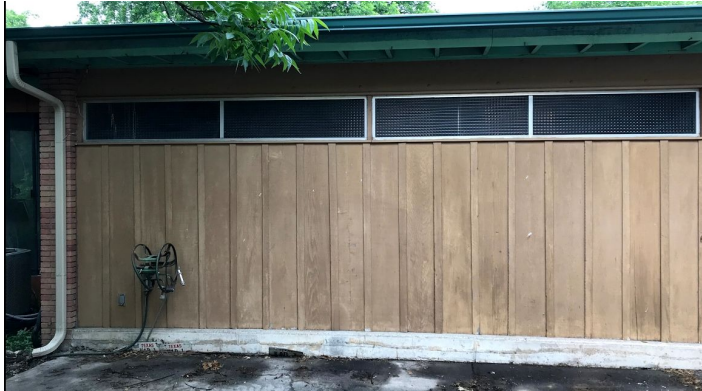
- b. **SIDING REPLACEMENT** – The applicant has proposed to replace approximately 20 feet of wooden board and batten siding with new Hardie siding to match the same configuration. The siding is located on a side façade and is not visible from the public right-of-way. The siding also appears to be an infill condition of a former garage. Based on the location and the minimal impact from the public right-of-way, staff finds the replacement appropriate.

At (1) exterior wall, existing siding is bowed, due to decay. Wall does not face street.

Item 1, Staff recommends approval of the siding replacement based on finding b.

Proposed product: HardiePanel Vertical Fiber Cement Siding, to match profile of existing siding.

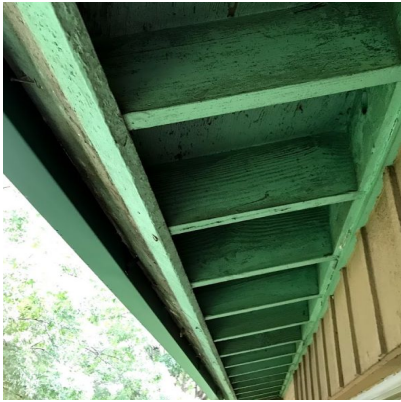
- c. **EAVE AND SOFFIT MODIFICATIONS** – The applicant has proposed to modify the existing eave and soffit details. The existing eaves are wood with an exposed rafter tail detail. The applicant has proposed to remove these details and install a cement board vented soffit. According to the Guidelines, existing details, including roof elements, should be retained. Staff does not find the proposal consistent with the Guidelines.

Roof line/trusses are exposed, not protected from moisture or pest.

Item 2, Staff does not recommend approval of the eave and soffit modifications based on finding c.

Proposed product: Hardie vented cement board, to allow for ventilation.

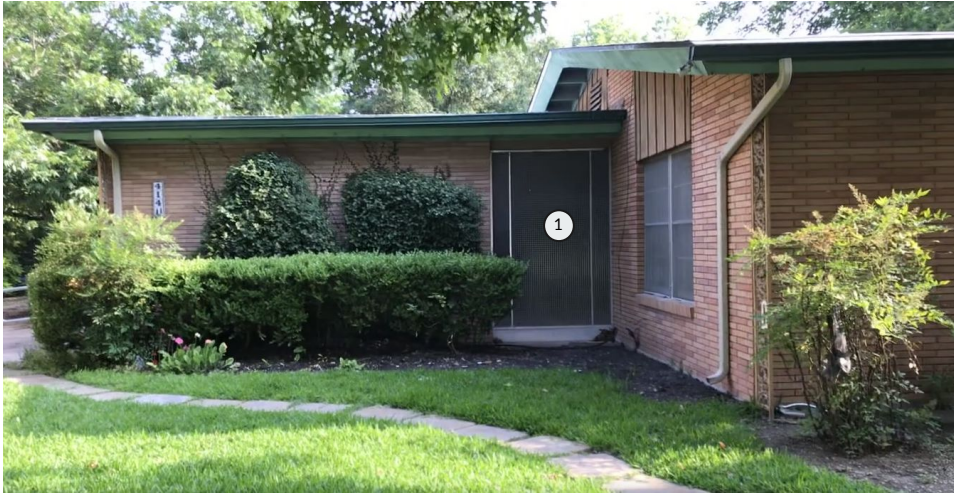
- d. **WINDOW REPLACEMENT** – The applicant has proposed to replace an existing rectangular aluminum picture window on the front façade with a new vinyl window. The new window will feature a modified size and be square in proportion. According to the Guidelines, when windows are deteriorated beyond repair and necessitate replacement, new windows should match the size, configuration, proportion, and detailing of the original. Staff generally finds that replacement is appropriate, but finds the proposed size modification to be inconsistent with the Guidelines. Staff finds that the existing opening size should be retained.

- ① Removal of (1) non-historic window to replace with windows that match the original windows as closely as possible in material and design. The existing window appears to have been installed in the early 1980s during a garage conversion, is a metal aluminium frame and heavily corroded, and does not match the appearance of the other 1950s era windows. No structural modifications required.

Item 3, Staff recommends approval of the window replacement based on finding d with the following stipulation:

- i. That the window size matches the existing opening and configuration. The applicant is required to submit an updated window specification to staff with dimensions for review and approval.

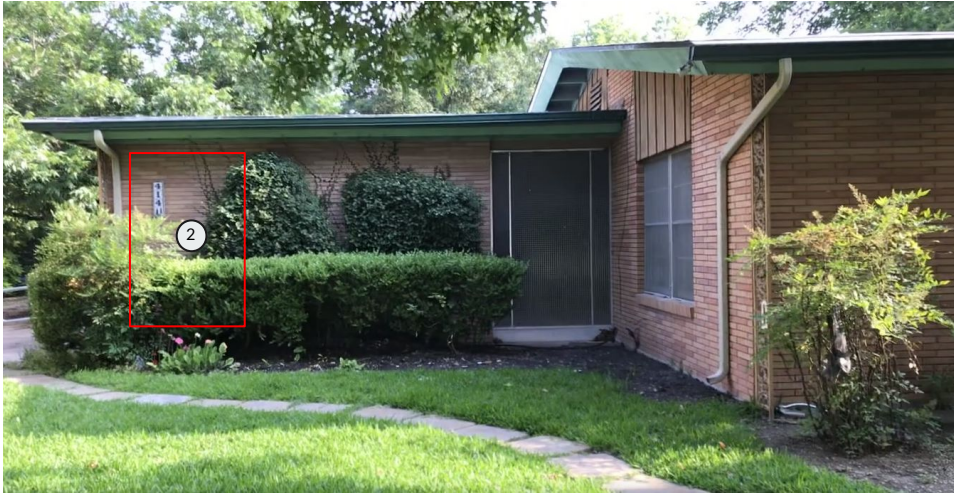
- e. WINDOW INSTALLATION – The applicant has proposed to install a new window on the front façade. The window is to match the size, material, and configuration of the proposed replacement window noted in finding d. The new window will be visible from the public right-of-way. Staff generally finds the location appropriate, but does not find a square window to be appropriate. Staff finds that a rectangular window that matches the existing size of the adjacent window in finding d be installed to add balance and maintain the original proportionality of the windows.

- ② Add (1) window to balance out the exterior elevation. Currently, the existing window is asymmetrical. See next page of view of entire facade

Item 4, Staff recommends approval of the installation of a new window opening on the front façade based on finding e with the following stipulation:

- i. That the window size matches the existing opening on the front façade as noted in finding d. The applicant is required to submit an updated window specification to staff with dimensions for review and approval.

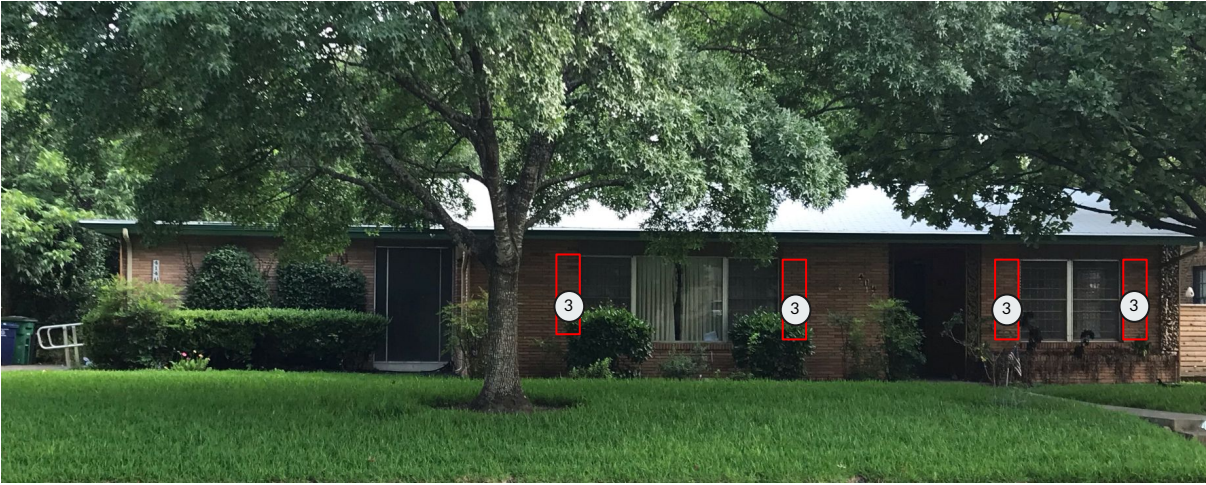
- f. SHUTTERS – The applicant has proposed to install shaker-style shutters on the existing front windows on the home. The applicant has not provided detailed specifications, but has provided a photo example of the shutter style and has indicated proposed locations. According to the Historic Design Guidelines, shutters should only be incorporated where they existed historically and where appropriate to the architectural style of the house. Shutters should match the height and width of the opening and be mounted to be operational or appear to be operational. Traditionally in San Antonio, Minimal Traditional homes of this era did not feature shutters. The configuration of the front façade windows does not allow for the space for proportionately appropriate shutters. The installation of shutters is not stylistically, functionally, or historically appropriate.

Decorative shutters are consistent with the district characteristics

Item 5, Staff does not recommend approval of the shutter installation based on finding f.
