HISTORIC AND DESIGN REVIEW COMMISSION

HDRC CASE NO: 2019-427
ADDRESS: 519 S PRESA ST
LEGAL DESCRIPTION: NCB 902 BLK LOT 24 AT 724 ST MARY'S
ZONING: IDZ,HL
CITY COUNCIL DIST.: 1
DISTRICT: Lavaca Historic District
APPLICANT: Rebekah Perez/Work5hop
OWNER: WONG WAY LLC
TYPE OF WORK: Reconstruction of 1-story front porch with extension
APPLICATION RECEIVED: July 17, 2019
60-DAY REVIEW: September 15, 2019
CASE MANAGER: Stephanie Phillips
REQUEST:

519 South Presa St. Repair

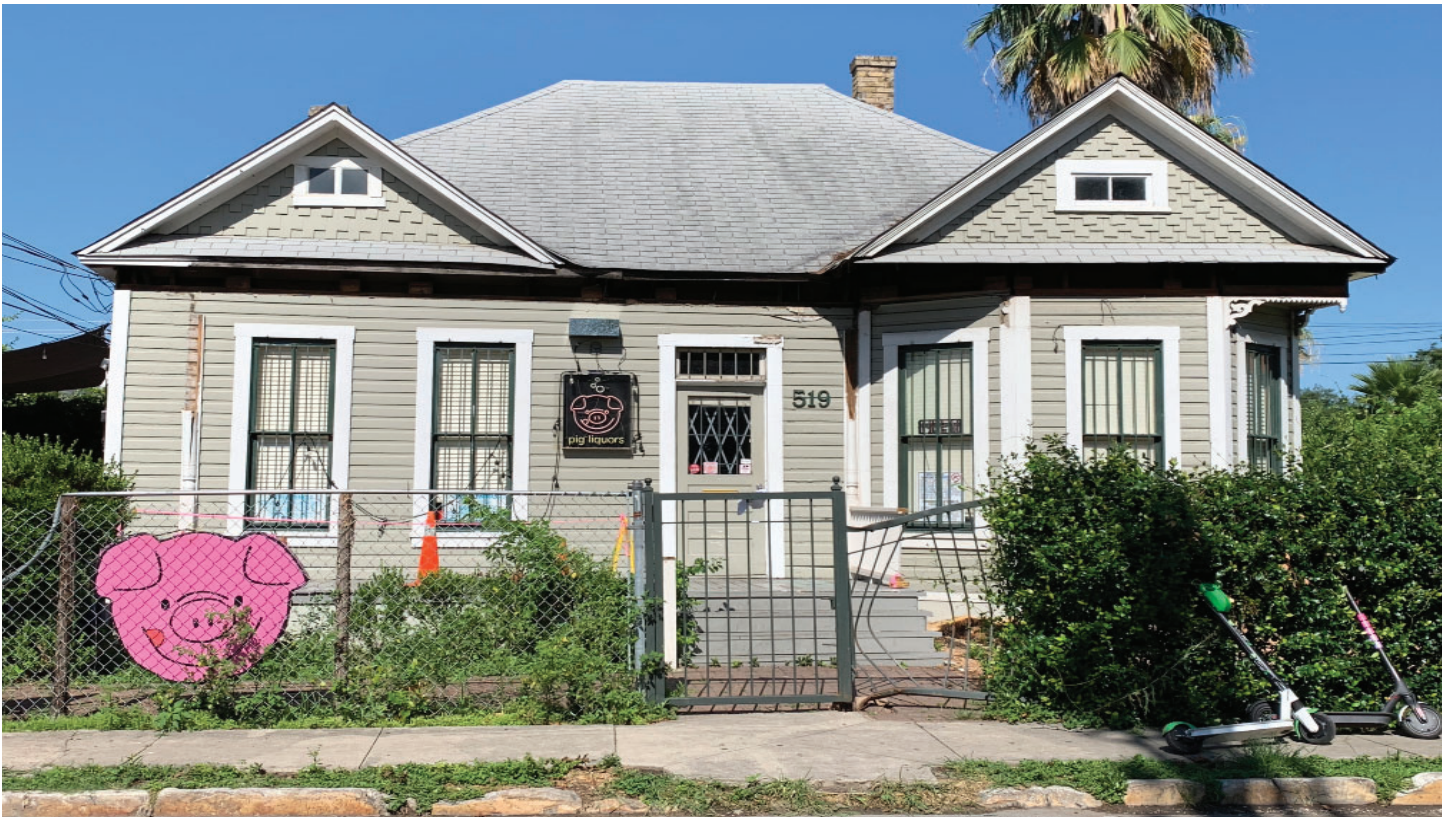
South Elevation

- d. STAIRCASE – The applicant has proposed to add a second porch staircase to the south (side) elevation of the primary structure. A roofline extension will not be required on this portion. According to the Guidelines, new porch elements, such as stairs, should be simple in design and should not detract from the character defining features. Staff finds this request appropriate.

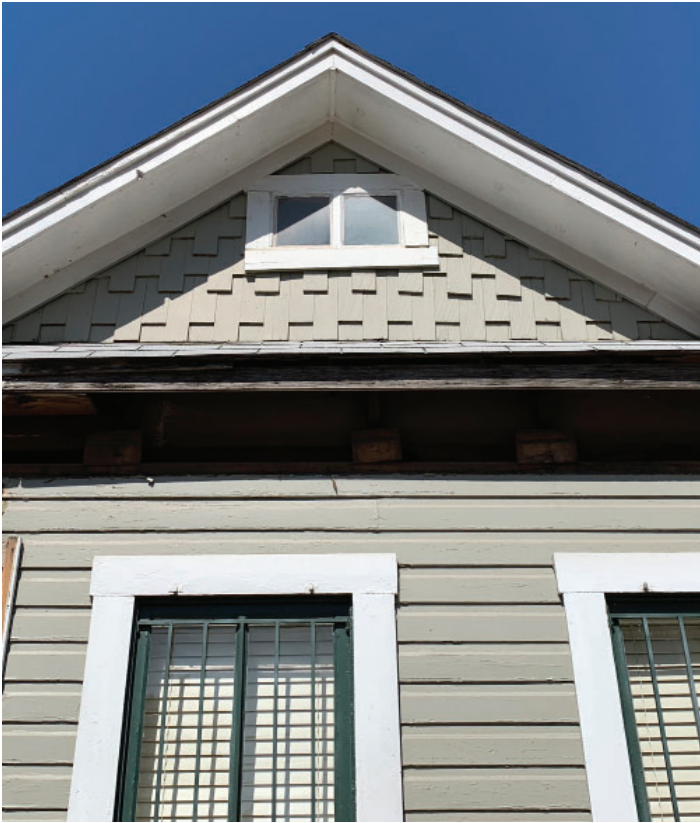
Damaged fascia & soffit

Fascia board & Soffit: Damaged areas to be replaced with fascia & soffit matching historic cornice.

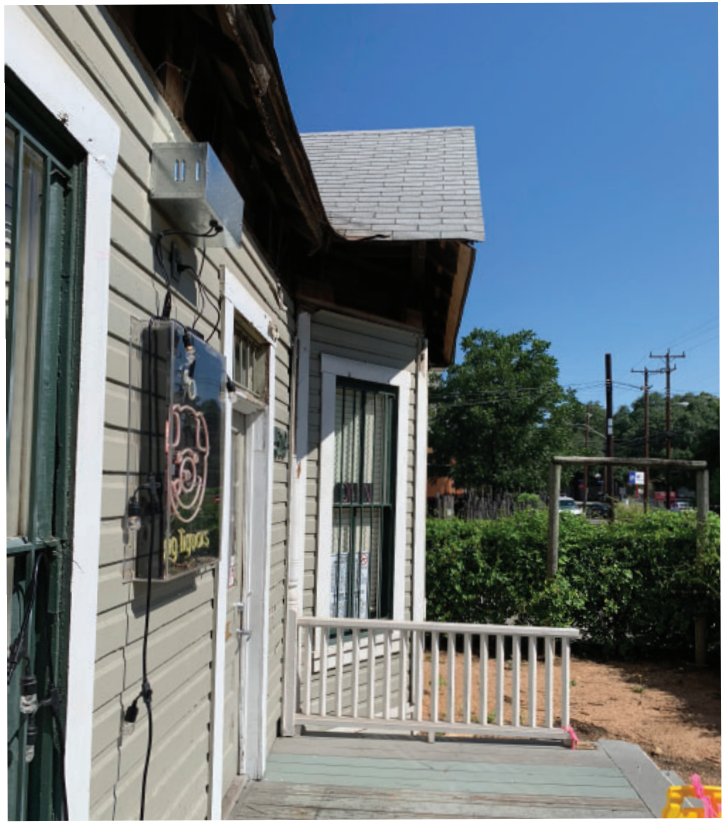
Porch roof and columns damaged and removed

Columns: Wood columns to replace damaged units. Pre-primed pine columns will match historic units as closely as possible.

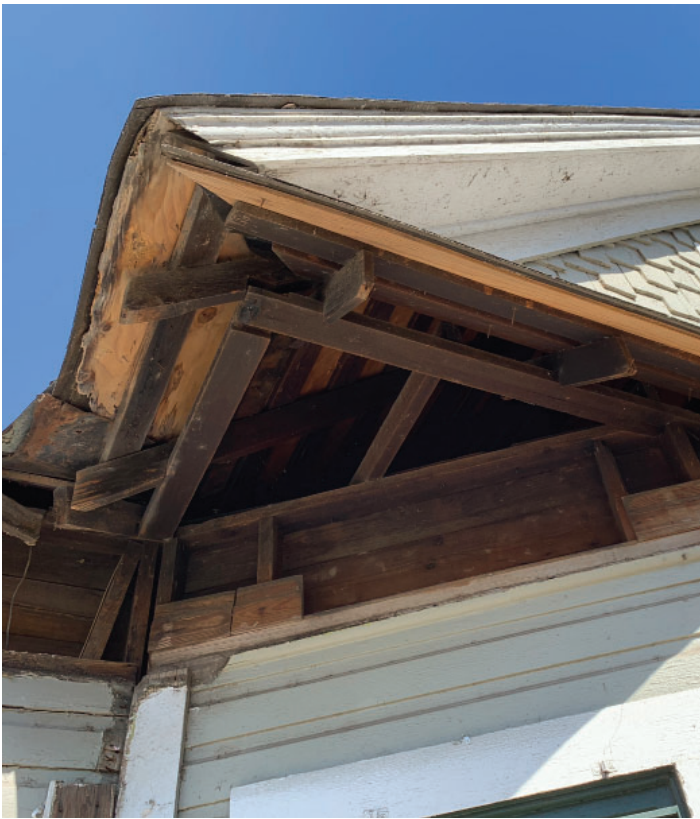
Damaged fascia, soffit, trim, freize boards, decorative running trim

Decorative Trim: Running trim to match historic trim as closely as possible.

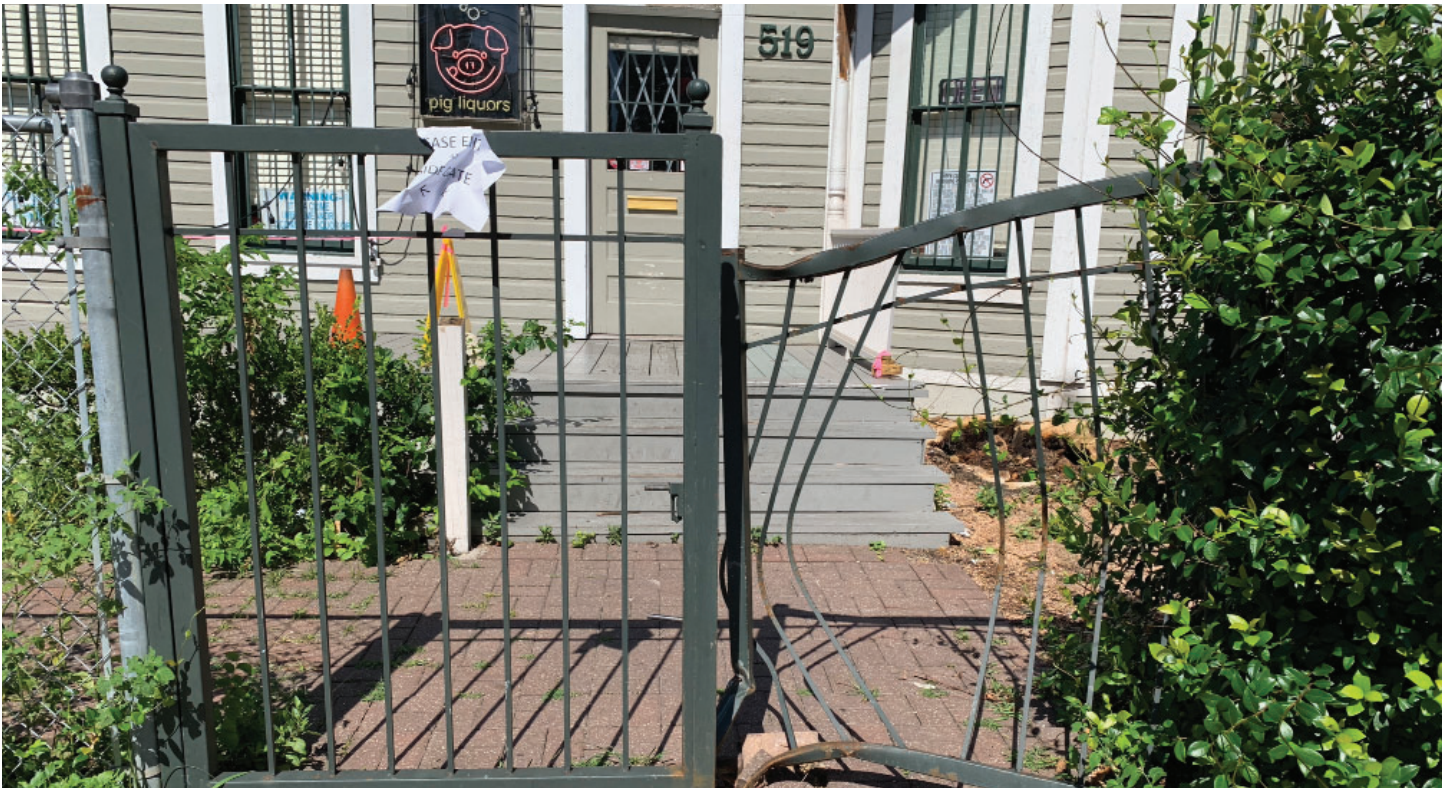
Damaged iron fence & gate

A recent storm damaged a large tree on the near east side of the building. The damage caused the tree to fall on top of the existing front porch roof, destroying the roof structure, columns, railing, fascia, soffit, and decorative wood trim, as well as a portion of the iron gate and fence near the street.
