# HISTORIC AND DESIGN REVIEW COMMISSION

**HDRC CASE NO:** 2019-431  
**ADDRESS:** 2026 W GRAMERCY PLACE  
**LEGAL DESCRIPTION:** NCB 1933 BLK 31 LOT 22  
**ZONING:** R-6,H  
**CITY COUNCIL DIST.:** 7  
**DISTRICT:** Monticello Park Historic District  
**TYPE OF WORK:** Window replacement, fenestration modifications, exterior modifications  
**APPLICATION RECEIVED:** July 22, 2019  
**60-DAY REVIEW:** September 20, 2019  
**CASE MANAGER:** Stephanie Phillips  
**REQUEST:**

## Investigation Report

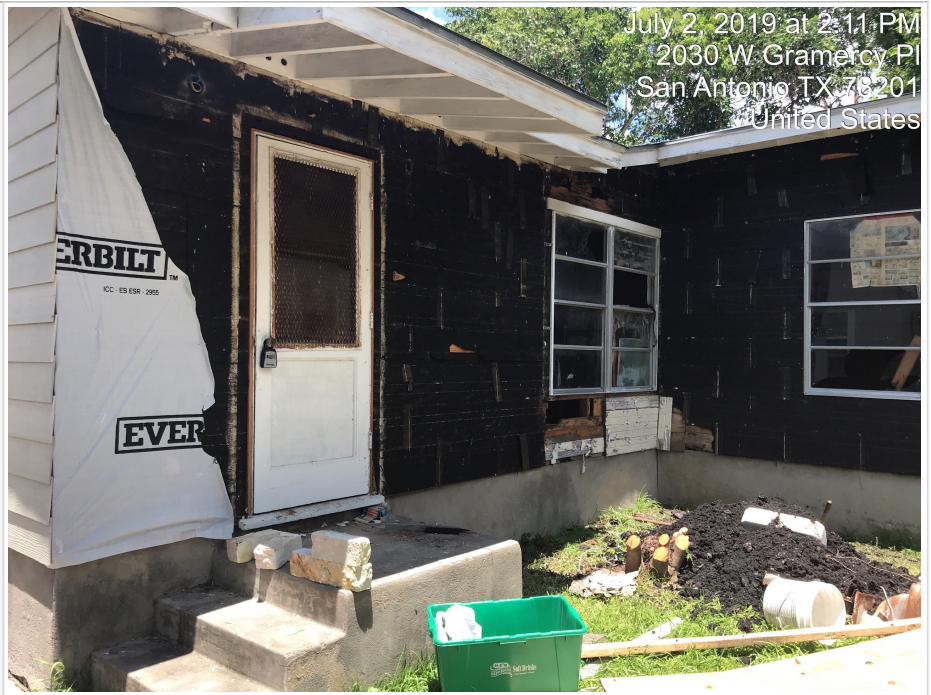
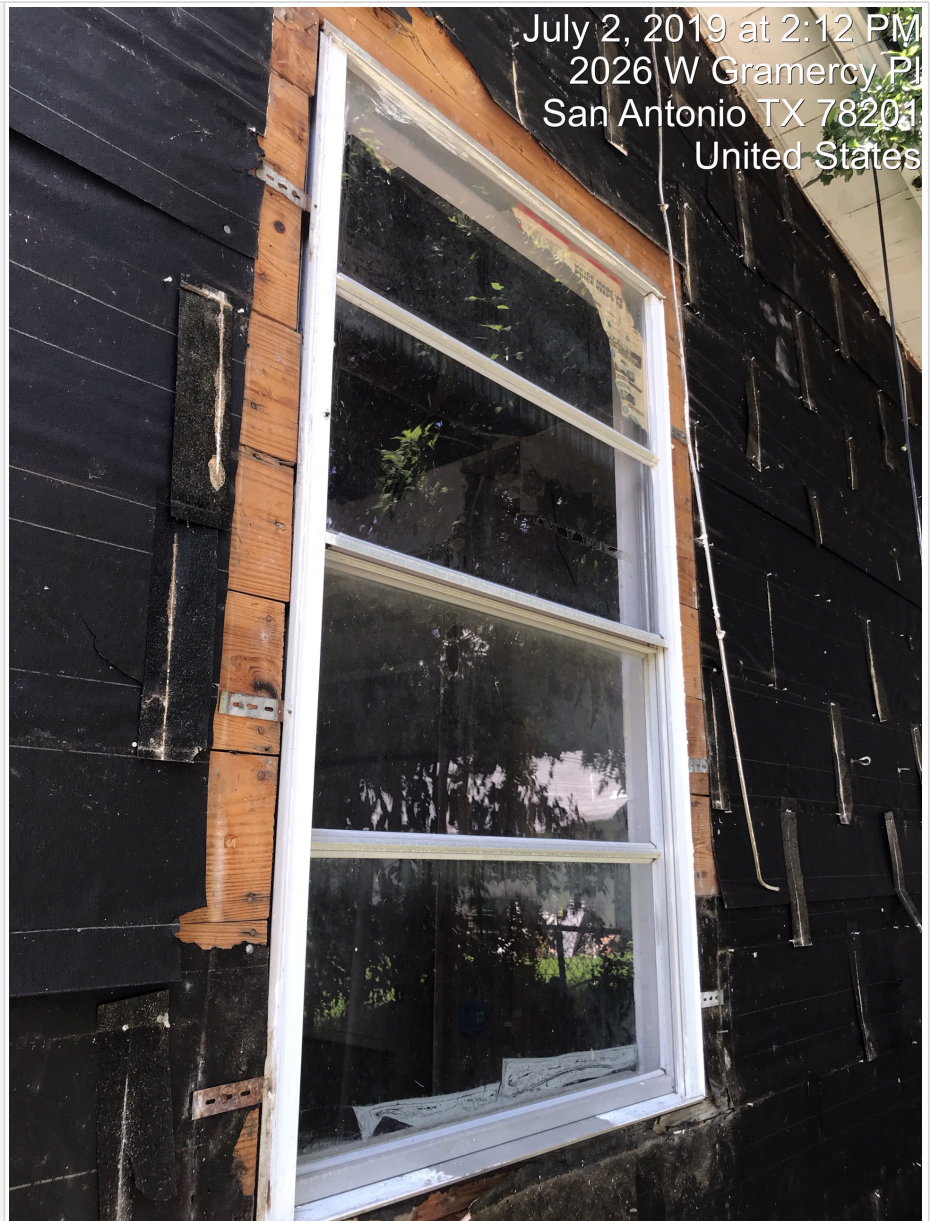
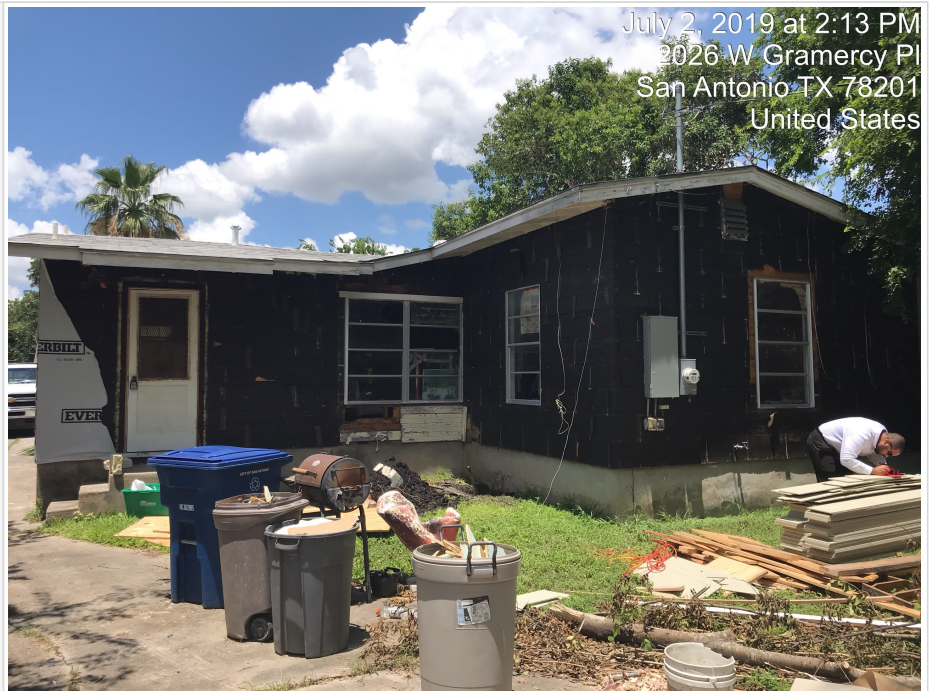
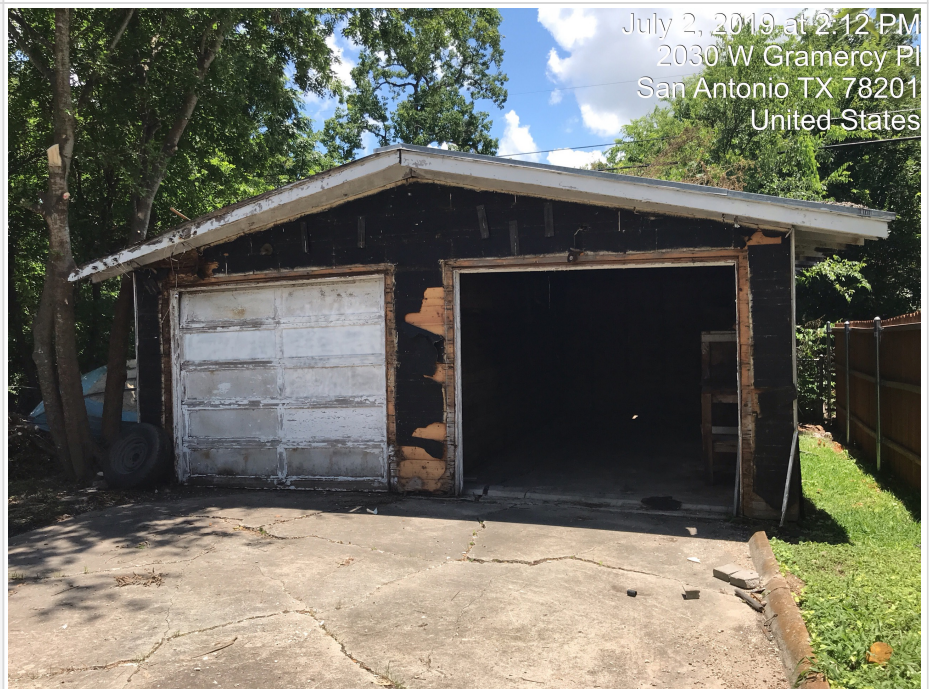
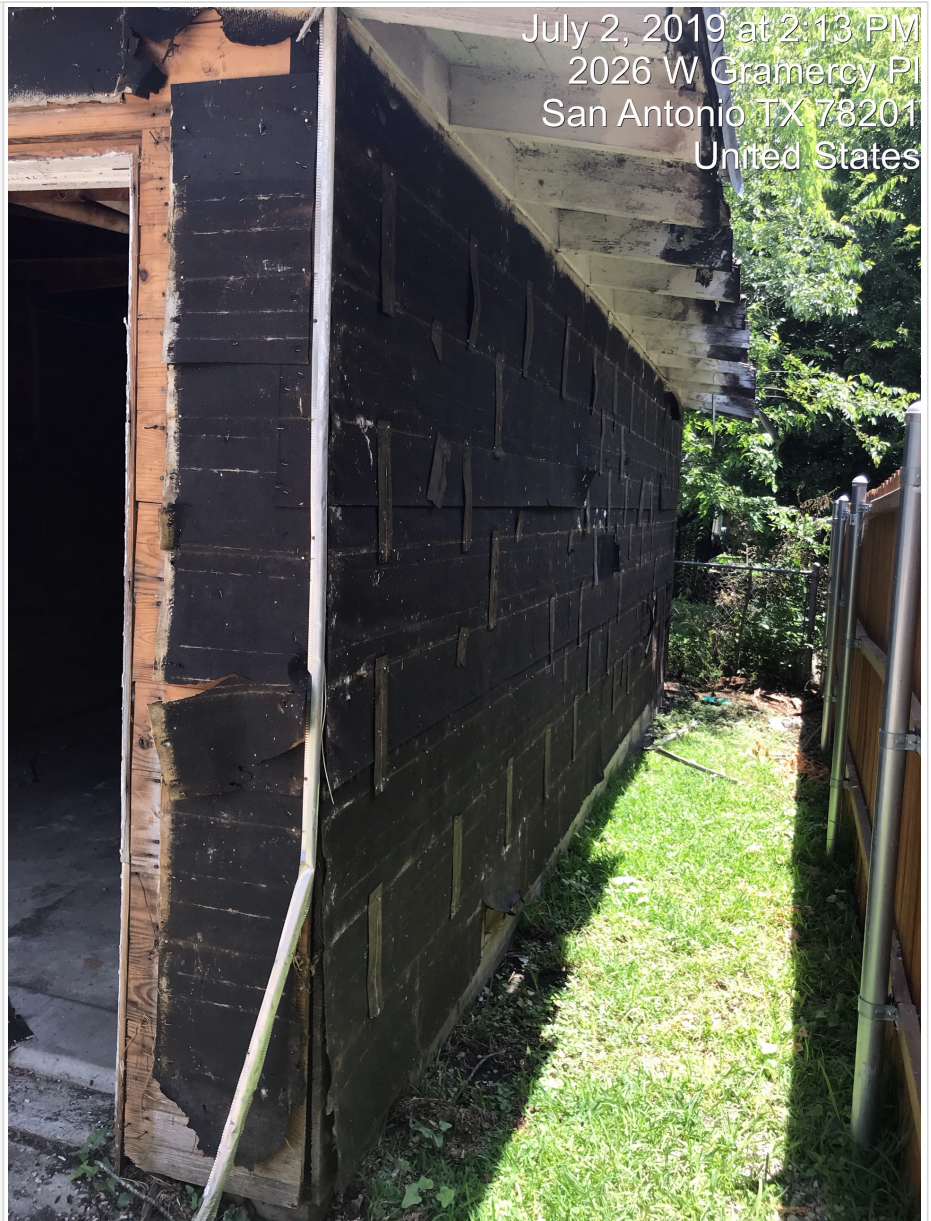
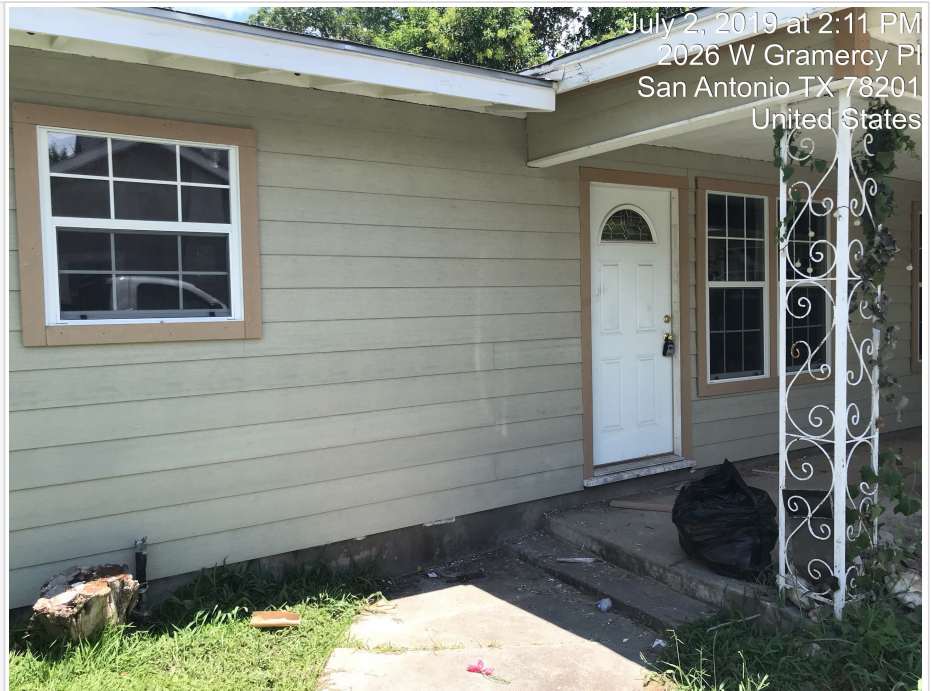
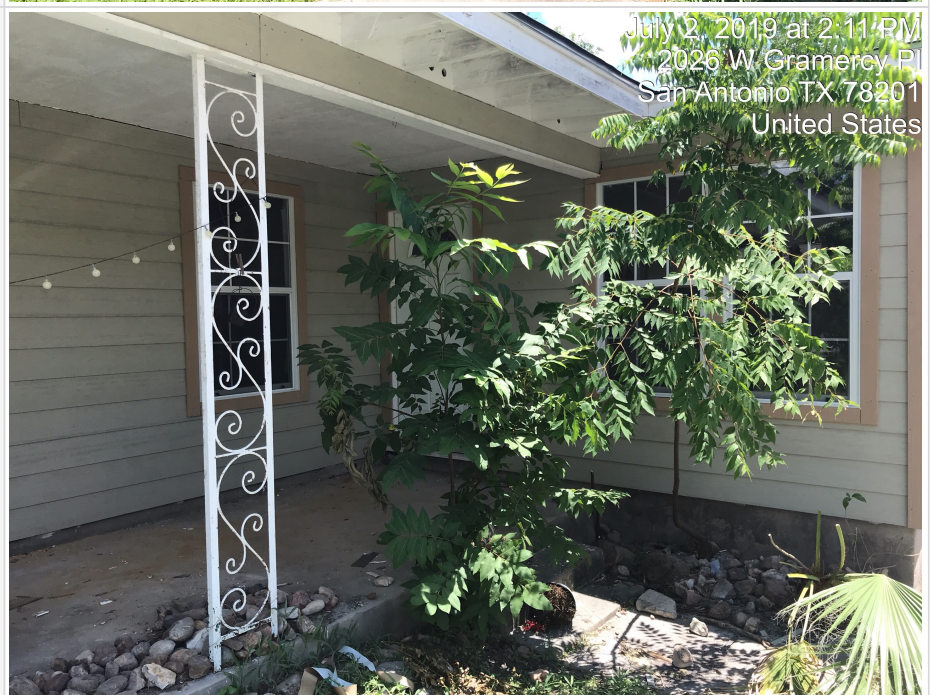
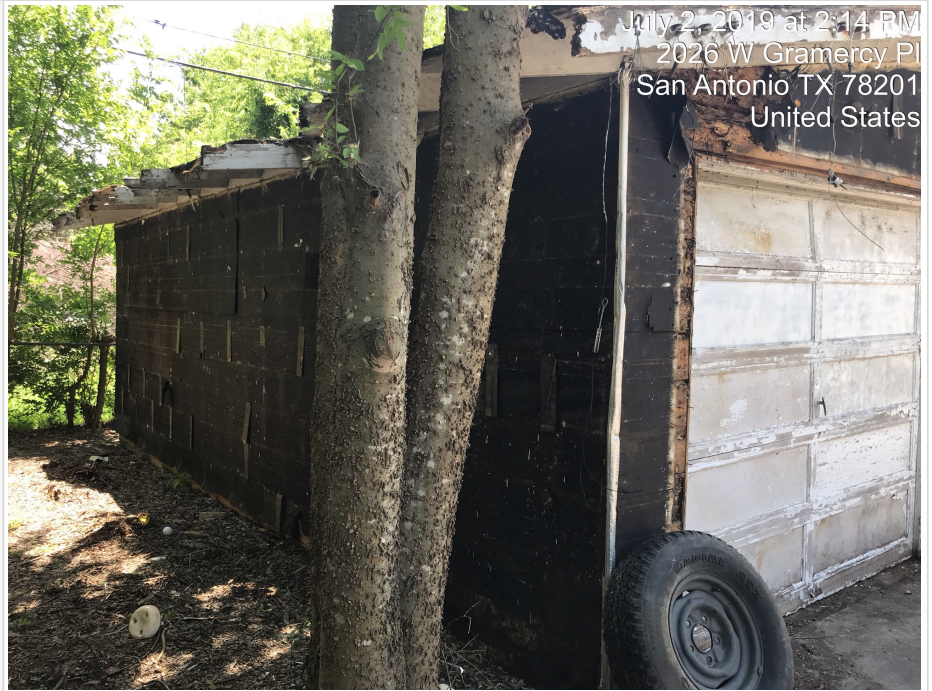
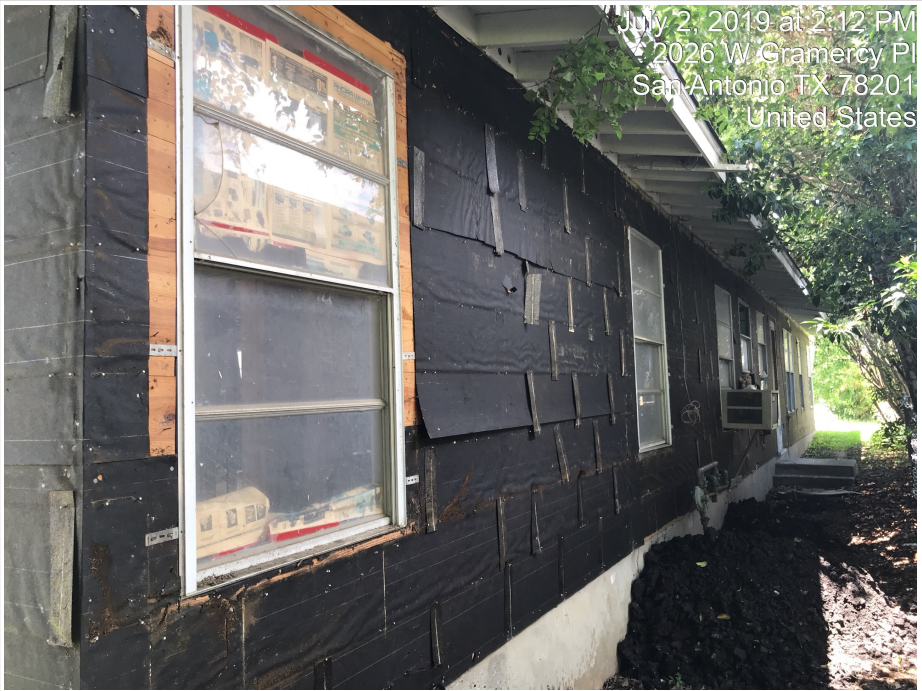
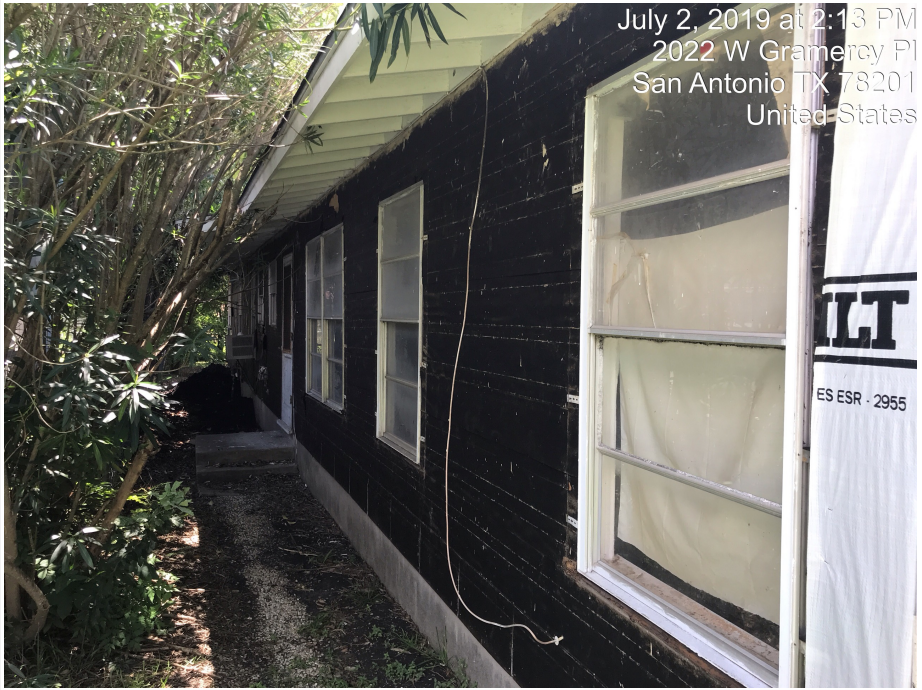
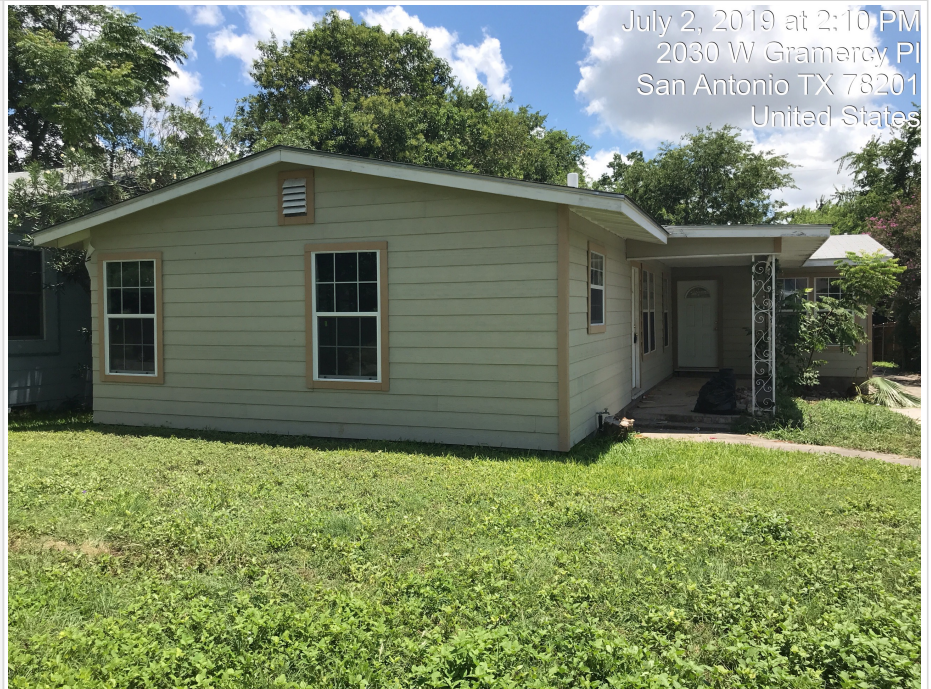
- b. **PROPERTY HISTORY** – Staff conducted an investigation on July 2, 2019. Work had begun without approval on the removal of asbestos siding, installation of hardie plank siding with faux wood grain, and window replacement with vinyl windows with faux divided lites. The applicant has been working in good faith with staff and has stated their intent to replace the faux grain siding with smooth hardie siding, which is eligible for administrative approval. A different window product is being considered as part of this application.

Date	07/02/2019
Time	02:18 PM (-5 GMT)
Context	citizen report
Present Staff	Huy Pham, Edward Hall
Present Individuals	Contractor(s)
Contractor/Realtor Companies	Kino
Types of Work Observed	Exterior Maintenance and Alterations
Amount of Work Completed	50%
Description of work	Window replacement, siding replacement. Rear accessory prepared for siding replacement and reroofing.
Description of interaction	Lead contractor Kino was cooperative to the stop work order and will submit applications for administration or HDRC approval. He said the owner closed on the property two days ago.
