HISTORIC AND DESIGN REVIEW COMMISSION

August 21, 2019

HDRC CASE NO: 2019-437
ADDRESS: 905 N MESQUITE ST
LEGAL DESCRIPTION: NCB 519 BLK 24 N 44.10 FT OF S 88.2 FT OF 17 & 18 ARB A18
ZONING: R-4, H
CITY COUNCIL DIST.: 2
DISTRICT: Dignowity Hill Historic District
APPLICANT: Shawn Collard/Shawn Collard Construction
OWNER: SNYDER JEFFREY W
TYPE OF WORK: Window replacement; exterior modifications
APPLICATION RECEIVED: July 24, 2019
60-DAY REVIEW: September 23, 2019
CASE MANAGER: Huy Pham
REQUEST:

Investigation Report

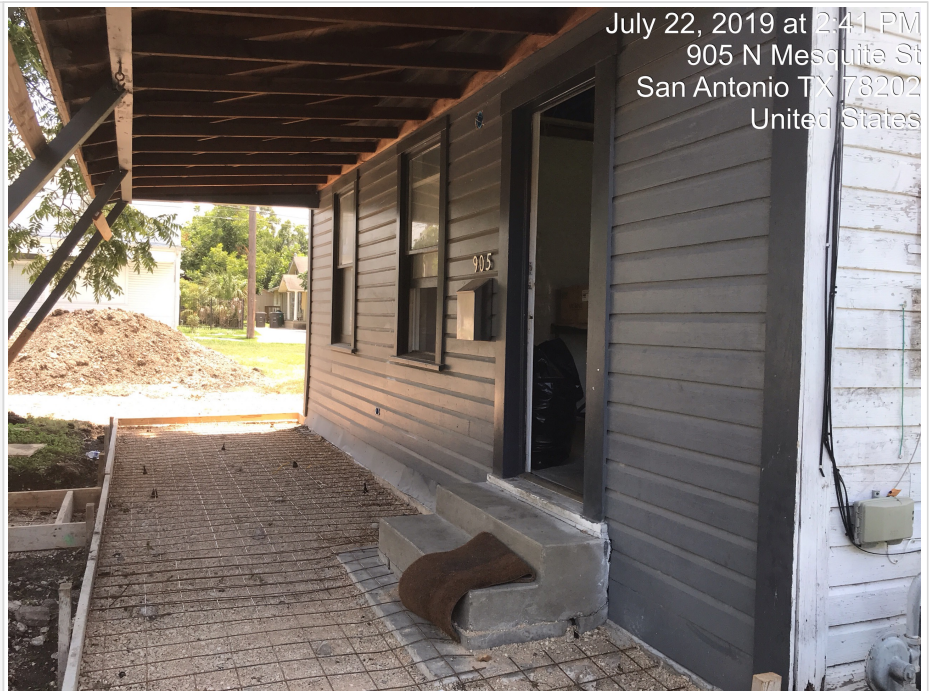
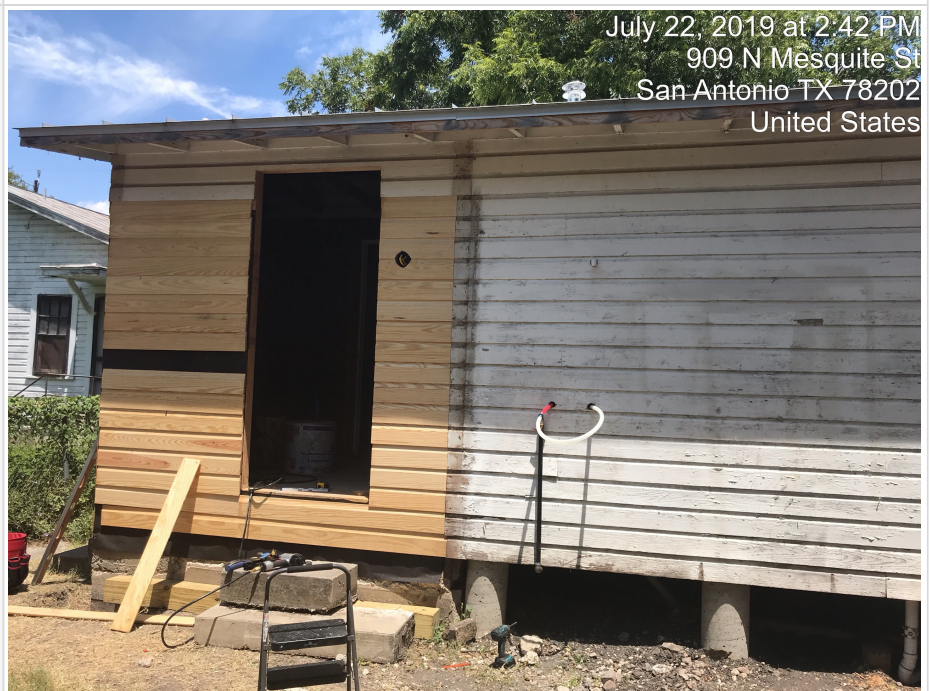
Date	07/22/2019
Time	02:46 PM (-5 GMT)
Context	citizen report
Present Staff	Huy Pham, Edward Hall
Present Individuals	Contractor(s)
Types of Work Observed	Exterior Maintenance and Alterations
Amount of Work Completed	75%
Description of work	Removal of one side window to install two smaller windows (original wood window), construction of a rear addition to square off the rear elevation.
Description of interaction	Spoke with contractor Ray who was cooperative to stop work and forward the notice of investigation to lead contractor (Sean?) and/or owners.
