HISTORIC AND DESIGN REVIEW COMMISSION

September 04, 2019

HDRC CASE NO: 2019-502
ADDRESS: 1323 FULTON AVE
LEGAL DESCRIPTION: NCB 2754 BLK 60 LOT 19 & W 25 FT OF 20
ZONING: R-4,H
CITY COUNCIL DIST.: 1
DISTRICT: Fulton Historic District
TYPE OF WORK: Window replacement, Historic Tax Certification
APPLICATION RECEIVED: August 16, 2019
60-DAY REVIEW: October 15, 2019
CASE MANAGER: Stephanie Phillips

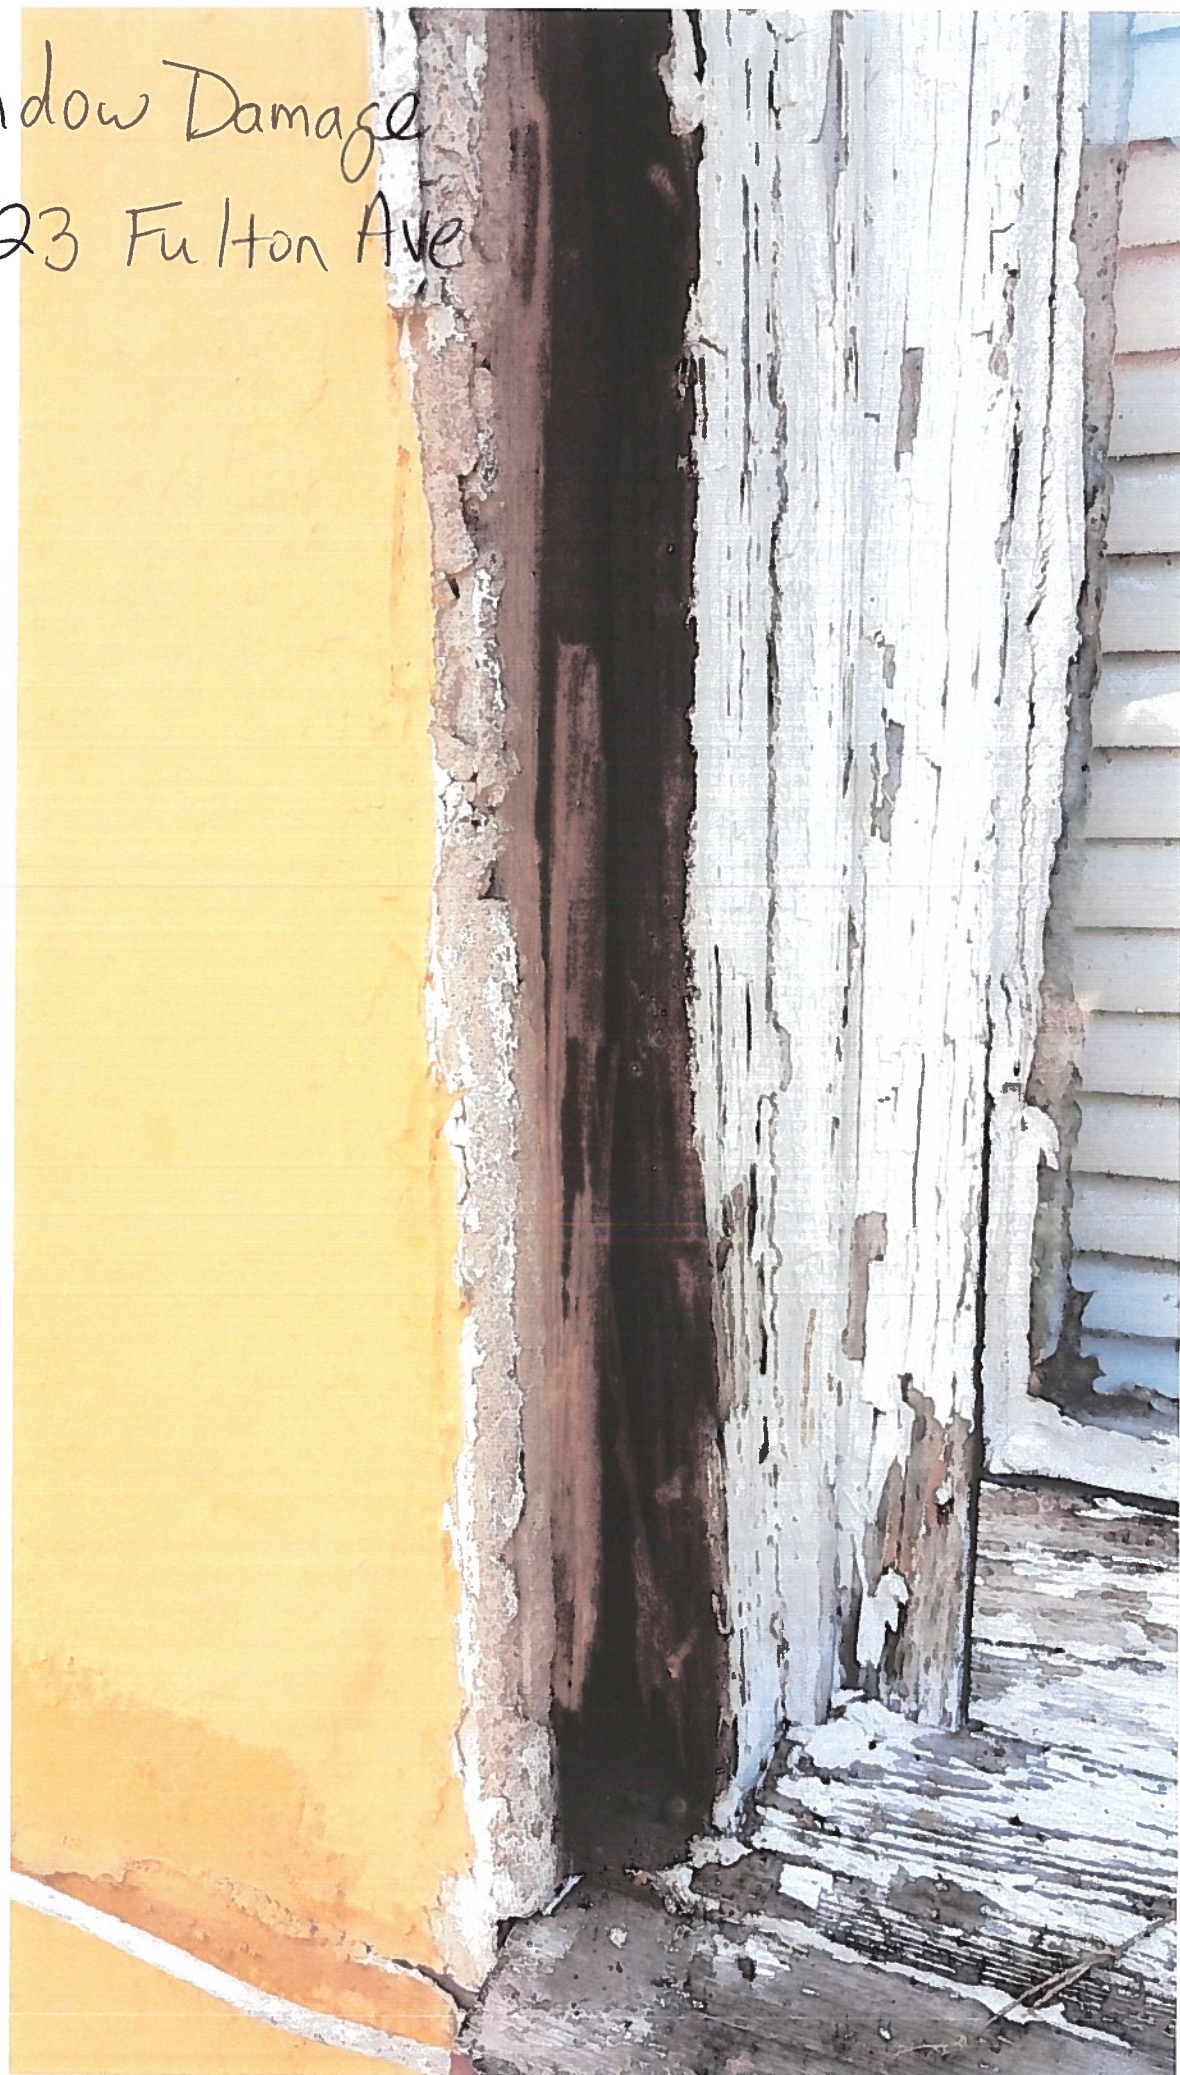
Window Damage
1323 Fulton Ave

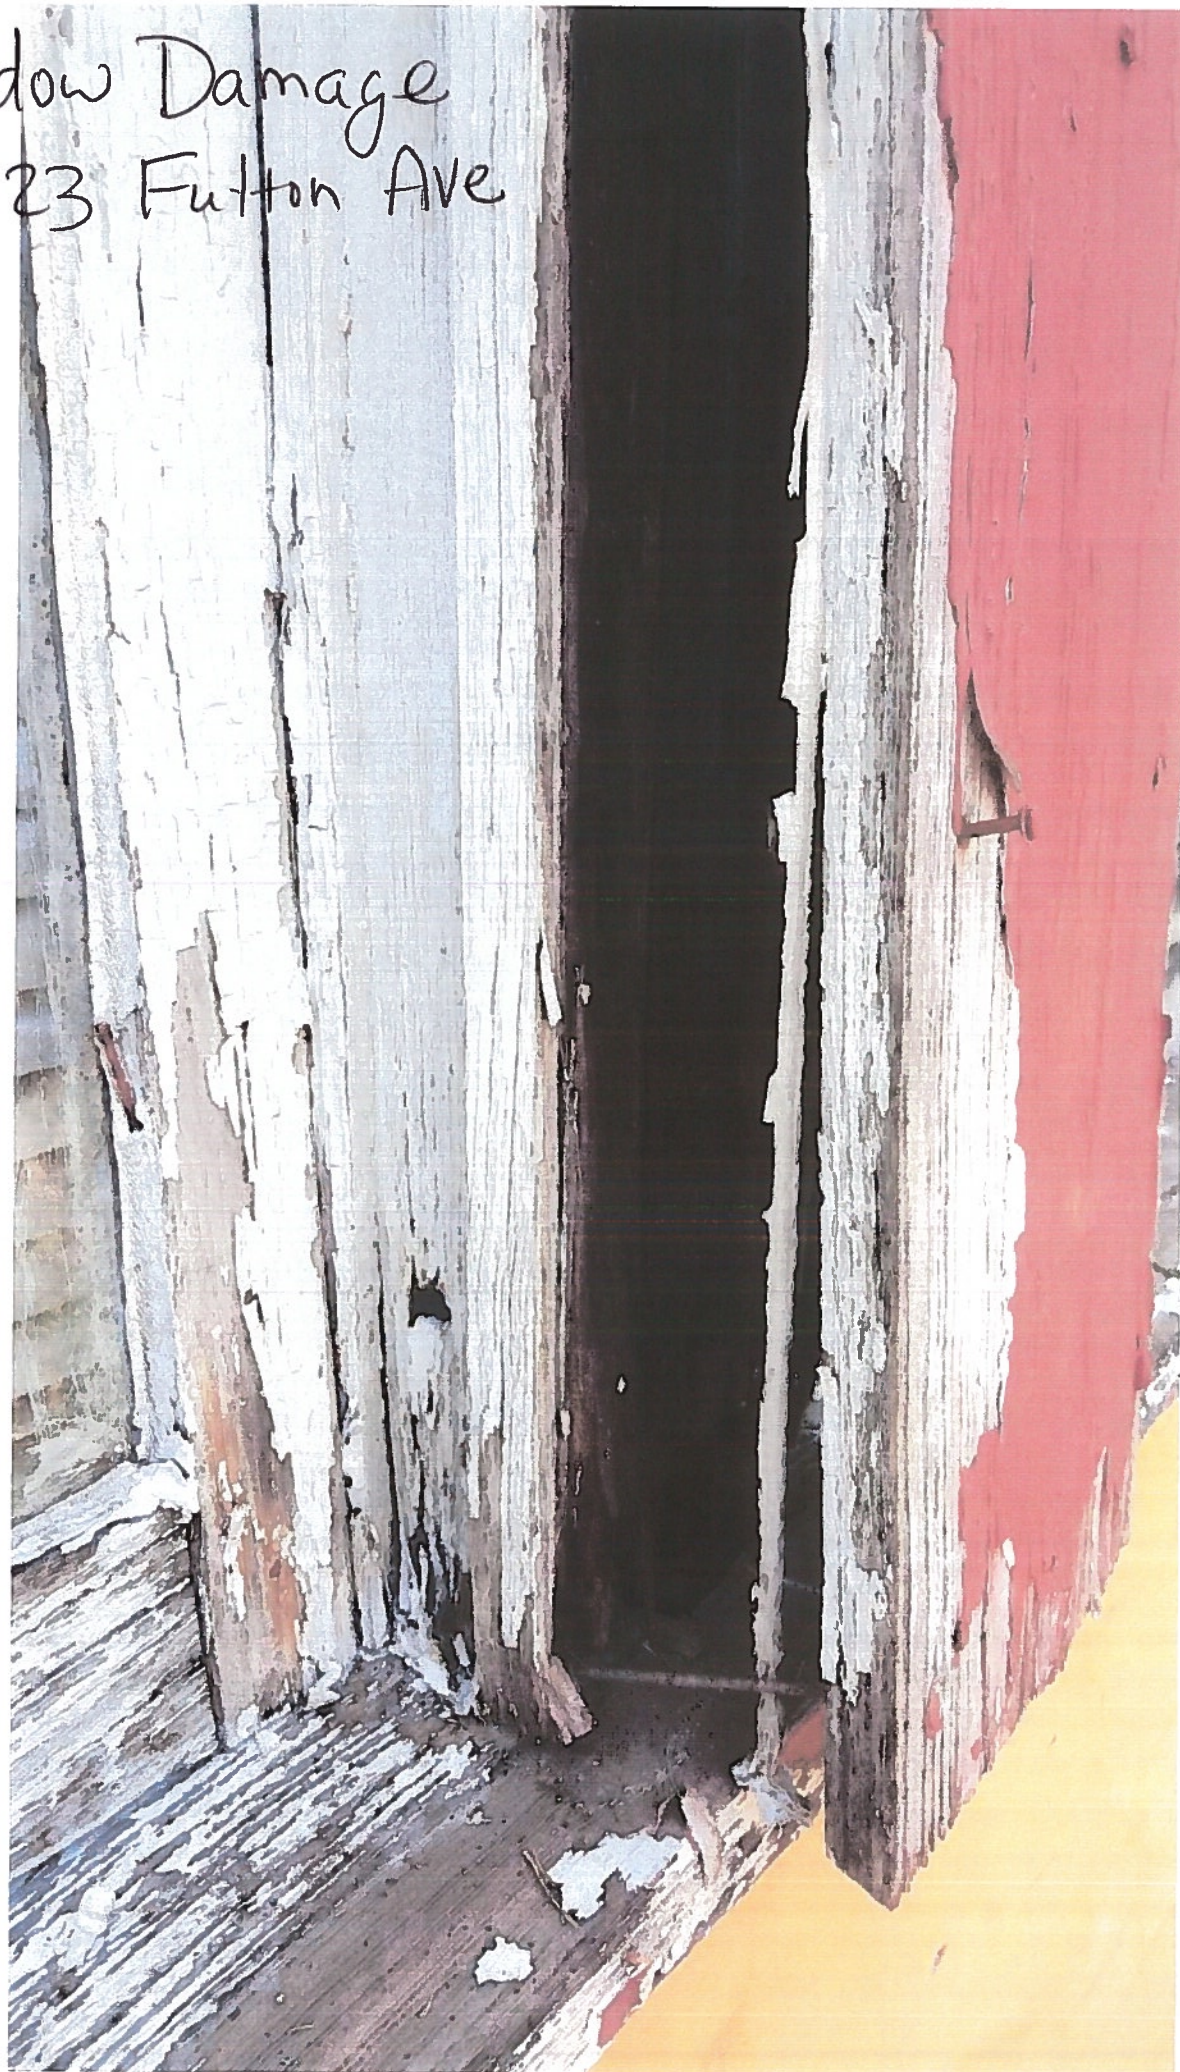
Window Damage
1323 Fulton Ave
