HISTORIC AND DESIGN REVIEW COMMISSION

September 18, 2019

HDRC CASE NO: 2019-524
ADDRESS: 1818 SAN PEDRO AVE
LEGAL DESCRIPTION: NCB 1863 BLK 3 LOT 1 & 2 W 25 FT. OF 3
ZONING: C-2,H
CITY COUNCIL DIST.: 1
DISTRICT: Monte Vista Historic District
APPLICANT: Sonia Lopez, Maximilion Ramirez
OWNER: Center for Family Relations
TYPE OF WORK: Door replacement
APPLICATION RECEIVED: August 30, 2019
60-DAY REVIEW: October 29, 2019
CASE MANAGER: Stephanie Phillips
REQUEST:

The applicant is requesting a Certificate of Appropriateness for approval to replace two existing Victorian-style wood doors on the front façade of the primary structure with new steel doors

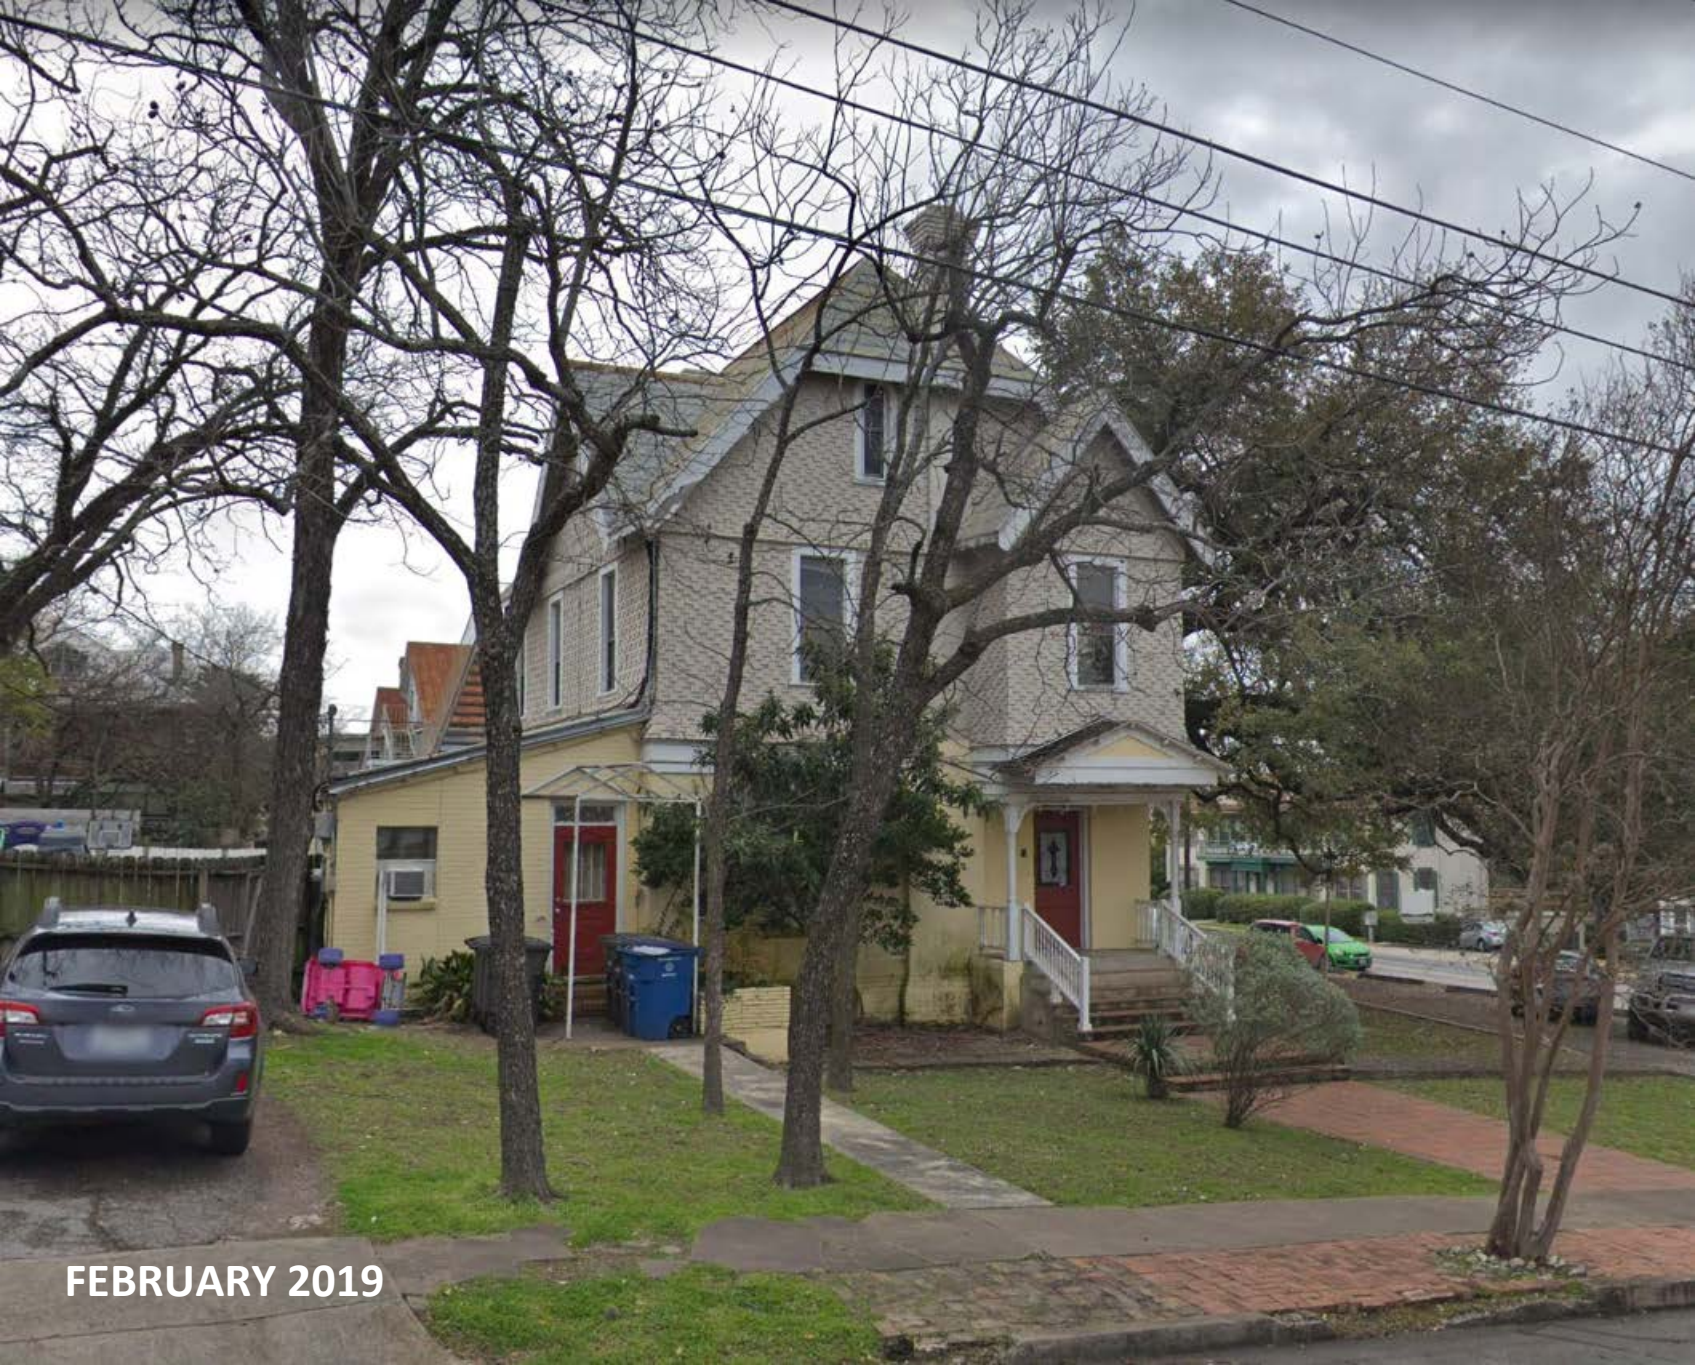
FEBRUARY 2019

- b. **DOOR REPLACEMENT-** The applicant has requested to replace two existing front doors on the primary façade. The applicant originally submitted a Certificate of Appropriateness request for the replacement of one of the two doors. Upon review of the documentation, staff discovered that a second wooden front door had already been replaced with a new steel door. One of the doors is the primary front door off of E Craig Pl, which has already been replaced. The second door is a secondary entrance to a 1-story mass, set back from the front façade, but is visible from the public right-of-way on E Craig Pl. The doors are made of wood and feature an elaborate Victorian-era design, including carved or applied organic detailing and a shelf under the main single glass pane. According to the Guidelines, existing doors should be repaired and preserved. Staff does not find the replacement steel doors appropriate. Staff finds that the doors should be repaired.

Staff does not recommend approval based on findings a and b. Staff recommends that the doors be repaired and retained.

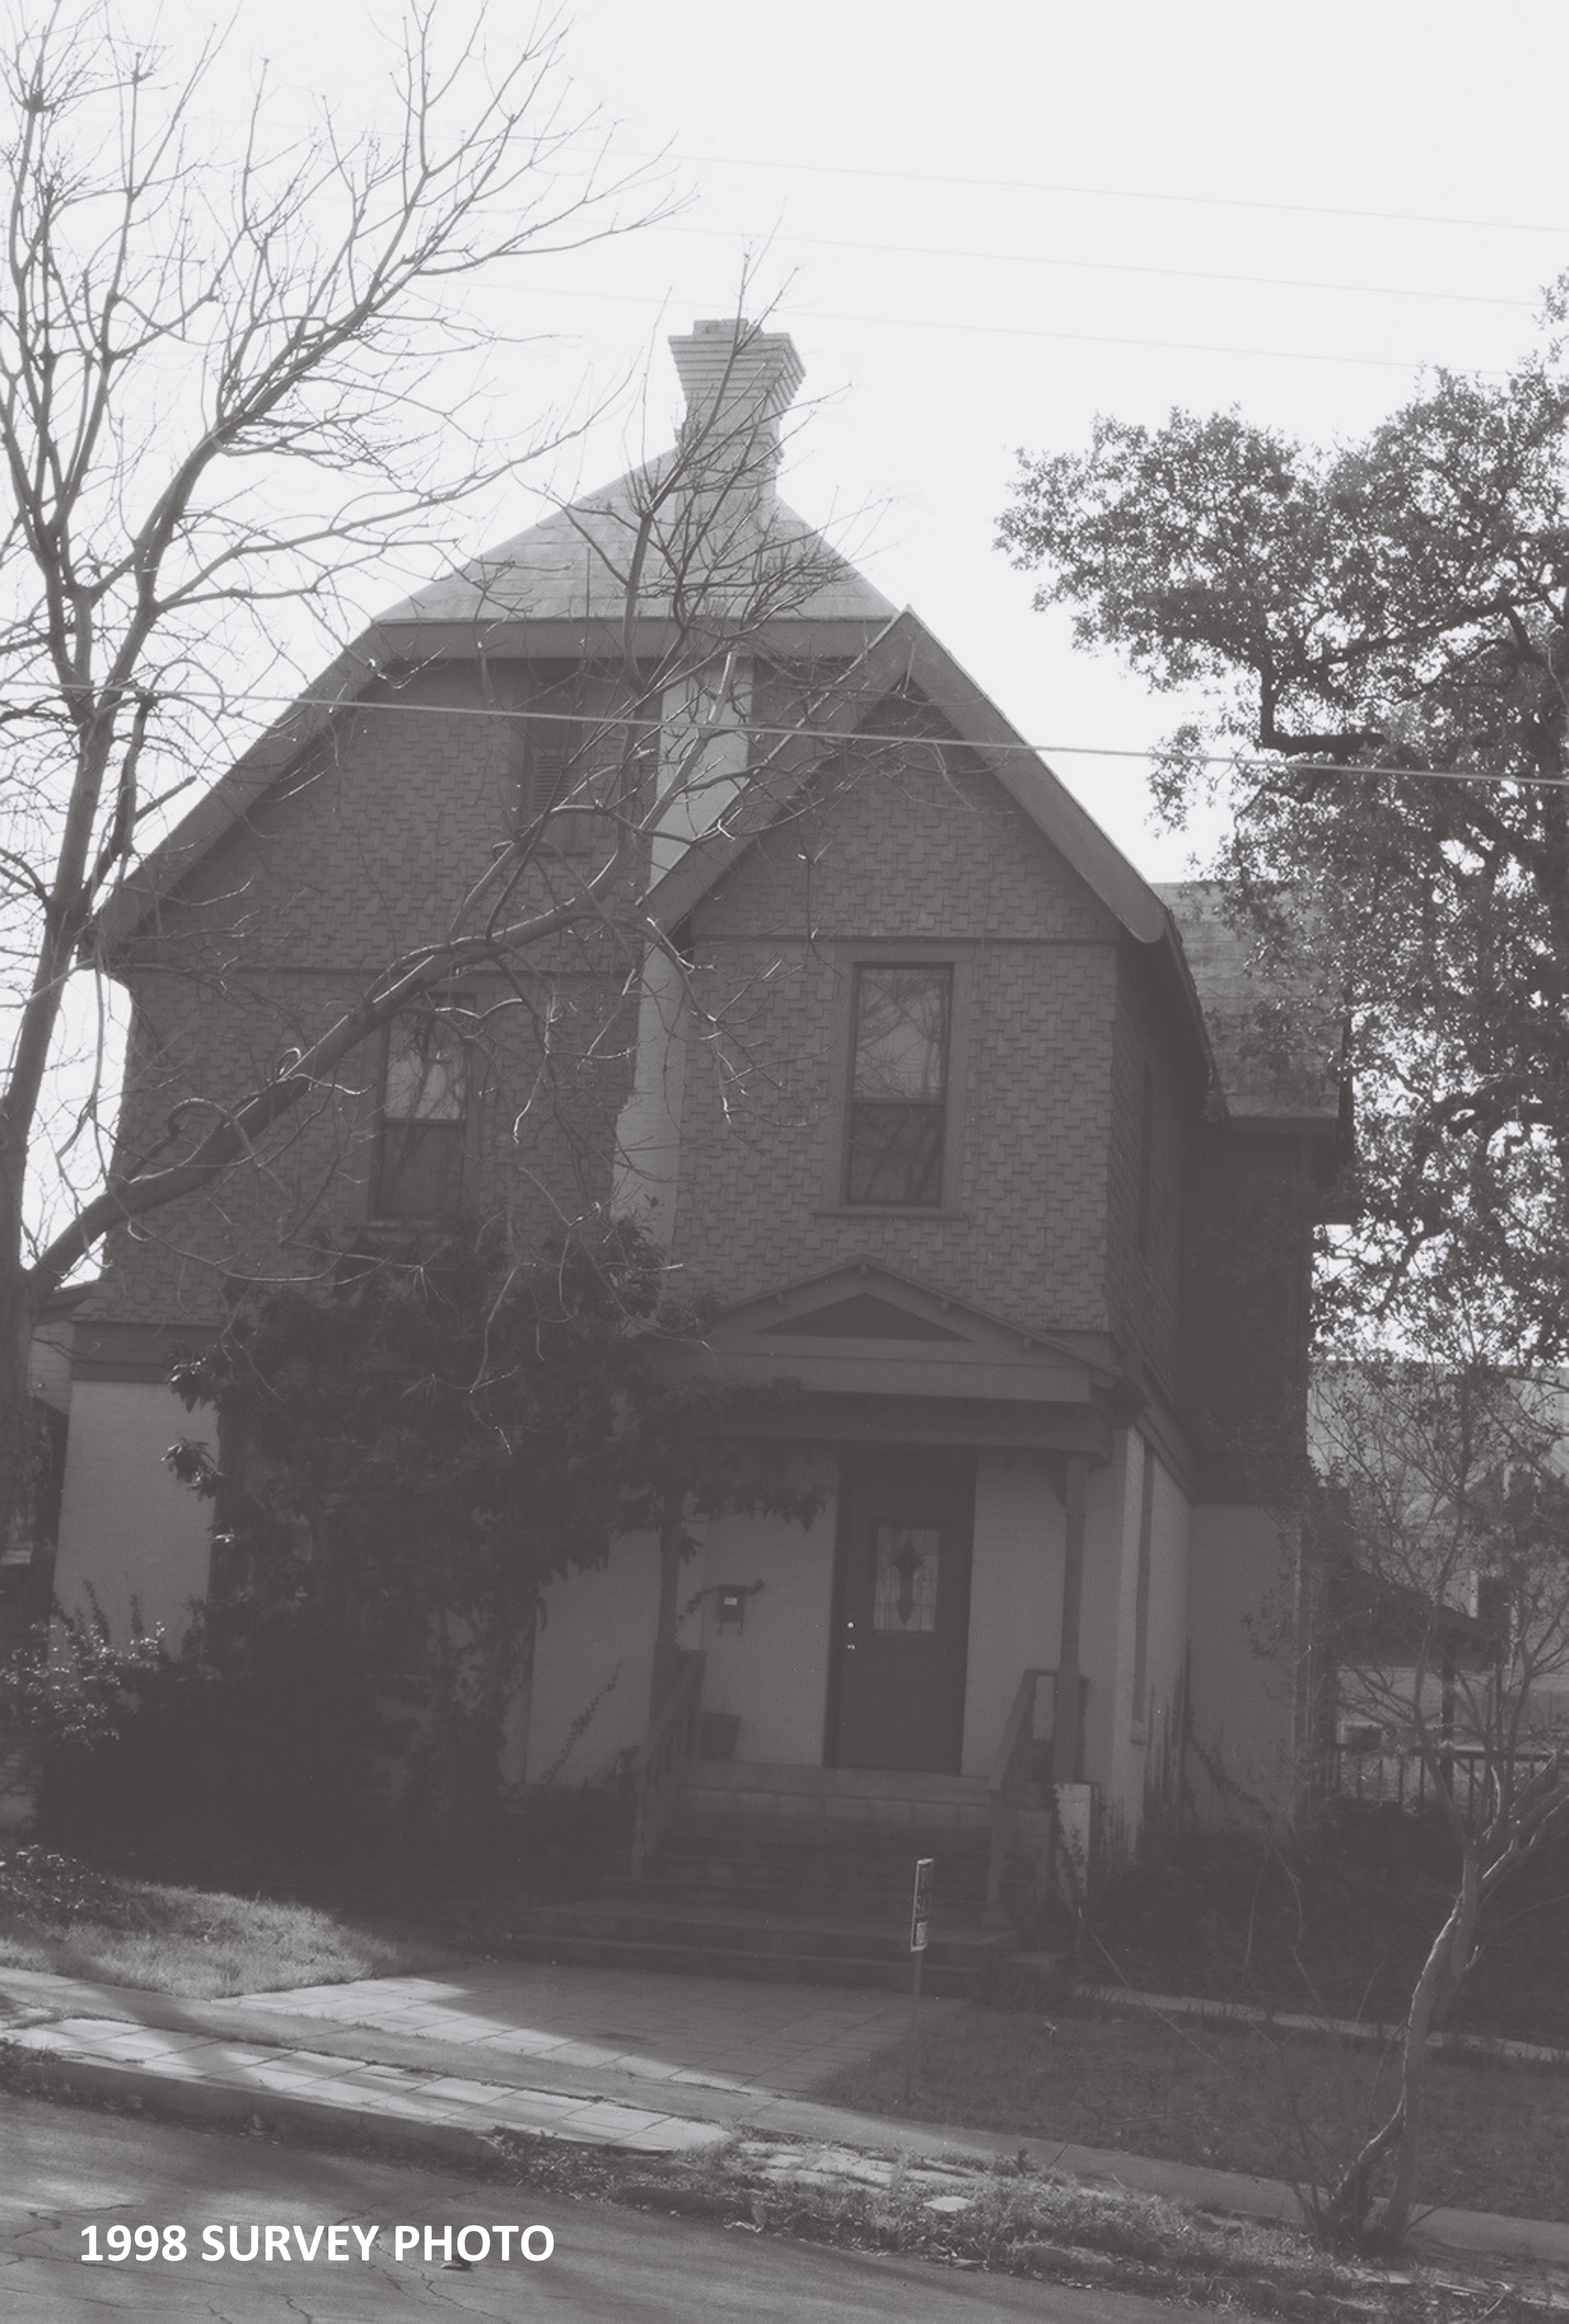
AUGUST 2019

The applicant originally submitted a Certificate of Appropriateness request for the replacement of one of the two doors. Upon review of the documentation, staff discovered that a second wooden front door had already been replaced with a new steel door.

If a door is deemed irreparable by the HDRC, staff recommends that the applicant installs two new fully wooden doors of a similar style that are compatible with the historic structure. A specification is required to be submitted to staff for review and approval prior to receiving a Certificate of Appropriateness.

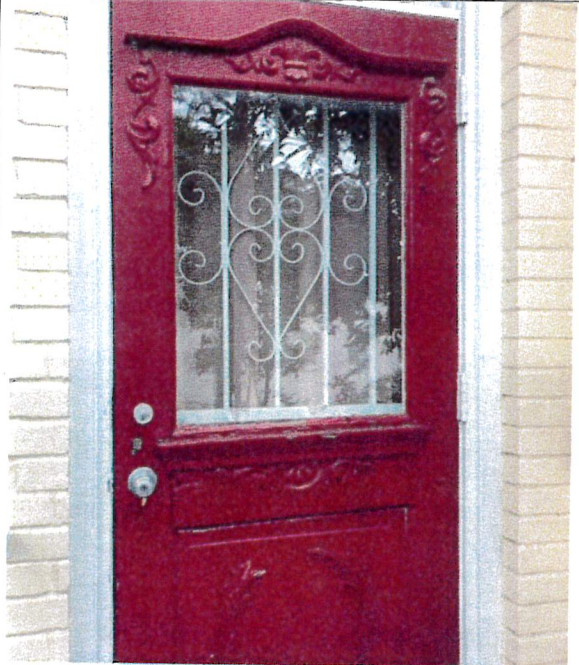
Door Replacement

</div> <p data-bbox="1501 519 1869 552">Color of the replacement door</p> <p data-bbox="1339 592 1764 657">The door style and color have been approved by the beneficiary</p> <p data-bbox="1339 698 1869 763">The door will be similar in style and color to another side entrance</p>
