# HISTORIC AND DESIGN REVIEW COMMISSION

**HDRC CASE NO:** 2019-524  
**ADDRESS:** 1818 SAN PEDRO AVE  
**LEGAL DESCRIPTION:** NCB 1863 BLK 3 LOT 1 & 2 W 25 FT. OF 3  
**ZONING:** C-2,H  
**CITY COUNCIL DIST.:** 1  
**DISTRICT:** Monte Vista Historic District  
**APPLICANT:** Sonia Lopez, Maximilion Ramirez  
**OWNER:** Center for Family Relations  
**TYPE OF WORK:** Door replacement  
**APPLICATION RECEIVED:** August 30, 2019  
**60-DAY REVIEW:** October 29, 2019  
**CASE MANAGER:** Stephanie Phillips  
**REQUEST:**

The applicant is requesting a Certificate of Appropriateness for approval to replace two existing Victorian-style wood doors on the front façade of the primary structure with new steel doors.

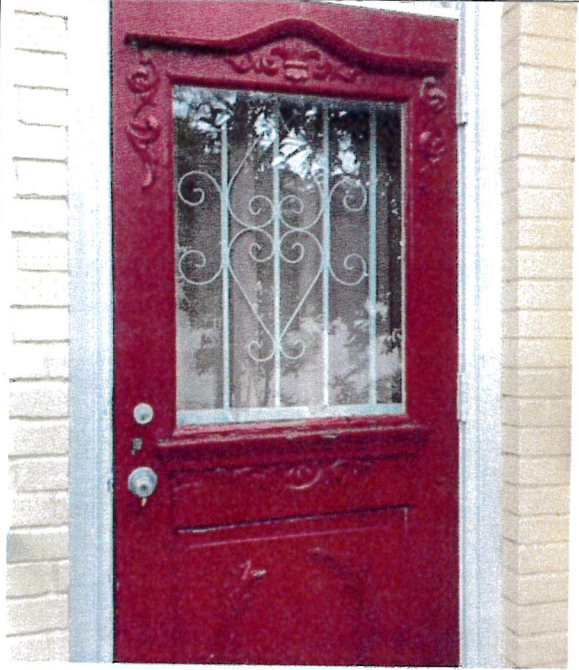
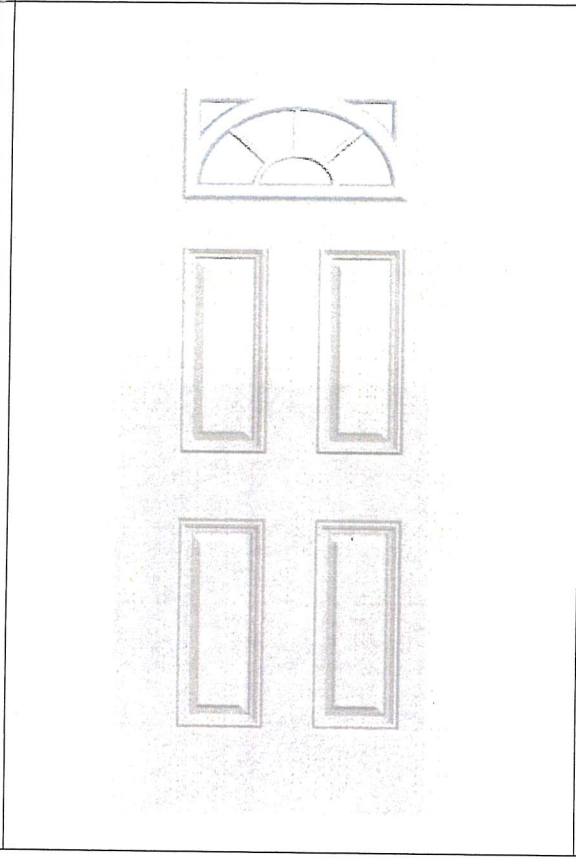
Door Replacement

Existing	Replaced with	Comments
