HISTORIC AND DESIGN REVIEW COMMISSION October 16, 2019

HDRC CASE NO: 2019-570

ADDRESS: 508 MASON ST

DISTRICT: Government Hill Historic District

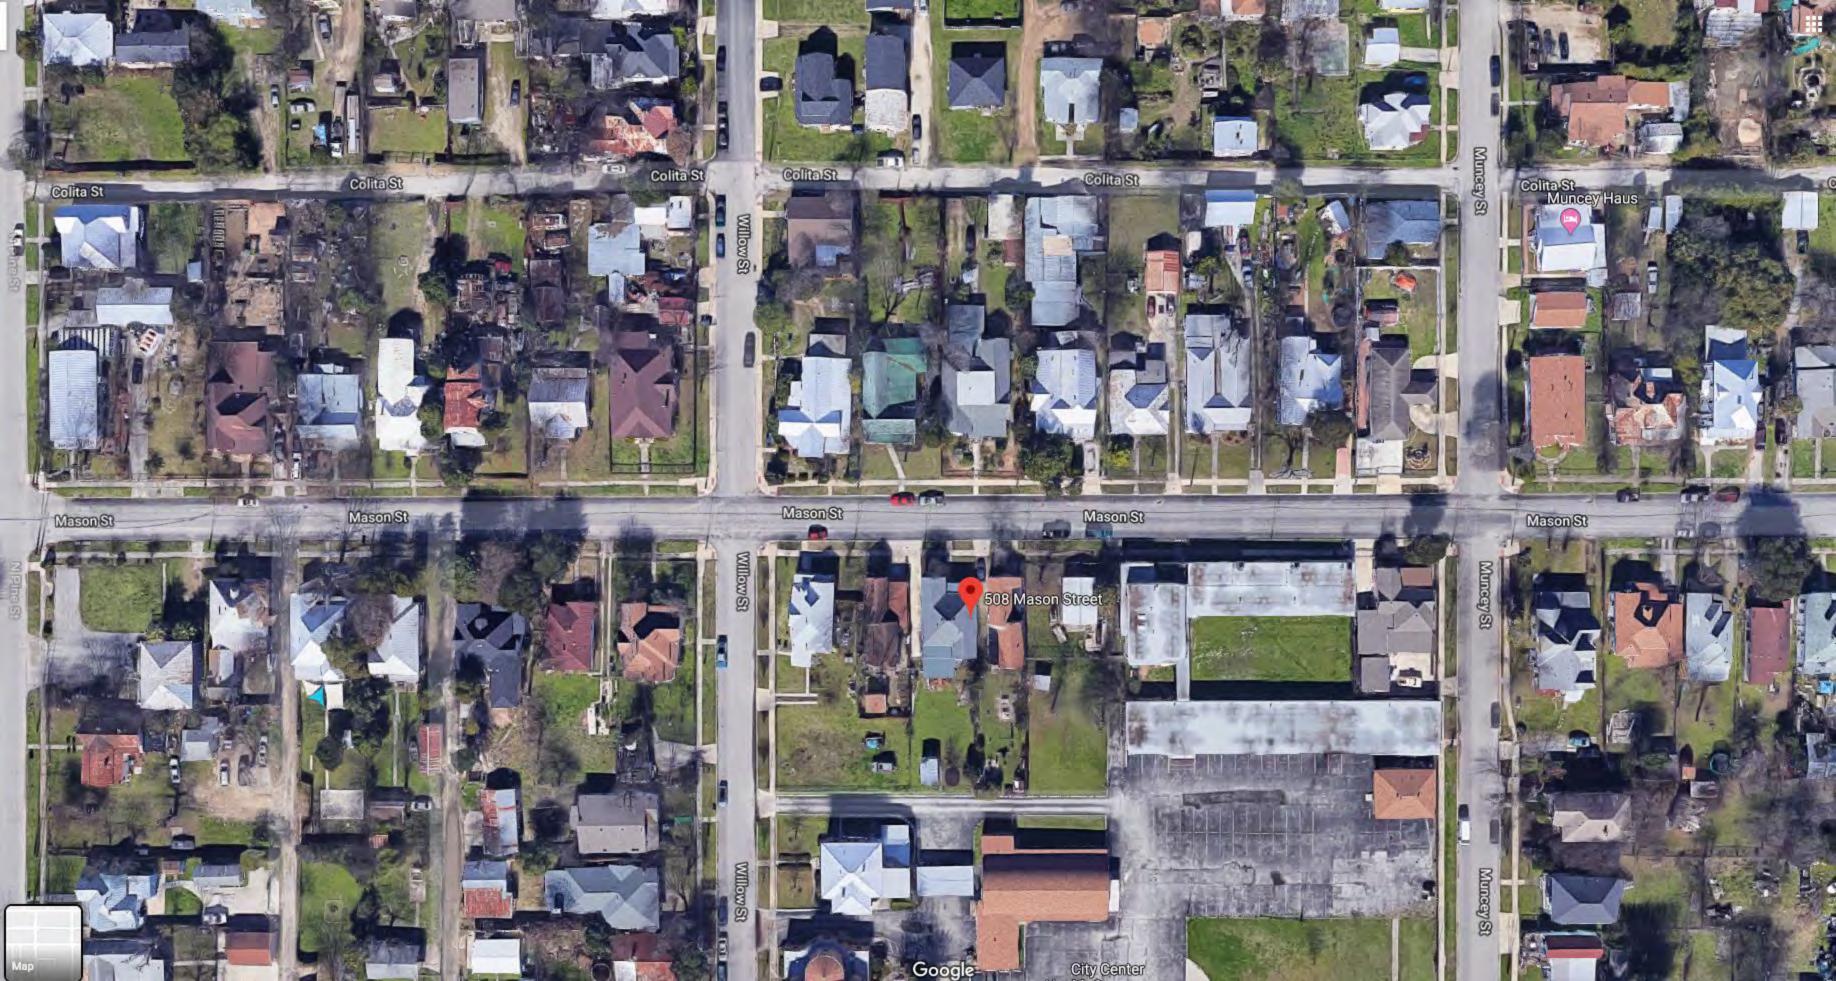
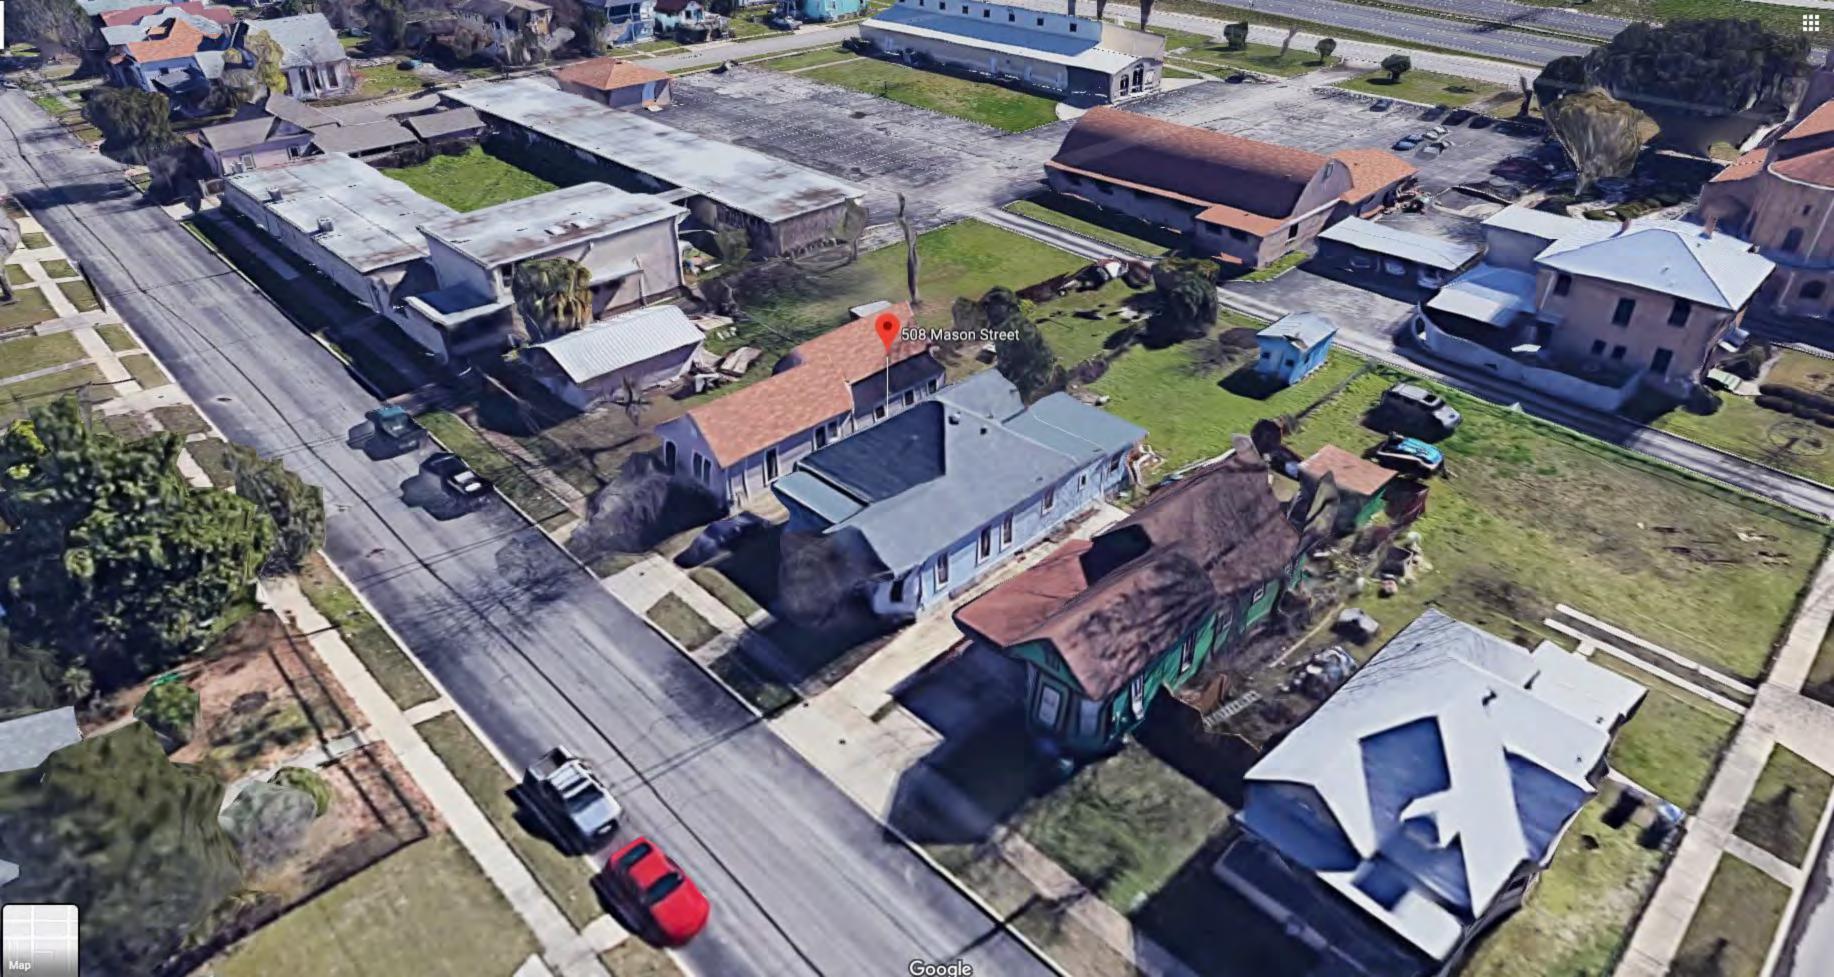
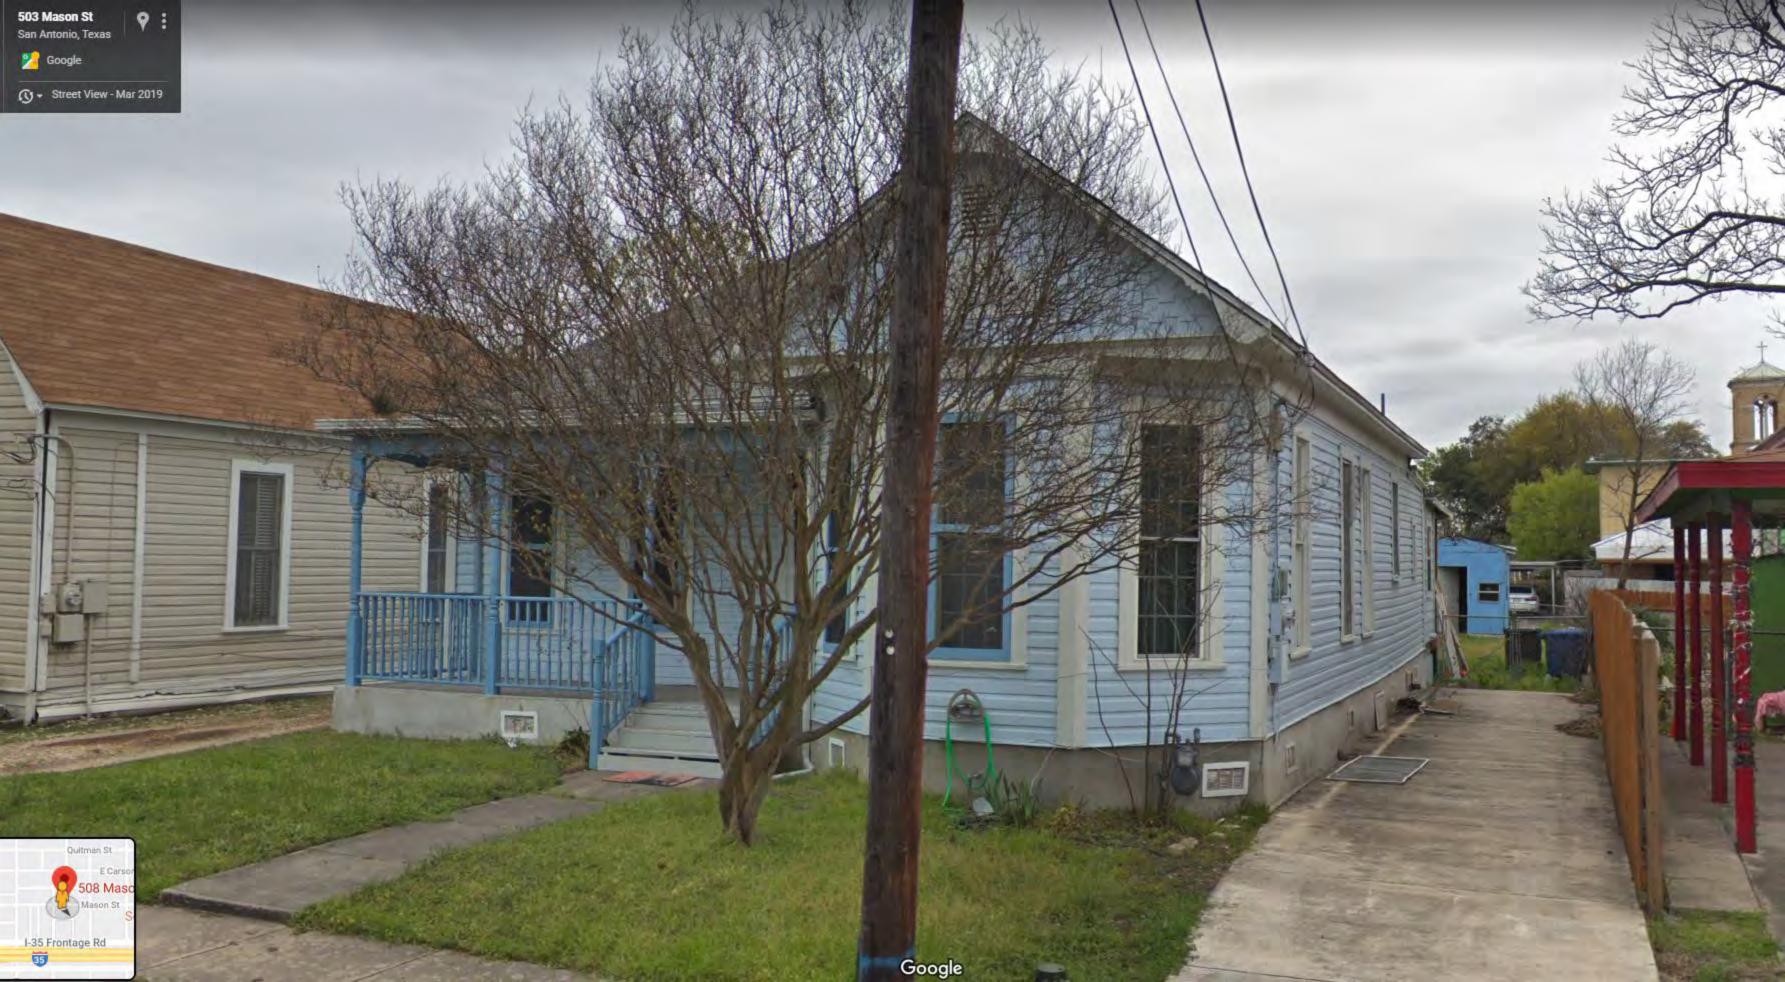
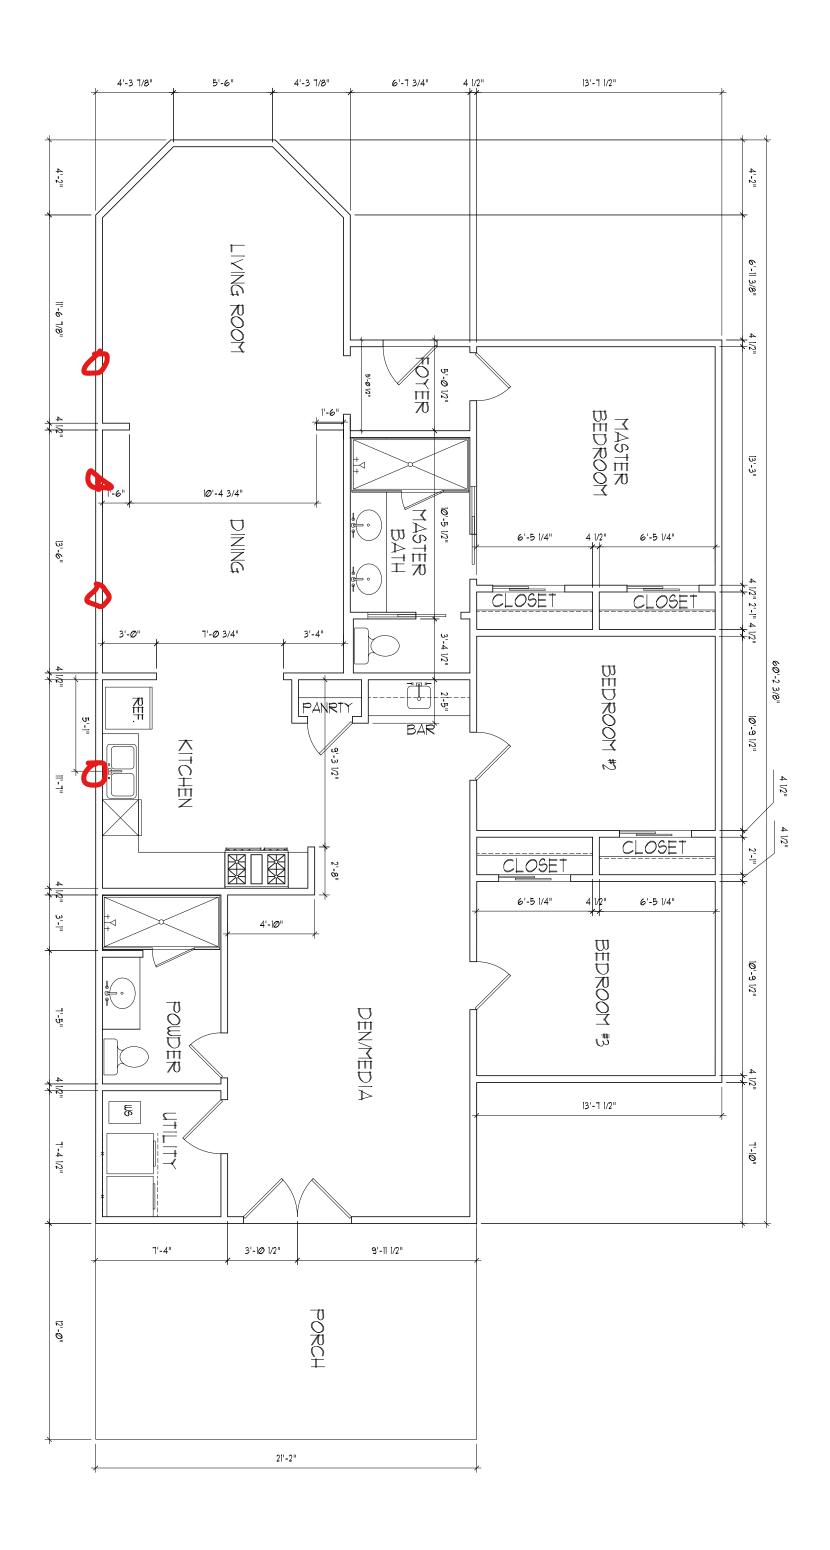
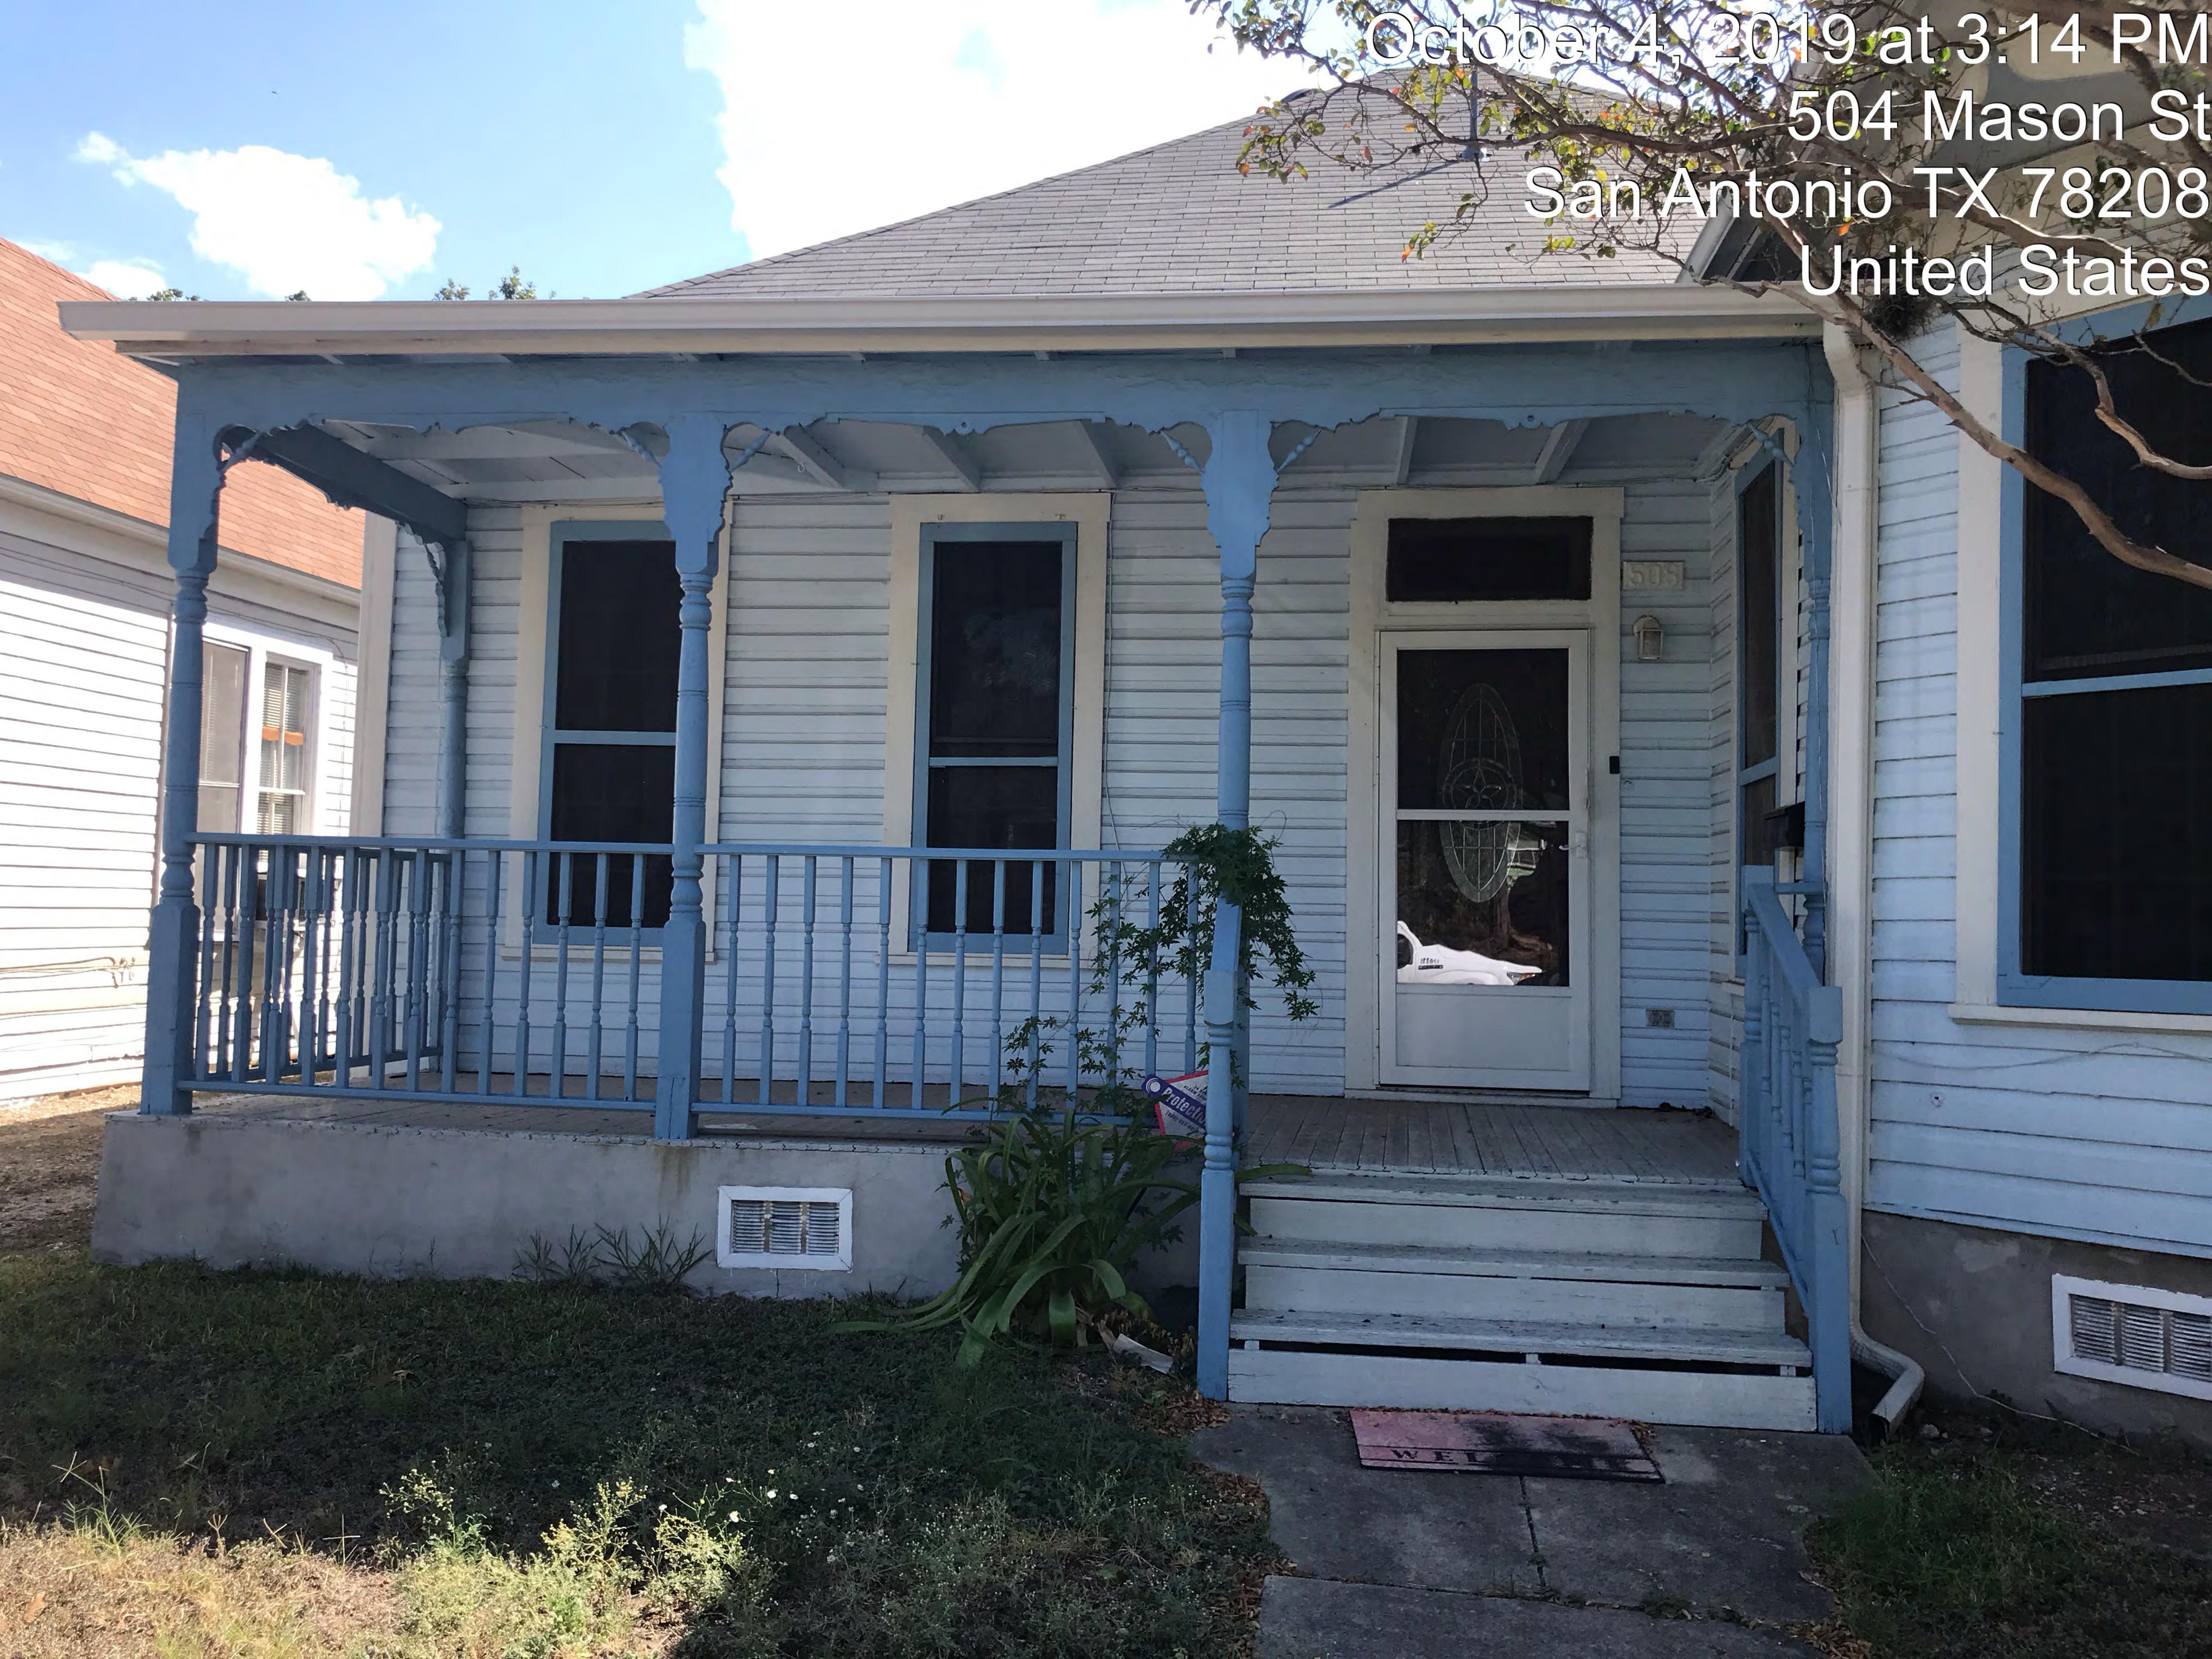
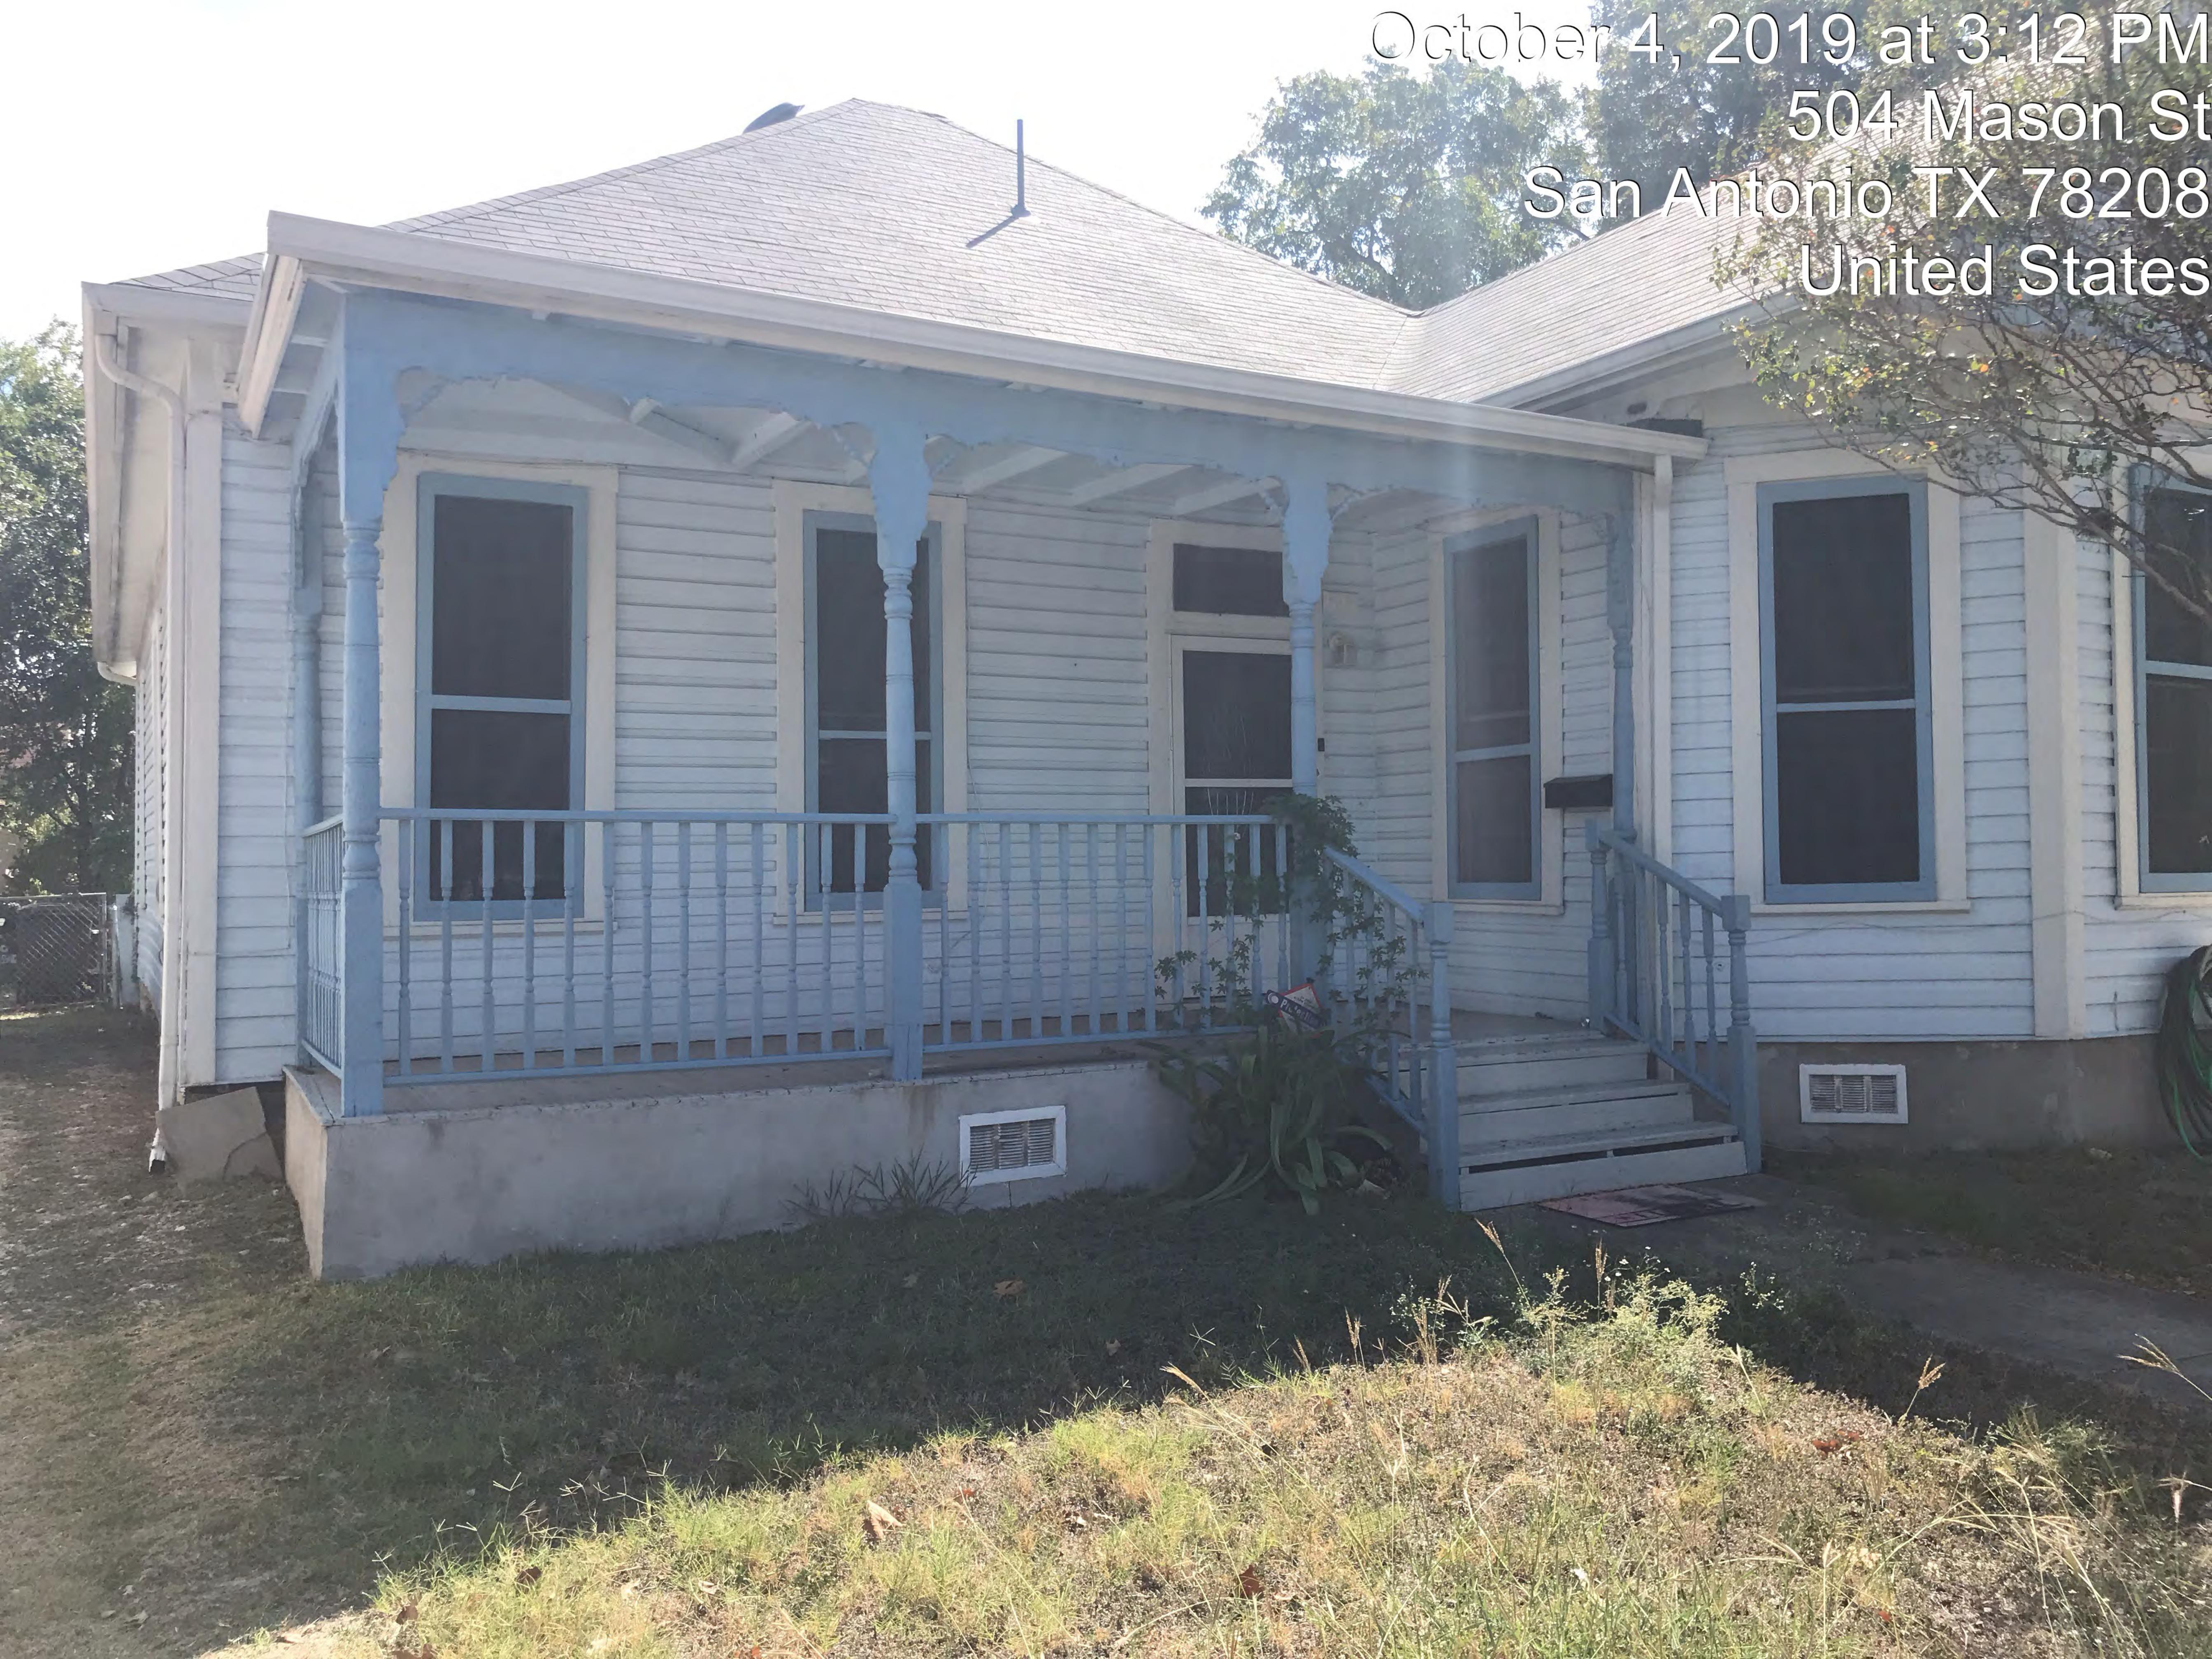
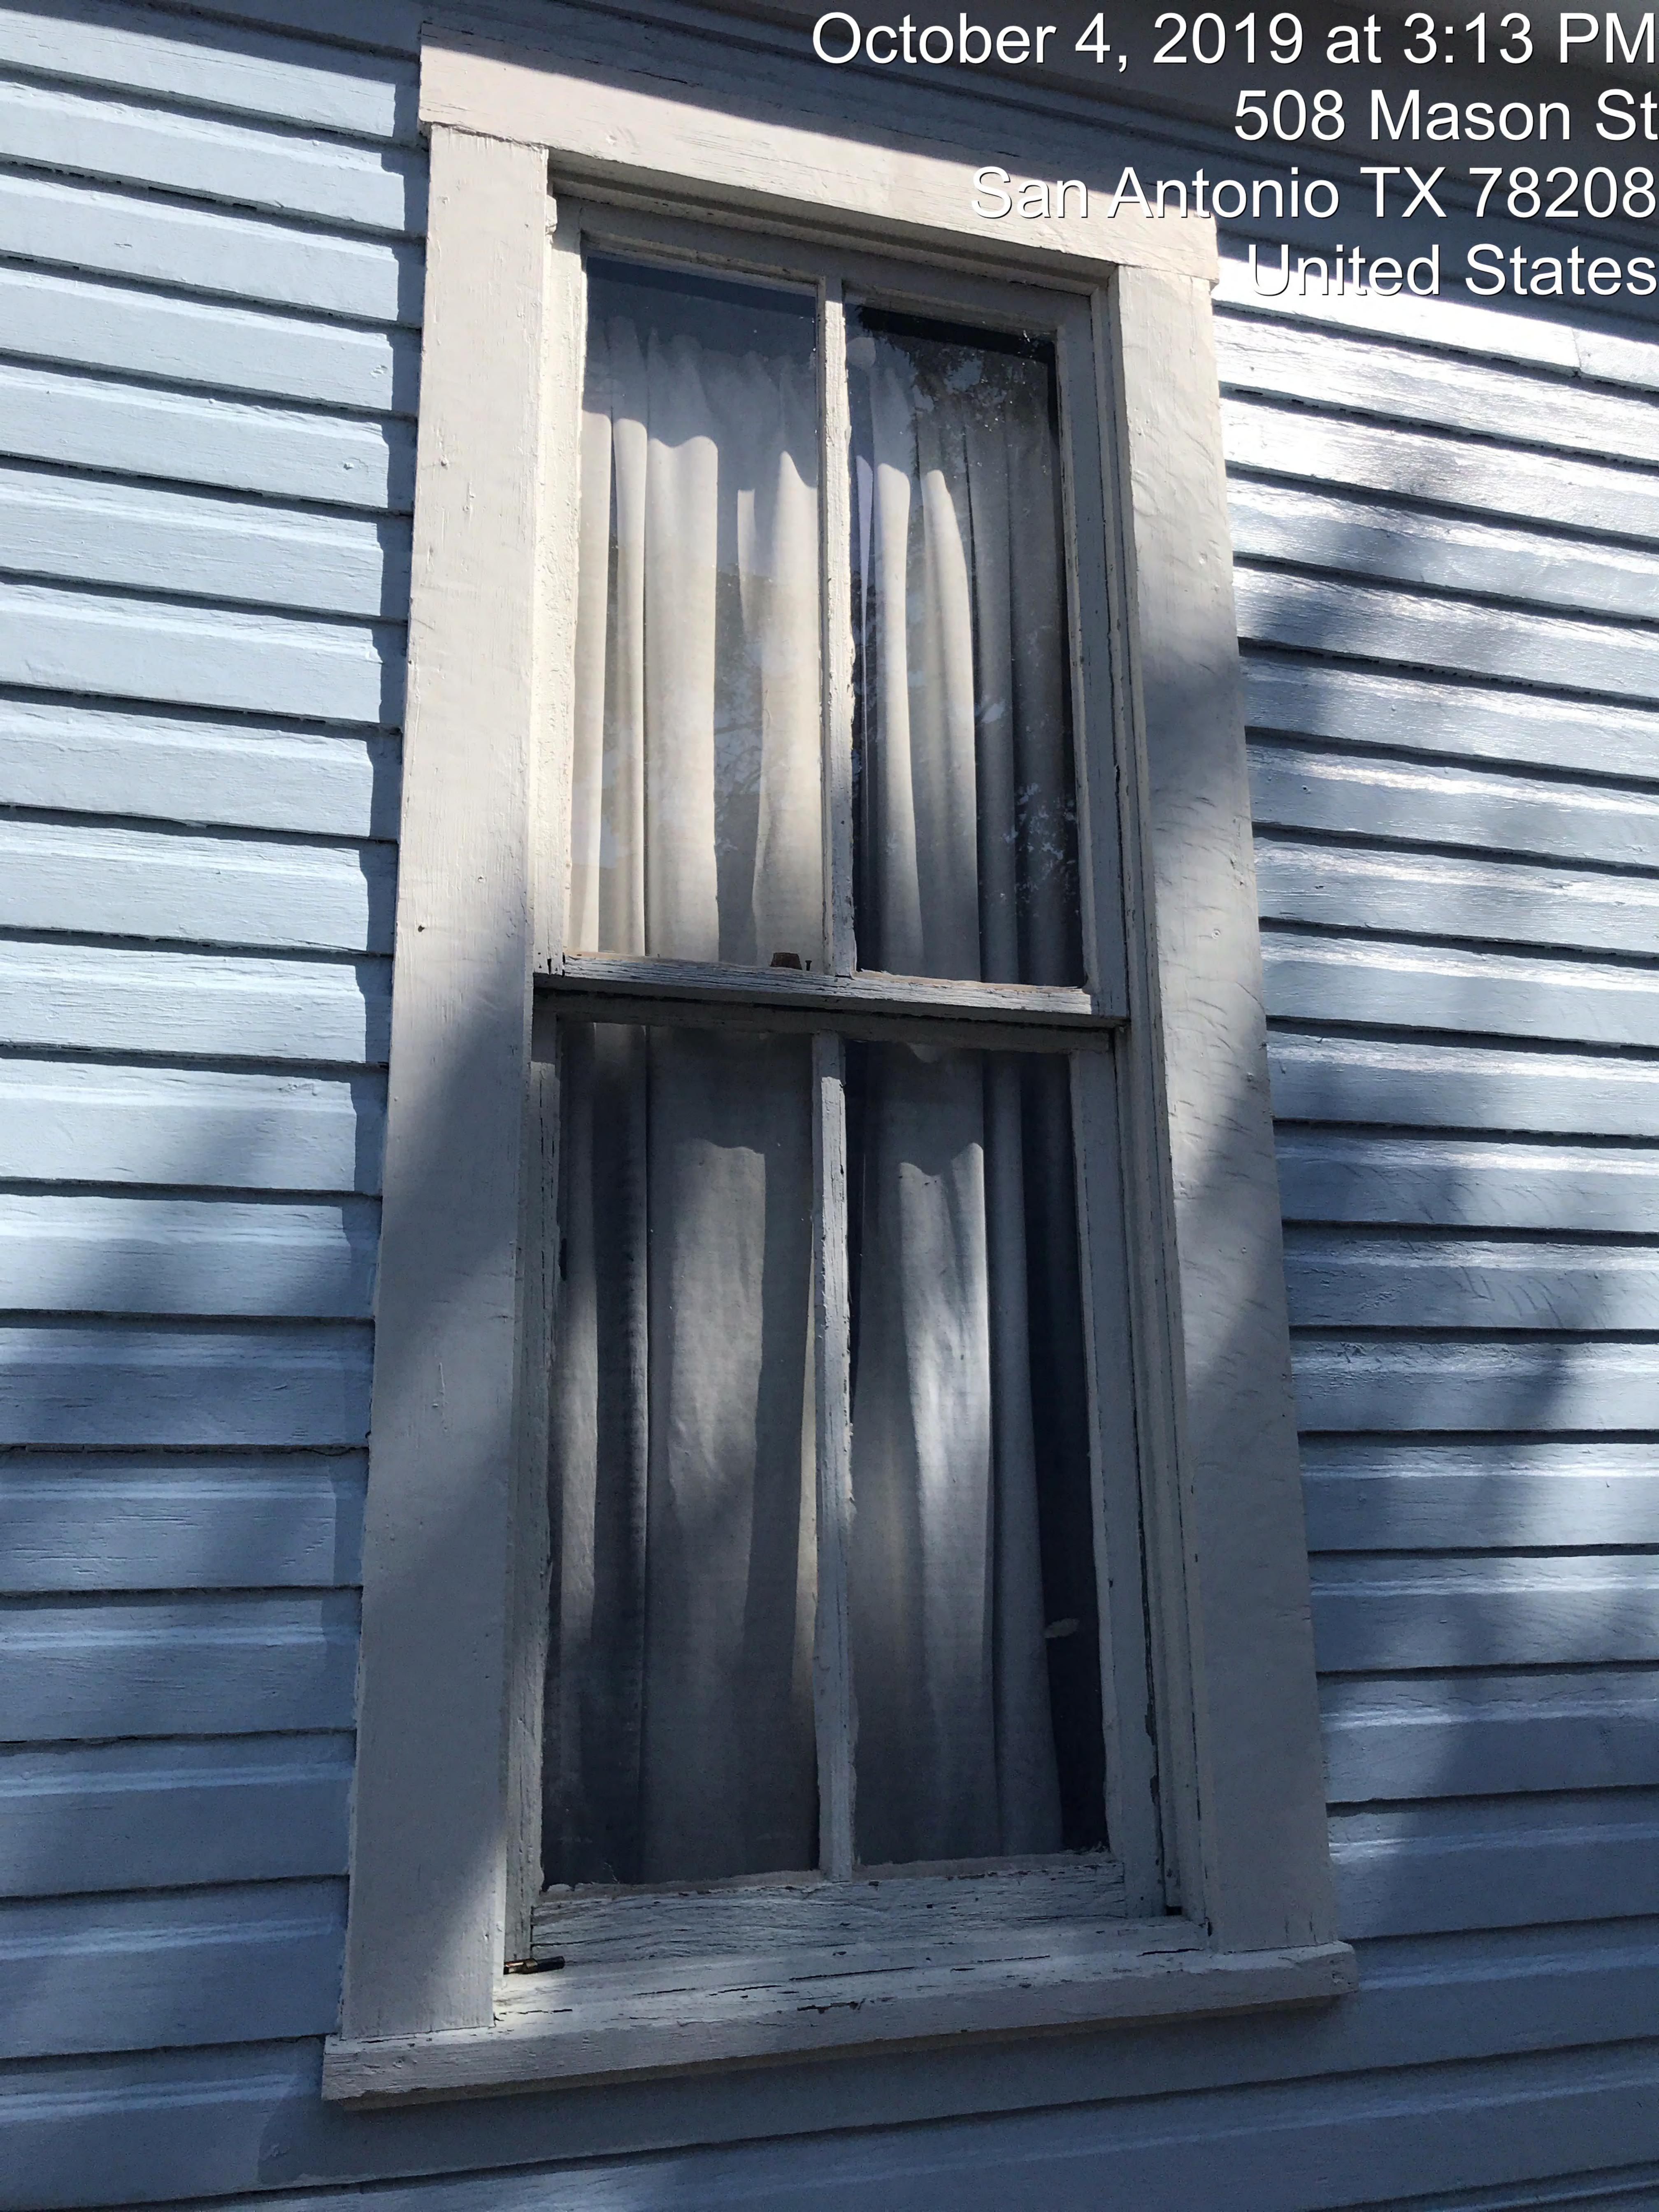
October 4, 2019

- c. SIDING TREATMENT The applicant has proposed to install new siding, and plywood on top of the original wood siding to cover deterioration. On a site visit on October 4, 2019, staff found that the wood siding was in good condition, with minimal water or insect damage. Staff finds that the request is generally inconsistent with the Guidelines for Exterior Maintenance and Alterations 1.A and B. Wood siding should be repaired in-place and only replaced when beyond repair. Wholesale replacement or covering would require approval by the Historic and Design Review Commission.

Staff does not recommend approval of items 1 through 3 based on the findings. Staff recommends that wood windows be repaired and that wood siding should be repaired in kind. Wholesale replacement of either should not occur.
