HISTORIC AND DESIGN REVIEW COMMISSION

November 20, 2019

HDRC CASE NO: 2019-683
ADDRESS: 1418 W ROSEWOOD AVE
LEGAL DESCRIPTION: NCB 2763 BLK 68 LOT 8
ZONING: R-4, H
CITY COUNCIL DIST.: 1
DISTRICT: Keystone Park Historic District
APPLICANT: David Rodriguez/J D ROMI GROUP LLC
OWNER: David Rodriguez/J D ROMI GROUP LLC
TYPE OF WORK: Window replacement
APPLICATION RECEIVED: November 06, 2019
60-DAY REVIEW: January 05, 2020
CASE MANAGER: Huy Pham

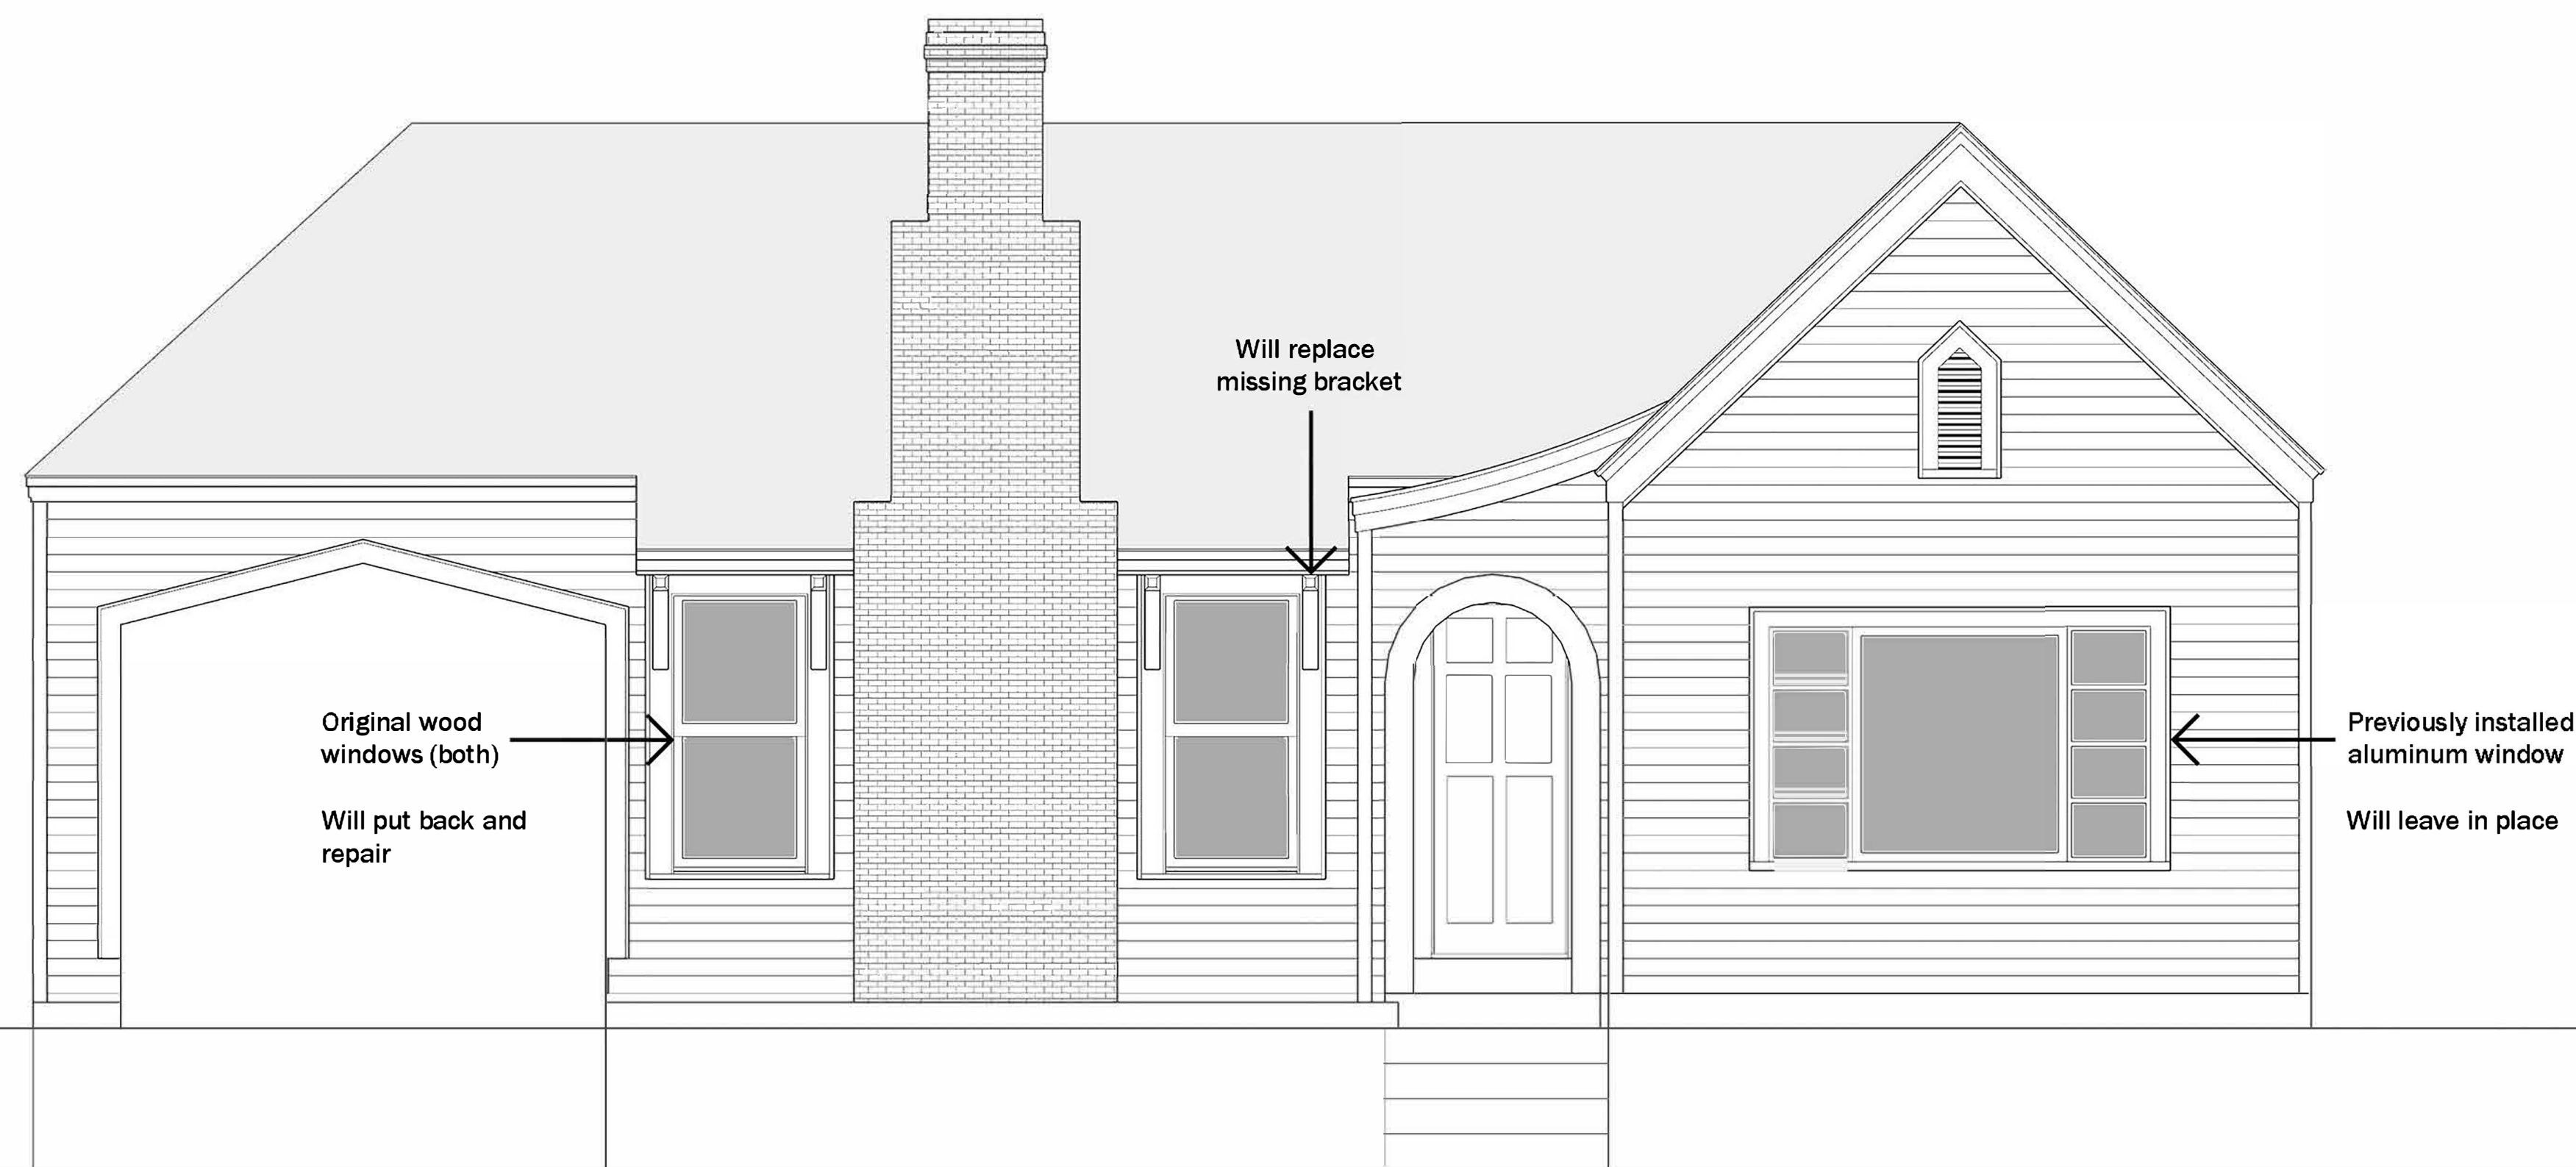
Existing gravel driveway has severe erosion. Driveway to be paved with concrete.

Exterior of house has had damaged original wood siding previously covered with vinyl siding.

Existing front steps have shifted and become a hazard. The intent is to adjust the existing steps to be flush with front walkway.

The intent is to replace damaged vinyl siding with new vinyl siding and paint.

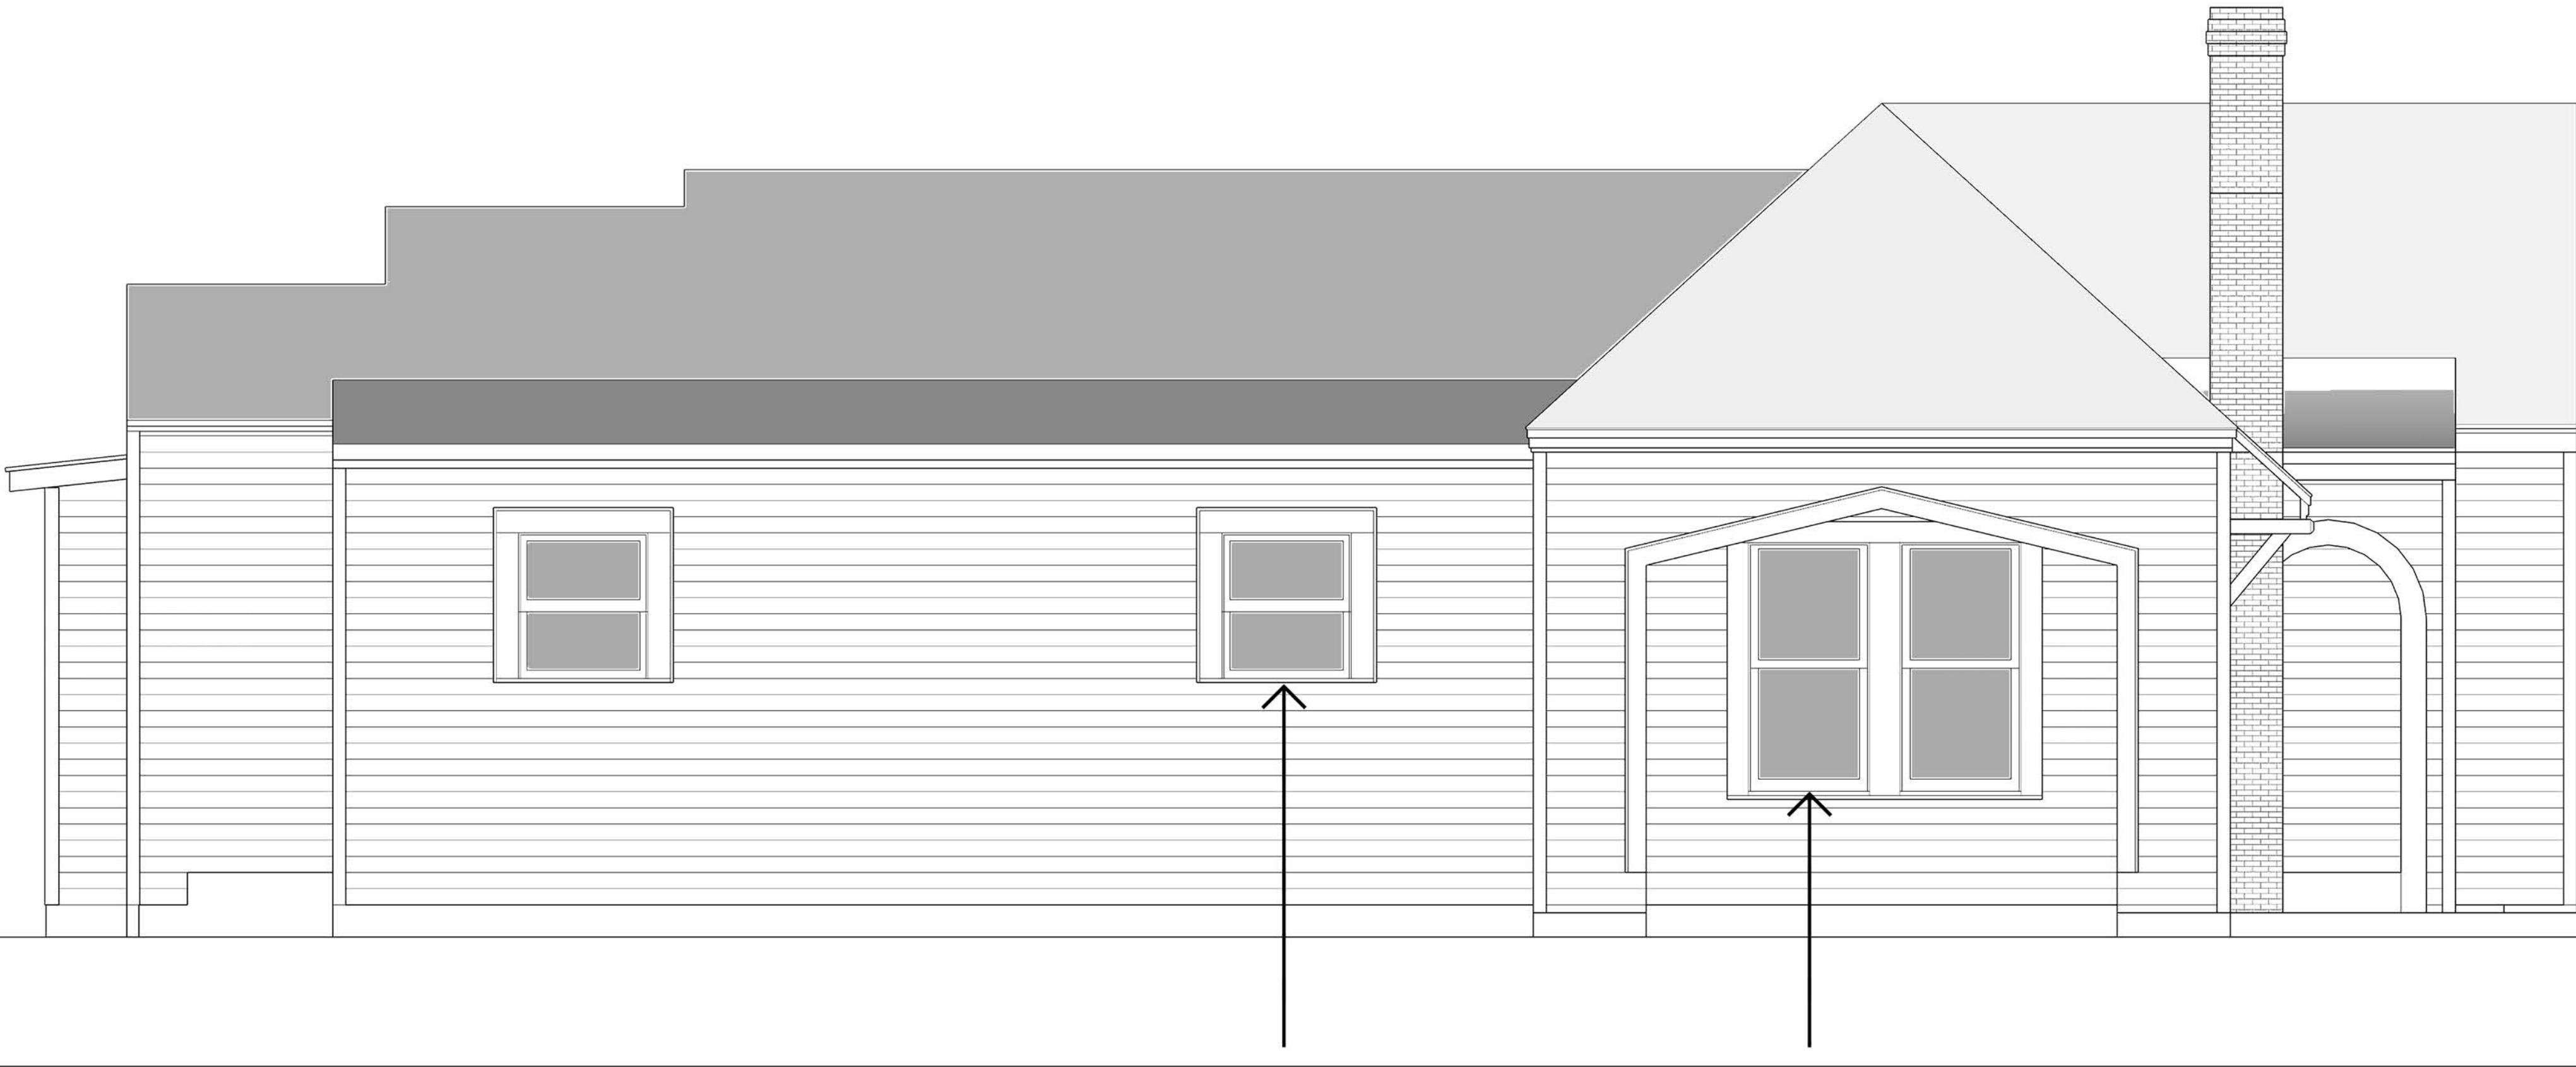
Previously enclosed porch was severely rotted as were the added walls and doors that completed the enclosure.

Walls reconstructed.
Matching vinyl siding will be put on this wall to match the rest of the exterior.

New 35" x 35" Aluminum Windows

Both installed on this wall to make the interior more functional

Original wood windows (both)

Will leave in place

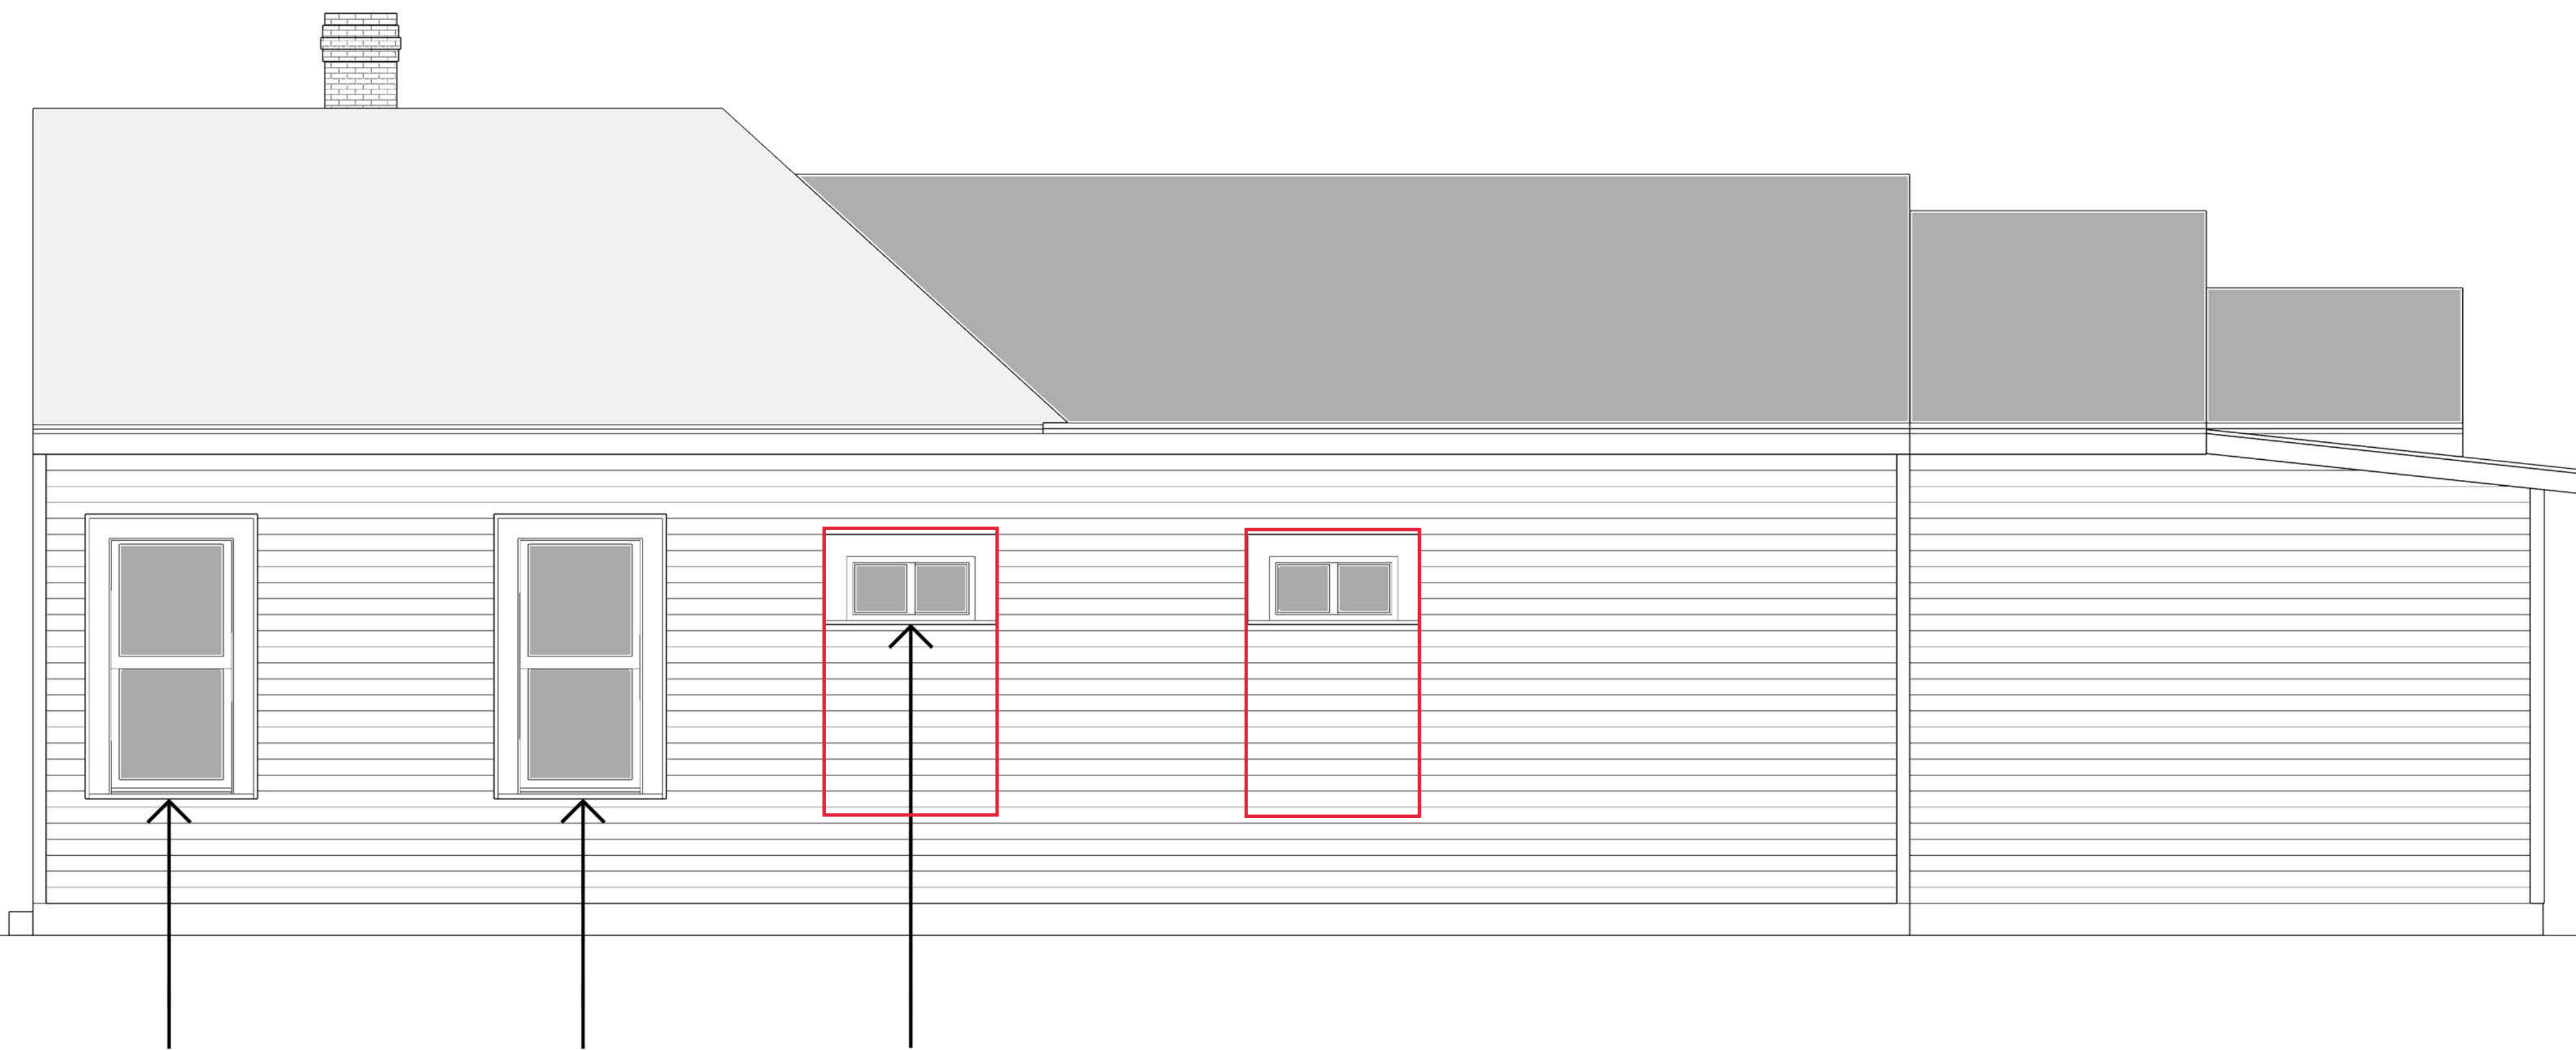
Original wood window to be left in place.

Original wood window to be reinstaled and repaired.

New 18" x 35" Aluminum Windows installed on this wall to correspond with interior (both).

The applicant has withdrawn the request to change these two window opening sizes.

The sizes will be restored with the request to replace with aluminum.

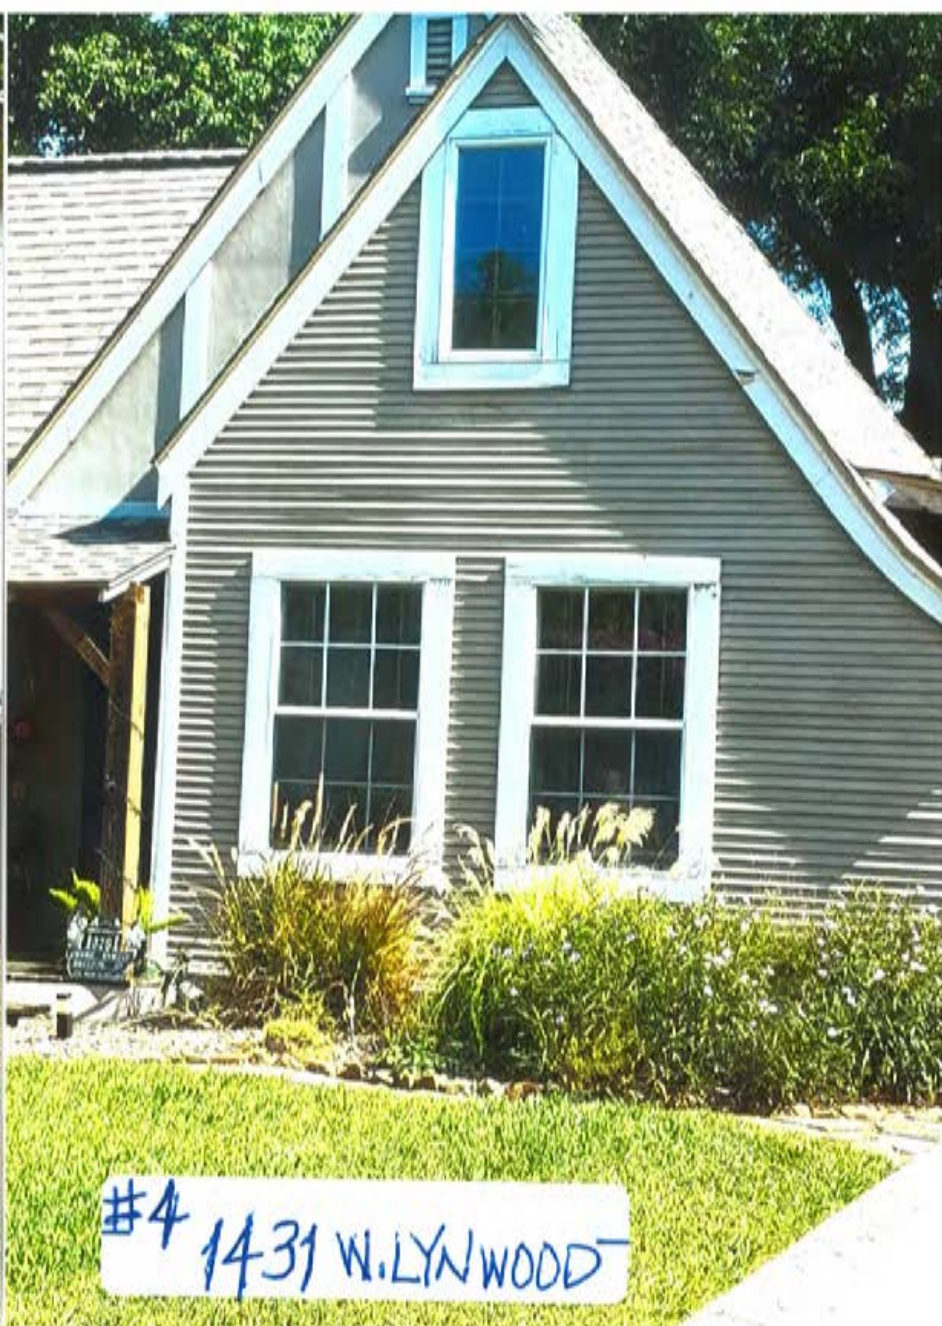
#4 1431 W. LYNWOOD

USED PROPOSED WINDOWS
AT THIS PROPERTY.
