HISTORIC AND DESIGN REVIEW COMMISSION

February 05, 2020

HDRC CASE NO: 2020-033
ADDRESS: 418 MISSION ST
LEGAL DESCRIPTION: NCB 945 BLK 2 LOT 32
ZONING: RM-4 CD, H
CITY COUNCIL DIST.: 1
DISTRICT: King William Historic District
APPLICANT: SCHEFF DENIESE M & CRITTENDEN ROBERT JR
OWNER: SCHEFF DENIESE M & CRITTENDEN ROBERT JR
TYPE OF WORK: Amendment to rear addition windows
APPLICATION RECEIVED: January 17, 2020
60-DAY REVIEW: March 16, 2020
CASE MANAGER: Huy Pham

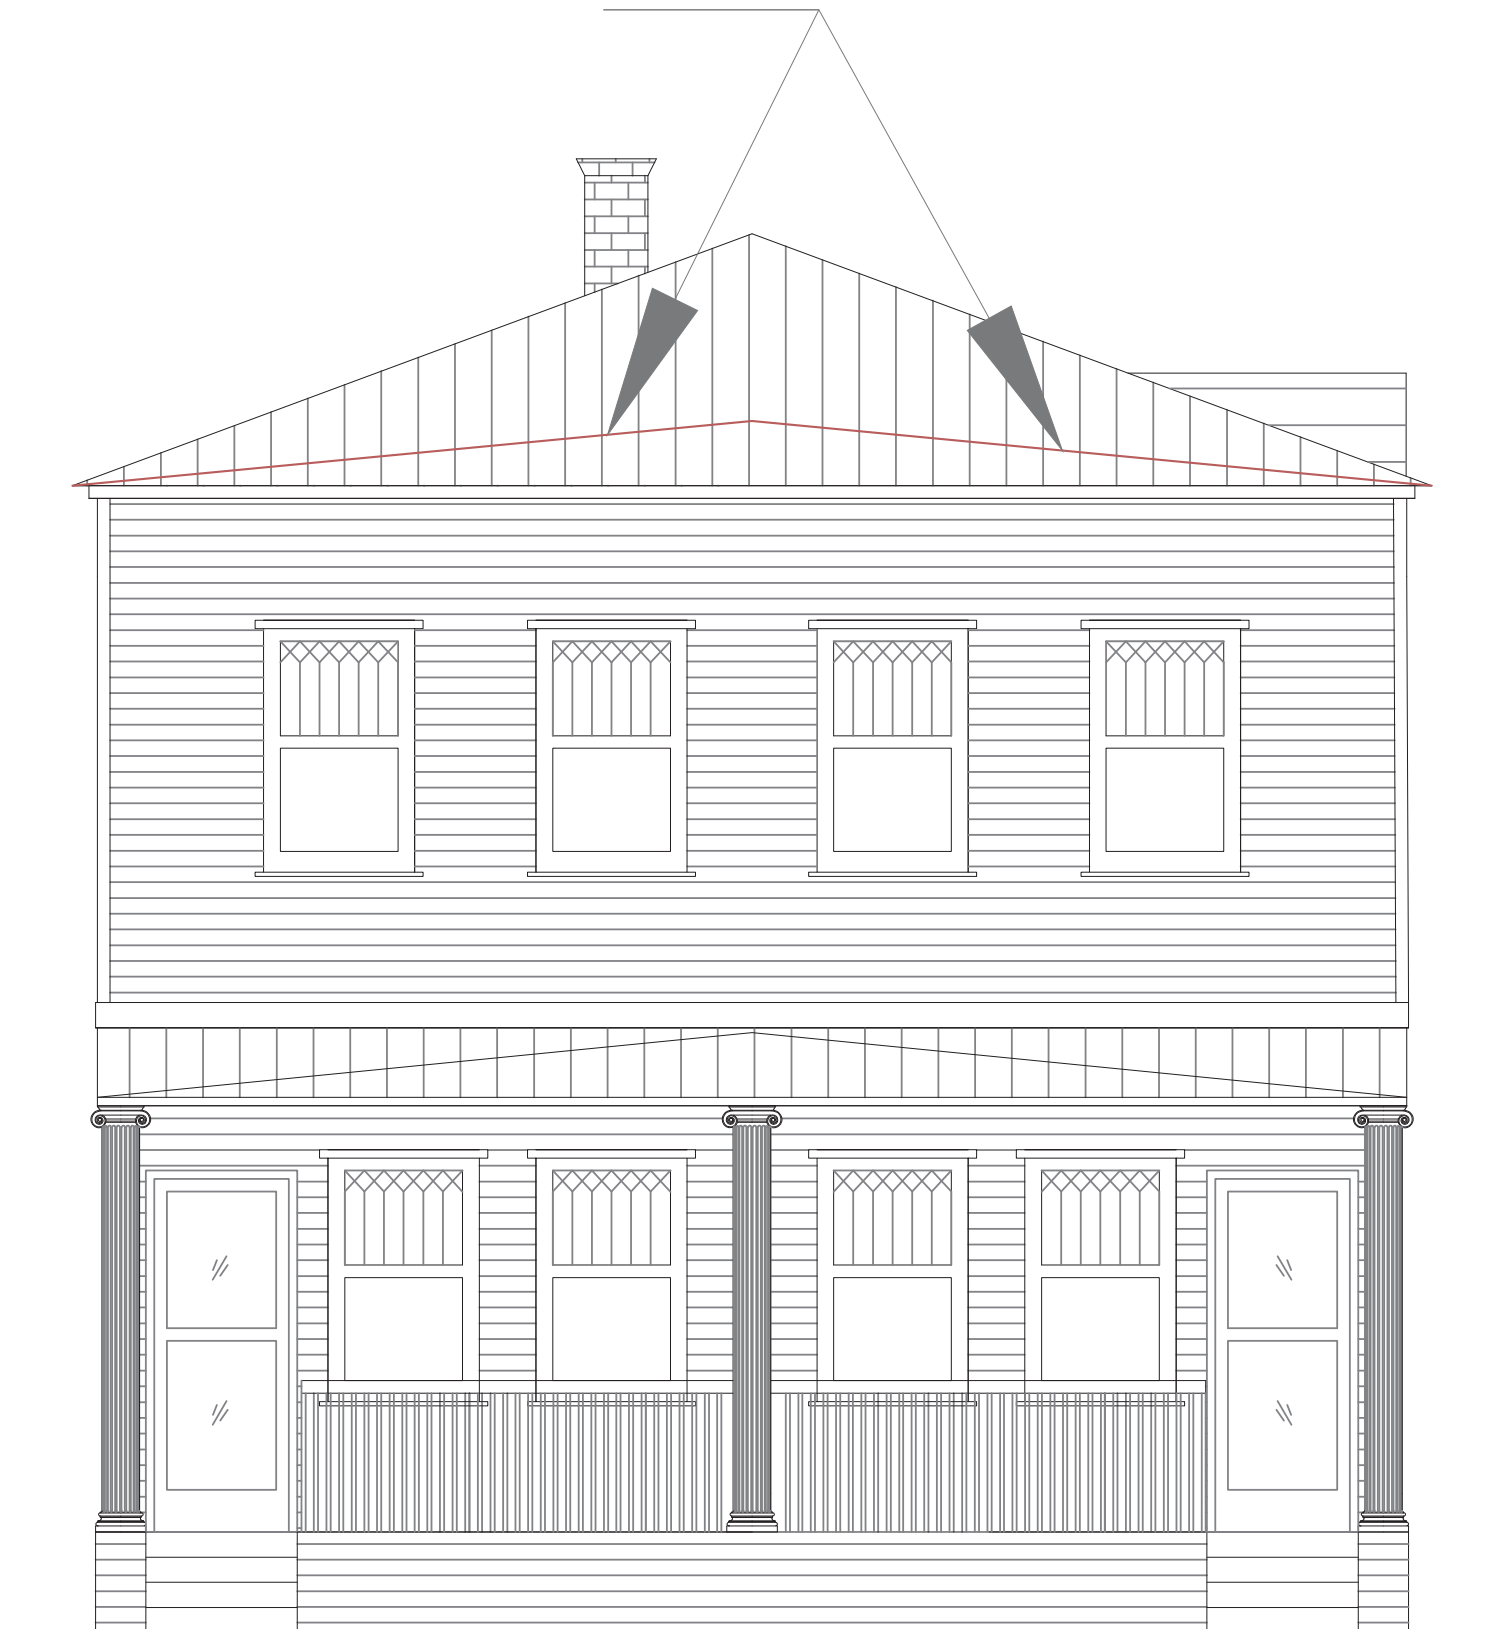
PRIMARY RESIDENCE: Back Elevation

New roof

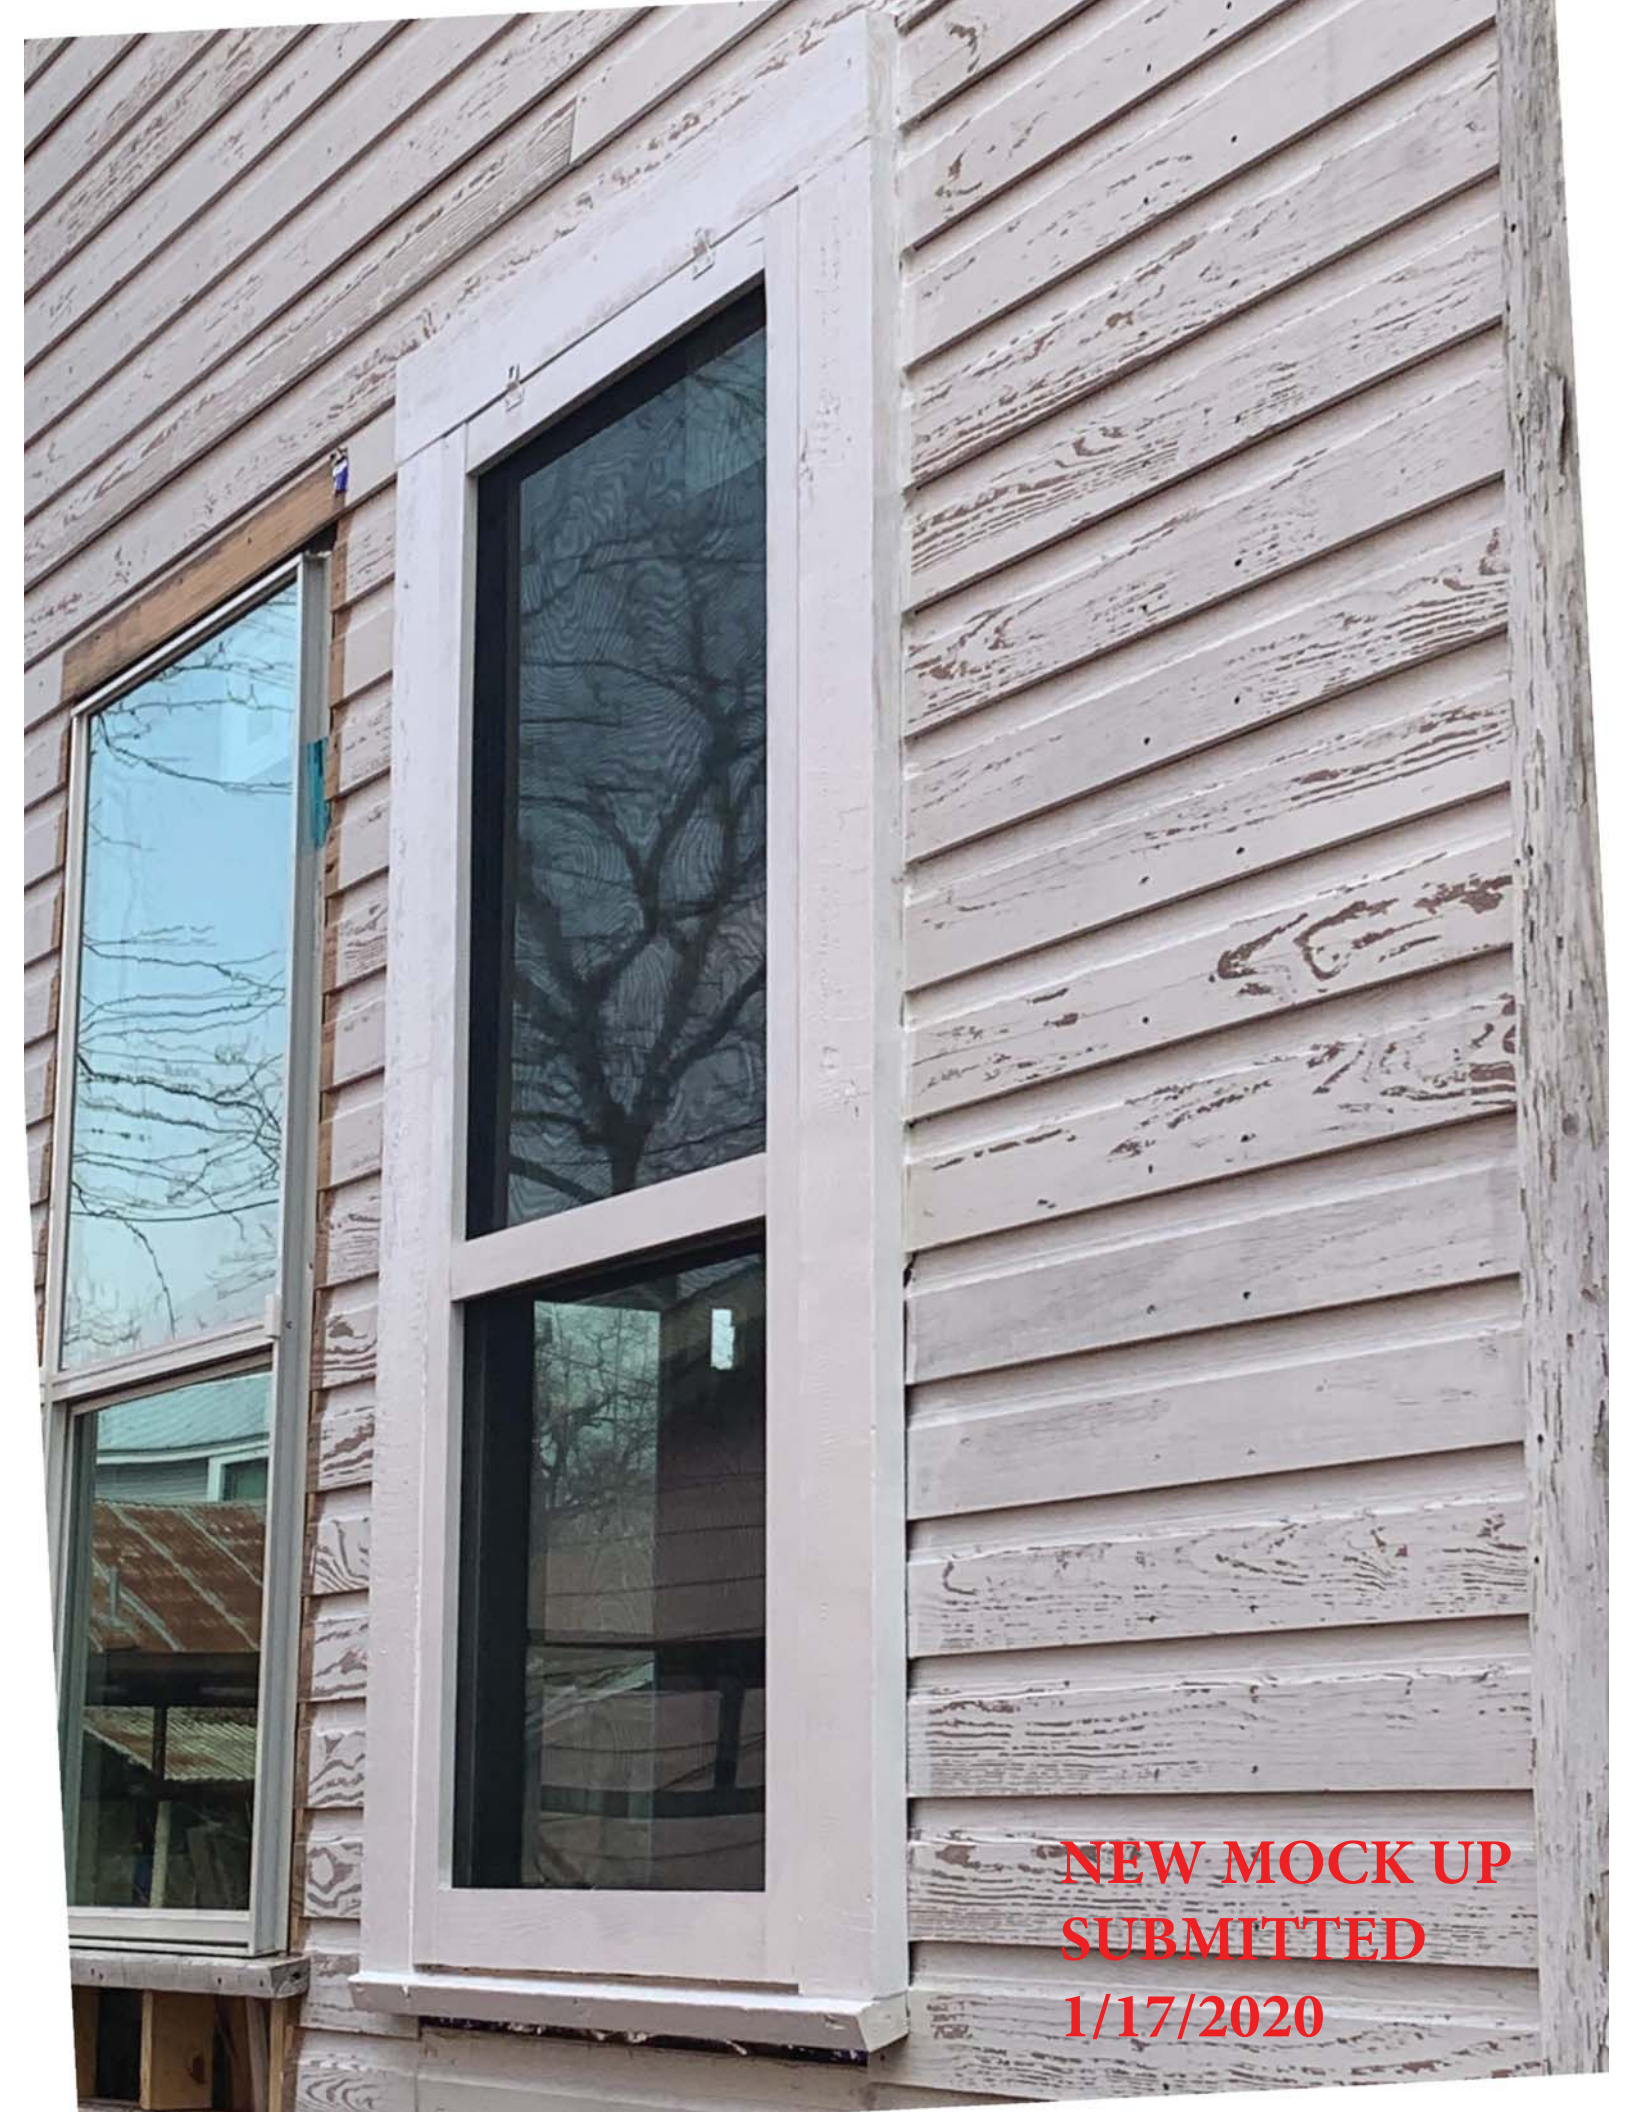
NEW MOCK UP SUBMITTED 1/17/2020

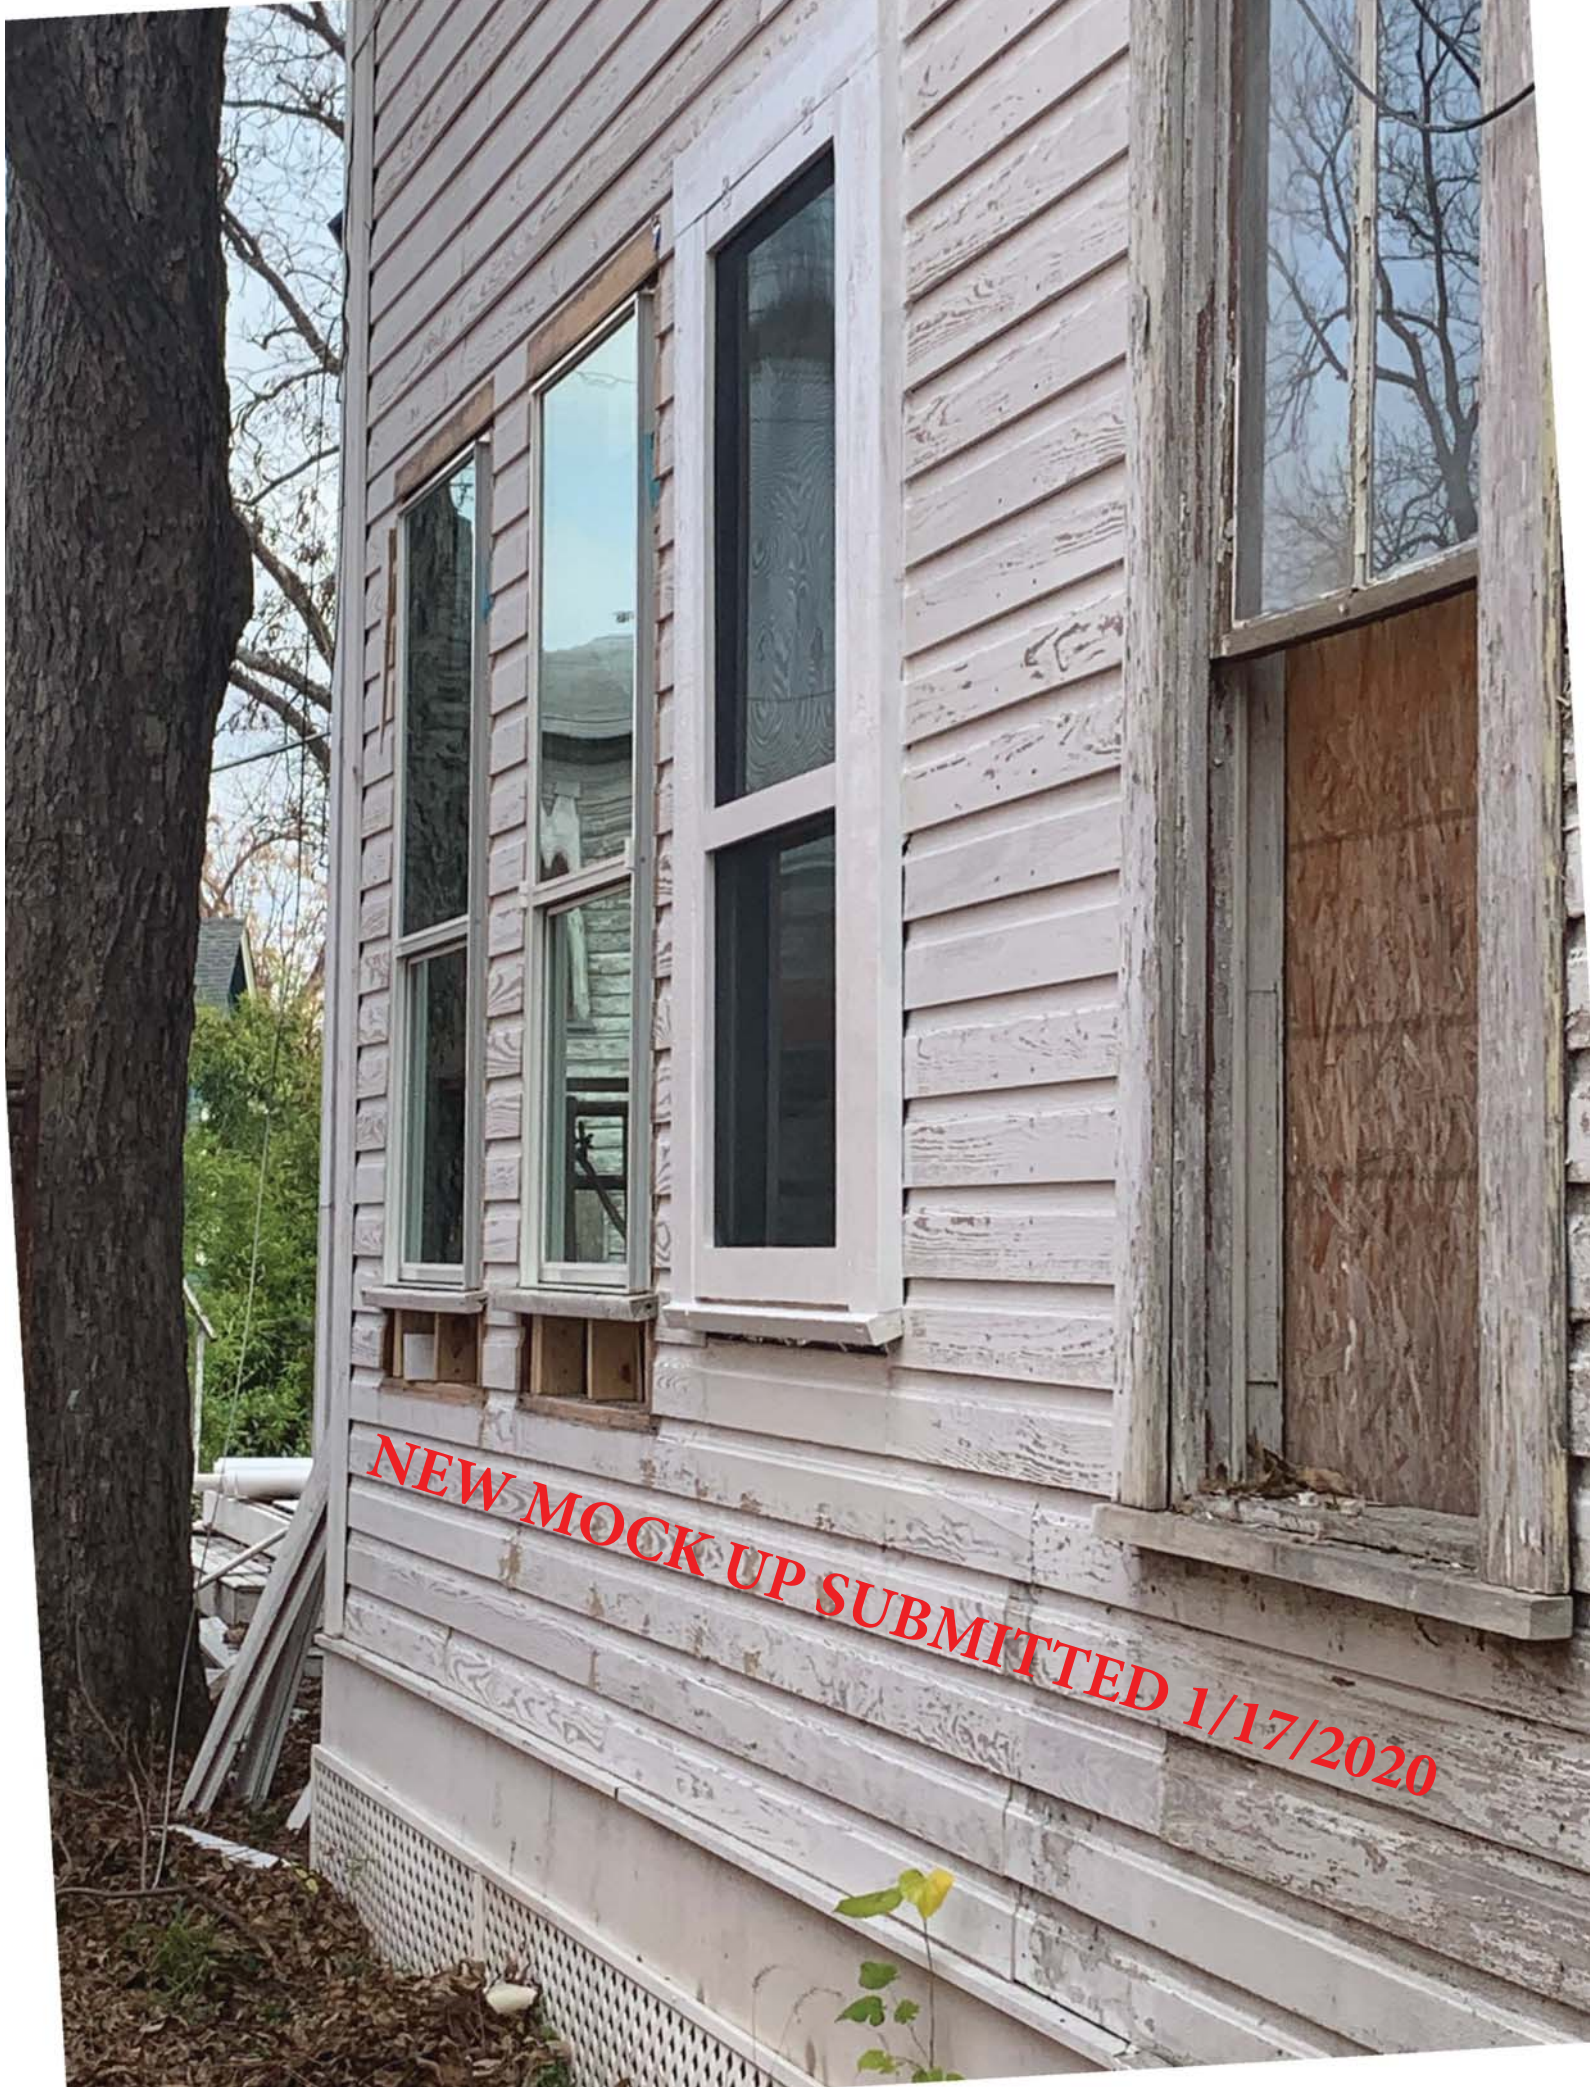
**NEW MOCK UP
SUBMITTED
1/17/2020**
