## HISTORIC AND DESIGN REVIEW COMMISSION

February 05, 2020

**HDRC CASE NO:** 2020-031  
**ADDRESS:** 533 E CARSON  
**LEGAL DESCRIPTION:** NCB 993 BLK 3 LOT S 96.91 FT 7 (ARB 7C)  
**ZONING:** MF-33, H  
**CITY COUNCIL DIST.:** 2  
**DISTRICT:** Government Hill Historic District  
**APPLICANT:** Mary Jo Vargas  
**OWNER:** Mary Jo Vargas  
**TYPE OF WORK:** Siding and window replacement  
**APPLICATION RECEIVED:** January 17, 2020  
**60-DAY REVIEW:** March 16, 2020  
**CASE MANAGER:** Huy Pham

# 533 E Carson

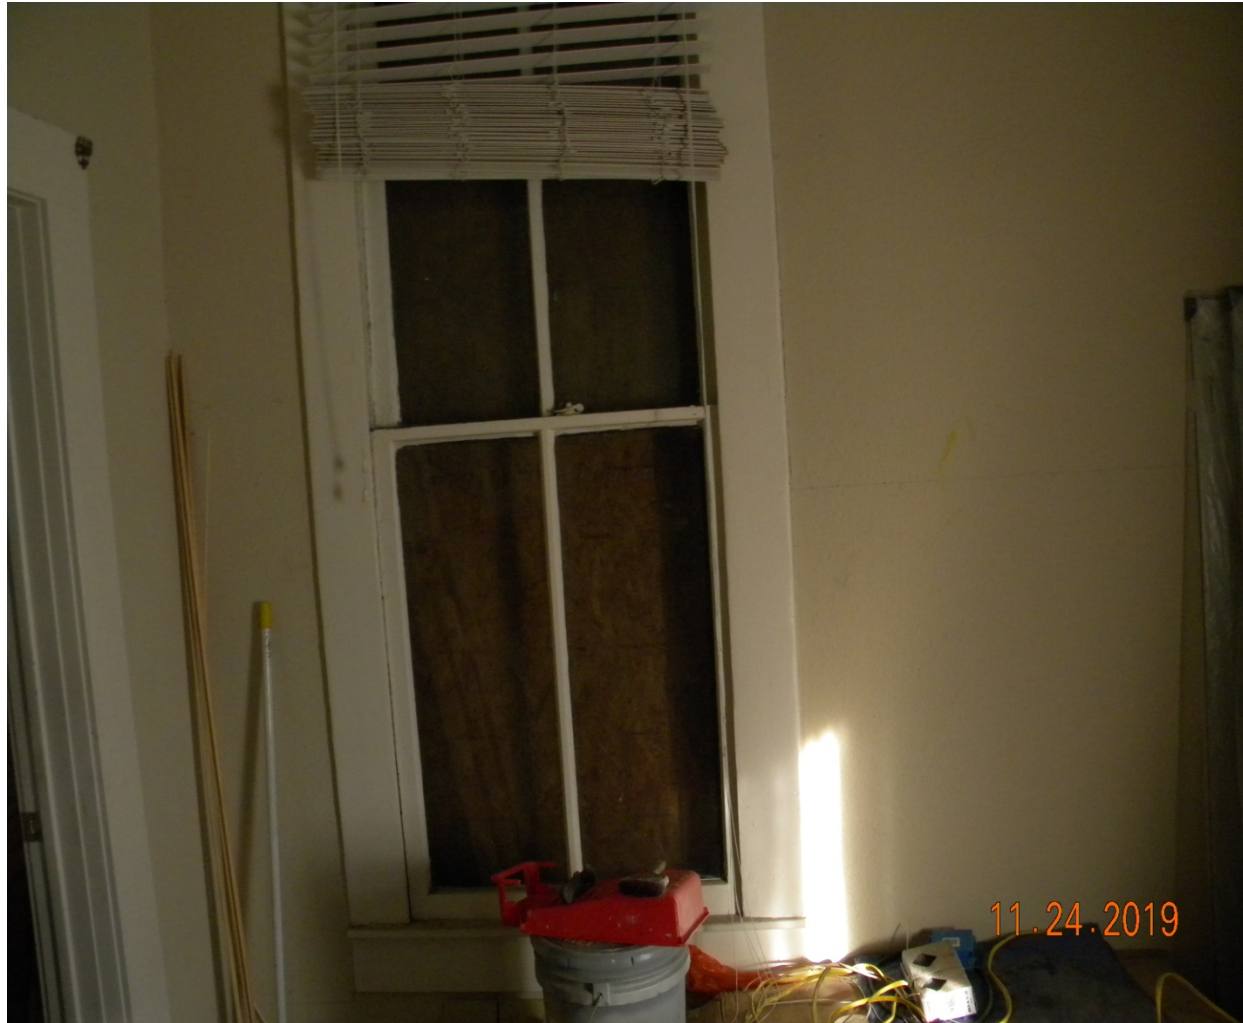
# Unit I, Living Room, Window B

Requires lead  
paint  
remediation  
and repairs.

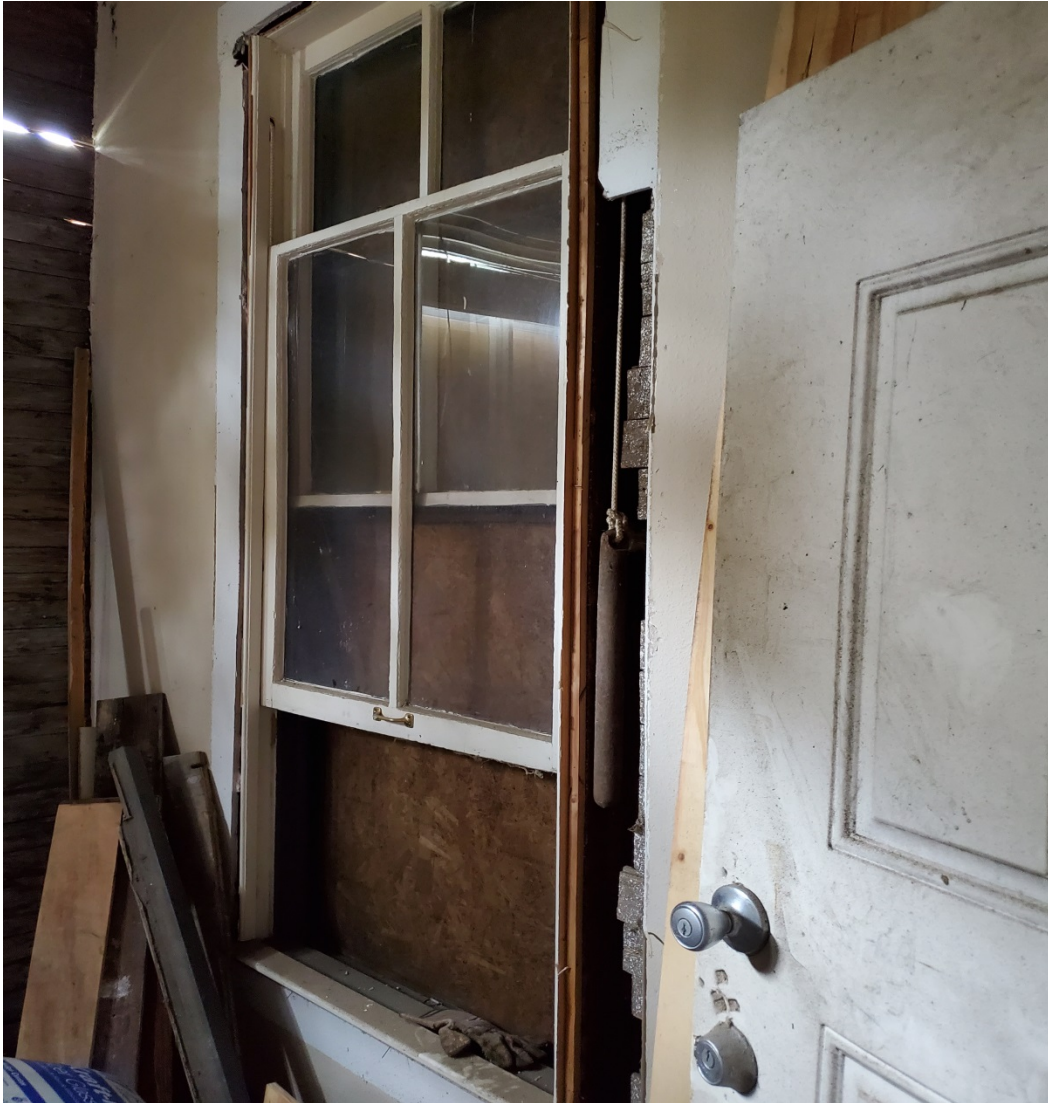
# Unit I, Bedroom 1, Window C

Requires lead  
paint  
remediation  
and repairs.

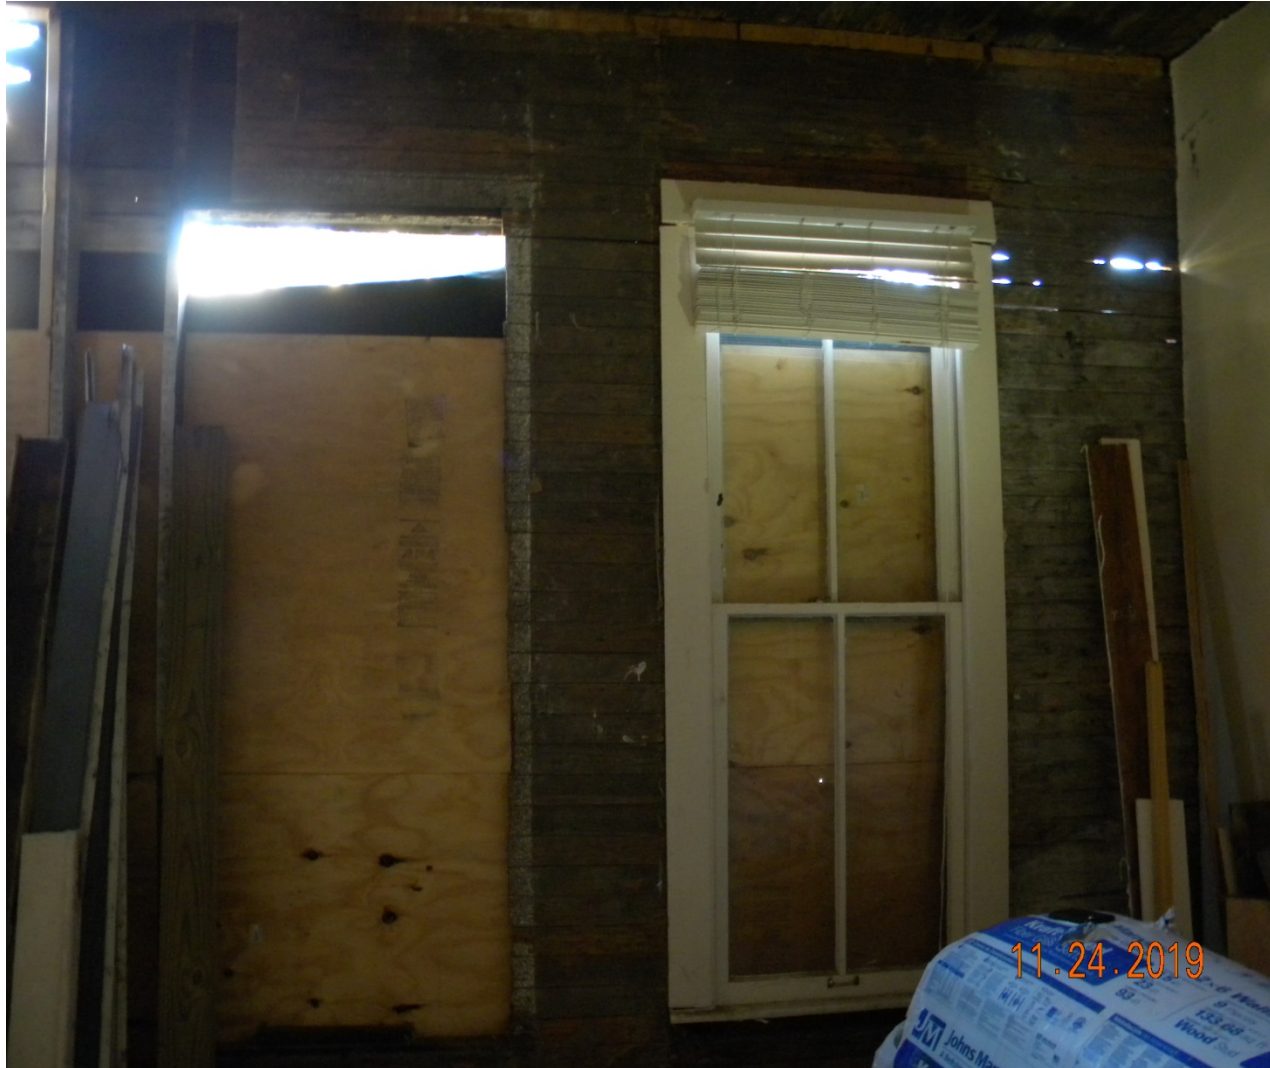
# Unit I, Bedroom 1, Windows

Windows D  
and E of  
Unit I,  
Bedroom 1

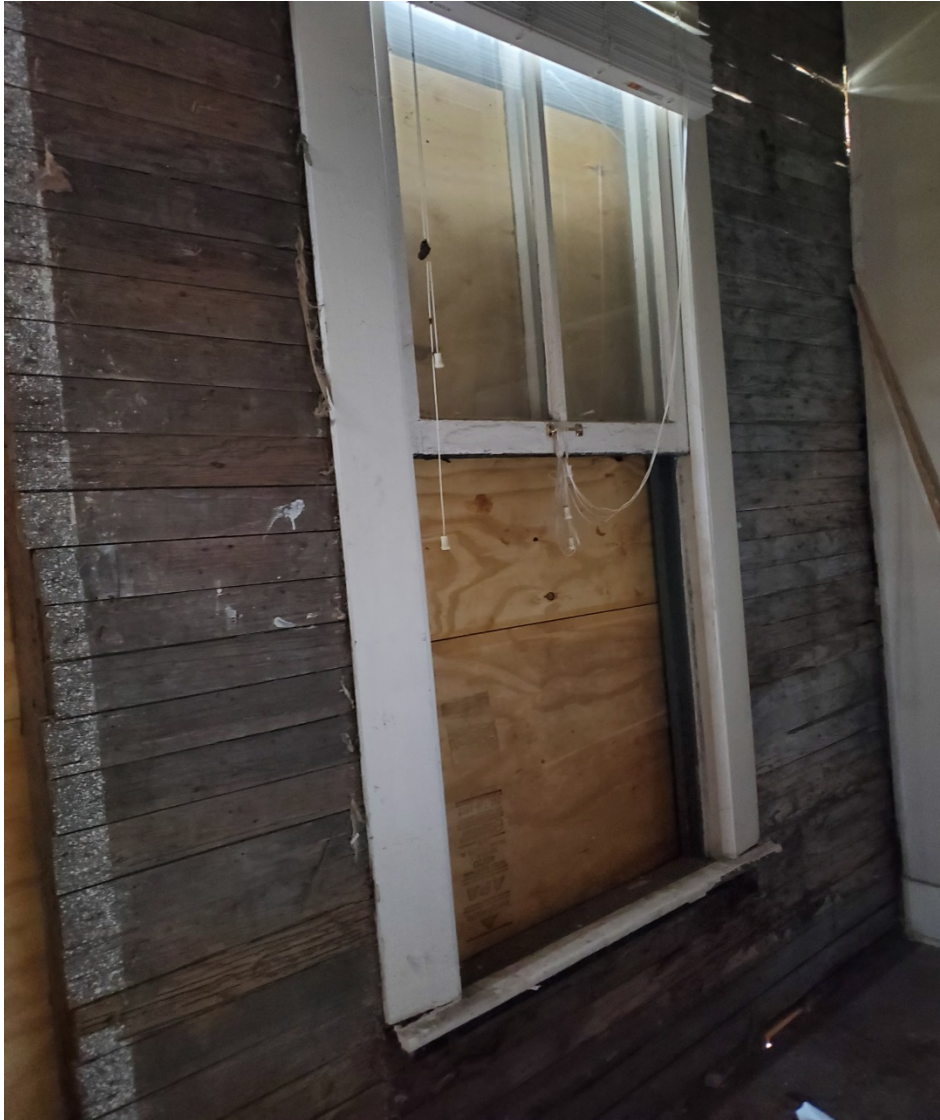
# Unit I, Bedroom 1, Window D

Requires lead  
paint  
remediation  
and repairs.

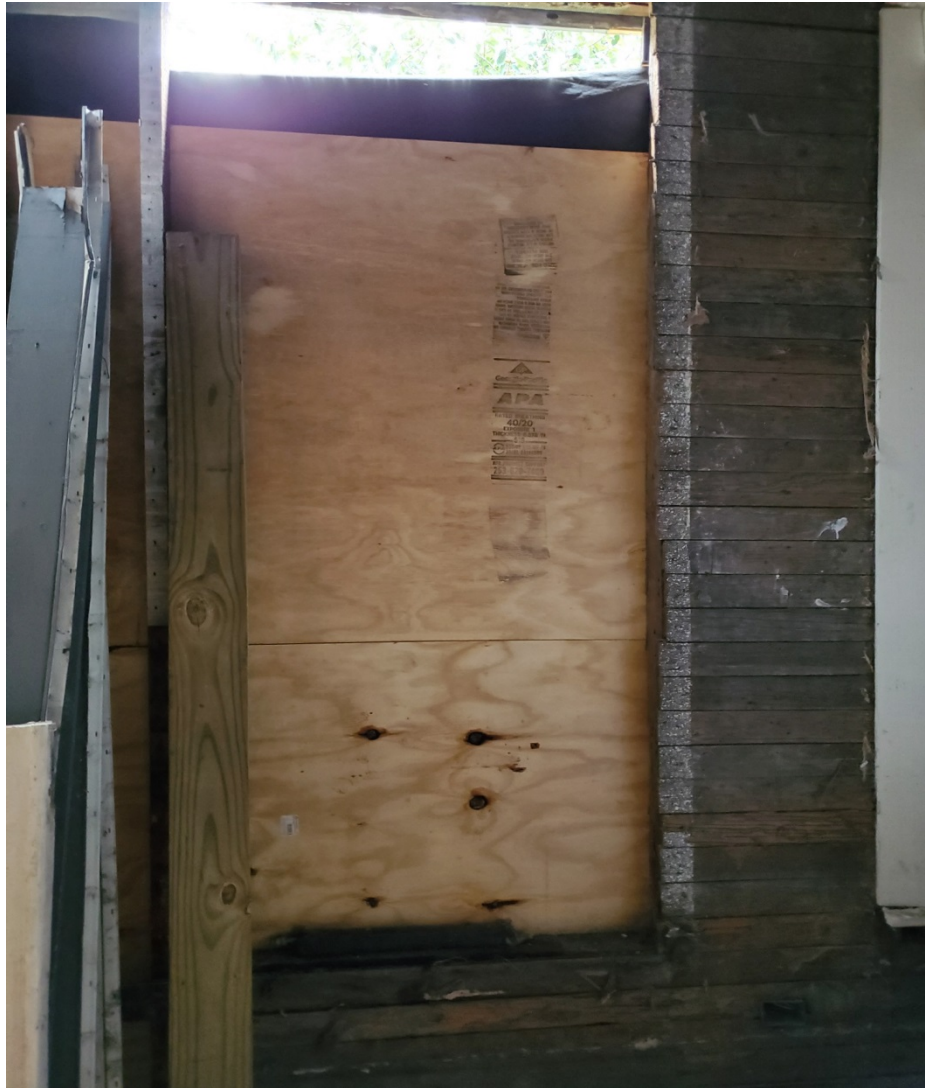
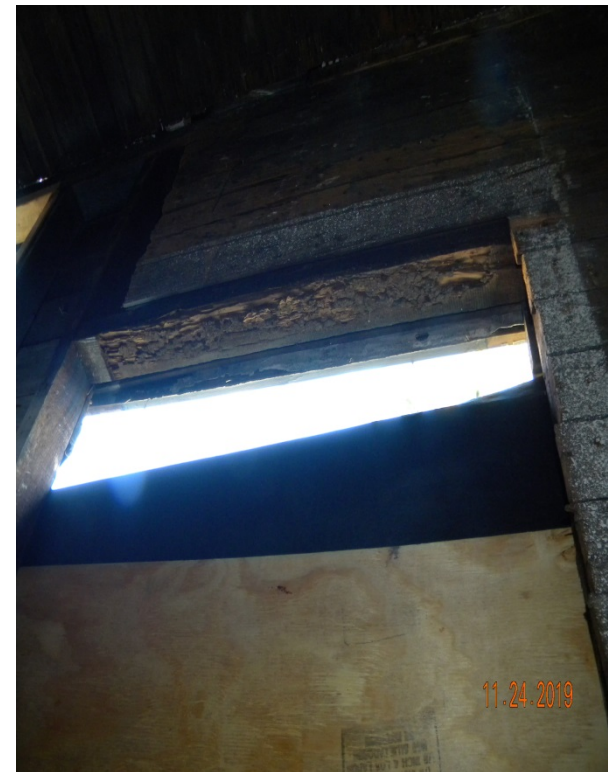
# Unit I, Bedroom 1, Window E

Window burned and damaged during fire suppression activities.

2. Staff recommends approval of window replacement for only one window (window E) based on finding d. The other eleven (11) windows are found to be repairable, where the applicant may replace missing or deteriorate elements such as individual sashes or casing, instead of discarding the complete historic window system. All window repair and replacement must adhere to *Standard Specifications for Original Wood Window Replacement*.

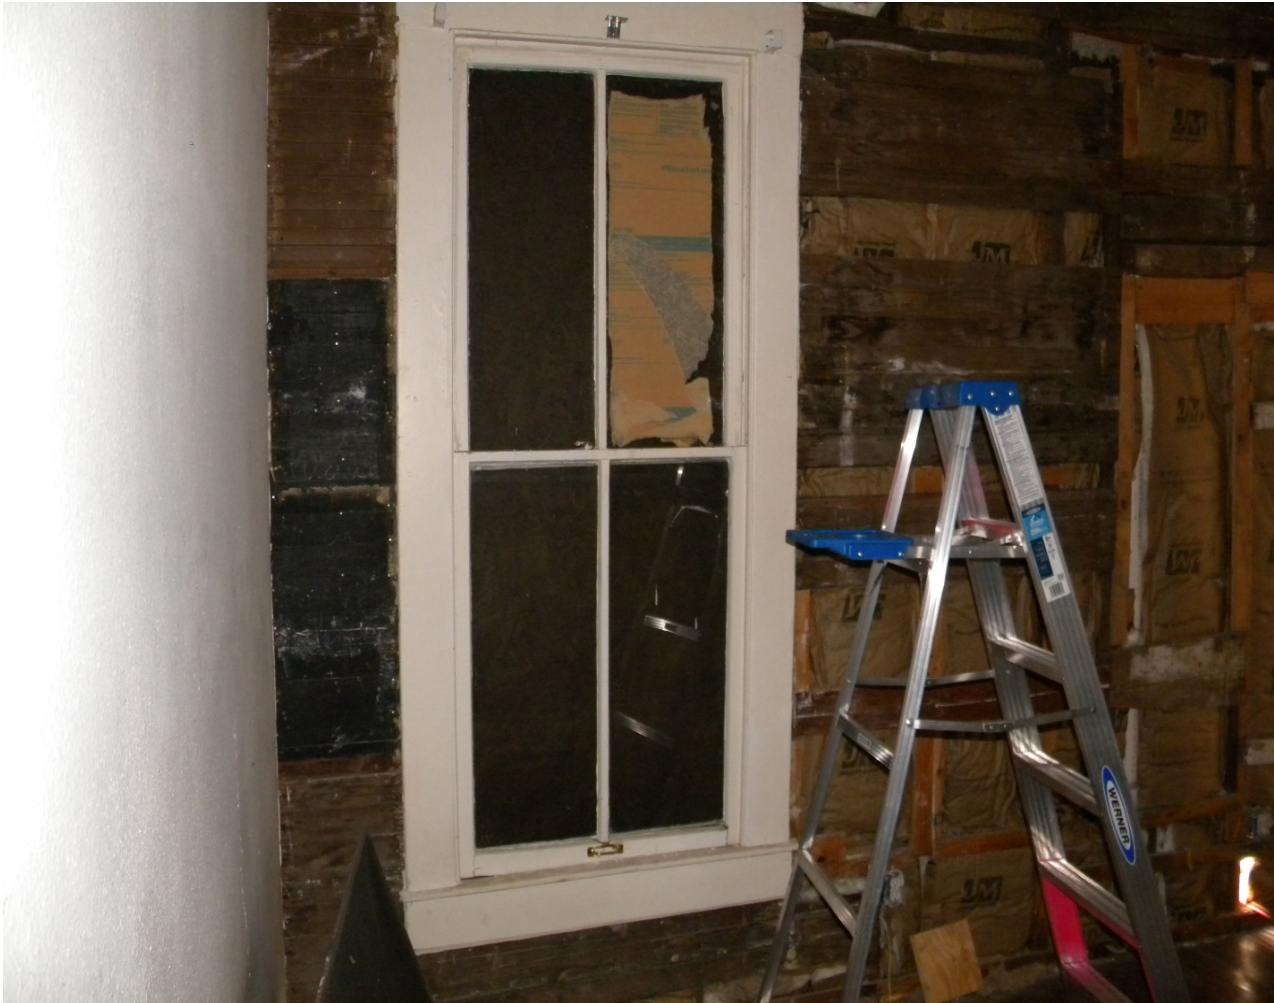
# Unit I, Bedroom 2, Window F

Requires lead paint remediation and repairs. Next two slides provide closer view of window.

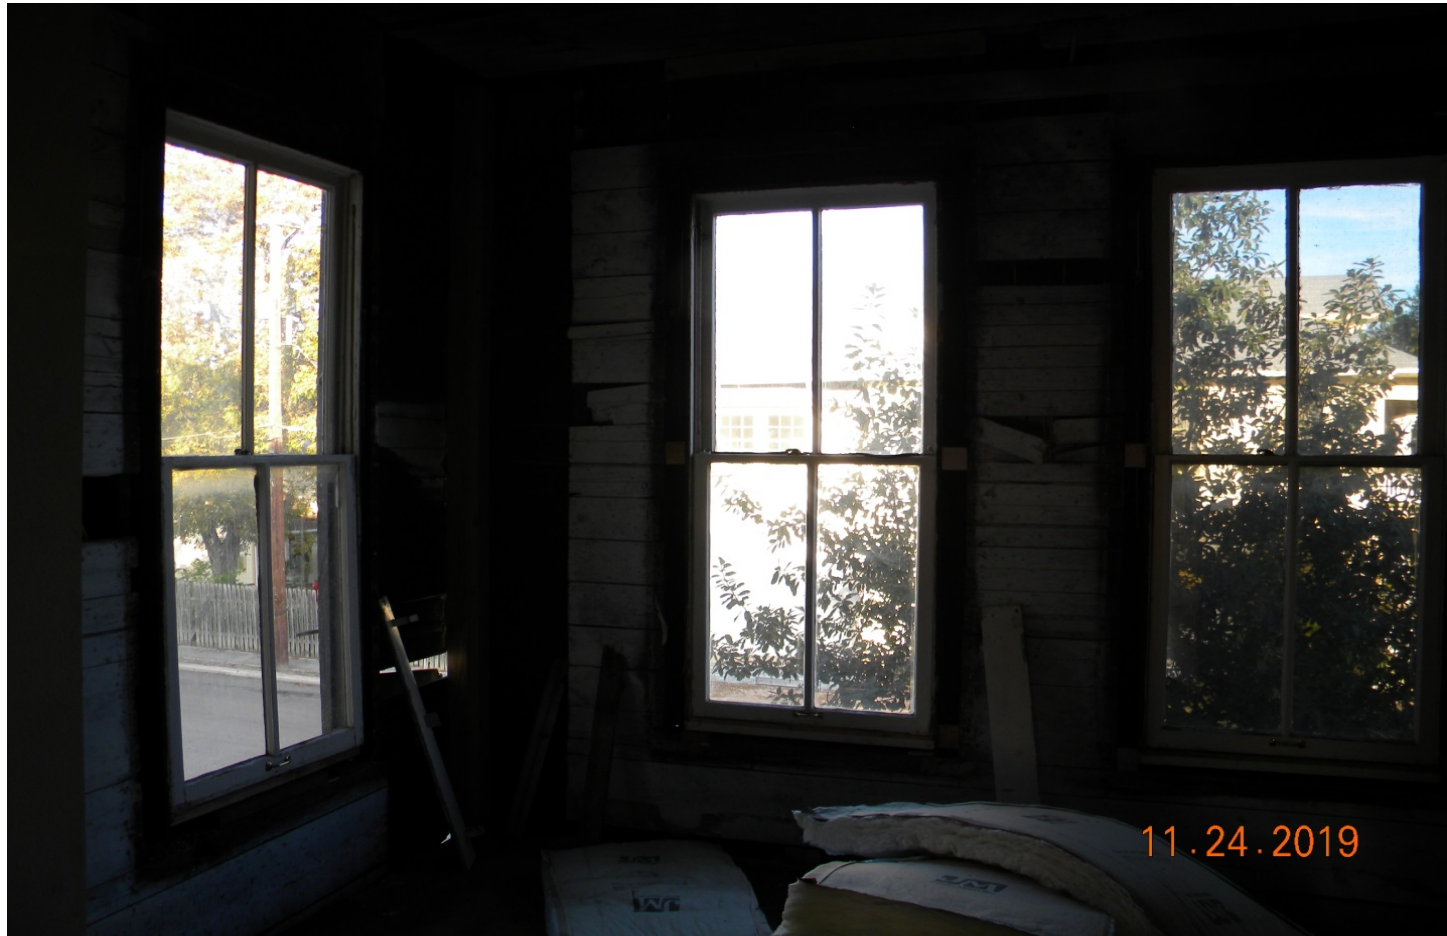
# Unit III, Bedroom 1, Windows

Windows from right to left are H, I and J

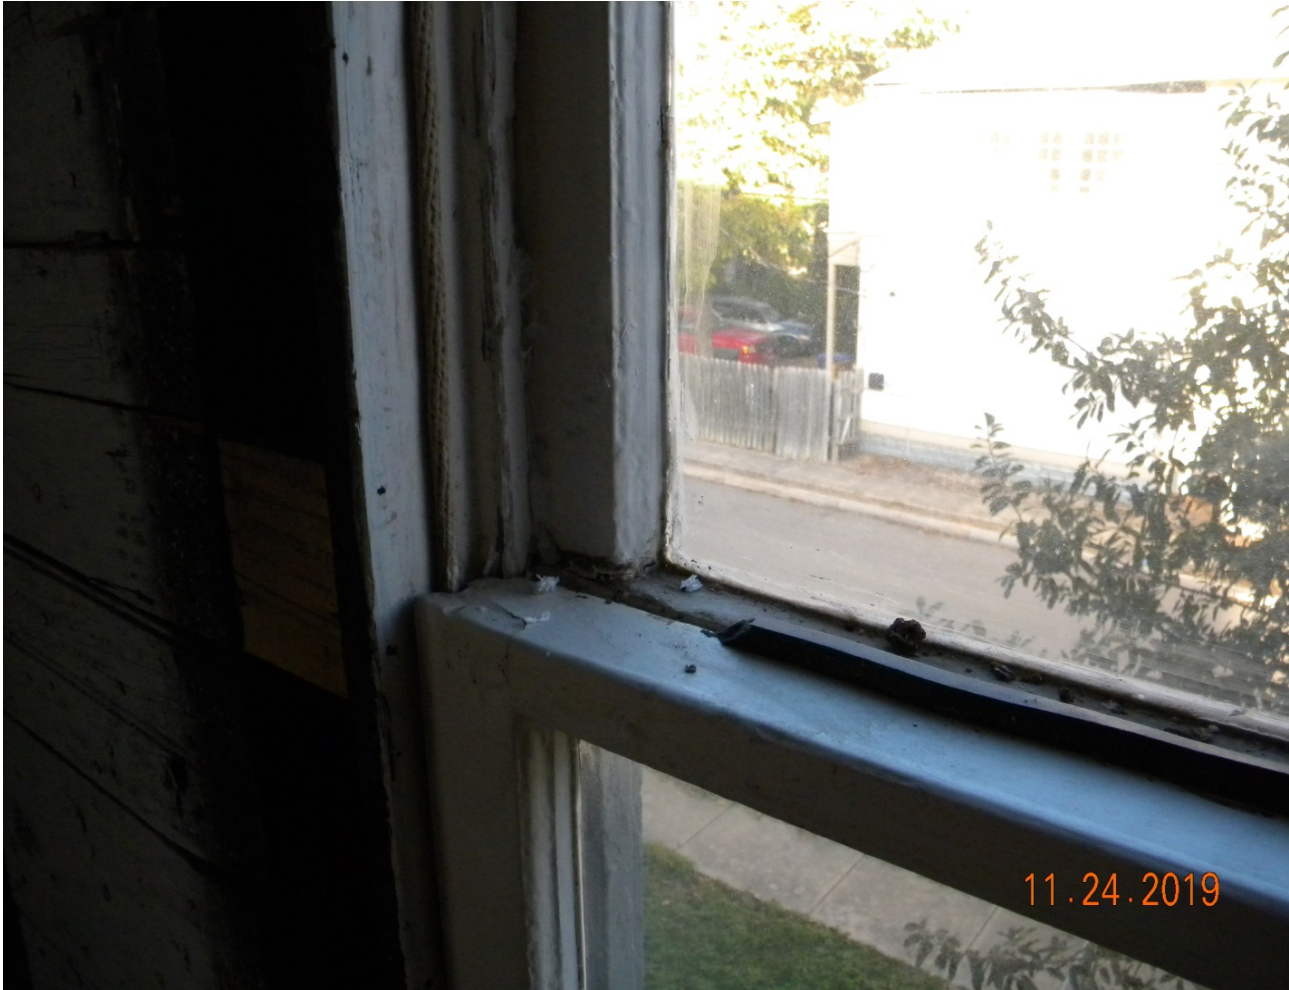
# Unit III, Bedroom 1, Window H

Use of foam  
between  
windows to  
reduce air  
drafts.

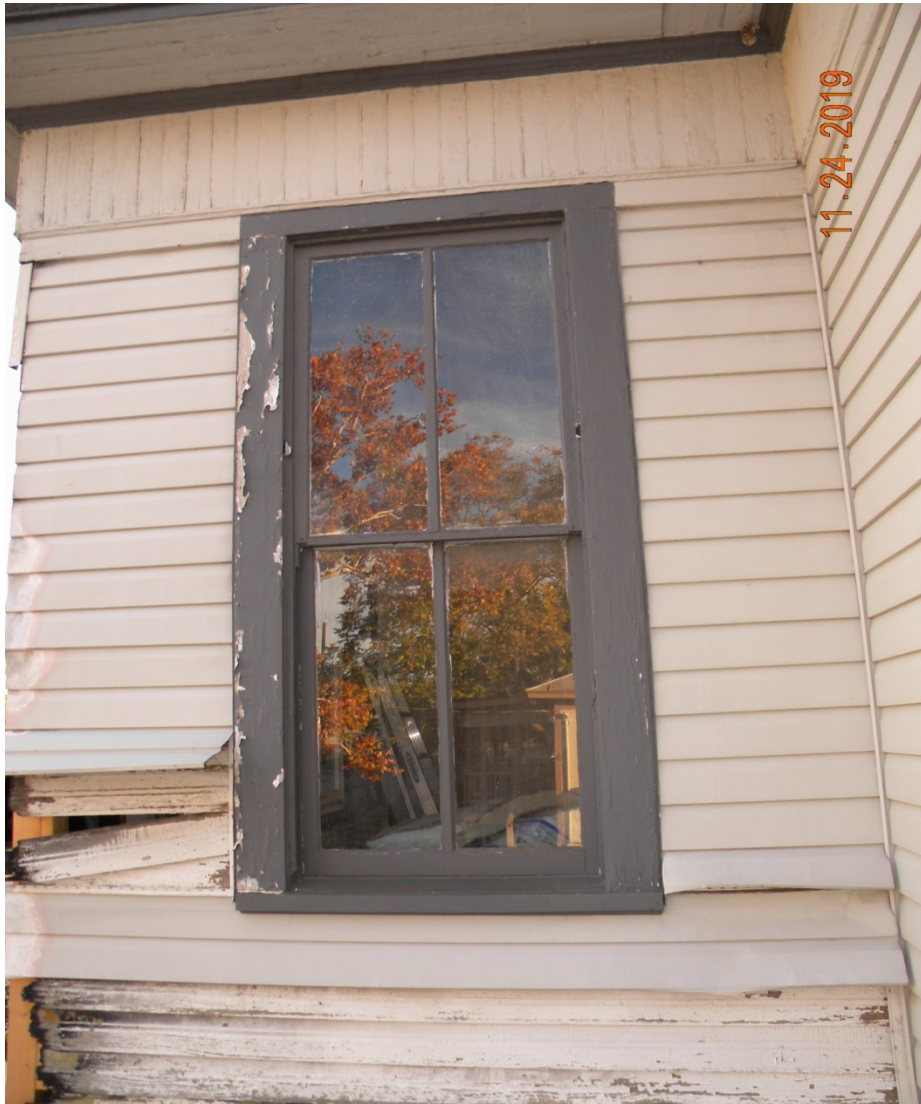
# Unit III, Bedroom 1, Window J

Exterior window  
requires lead paint  
remediation and repairs.

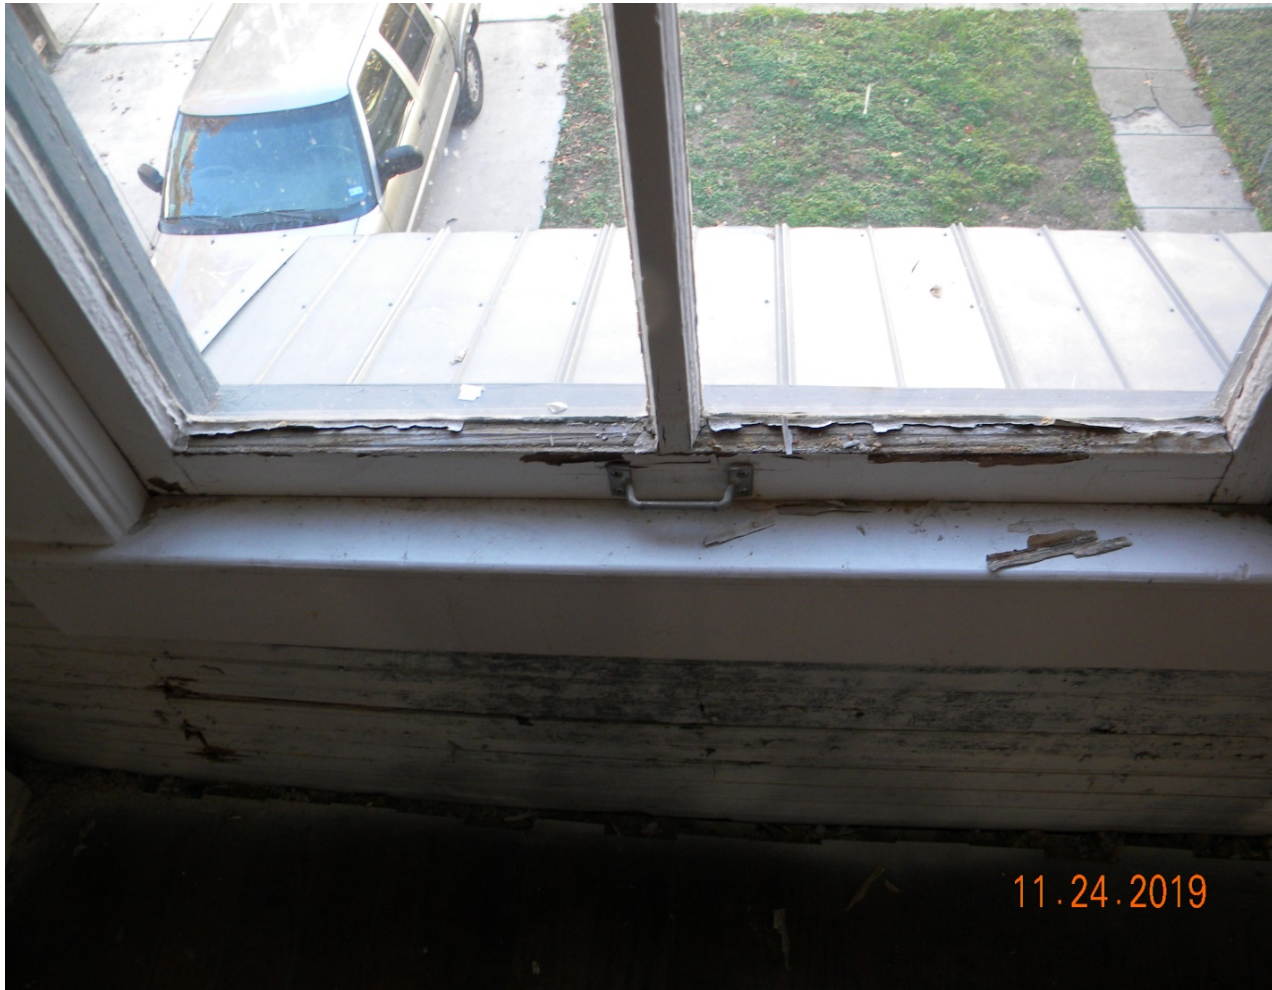
# Unit IV, Living Room Window M

Requires  
lead paint  
remediation  
and repairs.

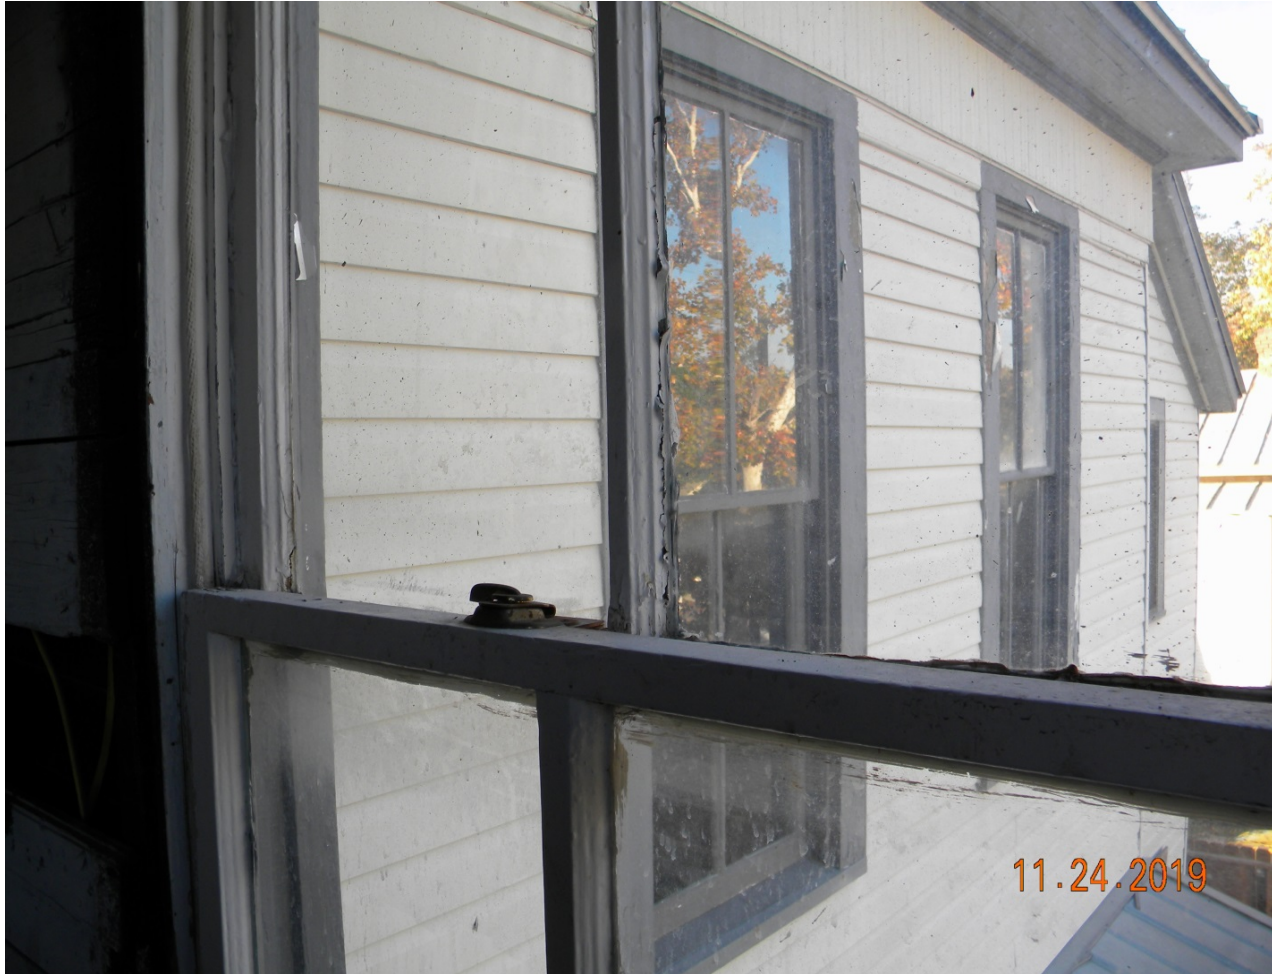
# Unit IV, Living Room Windows

Exterior windows L and M, requires lead paint remediation and repairs.

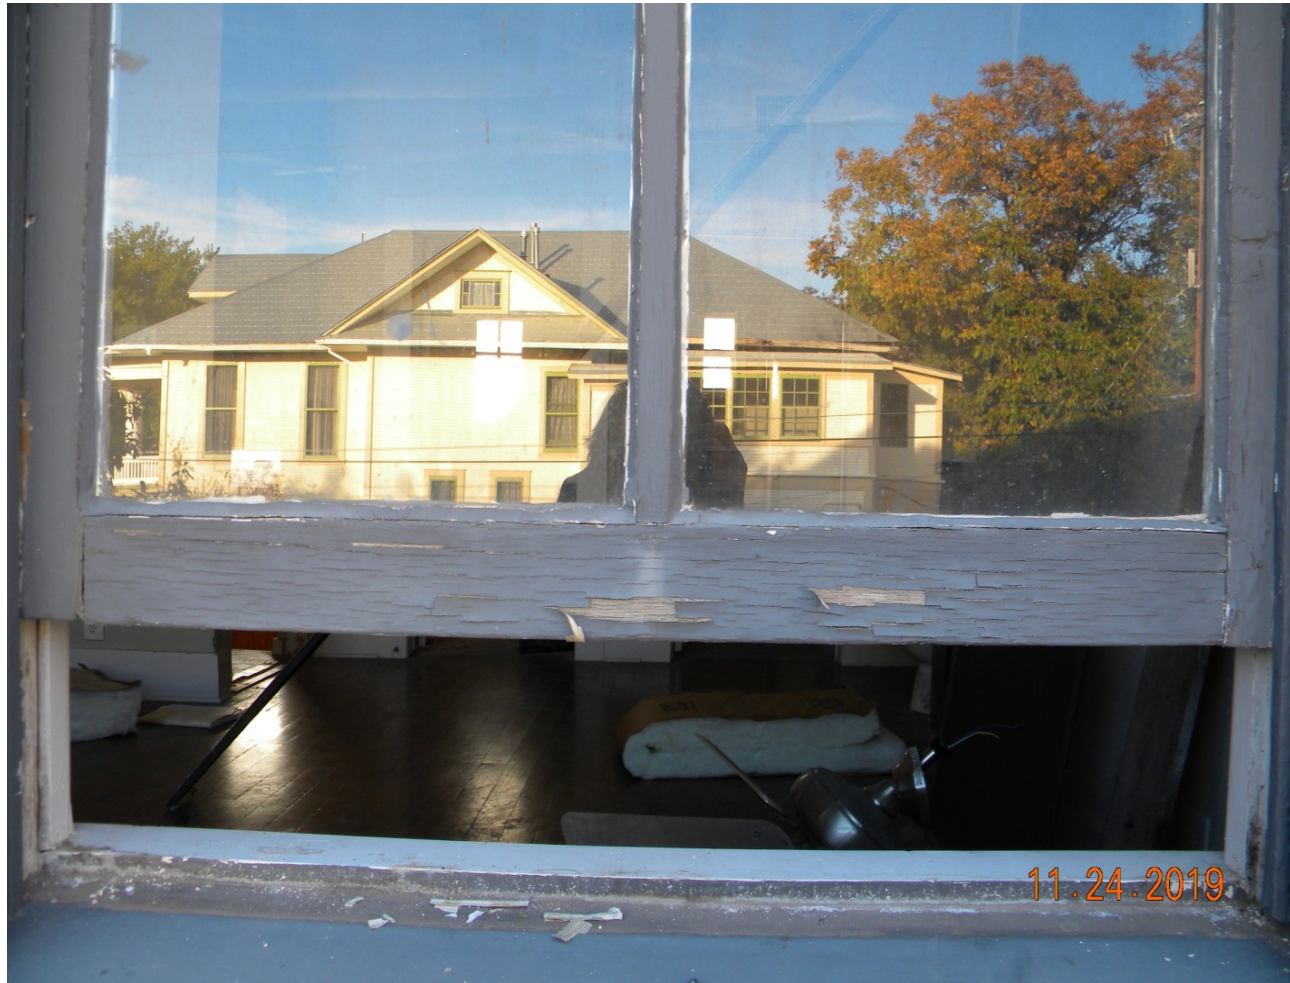
# Unit IV, Living Room Window L

Exterior window, requires lead paint remediation and repairs.

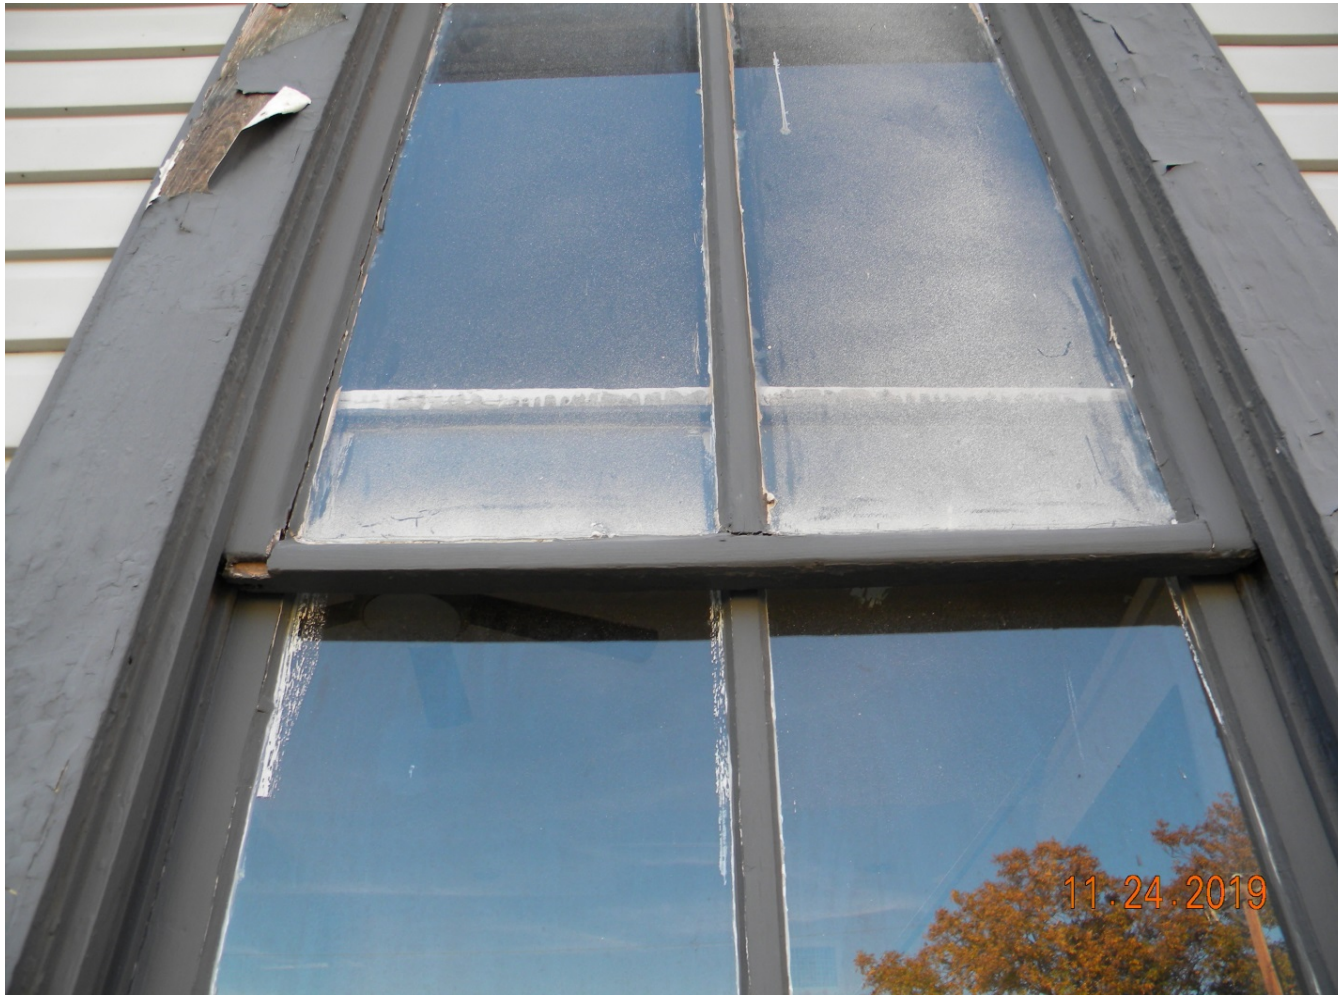
# Unit IV, Living Room Window M

Exterior  
window  
requires lead  
paint  
remediation  
and repairs.

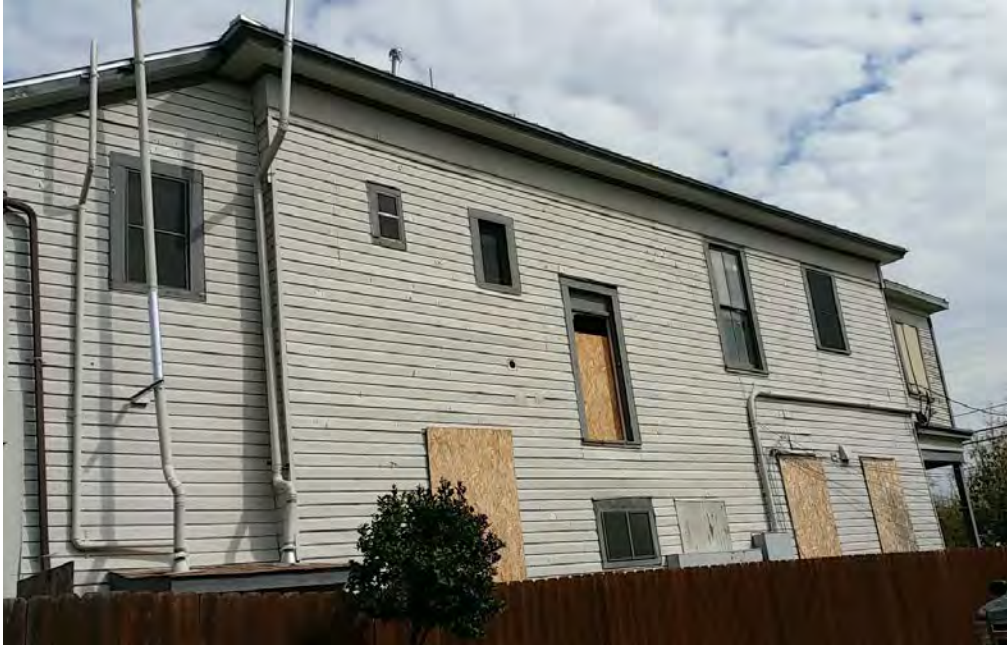
Aluminum siding on the east side of the property

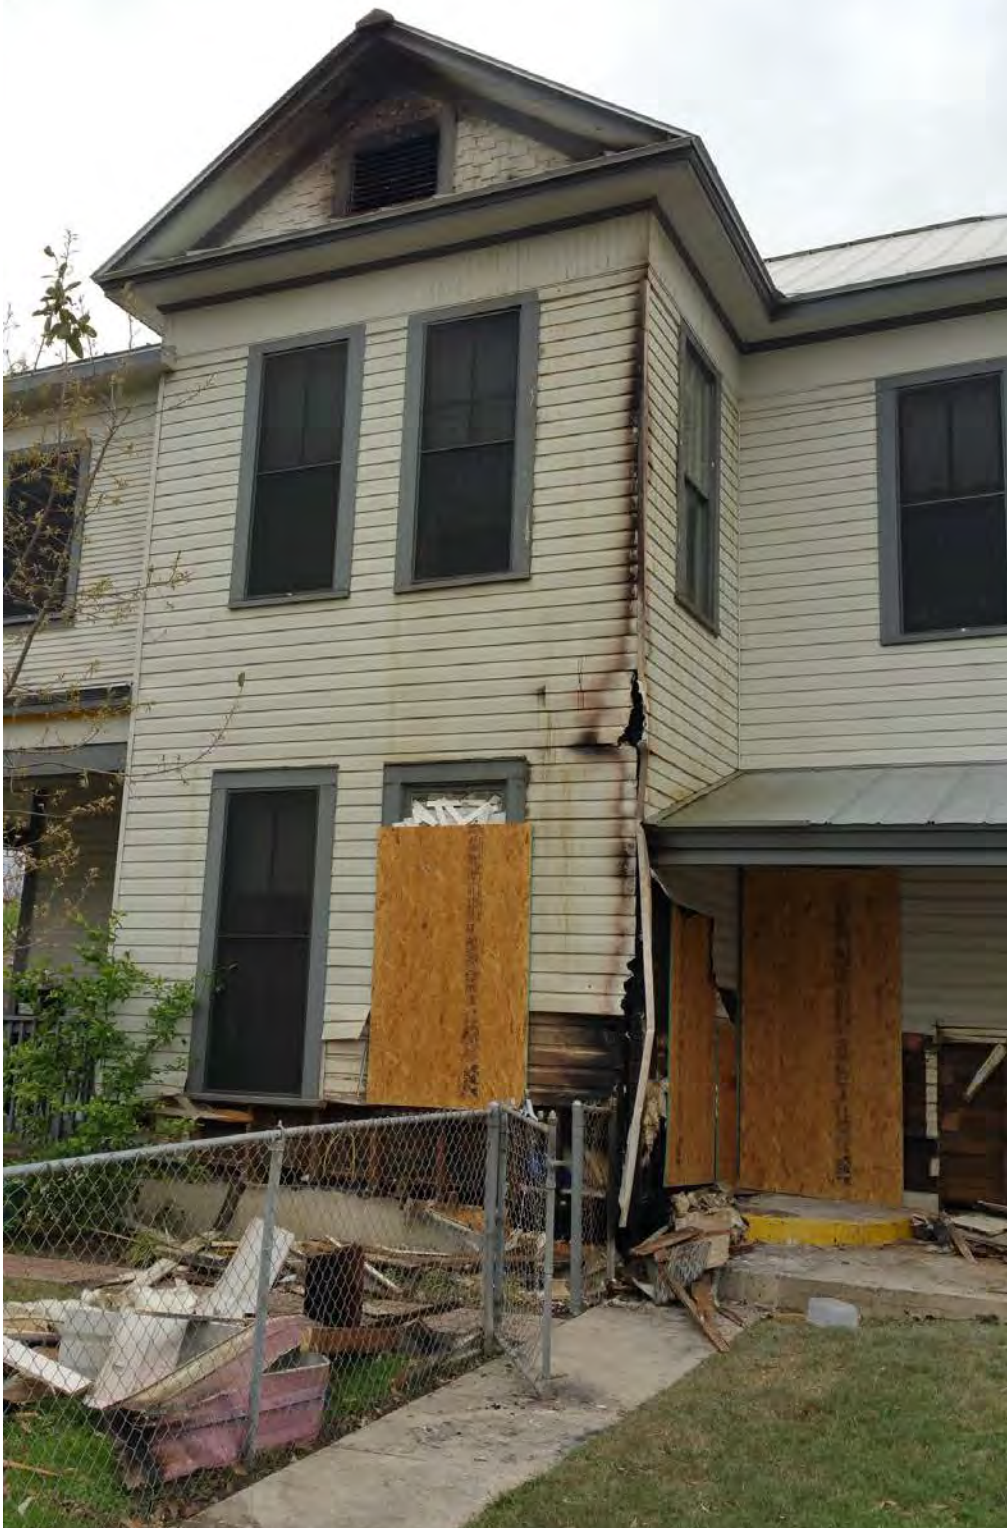
Above and below pictures shows how extensive the wood siding was fire damaged once the aluminum siding was removed.

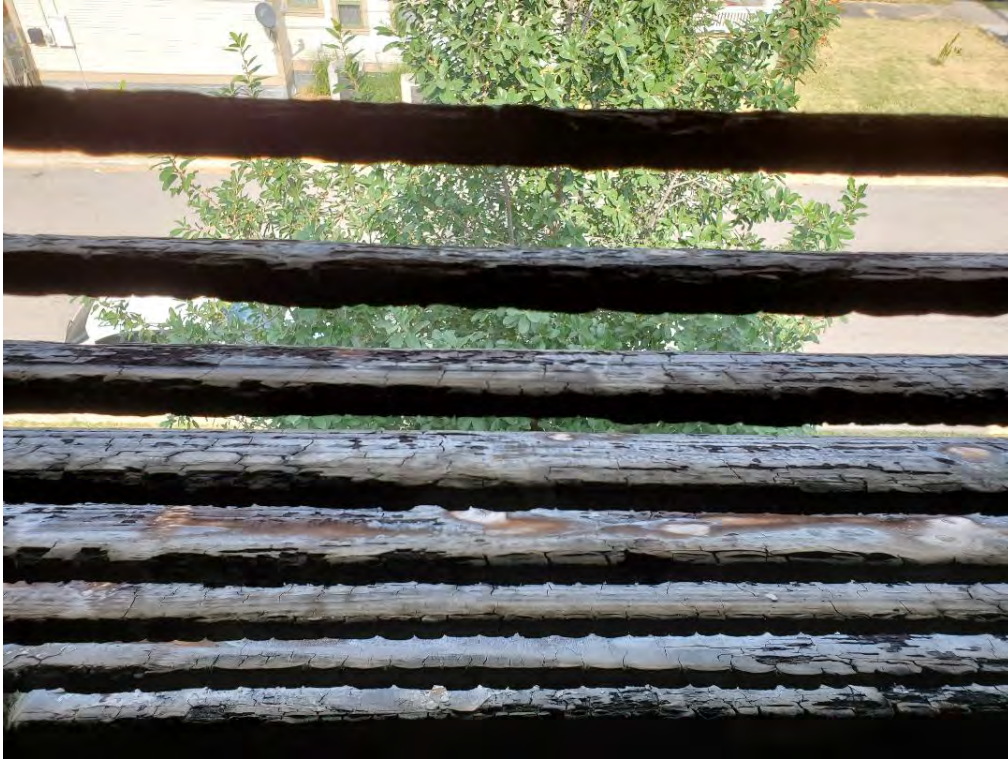
View from inside the attic looking through the gable on the east side of the property.

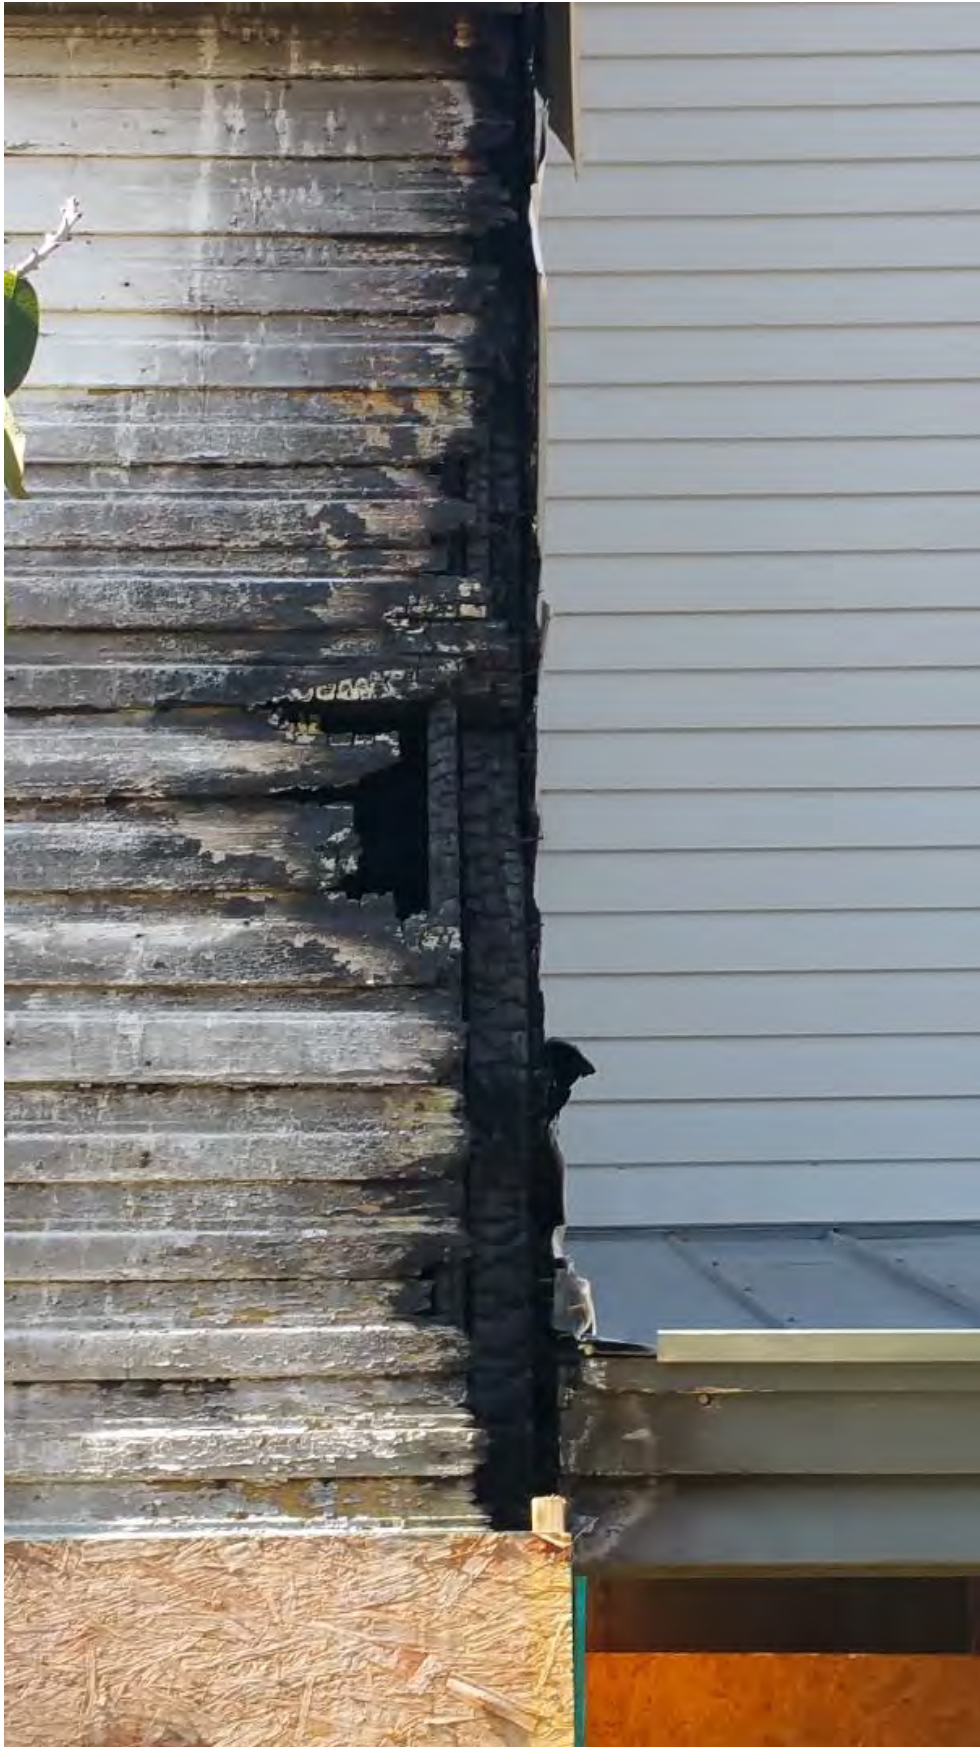
Fire damaged wall cavities that were removed.

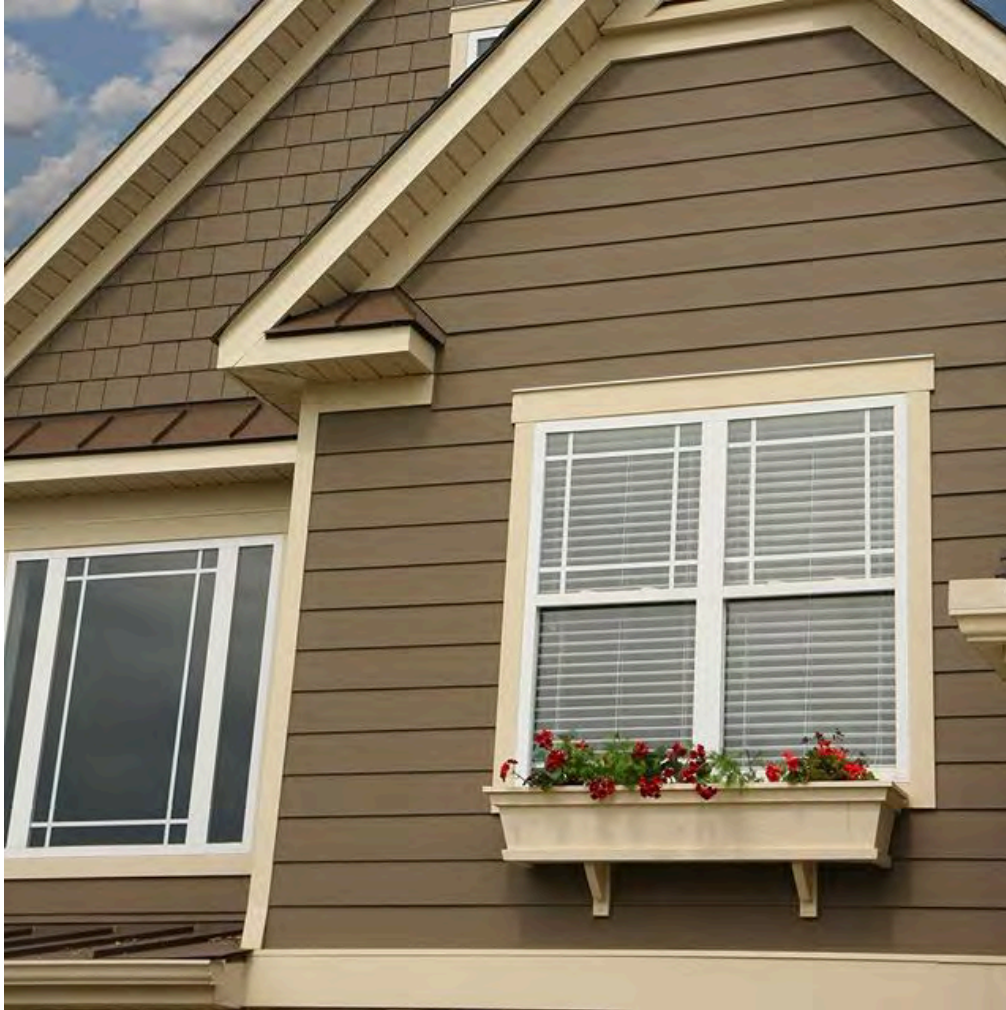
Hail damage in 2013
