# HISTORIC AND DESIGN REVIEW COMMISSION

May 01, 2020

**HDRC CASE NO:** 2020-114  
**ADDRESS:** 101 ARMOUR  
**LEGAL DESCRIPTION:** NCB 6202 BLK 3 LOT 1  
**ZONING:** R-4, H  
**CITY COUNCIL DIST.:** 1  
**DISTRICT:** River Road Historic District  
**APPLICANT:** Vicki Yuan/WALLACE MATTHEW D &  
**OWNER:** Vicki Yuan/WALLACE MATTHEW D &  
**TYPE OF WORK:** Window replacement, fenestration modifications, exterior modifications  
**APPLICATION RECEIVED:** February 28, 2020  
**60-DAY REVIEW:** April 30, 2020  
**CASE MANAGER:** Rachel Rettaliata

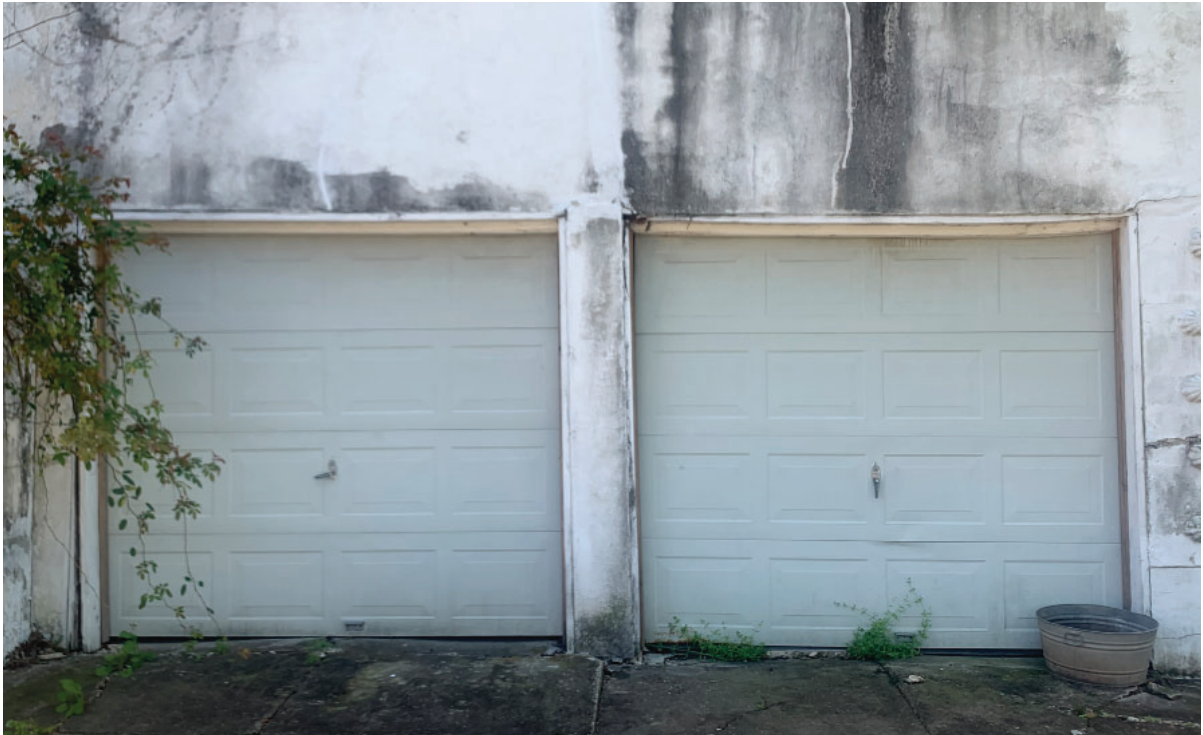
1.1 Garage Overhead Door - Painted Aluminum

- g. DOOR REPLACEMENT – The applicant has proposed to replace the existing painted aluminum garage doors (1.1 & 1.2) with new wood garage doors. The aluminum garage doors are not original to the structure. Staff finds the proposal consistent with the Guidelines. The applicant has additionally requested to replace the existing wood Dutch door on the exterior of the garage (1.3) and the solid wood door on the exterior of the kitchen (1.4) with new wood doors. Staff finds the proposal generally appropriate. The applicant has also requested to replace the double wood doors with divided lite (1.6) on the north elevation with new wood doors with divided lite and screen doors to match existing. Staff finds the proposal consistent with the Guidelines. The applicant has proposed to replace the existing divided lite wood door currently opening into the aviary (1.7) with an arched wood door with divided lite to match the historic arched opening. Staff finds the proposal consistent with the Guidelines.

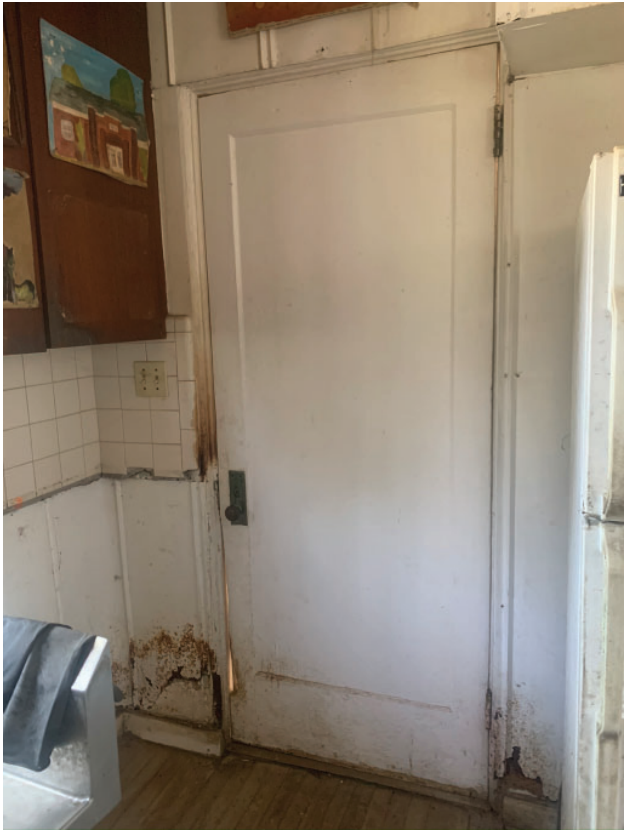
1.4 Solid Door - Wood

- h. FENESTRATION MODIFICATION: BREEZEWAY – The applicant has proposed to relocate the current door opening on the exterior of the kitchen in the breezeway (1.4) to be more centered in the interior space. As the door opening is within a breezeway between the garage and the west wing and is not visible from the public right-of-way, staff finds the proposal generally appropriate.

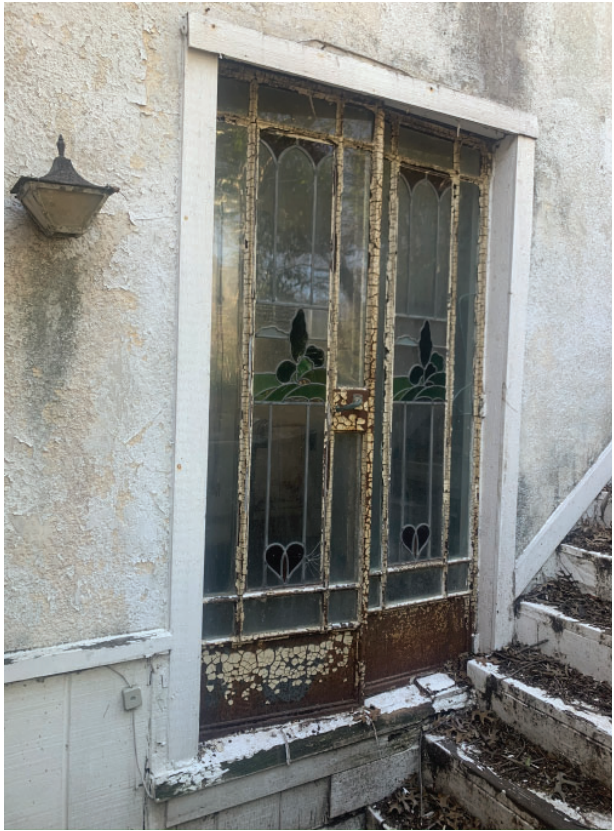
1.5 Double Doors - Steel-framed with stained glass

- i. FENESTRATION MODIFICATION: EAST ELEVATION, WEST WING – The applicant has proposed to remove the existing steel-framed double doors with stained glass (1.5) and install a new steel casement window to match the existing windows on the tower. As the opening currently opens onto existing exterior stairs and does not feature a safe egress, staff finds the proposal consistent with the Guidelines.

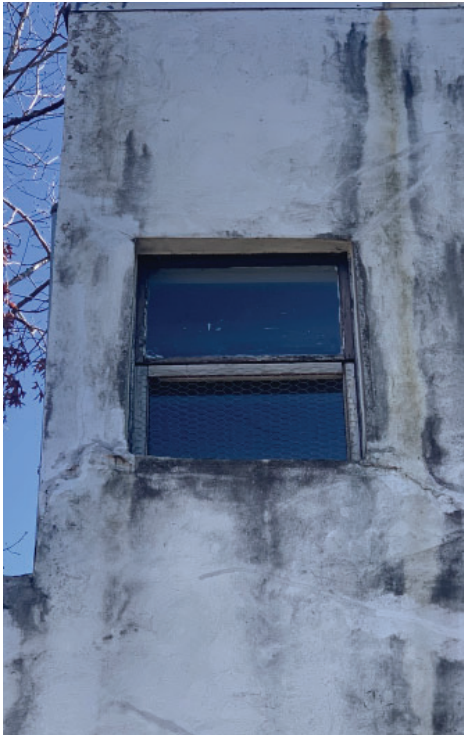
2.1 Window - Wood double hung

- c. WINDOW REPLACEMENT: ONE-OVER-ONE WOOD WINDOWS – The applicant has proposed to remove the existing one-over-one wood windows (2.1 & 2.3) in the second-floor bathroom on the west and east elevations and replace the windows with existing steel casement windows that will be salvaged from the second floor of the north elevation. The west wing of the structure was originally one story and the second story was constructed as an addition circa 1950; therefore, the existing wood windows and openings are not original to the structure. Staff finds the proposal consistent with the Guidelines.

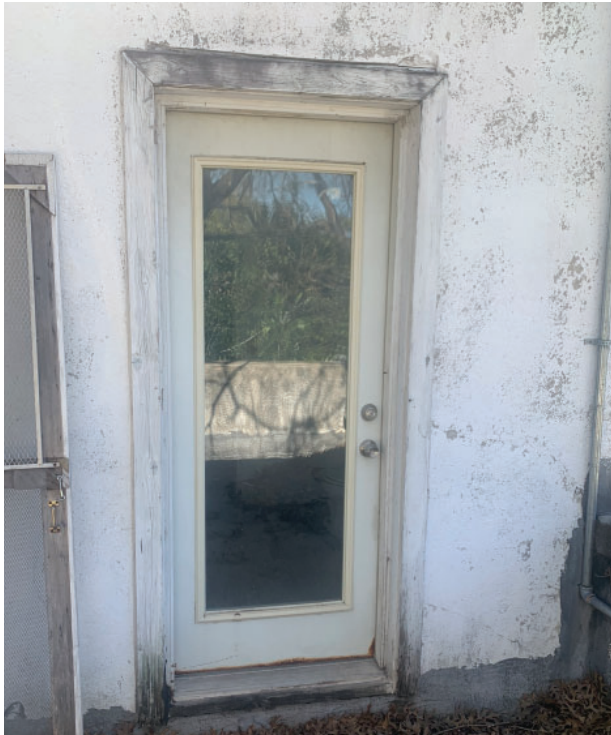
2.2 Door: Clad Wood and Glass

- j. FENESTRATION MODIFICATION: NORTH ELEVATION, WEST WING – The applicant has proposed to replace the existing full lite wood door on the second floor of the north elevation of the west wing (2.2) with new wood double doors with divided lite and screen doors and create a new opening beside opening 2.2 to install a matching set of doors. The two sets of doors will serve as egress for the roof terrace. As the second floor of the west wing is not original to the structure, staff finds the proposal consistent with the Guidelines.

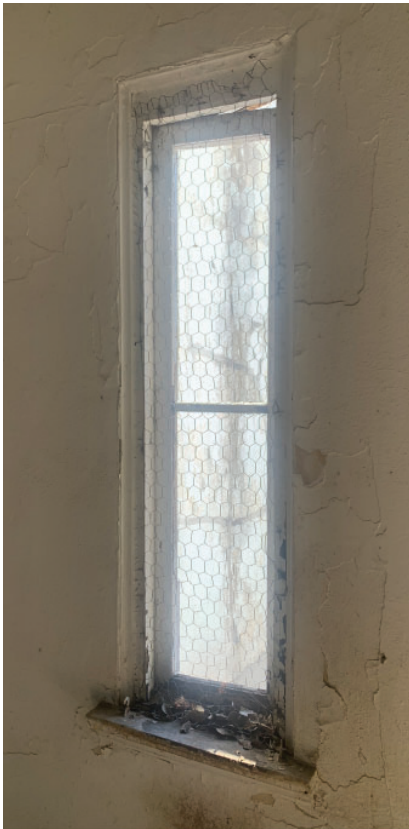
- d. WINDOW REPLACEMENT: WOOD CASEMENT WINDOWS – The applicant has proposed to remove the existing wood casement windows (2.4 & 2.6) from the second floor. The existing wood casement windows are missing all glass panes and hardware and do not close. The applicant has proposed to replace windows 2.4 and 2.6 with new steel casement windows to match the existing in size and profile. Guideline 6.B.iv for Exterior Maintenance and Alterations states that new windows should match the existing windows in terms of size, type, configuration, material, form, appearance, and detail when original windows are deteriorated beyond repair. However, staff finds that steel casement windows are appropriate for the style and age of this structure.

2.4 Window - Wood and Glass Casement (missing glass)

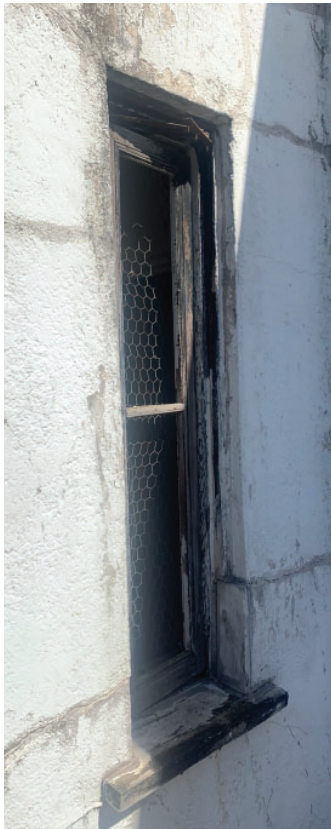
2.6 Window - Wood and Glass Casement (missing glass)

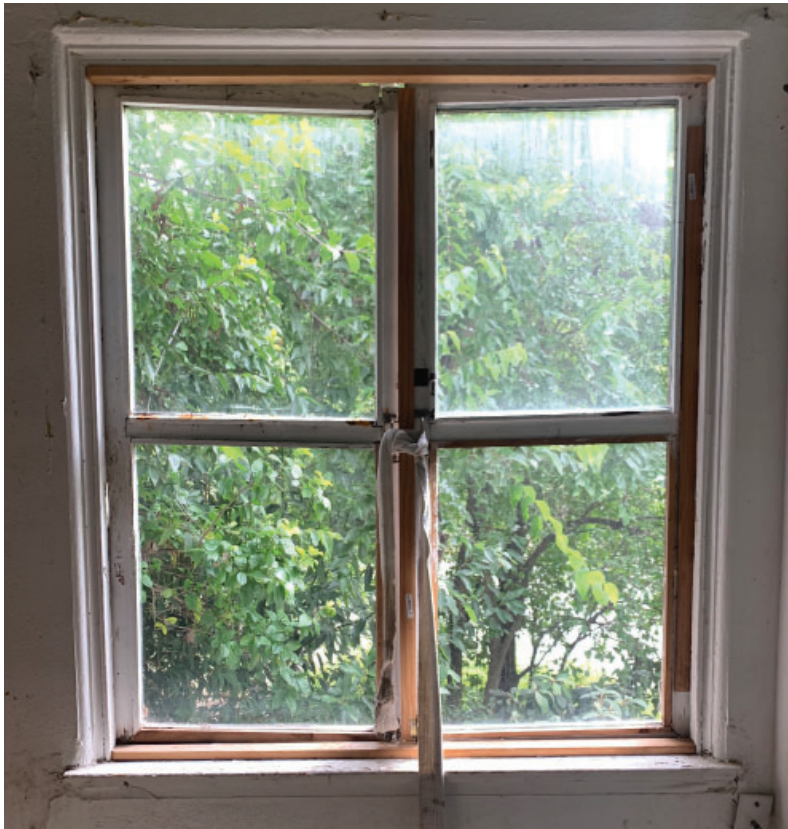
2.7 Window - Wood and Glass

- e. WINDOW REPLACEMENT: ONE-OVER-ONE WOOD CASEMENT WINDOWS – The applicant has proposed to replace the existing one-over-one wood casement windows on the second floor of the south elevation (2.7 & 2.8) with new wood casement windows to match the existing. The existing wood windows are

not original to the structure and appear to have been incorrectly installed and do not properly fit within the opening. Staff finds the proposal consistent with the Guidelines.

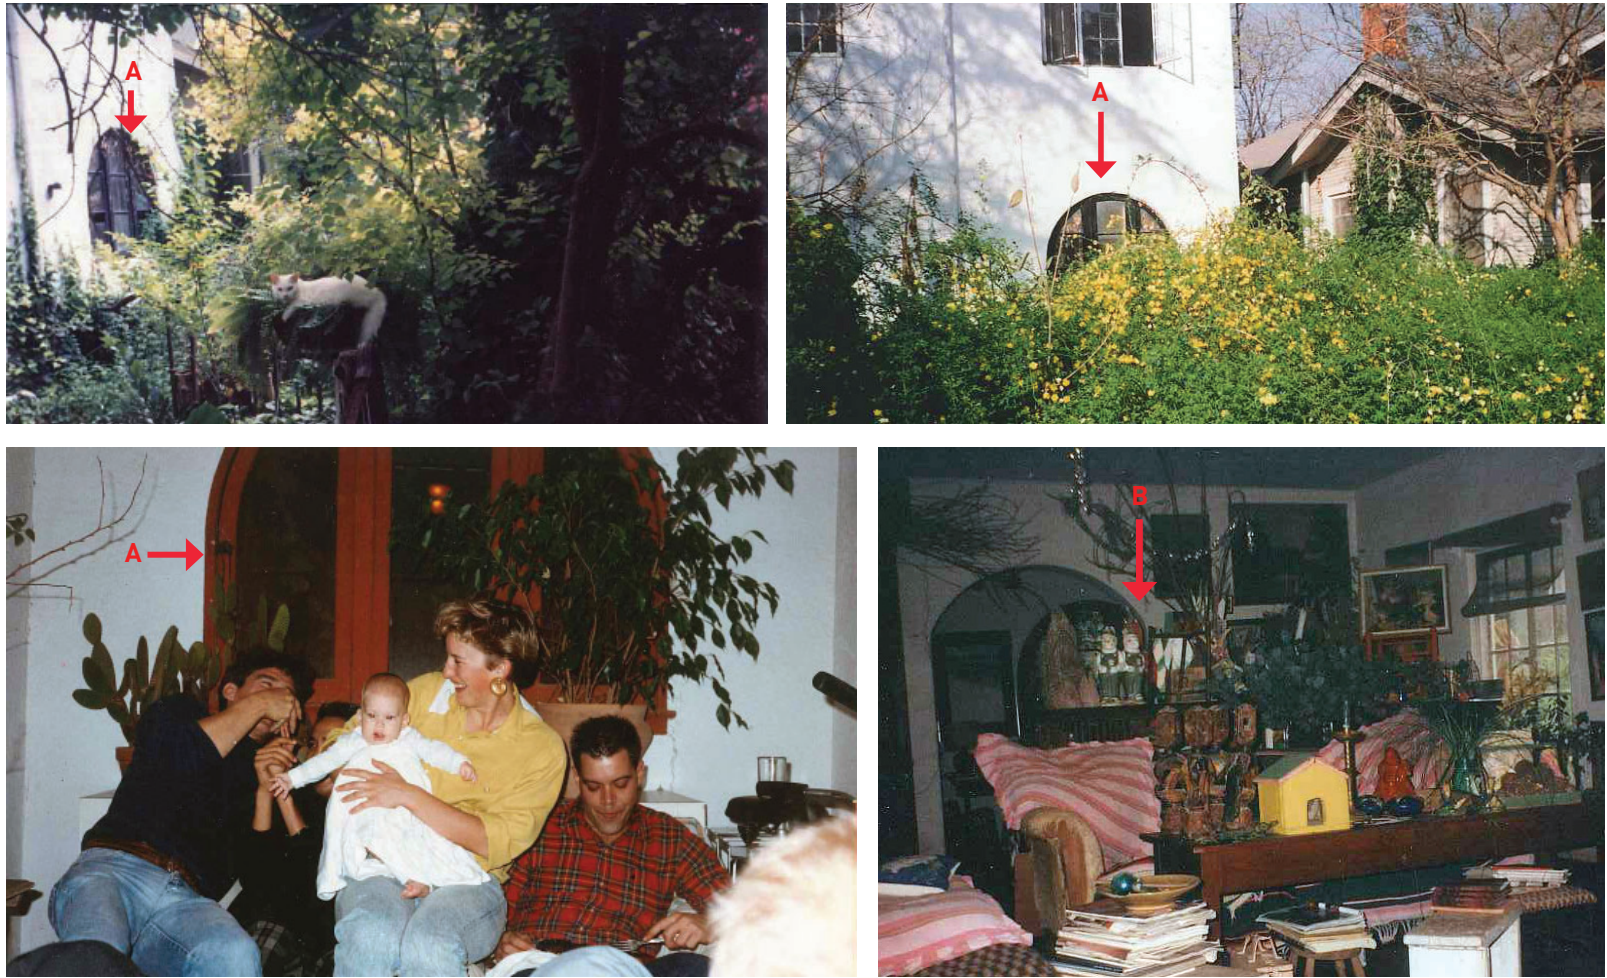
EXISTING CONDITION: VINYL WINDOWS

- f. WINDOW REPLACEMENT: VINYL WINDOWS – The applicant has proposed to remove the existing vinyl windows on the first floor of the south and east elevations (A, B, and C) with new arched wood windows to match the historic window openings as shown in historic photos of the interior and exterior. Staff finds the proposal consistent with the Guidelines.
