HISTORIC AND DESIGN REVIEW COMMISSION

HDRC CASE NO: 2020-117
ADDRESS: 230 ADAMS ST
LEGAL DESCRIPTION: NCB 943 BLK 1 LOT SW 100 FT OF 16
ZONING: RM-4 CD, H
CITY COUNCIL DIST.: 1
DISTRICT: King William Historic District
APPLICANT: David Robertson/Build Modern LLC
OWNER: Esteban Lopez
TYPE OF WORK: Window replacement
APPLICATION RECEIVED: March 02, 2020
60-DAY REVIEW: Not applicable due to City Council Emergency Orders
CASE MANAGER: Edward Hall

Historic Review: 230 Adams St

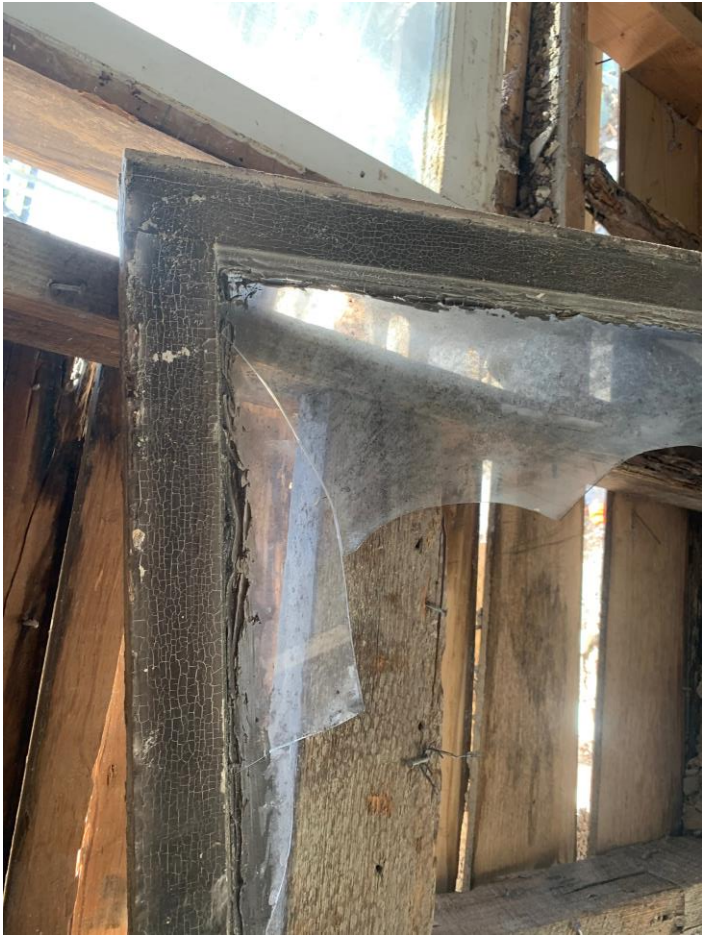
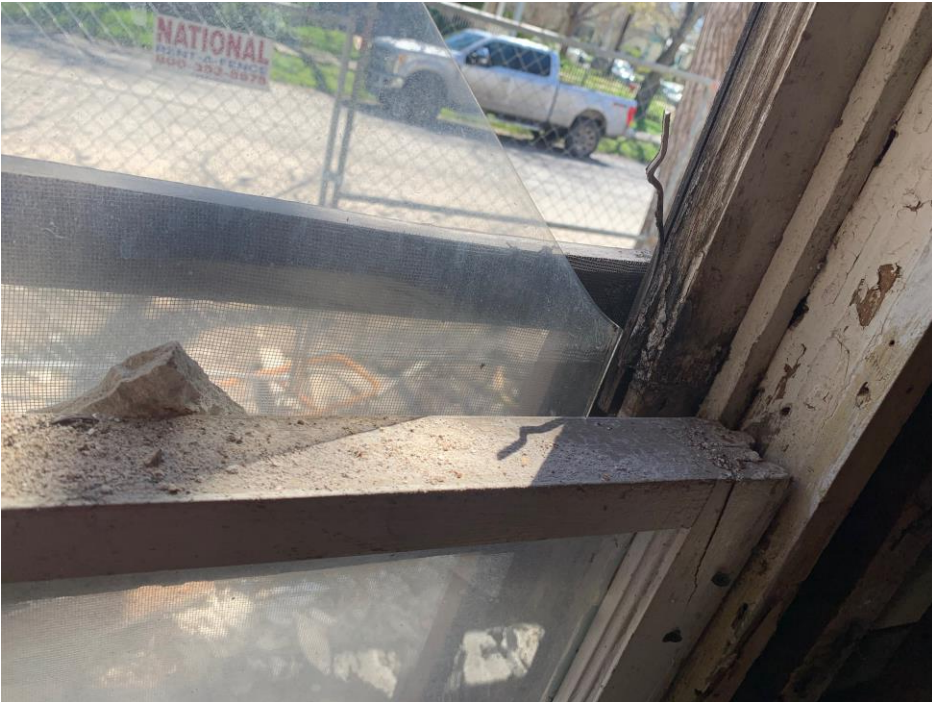
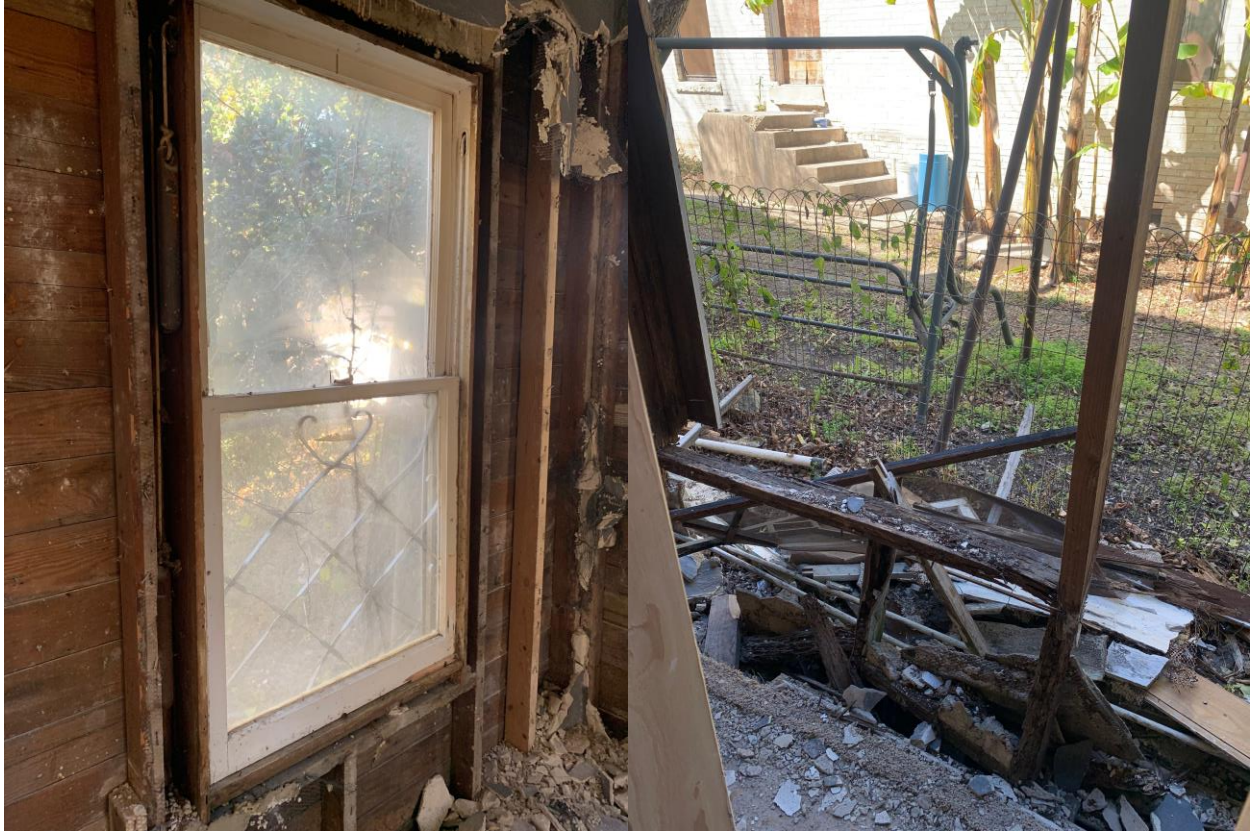
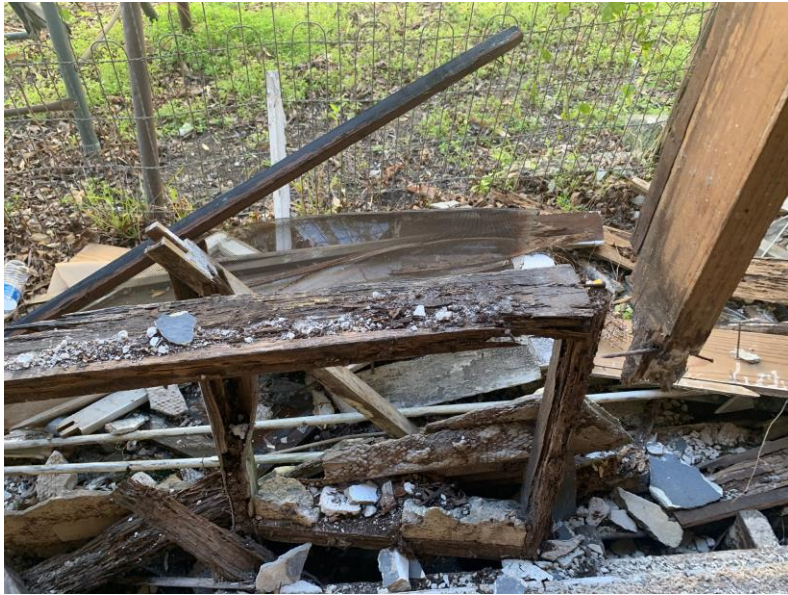
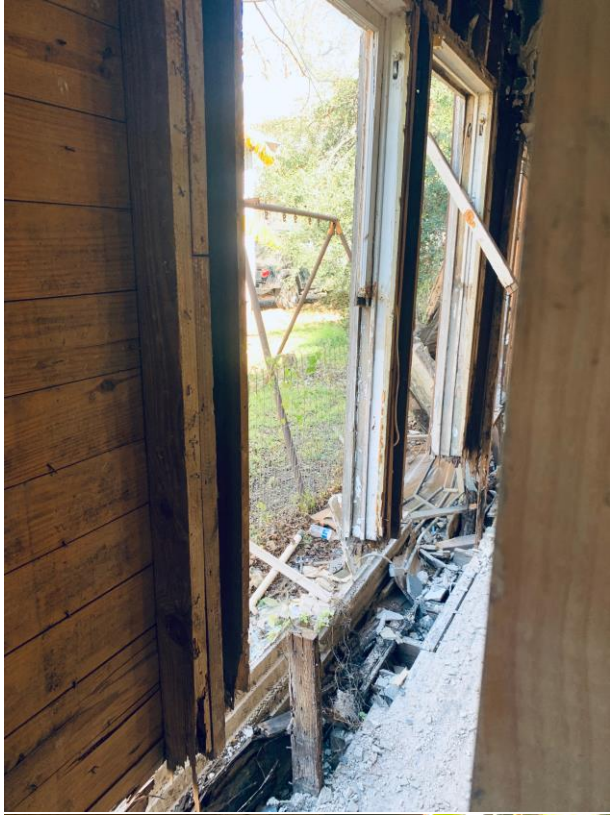
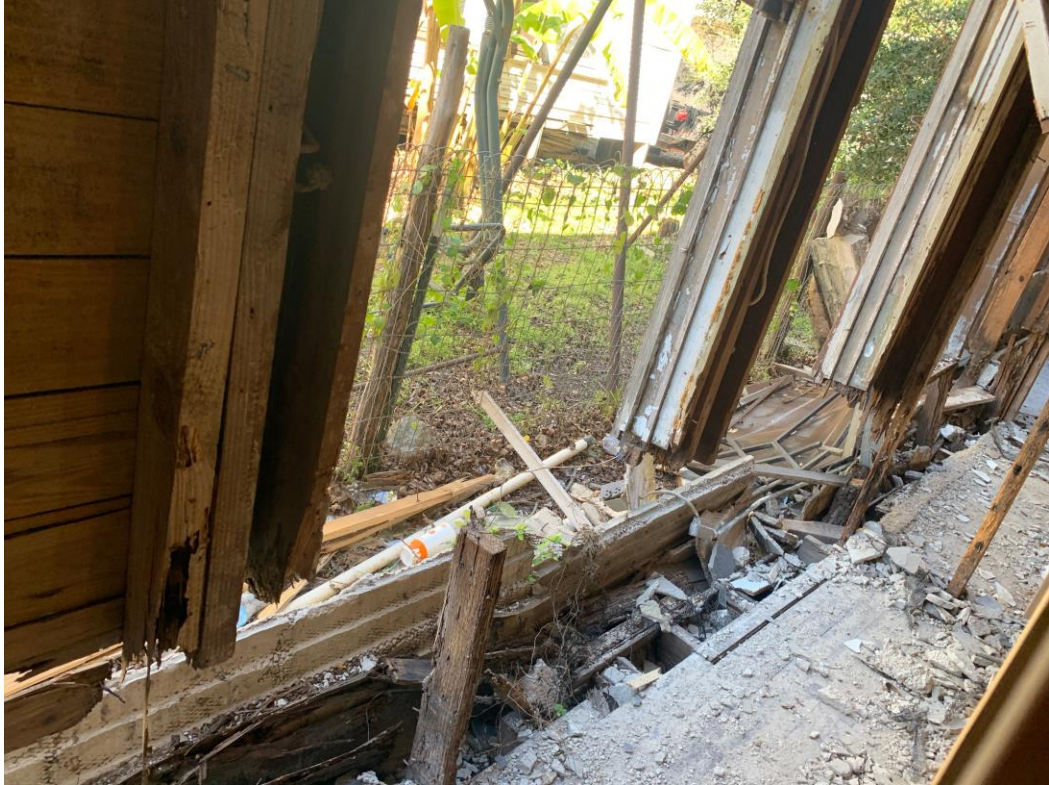
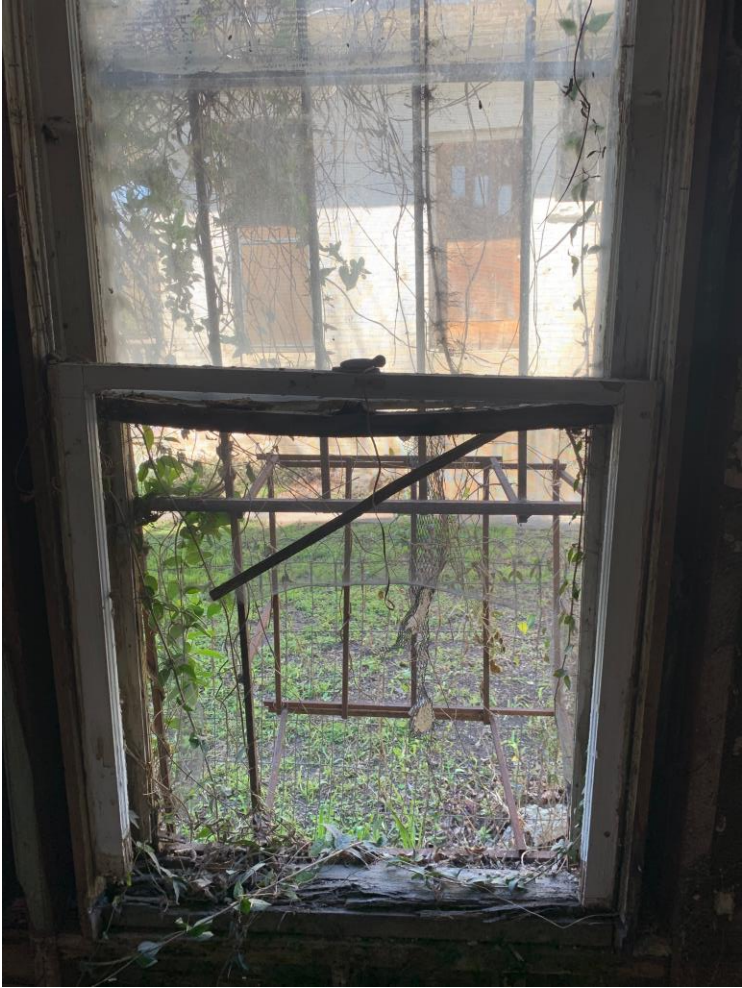
We are requesting permission to take out windows throughout the structure that are in salvageable condition to make completed full sets of windows to be moved to the front of the building. Windows have suffered fire, water, and termite damage.

The windows on the rest of the building will be replaced with a similar all wood double hung window matching the original look.

JELD-WEN W-2500 Series Primed Wood Double Hung w/ natural interior and low e glass.
