# HISTORIC AND DESIGN REVIEW COMMISSION

May 29, 2020

**HDRC CASE NO:** 2020-191  
**ADDRESS:** 320 N HACKBERRY ST  
**LEGAL DESCRIPTION:** NCB 584 BLK W 1/2 7 LOT 5 ARB A5  
**ZONING:** RM-4, H  
**CITY COUNCIL DIST.:** 2  
**DISTRICT:** Dignowity Hill Historic District  
**APPLICANT:** Johnrudy Balderrama/JRM CONSTRUCTION LLC  
**OWNER:** Johnrudy Balderrama/JRM CONSTRUCTION LLC  
**TYPE OF WORK:** Window and siding replacement  
**APPLICATION RECEIVED:** April 24, 2020  
**60-DAY REVIEW:** Not applicable due to City Council Emergency Orders  
**CASE MANAGER:** Huy Pham  
**REQUEST:**

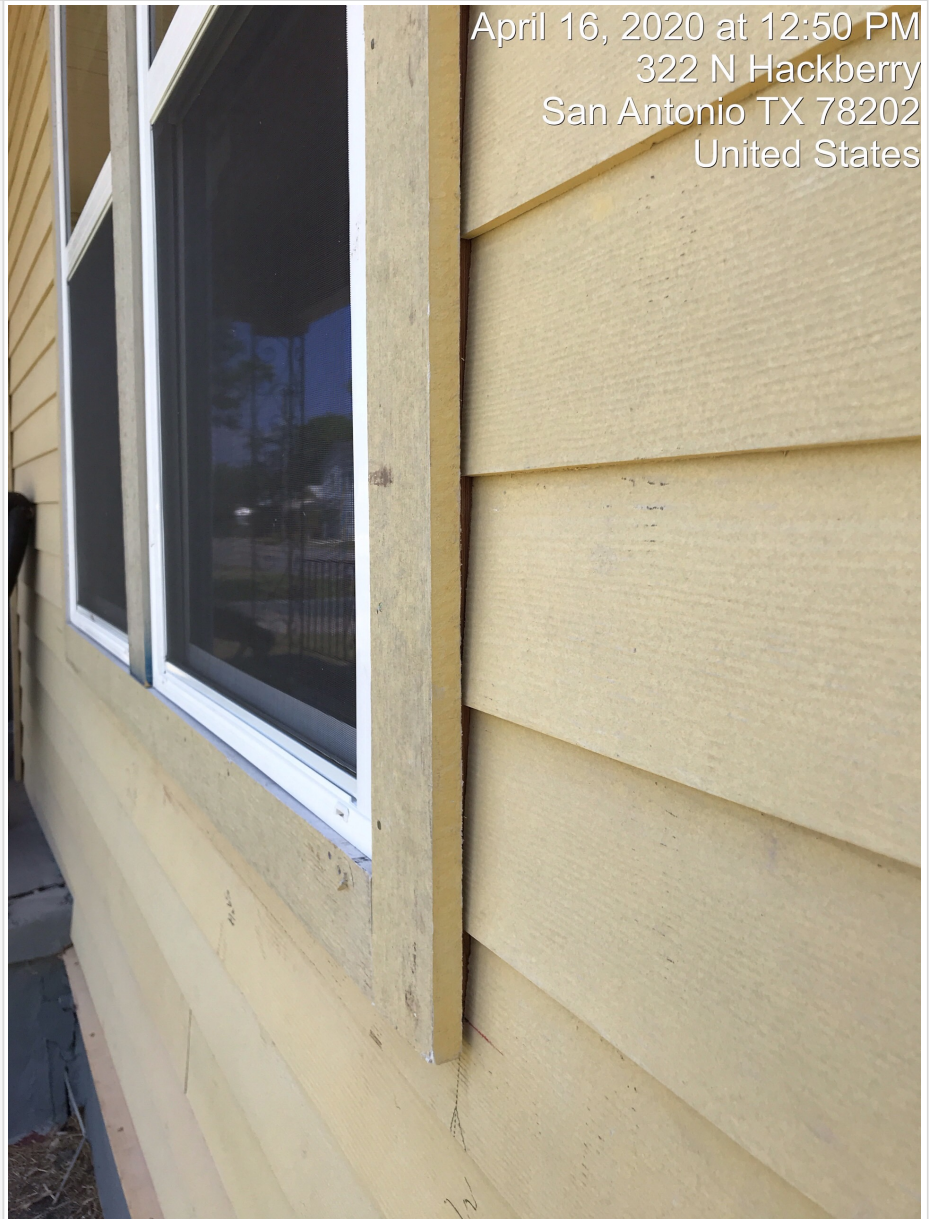
Date	04/16/2020
Time	12:51 PM (-5 GMT)
Context	citizen report
Present Staff	Huy Pham, Edward Hall
Present Individuals	None
Contractor/Realtor Companies	JRM Construction
Types of Work Observed	Exterior Maintenance and Alterations
Amount of Work Completed	75%
Description of work	Window replacement, siding removal and replacement

April 16, 2020 at 12:50 PM  
322 N Hackberry  
San Antonio TX 78202  
United States

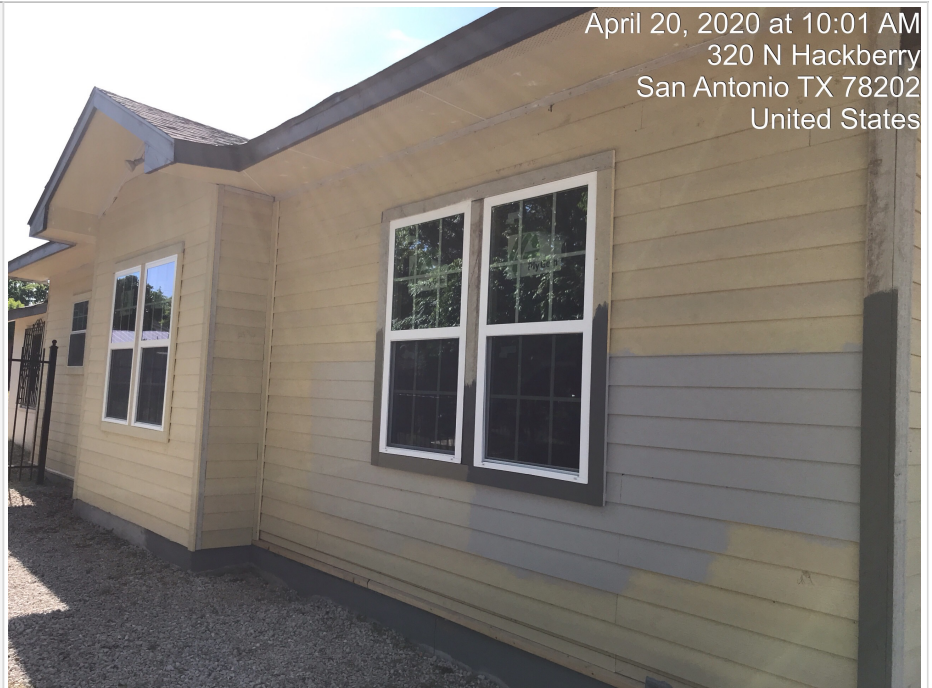
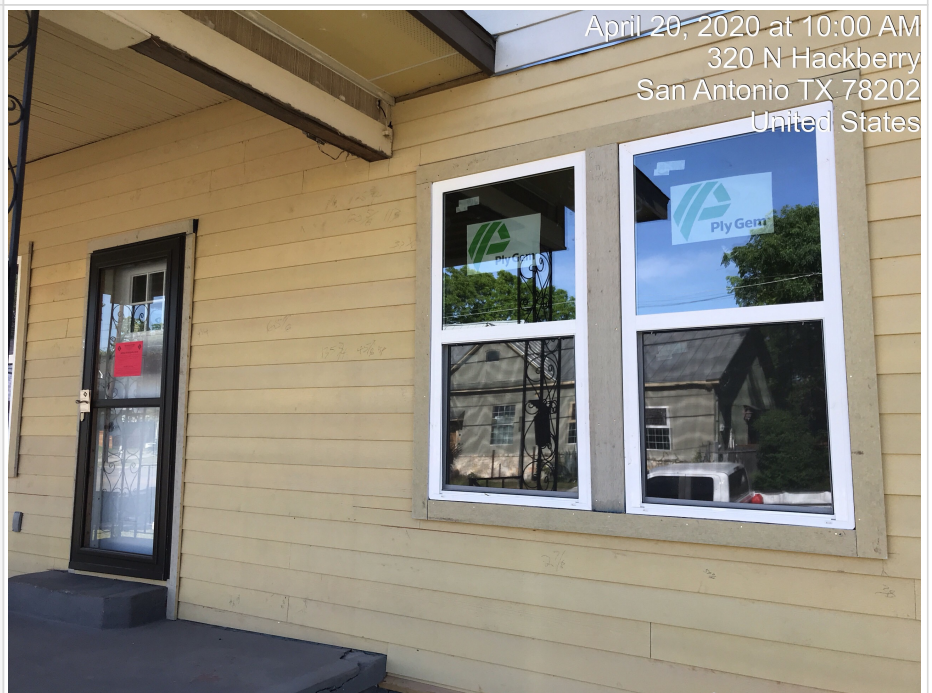
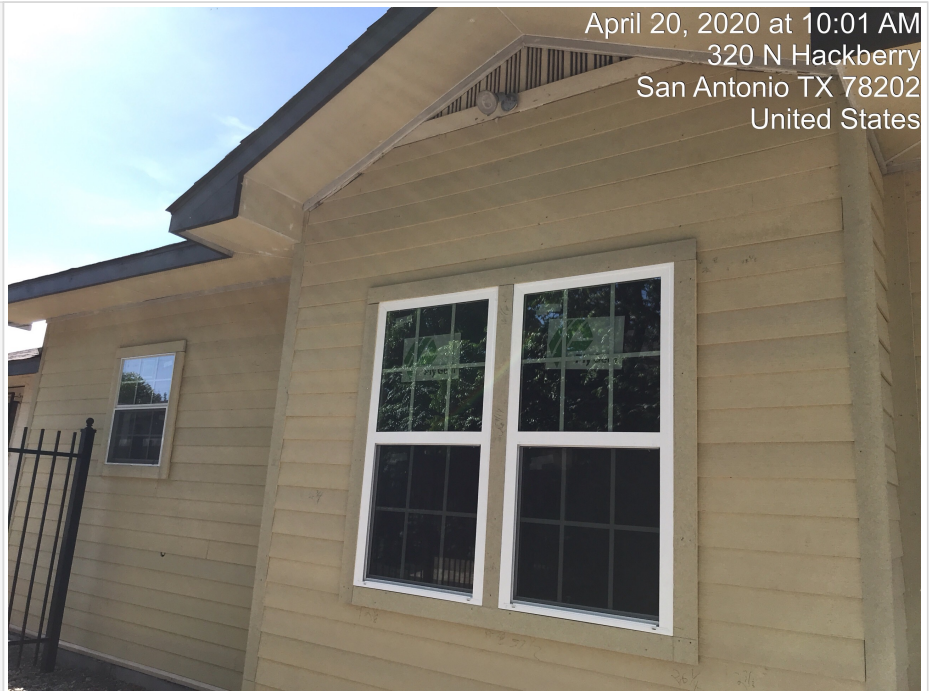
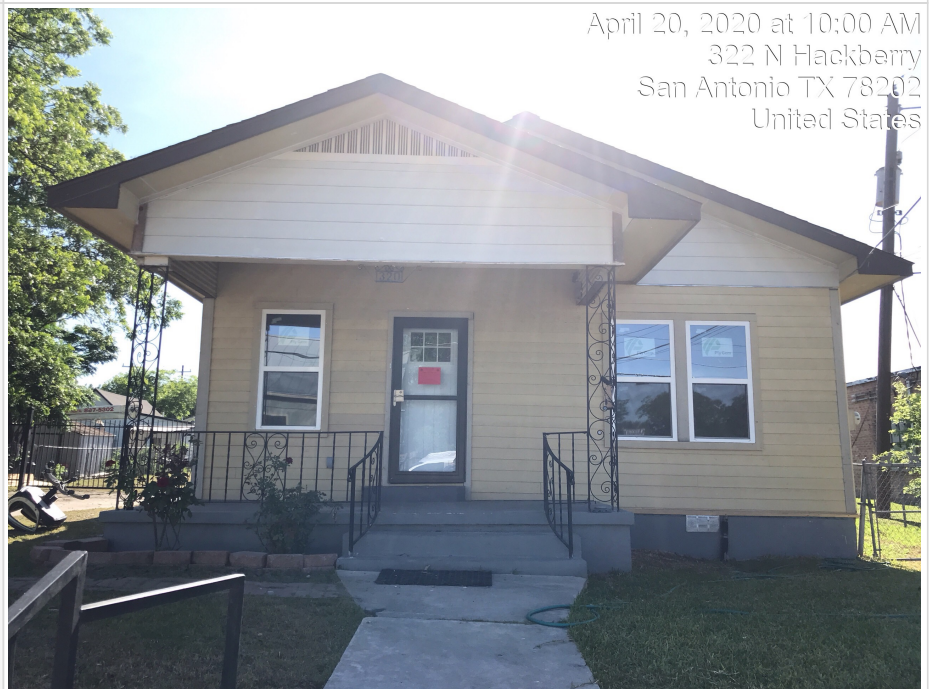
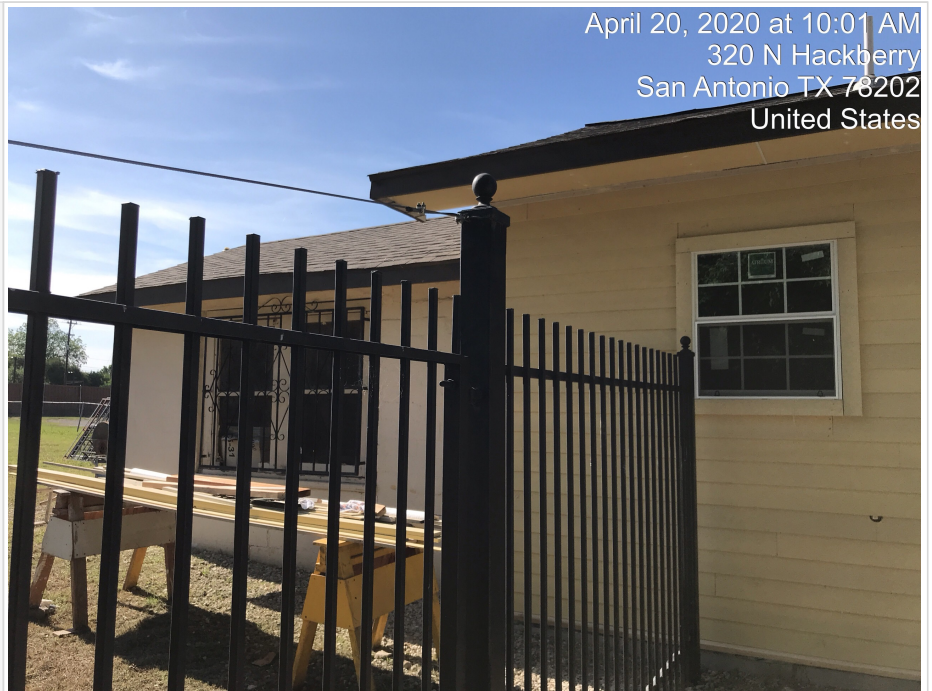
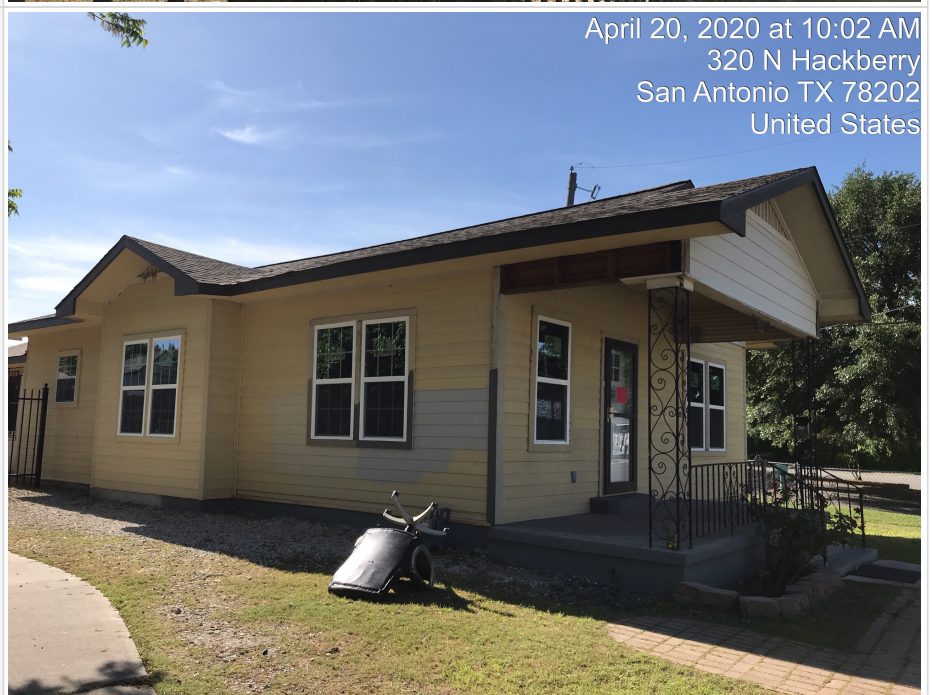
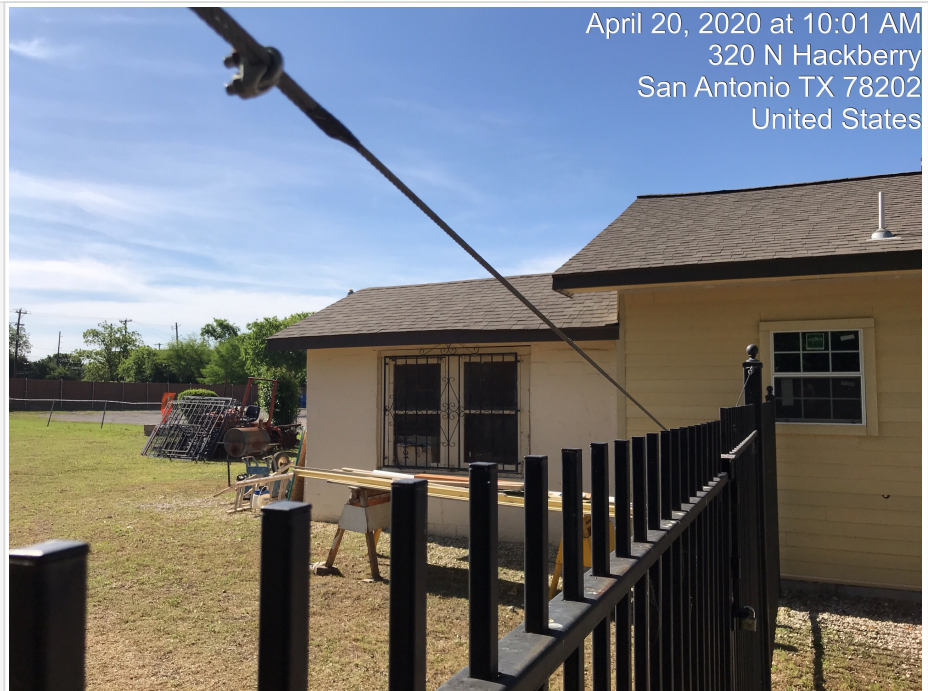
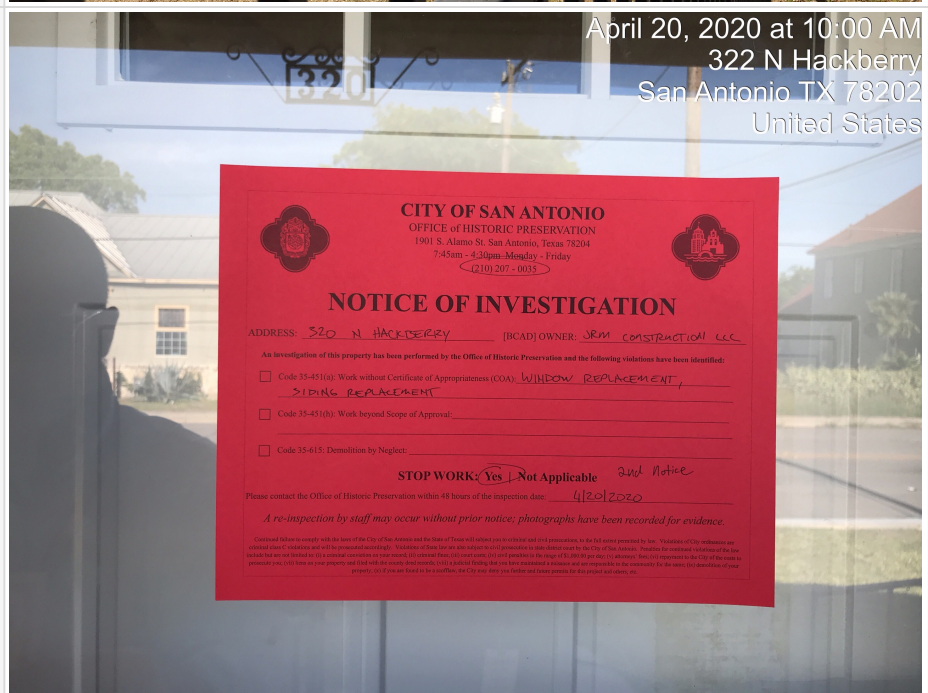
Date	04/20/2020
Time	10:02 AM (-5 GMT)
Context	citizen report
Present Staff	Huy Pham, Edward Hall
Present Individuals	None
Types of Work Observed	Exterior Maintenance and Alterations
Amount of Work Completed	75%
Description of work	More windows and siding had been replaced after first Stop Work Order.
