### HISTORIC AND DESIGN REVIEW COMMISSION June 17, 2020

HDRC CASE NO: 2020-152

**ADDRESS:** 2158 W KINGS HWY

**TYPE OF WORK:** Enclosure of front porch with windows and door

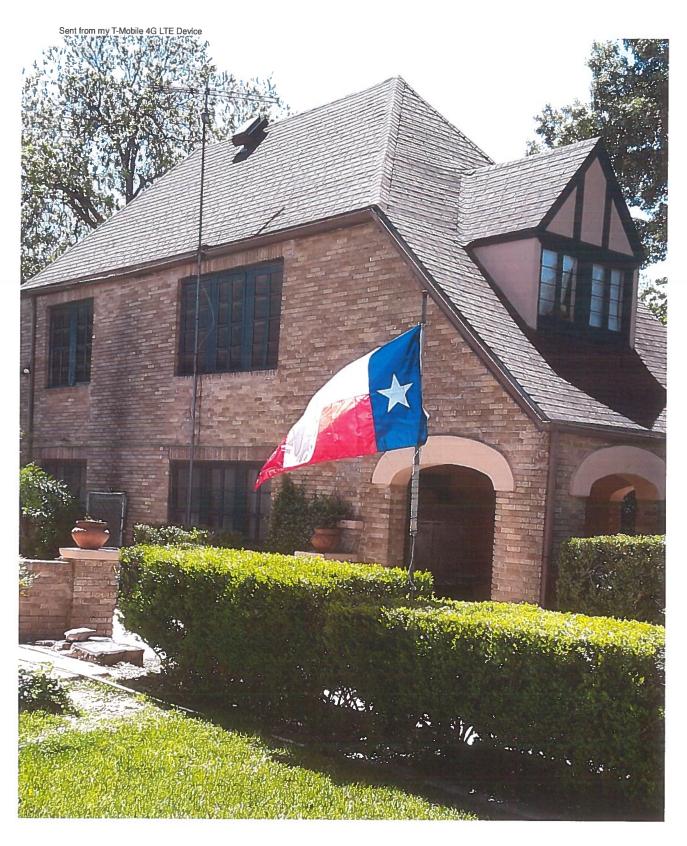
damage of dormer which pushed the dormer of roof down-leading to joist domage.

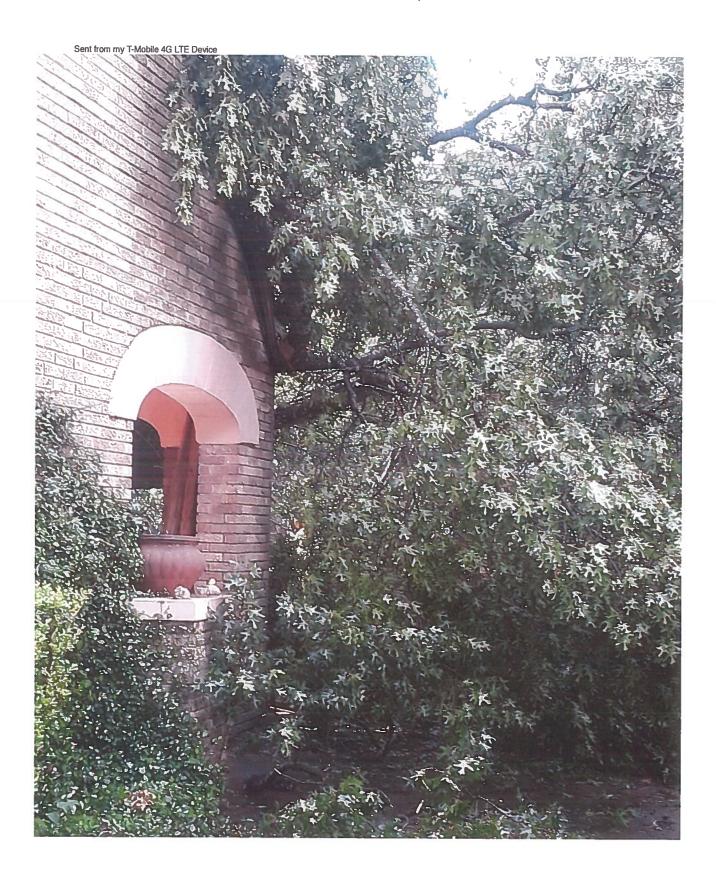
# drive way side ut house

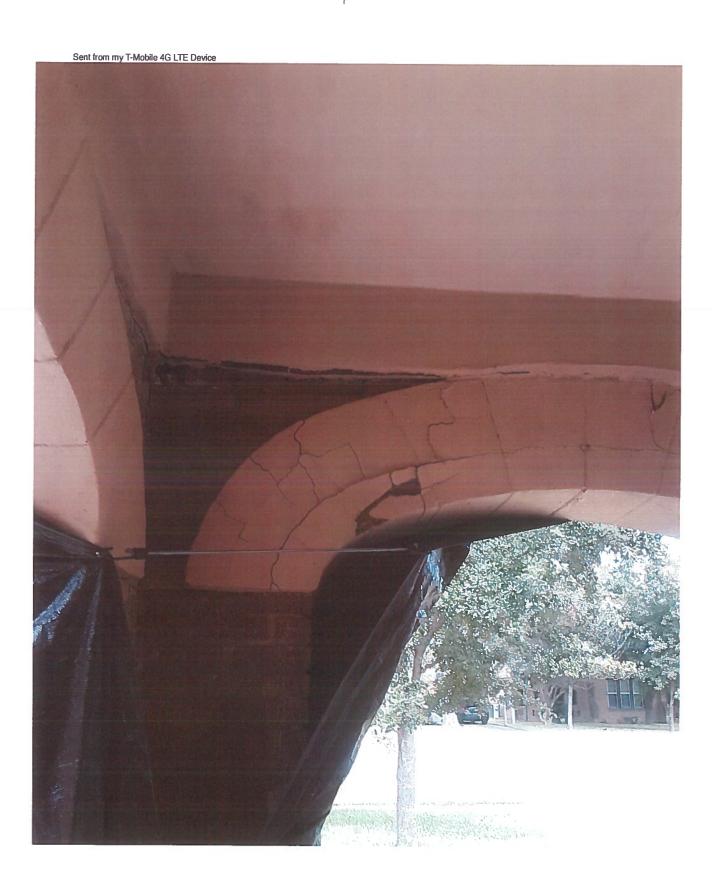
# broken stucco porch

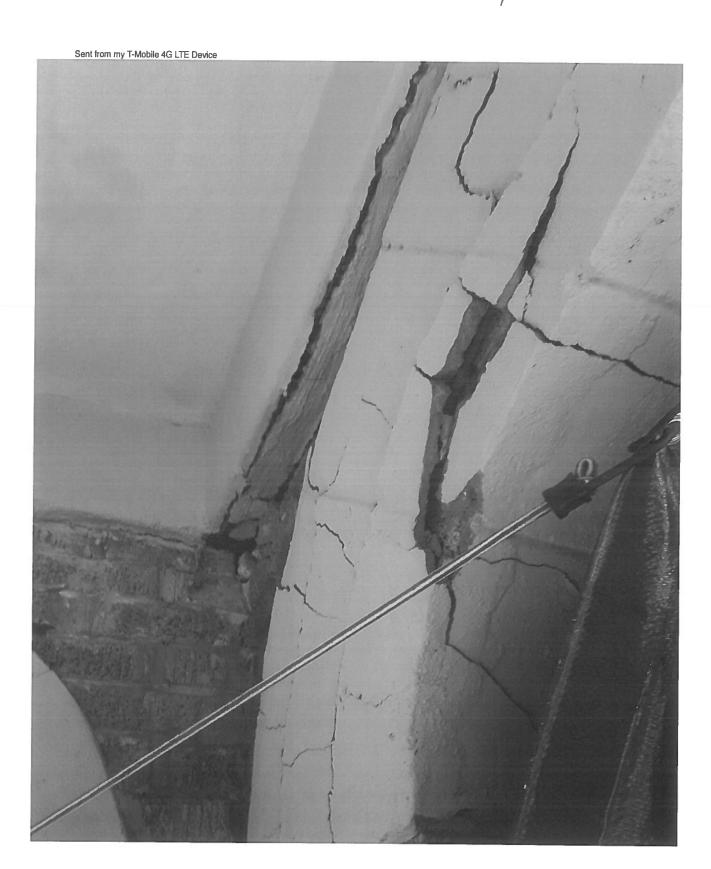
Broken stucio d bricio on arch

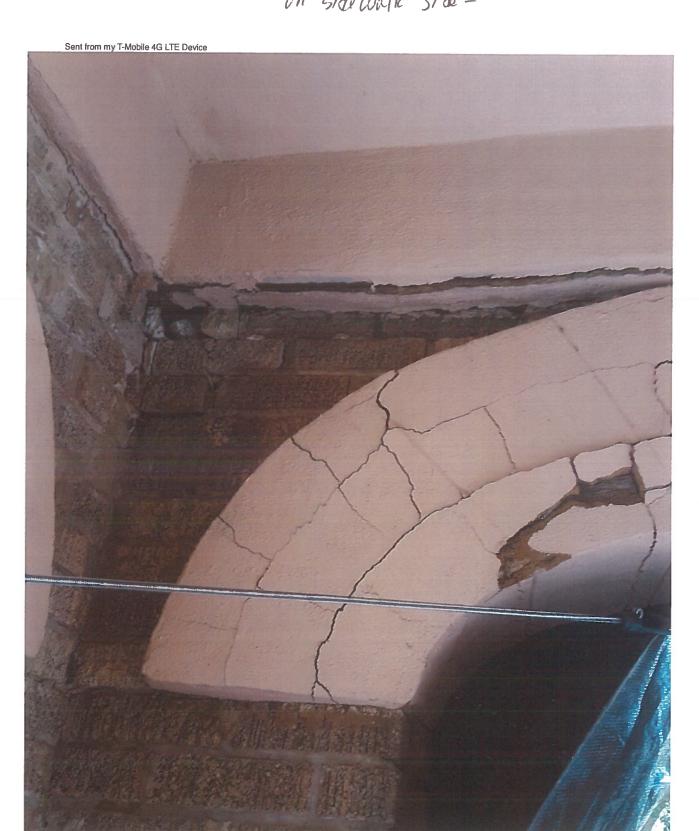
# water domage

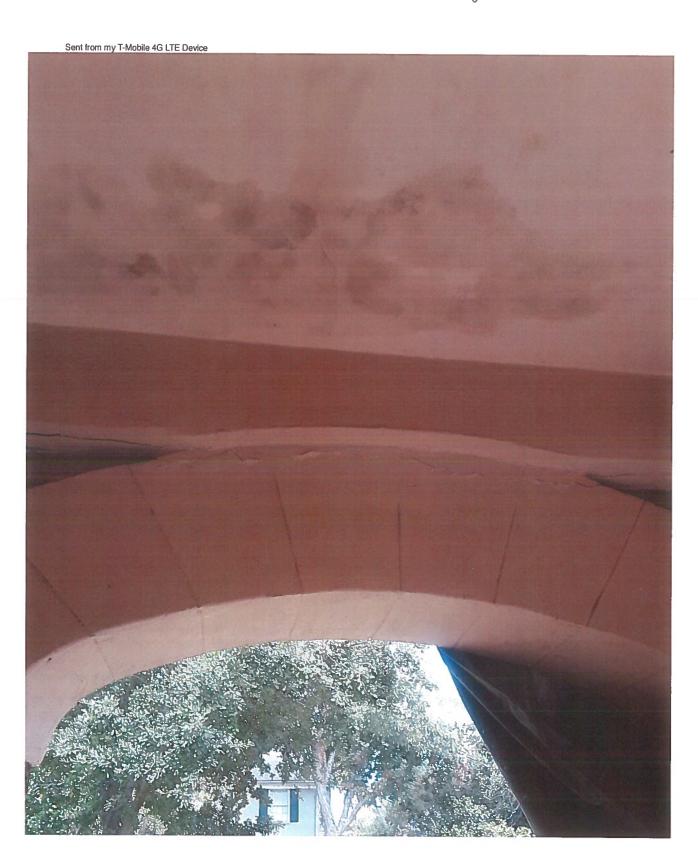
# water domage of cracked arches

## porch anhes

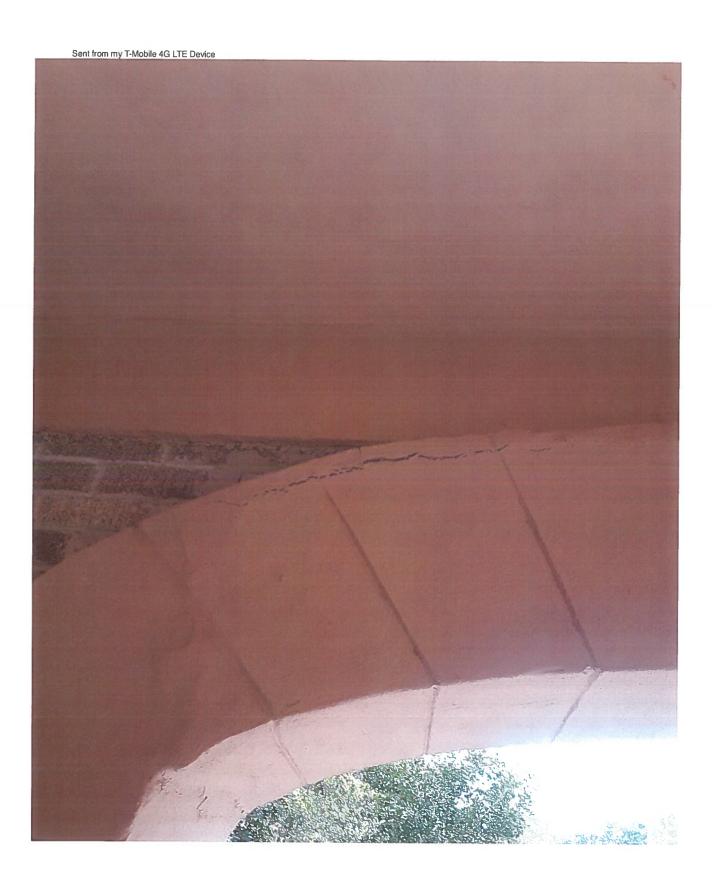
# Cracks porch ceiling

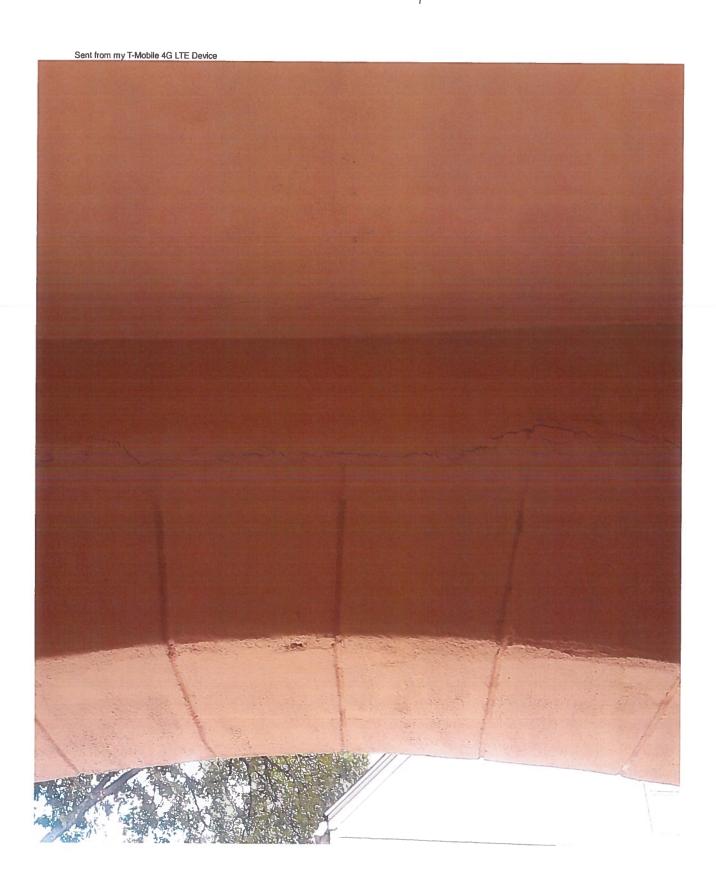
Jue to porch ceiling joist broken when dormar was hit.

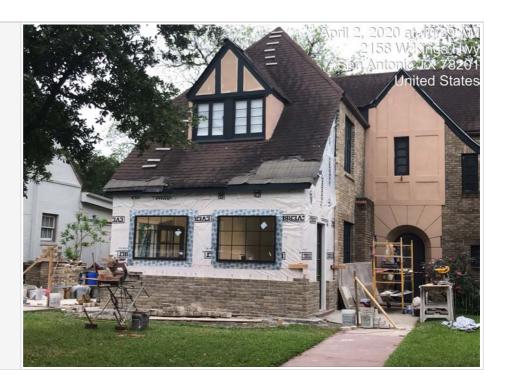
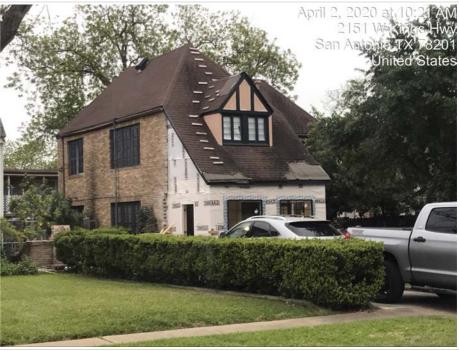
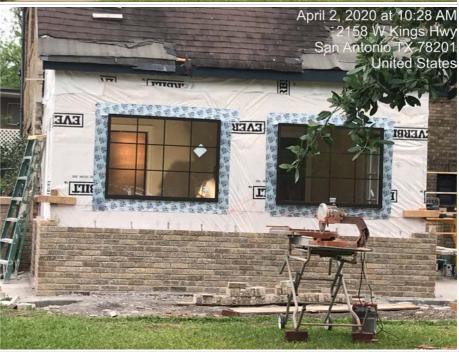
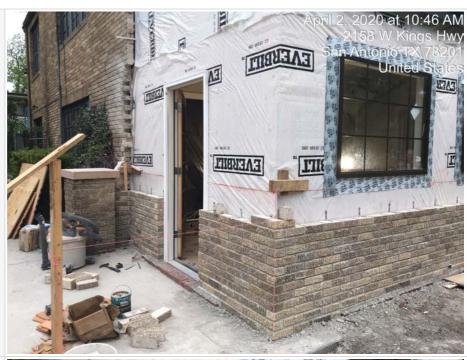
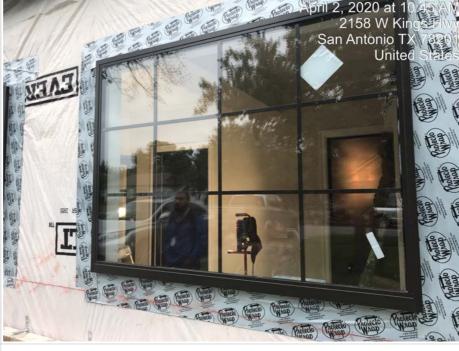
Oite visit	
Date	04/02/2020
Time	10:23 AM (-5 GMT)
Context	citizen report
Present Staff	Huy Pham, Edward Hall
Present Individuals	Homeowner, Contractor(s)
Types of Work Observed	Exterior Maintenance and Alterations
Amount of Work Completed	50%
Description of work	Porch reconstruction and enclosure
Description of interaction	Homeowners were cooperative to stop work order and will work with staff to submit missing application materials.

Violation Type	Beyond scope of Certificate of Appropriateness (Code 35-451h)
OHP Action	Spoke with property owner, Spoke with contractor(s)
Will post-work application fee apply?	No
