HISTORIC AND DESIGN REVIEW COMMISSION

June 17, 2020

HDRC CASE NO: 2020-241
ADDRESS: 1119 N OLIVE ST
LEGAL DESCRIPTION: NCB 514 BLK 18 LOT 16
ZONING: R-6, H
CITY COUNCIL DIST.: 2
DISTRICT: Dignowity Hill Historic District
APPLICANT: Matt Forrester
OWNER: ROBUS PROPERTIES LLC
60-DAY REVIEW: Not applicable due to City Council Emergency Orders
CASE MANAGER: Huy Pham
REQUEST:

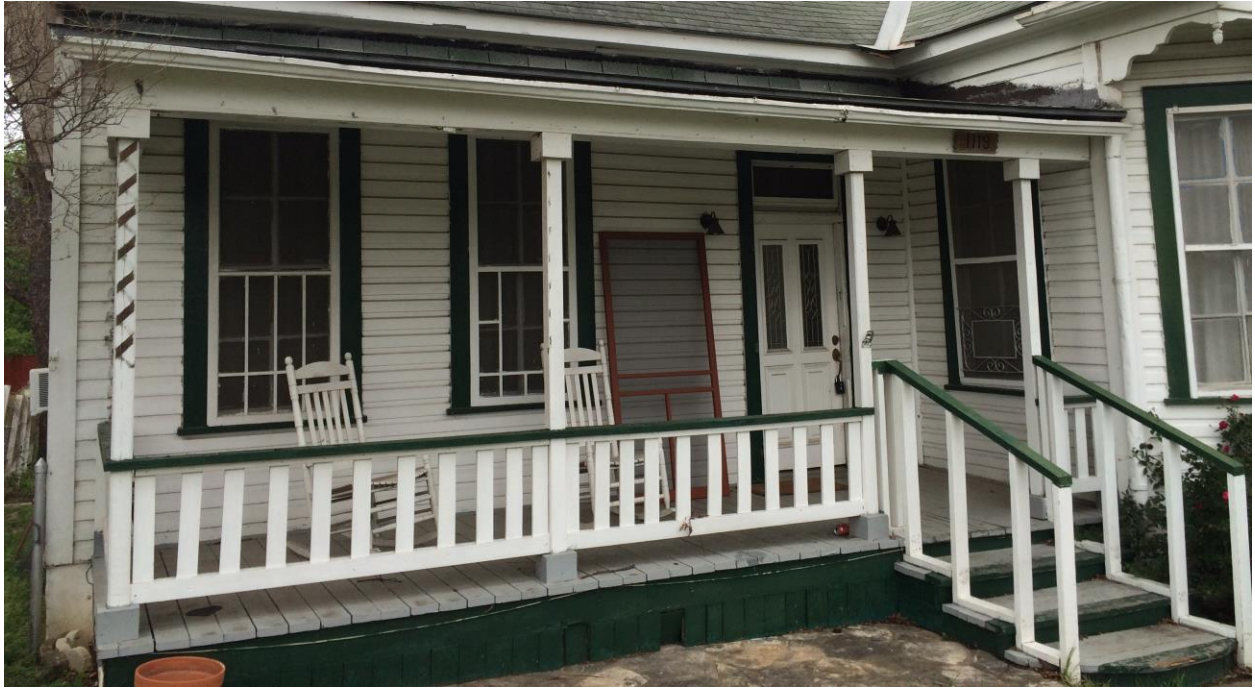
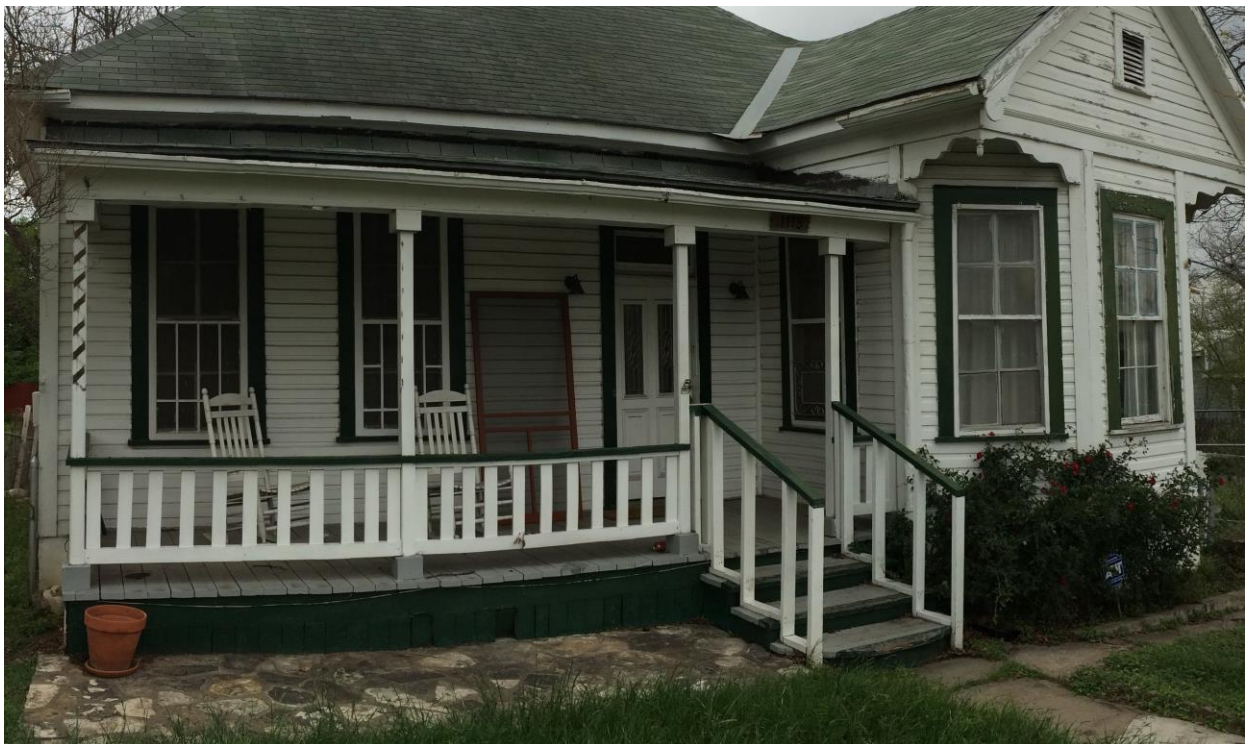
1. 2016 pictures after purchase of home by Robus and before repainting (also before removal of railing and replacement of steps)

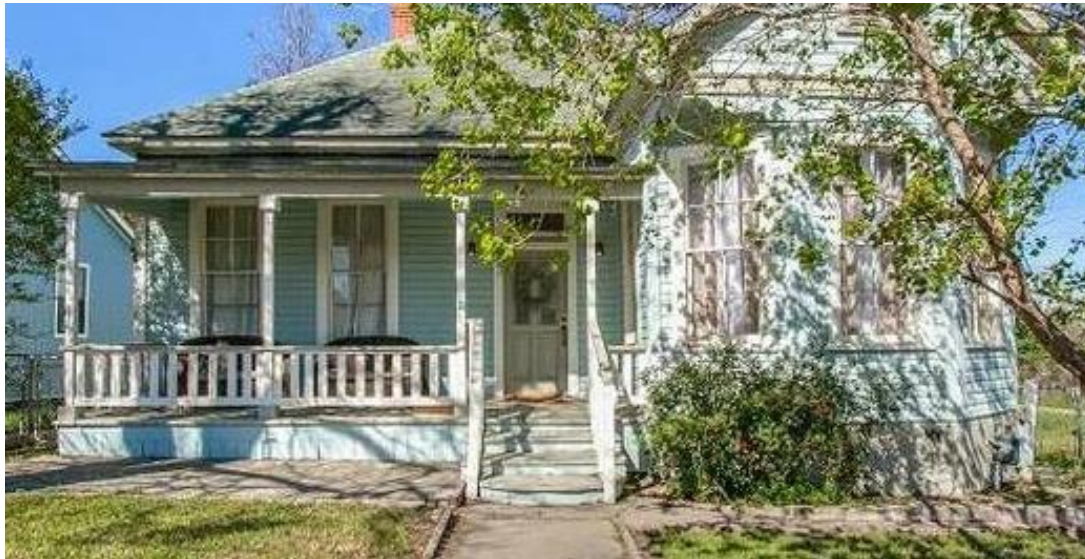
2. 2019 picture before removal of railing and replacement of steps

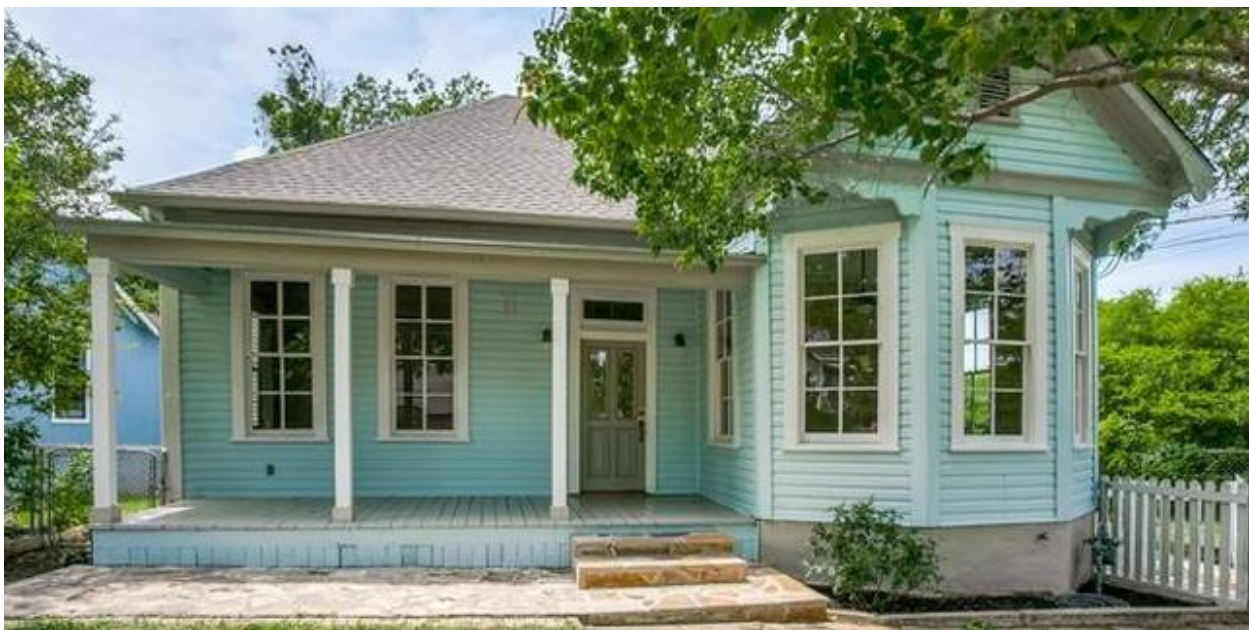
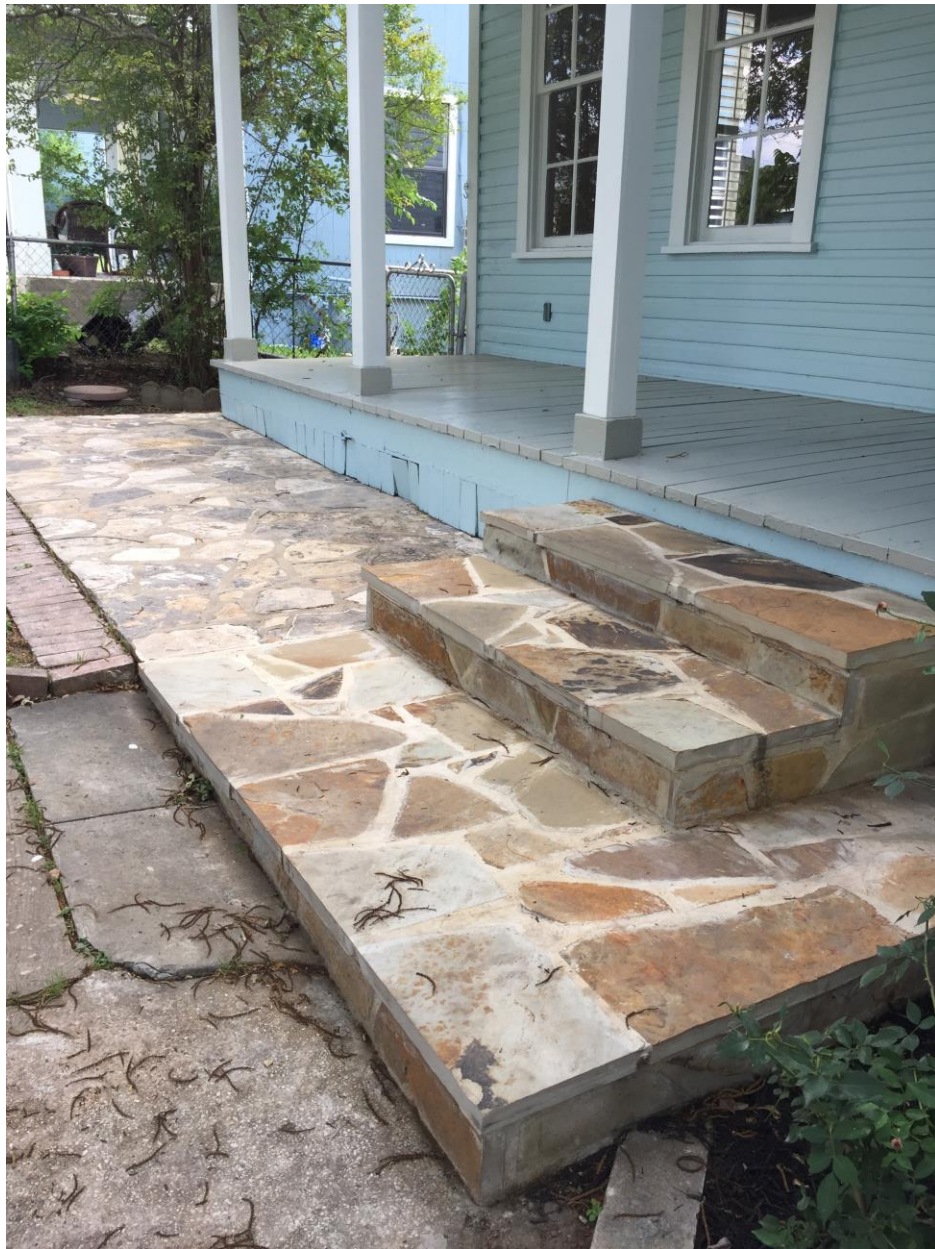
- b. COMPLIANCE – On a site visit conducted on May 18, 2020, staff found that the property at 1119 N Olive was subject to porch railing removal and the installation of flagstone steps prior to approval. The applicant was cooperative with the Stop Work Order and submitted an application to be heard at the next Historic and Design Review Commission hearing.

- d. PORCH STEPS – The applicant has proposed to remove the wood steps and install flagstone steps to match the existing flagstone patio in front of the porch. Per the Guidelines for Exterior Maintenance and Alterations 7.B.iii., applicants should replace in-kind porches, balconies, porte-cocheres, and related elements, such as ceilings, floors, and columns, when such features are deteriorated beyond repair. When in-kind replacement is not feasible, the design should be compatible in scale, massing, and detail while materials should match in color, texture, dimensions, and finish. Staff finds that the flagstone patio is an existing, non-conforming feature and should not be used as reference material. Staff finds that installing simple wood steps would be more appropriate and mitigate the visual impact of the inappropriate flagstone patio.

3. 2020 Pictures after removal of railing and installation of stone landing and steps

Staff does not recommend approval of the replacement the porch steps with flagstone steps based on finding d; simple wood steps should be restored after a measured drawing is approved by staff.

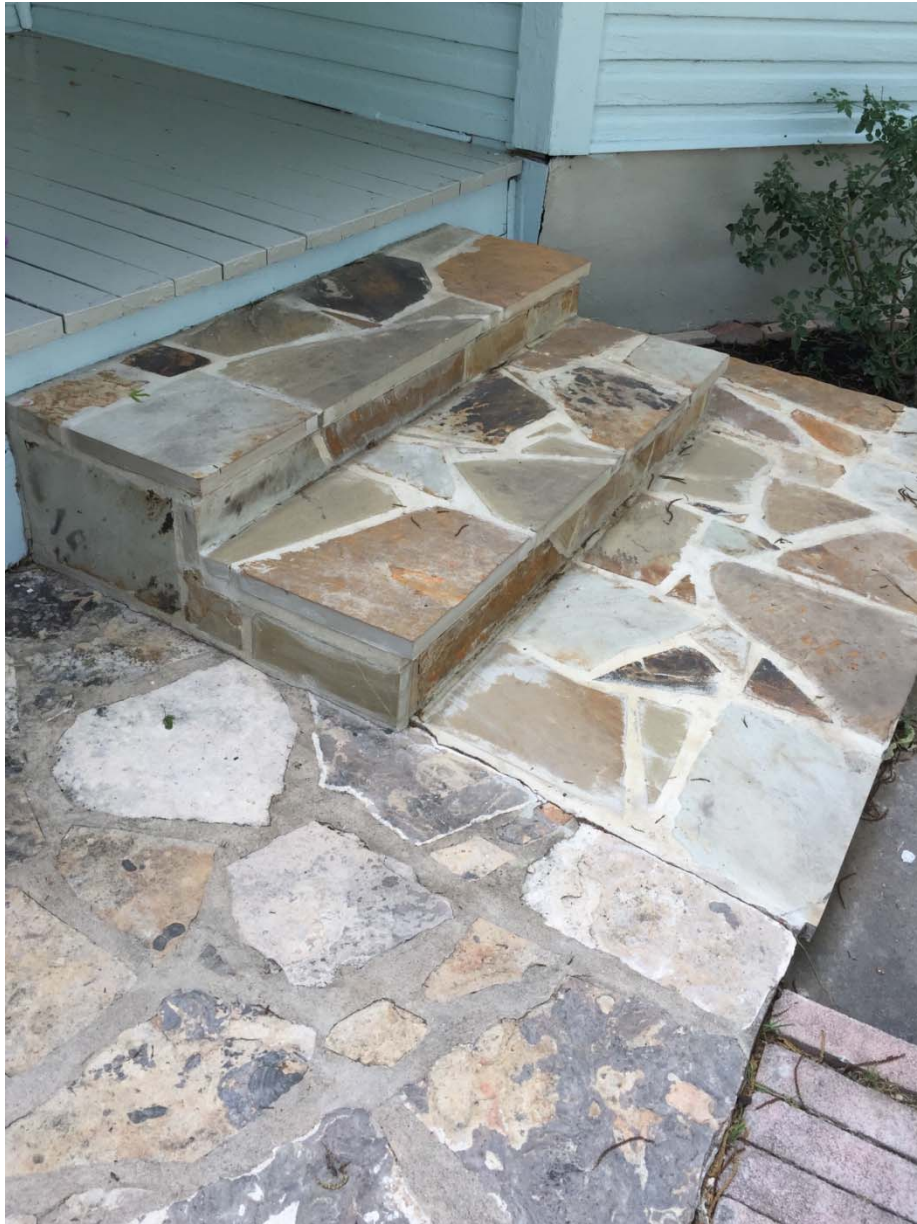
Brown and tan stones used for new front steps

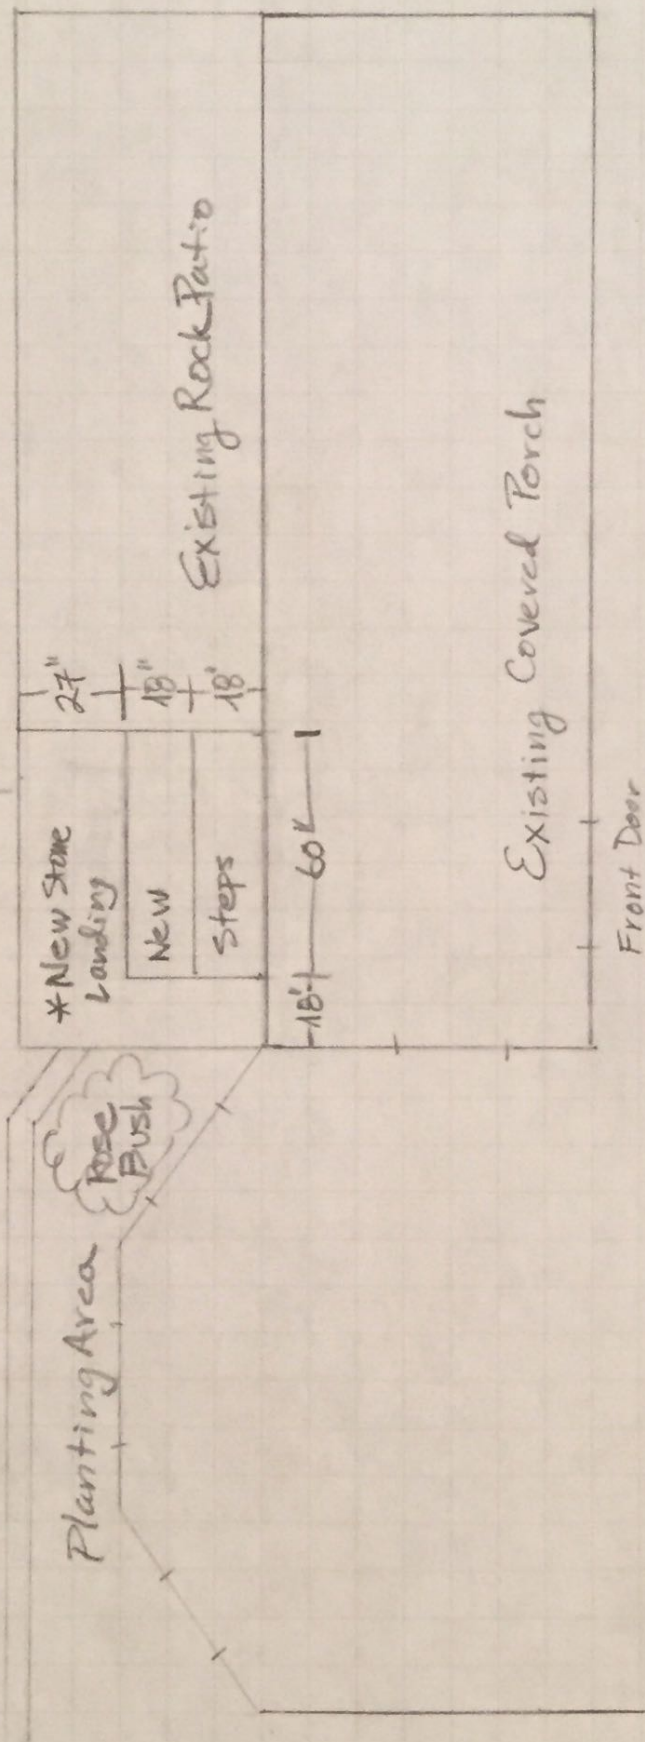
1119 N. Olive St.

Top view of front of house, porch, patio and steps

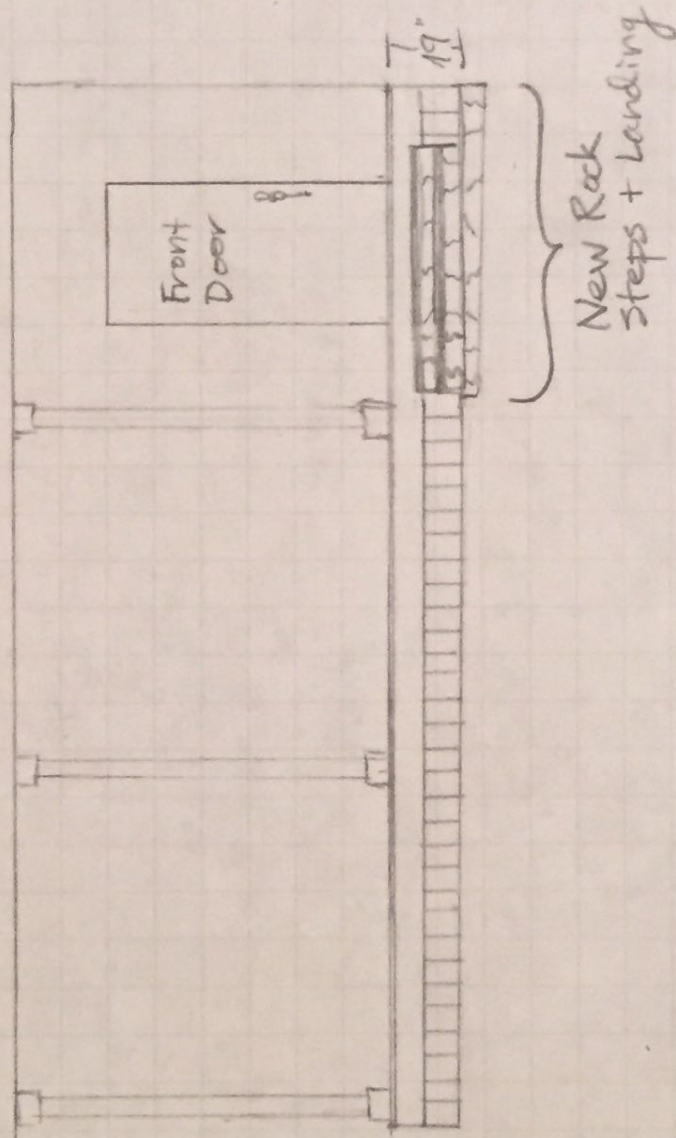
1119 N. Olive St.

Front View of Porch, patio and steps
