HISTORIC AND DESIGN REVIEW COMMISSION

HDRC CASE NO: 2020-251
ADDRESS: 2158 W KINGS HWY
LEGAL DESCRIPTION: NCB 6825 BLK LOT 15 & W 12.5 FT OF 14
ZONING: R-6, H
CITY COUNCIL DIST.: 7
DISTRICT: Monticello Park Historic District
APPLICANT: John Speegle, speegle & KIM-davis Architecture
OWNER: William Hazlewood
TYPE OF WORK: Enclosure of front porch with windows and door
APPLICATION RECEIVED: April 03, 2020
60-DAY REVIEW: Not applicable due to City Council Emergency Orders
CASE MANAGER: Huy Pham

REQUEST:

The applicant is requesting a Certificate of Appropriateness for approval to enclose the front porch to feature aluminum windows in the two front arches and doors in the side-facing arches.

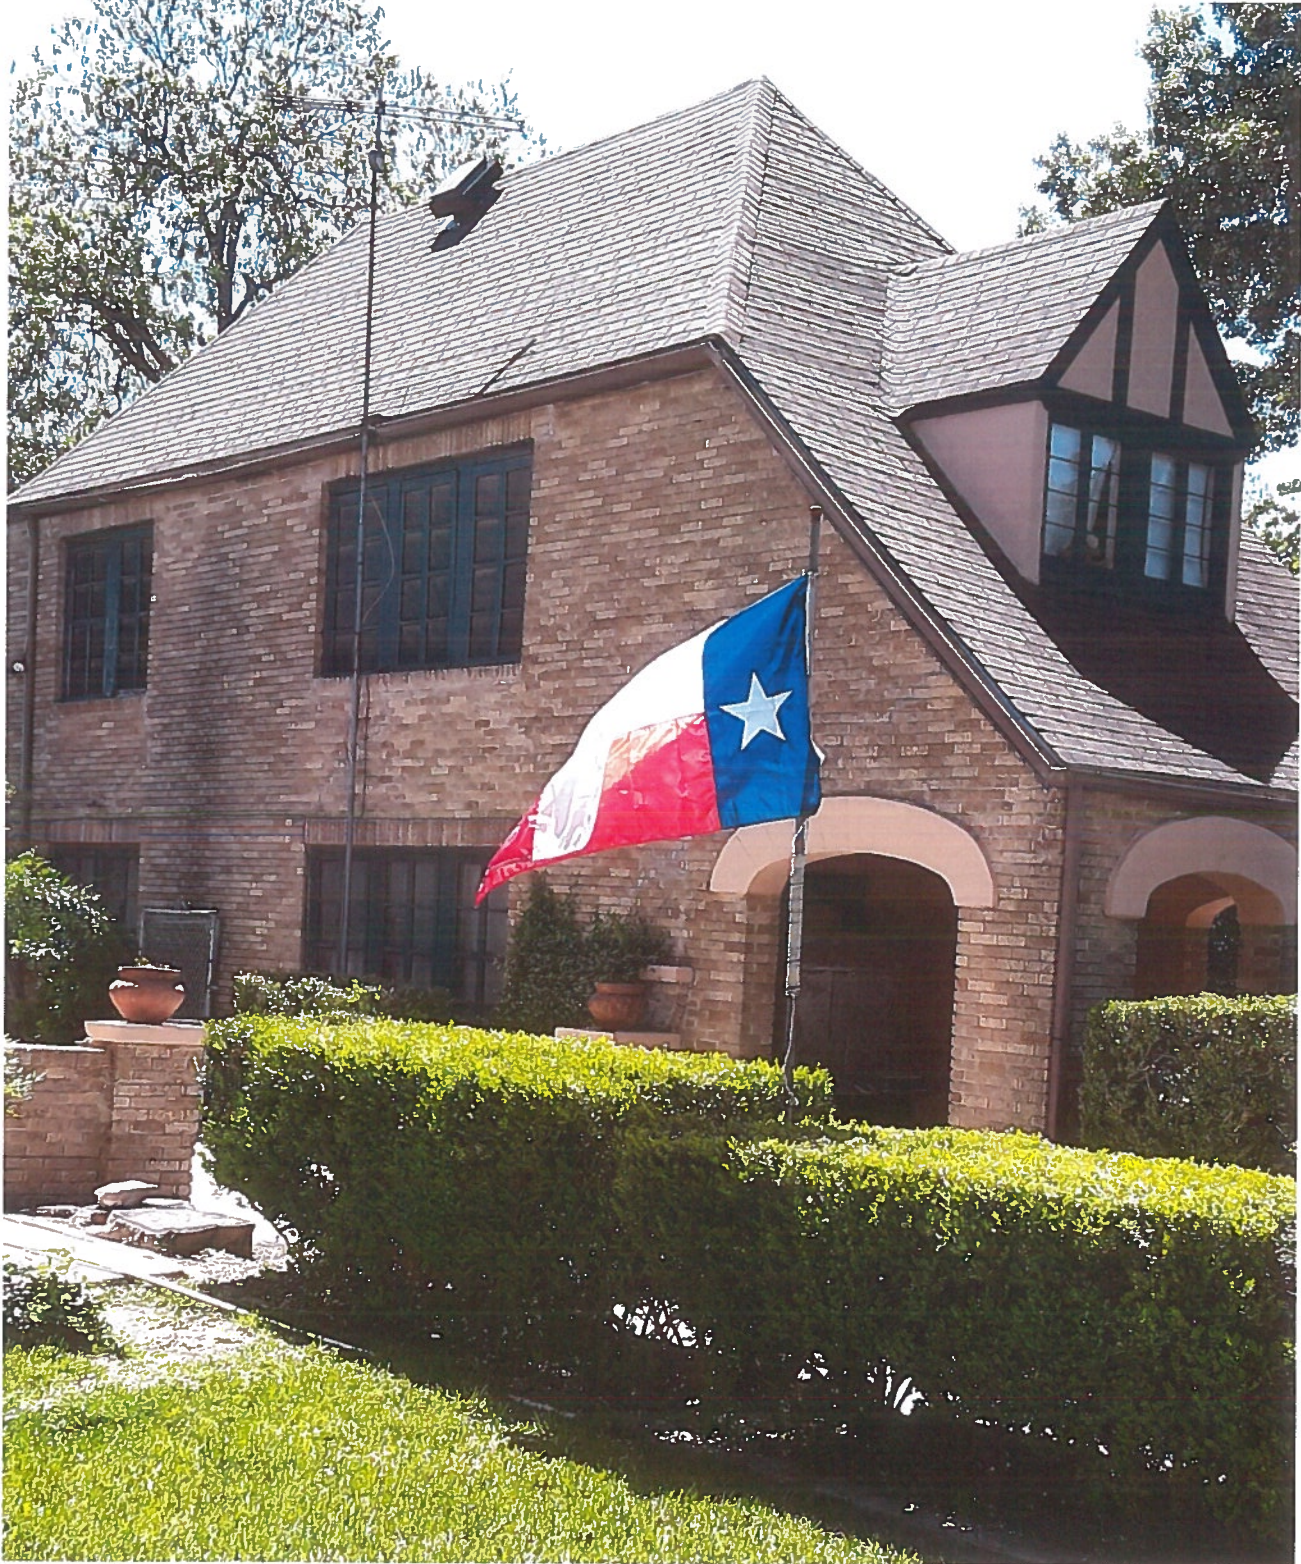
damage of dormer which pushed
the dormer & roof down - leading to
joist damage.

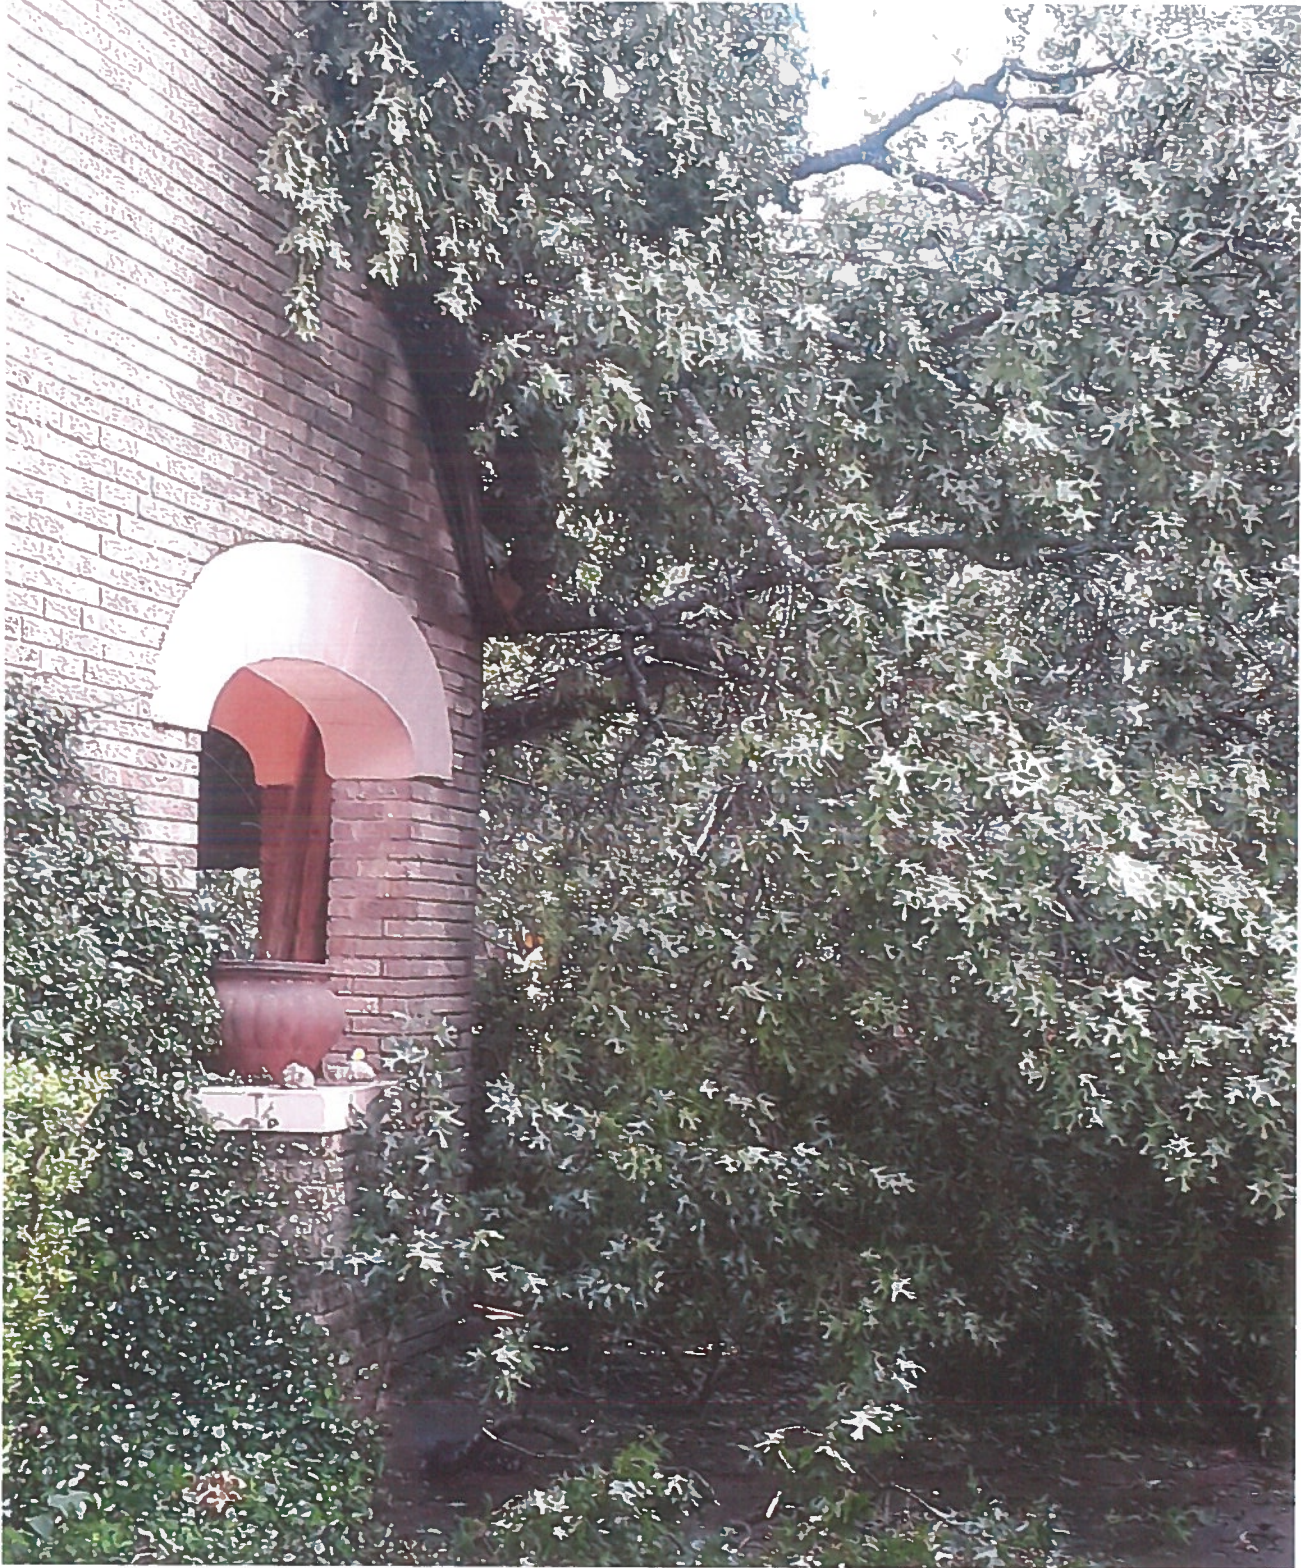
drive way side of house

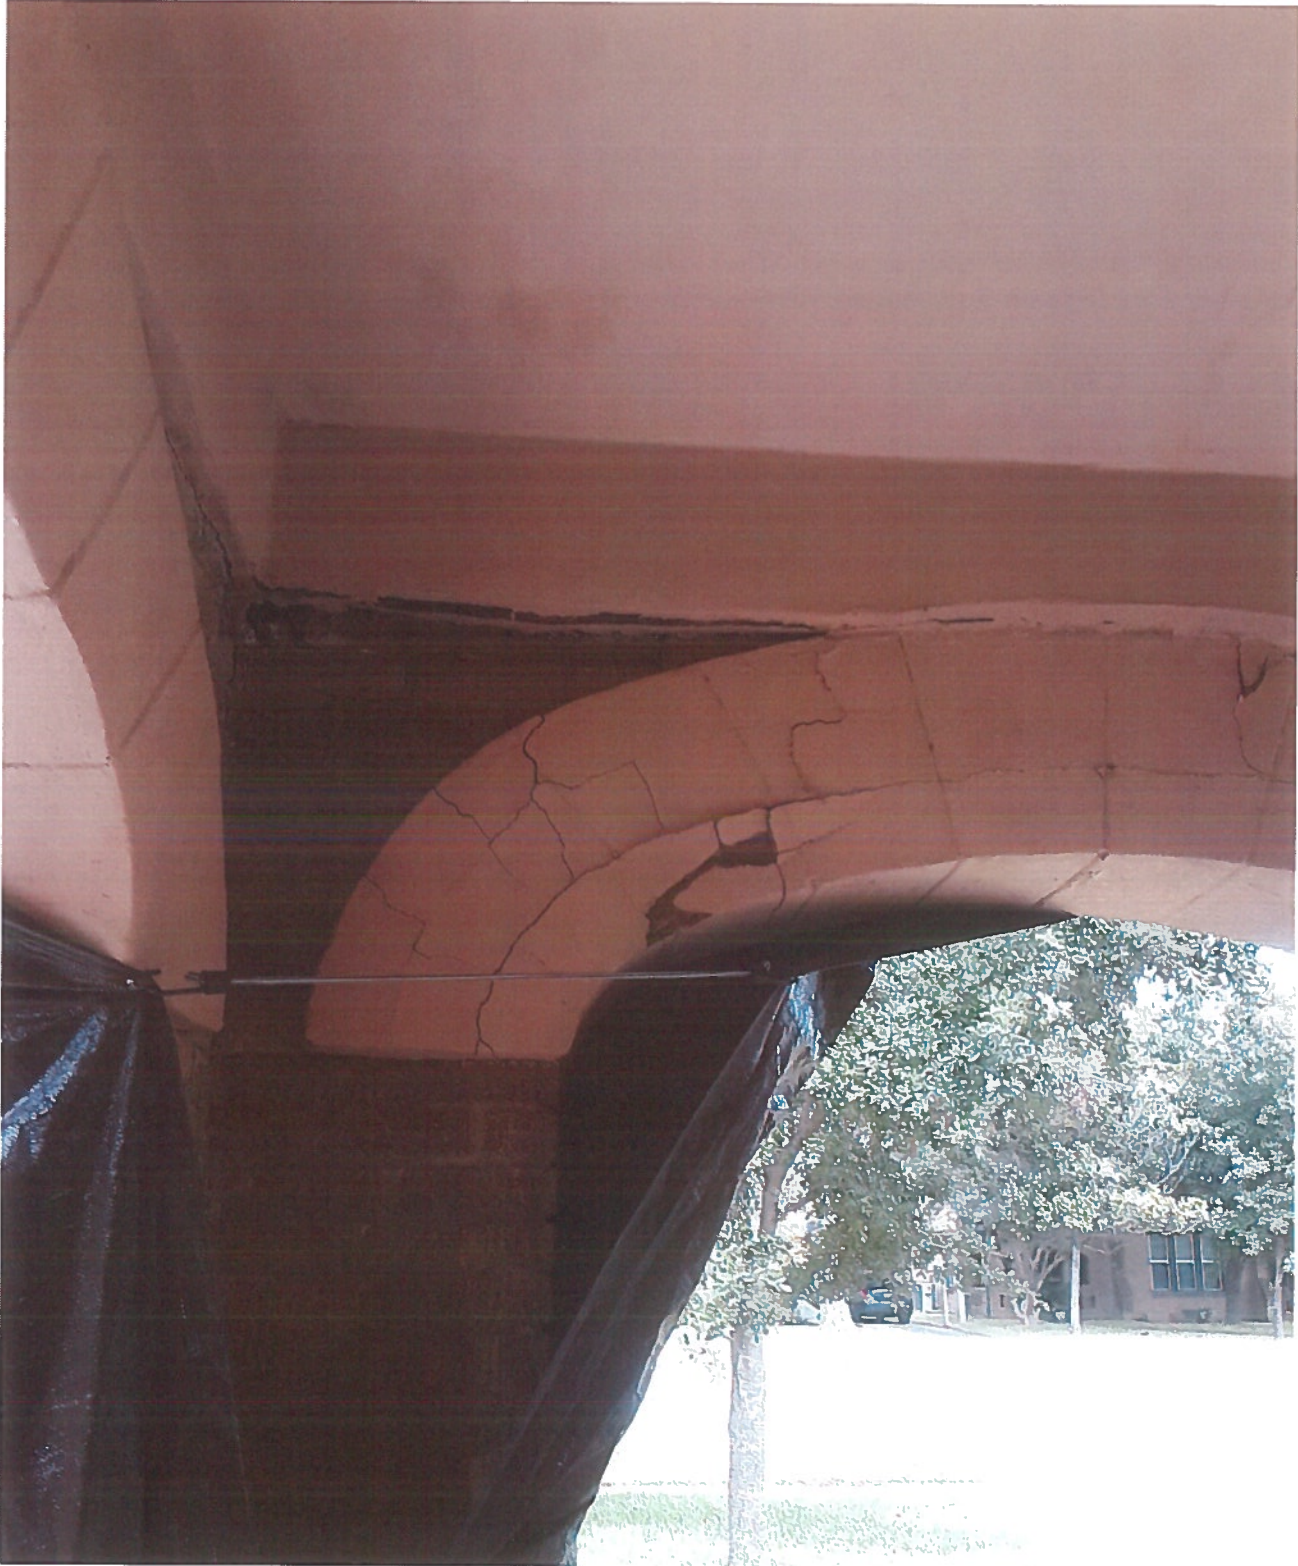
porch

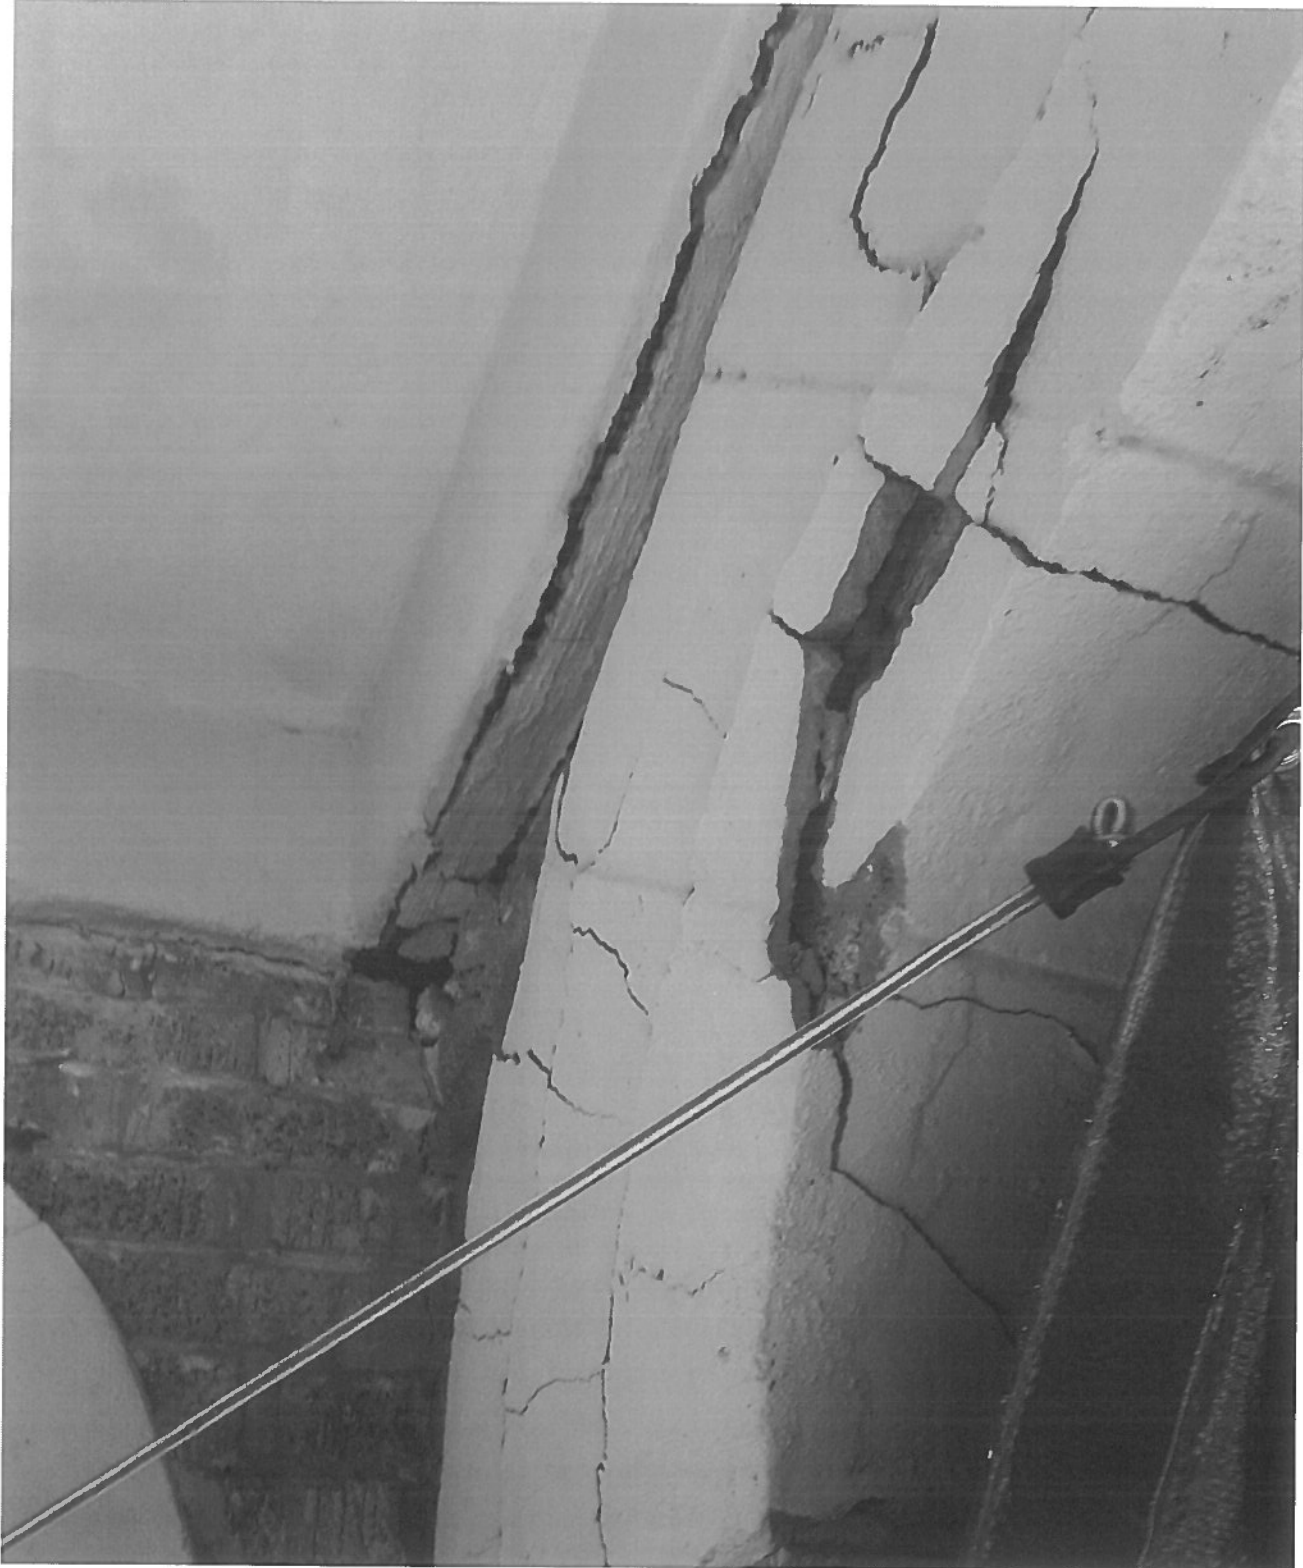
broken stucco porch

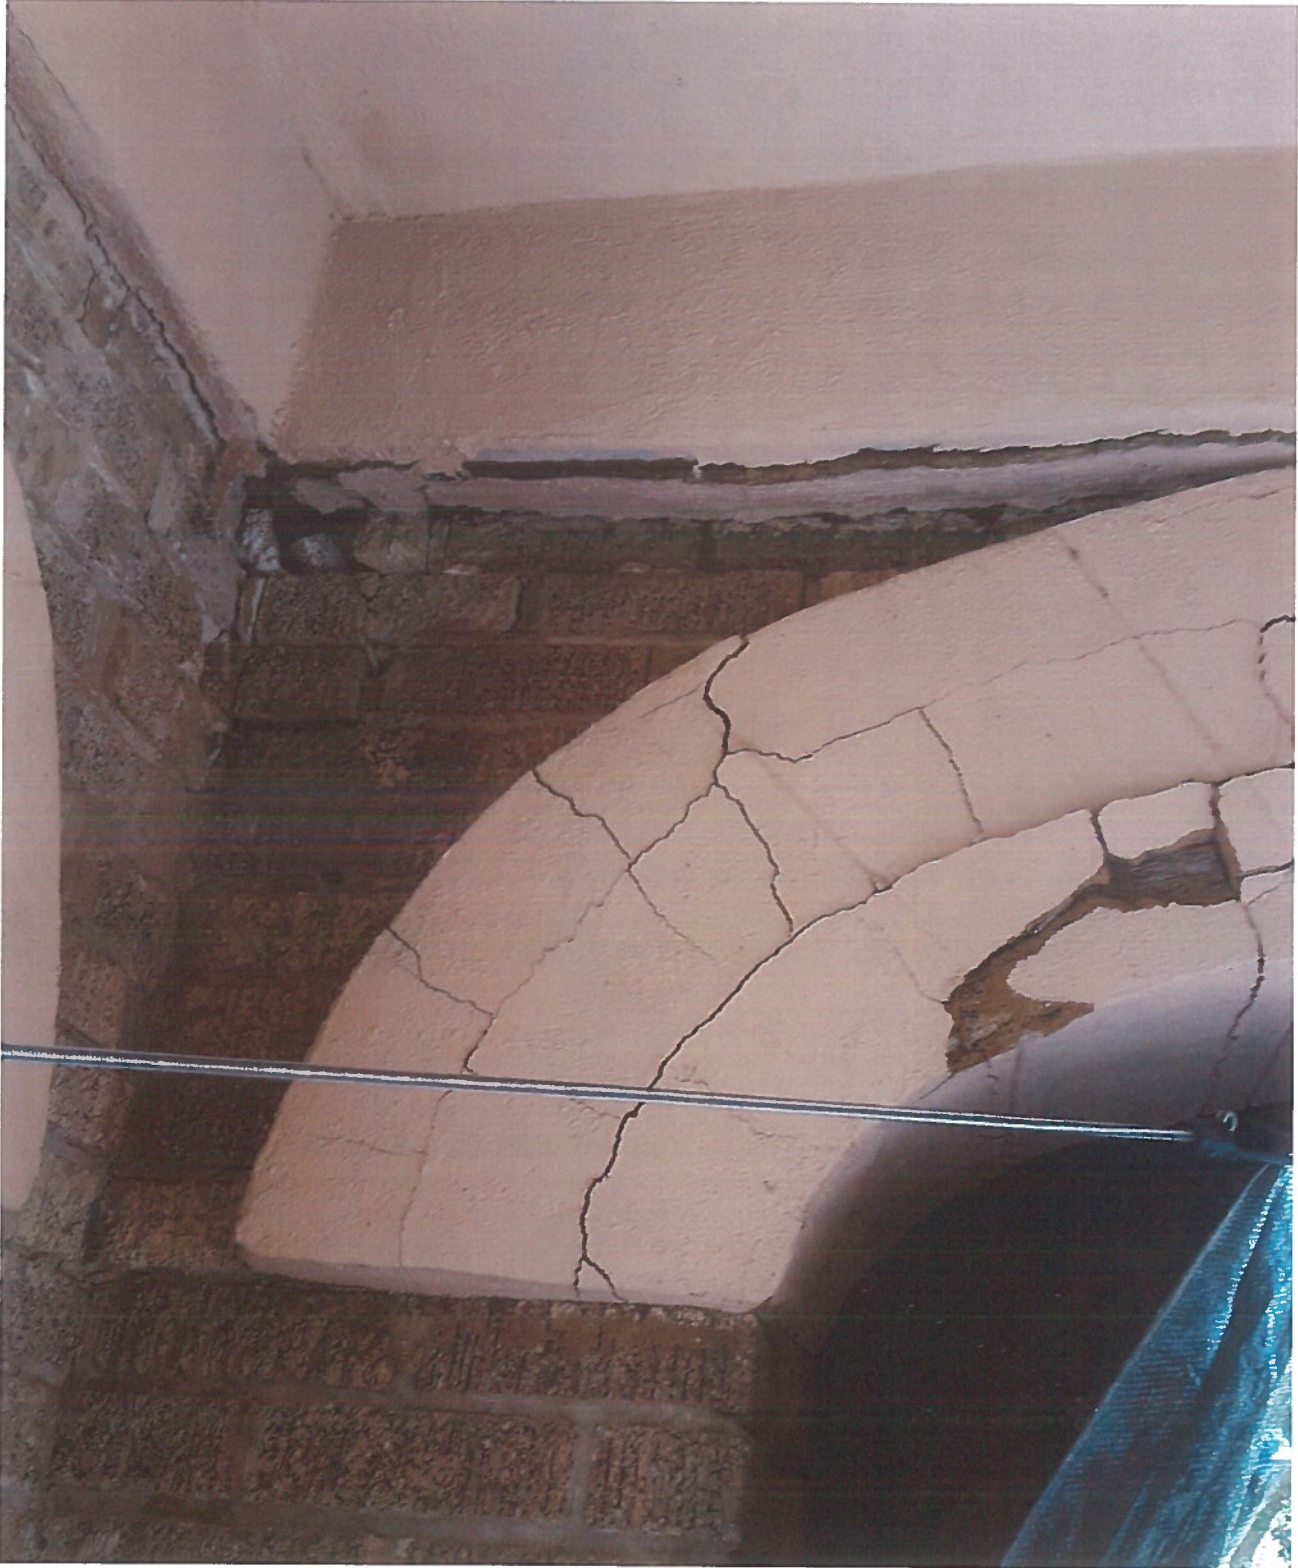
broken stucco & brick on arch
on sidewalk side -

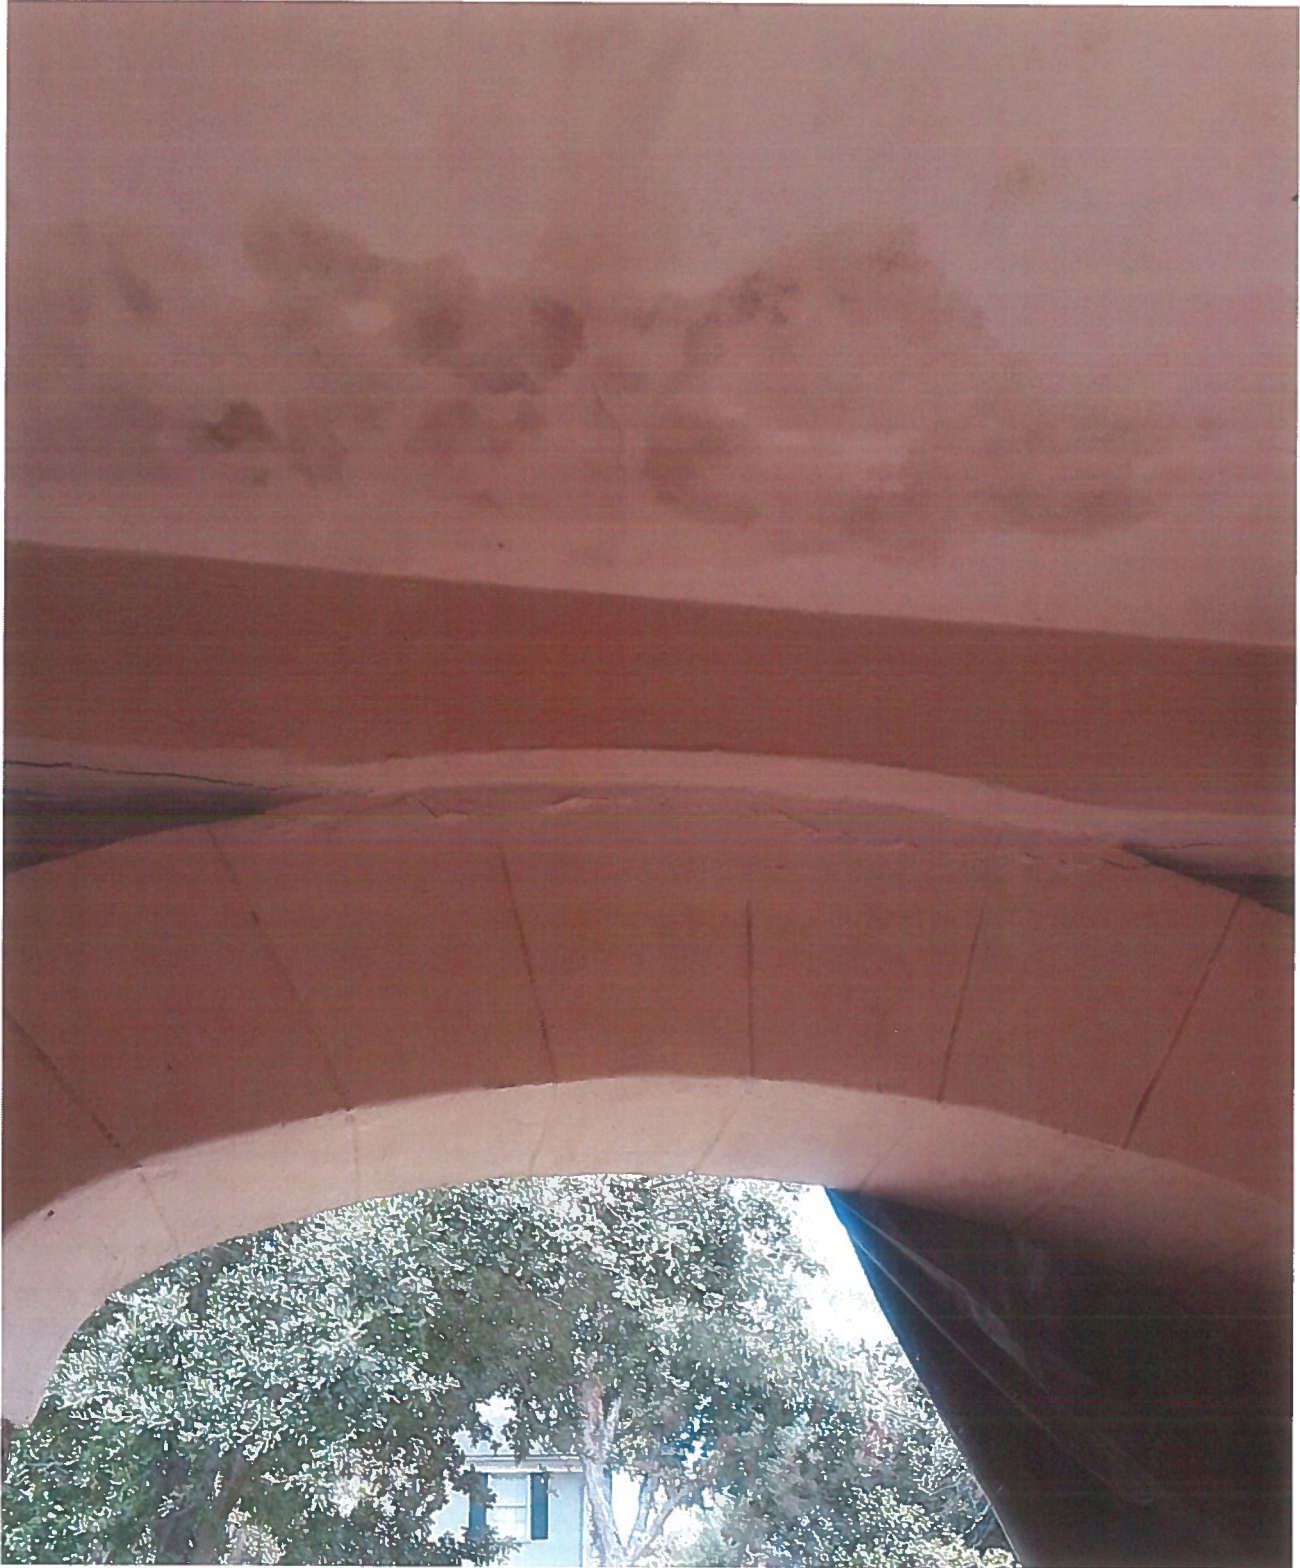
water damage

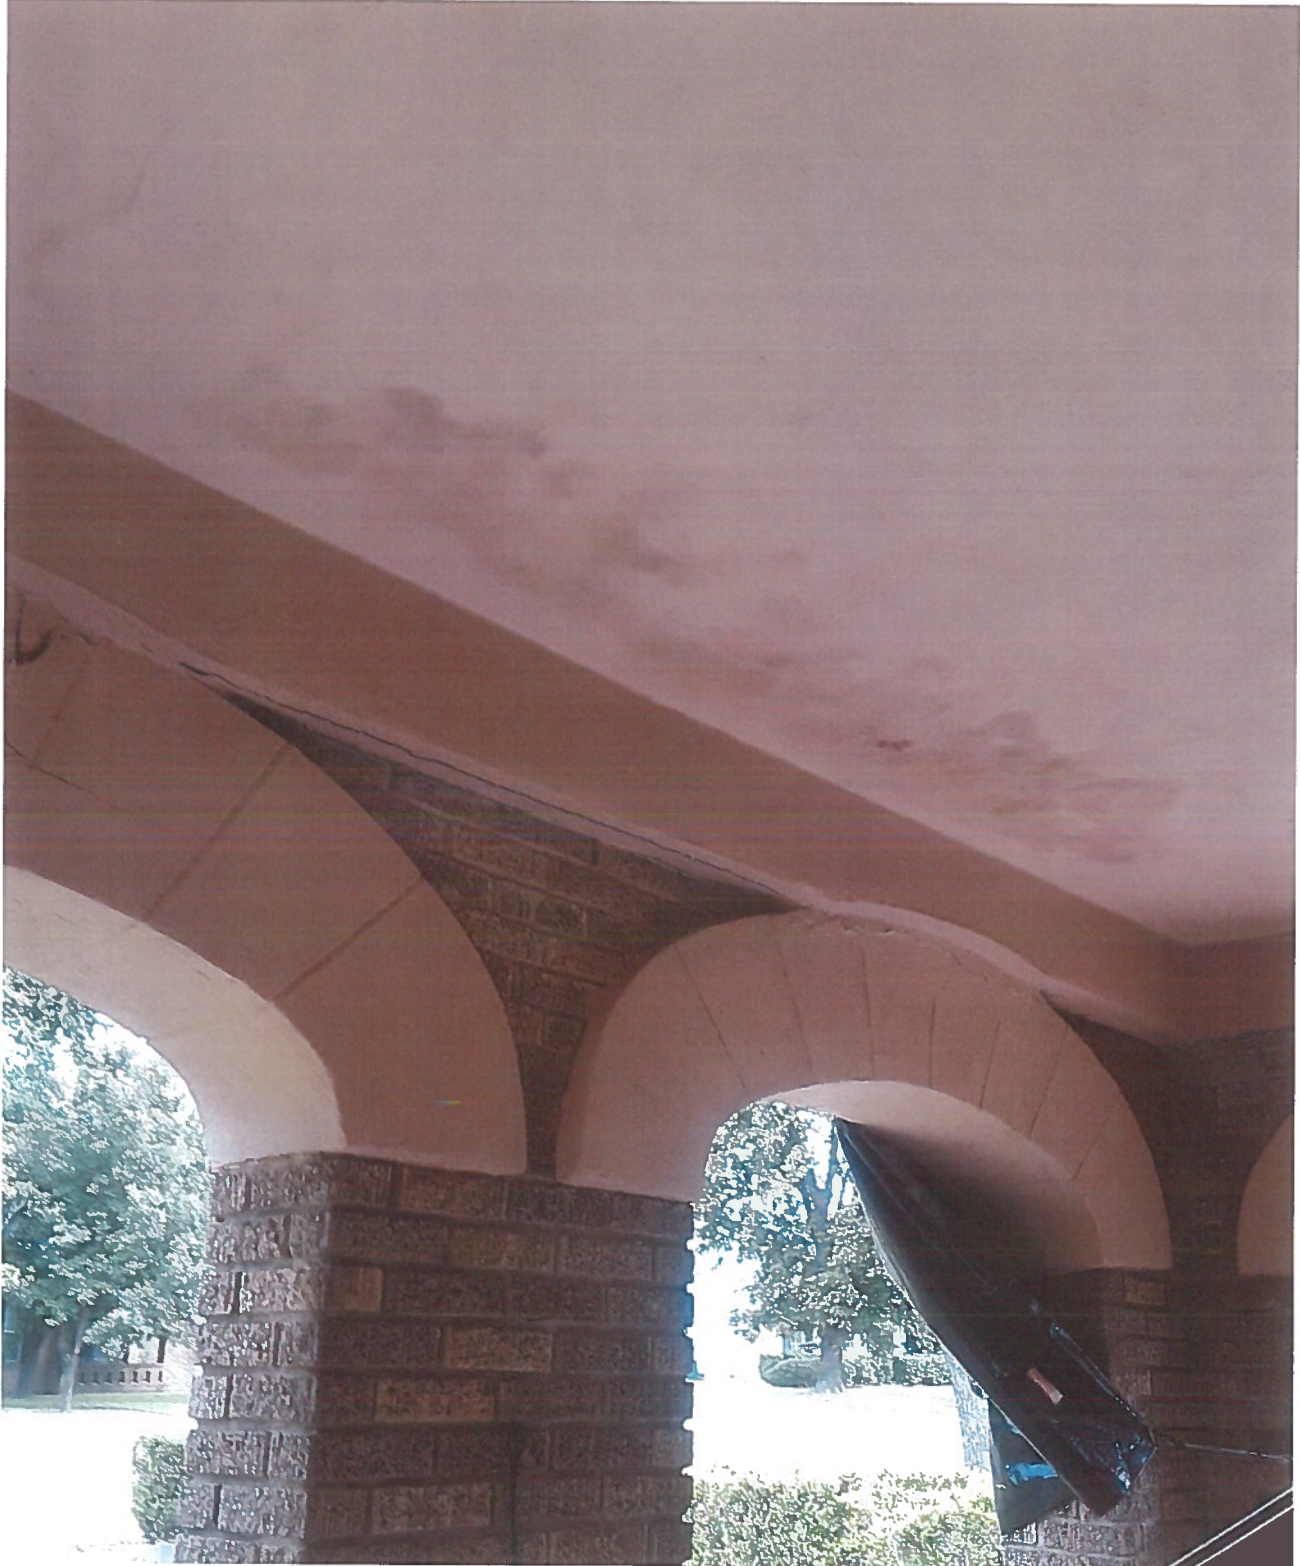
water damage & cracked arches
in porch.

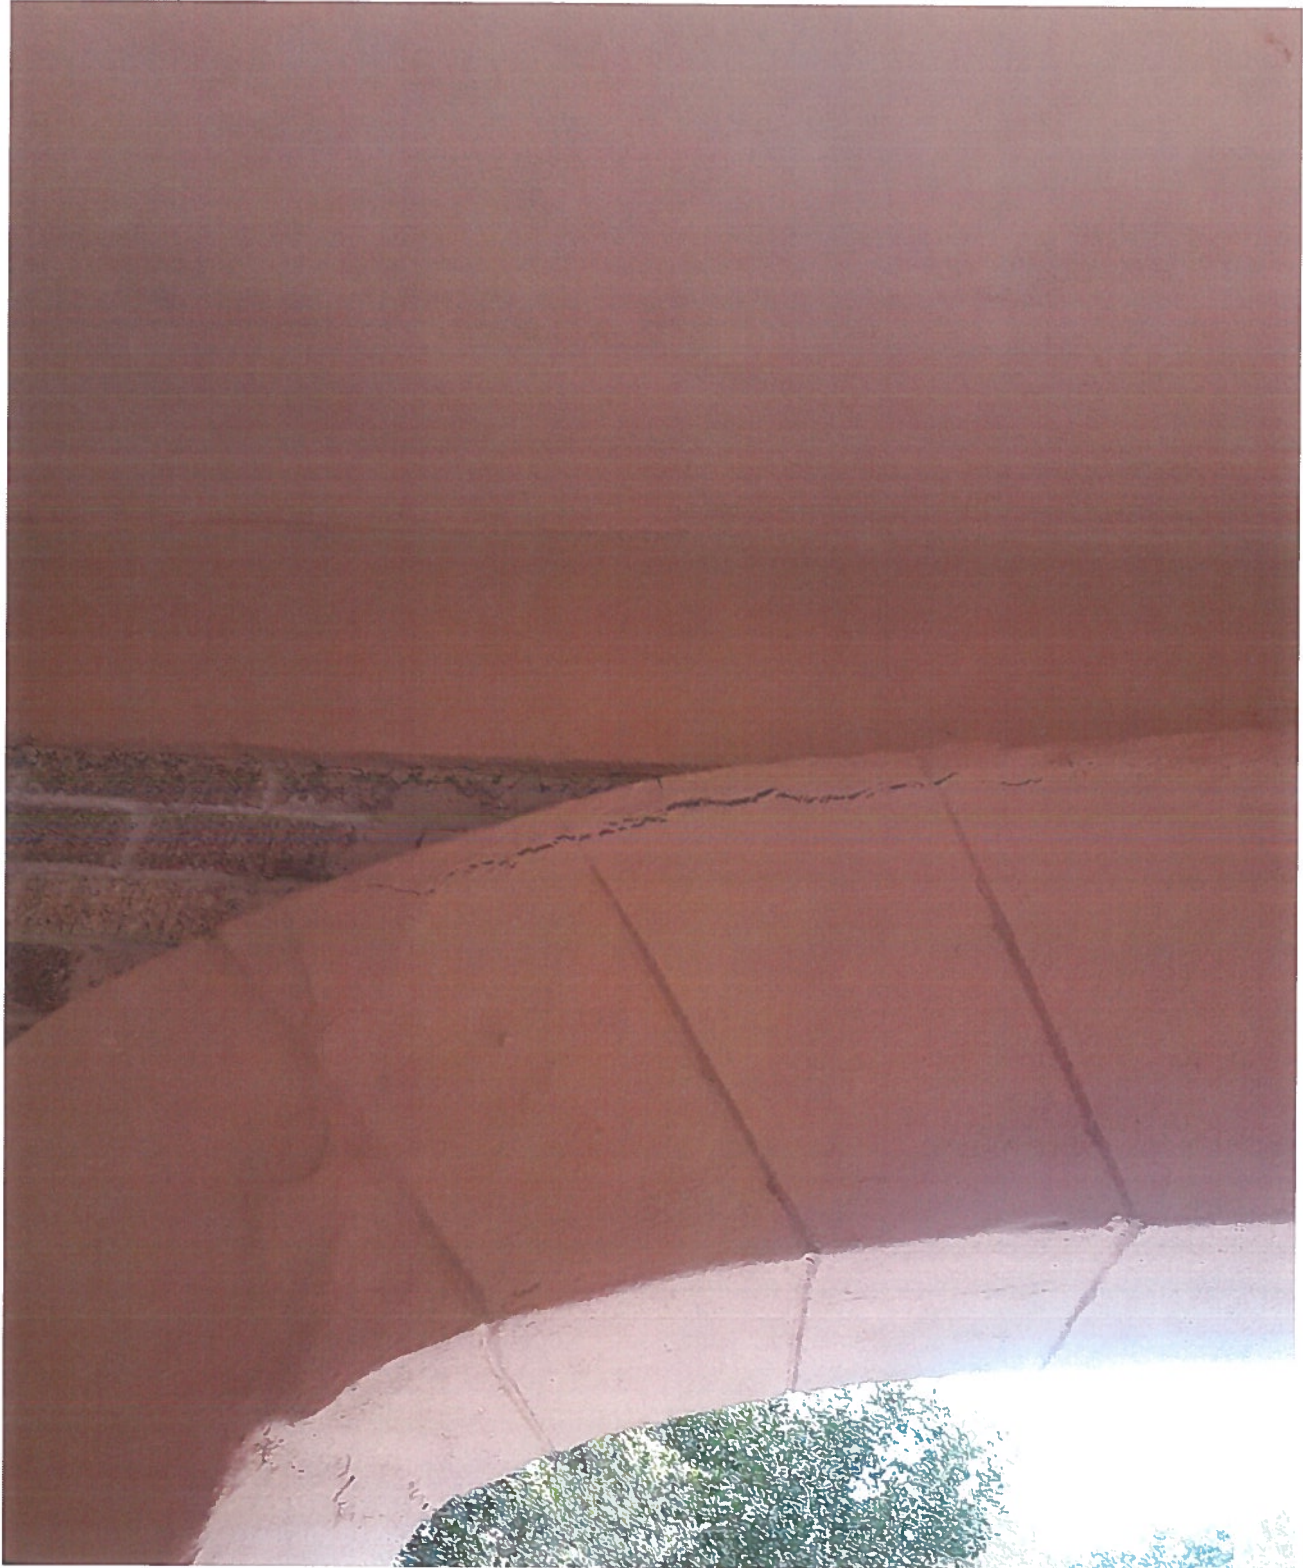
porch arches

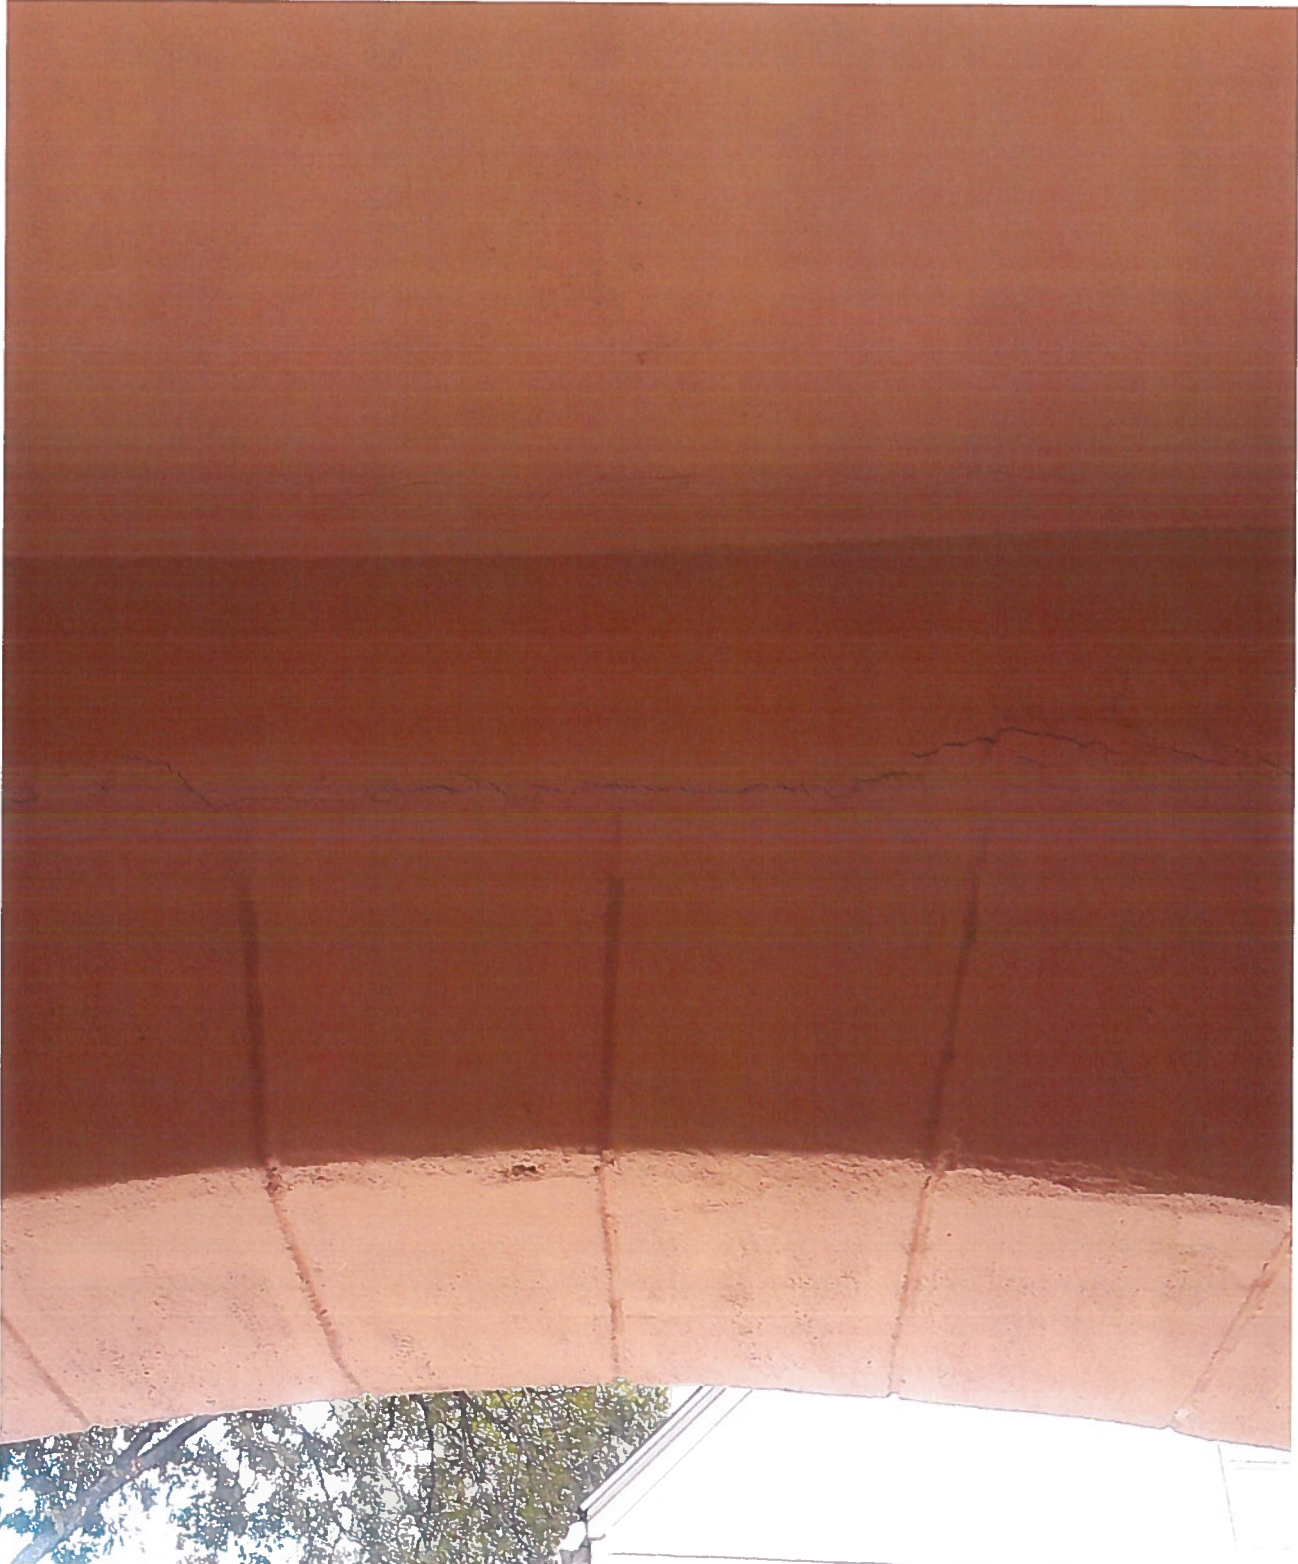
Cracks porch ceiling

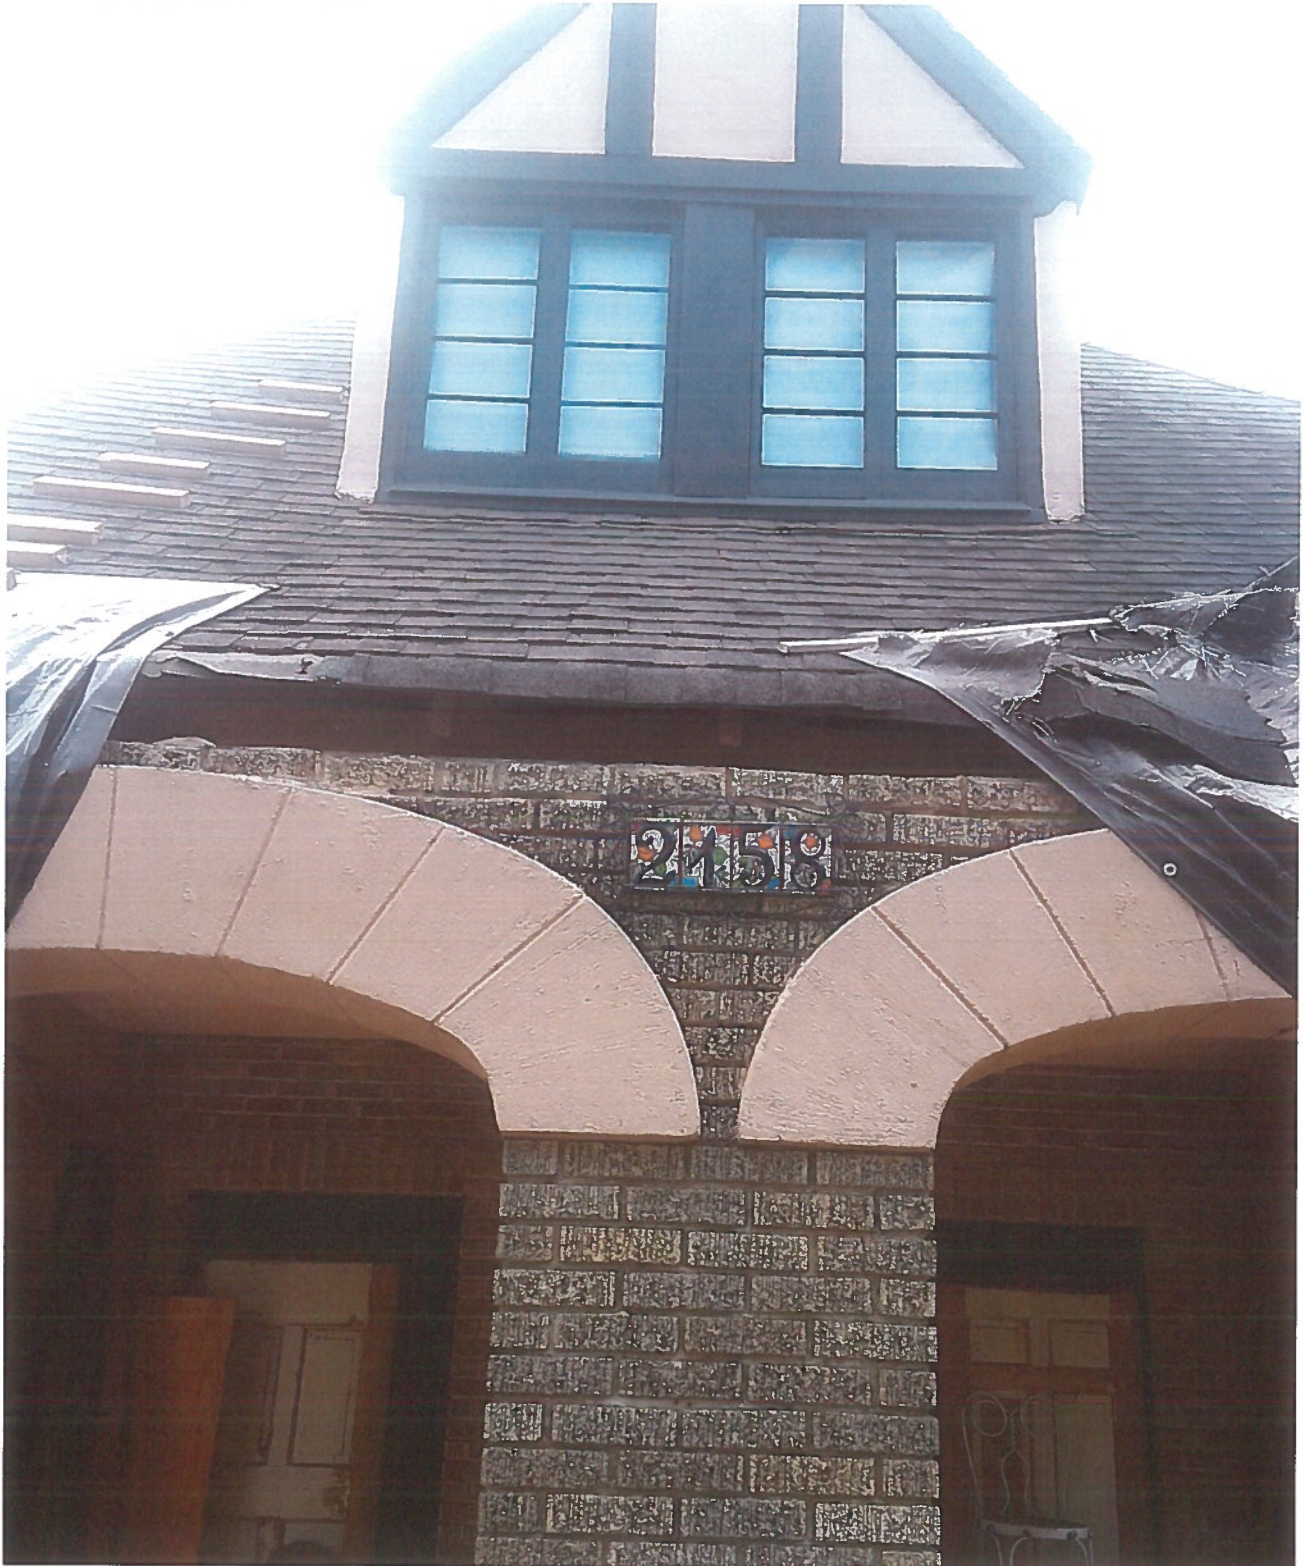
sunken roof under dormer window
due to porch ceiling joist broken when
dormer was hit.

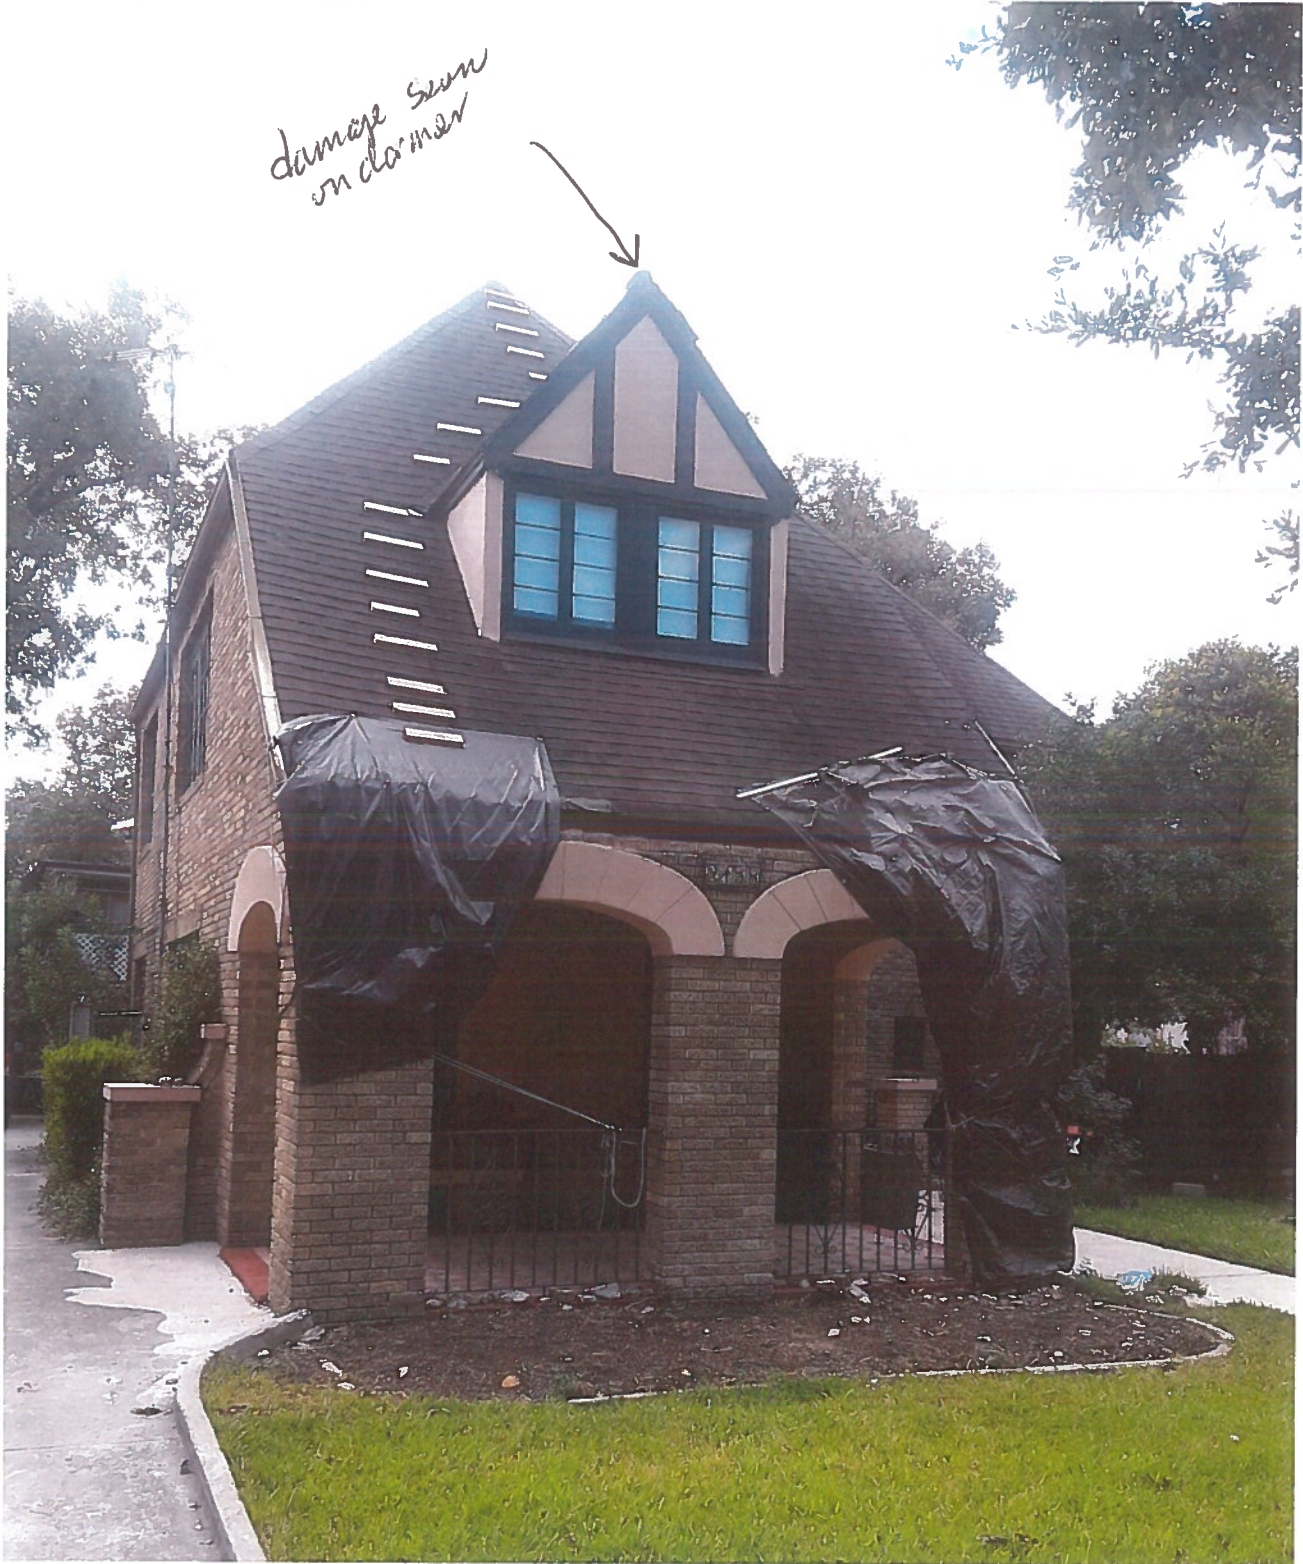
damage seen
on dormer

add curved picture windows in arched opening. Follow the distinct characteristics in the window framings - keep iron rails -
