HISTORIC AND DESIGN REVIEW COMMISSION

HDRC CASE NO: 2020-251
ADDRESS: 2158 W KINGS HWY
LEGAL DESCRIPTION: NCB 6825 BLK LOT 15 & W 12.5 FT OF 14
ZONING: R-6, H
CITY COUNCIL DIST.: 7
DISTRICT: Monticello Park Historic District
APPLICANT: John Speegle, speegle & KIM-davis Architecture
OWNER: William Hazlewood
TYPE OF WORK: Enclosure of front porch with windows and door
APPLICATION RECEIVED: April 03, 2020
60-DAY REVIEW: Not applicable due to City Council Emergency Orders
CASE MANAGER: Huy Pham

REQUEST:

The applicant is requesting a Certificate of Appropriateness for approval to enclose the front porch to feature aluminum windows in the two front arches and doors in the side-facing arches.

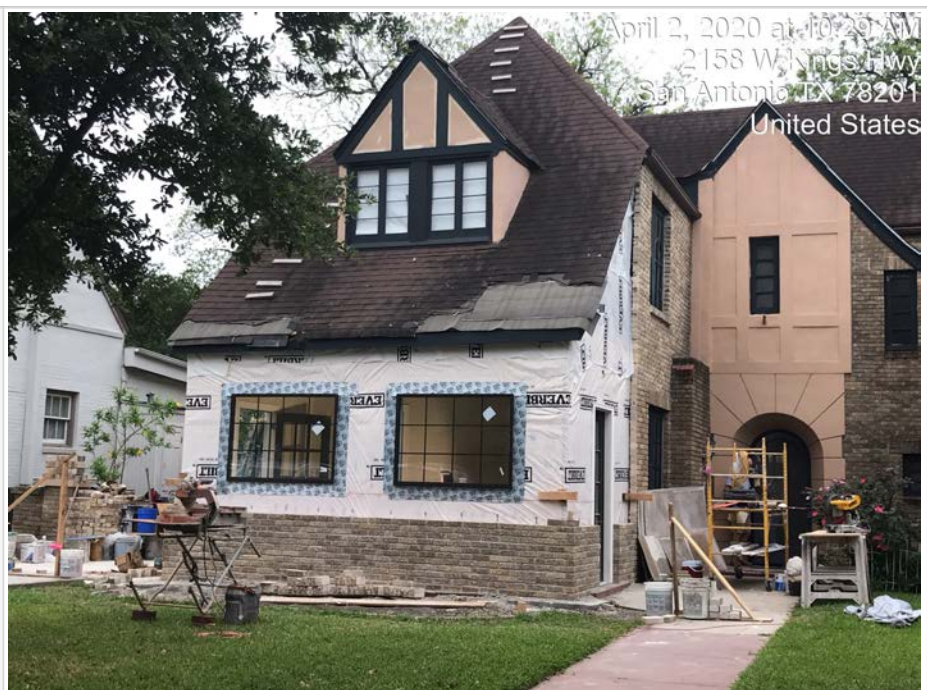
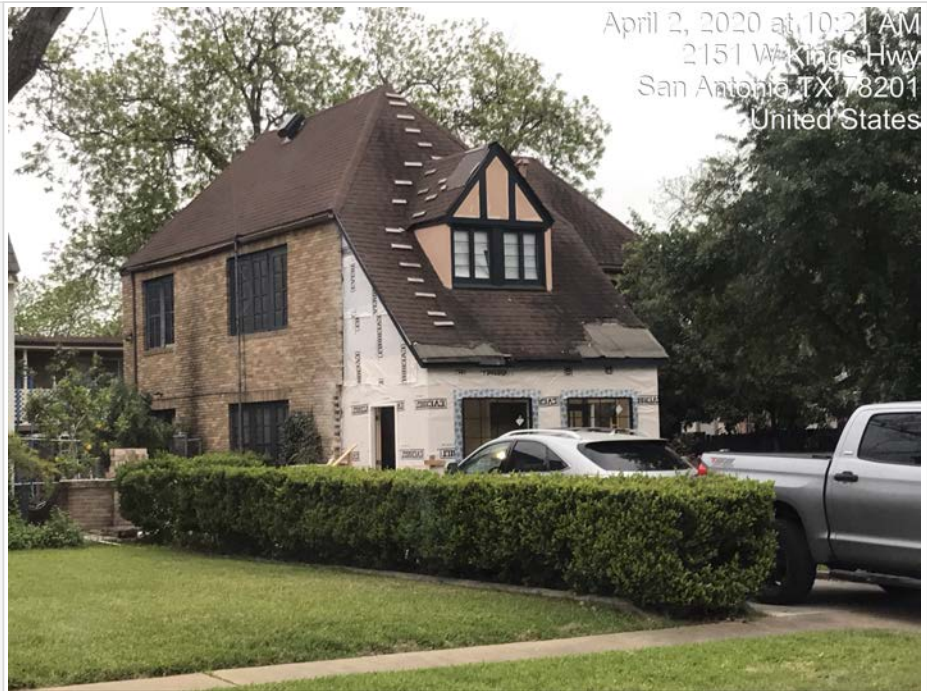
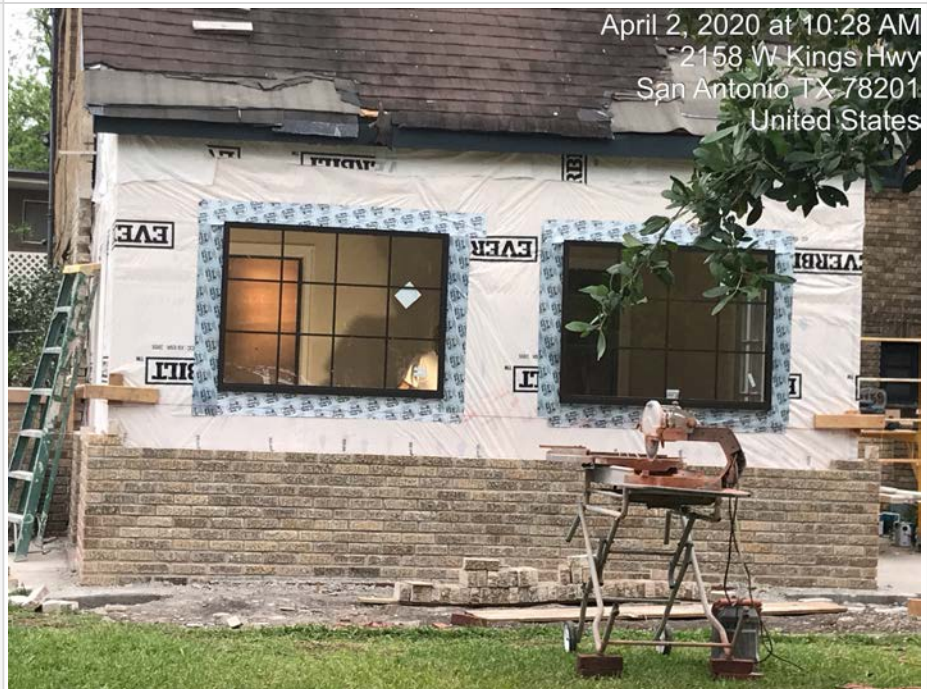
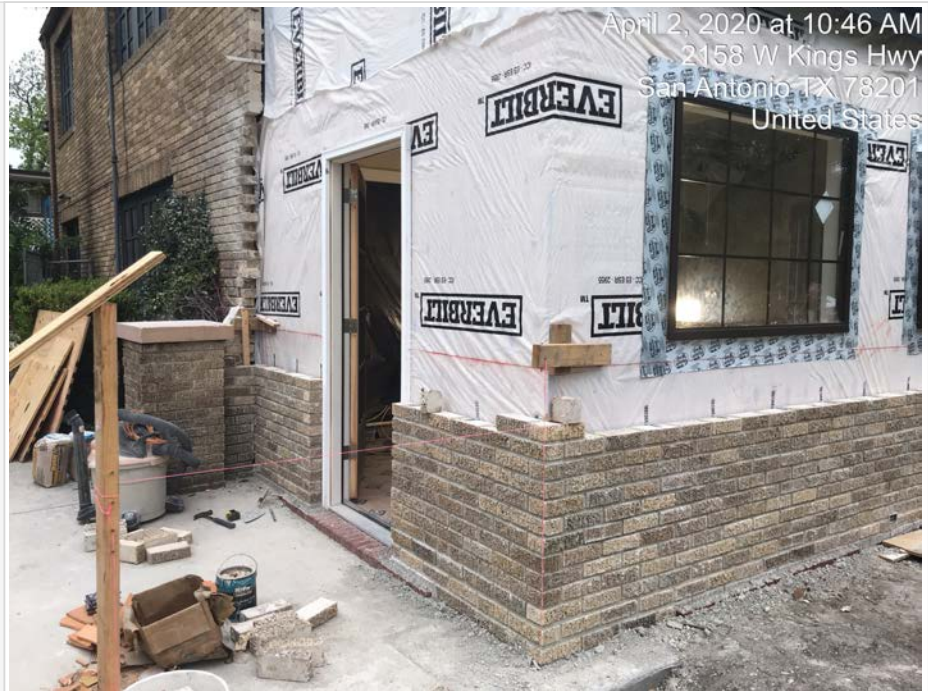
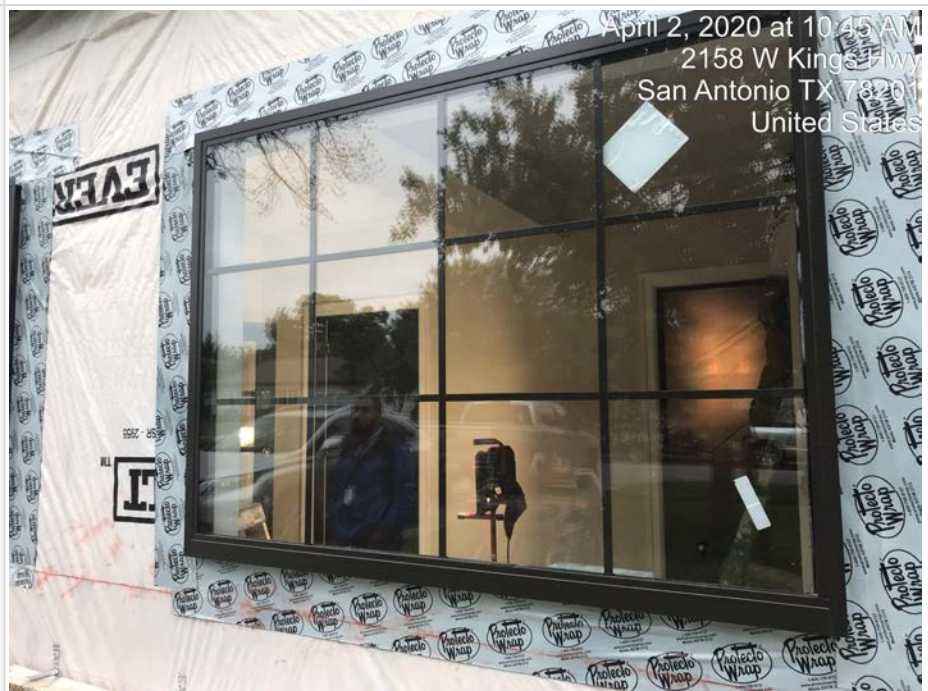
Photographs

Date	04/02/2020
Time	10:23 AM (-5 GMT)
Context	citizen report
Present Staff	Huy Pham, Edward Hall
Present Individuals	Homeowner, Contractor(s)
Types of Work Observed	Exterior Maintenance and Alterations
Amount of Work Completed	50%
Description of work	Porch reconstruction and enclosure
Description of interaction	Homeowners were cooperative to stop work order and will work with staff to submit missing application materials.

Violation Type	Beyond scope of Certificate of Appropriateness (Code 35-451h)
OHP Action	Spoke with property owner, Spoke with contractor(s)
Will post-work application fee apply?	No
