# HISTORIC AND DESIGN REVIEW COMMISSION

**HDRC CASE NO:** 2020-284  
**ADDRESS:** 724 N PINE ST  
**LEGAL DESCRIPTION:** NCB 1659 BLK G LOT 3  
**ZONING:** R-6, H  
**CITY COUNCIL DIST.:** 2  
**DISTRICT:** Dignowity Hill Historic District  
**APPLICANT:** Sunnie Diaz/SOFLIN DAVID & DIAZ SUNNIE R  
**OWNER:** Sunnie Diaz/SOFLIN DAVID & DIAZ SUNNIE R  
**TYPE OF WORK:** Demolition of a rear accessory structure new construction of rear accessory structure  
**APPLICATION RECEIVED:** May 21, 2020  
**60-DAY REVIEW:** Not applicable due to City Council Emergency Orders  
**CASE MANAGER:** Edward Hall  
**REQUEST:**

The applicant is requesting a Certificate of Appropriateness for approval to demolish the rear accessory structure at 724 N Pine.

## 724 N Pine St - Existing Garage

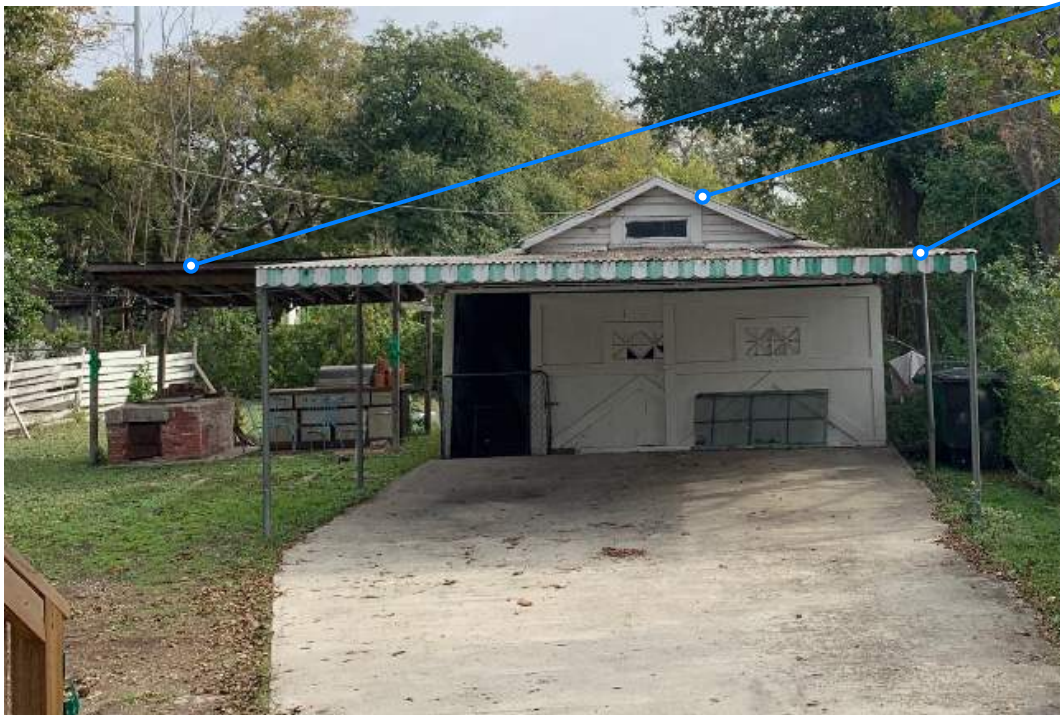
Front

covered canopy

garage

covered carport

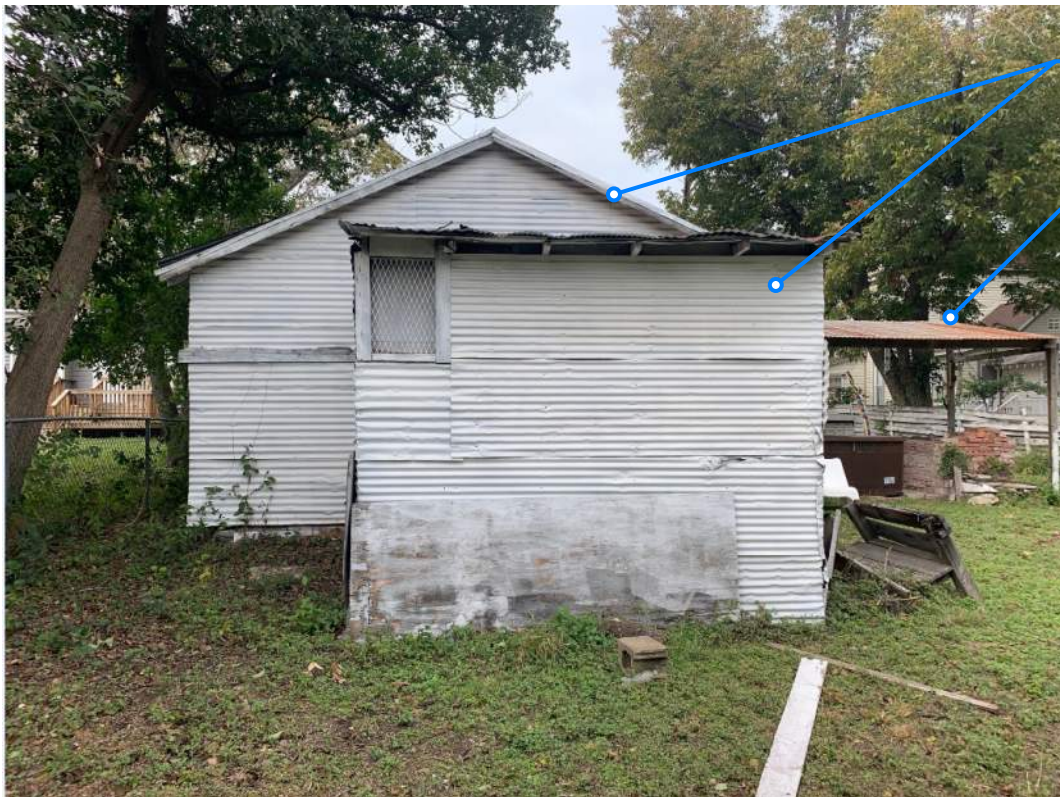
Rear

garage

covered canopy

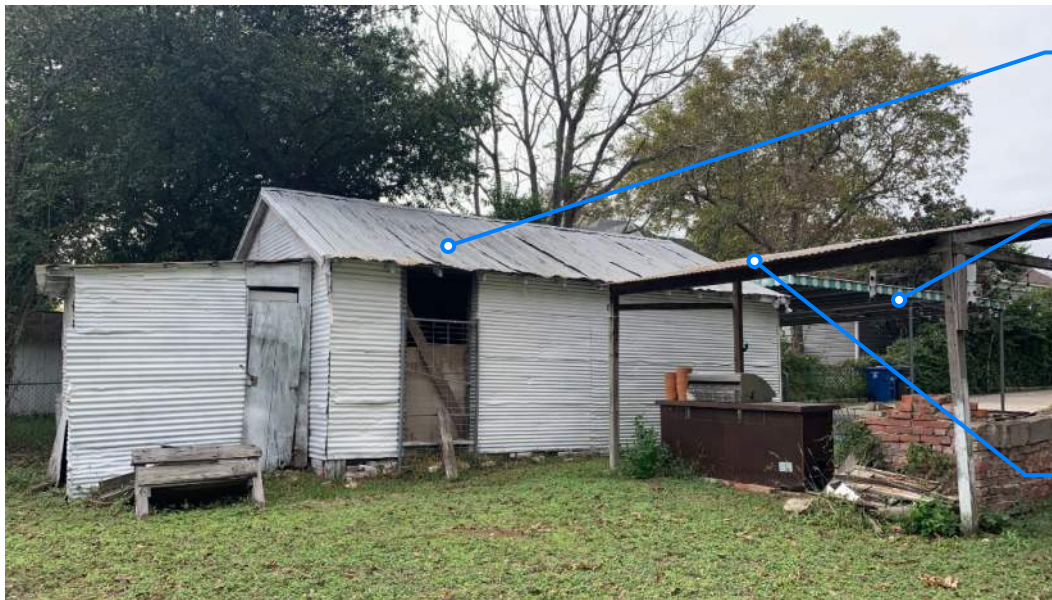
Left Side

garage

carport

covered canopy

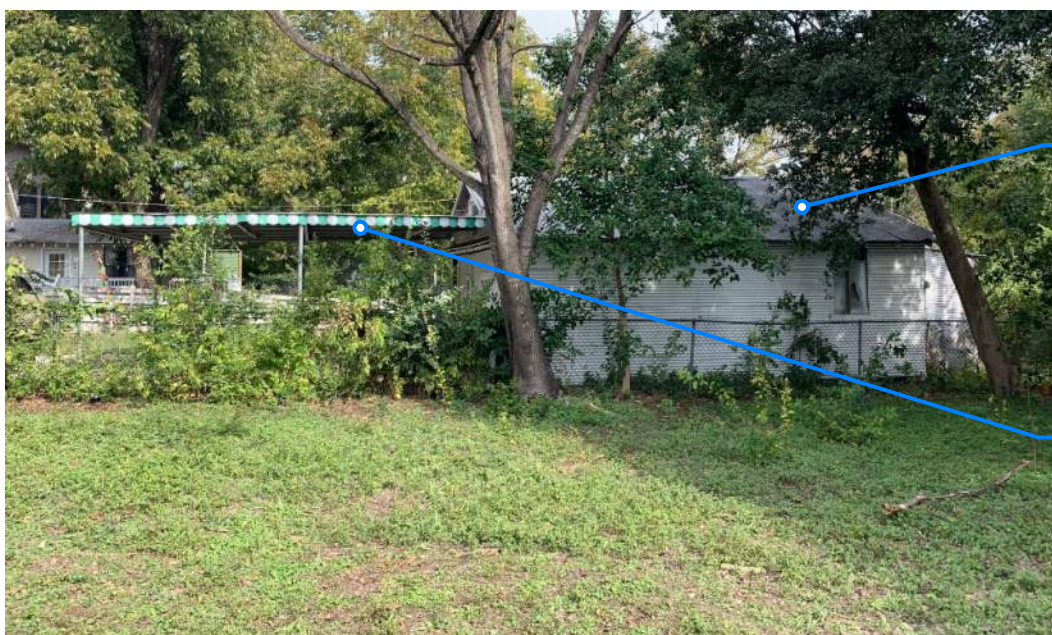
Right Side

garage

covered carport

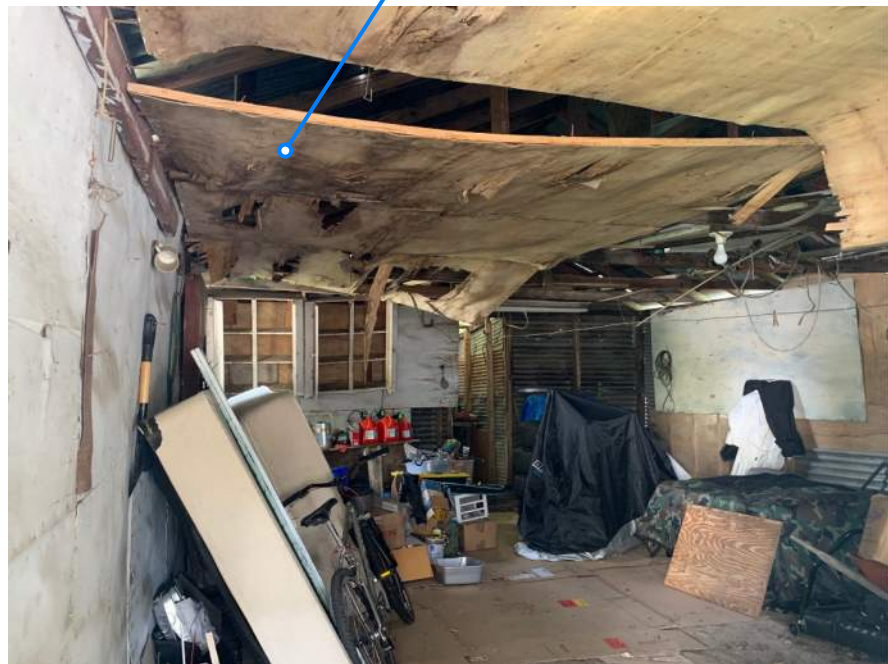
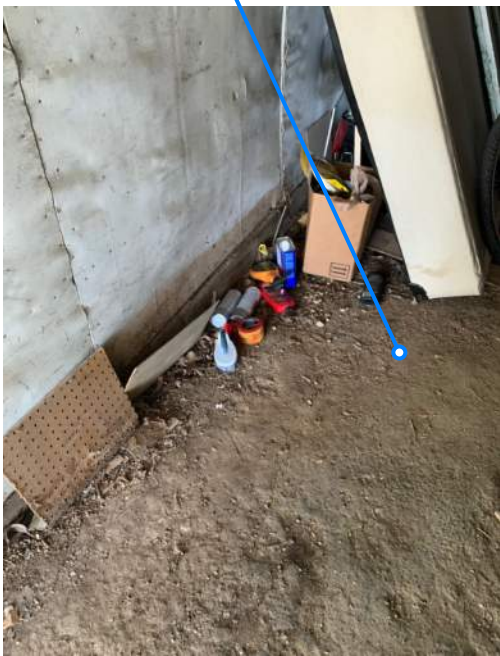
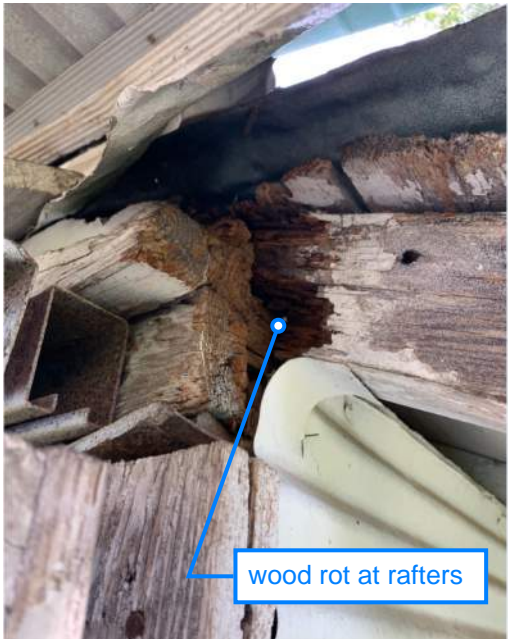
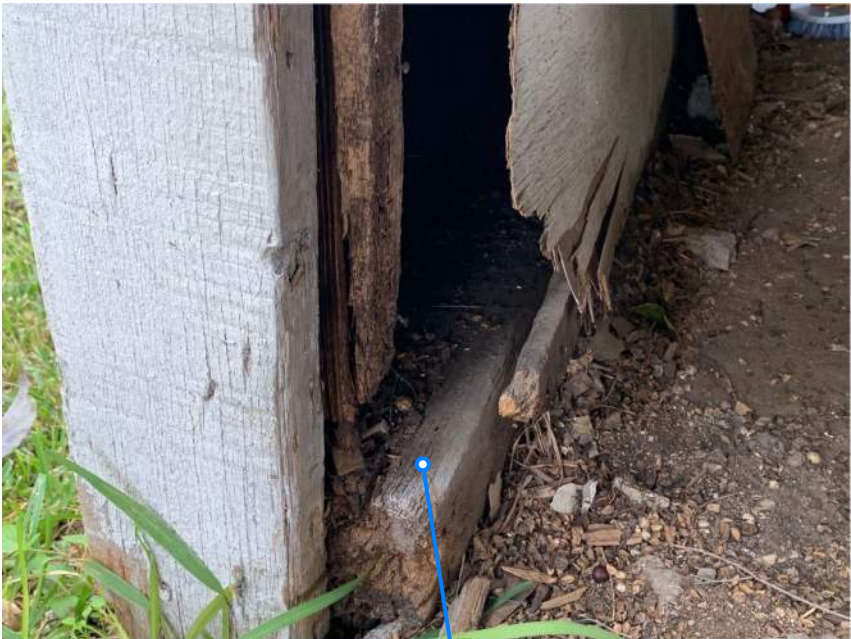
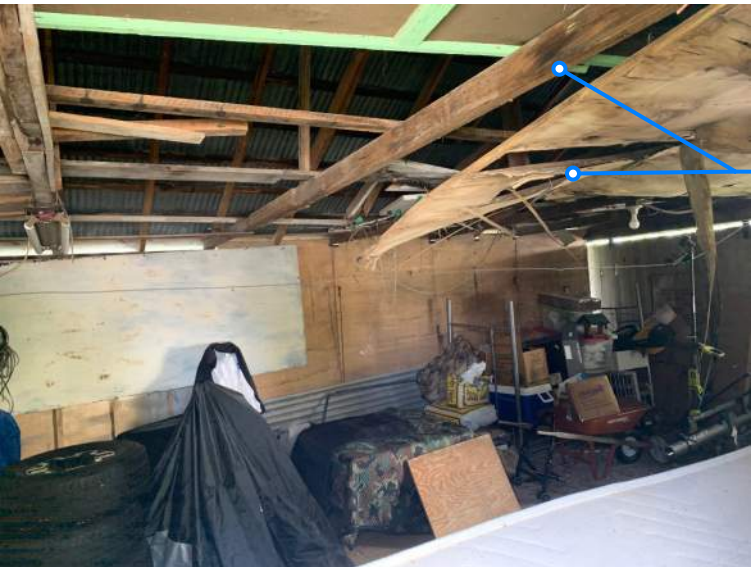
Interior Detail Images

1. The garage structure has no reasonable foundation. The floors are exposed earth and asphalt. The perimeter wood base beams are in contact with the earth and are damaged by water and or termites. The building is not anchored to the ground to resist wind loading.

3. The ceilings below the roof structure are failing and sagging. The roof structure above is lightly framed with no capacity for resisting uplift from wind and no diaphragm for resisting lateral loads. The corrugated steel roof above the roof framing is inadequate to resist a live loads of 20 PSF.

water damaged ceilings + framing

dirt floors

water damage to framing and sheathing

load bearing wall on grade with wood rot and termite damage

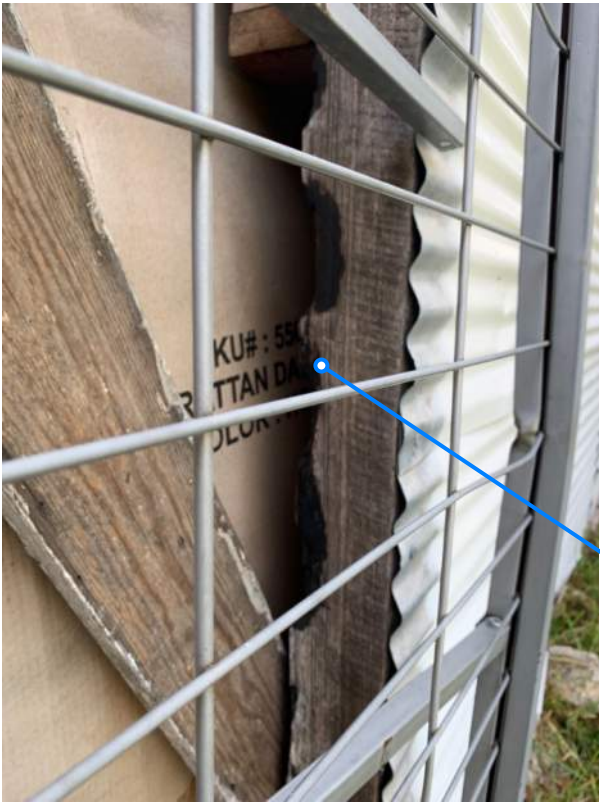
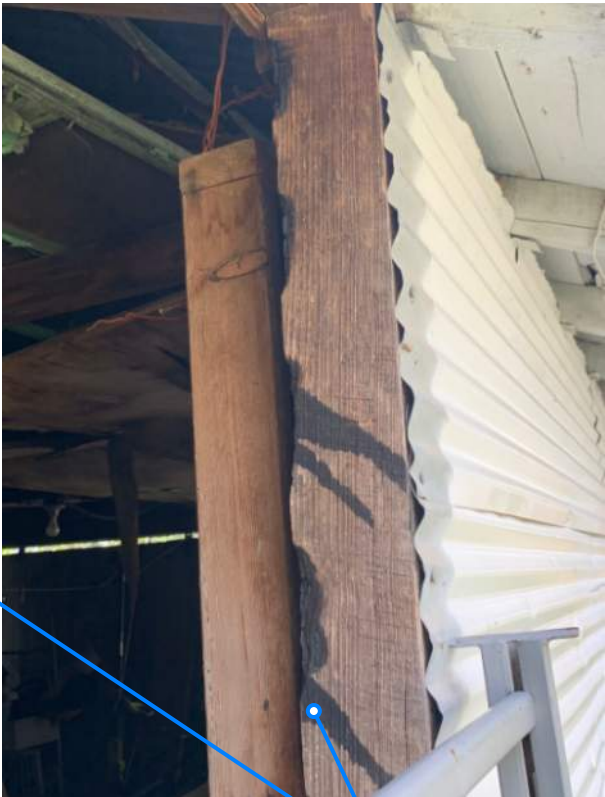
Exterior Detail Images

4. The small rear addition is also lightly framed with the opening into the garage compromised.
5. All exterior corrugated steel skin is damaged by hail and not properly attached to the structure.

fire damage to wall framing

damaged roof panels causing water leaks
