HISTORIC AND DESIGN REVIEW COMMISSION

July 15, 2020

HDRC CASE NO: 2020-237
ADDRESS: 1438 W ROSEWOOD AVE
LEGAL DESCRIPTION: NCB 2763 BLK 68 LOT 3
ZONING: R-4, H
CITY COUNCIL DIST.: 1
DISTRICT: Keystone Park Historic District
APPLICANT: Erasmo Castillo/Castillo's Complete Construction
OWNER: AEBB PROPERTIES LLC
TYPE OF WORK: Rear addition, enclosure, porch
APPLICATION RECEIVED: June 26, 2020
60-DAY REVIEW: Not applicable due to City Council Emergency Orders
CASE MANAGER: Huy Pham

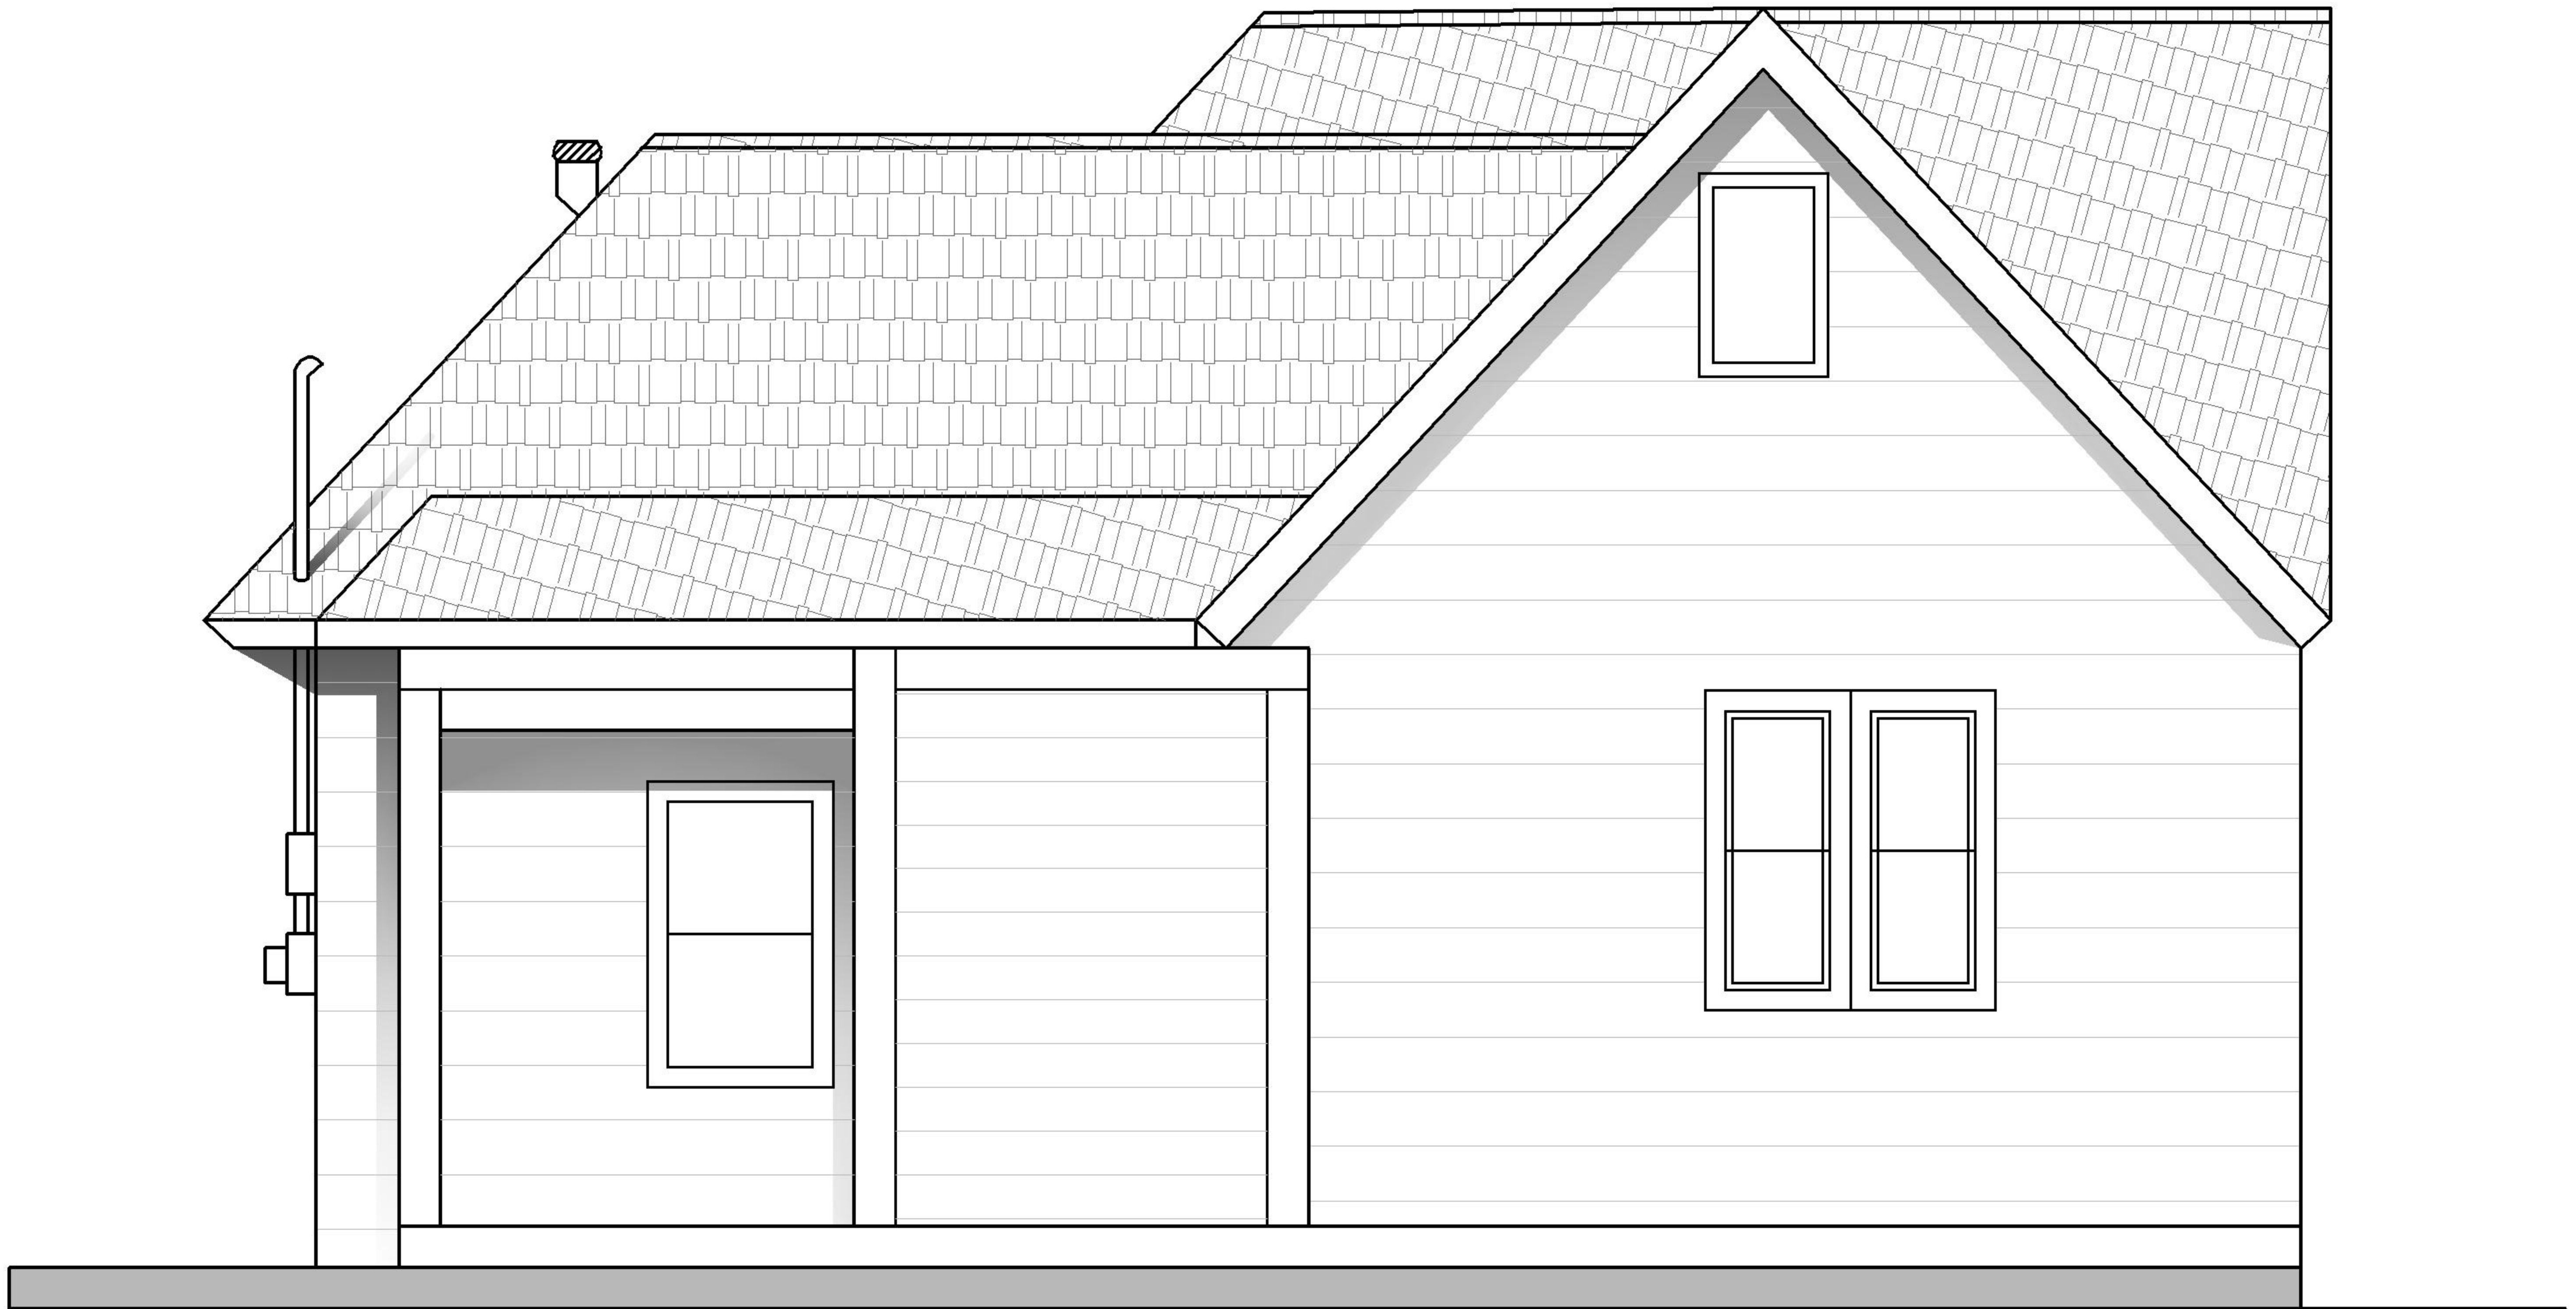
- c. EAST REAR ADDITION – The applicant has proposed to construct a rear addition on the rear of the east elevation featuring a 6’-6” deep by 8’ wide enclosed room with a 6’ deep rear-facing covered porch. The proposed addition features the reuse of existing windows, wood lap siding with a 6’ exposure, and a subordinate shed roof with vertical trim pieces between old and new wall planes. Staff finds the addition generally consistent with the Guidelines for Additions.

- d. WEST REAR ADDITION – The applicant has proposed to construct a rear addition on the rear of the west elevation to square off the inset corner of the existing building footprint. The proposed addition features approximately 5’ in depth and width, wood lap siding with a 6” exposure, a subordinate shed roof, and vertical trim pieces between old and new wall planes. Staff finds the addition generally consistent with the Guidelines

Staff recommends approval of item 1 and 2, the rear additions based on findings c and d with the stipulation that any historic wood windows should be reused or kept on site and that new windows products if used should be verified with staff prior to installation; no new window products are approved at this time.

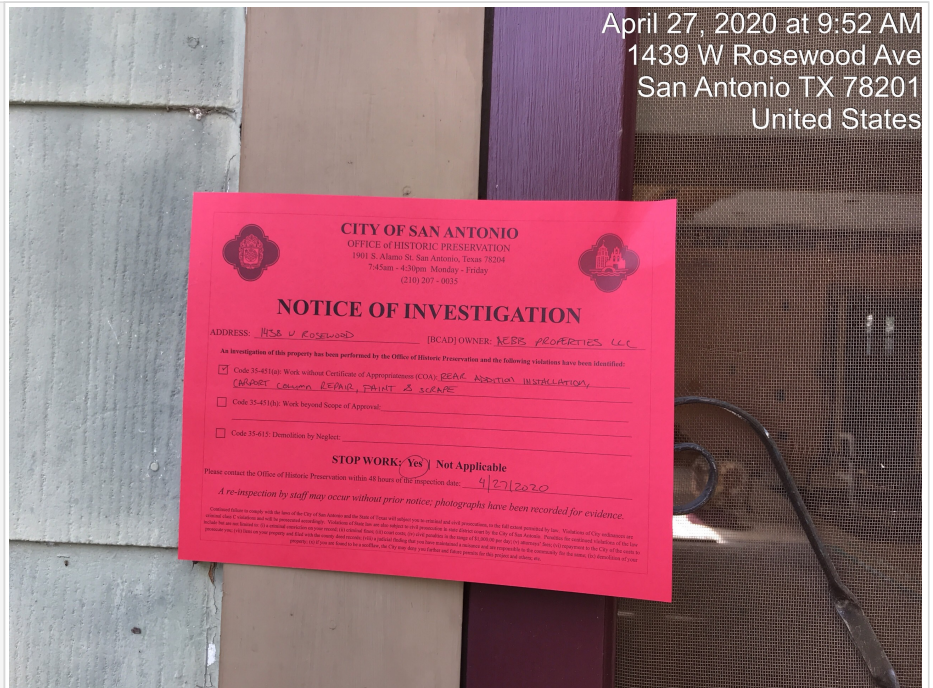
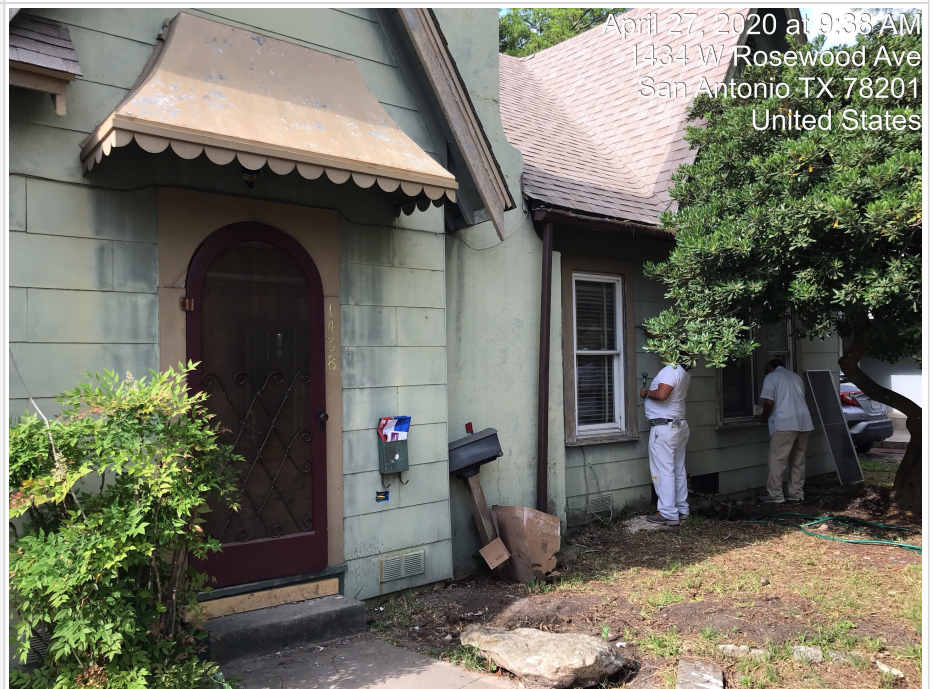
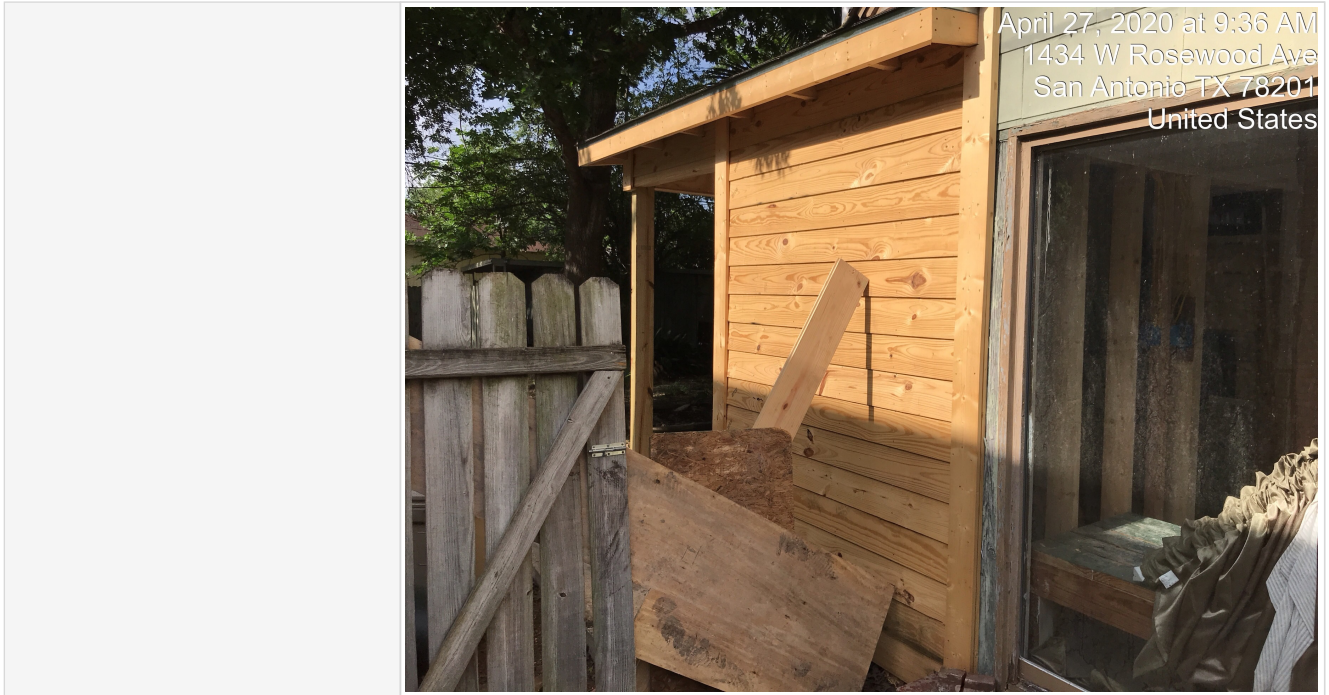
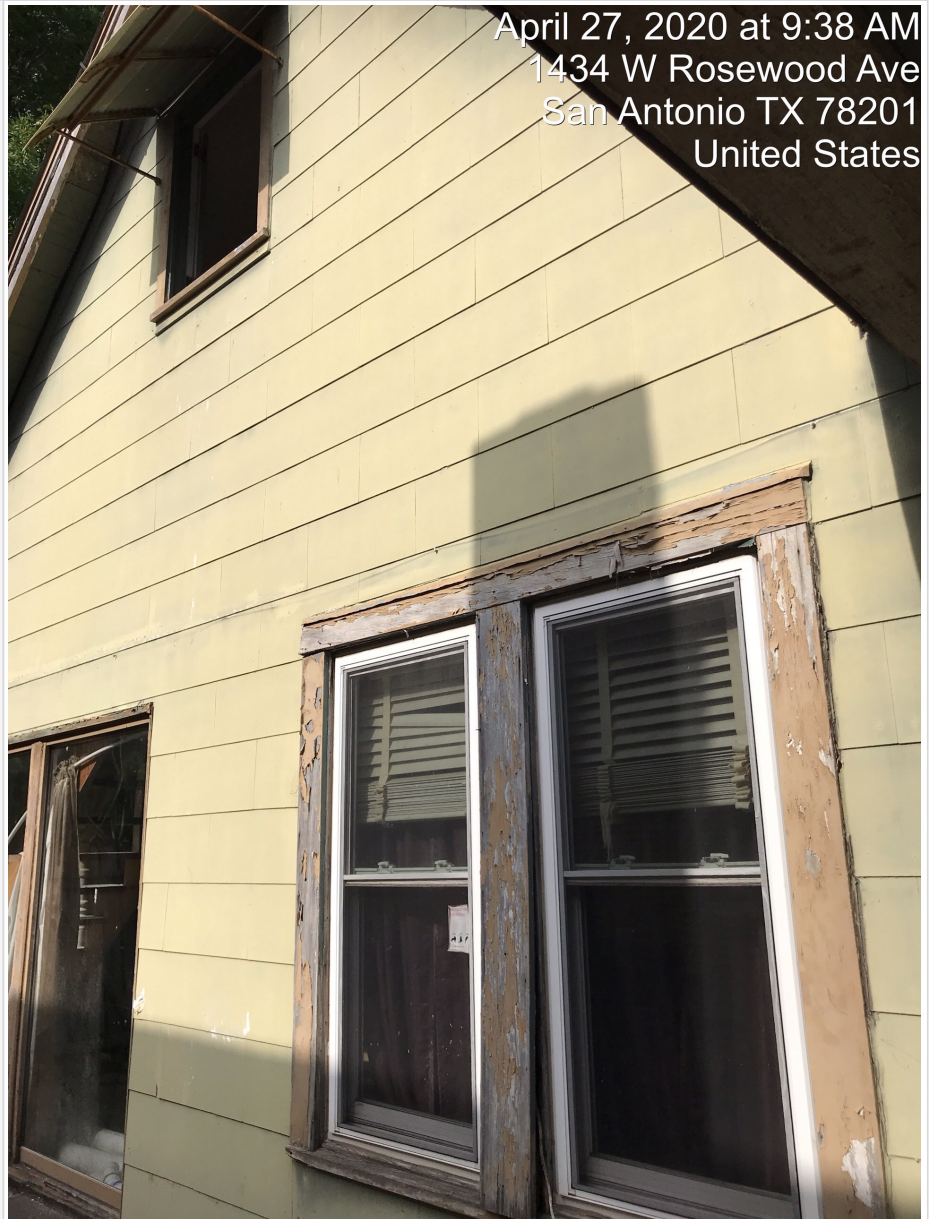
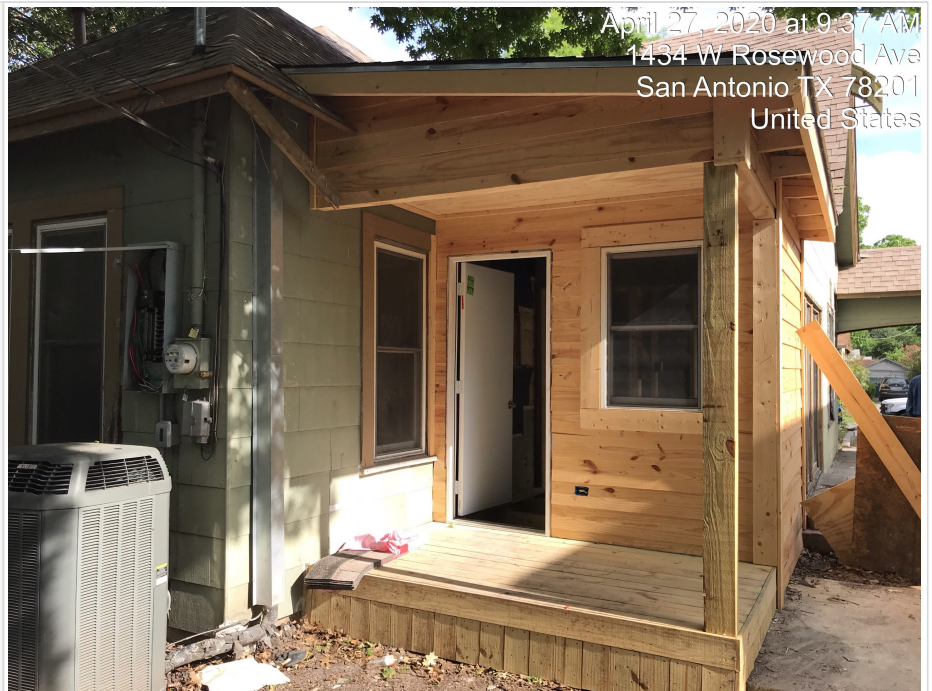
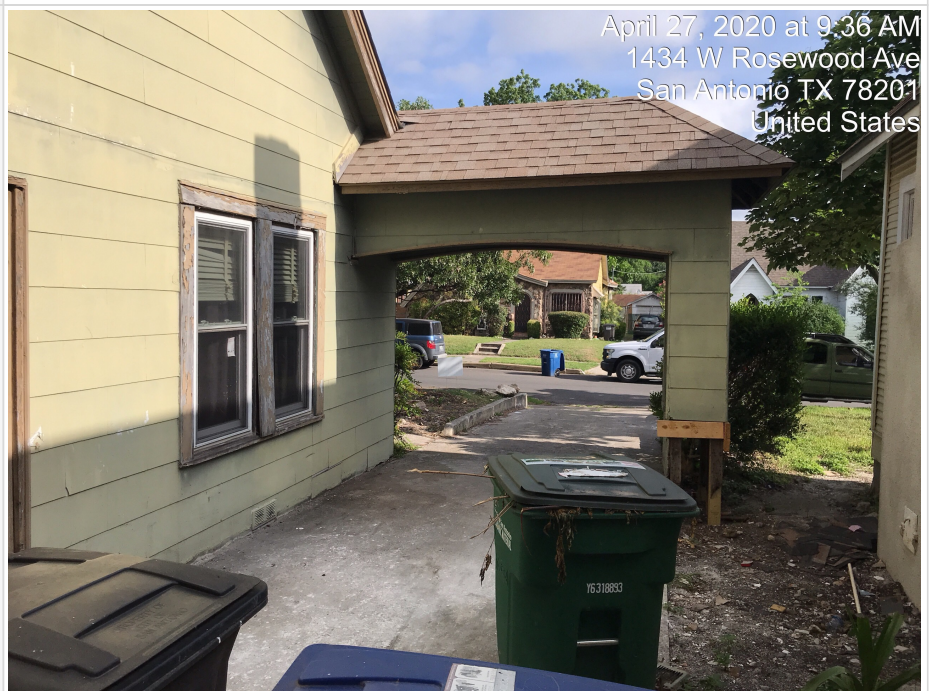
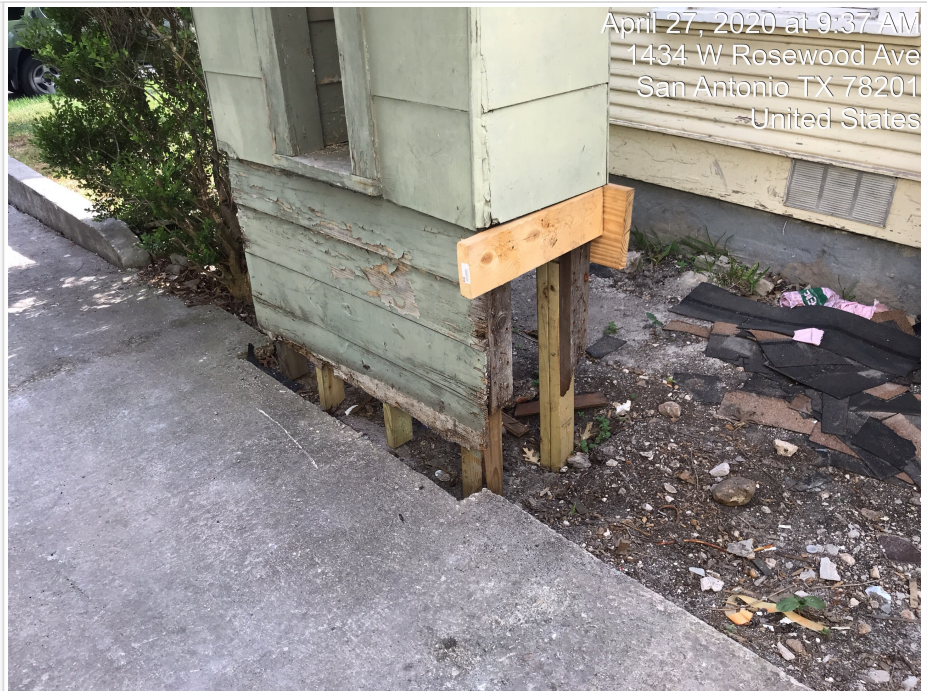
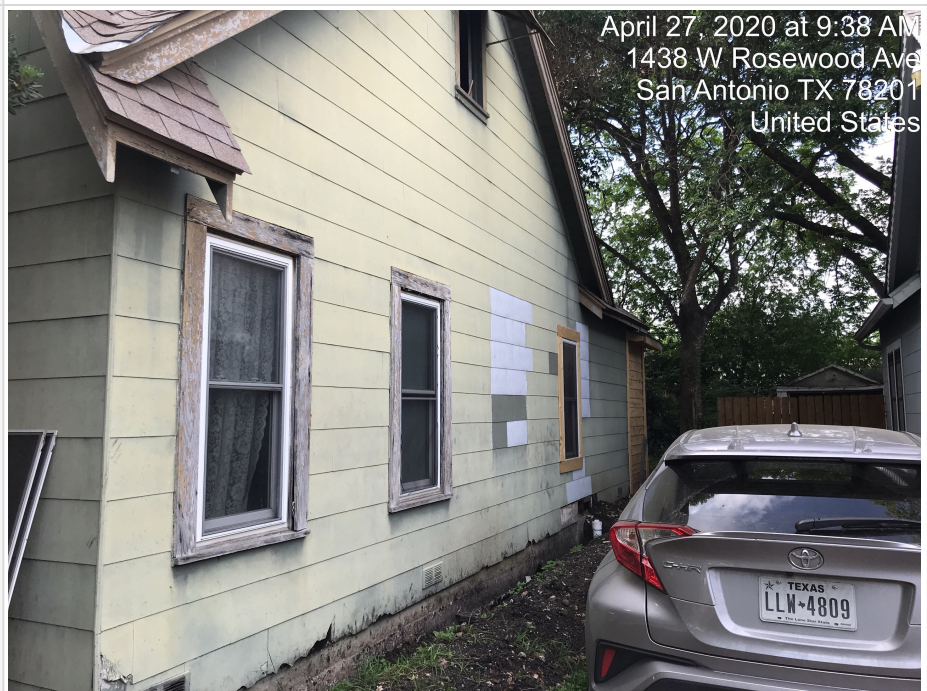
Date	04/27/2020
Time	09:53 AM (-5 GMT)
Context	citizen report
Present Staff	Huy Pham, Edward Hall
Present Individuals	Contractor(s)
Contractor/Realtor Companies	Castillos Construction
Types of Work Observed	Additions
Amount of Work Completed	75%
Description of work	Installation of a rear addition. Other work initiated included carport column repair and window trim scraping.
Description of interaction	Staff called the company number and the contractor Erasmo Castillo committed to submitting and COA application.

Violation Type	No Certificate of Appropriateness (Code 35-451a)
OHP Action	Spoke with contractor(s), Posted "Notice of Investigation"
Will post-work application fee apply?	To be determined
