HISTORIC AND DESIGN REVIEW COMMISSION

September 16, 2020

HDRC CASE NO: 2020-396
ADDRESS: 1013 E CROCKETT ST
LEGAL DESCRIPTION: NCB 577 BLK 16 LOT A17
ZONING: RM-4, H
CITY COUNCIL DIST.: 2
DISTRICT: Dignowity Hill Historic District
APPLICANT: Erik Campos/CAMPOS ERIK
OWNER: Erik Campos/CAMPOS ERIK
TYPE OF WORK: Carport installation
APPLICATION RECEIVED: August 25, 2020
60-DAY REVIEW: Not applicable due to City Council Emergency Orders
CASE MANAGER: Huy Pham

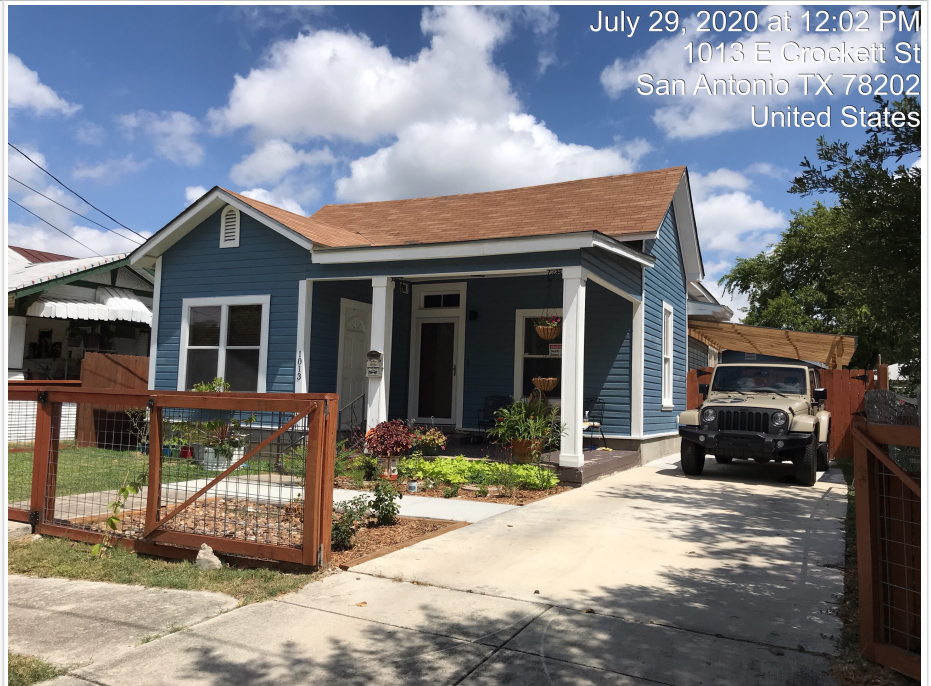
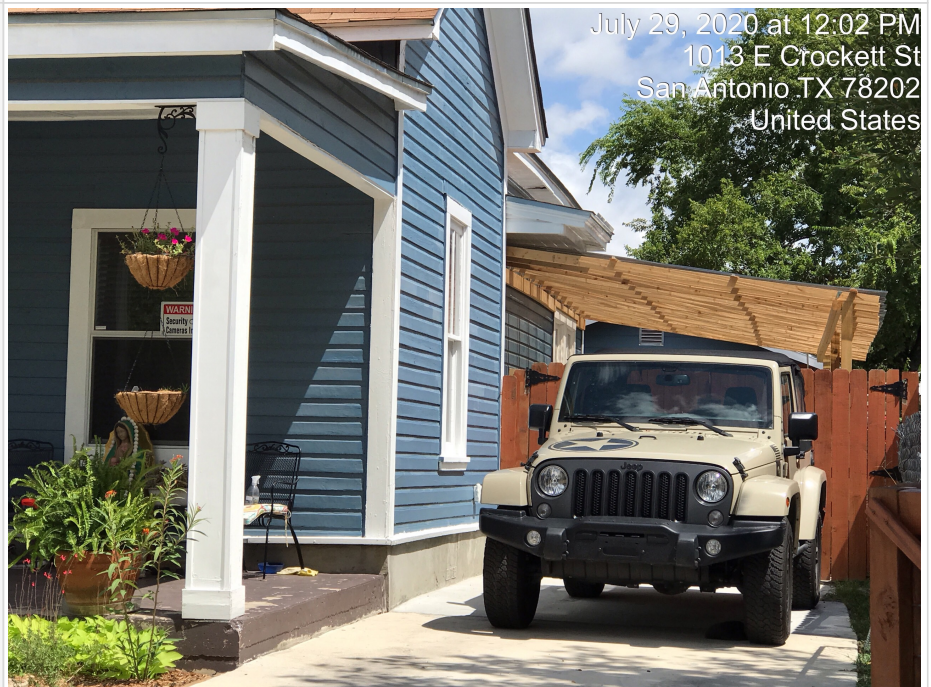
07/29/2020 12:08 PM

Date	07/29/2020
Time	12:06 PM (-5 GMT)
Context	citizen report
Present Staff	Huy Pham, Edward Hall
Present Individuals	None
Types of Work Observed	Additions, Site Elements
Description of work	Construction of attached side carport
Description of interaction	Staff spoke to homeowner through digital doorbell and left Stop Work Order on the mailbox.

Violation Type	No Certificate of Appropriateness (Code 35-451a)
OHP Action	Spoke with property owner, Posted "Notice of Investigation"

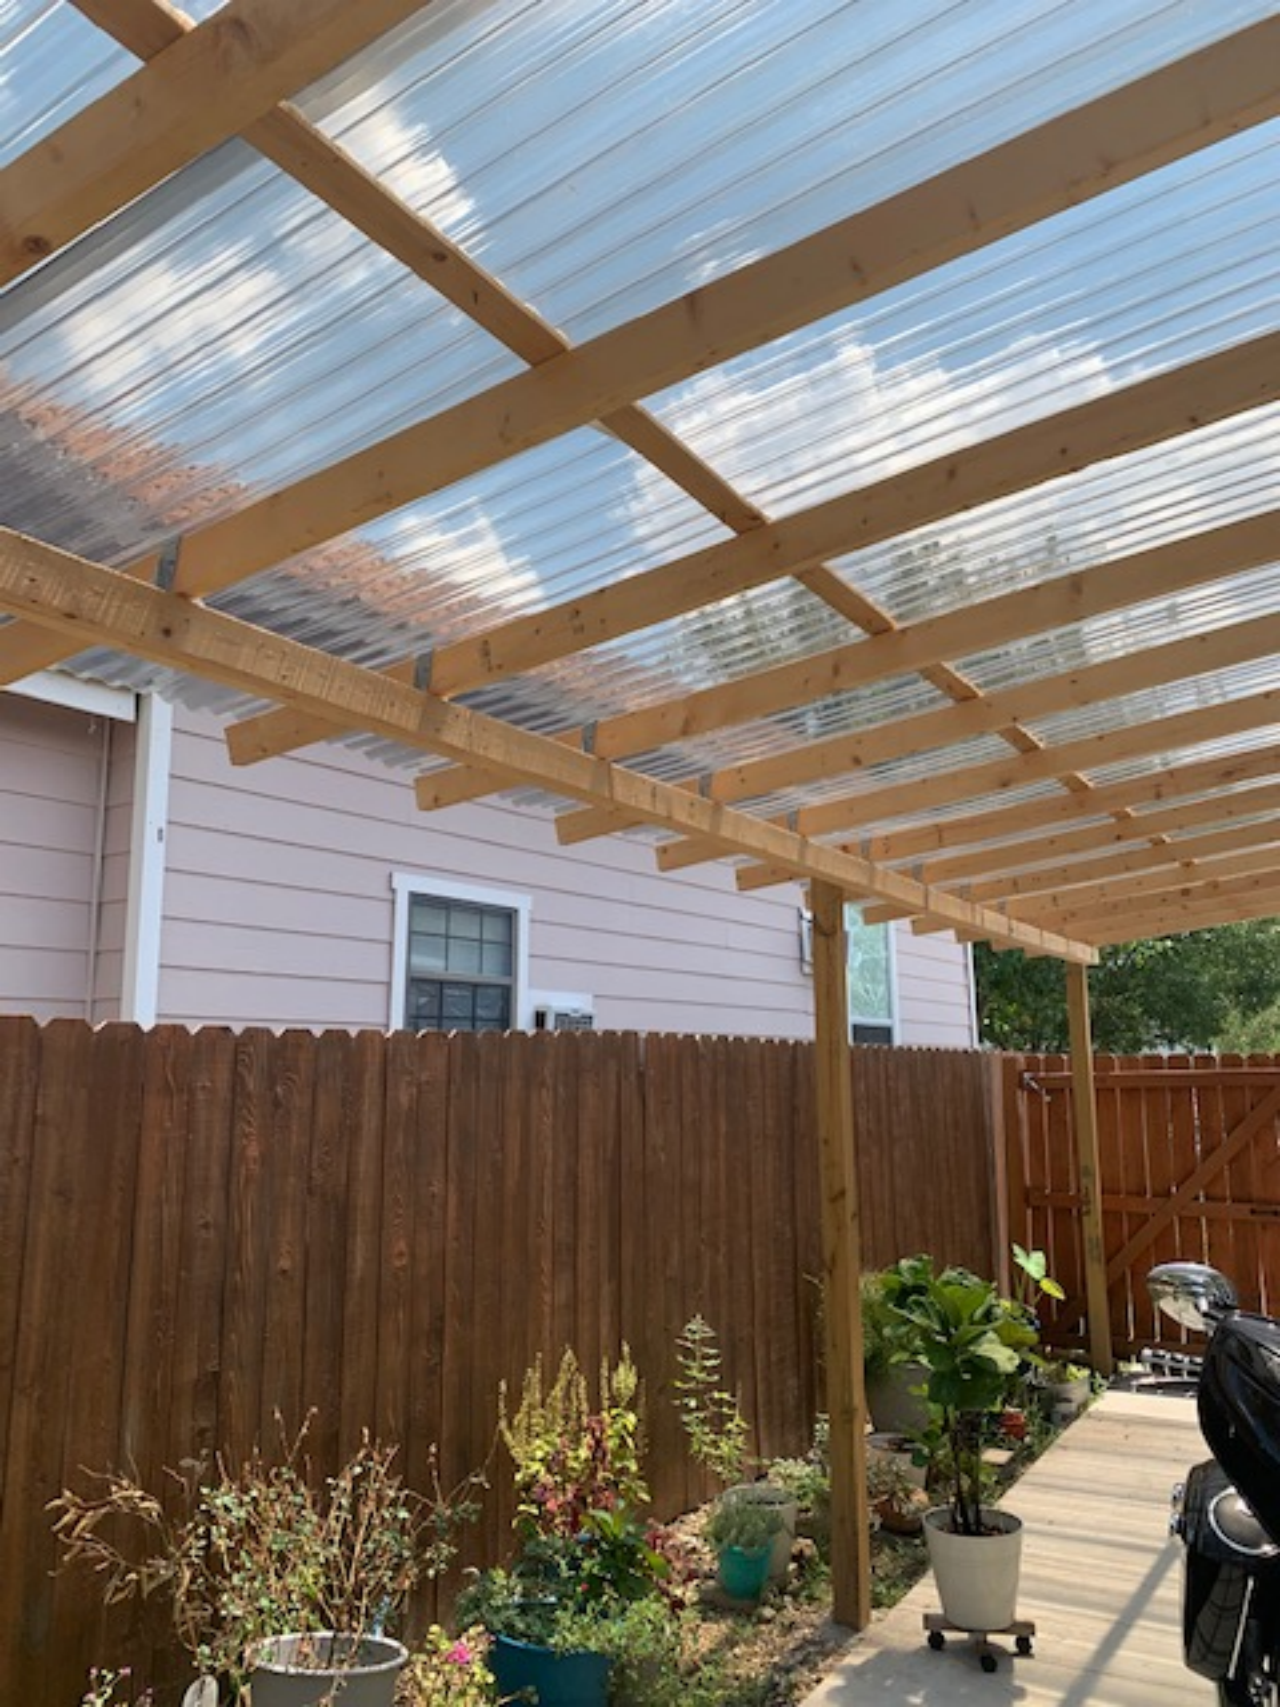
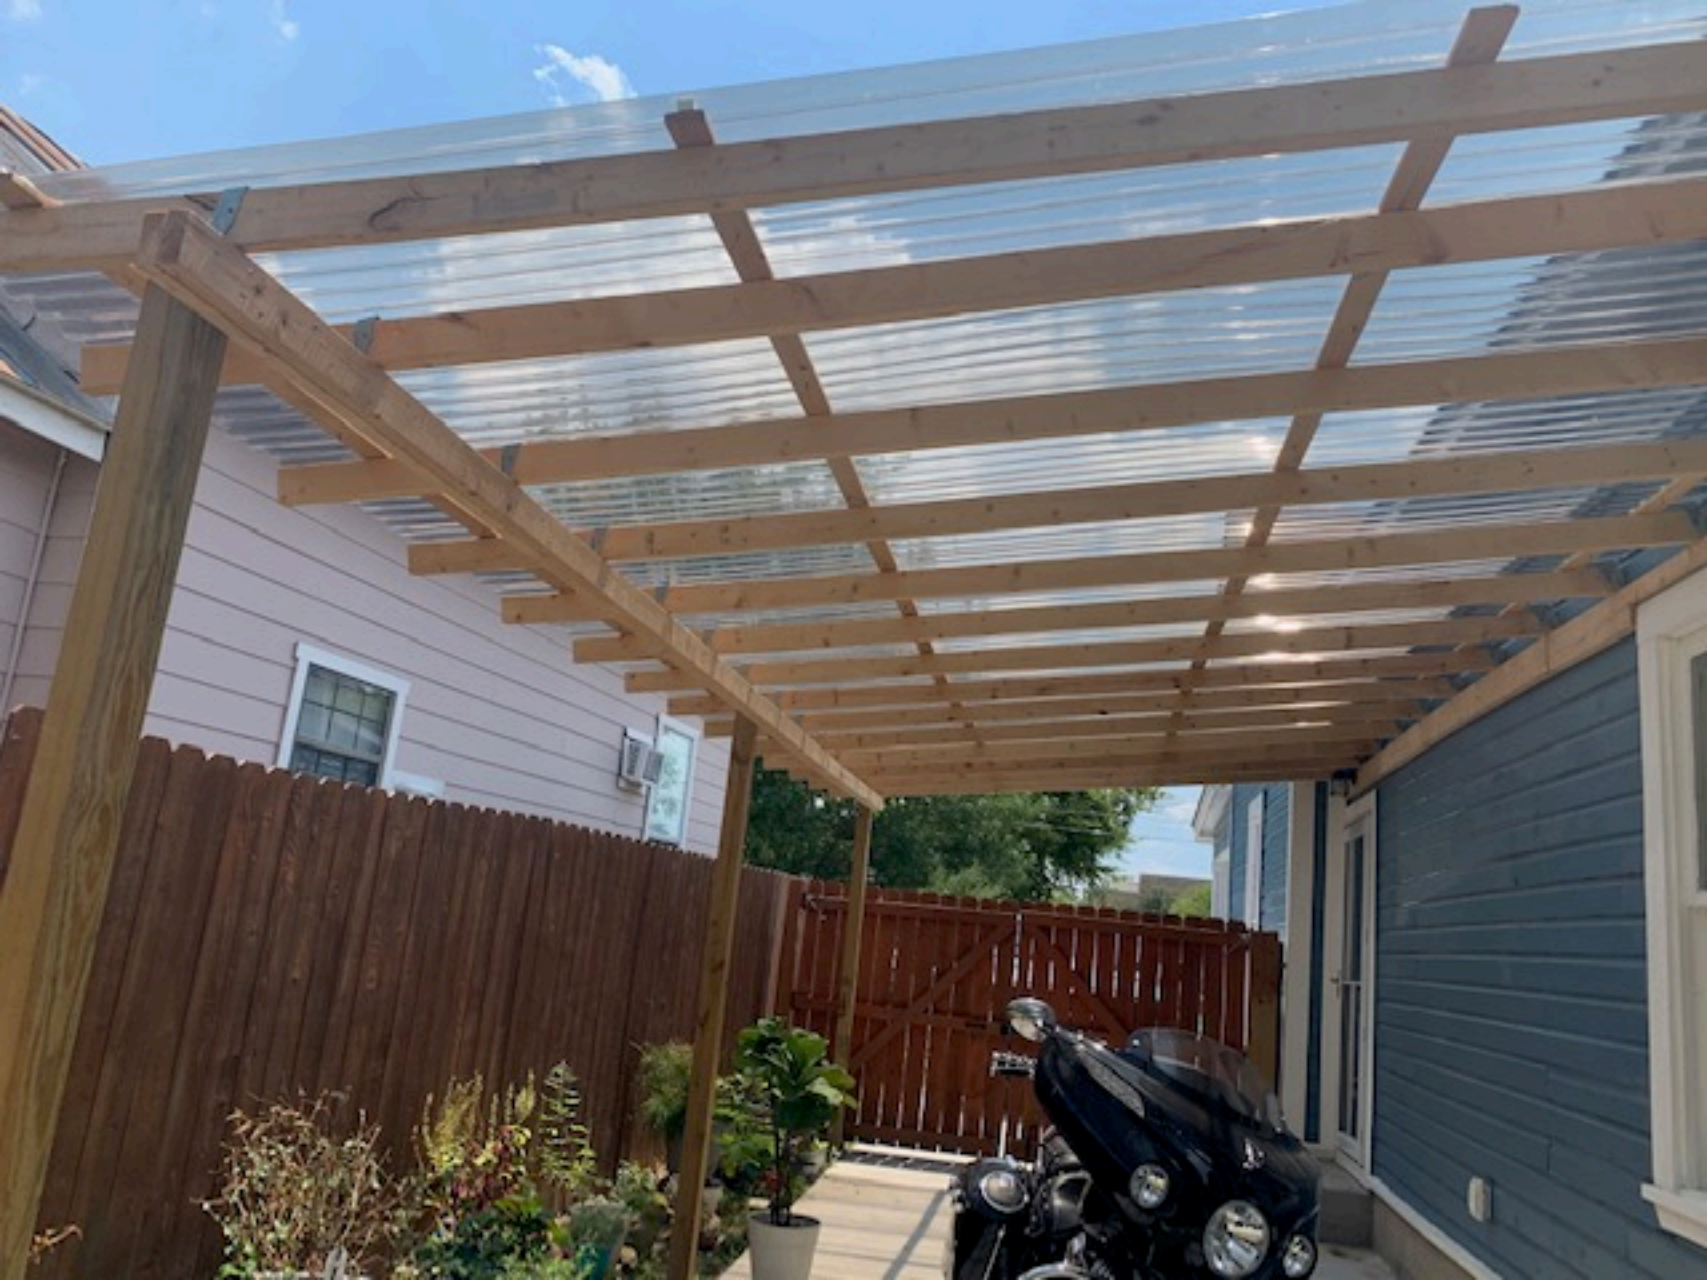
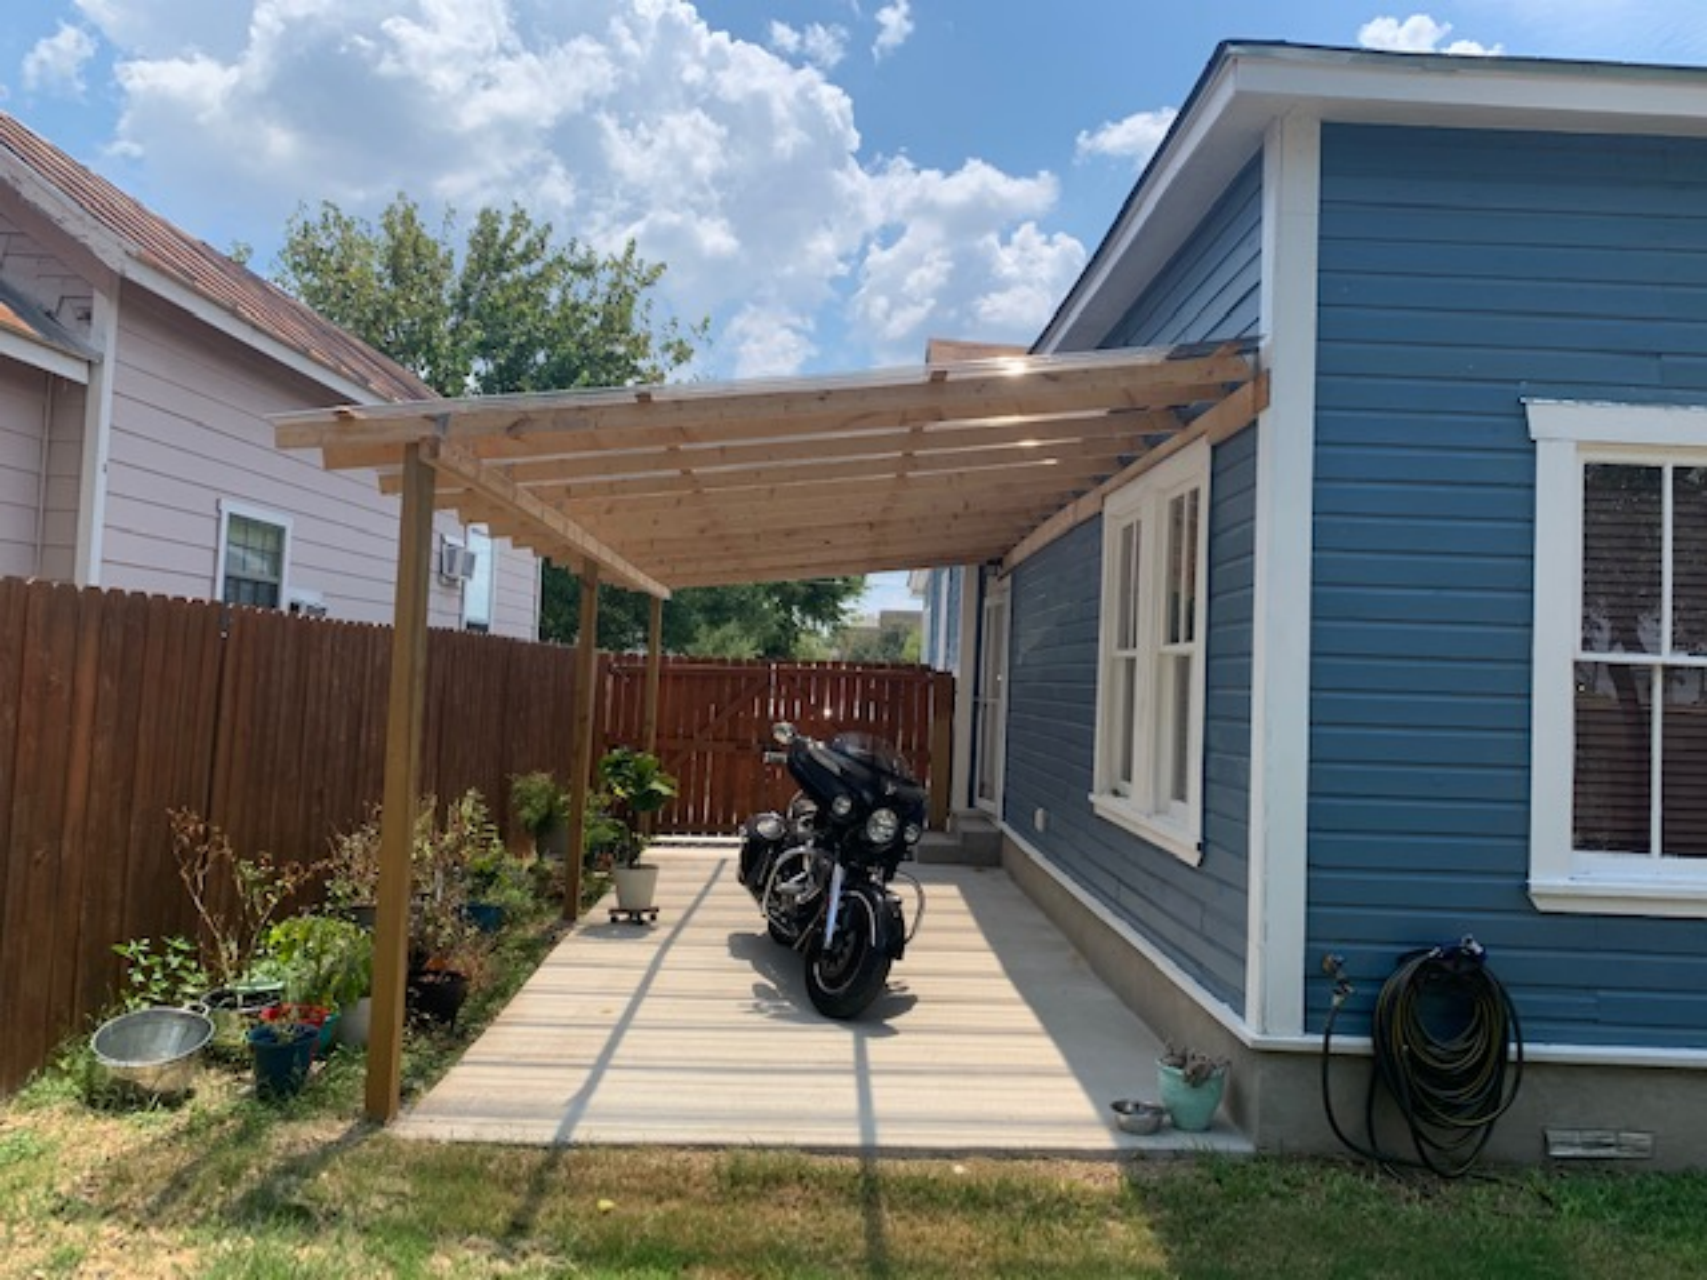
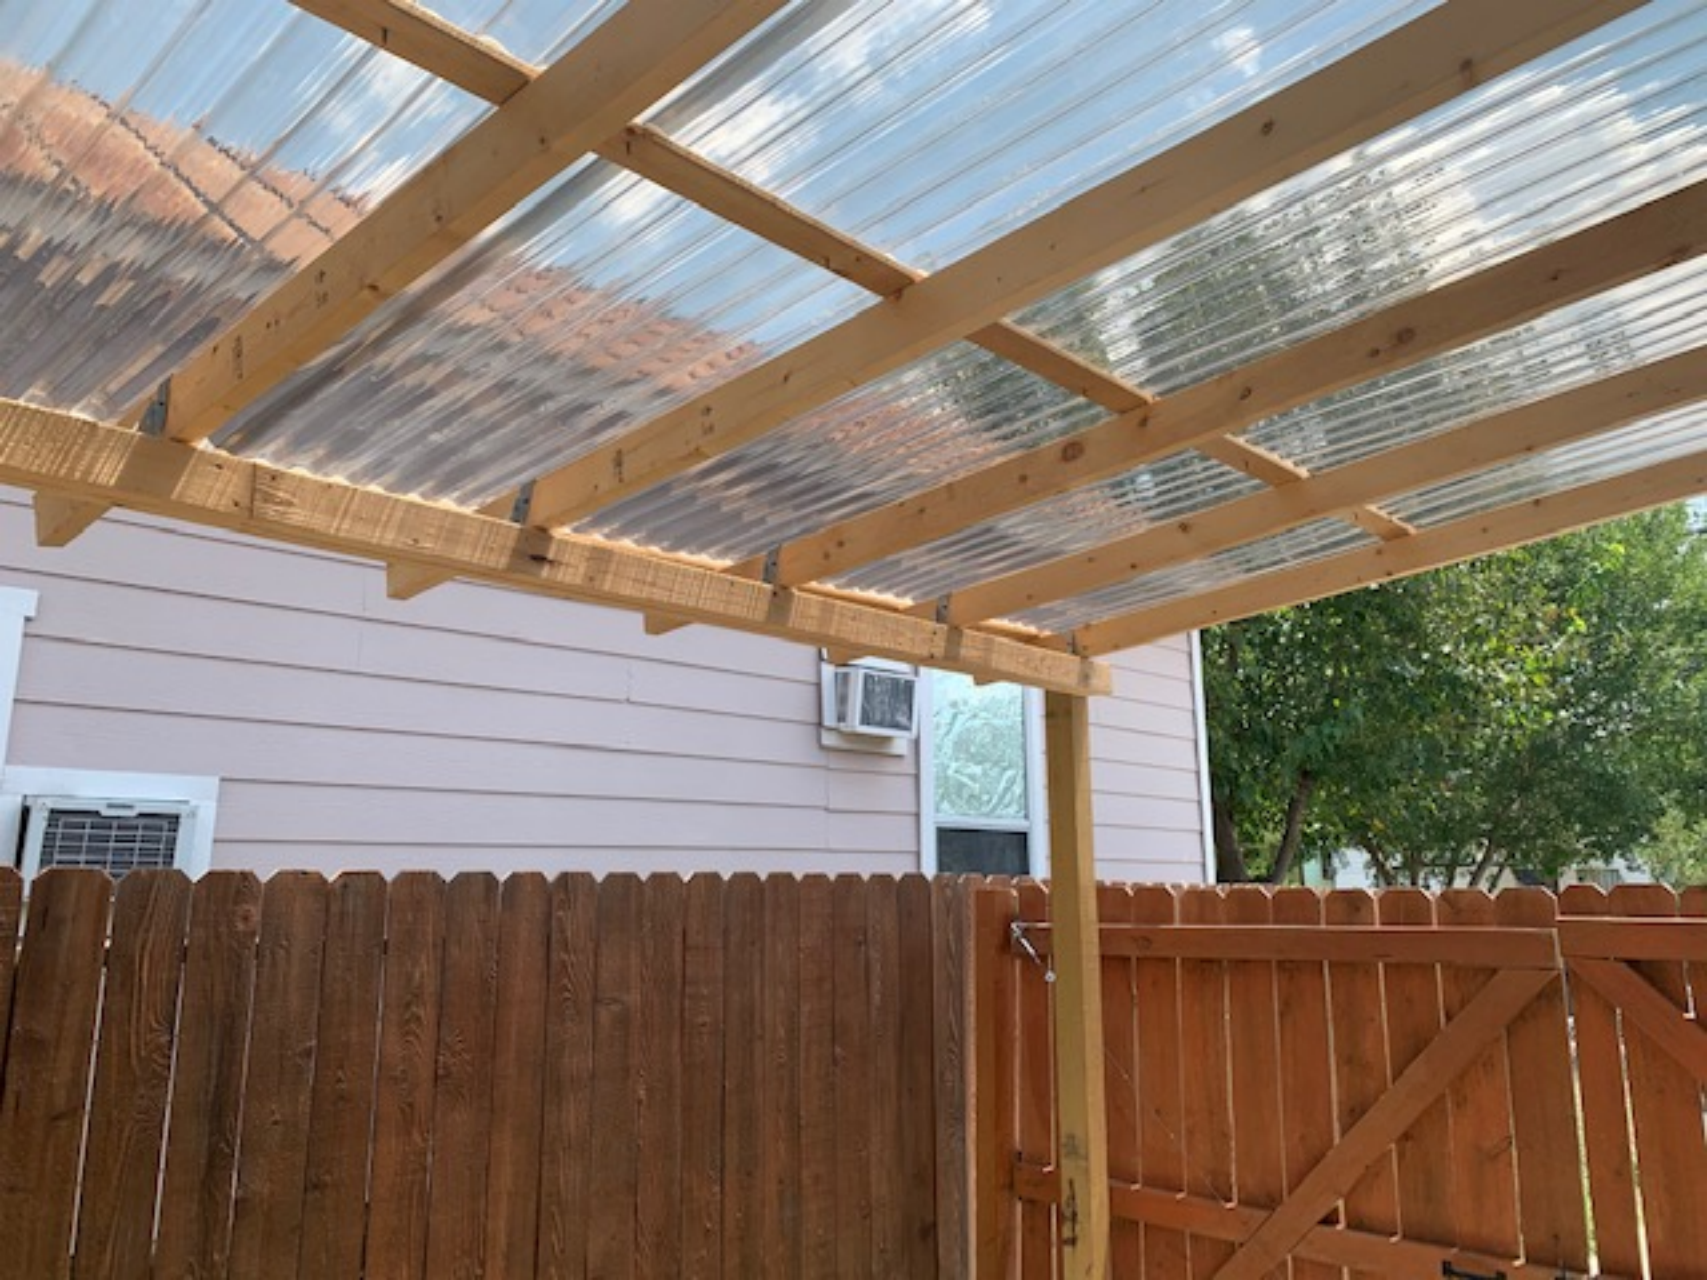
- b. COMPLIANCE – On a site visit conducted on July 29, 2020, staff found that an attached carport was constructed prior to approval. The applicant submitted an application on August 25, 2020 to be heard at the next available Historic and Design Review Commission hearing.

- d. VISUAL IMPACT - Per the Guidelines for Additions 1.A.i., applicants should site residential additions at the side or rear of the building whenever possible to minimize views of the addition from the public right-of-way. Staff finds the addition is visible from the front right-of-way.

Staff does not recommend approval based on the findings. Staff recommends the attached carport is removed and the applicant may resubmit a revised design of a detached structure that excludes polycarbonate roofing panels.
