## HISTORIC AND DESIGN REVIEW COMMISSION

**HDRC CASE NO:** 2020-335  
**ADDRESS:** 529 N PALMETTO  
**LEGAL DESCRIPTION:** NCB 1371 BLK 3 LOT 29 & 30  
**ZONING:** RM-4, H  
**CITY COUNCIL DIST.:** 2  
**DISTRICT:** Dignowity Hill Historic District  
**APPLICANT:** Abigail Arispe/GALLEGO LAZARO A & OZUNA LILLIAN  
**OWNER:** Abigail Arispe/GALLEGO LAZARO A & OZUNA LILLIAN  
**TYPE OF WORK:** Removal of brick chimney  
**APPLICATION RECEIVED:** July 20, 2020  
**60-DAY REVIEW:** Not applicable due to City Council Emergency Orders  
**CASE MANAGER:** Huy Pham

The applicant is requesting a Certificate of Appropriateness for approval to remove the existing brick chimney.

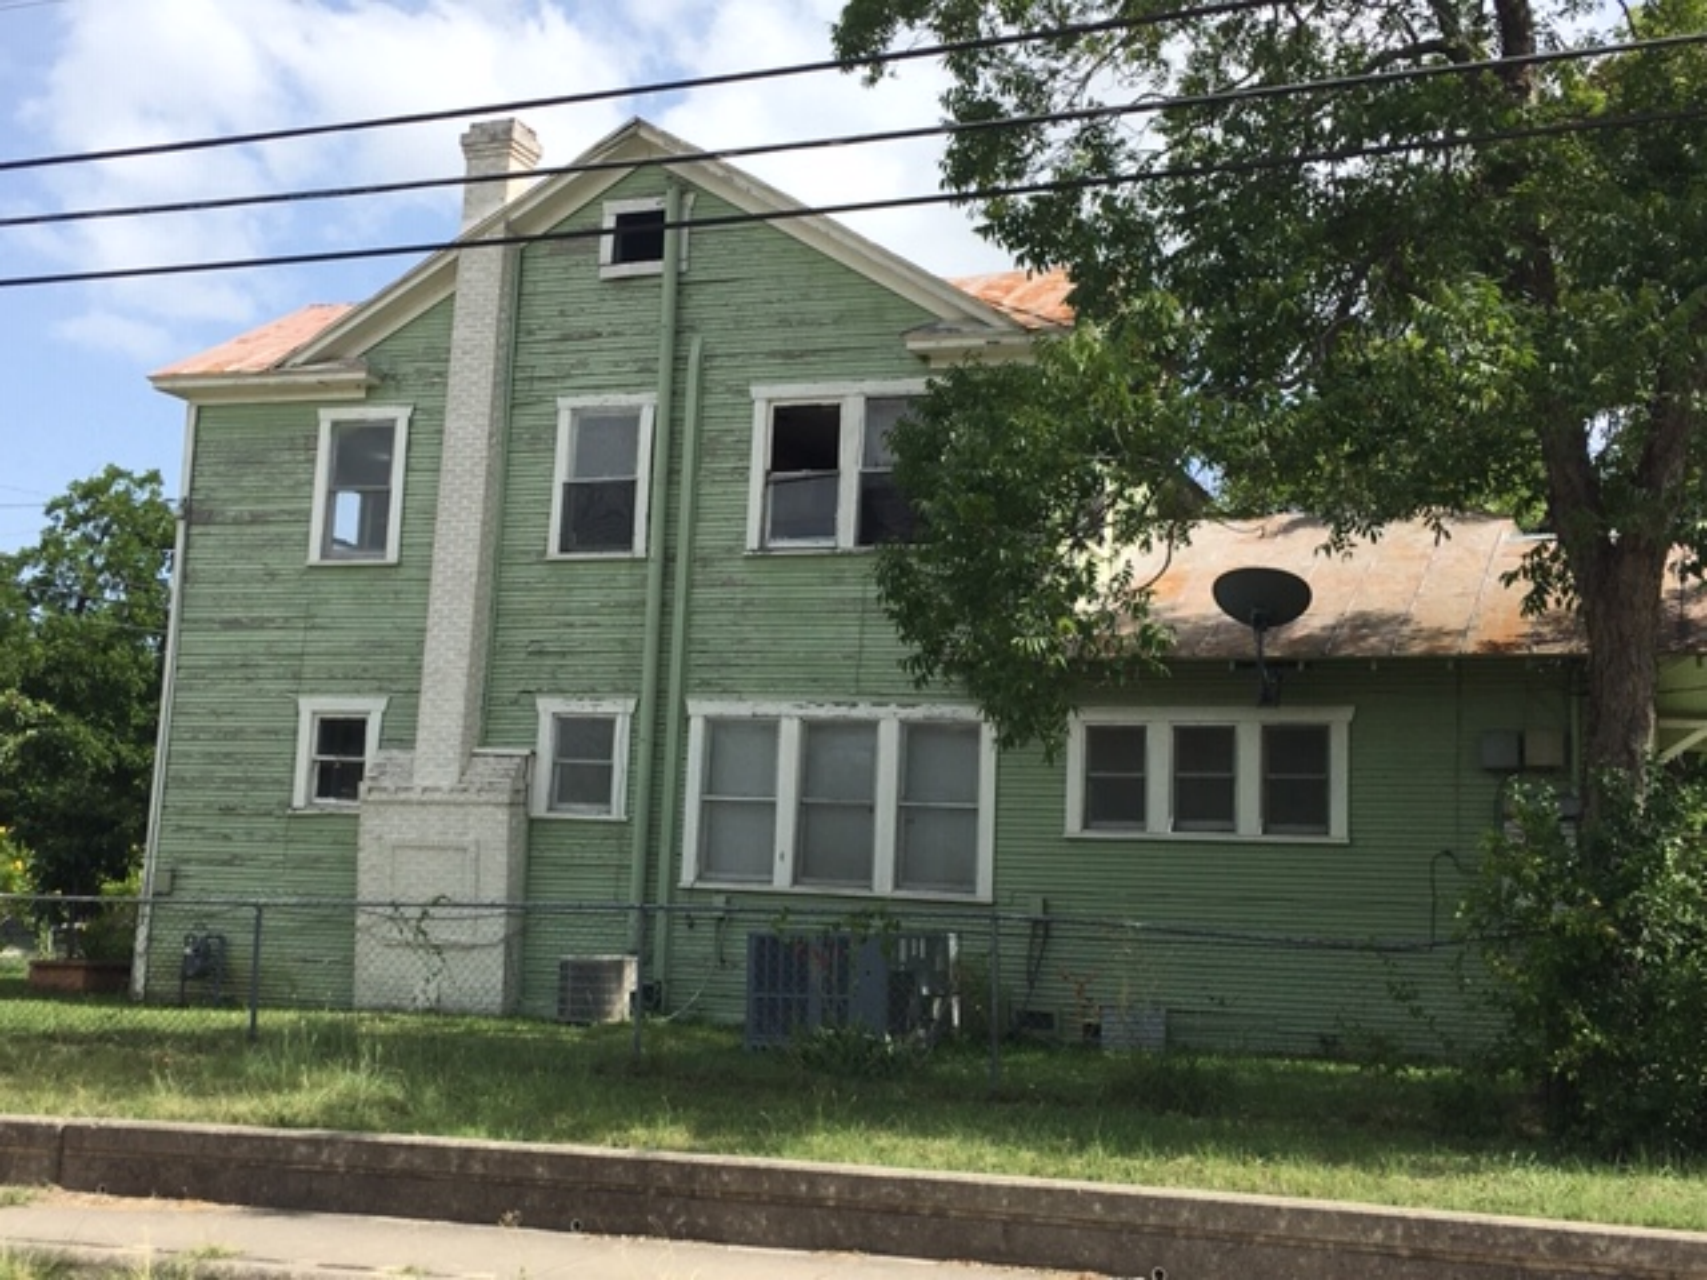
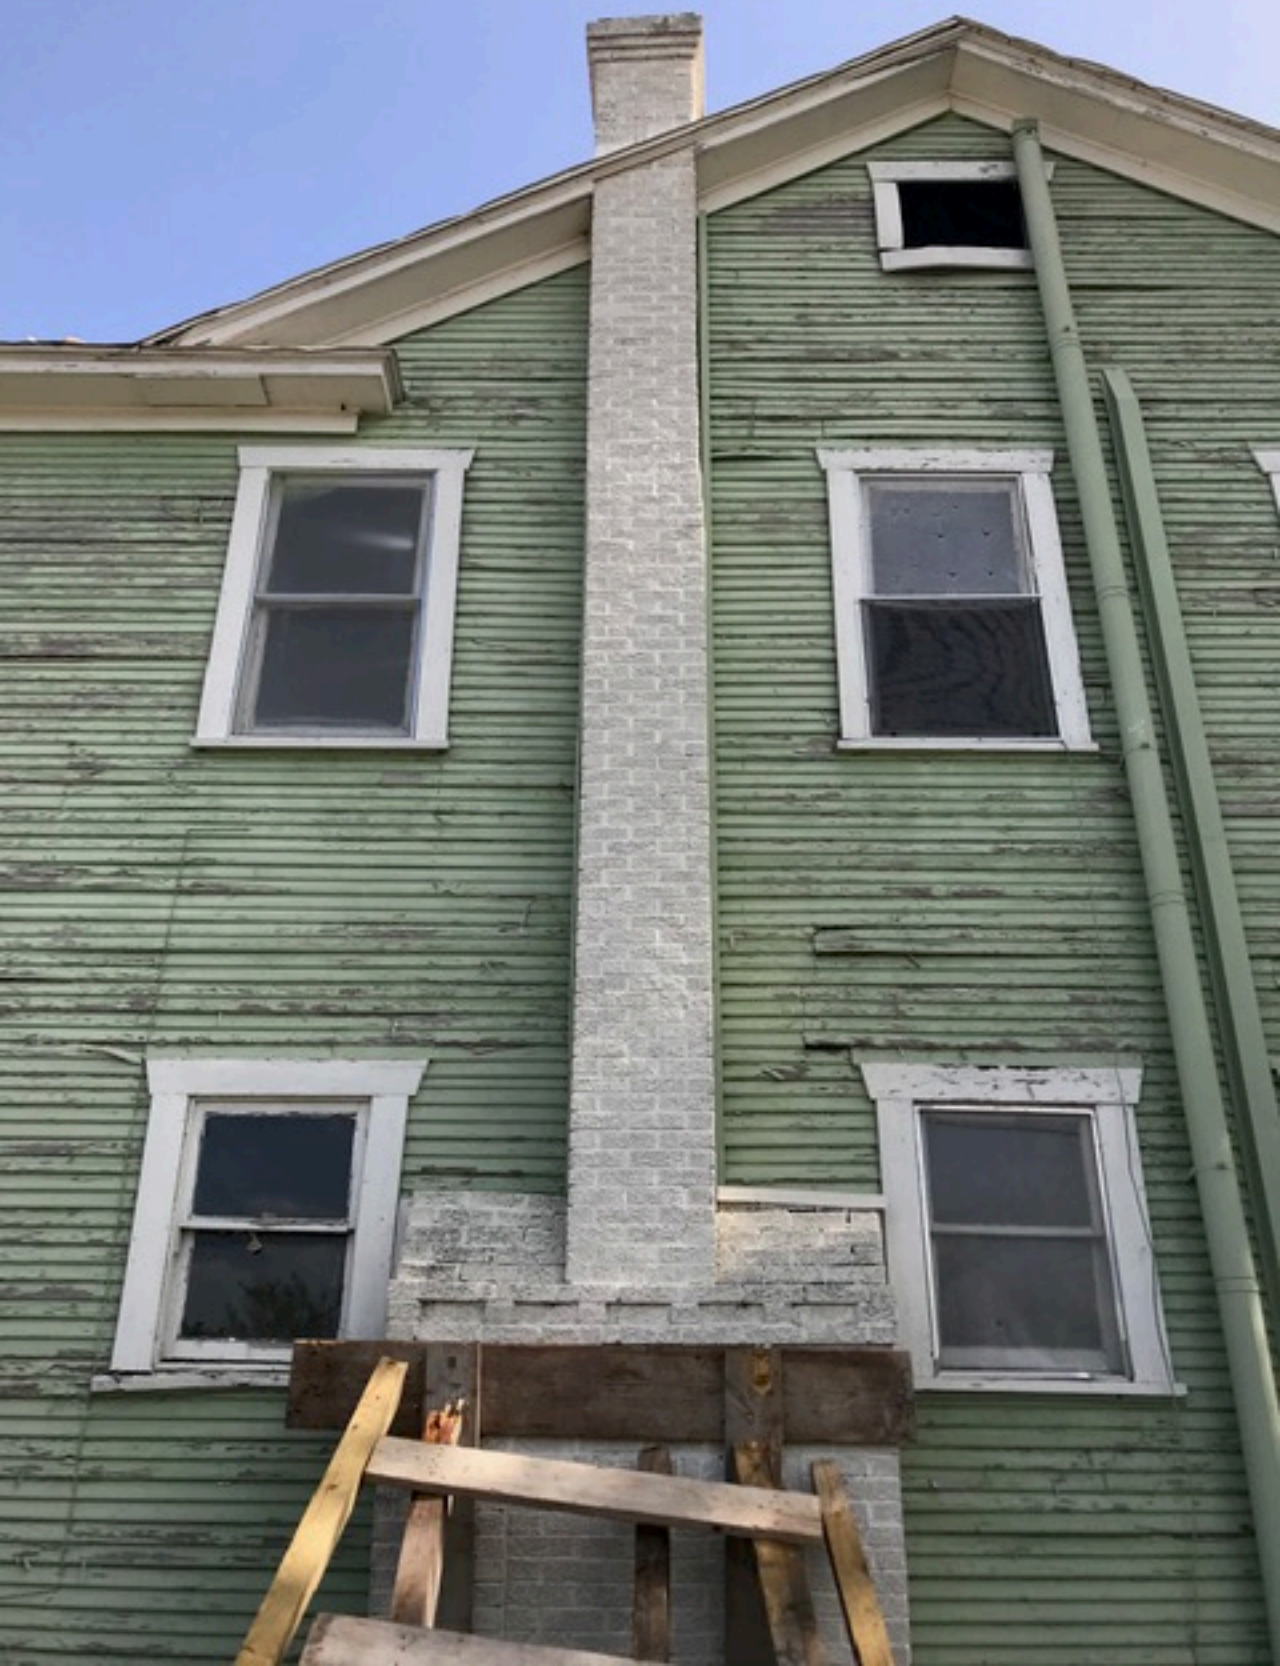
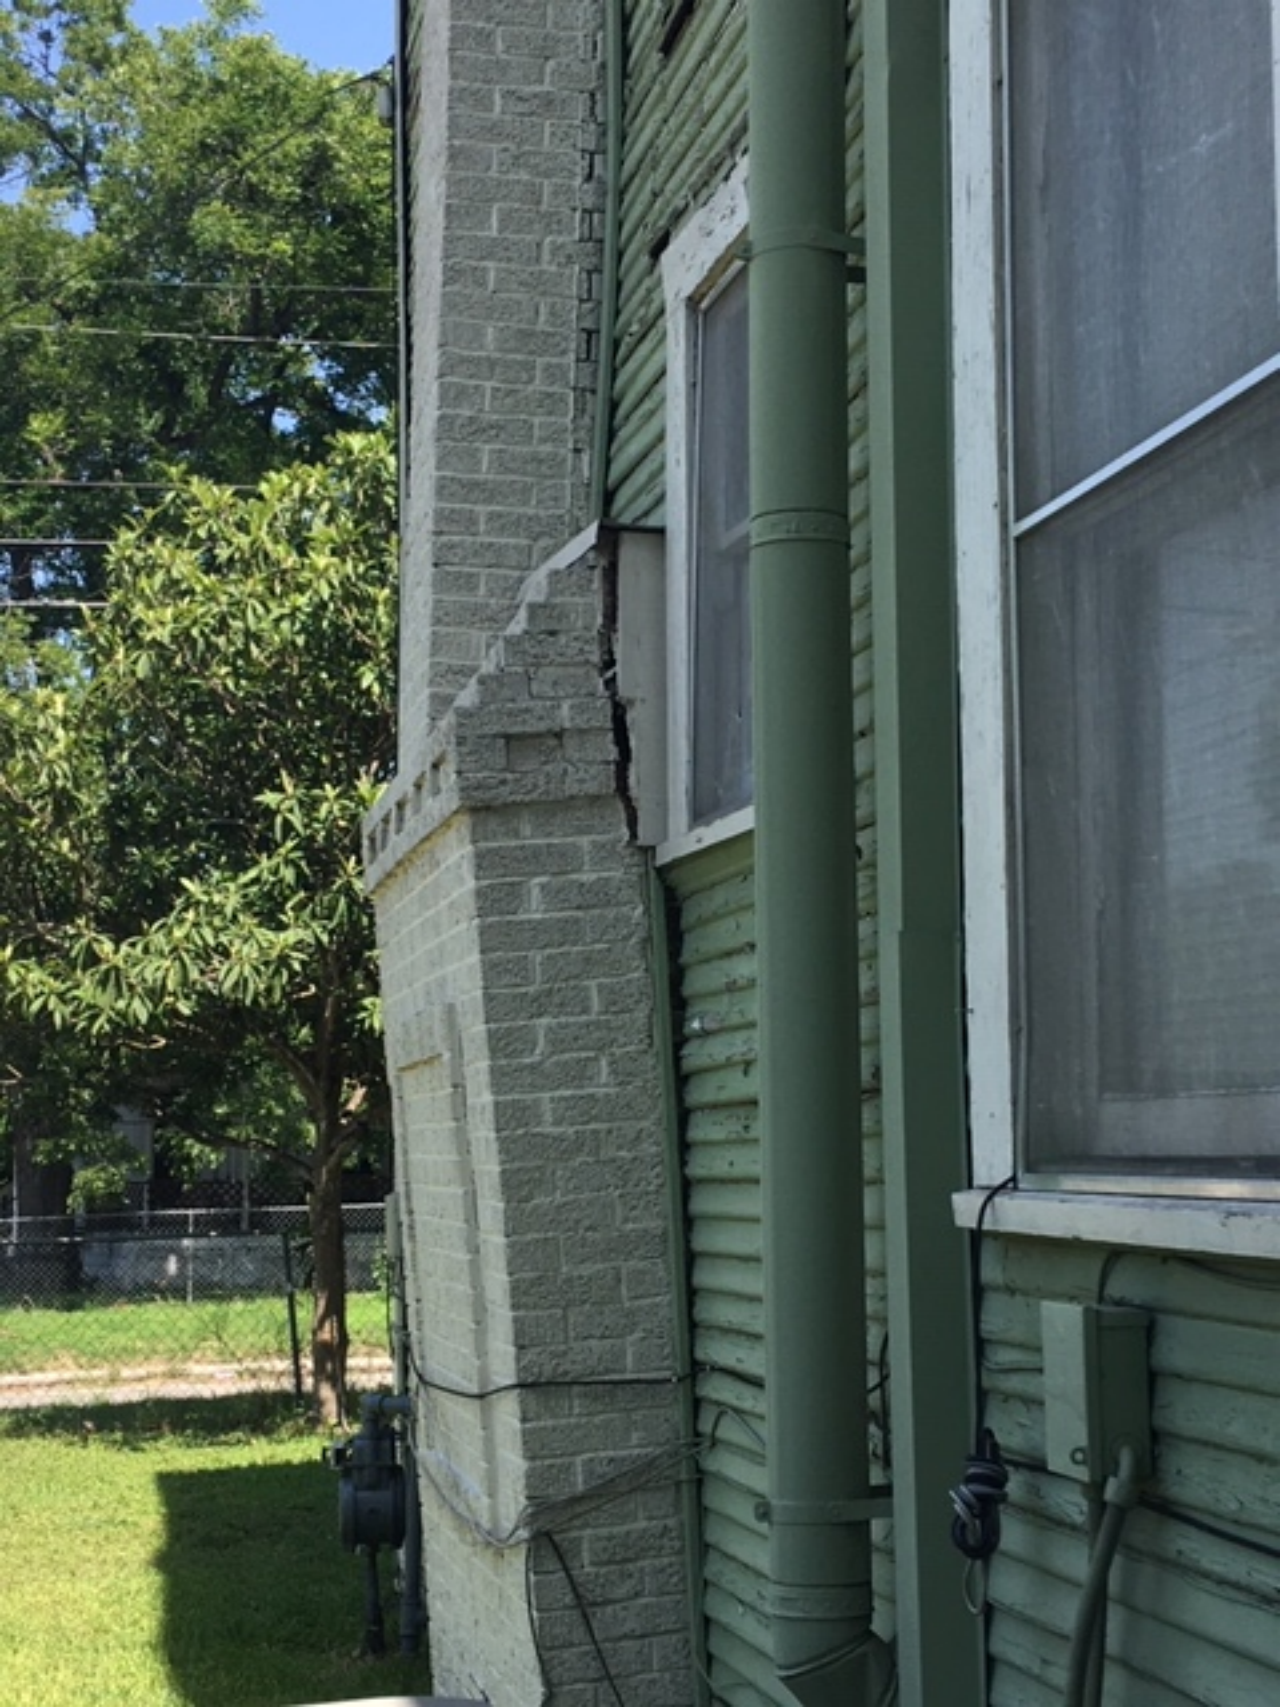
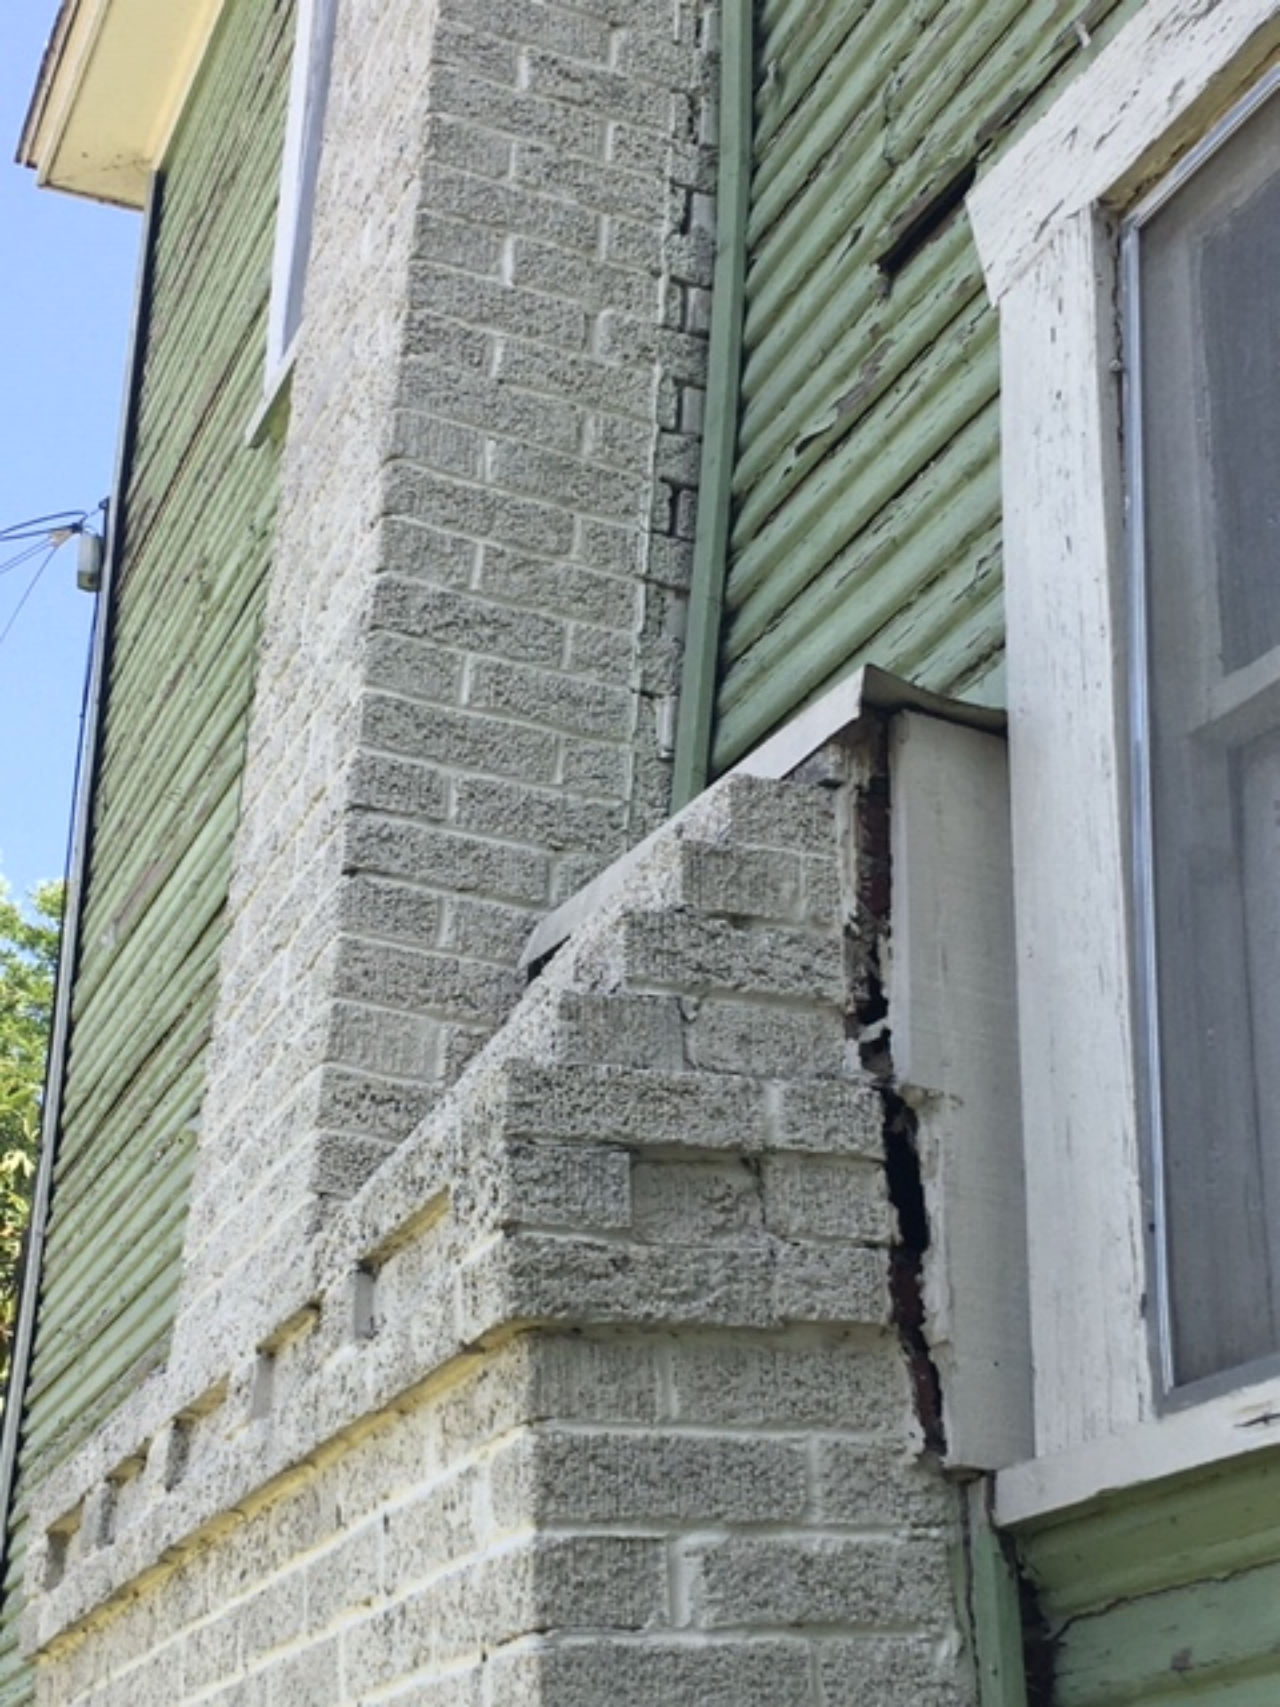
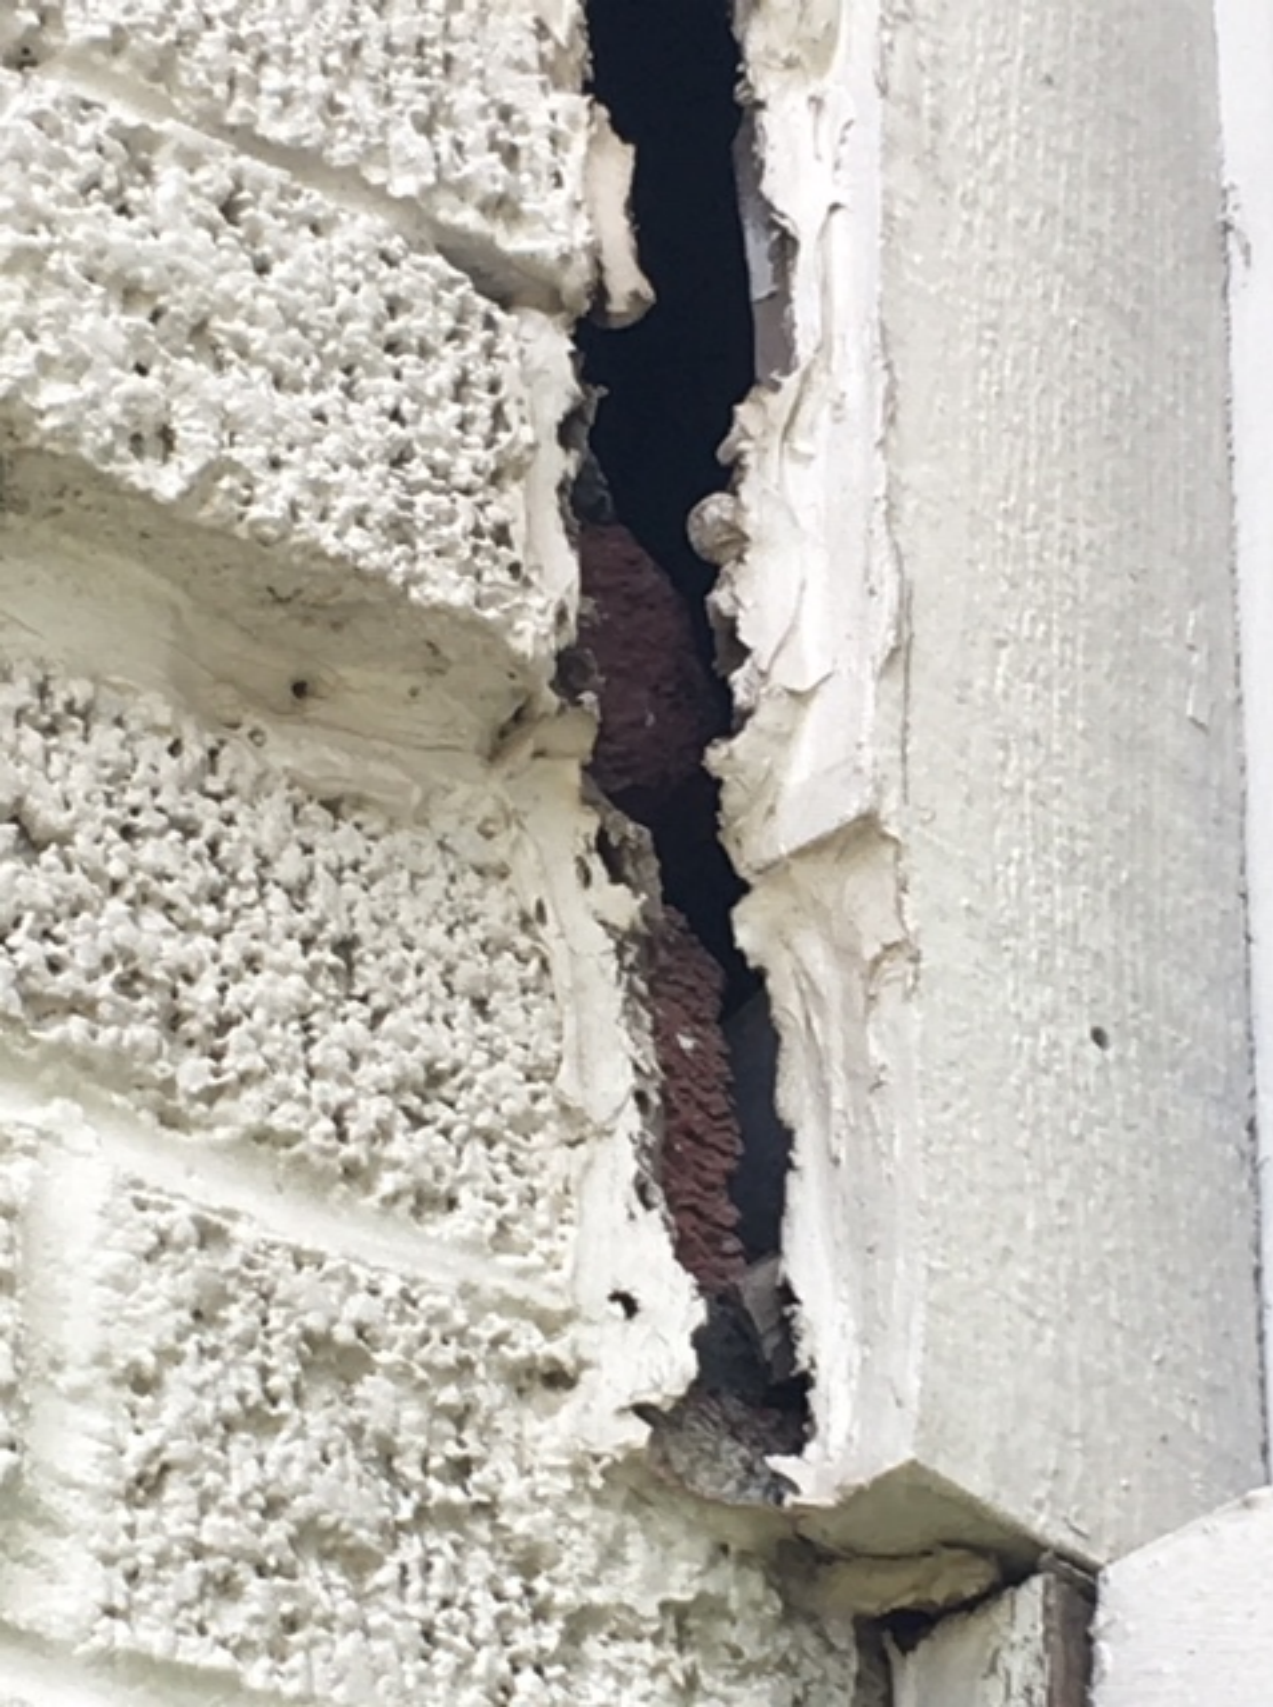
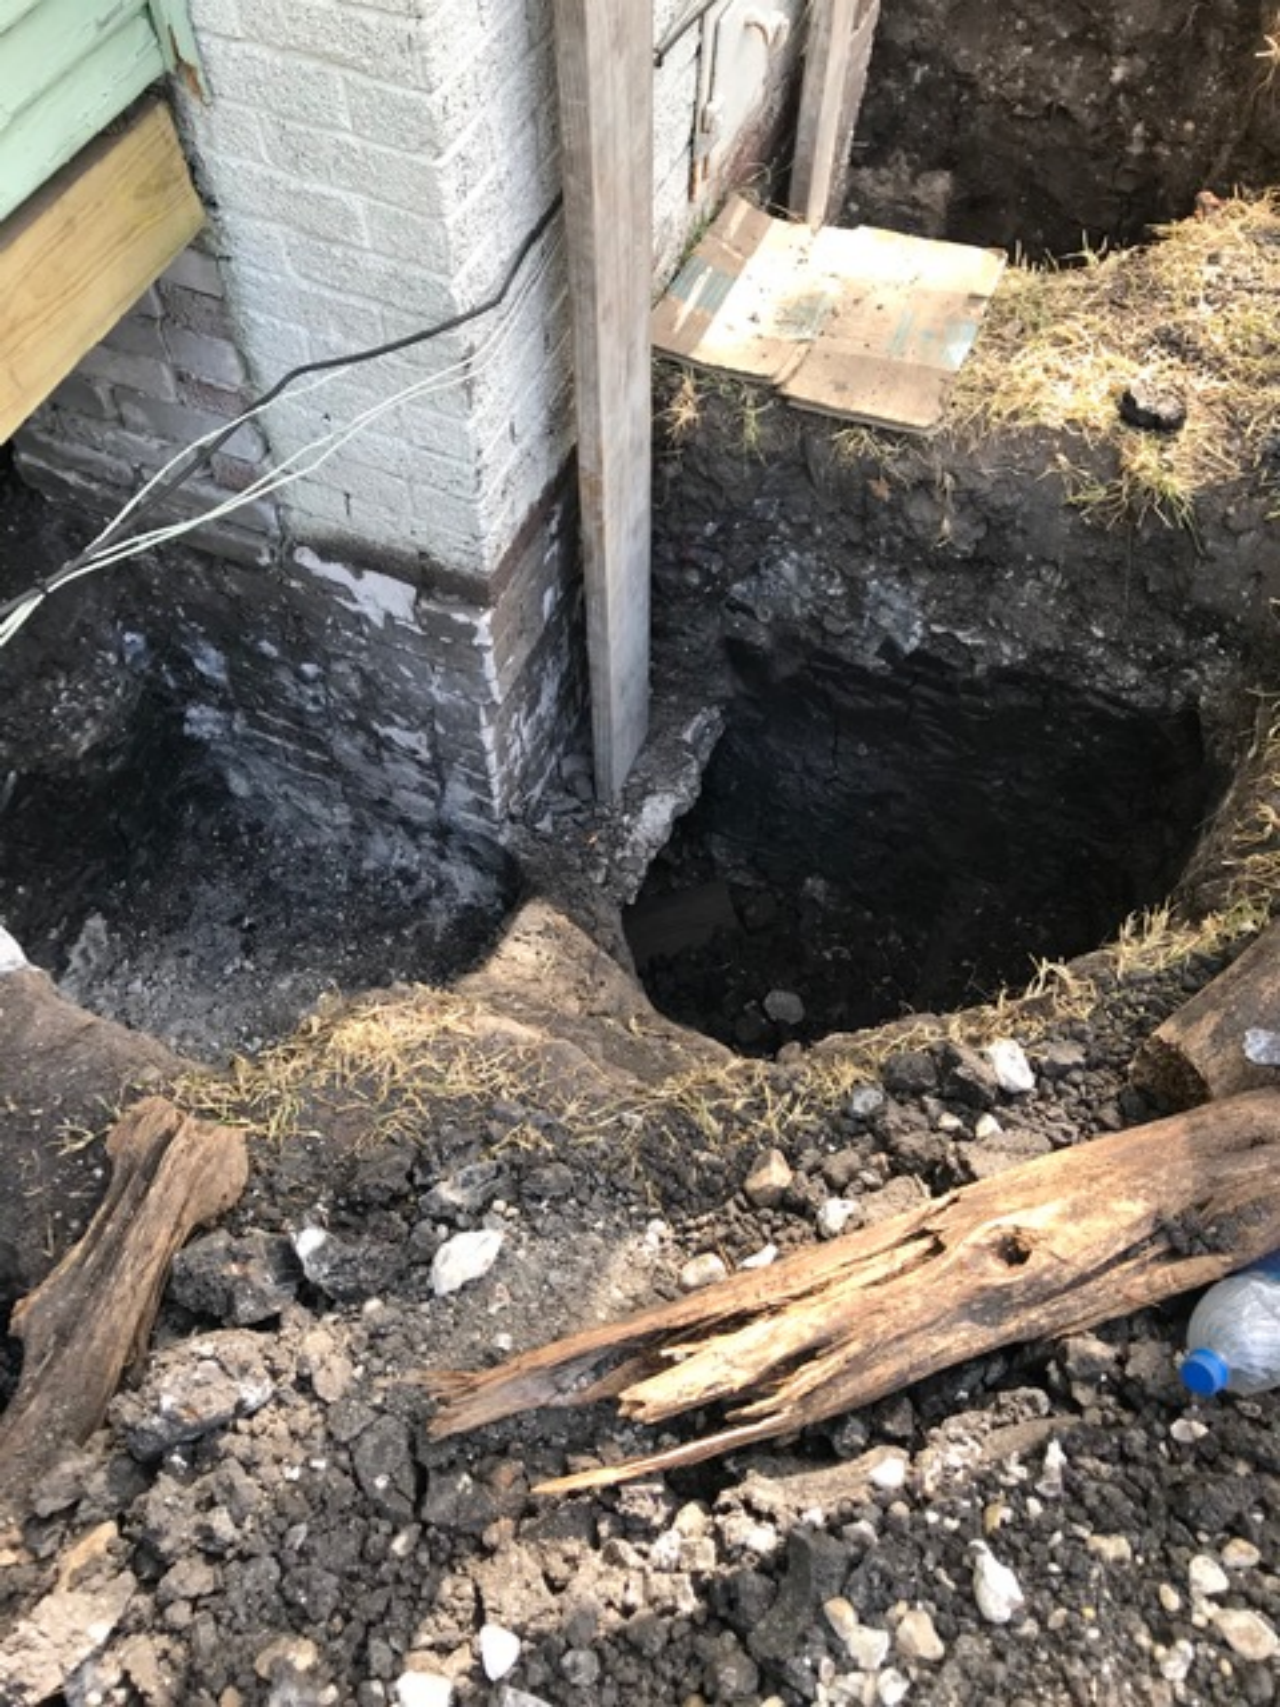
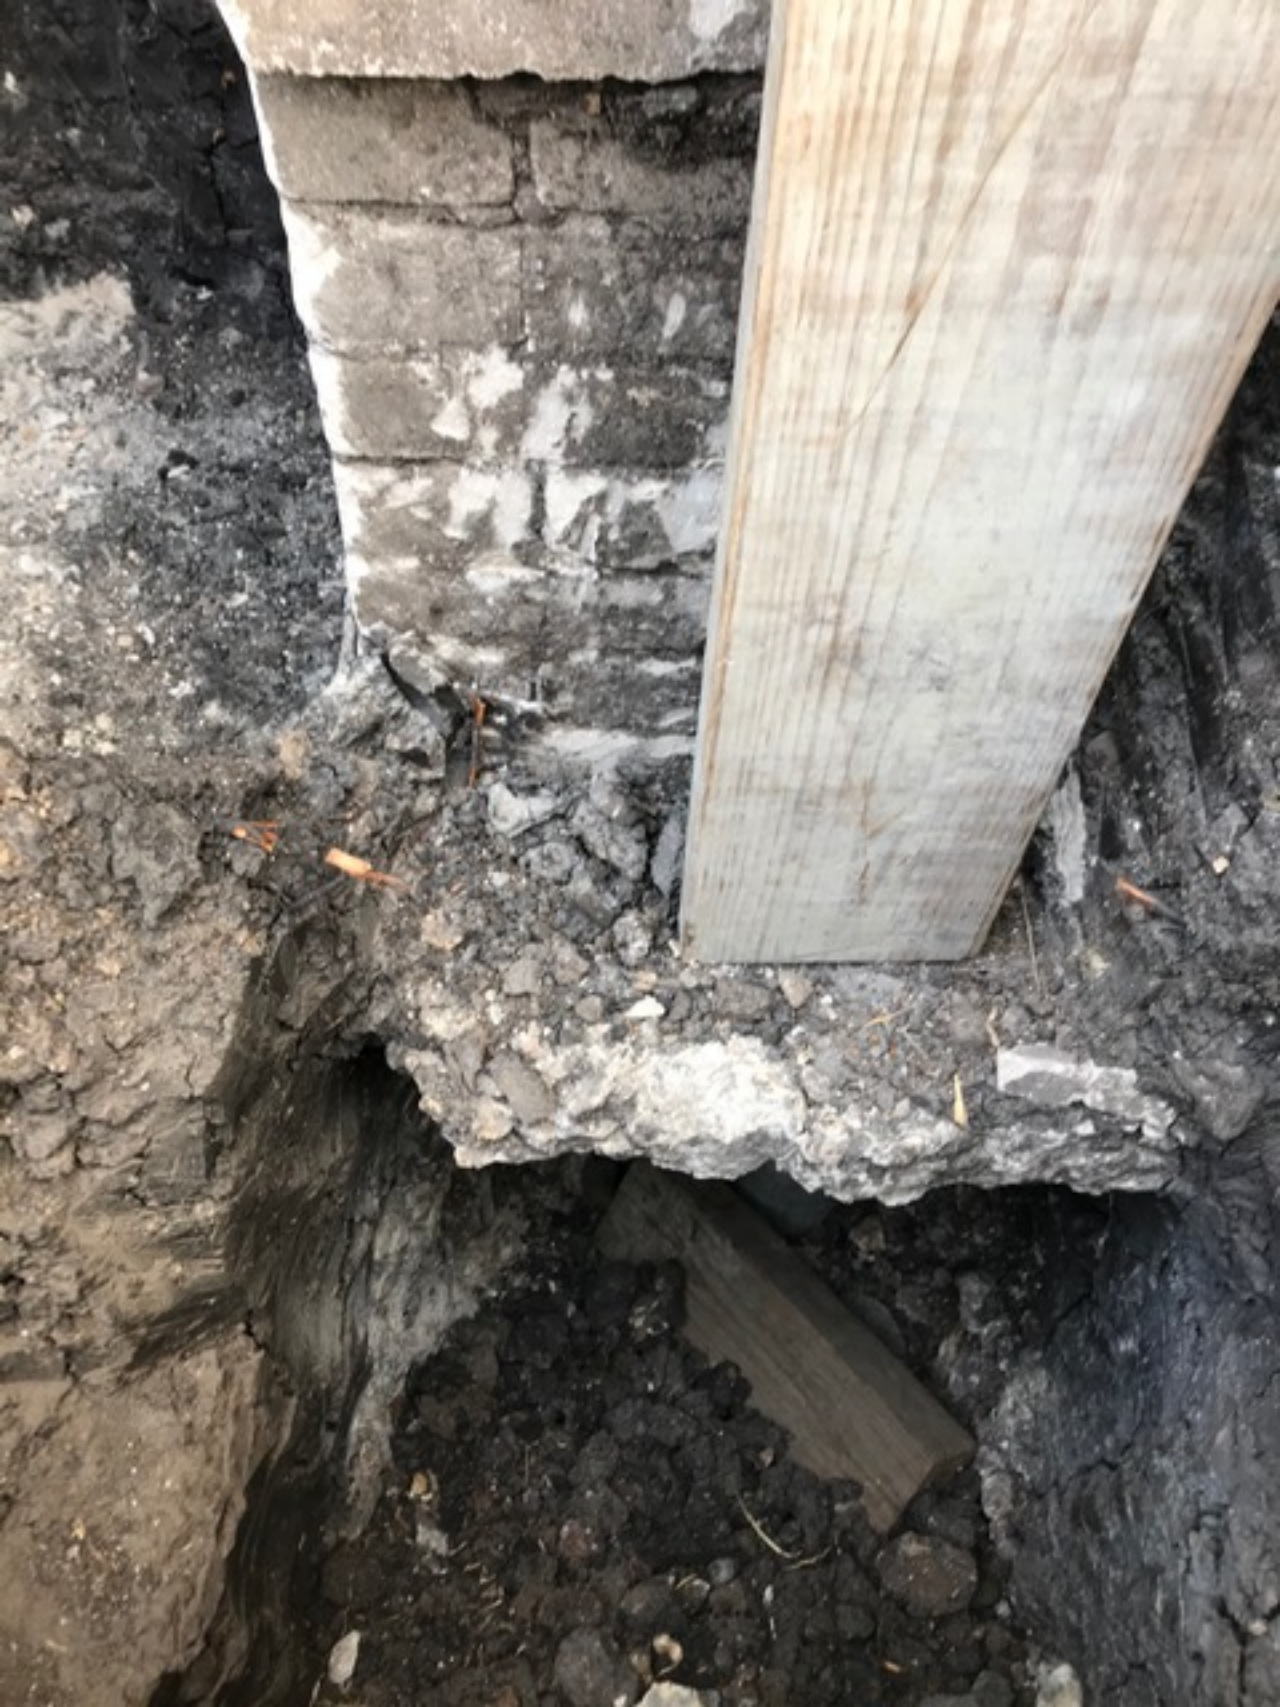
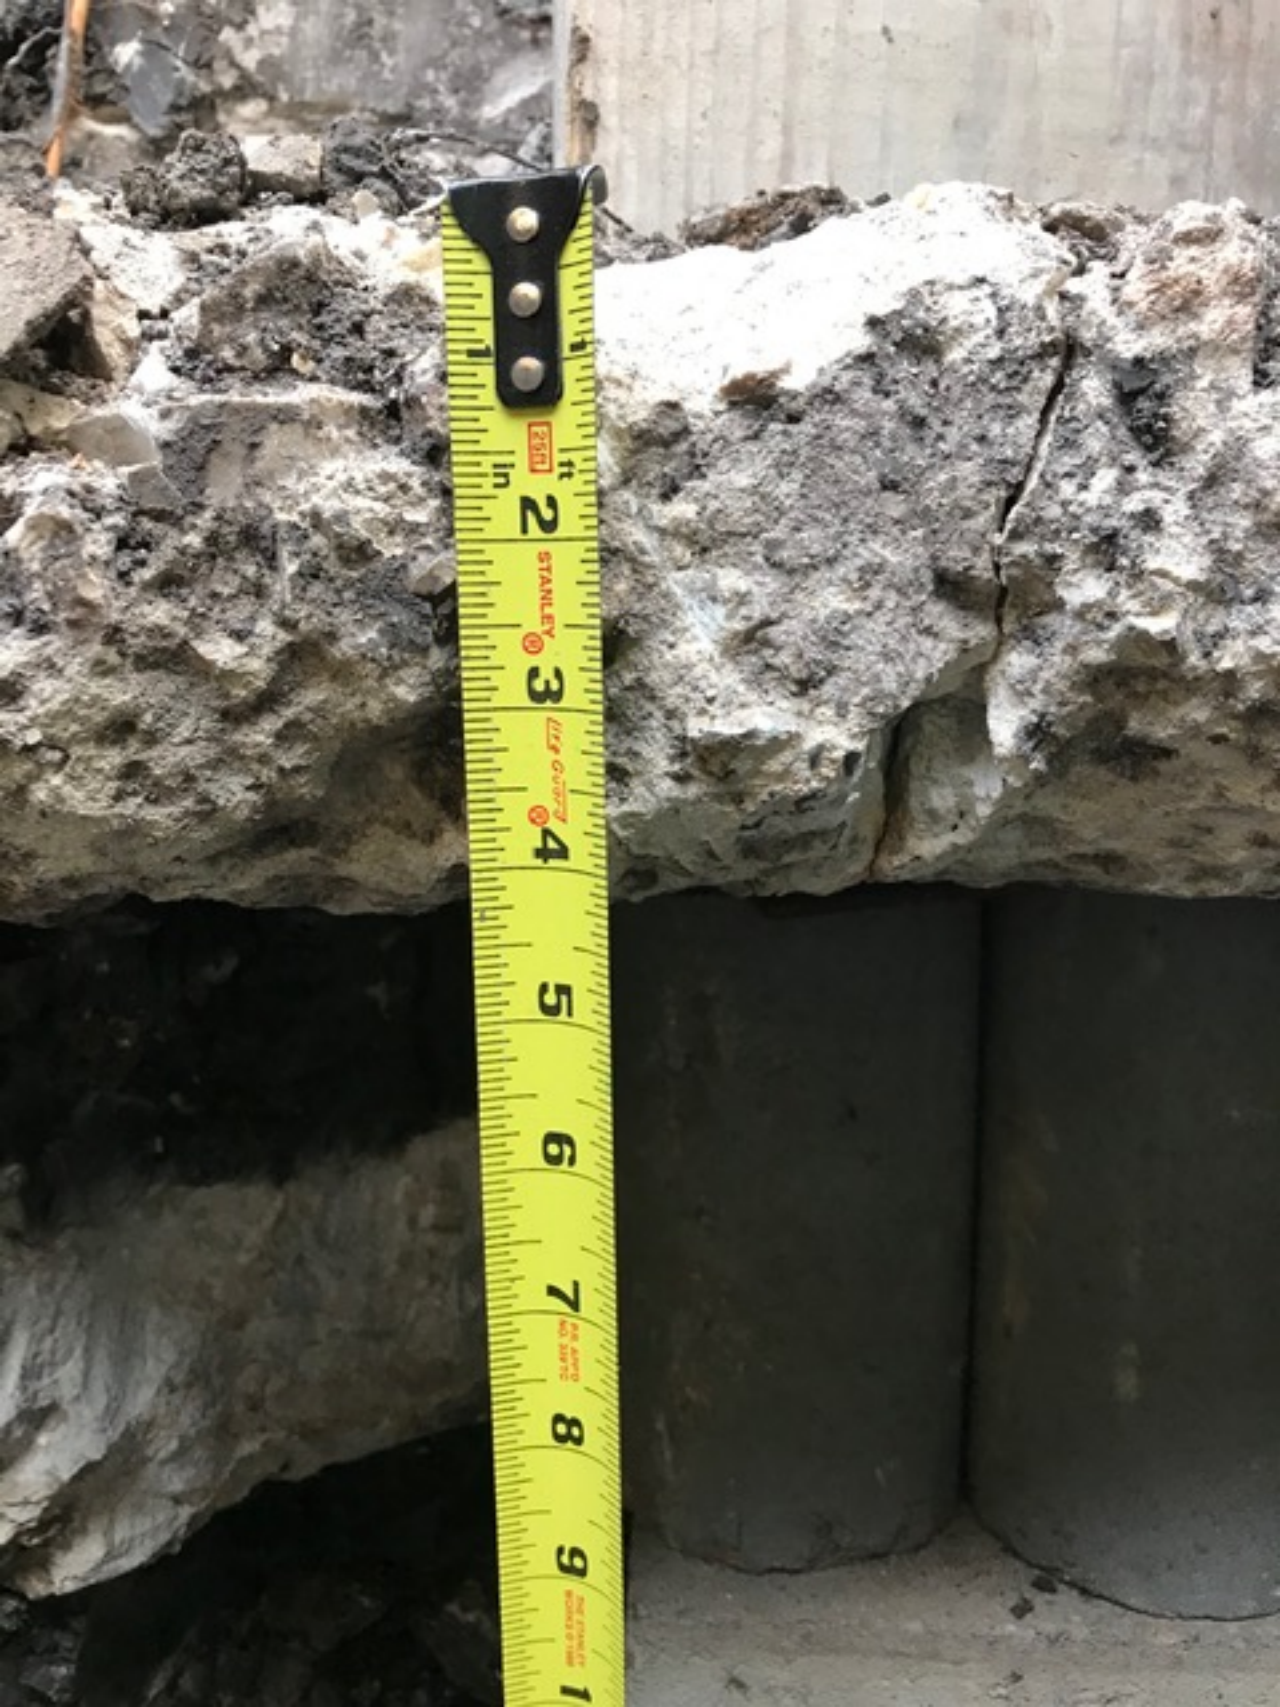
- b. CHIMNEY – The applicant has proposed to remove the brick chimney located on the north façade facing Dawson. The chimney features fully exposed brick construction with a tapered crown, stepped shoulders on the exterior of the mantle, and white paint finish. The chimney has begun buckling most at the mantle. Staff finds that the chimney is a character-defining feature of the structure and while it may be temporary deconstructed during structural repairs of the primary structure, it should be reconstructed based photo-documentation and a measured drawing submitted to staff.

Staff does not recommend chimney removal based on finding b. If temporary removal is required for structural repairs on the primary structure, staff recommends the chimney is reconstructed in-kind with the following stipulations:

1. That the chimney is deconstructed to salvage and reuse as many original bricks as possible
2. That no work is performed prior to submitting thorough photo-documentation and a measured drawing of the chimney.
