# HISTORIC AND DESIGN REVIEW COMMISSION

November 04, 2020

**HDRC CASE NO:** 2020-474  
**ADDRESS:** 333 W LULLWOOD AVE  
**LEGAL DESCRIPTION:** NCB 6537 BLK 17 LOT 5&6  
**ZONING:** R-5, H  
**CITY COUNCIL DIST.:** 1  
**DISTRICT:** Monte Vista Historic District  
**APPLICANT:** Josephat Valdez  
**OWNER:** Josephat Valdez  
**TYPE OF WORK:** Window replacement, fenestration modifications  
**APPLICATION RECEIVED:** October 15, 2020  
**60-DAY REVIEW:** Not applicable due to City Council Emergency Orders  
**CASE MANAGER:** Rachel Rettaliata

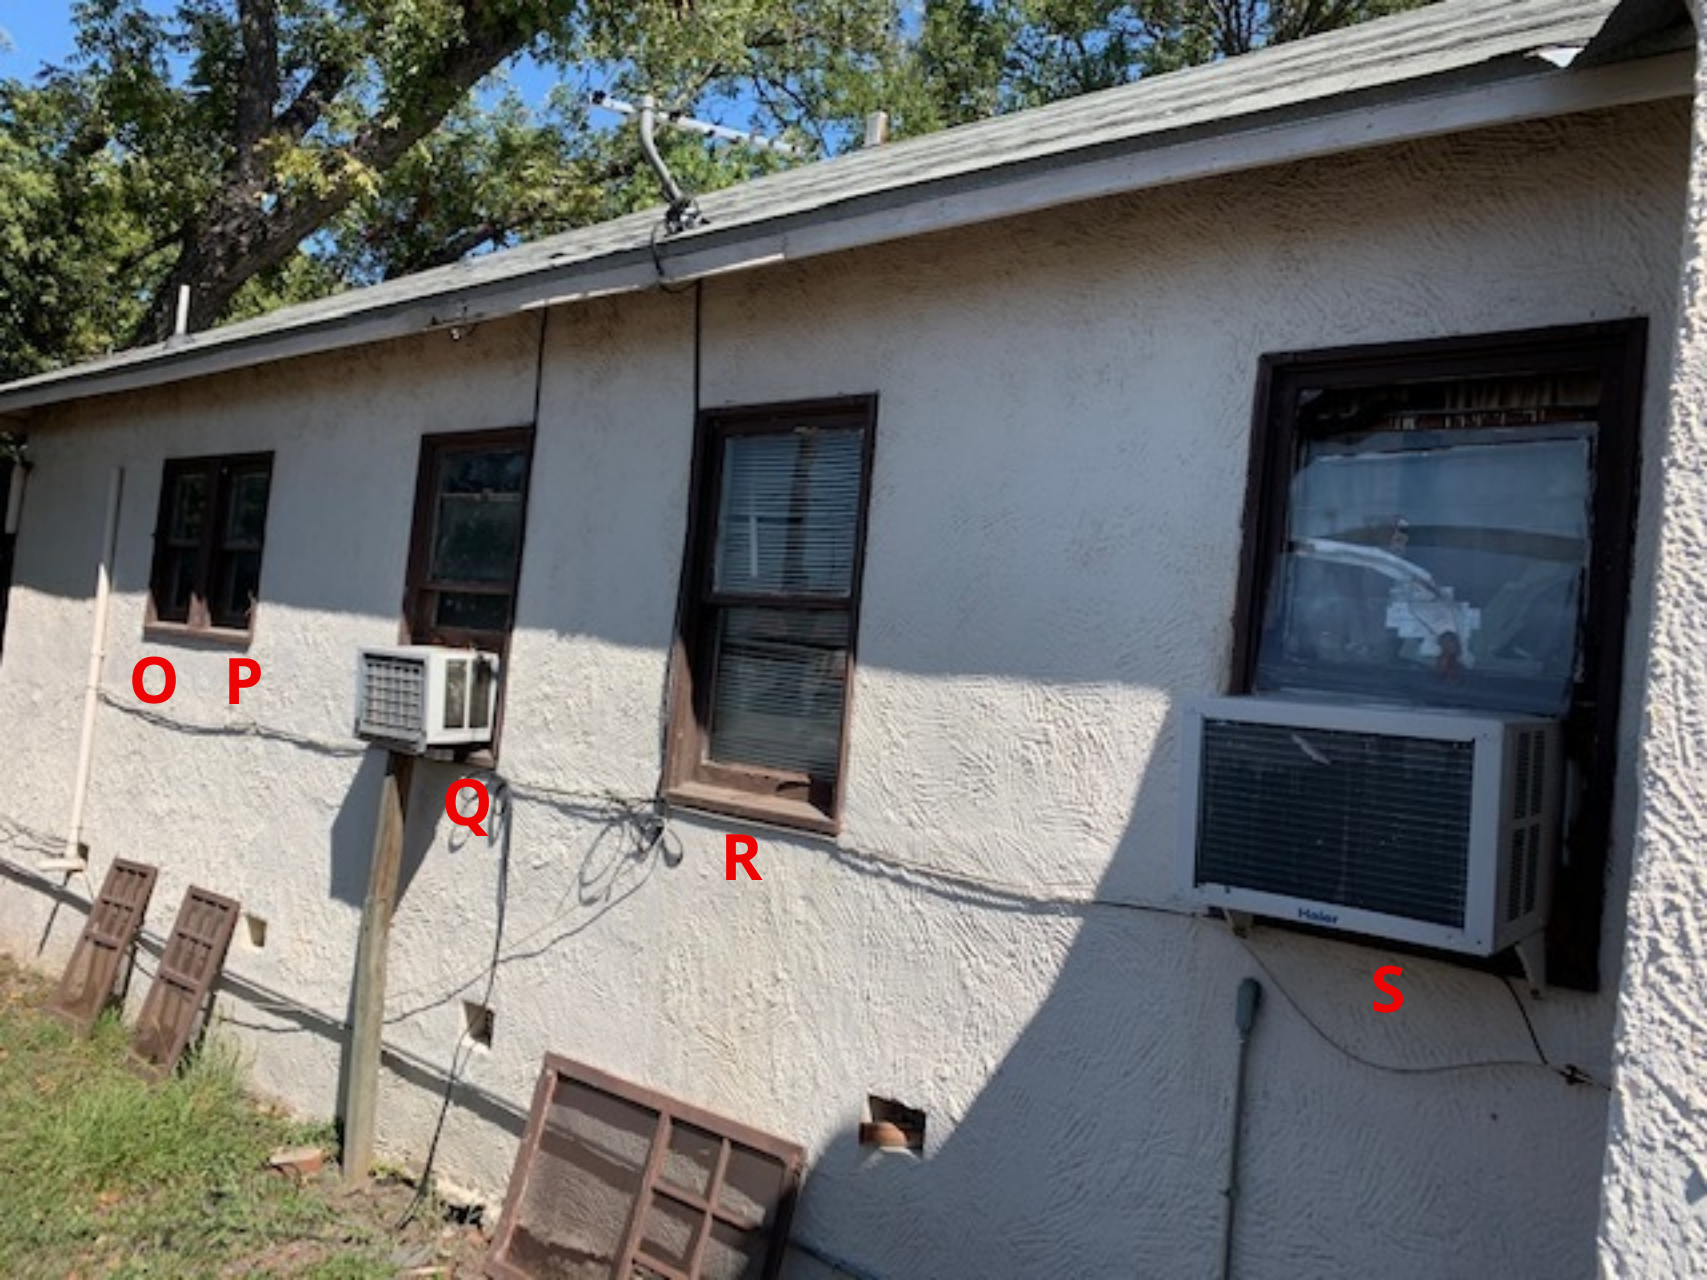
- e. **WINDOW REPLACEMENT: WEST ELEVATION** – The applicant has proposed to replace a window on the west elevation with a smaller window (window Q) to accommodate a kitchen sink. Staff observed that window Q features broken cords and extensive wood rot. The applicant has proposed to install a 32-inch x 36-inch Jeld-Wen W-2500 double hung wood window. Guideline 6.B.iv states that new windows should be installed to match the historic or existing windows in terms of size, type, configuration, material, form, appearance, and detail when original windows are deteriorated beyond repair. Staff finds that the window is eligible for replacement but finds the proposal to modify the size of the opening to be inconsistent with the Guidelines.

- f. **WINDOW REMOVAL: WEST ELEVATION** – The applicant has proposed to remove window R on the west elevation to accommodate new kitchen cabinets. The applicant has proposed to remove window R and enclose the opening. Guideline 6.A.i for Exterior Maintenance and Alterations states that existing window and door openings should be preserved. Avoid enlarging or diminishing to fit stock sizes or air conditioning units. Avoid filling in historic door or window openings. Staff finds the proposal inconsistent with the Guidelines.

- g. **WINDOW REPLACEMENT: WEST ELEVATION** – The applicant has proposed to replace window S on the west elevation with a new door opening. The applicant has proposed to install a Jeld-Wen fully wood door. Staff observed that window S was in poor condition and featured extensive wood rot and missing frame elements. Guidelines 6.B.ii for Exterior Maintenance and Alterations states that applicants should ensure that new entrances, when necessary to comply with other regulations, are compatible in size, scale, shape, proportion, material, and massing with historic entrances. Due to the

location of the existing opening out of view of the public right-of-way and the condition of the existing window, staff finds the proposal appropriate. .

Item 4, staff does not recommend approval of the request to replace the window on the west elevation based on finding e. Staff recommends that the applicant maintain the size of the historic window opening and installs a replacement window that meets the following stipulation:

- i. That the applicant installs a fully wood window that meet staff's standard window stipulations and submits updated specifications to staff for review and approval. The windows should feature an inset of two (2) inches within facades and should feature profiles that are found historically within the immediate vicinity. Meeting rails must be no taller than 1.25" and stiles no wider than 2.25". White manufacturer's color is not allowed, and color selection must be presented to staff. There should be a minimum of two inches in depth between the front face of the window trim and the front face of the top window sash. This must be accomplished by recessing the window sufficiently within the opening or with the installation of additional window trim to add thickness. Window trim must feature traditional dimensions and architecturally appropriate sill detail. Window track components must be painted to match the window trim or concealed by a wood window screen set within the opening.

Item 5, staff does not recommend approval of the request to remove and enclose the window opening on the west elevation based on finding f. Staff recommends that the applicant maintain the historic window opening.

Item 6, staff recommends approval of the request to modify the existing window opening on the west elevation to accommodate a door installation based on finding g with the following stipulations:

- i. That the applicant submits final material specifications for a fully wood door to staff for review and approval prior to the issuance of a Certificate of Appropriateness.
- ii. That the applicant receives approval for any side porch and/or decking installation prior to installing the new door opening.

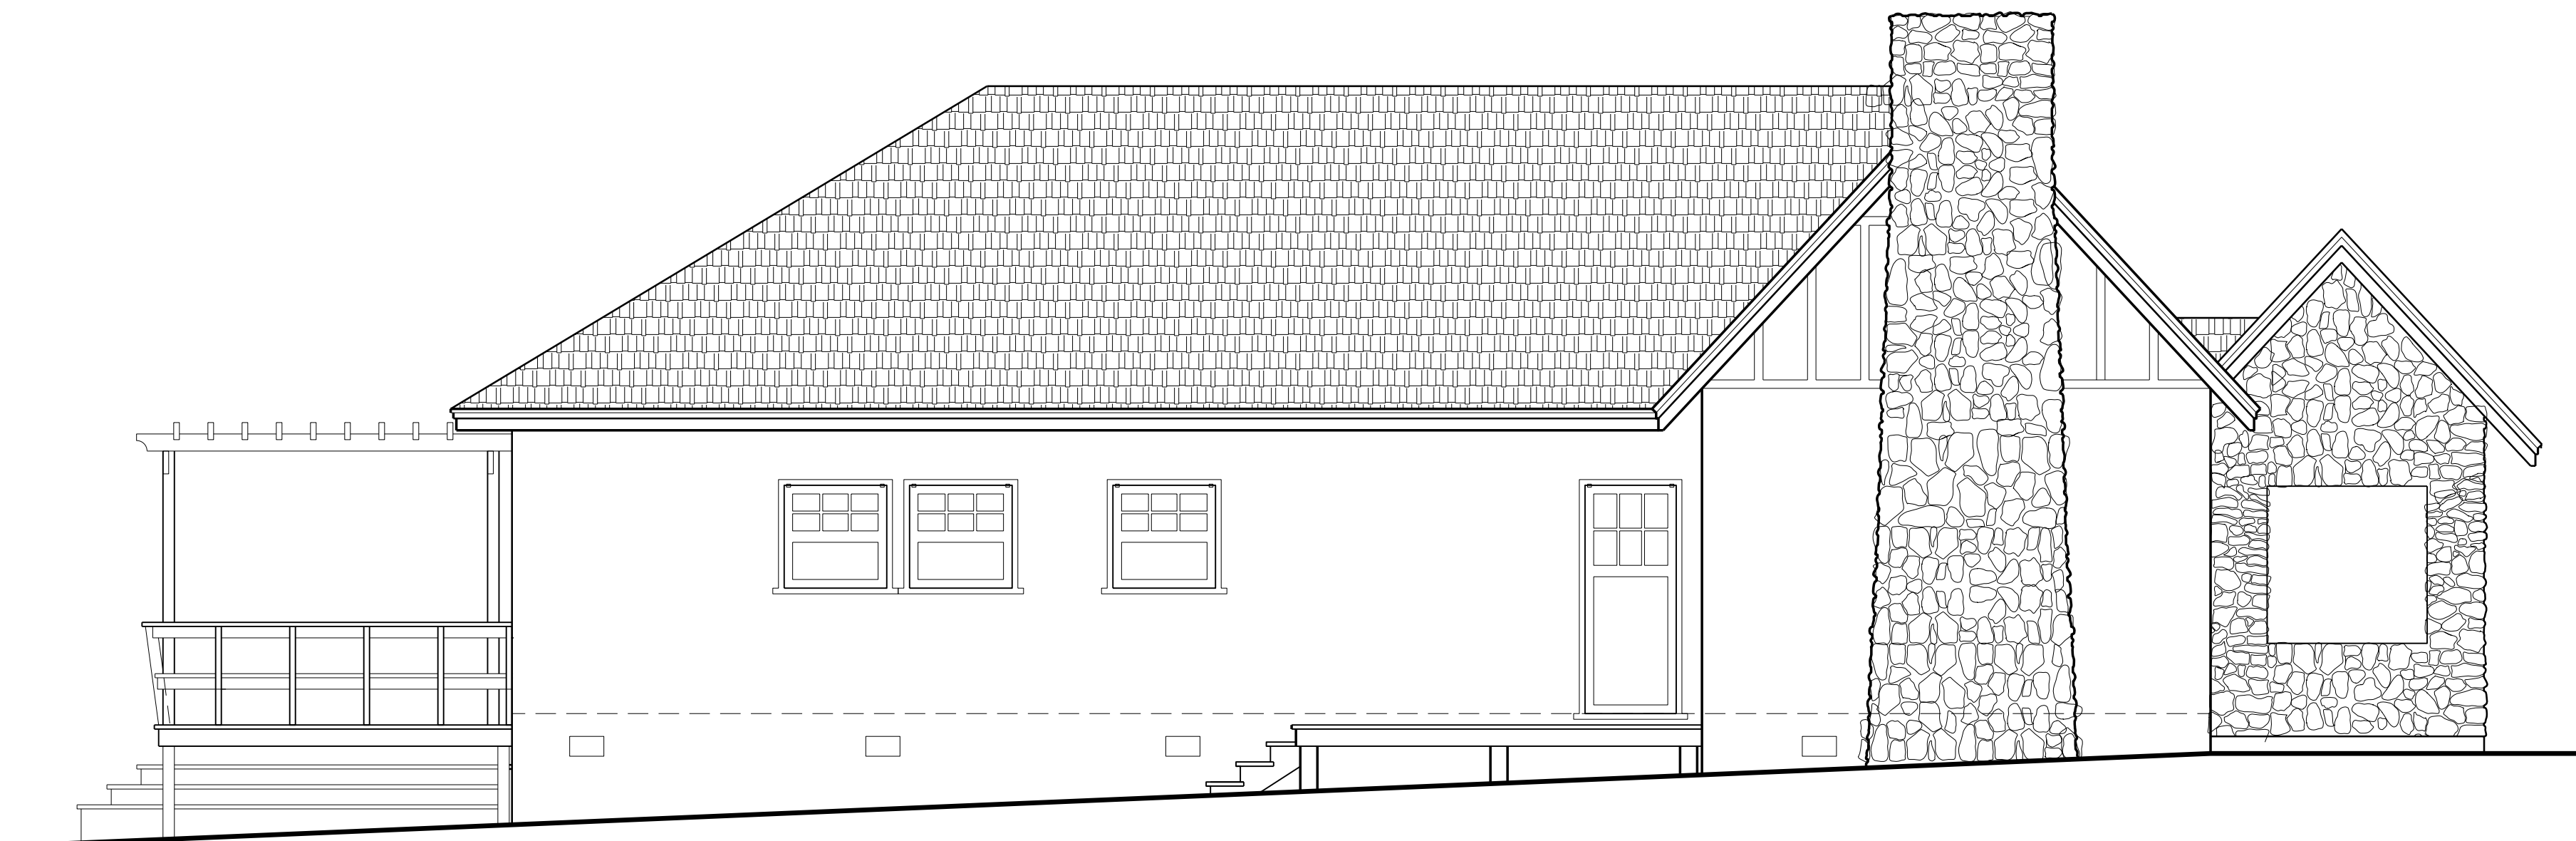
**4** LEFT SIDE ELEVATION  
SCALE : 1/4"=1'-0"

- c. **FENESTRATION MODIFICATIONS: EAST ELEVATION** – The applicant has proposed to replace windows G and I with Jeld-Wen W-5500 double slider windows and remove and enclose windows H and J in order to accommodate the size of the proposed replacement windows. Due to modifications to the interior layout, windows G, H, I, and J will be located in bathrooms. Guideline 6.A.i for Exterior Maintenance and Alterations states that existing window and door openings should be preserved. Avoid enlarging or diminishing to fit stock sizes or air conditioning units. Avoid filling in historic door or window openings. Staff finds that window G is a smaller sized window that could function well as a bathroom window and is in repairable condition. Staff finds that the request is inconsistent with the Guidelines.

Item 1, staff does not recommend approval of the request to replace 2 windows on the east elevation based on finding c.

Item 2, staff does not recommend approval of the request to remove and enclose 2 window openings on the east elevation based on finding c. Staff recommends that the applicant maintain the historic window openings.

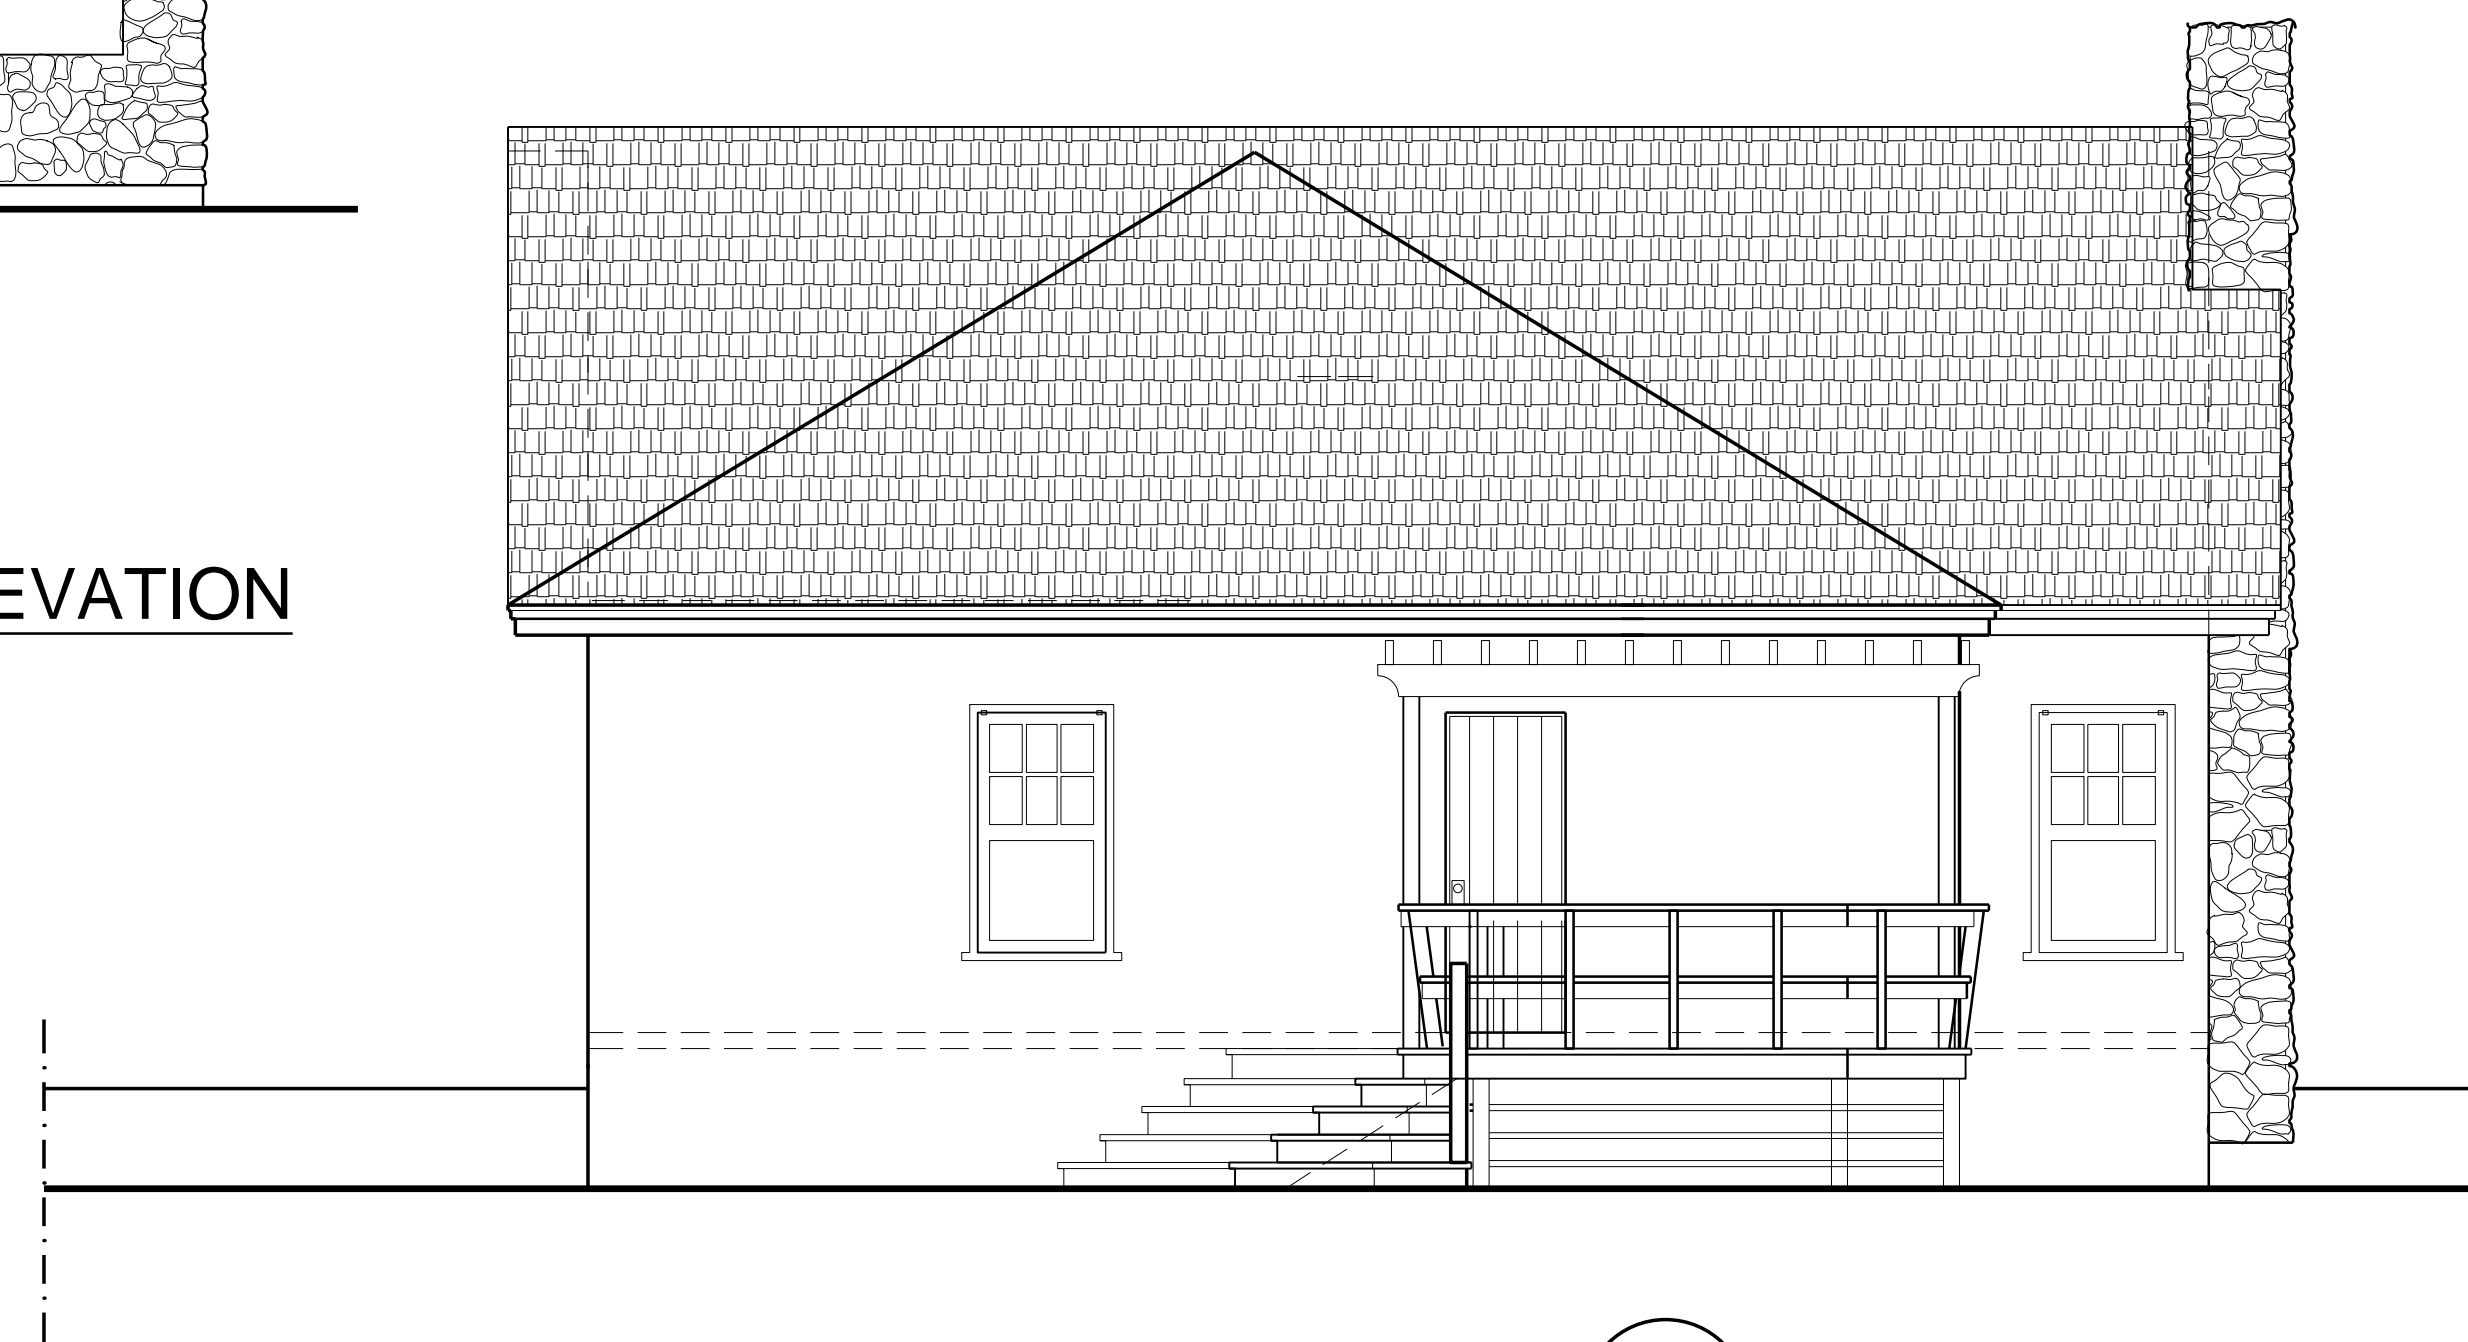
**3** REAR ELEVATION  
SCALE : 1/4"=1'-0"

- d. **WINDOW REPLACEMENT: REAR ELEVATION** – The applicant has proposed to remove the non-original aluminum window on the rear elevation (window N) with a window salvaged from the east elevation. According to Guideline 6.B.vii, replace non-historic incompatible windows with windows that are typical of the architectural style of the building. Staff finds the proposal appropriate.

Item 3, staff recommends approval of the request to replace the rear window based on finding d. Due to staff's recommendation against removing the windows on the east elevation, staff recommends that the applicant replace the rear window with a window that meets the following stipulation:

- i. That the applicant installs a fully wood window that meet staff's standard window stipulations and submits updated specifications to staff for review and approval. The windows should feature an inset of two (2) inches within facades and should feature profiles that are found historically within the immediate vicinity. Meeting rails must be no taller than 1.25" and stiles no wider than 2.25". White manufacturer's color is not allowed, and color selection must be presented to staff. There should be a minimum of two inches in depth between the front face of the window trim and the front face of the top window sash. This must be accomplished by recessing the window sufficiently within the opening or with the installation of additional window trim to add thickness. Window trim must feature traditional dimensions and architecturally appropriate sill detail. Window track components must be painted to match the window trim or concealed by a wood window screen set within the opening.
