## HISTORIC AND DESIGN REVIEW COMMISSION

December 2, 2020

**HDRC CASE NO:** 2020-417  
**ADDRESS:** 253 LOTUS ST  
**LEGAL DESCRIPTION:** NCB 2956 LOT S 68 FT OF E NCB 3036 LOT E TRI 46 FT OF 24  
**ZONING:** R-6, H  
**CITY COUNCIL DIST.:** 1  
**DISTRICT:** Lavaca Historic District  
**APPLICANT:** Adams Joseph/MATHEW ANGELINE & ADAMS J JOSEPH  
**OWNER:** Adams Joseph/MATHEW ANGELINE & ADAMS J JOSEPH  
**TYPE OF WORK:** Stucco over wood siding, window replacement  
**APPLICATION RECEIVED:** September 21, 2020  
**60-DAY REVIEW:** Not applicable due to City Council Emergency Orders  
**CASE MANAGER:** Huy Pham  
**REQUEST:**

## Investigation Report

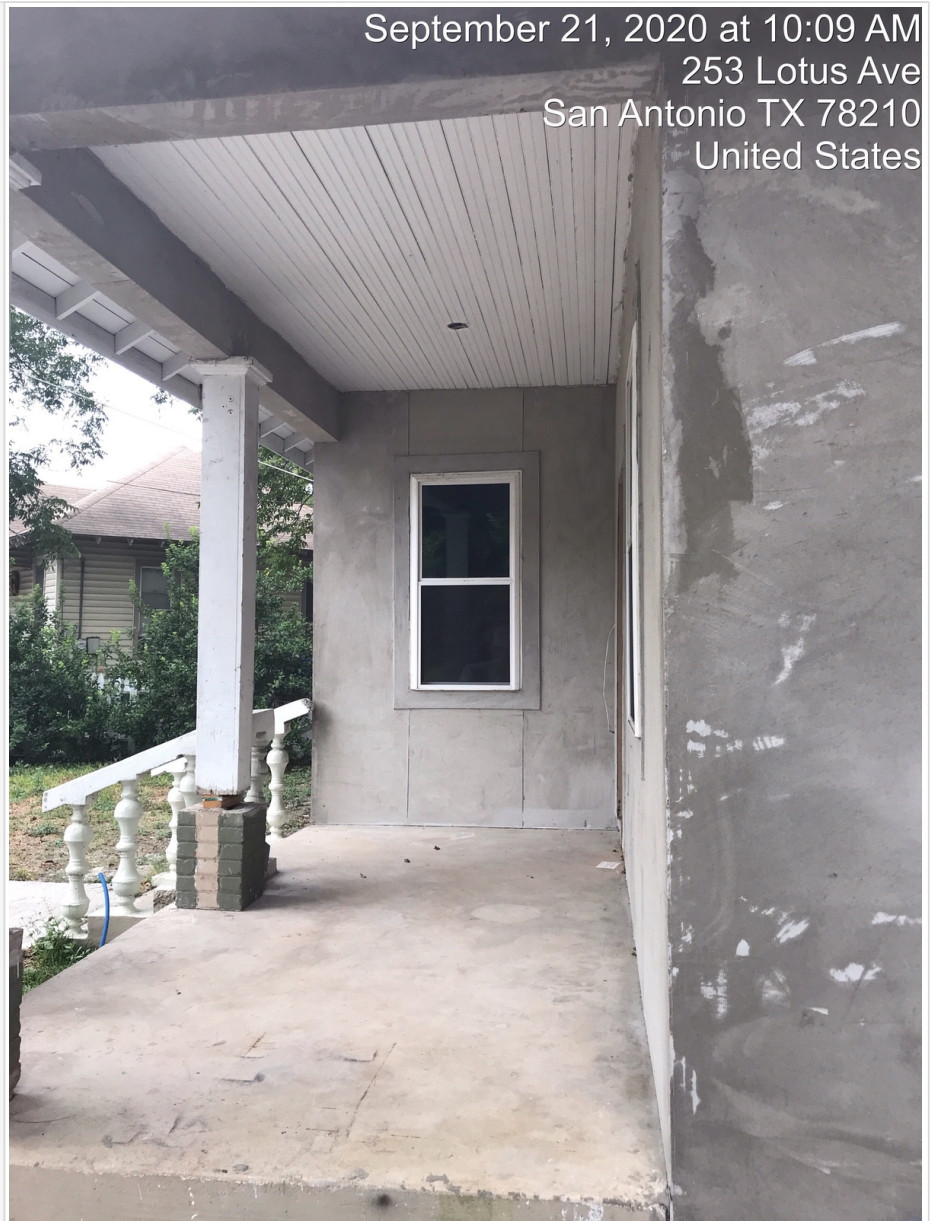
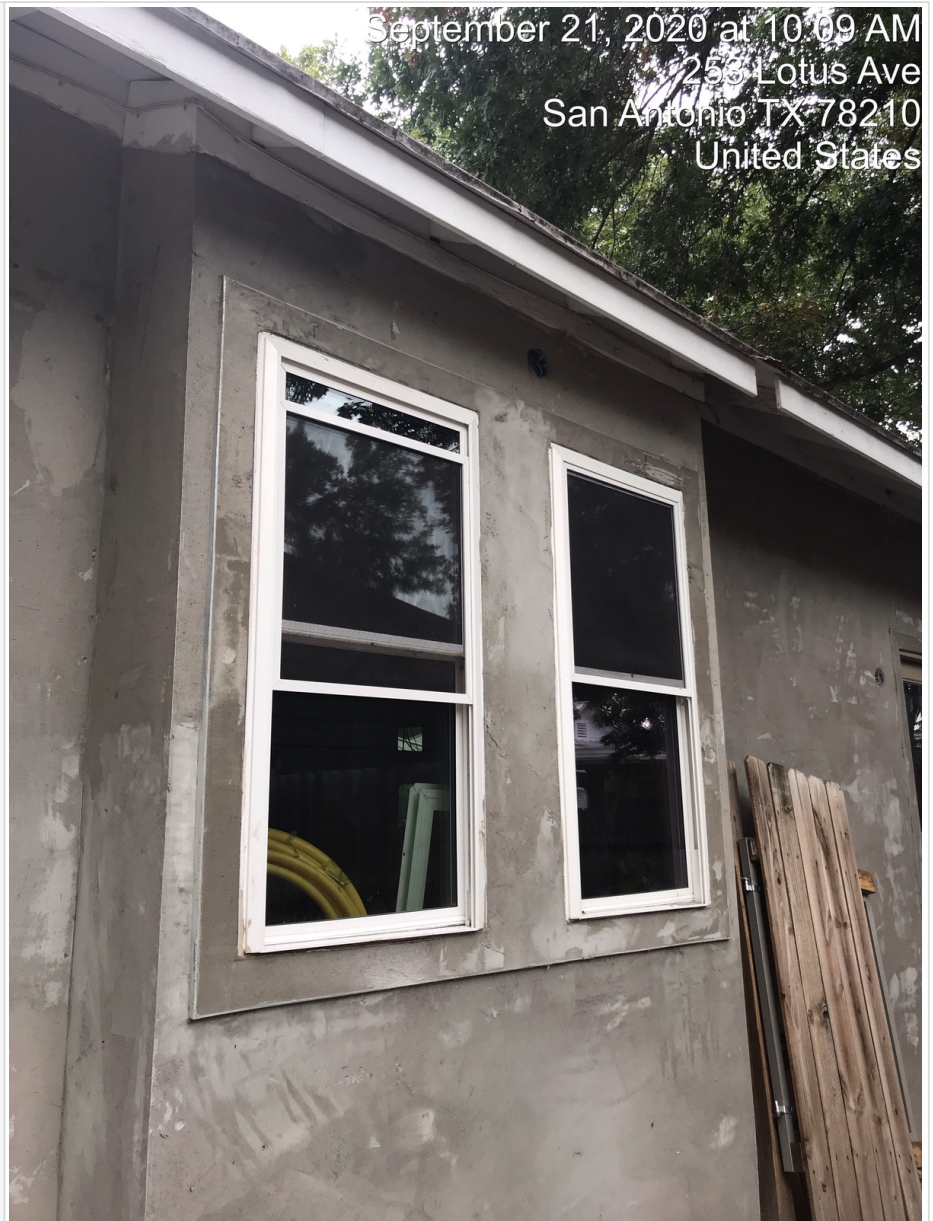
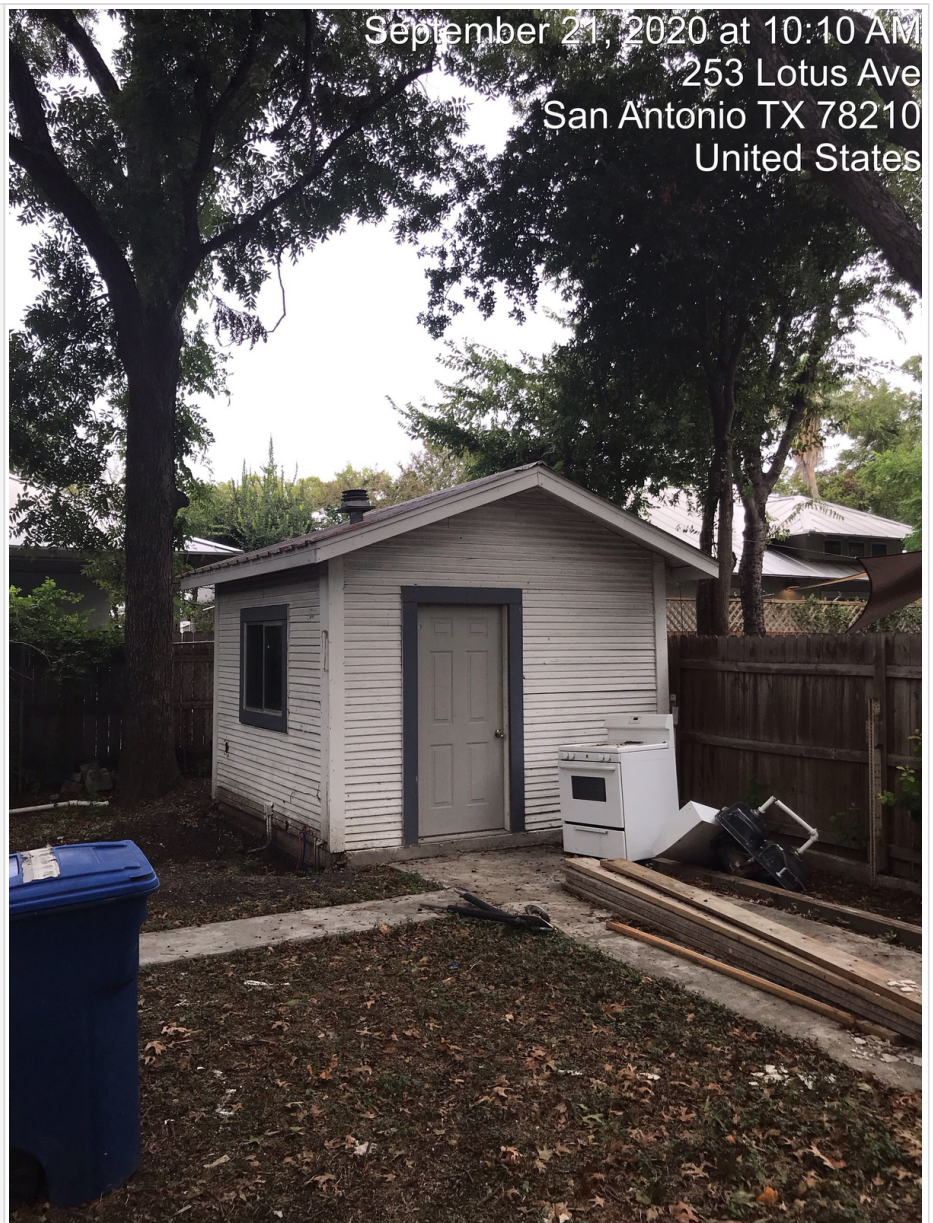
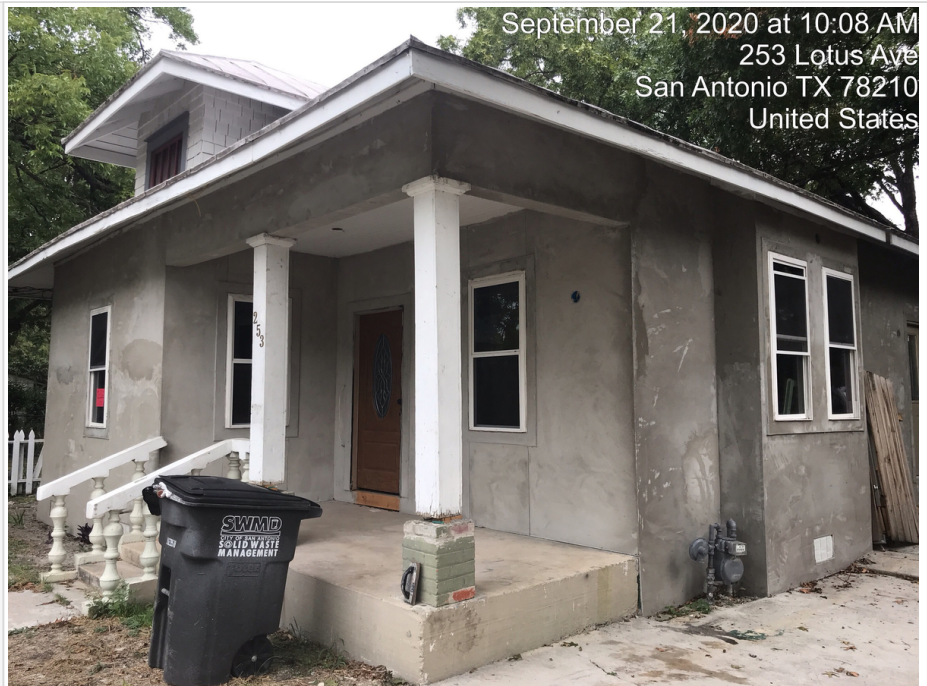
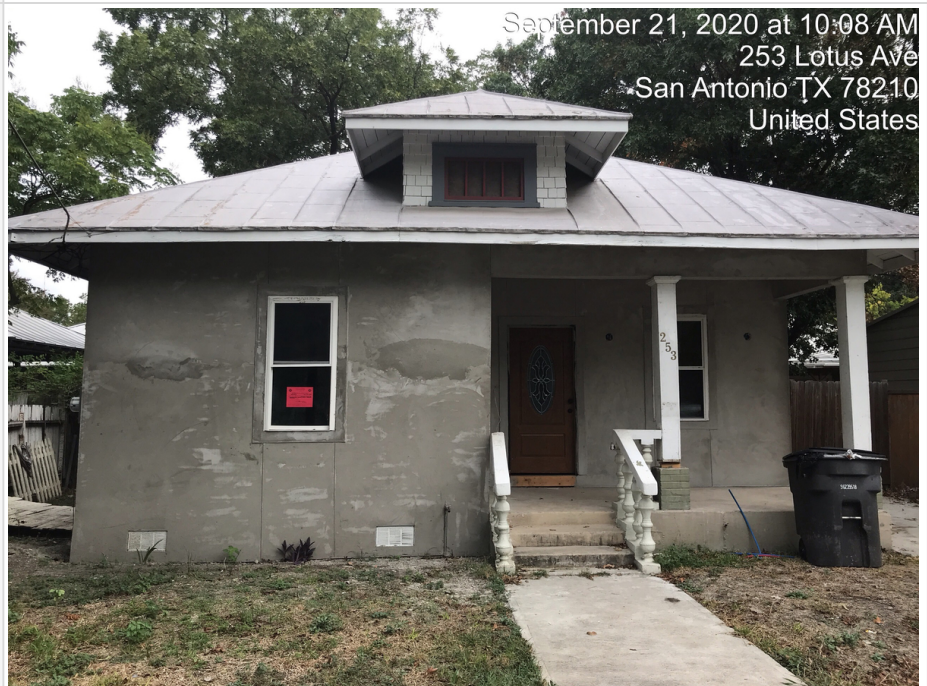
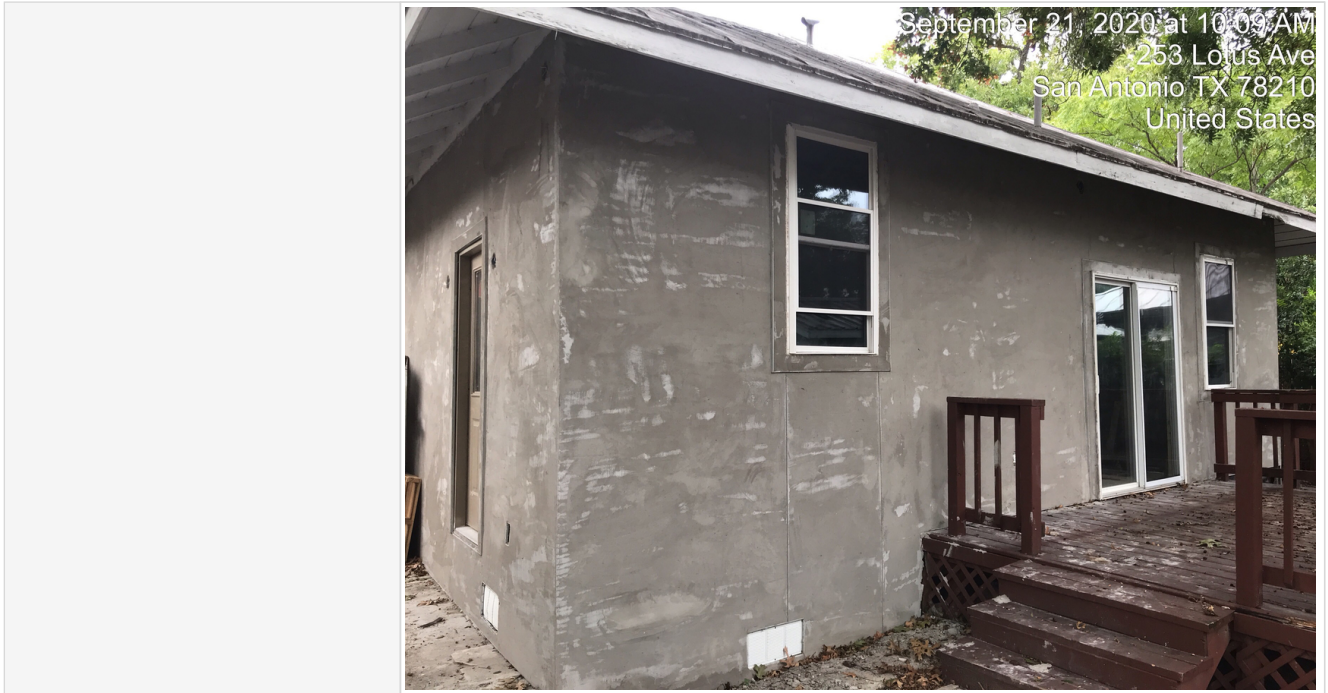
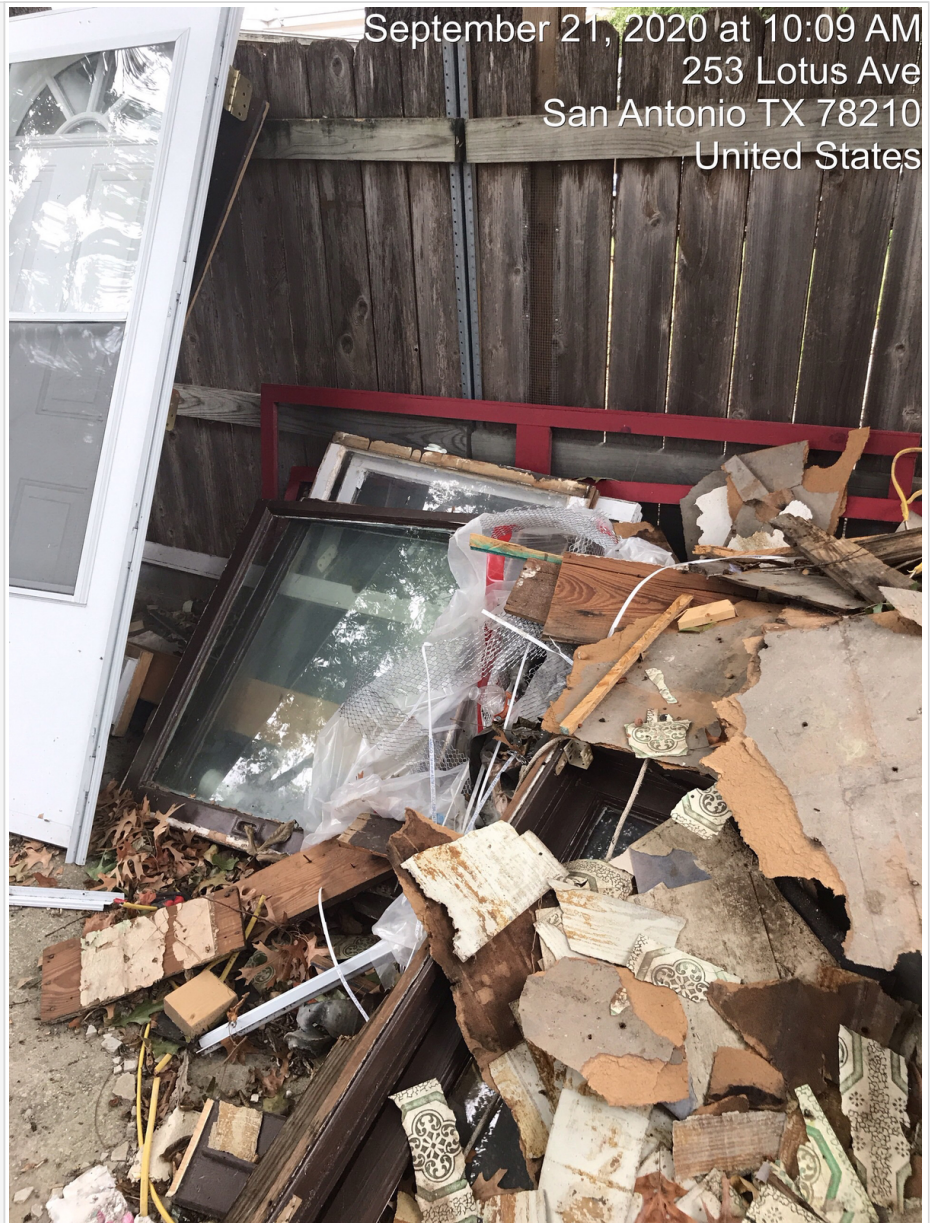
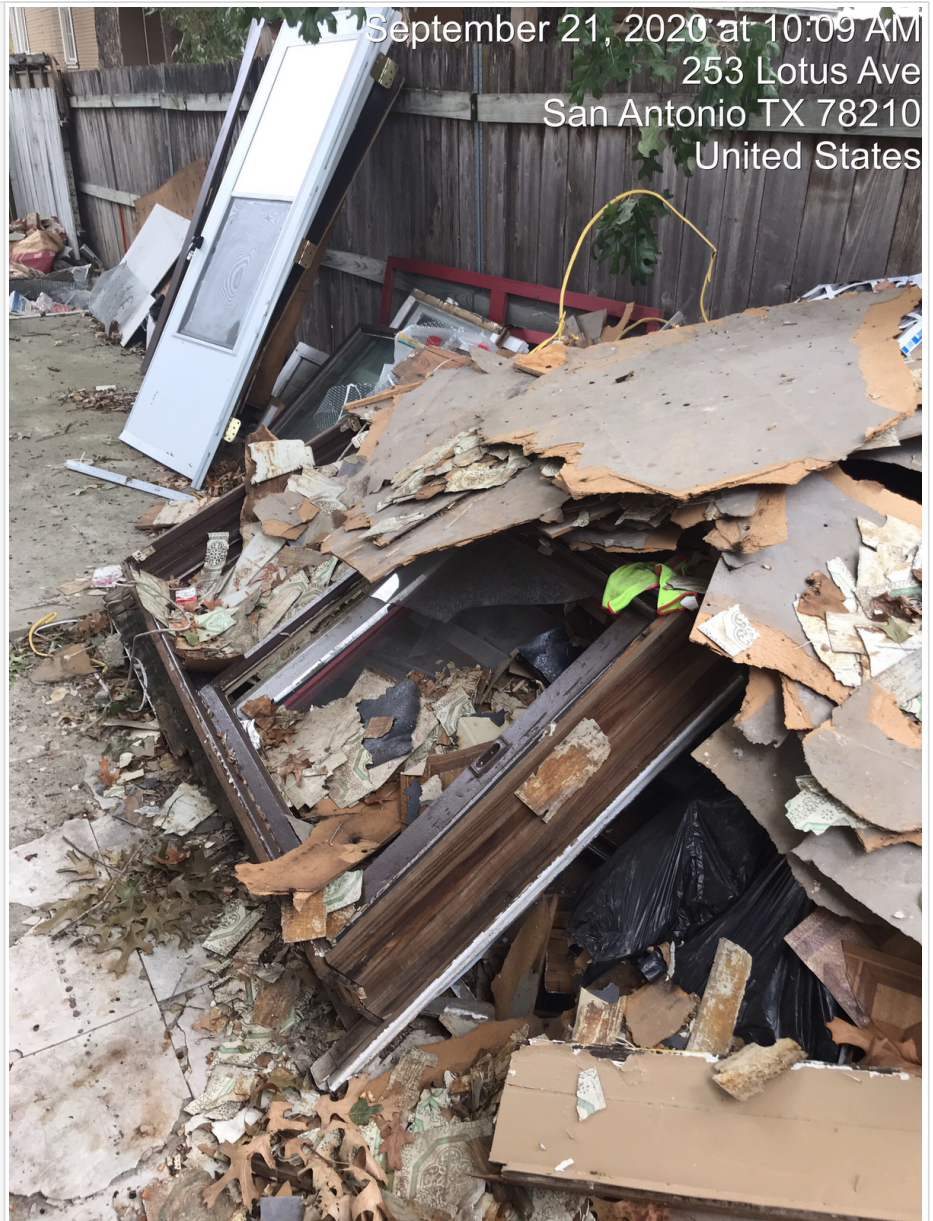
Date	09/21/2020
Time	10:11 AM (-5 GMT)
Context	internal report
Present Staff	Huy Pham, Edward Hall
Present Individuals	None
Types of Work Observed	Exterior Maintenance and Alterations
Amount of Work Completed	75%
Description of work	Installation of stucco over wood siding, replacement of wood windows with vinyl windows, exterior modifications, fenestration modifications.

☒ Code 35-451(a): Work without Certificate of Appropriateness (COA): **INSTALLATION OF STUCCO OVER WOOD SIDING, WINDOW REPLACEMENT, EXTERIOR + PENETRATION MODIFICATIONS**

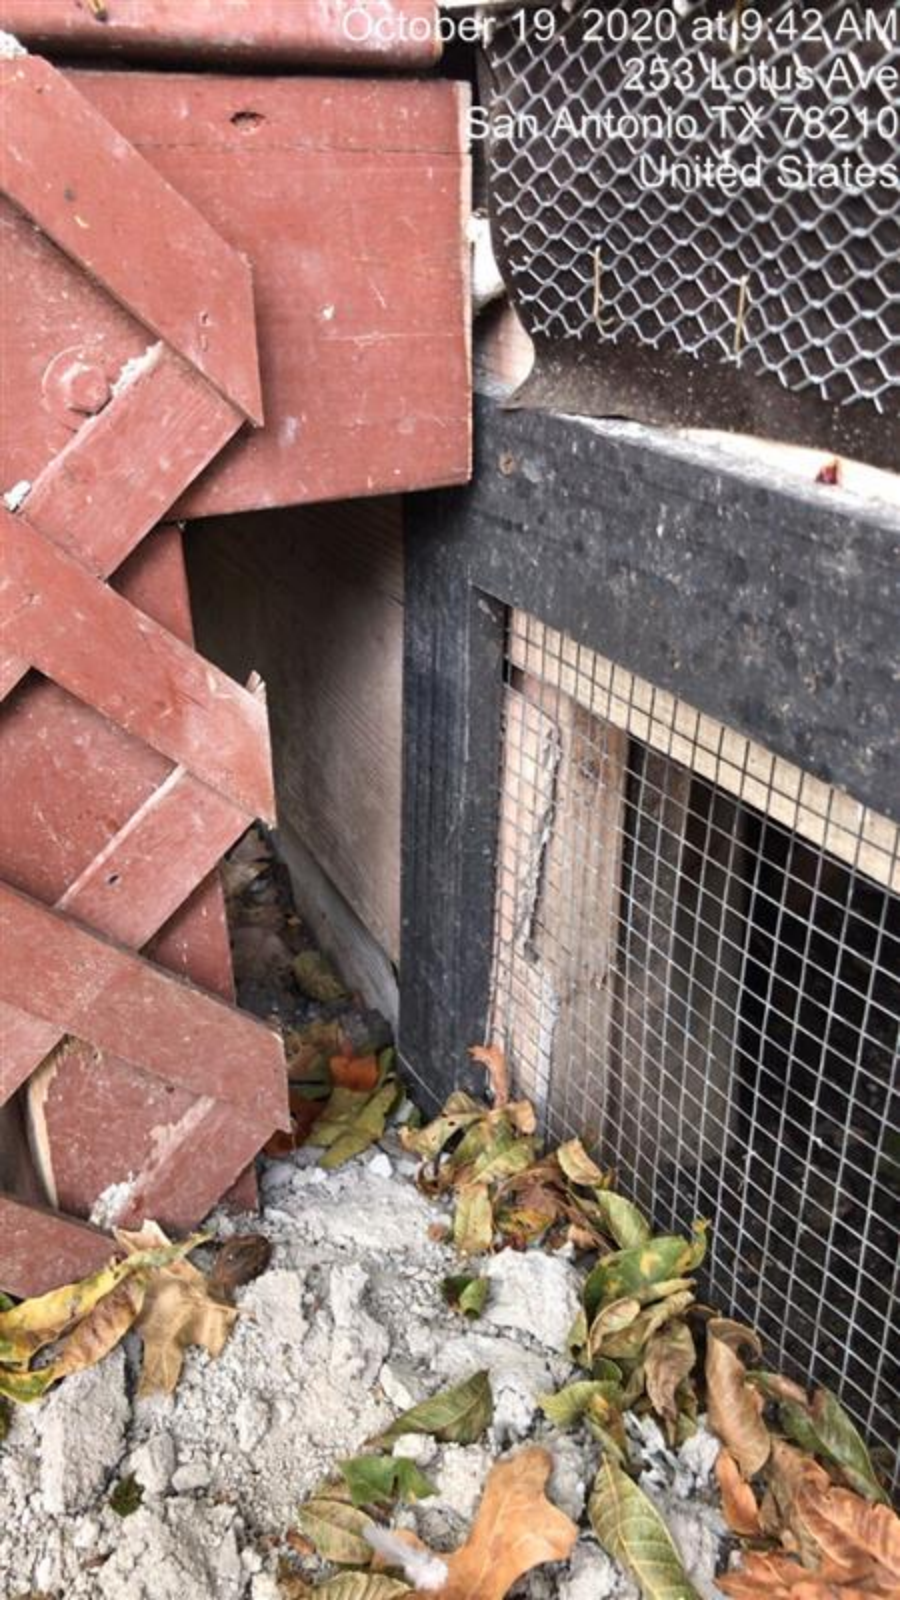
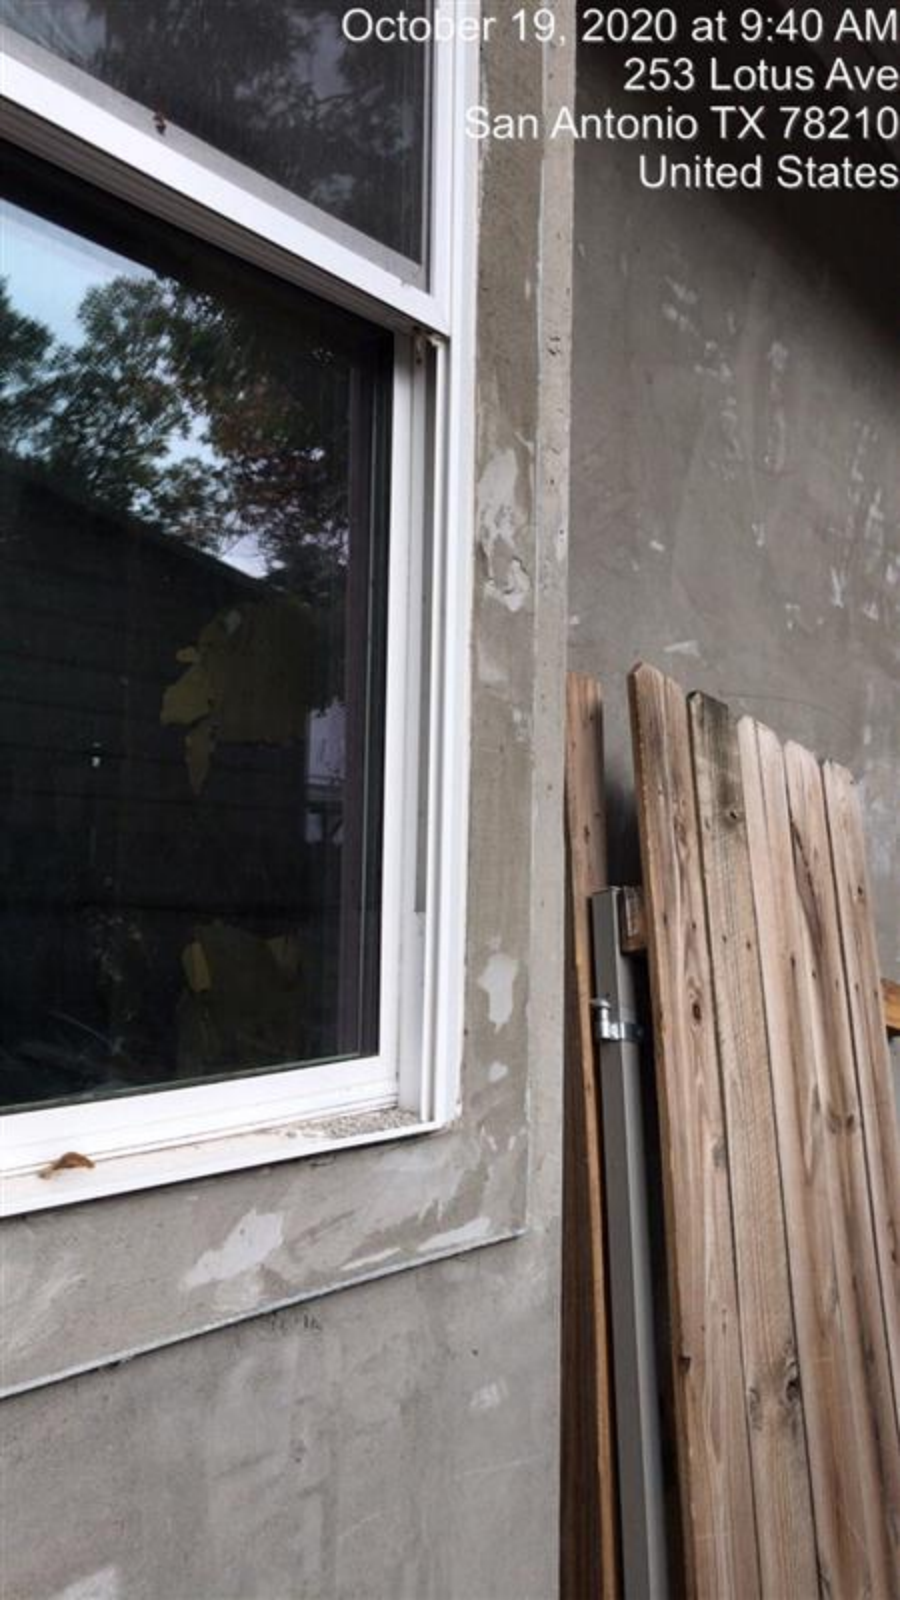
- f. SITE VISIT – On site visit on October 19, 2020, staff met with the applicant to investigate the method of stucco application and the condition of the siding beneath it. Staff found that building wrap and metal lath was nailed to the wood siding then stucco was applied over the lath instead of directly onto the siding. Staff then advised the applicant that the siding appears salvageable and that the applicant may investigate further by removing portions of the stucco to document more of the siding condition underneath. One full wood window and screen was also found on site.

- iii. The proposed stucco should be reversed by removing the stucco and potentially replacing any permanently damaged wood siding in-kind. Per finding f, the siding appears salvageable and that the applicant may investigate further by removing portions of the stucco to document more of the siding condition underneath. No further siding replacement or alteration may be done until the remove of stucco is documented and submitted to staff.

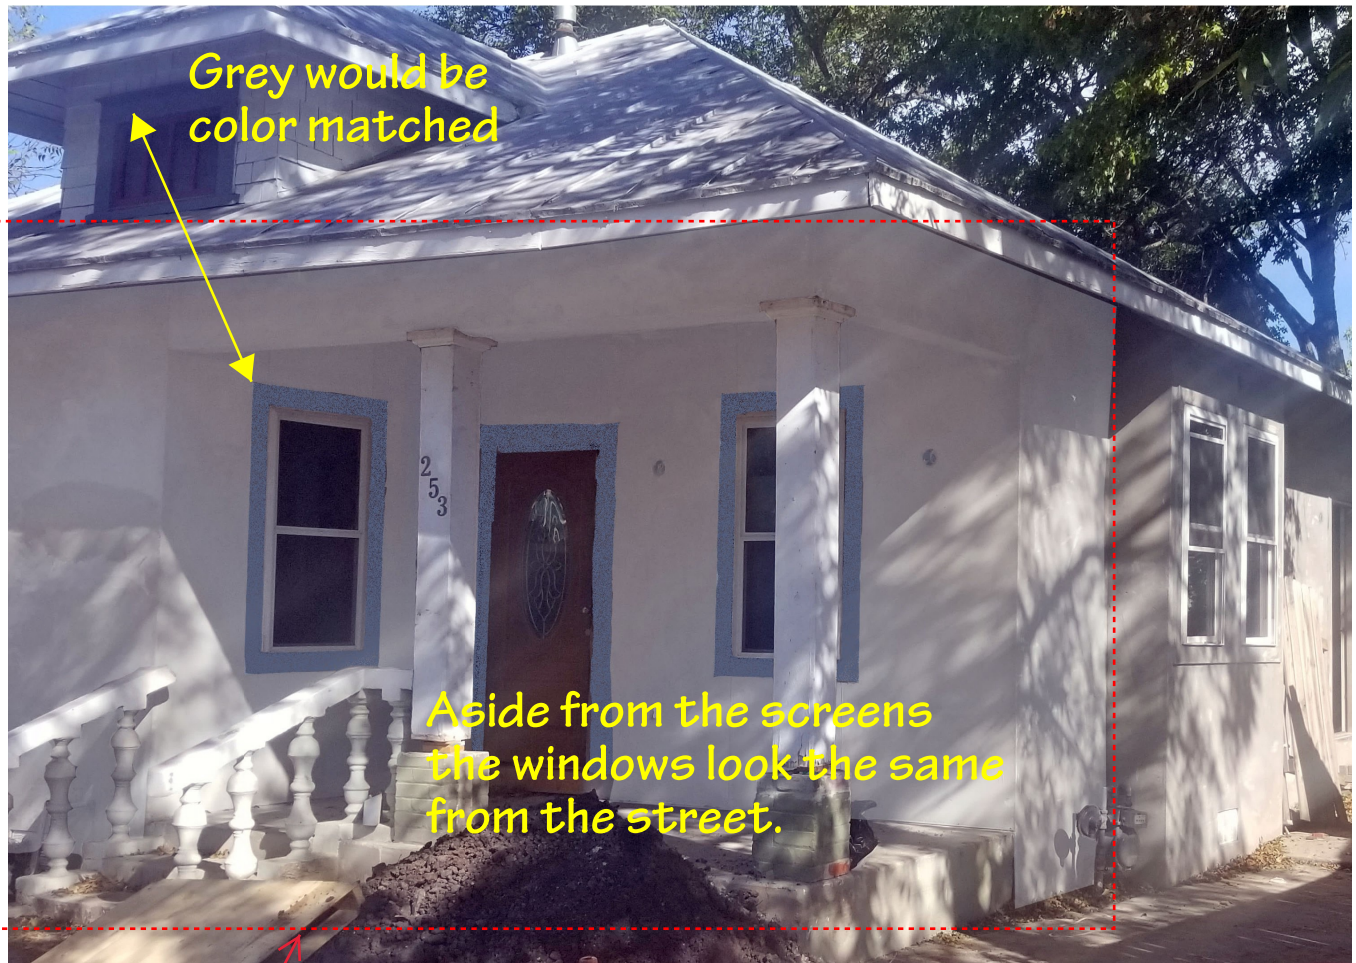
Grey would be  
color matched

Aside from the screens  
the windows look the same  
from the street.

Area inside of red box has been  
digitally colored

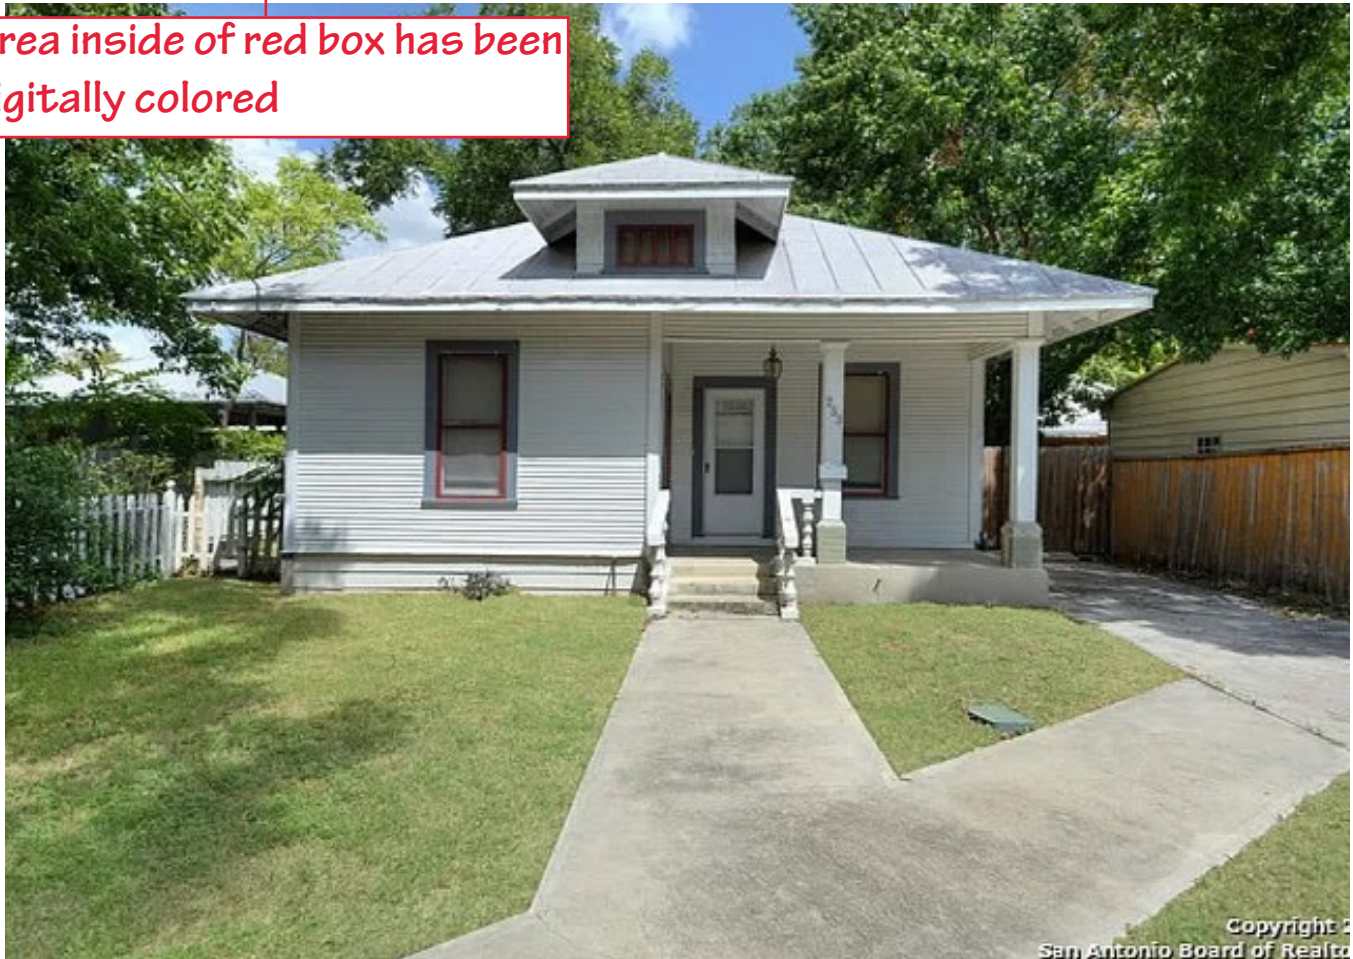
As home looks today.
