HISTORIC AND DESIGN REVIEW COMMISSION

January 20, 2021

HDRC CASE NO: 2020-559
ADDRESS: 533 E CARSON
LEGAL DESCRIPTION: NCB 993 BLK 3 LOT S 96.91 FT 7 (ARB 7C)
ZONING: MF-33, H
CITY COUNCIL DIST.: 2
DISTRICT: Government Hill Historic District
APPLICANT: Mary Vargas/VARGAS MARY JOSEPHINE
OWNER: Mary Vargas/VARGAS MARY JOSEPHINE
TYPE OF WORK: Window replacement and fenestration modifications
APPLICATION RECEIVED: December 14, 2020
60-DAY REVIEW: Not applicable due to City Council Emergency Orders
CASE MANAGER: Huy Pham

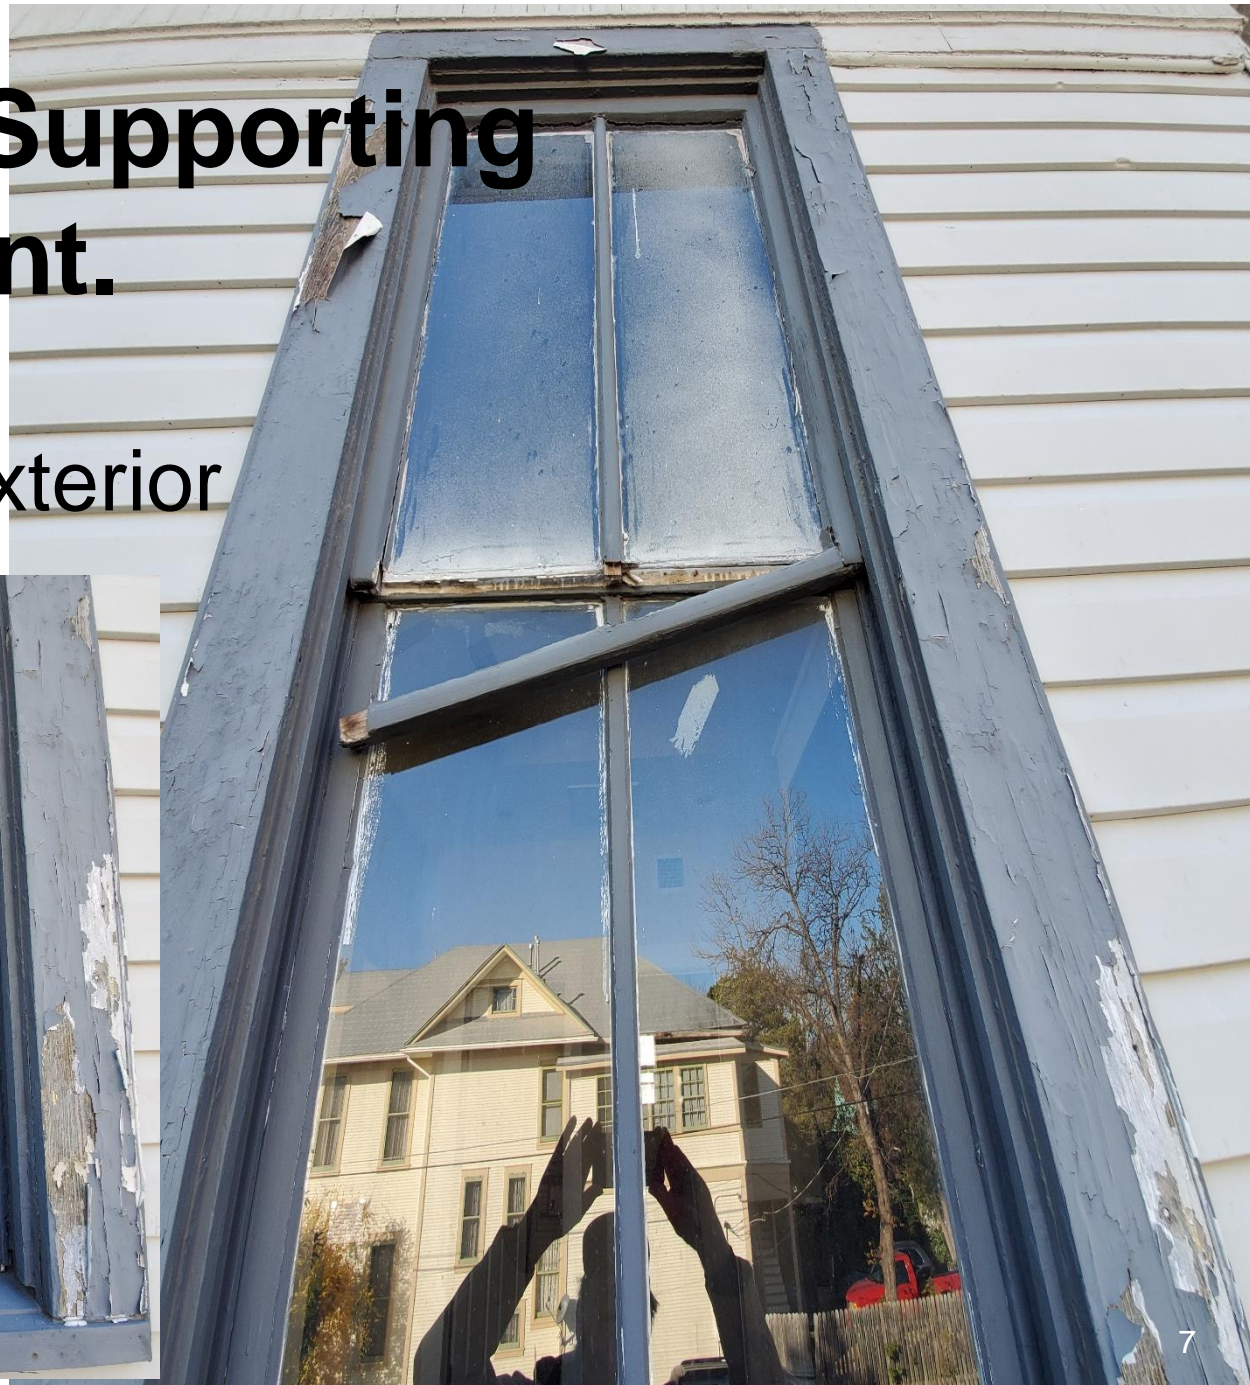
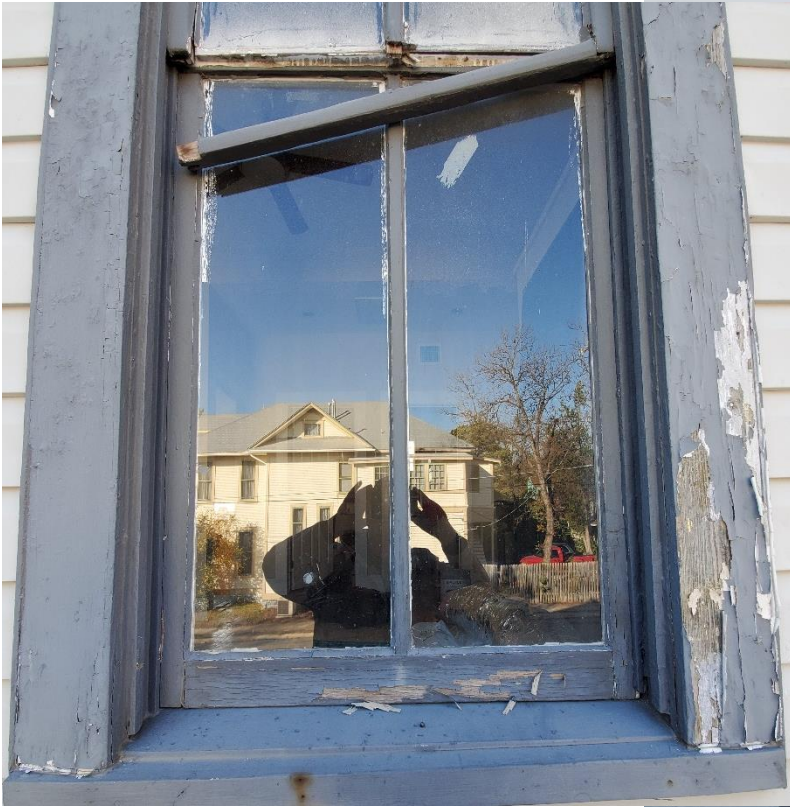
- Window M, Exterior

- a. Window M is not likely to be salvageable.
- b. Windows K and F could be salvaged as parts for the remaining windows that still require repairs: Windows H, I and J.
- c. Windows would be replaced with Pella Architectural Series windows.
 - They are approved by the Office of Historic Preservation.
 - They have the same look and size as the original historic windows.
 - They are single hung, 3'x7' wood windows that are primed with insulated low-e glass.
- d. Windows K and F are West facing and do not face the street.
- e. Benefits of Pella Architectural Series Windows.
 - Maintains the historic look of the original windows
 - Addresses lead remediation
 - Energy efficient
 - Cost impact

Staff does not recommend approval of item 1. window replacement M, F, K based on finding b. Staff finds that individual repair and potential reconstruction of individual sashes should be considered prior to wholesale window replacement. If replacement is approved by the commission, staff finds that the submitted Pella Architectural Series windows is generally consistent with *Standard Specifications for Original Wood Window Replacement*.

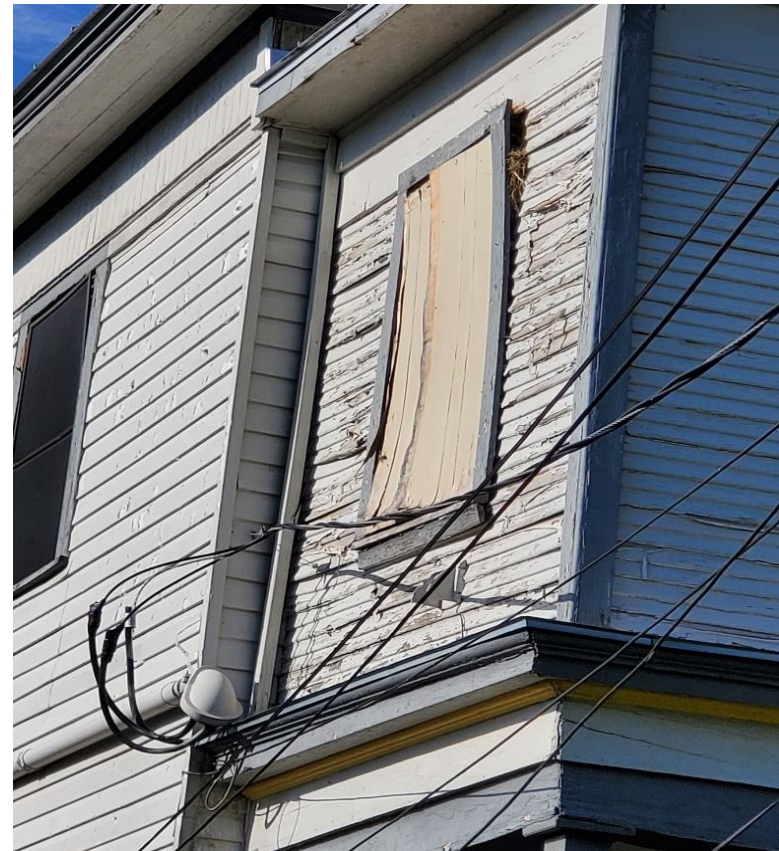
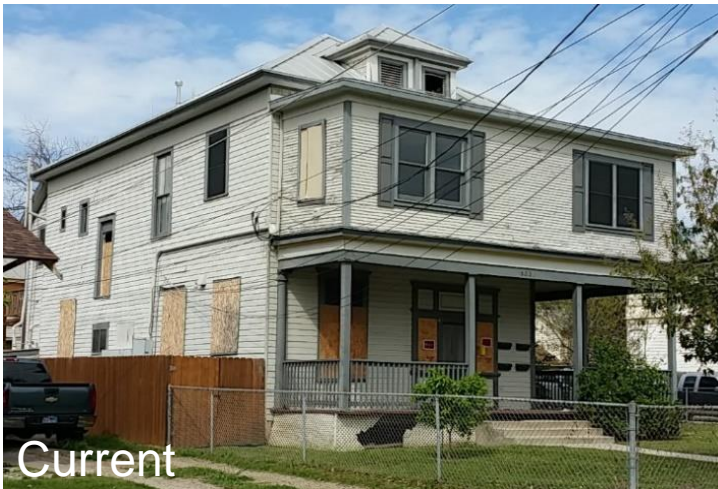
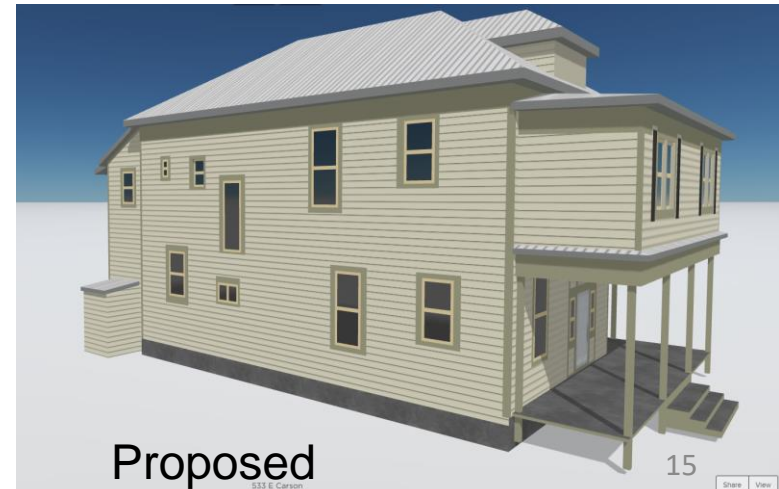
Request 3. Supporting Information

- d. **NON-ORIGINAL WINDOW REMOVAL** – The applicant has proposed to remove the non-original, west side-facing window on the second floor of the enclosed front balcony and infill with matching wood siding. Per the Guidelines for Exterior Maintenance and Alterations 7.B.i., applicants should refrain from enclosing front porches. Approved screen panels should be simple in design as to not change the character of the structure or the historic fabric. Staff finds that that enclosing the existing window opening with a shutter configuration or interior

3. Remove west side non-historic window located in the enclosed balcony porch and replace with waterfall siding.
 - a. Violation of City Electrical Codes.
 - b. Window is located within 18 inches of high voltage electric lines.
 - c. Safety issues for workers performing regular maintenance.

Staff does not recommends approval of item 3 based on finding d. Staff recommends enclosing the existing window opening with a shutter configuration or interior treatment while keeping the window opening in-place will maintain the visual appearance of a balcony and would be more appropriate than furthering the non-conforming condition of a front porch enclosure.
