HISTORIC AND DESIGN REVIEW COMMISSION

February 17, 2021

HDRC CASE NO: 2021-047
ADDRESS: 2211 N ST MARYS ST
LEGAL DESCRIPTION: NCB 1735 BLK 14 LOT 15
ZONING: C-3NA, H
CITY COUNCIL DIST.: 1
DISTRICT: Tobin Hill Historic District
APPLICANT: Jason Balderas/S.A.C.S
OWNER: GARZA YOLANDA BEATRICE &
TYPE OF WORK: Front yard fencing
APPLICATION RECEIVED: January 22, 2021
60-DAY REVIEW: Not applicable due to City Council Emergency Orders
CASE MANAGER: Huy Pham
REQUEST:

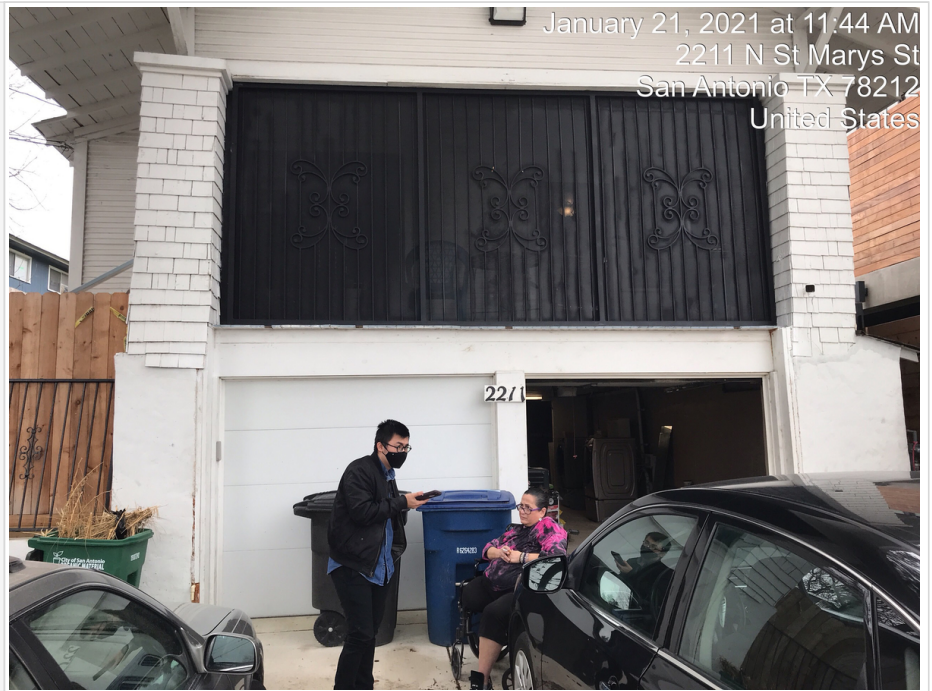
Photographs

| Description of work | Front porch has been fully enclosed with wrought iron screens. Metal fences posts have been installed but not completed. |

Staff does not recommend approval of item 2. porch enclosure based on finding d. The porch railing should be restored and the screens should be removed.
