## HISTORIC AND DESIGN REVIEW COMMISSION

March 3, 2021

**HDRC CASE NO:** 2021-047  
**ADDRESS:** 2211 N ST MARYS ST  
**LEGAL DESCRIPTION:** NCB 1735 BLK 14 LOT 15  
**ZONING:** C-3NA, H  
**CITY COUNCIL DIST.:** 1  
**DISTRICT:** Tobin Hill Historic District  
**APPLICANT:** Jason Balderas/S.A.C.S  
**OWNER:** GARZA YOLANDA BEATRICE &  
**TYPE OF WORK:** Front yard fencing  
**APPLICATION RECEIVED:** January 22, 2021  
**60-DAY REVIEW:** Not applicable due to City Council Emergency Orders  
**CASE MANAGER:** Huy Pham  
**REQUEST:**

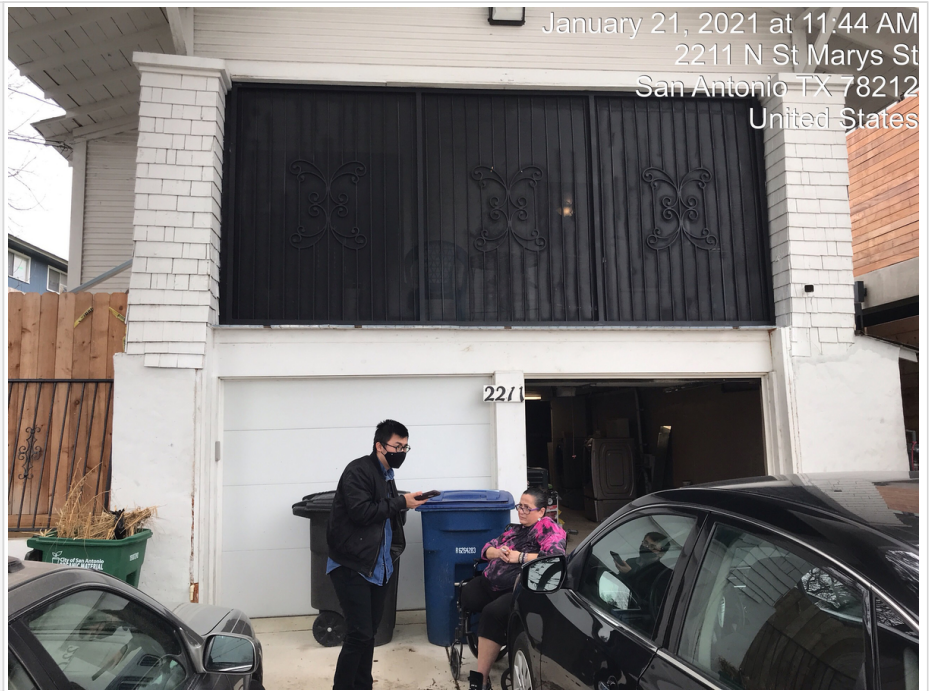
Date	01/21/2021
Time	11:48 AM (-6 GMT)
Context	citizen report
Present Staff	Huy Pham, Edward Hall
Present Individuals	Homeowner, Family/Tenant
Types of Work Observed	Site Elements, Exterior Maintenance and Alterations
Amount of Work Completed	75%
Description of work	Front porch has been fully enclosed with wrought iron screens. Metal fences posts have been installed but not completed.
Description of interaction	Staff spoke to owner/tenant who called the contractor to speak. Staff advise the property owner to obtain historic approvals and permits for the cited work. The contractor committed to compliance.
