HISTORIC AND DESIGN REVIEW COMMISSION

June 16, 2021

HDRC CASE NO: 2021-264
ADDRESS: 922 E CROCKETT ST
LEGAL DESCRIPTION: NCB 583 BLK 8 LOT 3 & E 3.71 FT OF 4
ZONING: RM-4, H
CITY COUNCIL DIST.: 2
DISTRICT: Dignowity Hill Historic District
APPLICANT: Ligaya Thompson
OWNER: THOMPSON LEE CAPITAL LLC
TYPE OF WORK: Window replacement
APPLICATION RECEIVED: May 26, 2021
60-DAY REVIEW: Not applicable due to City Council Emergency Orders
CASE MANAGER: Edward Hall

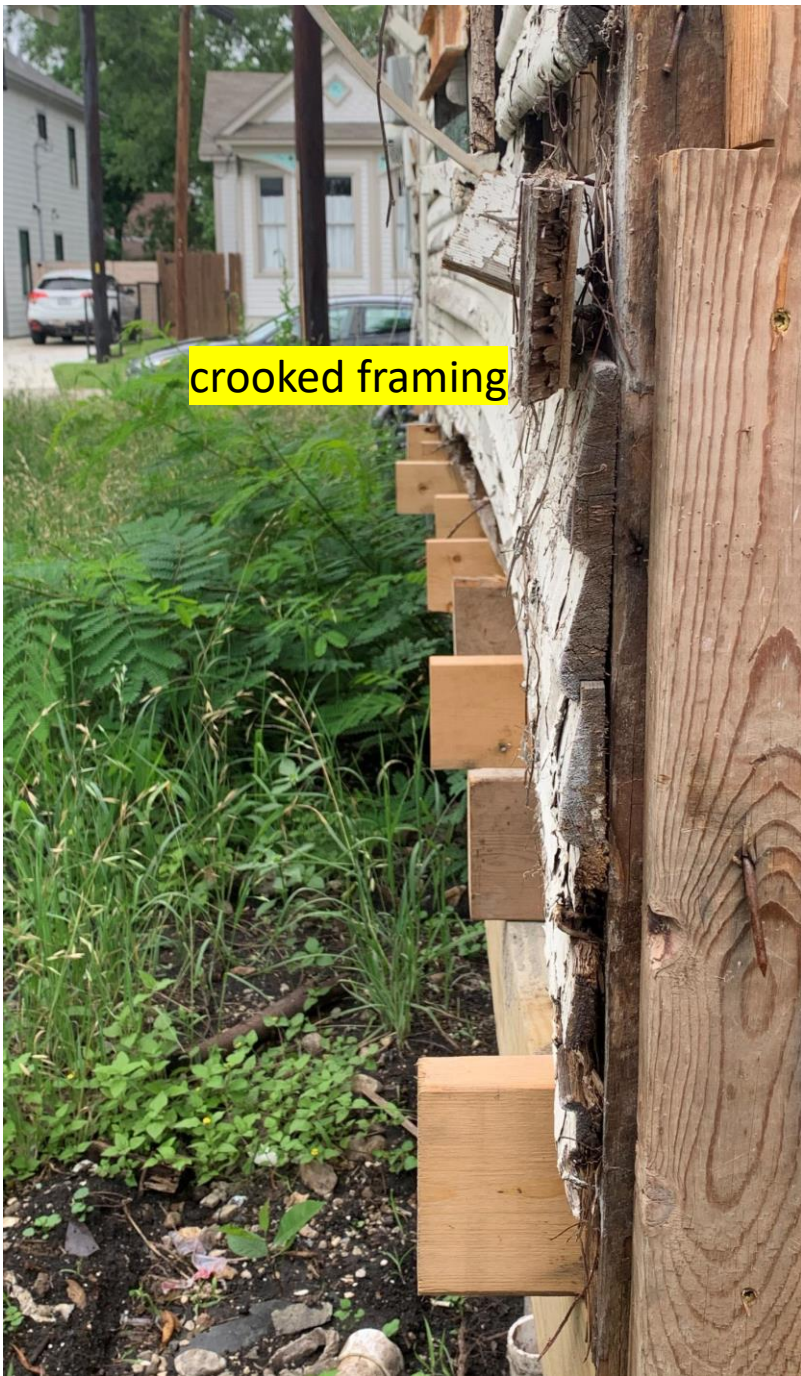
As we began to replace the siding and begin working on the addition our findings are:
Framing is uneven and the home is not properly supported to the rear.
This has caused the home to shift and misaligned the entire house.

crooked framing

In order for us to continue restoring the home back to livable condition, the house will need to be braced to prevent the home from collapsing entirely as siding and framing is completed.

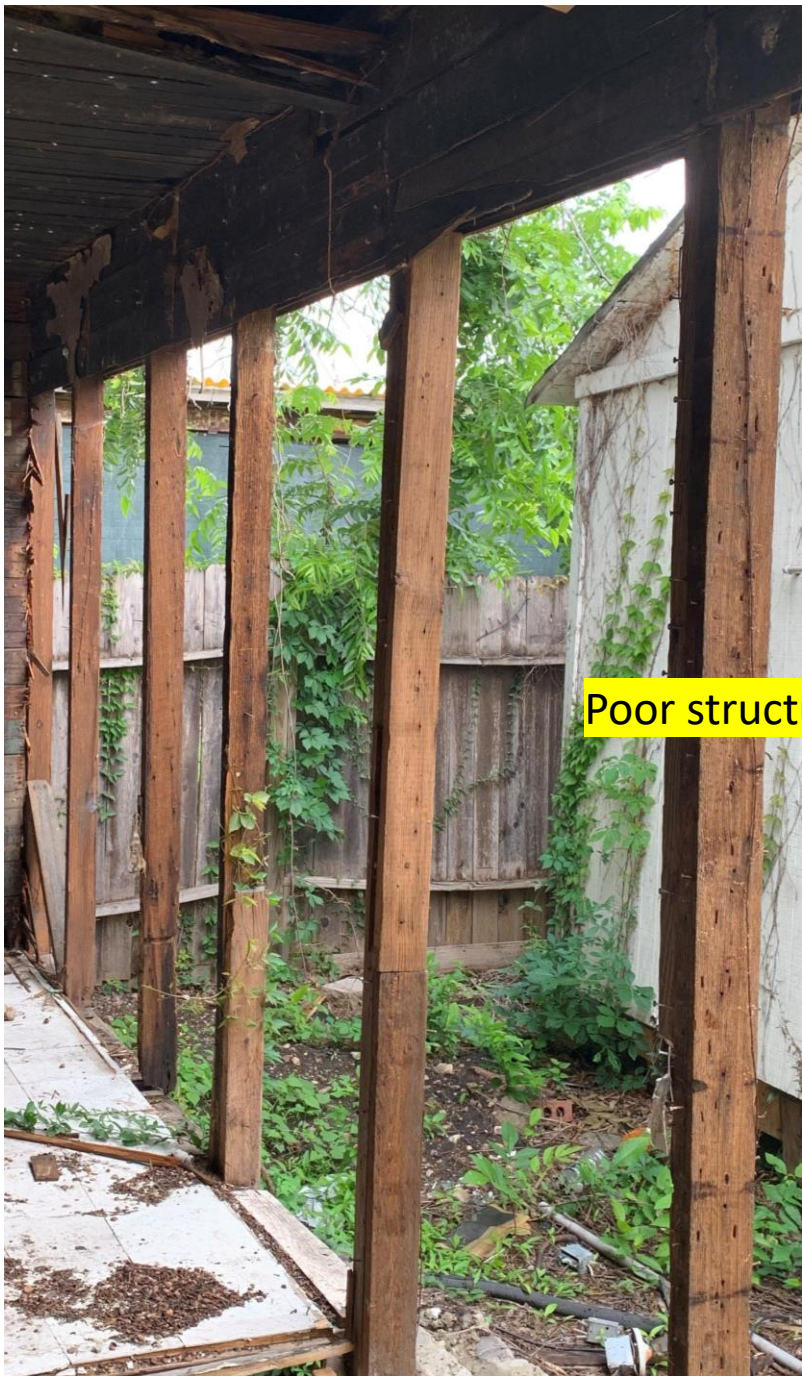
Poor structural support

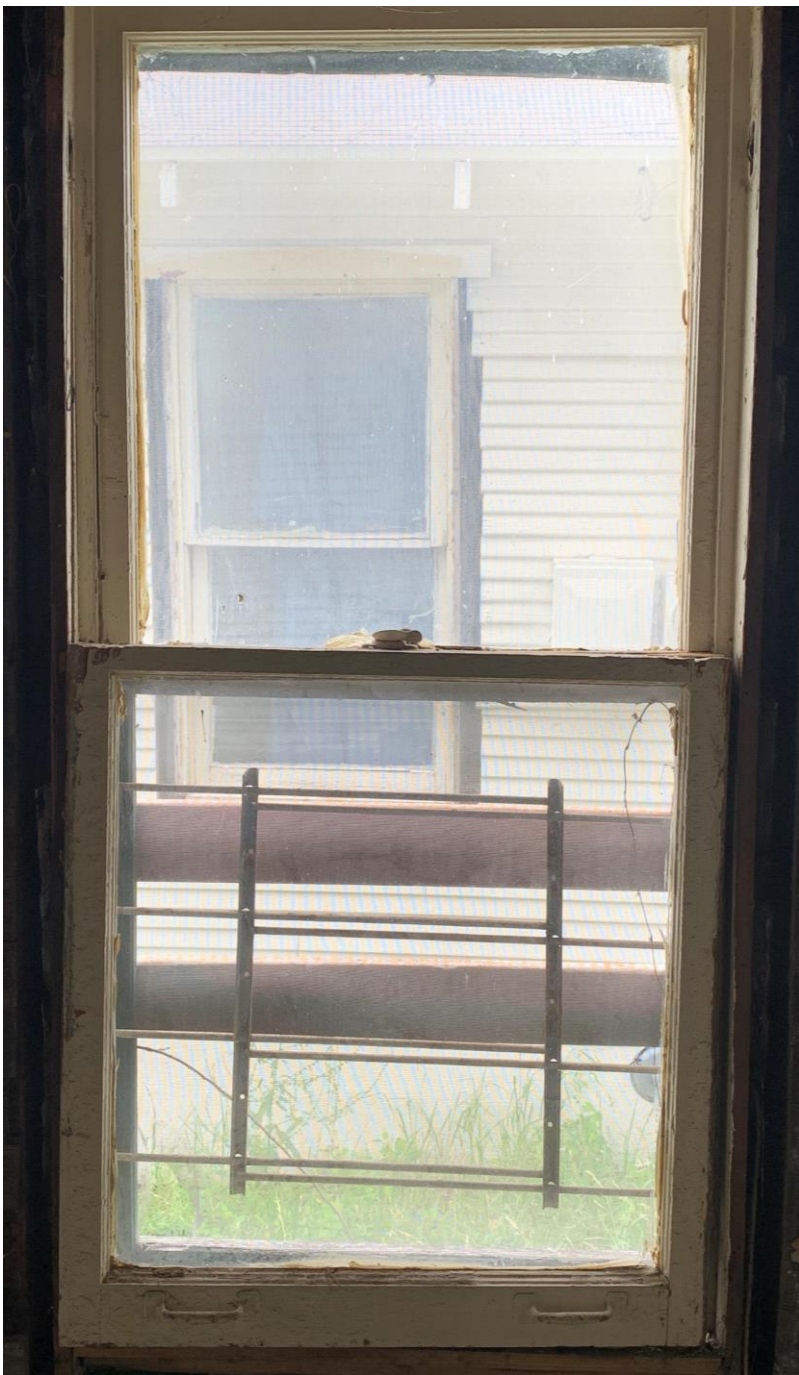
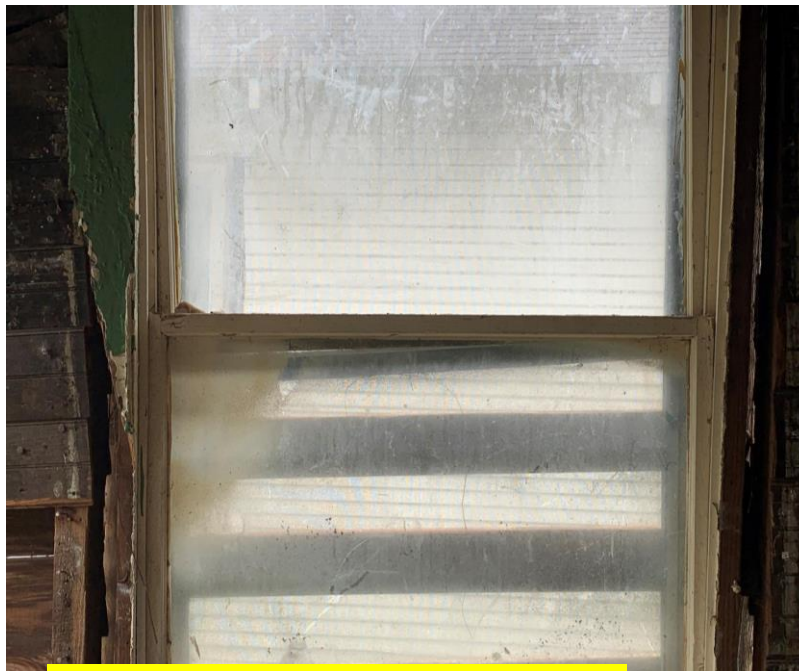
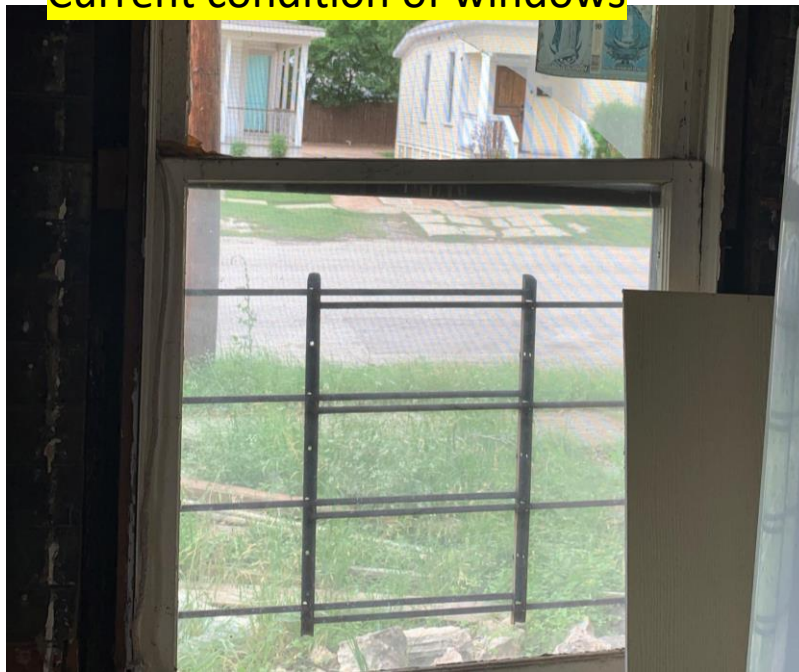
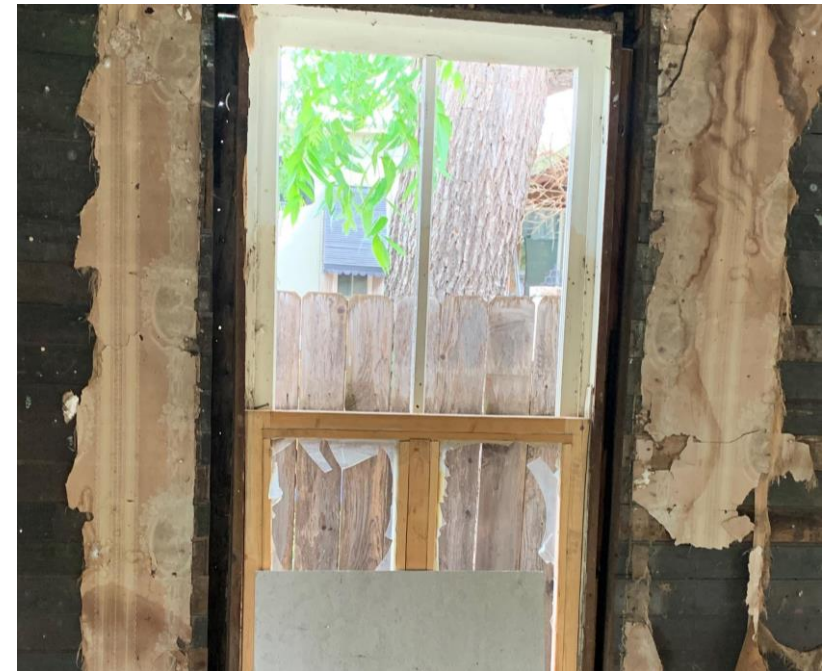
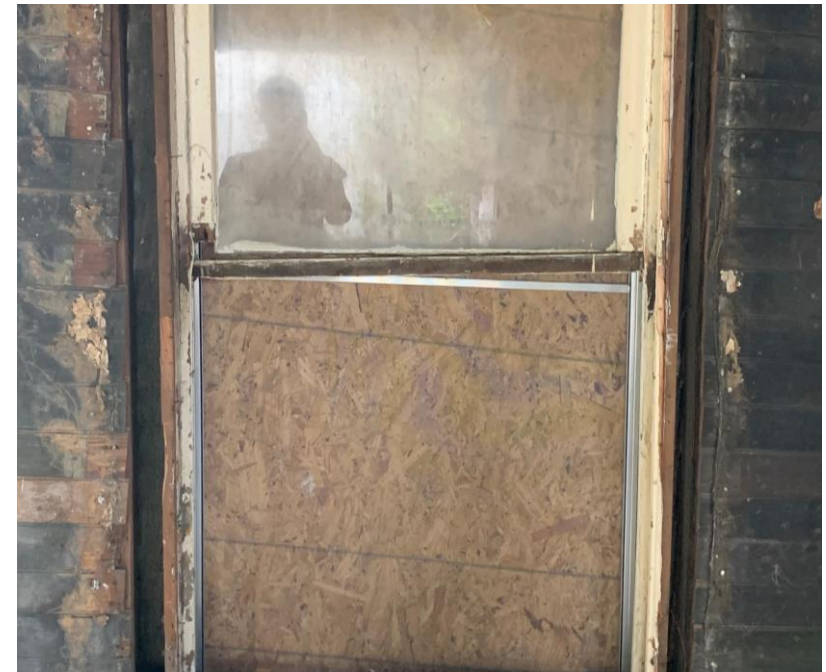
- c. WINDOW REPLACEMENT – The applicant has proposed to replace seven (7) wood windows. OHP staff performed a site visit on June 3, 2021, and found five of the seven wood windows to be in a repairable state. One existing window featured non-original sashes and the other was missing a bottom sash and had significantly deteriorated. Both of these windows are located in room 1 on the plan.

Current condition of windows

- 1. Staff recommends approval of item #1, the removal of the existing siding to provide structural and framing repairs to the historic structure with the stipulation that all framing be done in-kind, that window openings are fully documented and remain in their exact location, and that existing, original siding be repaired and re-installed.
- 2. Staff does not recommend approval of item #2, window replacement. Staff recommends repair of the existing windows with in-kind replacement of only two windows, both located in room 1, noted on the floor plan.

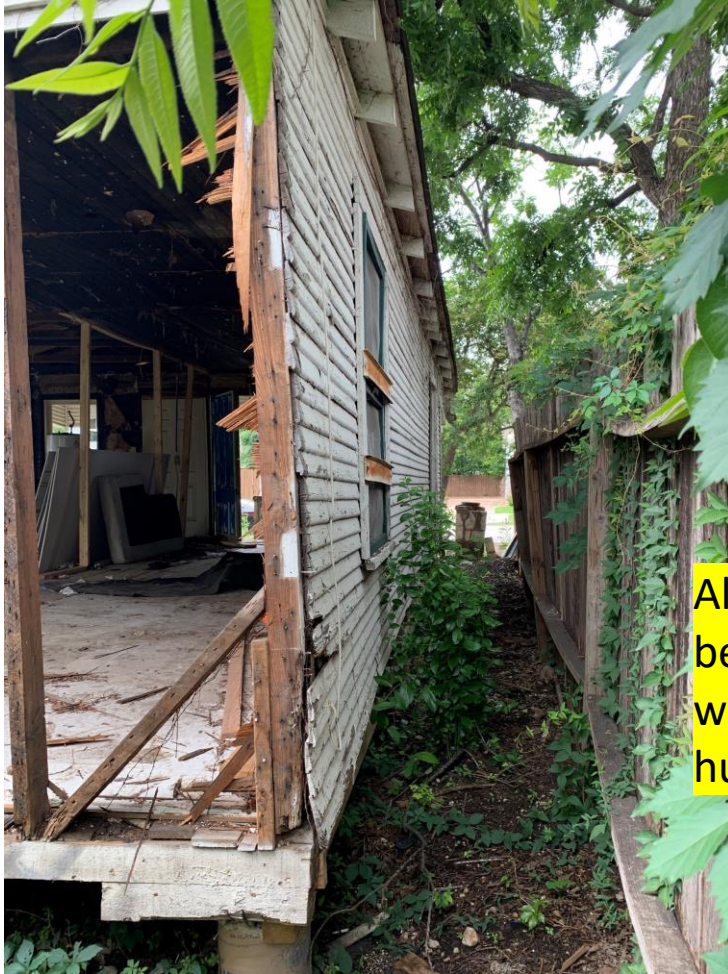
Window Replacement Schedule

All windows to
be replaced
with 3x5 single
hung aluminum
