HISTORIC AND DESIGN REVIEW COMMISSION

HDRC CASE NO: 2021-198

ADDRESS: 324 GARFIELD ST

TYPE OF WORK: Demolition of primary structure with new construction of a 3-story

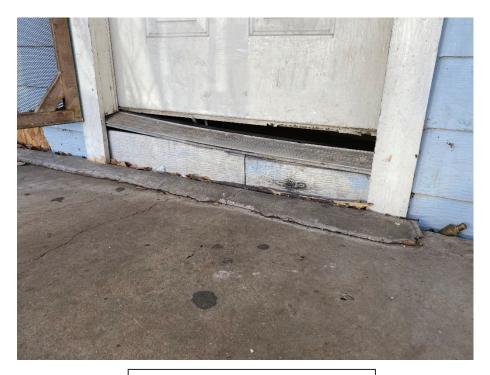
Entry door with gap due to failing structure

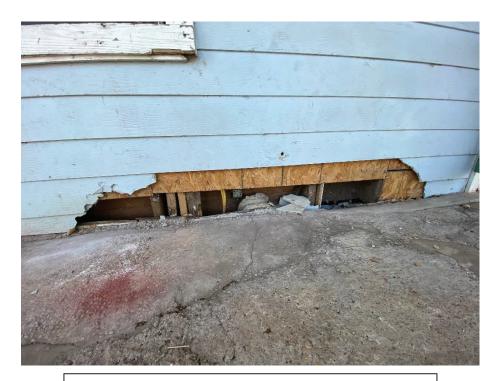
- Perimeter walls appear to be sitting directly upon the soil and are deteriorated
 - o Around most of the perimeter of the structure, the exterior grade is in direct contact with the main structural framing elements of the building. Over time, this condition leads to deterioration and, if left long enough a complete loss of the member itself. One area this is very apparent is at the front of the house where the bottom sill plate of the exterior wall is no longer there, refer to the attached photograph of this area. Signs of termite damage was also observed at many of these areas exposed.

Gap in front wall with missing sill plate and termite damage on studs

The structural integrity issues mentioned above are just a few of the ones observed. To be able to provide a safe structure to the client for use by the public that meets international residential code requirements, the original foundation below the existing deteriorated one would need to be removed completely meaning the existing structure would need to be moved from its current position, which I am not sure it would survive. Then if it did survive this move, the building would need to be stripped to its main structural skeleton to have all deteriorated, or missing members, removed and replaced.
