## HISTORIC AND DESIGN REVIEW COMMISSION

August 04, 2021

**HDRC CASE NO:** 2021-369  
**ADDRESS:** 1235 E CROCKETT ST  
**LEGAL DESCRIPTION:** NCB 1373 BLK 1 LOT S 89.45 FT OF 27 (AKA S 125 FT OF 27)  
**ZONING:** RM-4, H  
**CITY COUNCIL DIST.:** 2  
**DISTRICT:** Dignowity Hill Historic District  
**APPLICANT:** Samuel Tripp/TRIPP FLIP LLC  
**OWNER:** TRIPP FLIP LLC  
**TYPE OF WORK:** Amendments to a previously approved design regarding porch decking, columns and porch railing  
**APPLICATION RECEIVED:** July 24, 2021  
**60-DAY REVIEW:** Not applicable due to City Council Emergency Orders  
**CASE MANAGER:** Edward Hall

## Investigation Report

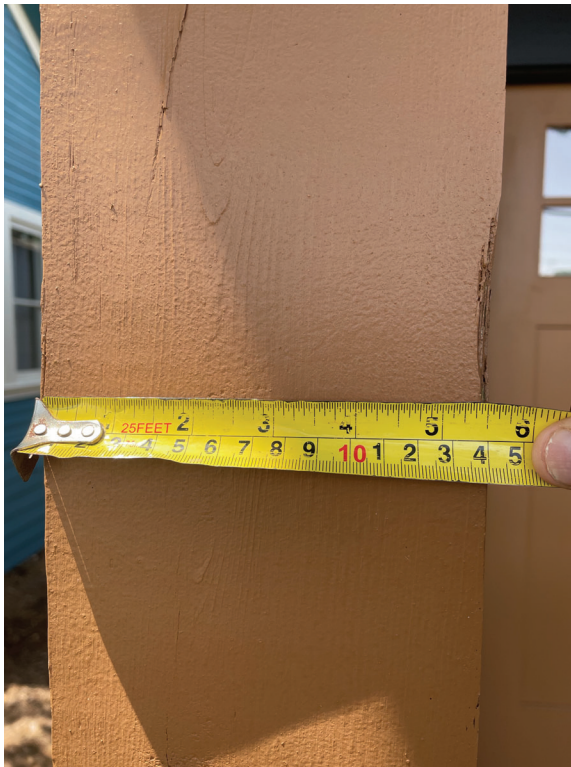
**1235 (new)**

\* The columns are six inches wide (correct facing the street), but only four inches thick. In fact, they're exactly the same as the preexisting 1231 columns (pictured in white), as is the trim atop the columns. While technically a violation, they do seem to align with the OHP porch policy guide which states: "Keep it simple... When photograph evidence is not available, design new porch elements to replicate features found on nearby historic houses with similar architectural styles." Since they match the preexisting columns next door (neither have capitol or base trim), we hope this justifies amending the original COA.

1. Staff does not recommend approval of item #1, porch columns, based on finding d. Staff recommends that the previously approved stipulation for columns be adhered to; the installation of columns that are 6 inches square that feature capital and base trim.
2. Staff recommends approval of item #2, the porch railing as installed, as the railing meets the spirit of staff’s standard and does not negatively impact the architectural integrity of the historic structure.
3. Staff does not recommend approval of item #3, 1x6 porch decking. Staff recommends that the previously approved stipulations be adhered to; 1x3 members installed perpendicular to the front façade.

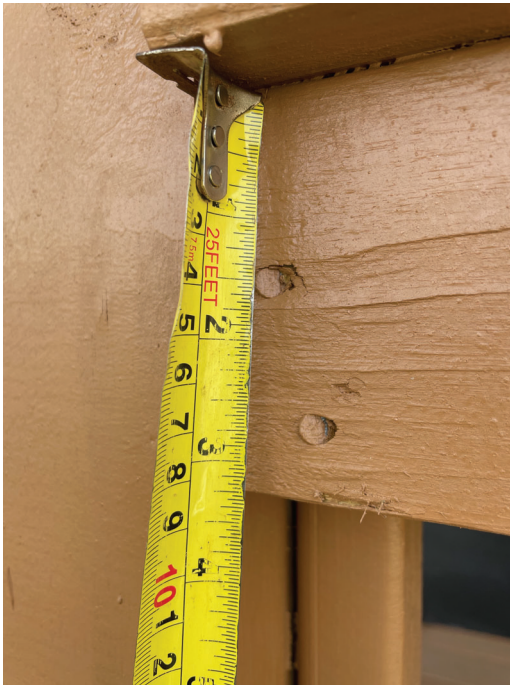
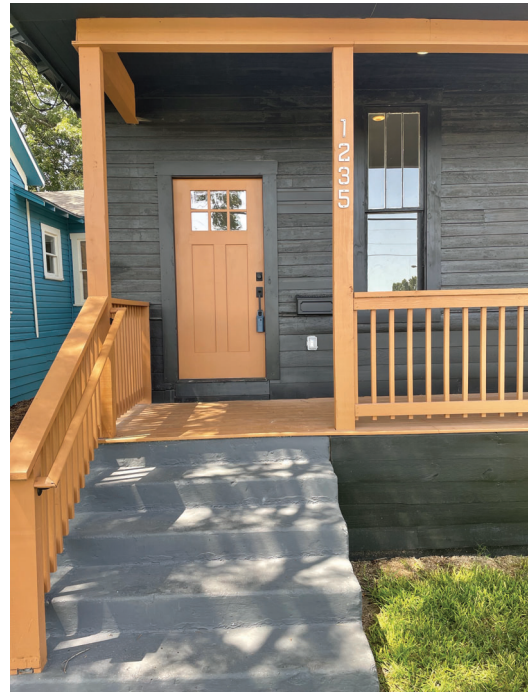
\* The top rail and square pickets are correct.

\* The rail trim piece is about 1.25 inches too long, but it does match the bottom rail and is placed correctly below the top rail.

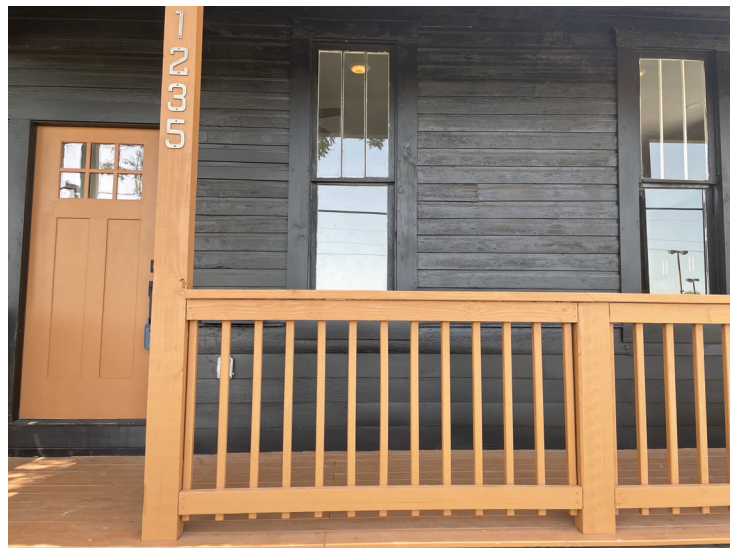
\* The bottom rail is not notched in, but it is the correct size, and looks identical from the street as the terms of the COA stipulate. We agree that there are minor inconsistencies, but we also feel that the overall product still executes the vision of the COA. It is on this basis that we hope it allows for an amendment to maintain the work as it currently stands.

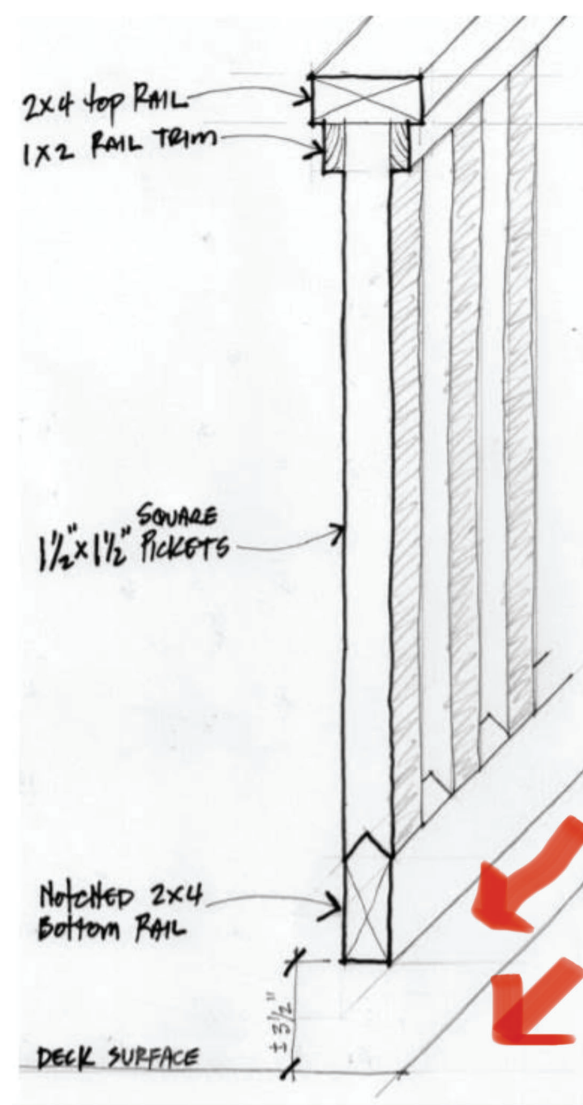
\* The decking was installed parallel to the front facade, due to a basic misunderstanding. It was not original to the home, so we were building it strictly from the COA stipulation sketch. My wife and I looked at the sketch (pictured below, edited in red for effect), as did our contractors, and nobody caught the error. I now understand the sketch as it was intended, but the bottom of the drawing shows an extra line which makes it seem like the decking is laid parallel to the facade, as we thought we complied with.

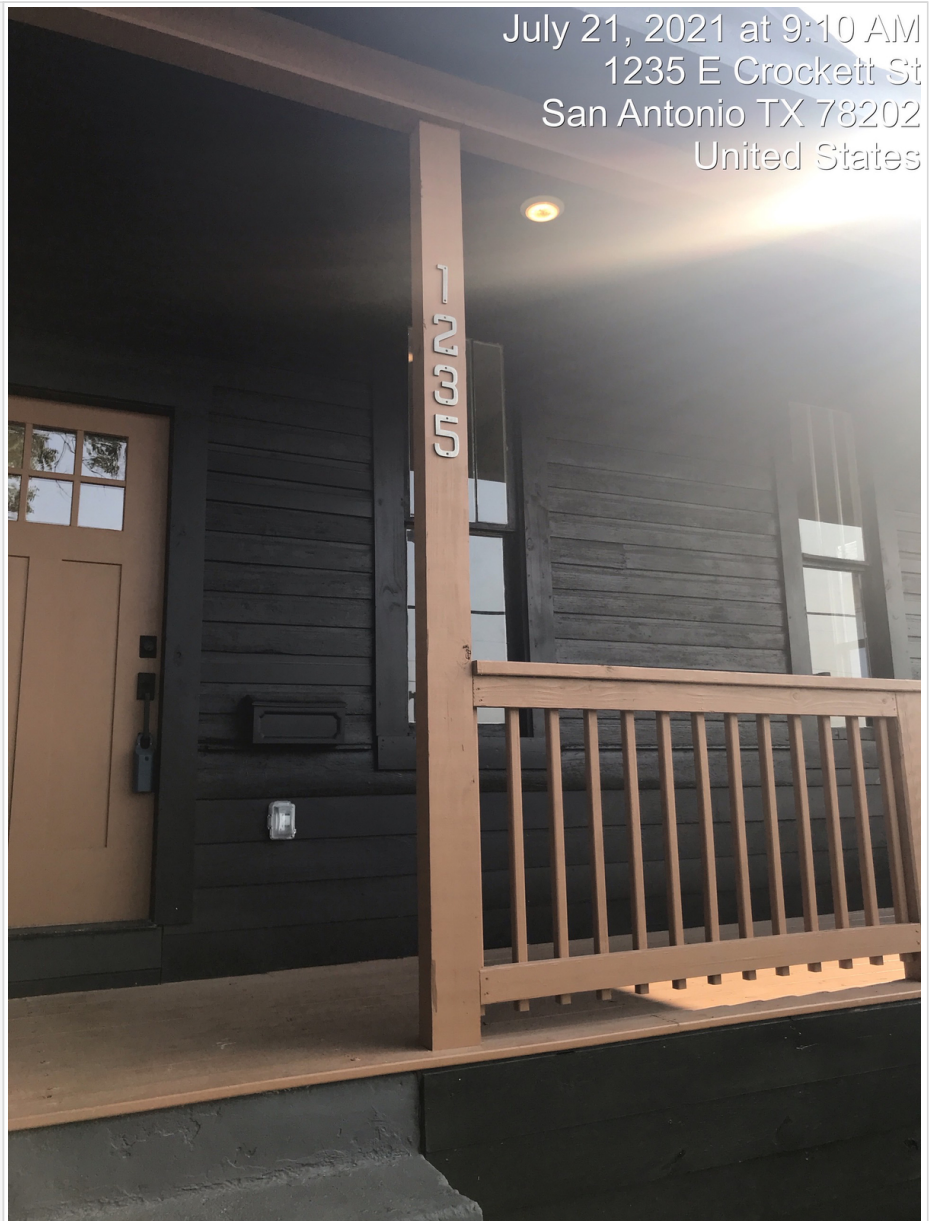
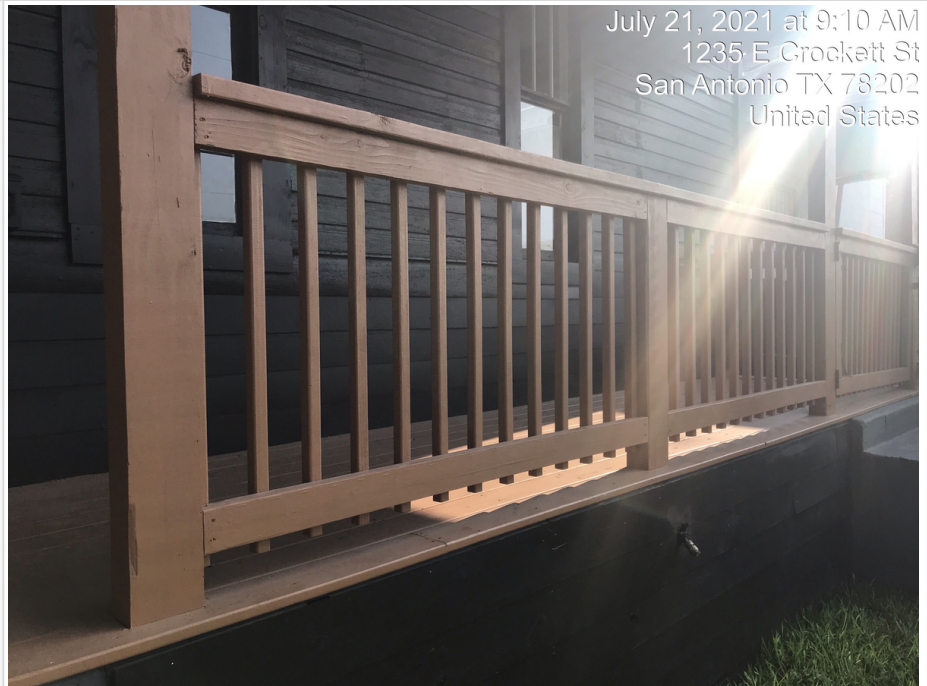
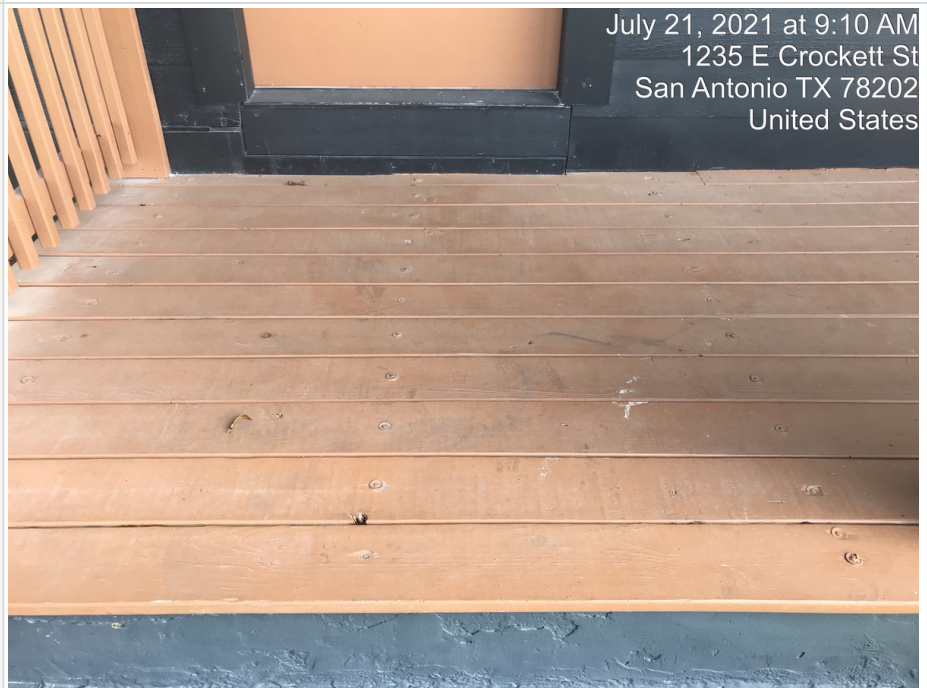
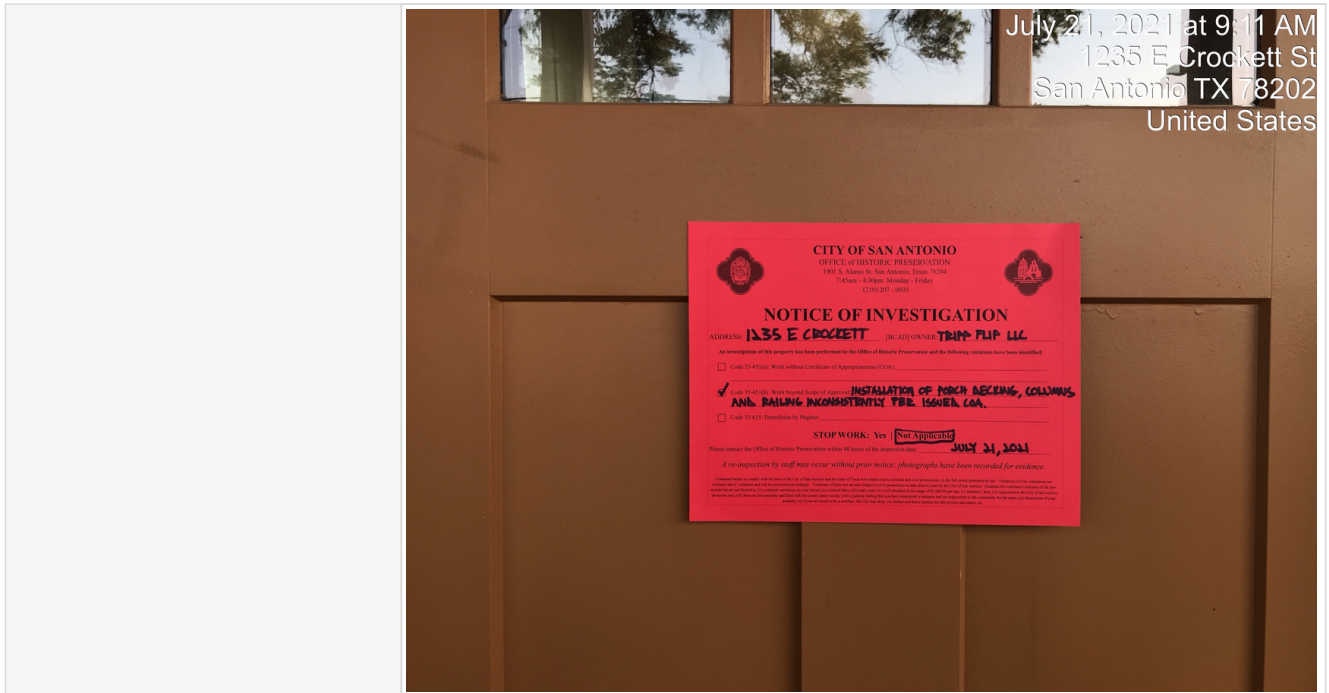
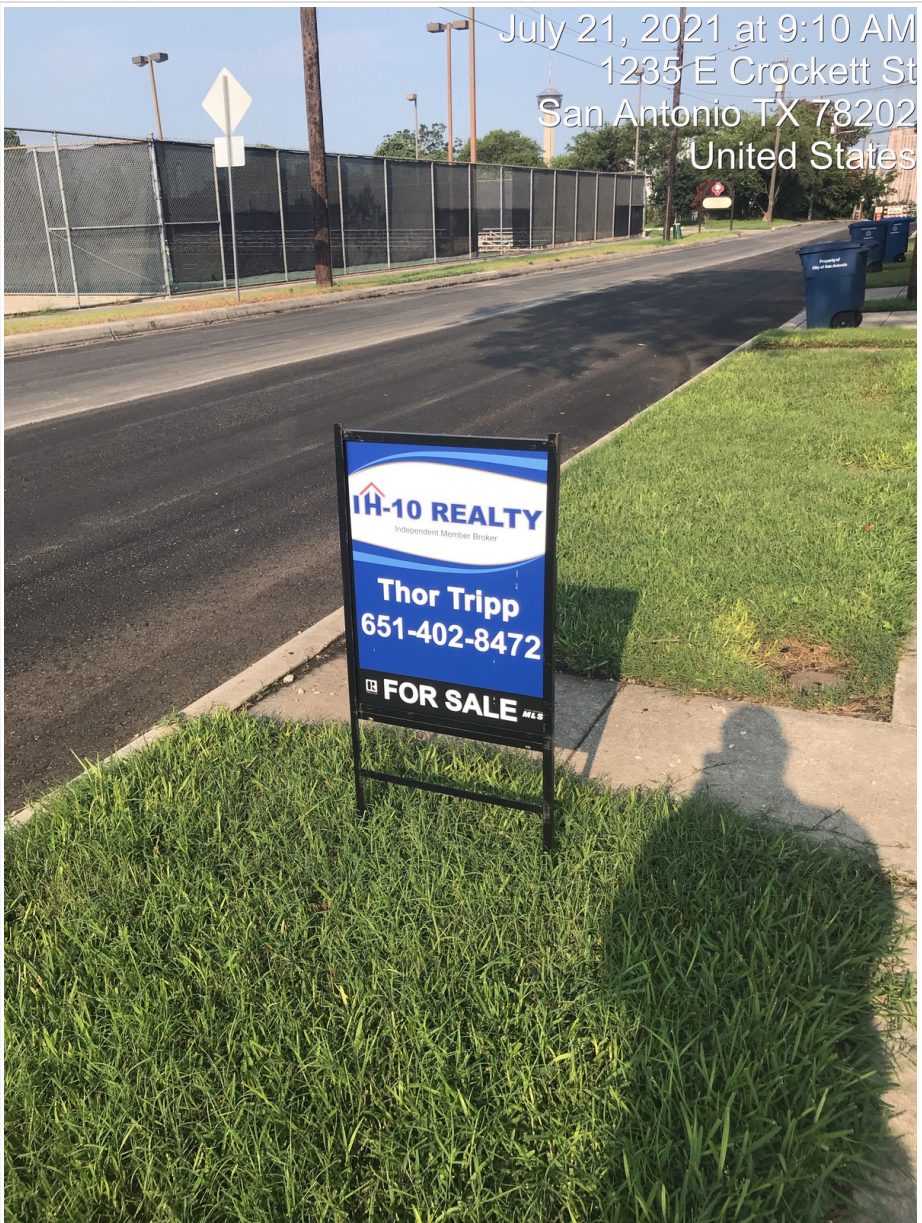
Photographs	  <p>July 21, 2021 at 9:10 AM 1235 E Crockett St San Antonio TX 78202 United States</p>
-------------	----------------------------------------------------------------------------------------------------------------------------------------------------------------------------------------

Date	07/21/2021
Time	09:13 AM (-5 GMT)
Context	citizen report
Present Staff	Edward Hall
Present Individuals	None
Contractor/Realtor Companies	Thor Tripp
Types of Work Observed	Exterior Maintenance and Alterations
Amount of Work Completed	Completed
Description of work	The installation of porch decking, porch columns and porch railing inconsistently per the issued COA.
