HISTORIC AND DESIGN REVIEW COMMISSION

HDRC CASE NO: 2018-587
ADDRESS: 601 N ST MARYS
LEGAL DESCRIPTION: NCB: 401 BLK: 1 LOT: S 50 FT OF E 100 FT OF 7
ZONING: D, H, RIO-3
CITY COUNCIL DIST.: 1
APPLICANT: Miguel Saldana/B&A Architects, Inc.
OWNER: Uri Villarreal, Craig Glendenning/UC210 LLC
TYPE OF WORK: Rehabilitation, egress additions, exterior modifications
APPLICATION RECEIVED: November 16, 2018
60-DAY REVIEW: January 15, 2019
REQUEST:

REAL ESTATE BUILDING REHABILITATION

Flats on St. Mary's, Inc.
Real Estate Bldg Rehab

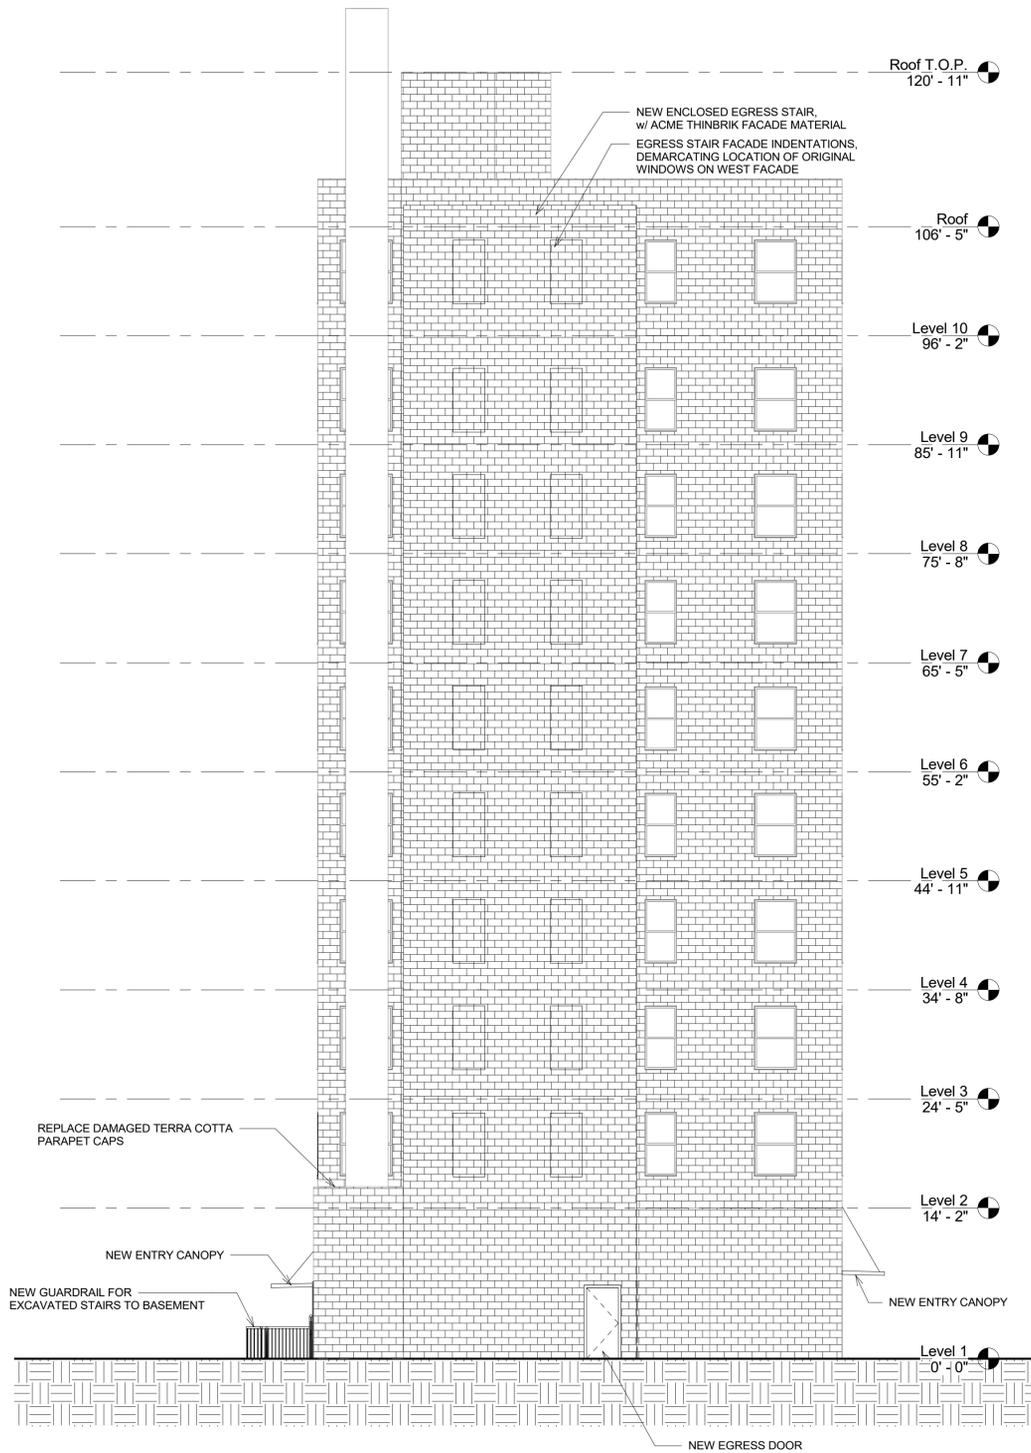
1 EXTERIOR ELEVATION - WEST
1/8" = 1'-0"

- f. EGRESS STAIR ADDITION – On the west elevation, the applicant has proposed to construct a rear egress

staircase. The proposed staircase will be enclosed by brick to match that of the historic structure and will feature both a subordinate height and subordinate widths. The addition will feature recessed in the brick façade noting the locations of window openings that will be covered through the construction of the addition. Staff finds the proposed addition to be appropriate and consistent with the Guidelines.

METAL WINDOWS
PREVIOUSLY RESTORED

BRICK FACADE
PREVIOUSLY PAINTED
ORIGINAL BRICK COLOR

REPLACE DAMAGED
TERRA COTTA PARAPET
CAPS W/ LIKE

NEW ENCLOSED EGRESS STAIR

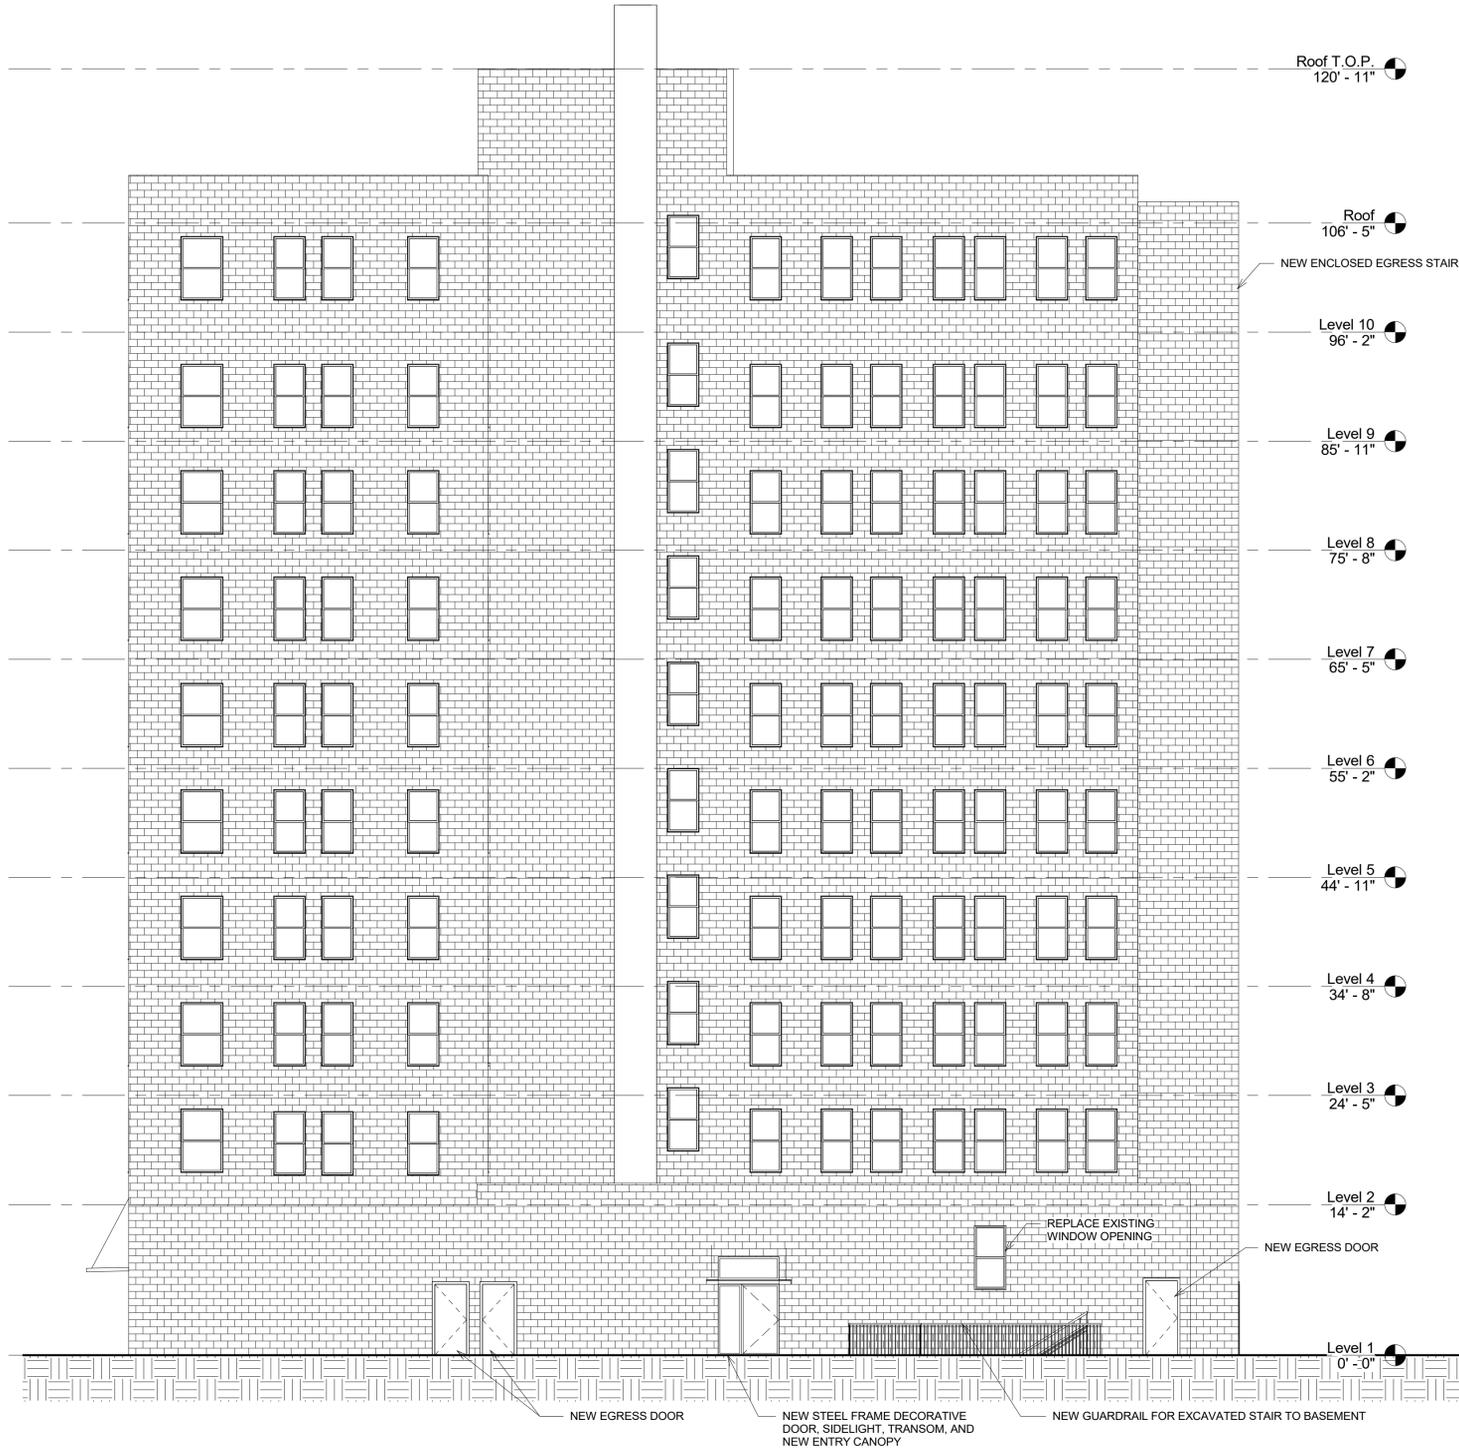
1 EXTERIOR ELEVATION - NORTH
1/8" = 1'-0"

NEW EGRESS DOOR

NEW STEEL FRAME DECORATIVE
DOOR, SIDELIGHT, TRANSOM, AND
NEW ENTRY CANOPY

NEW GUARDRAIL FOR EXCAVATED STAIR TO BASEMENT

- g. EGRESS DOORS –The applicant has proposed to install a total of five new egress doors. Four of these doors will be located on the north elevation, facing a planned interior courtyard. One door will be located on the west elevation, facing a surface parking lot. The applicant has proposed for all but one door to feature a solid steel profile. One door will feature a storefront system profile with a transom window. Generally, staff finds the proposed door additions to be appropriate; however, specifications for each door should be submitted to staff prior to the issuance of a Certificate of Appropriateness. Staff finds that a dark aluminum storefront system and dark colored solid doors are most appropriate.

- h. EXCAVATED STAIRCASE – The applicant has proposed to construct an excavated staircase to provide access and egress from a basement level tenant space. The staircase will be located on the north façade of the building and will feature a guardrail at the street level. Staff finds the proposed staircase to be appropriate.

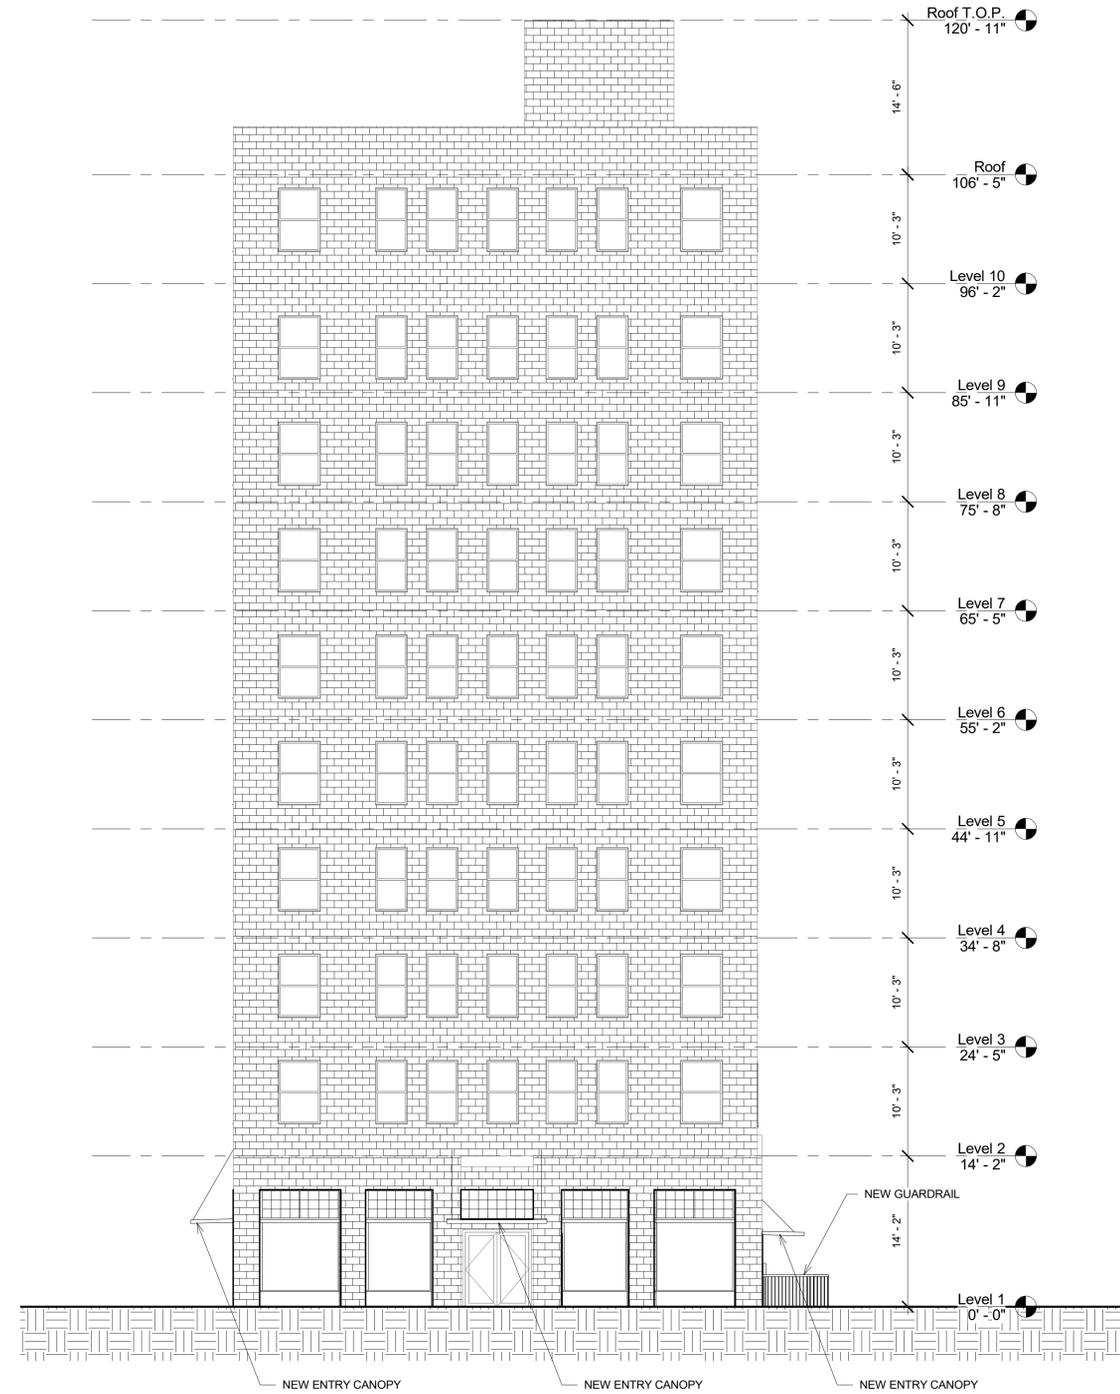
1 EXTERIOR ELEVATION - EAST
1/8" = 1'-0"

REPLACE DAMAGED OR MISSING
TERRA COTTA PARAPET CAPS
W/ LIKE

REPLACE TERRA COTTA BELT BAND W/ LIKE

REPLACE DAMAGED TERRA COTTA W/ LIKE

PREVIOUSLY REMOVED PAST REMODEL
STOREFRONTS. TO BE REPLACED WITH
WOOD STOREFRONTS

CAST STONE FACADE TO COVER EXPOSED
BRICK AT STREET LEVEL AND BULKHEADS
AT NEW WOOD STOREFRONT

- c. STOREFRONT SYSTEM – The applicant has proposed to restore the structure’s historic façade through the reconstruction of the wood storefront system. The Guidelines for Exterior Maintenance and Alterations 10.B.ii. notes that historic facades should be returned to their original design. The applicant has submitted detailed sections and specifications of the proposed wood storefront system. Staff finds the proposed installation to be appropriate and consistent with the Guidelines.

- d. TERRA COTTA – This historic structure originally featured decorative terra cotta elements, many of which have been damaged over time. The applicant has proposed to replace any damaged terra cotta elements with new to match the existing. This is consistent with the Guidelines for Exterior Maintenance and Alterations 10.A.iii.
