HISTORIC AND DESIGN REVIEW COMMISSION

HDRC CASE NO: 2015-111
ADDRESS: 517 E HOUSTON ST
LEGAL DESCRIPTION: NCB 422 BLK 26 W 26 FT OF 5 ARB A2 2010-RESURVEY PER DEED 13852/200 EX 2/4/2009
ZONING: D H HS
CITY COUNCIL DIST.: 1
DISTRICT: Alamo Plaza Historic District
LANDMARK: Albert Maverick Building
APPLICANT: David Alvidrez
OWNER: David Alvidrez
TYPE OF WORK: Facade restoration, glass canopy installation and window and door opening replacement

HDRC PRESENTATION

517 Houston Street SAN ANTONIO

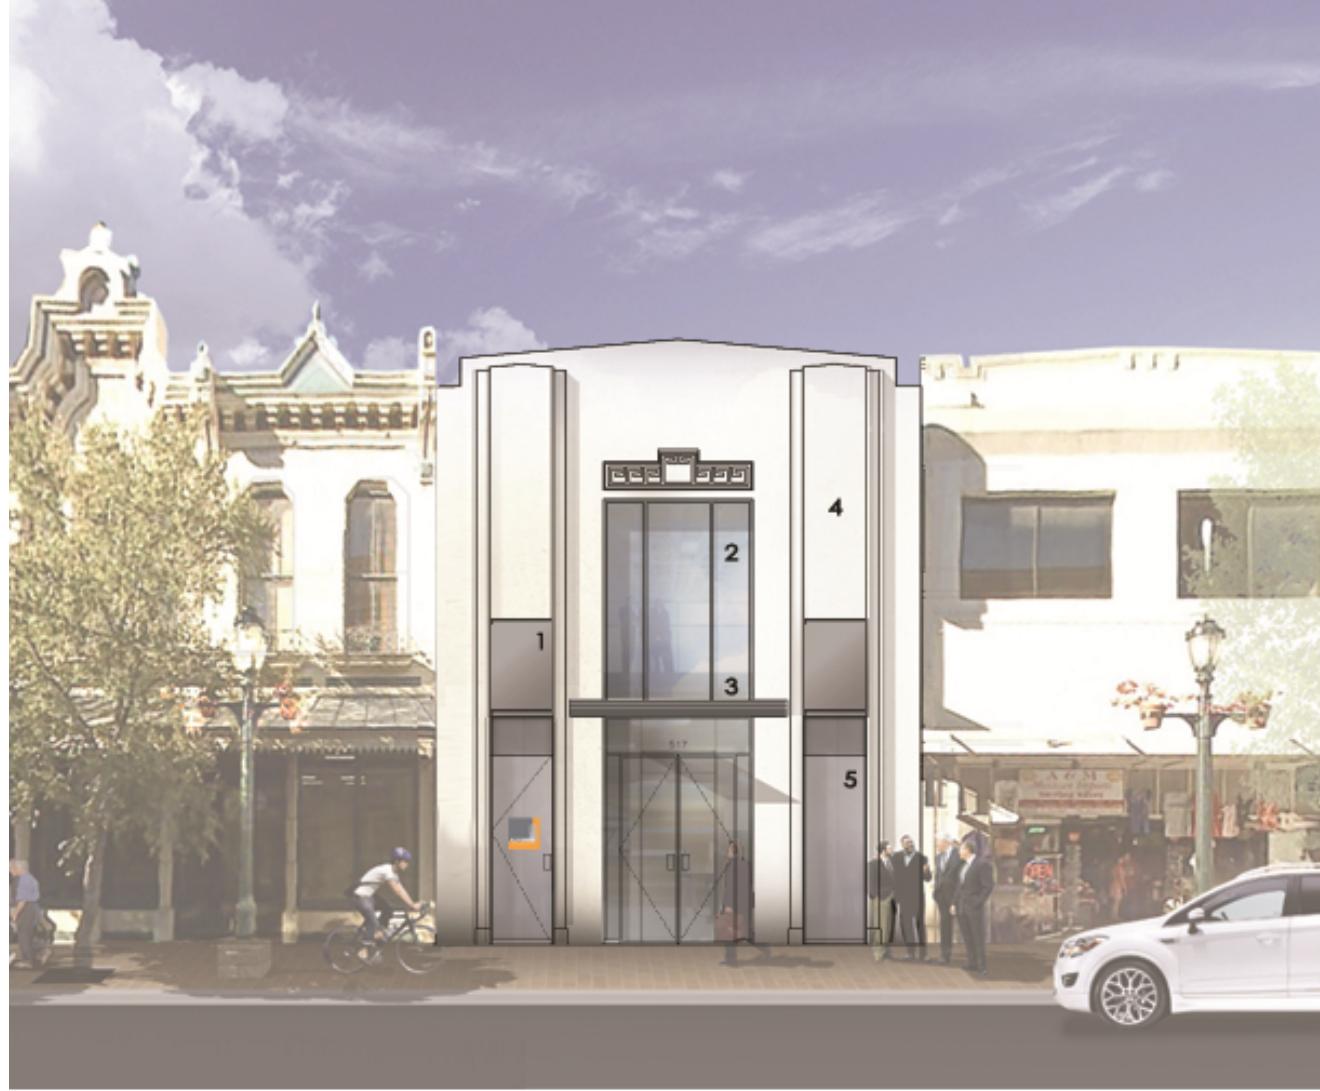
PARTIAL FLOOR PLAN

- 1 BENT ALUMINIUM
- 2 CLEAR INSULATED GLASS
- 3 GLASS CANOPY
- 4 EXISTING PLASTER
- 5 WHITE FROSTED GLASS

- e. According to the Guidelines for Exterior Maintenance and Alterations 10.B.i. regarding commercial facades, new façade elements that alter or destroy the historic building character such as inappropriate materials should not be added. The applicant’s proposal to install bent aluminum, clear insulated glass and white frosted glass on the Houston Street façade is not consistent with the Guidelines.

- g. Per a photograph dated October 2007, the Houston Street façade at 517 Houston featured a canopy which projected approximately eight (8) feet out over the sidewalk, which has since been removed. The applicant has proposed to install a projecting steel and glass canopy which is to extend over the sidewalk approximately five (5) feet and feature three sections to correspond with the entrance way and the proposed white frosted glass. While a replacement canopy would be appropriate on this façade and on Houston Street, the applicant’s proposed canopy is not due to its profile and materials. The Guidelines for Exterior Maintenance and Alterations 11.B.ii. states that new canopies should be based on accurate evidence of the original, the architectural style of the building and be proportionate in shape and size to the scale of the building façade to which they will be attached.

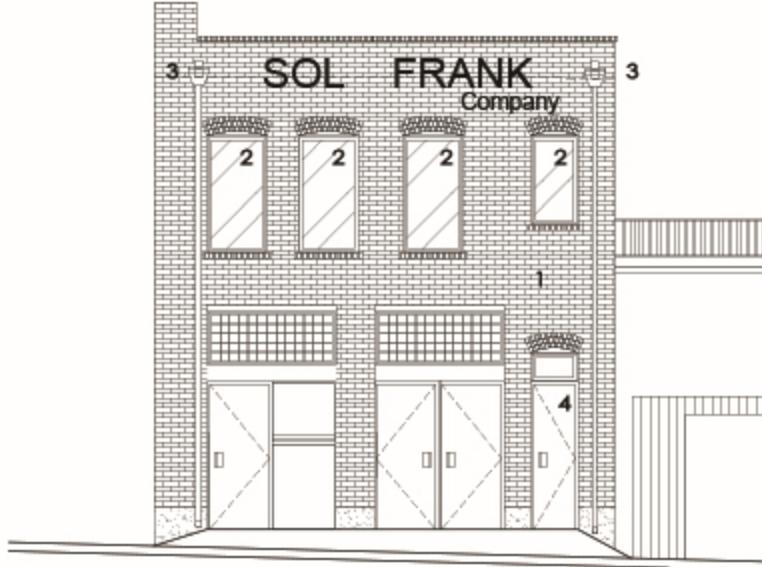
- 1 CLEAN AND RESTORE EXISTING BRICK
- 2 REPLACE WINDOWS
- 3 RESTORE SCUPPER, DOWNSPOUT
AND DOWN LEADER
- 4 NEW DOOR

- c. The applicant has proposed to restore the scuppers, downspouts and down leaders of the existing gutter system. While those that are currently on the façade are not historic, their repair is consistent with the Guidelines for Exterior Maintenance and Alterations 4.A.

- h. The applicant has proposed to create a new door opening on the Peacock Alley façade of the building where an existing window is currently located. The applicant has also proposed to reconfigure the size of the existing window. According to the Guidelines for Exterior Maintenance and Alterations 6.A.i. in regards to openings, all existing window and door openings should be preserved. The applicant’s proposal is not consistent with the Guidelines.

- i. The applicant has proposed to remove the existing windows on the Peacock Alley façade, which are currently covered by plywood and replace them with new windows, of which a material hasn’t been specified. According to the Guidelines for Maintenance and Alterations 6.A.iii., historic windows should be preserved. When replacing broken glass, the color and clarity of the replacement glass should match the original historic glass. The applicant’s proposal to replace the existing windows is not consistent with the Guidelines.
