HISTORIC AND DESIGN REVIEW COMMISSION

2020-112

602 KAMPMANN BLVD

Front door replacement

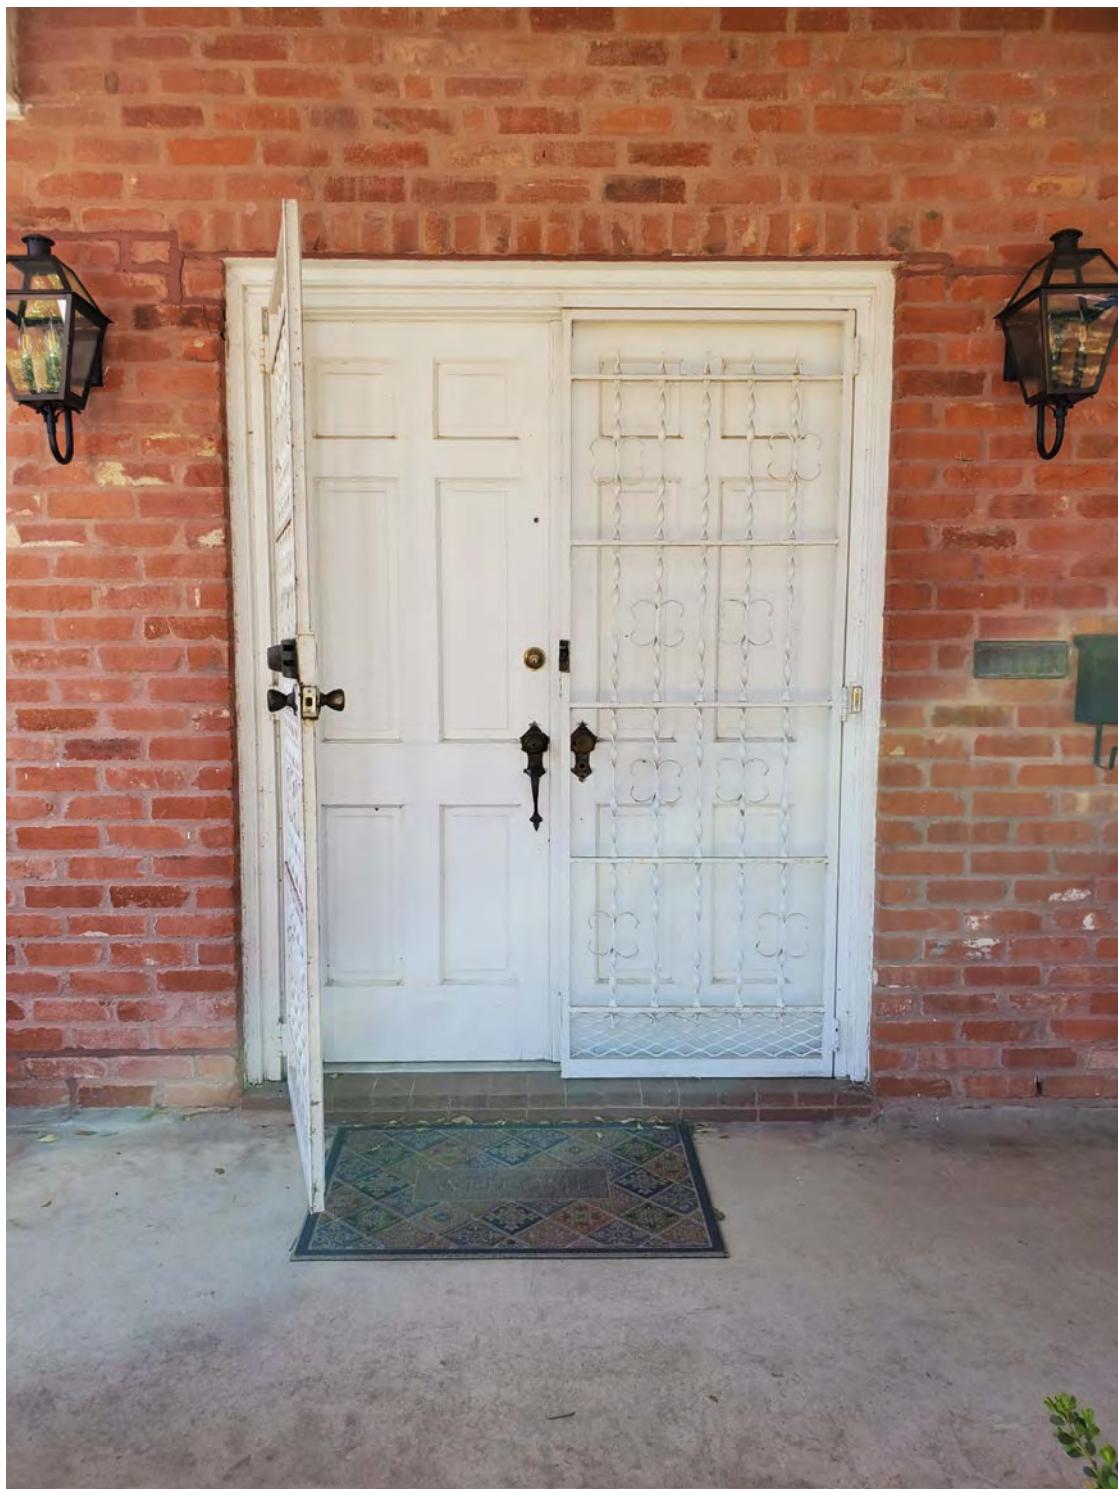
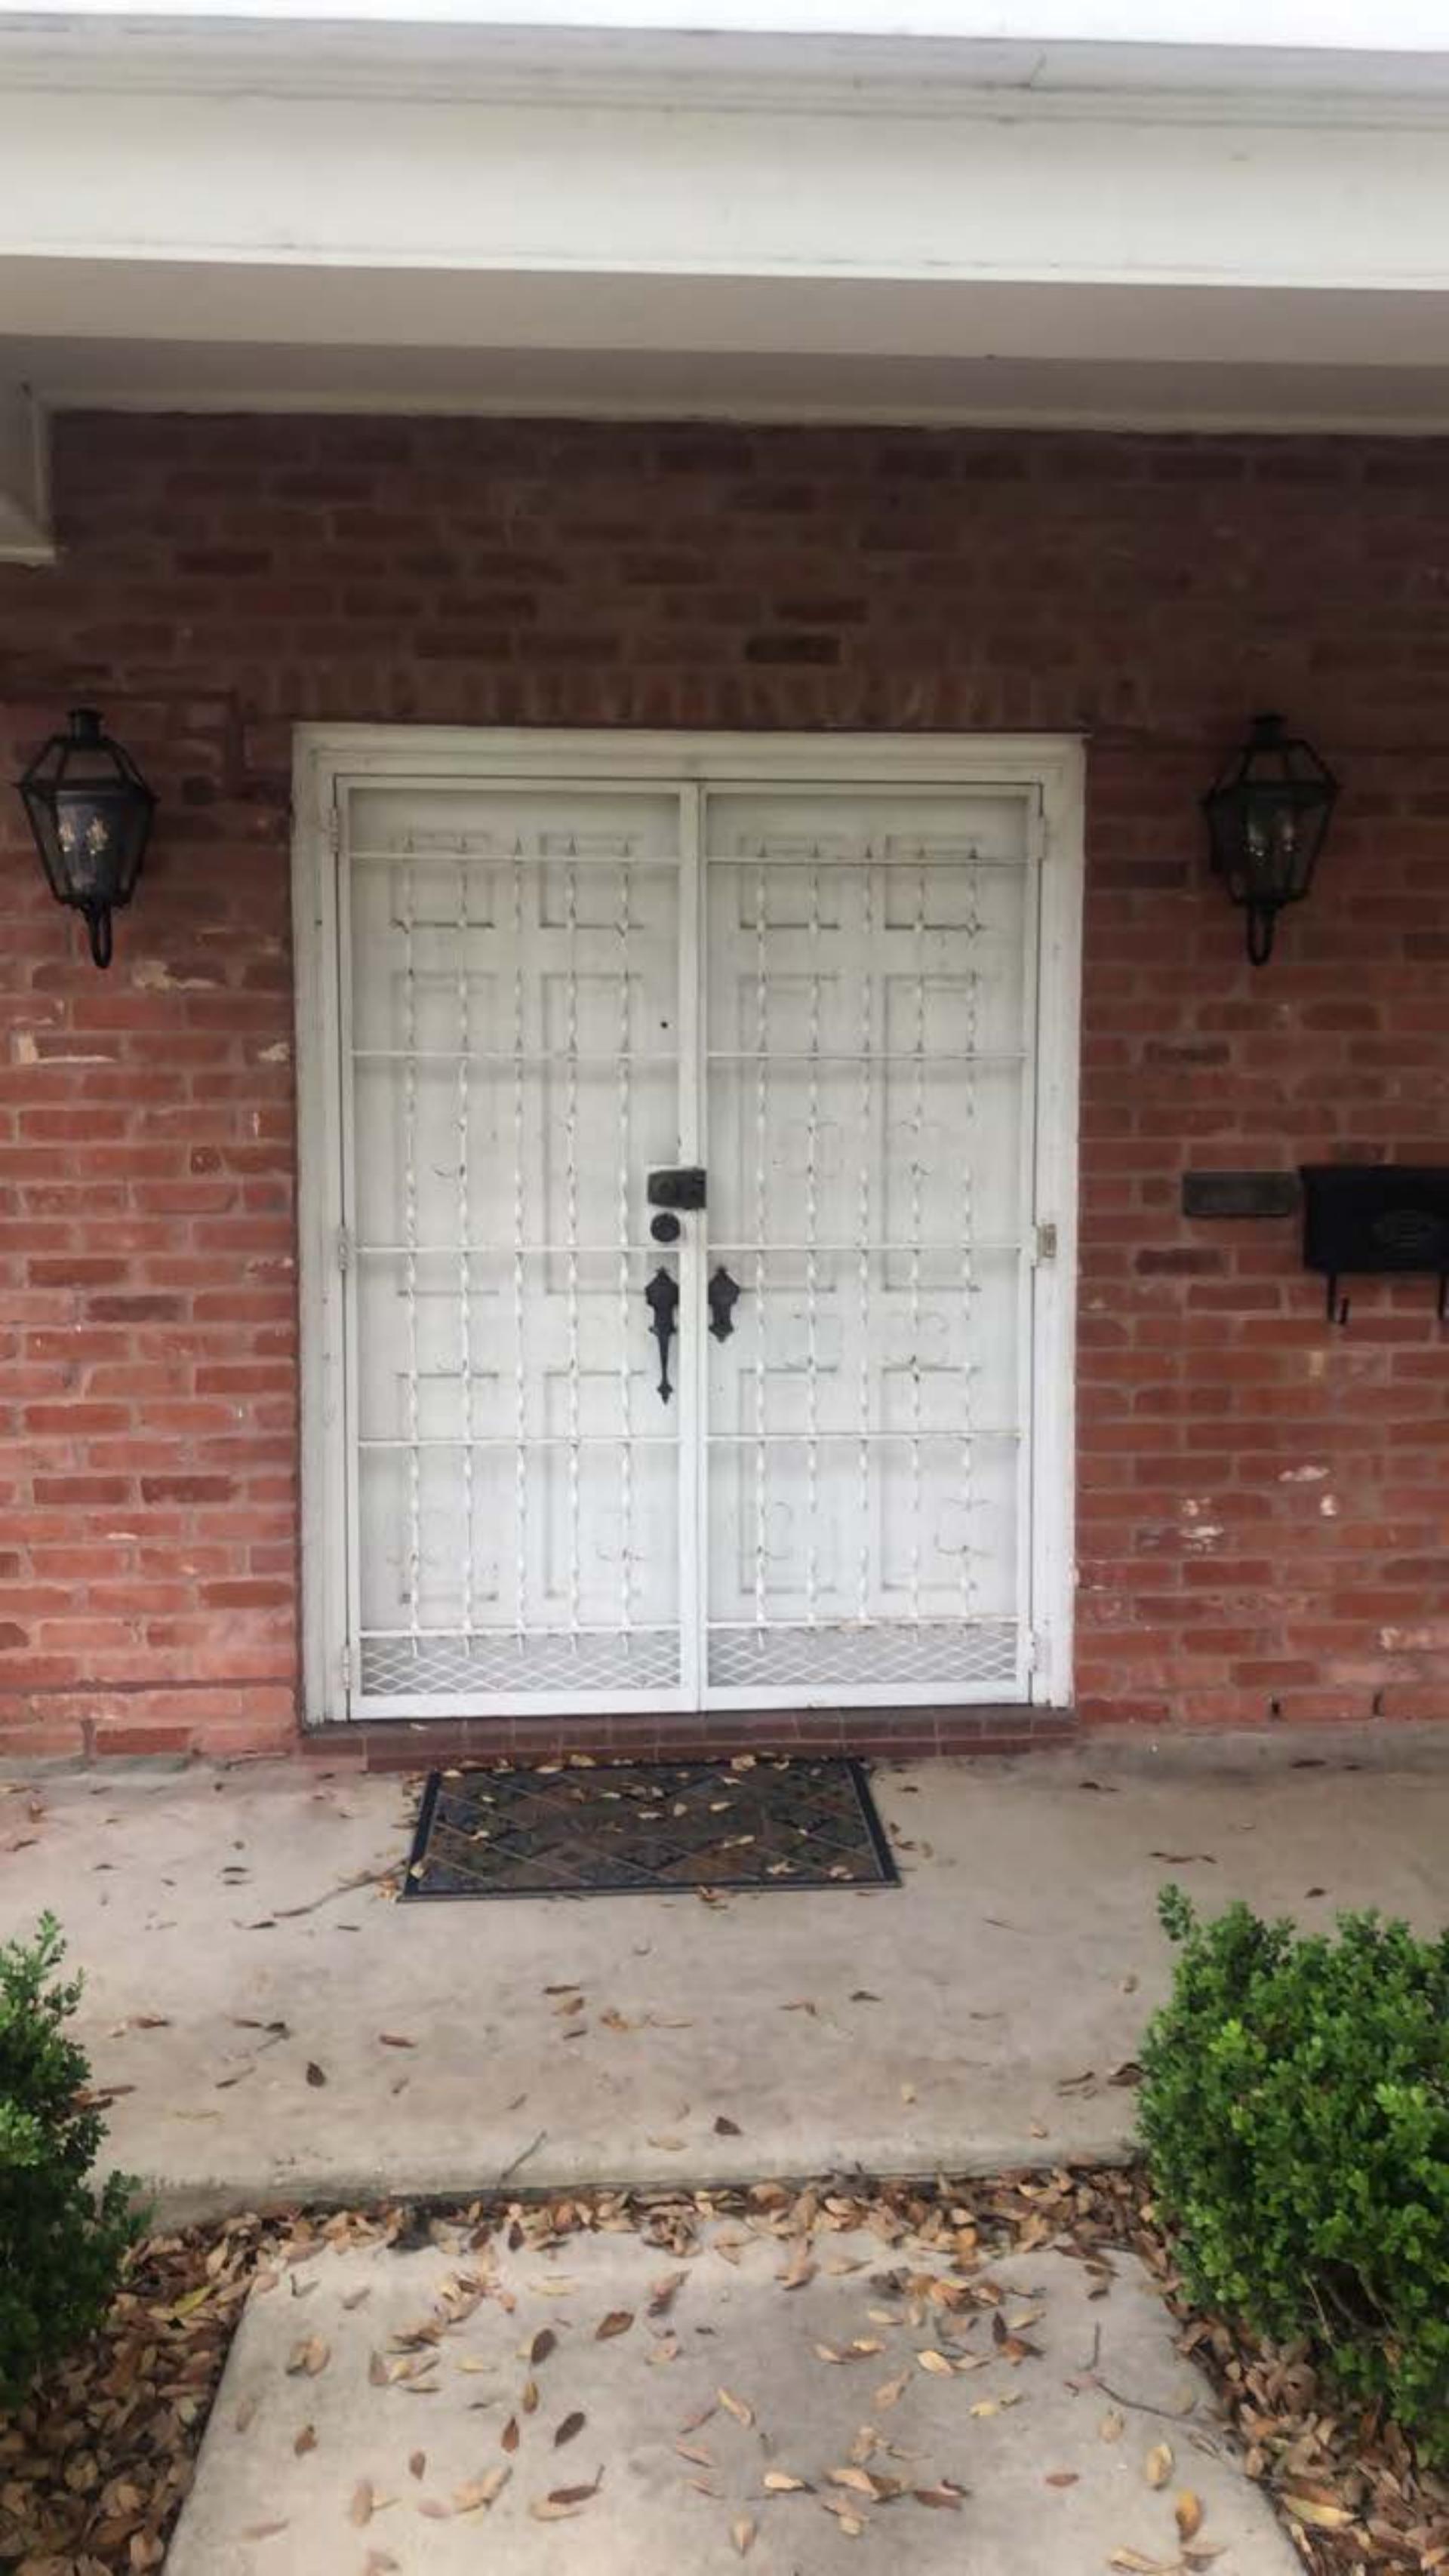
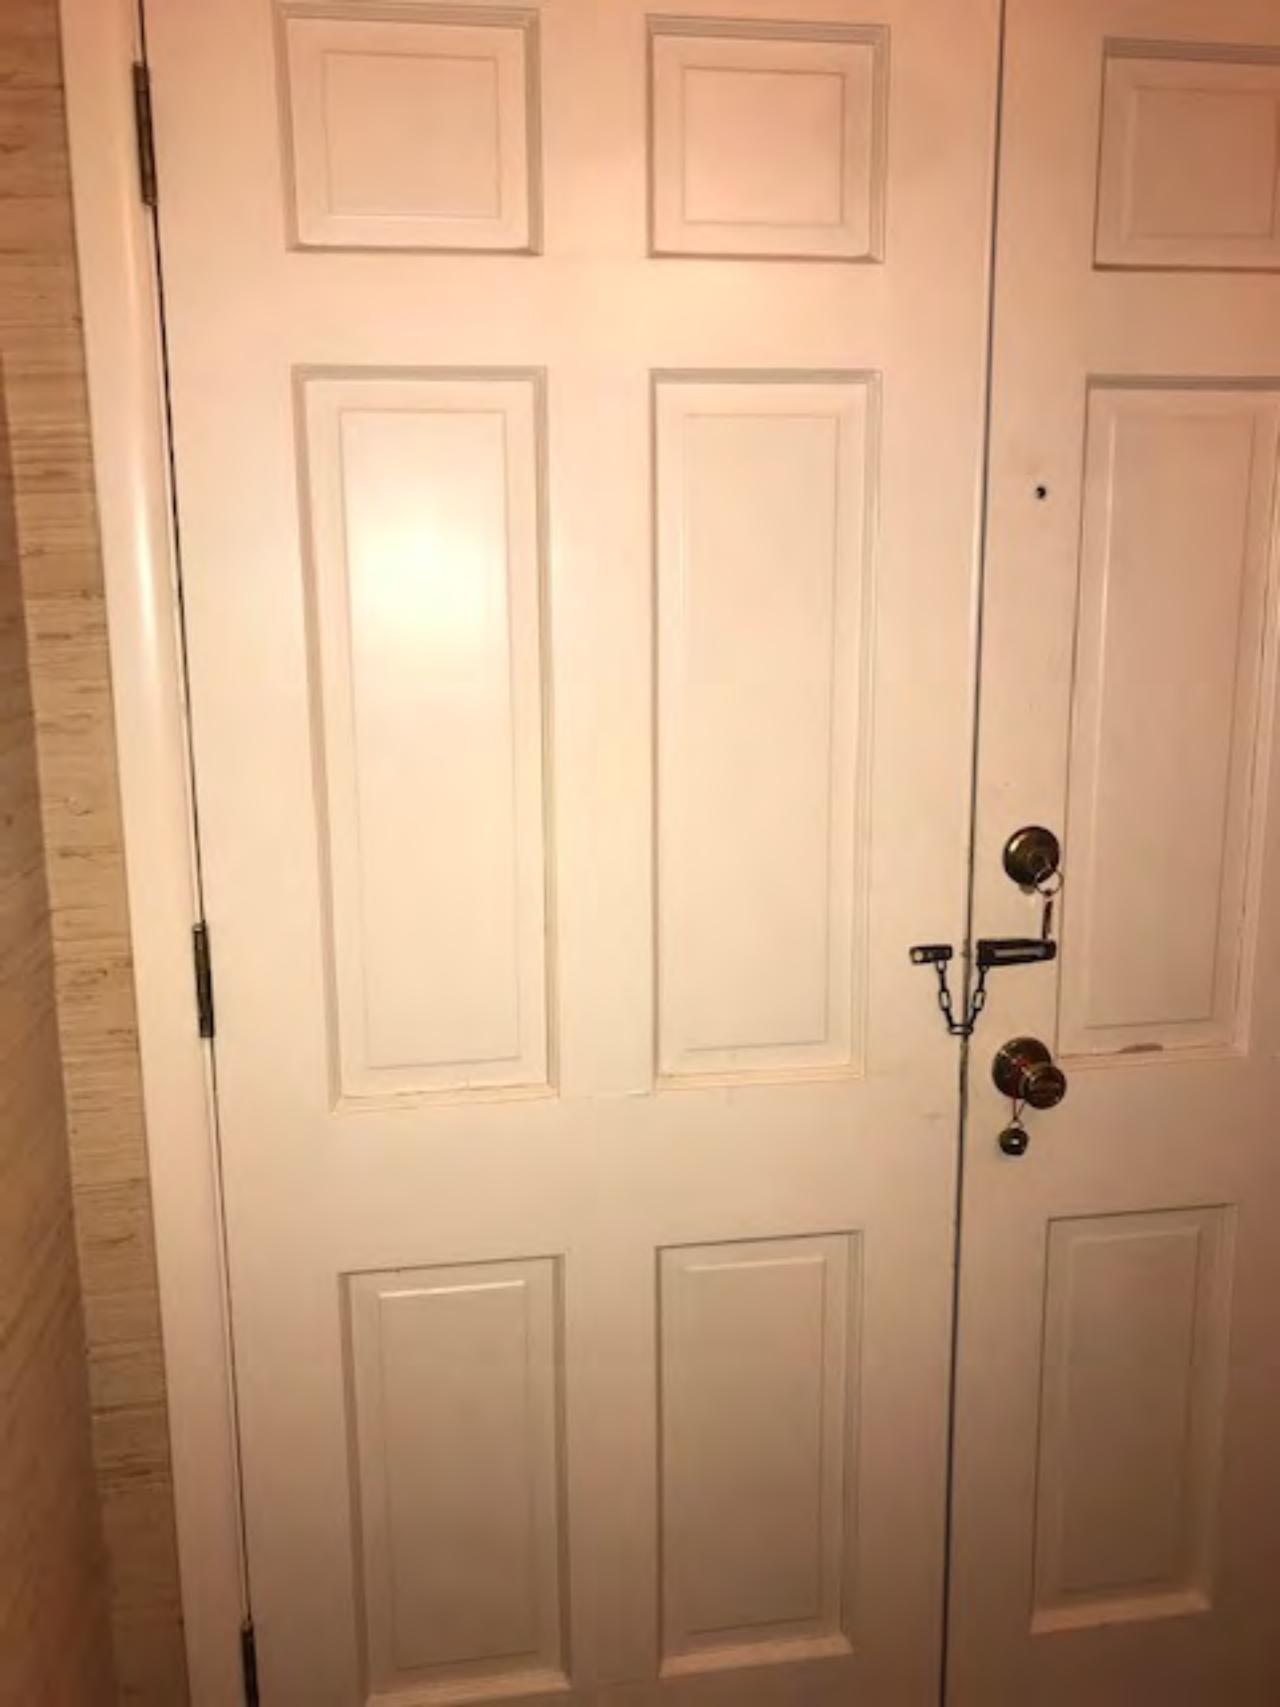
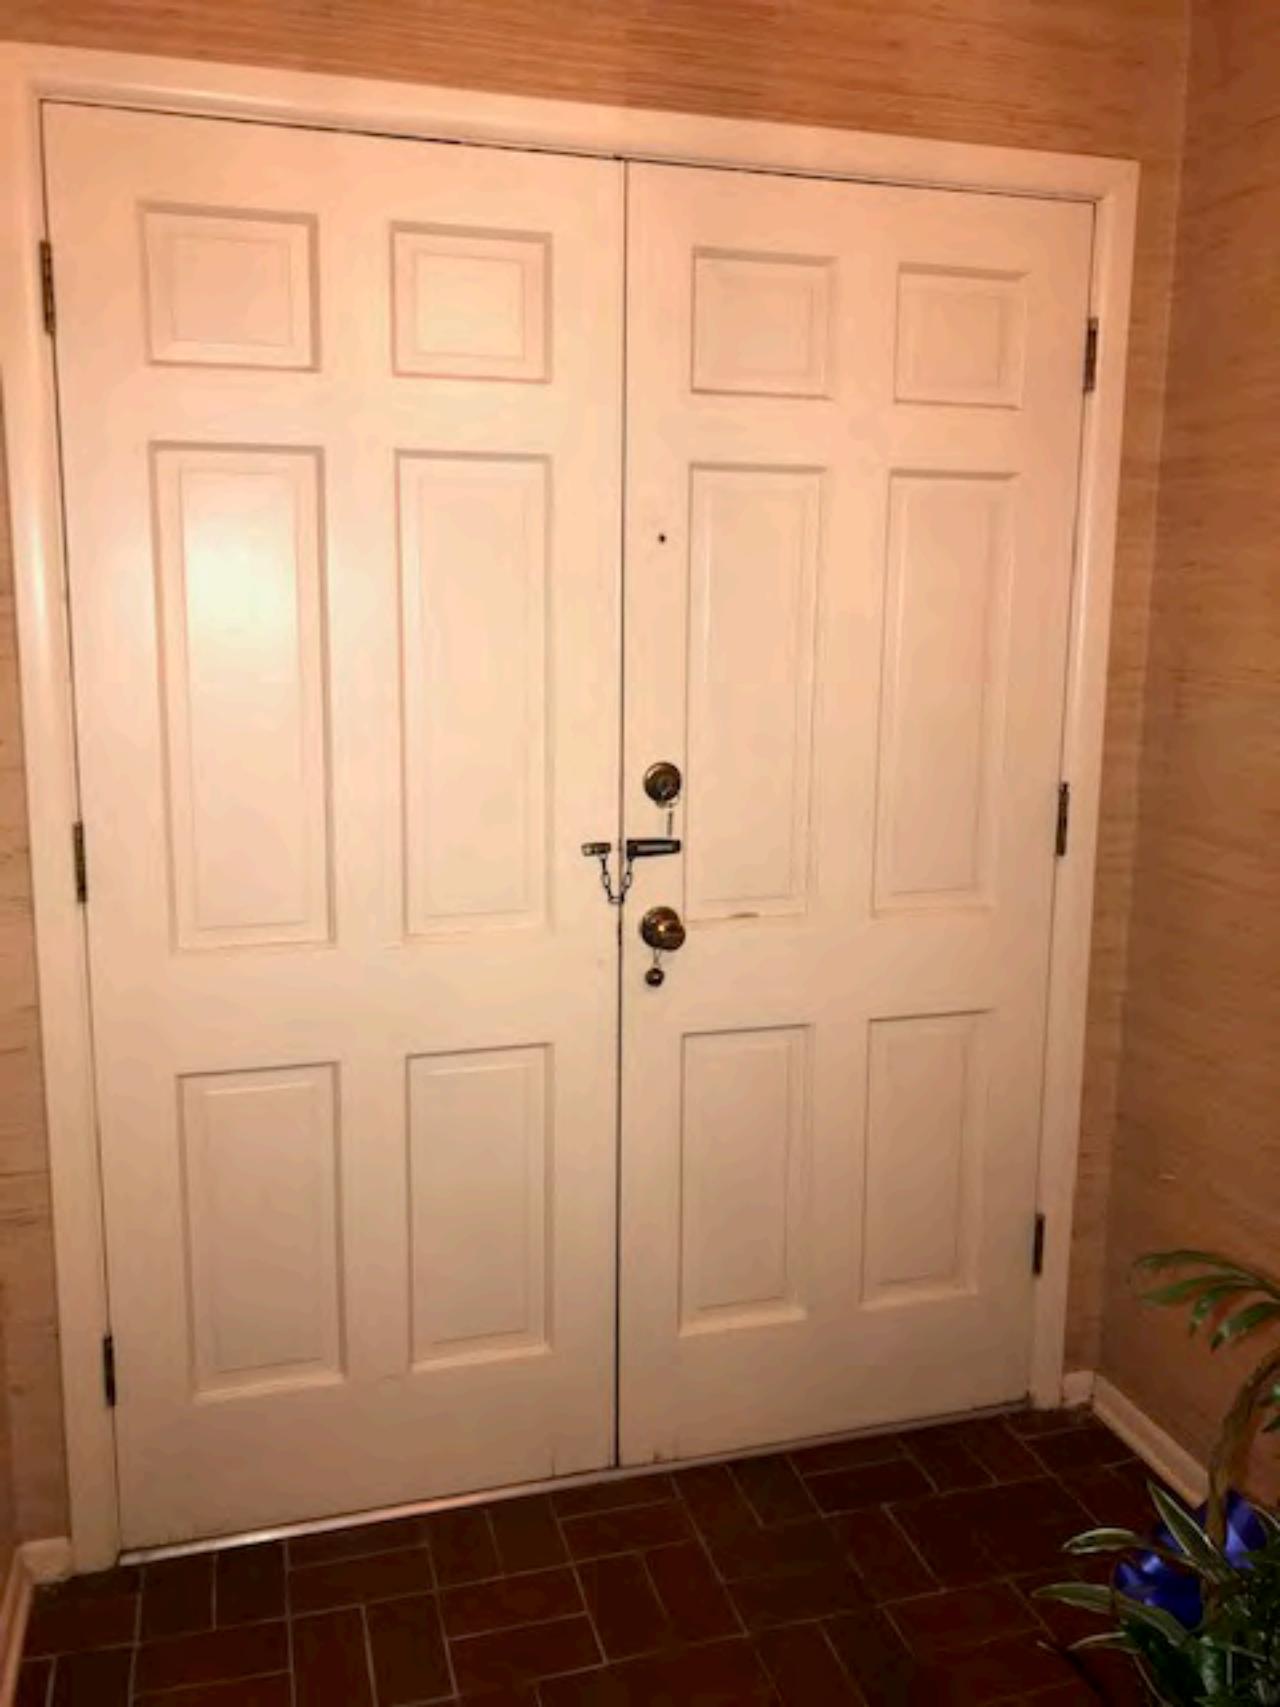
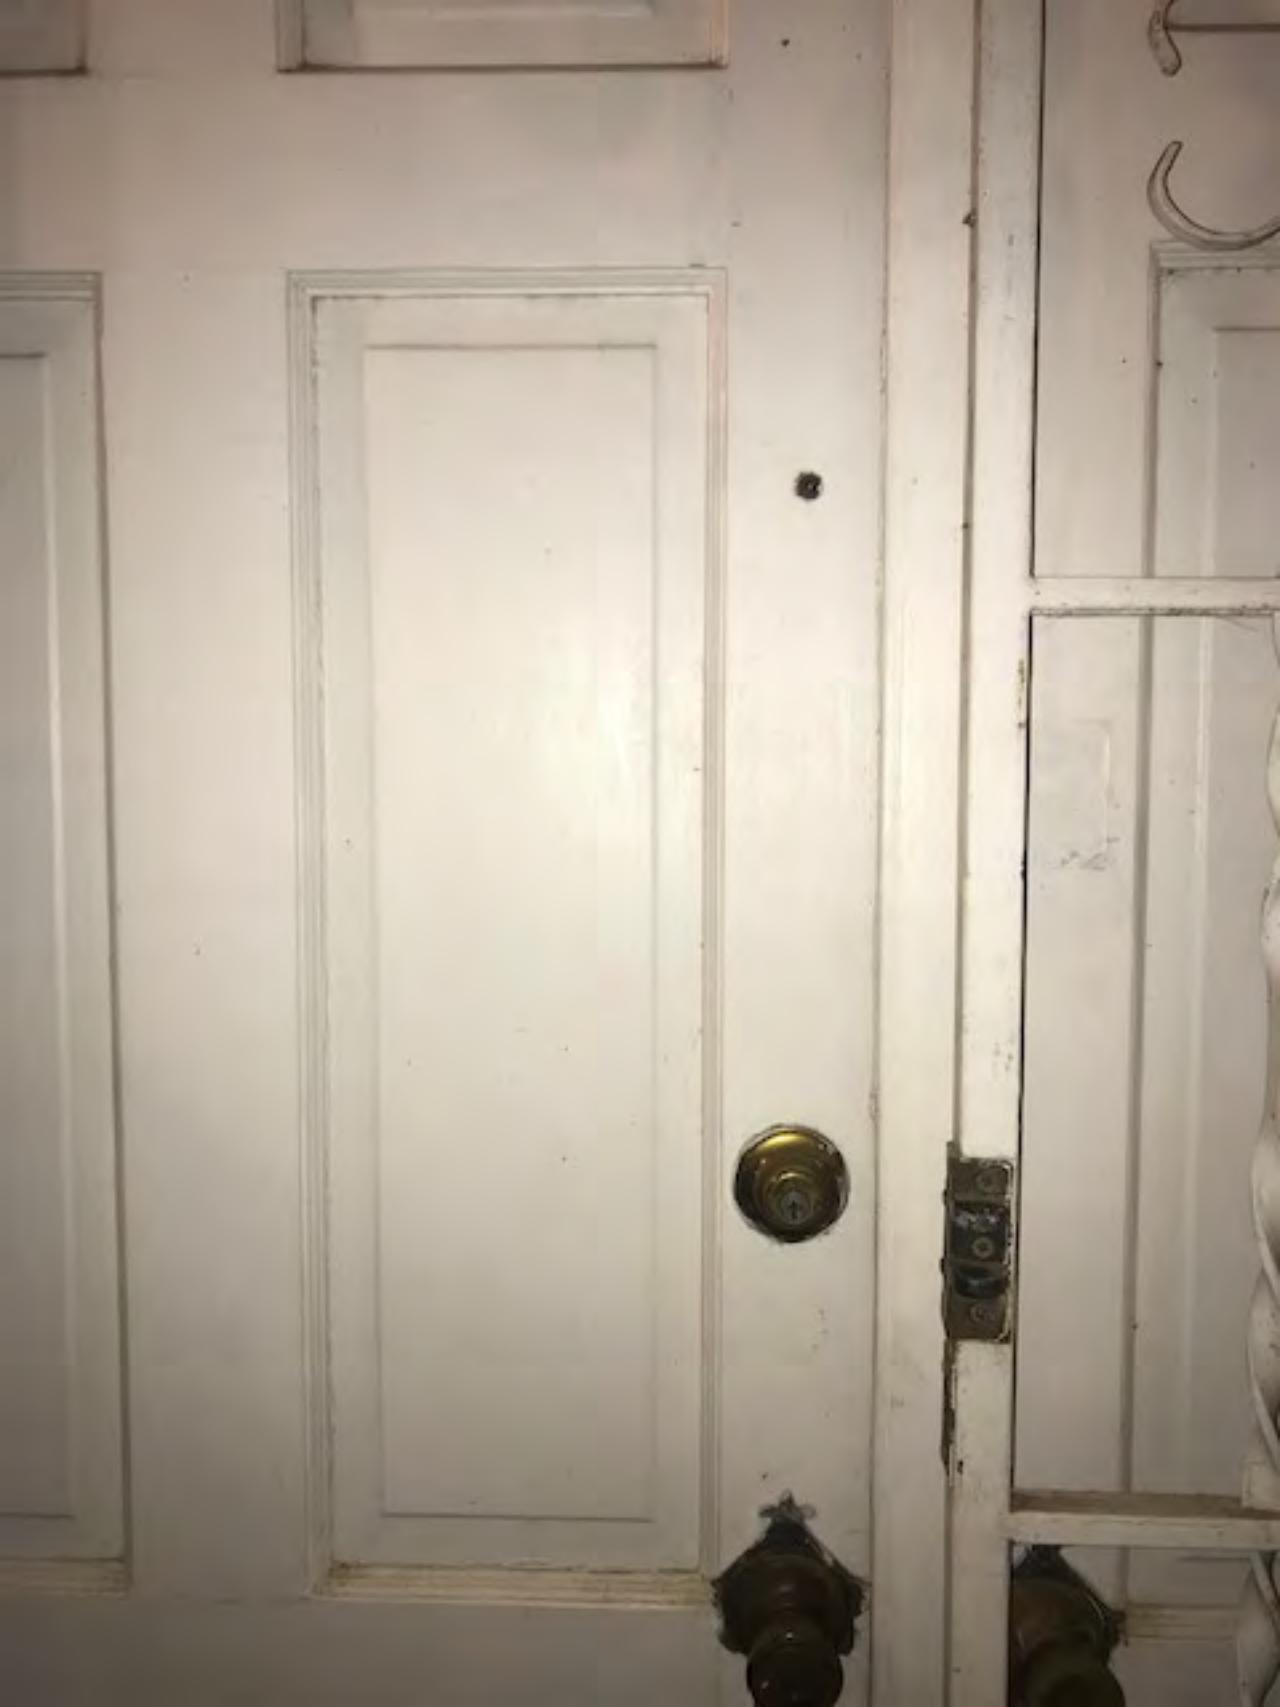
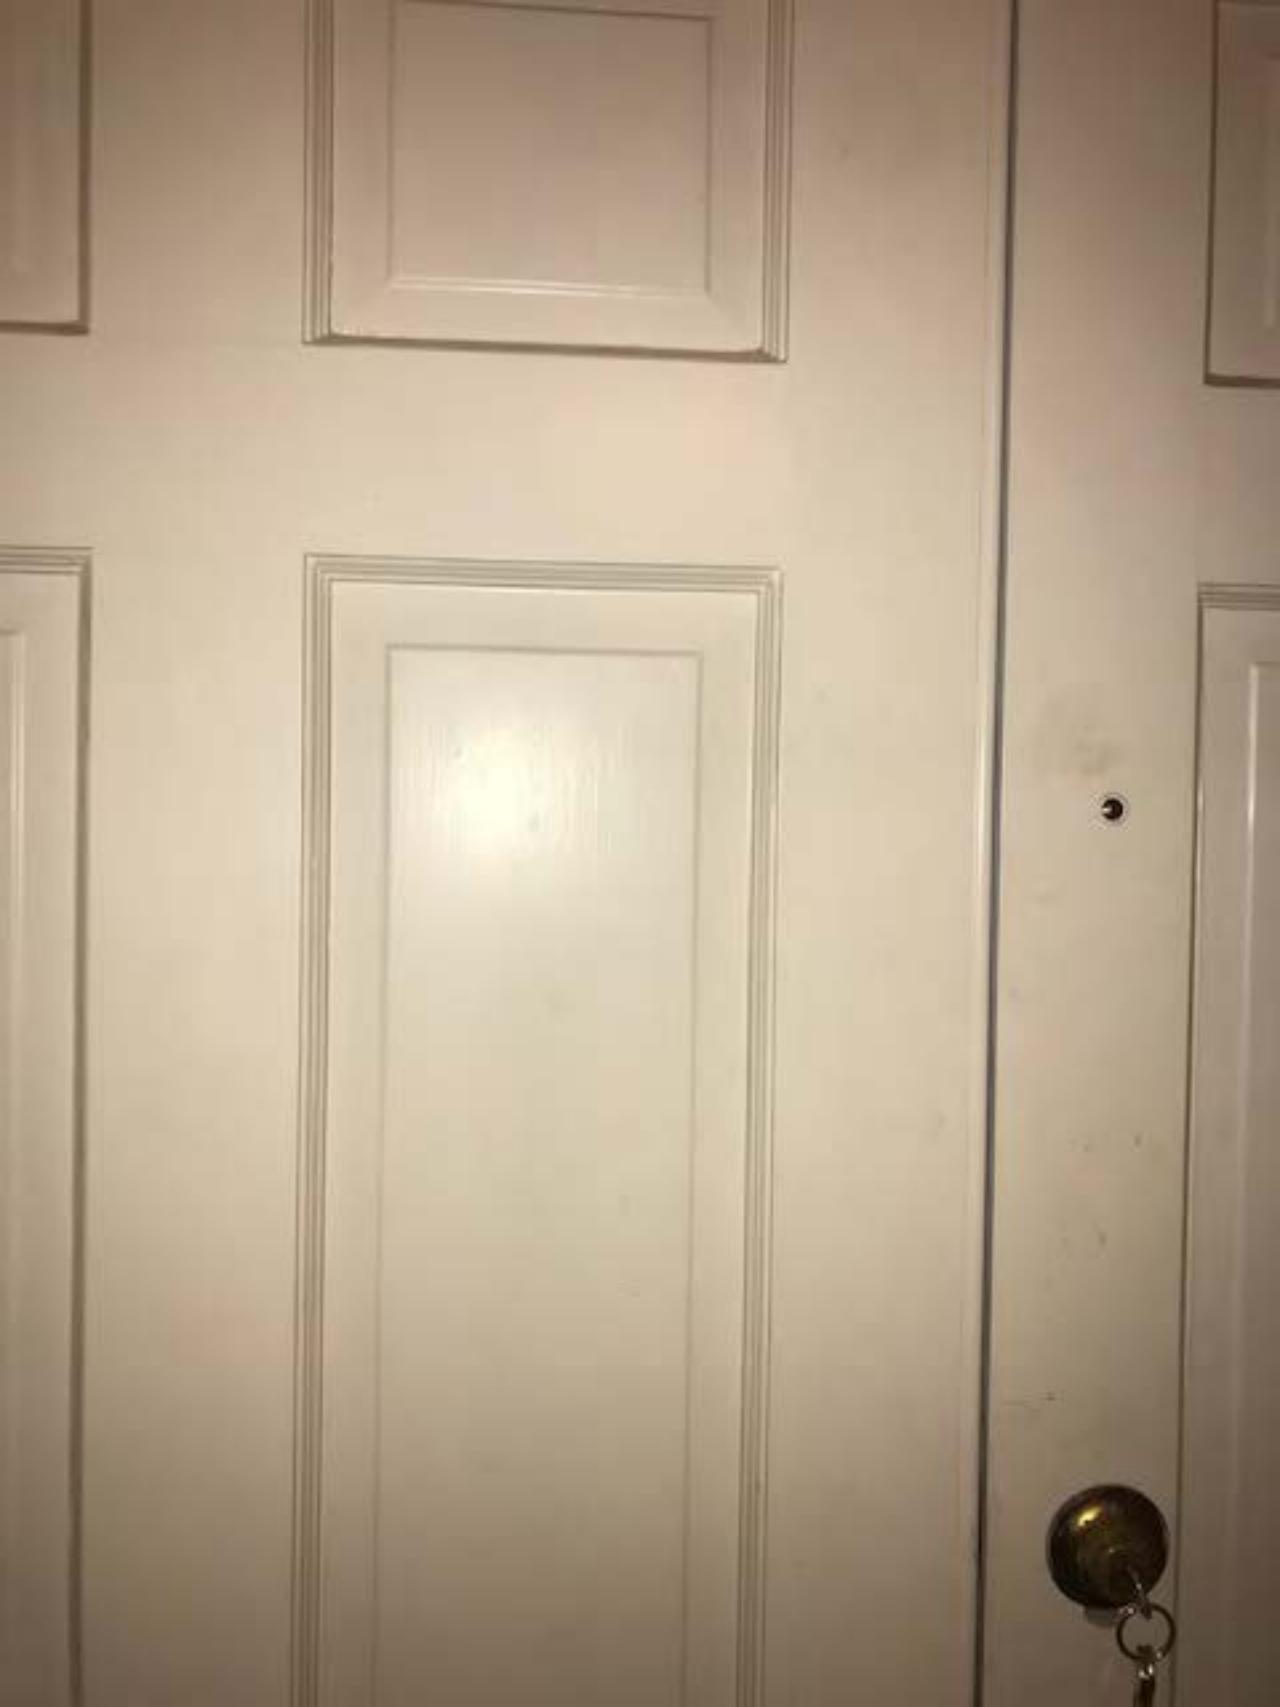
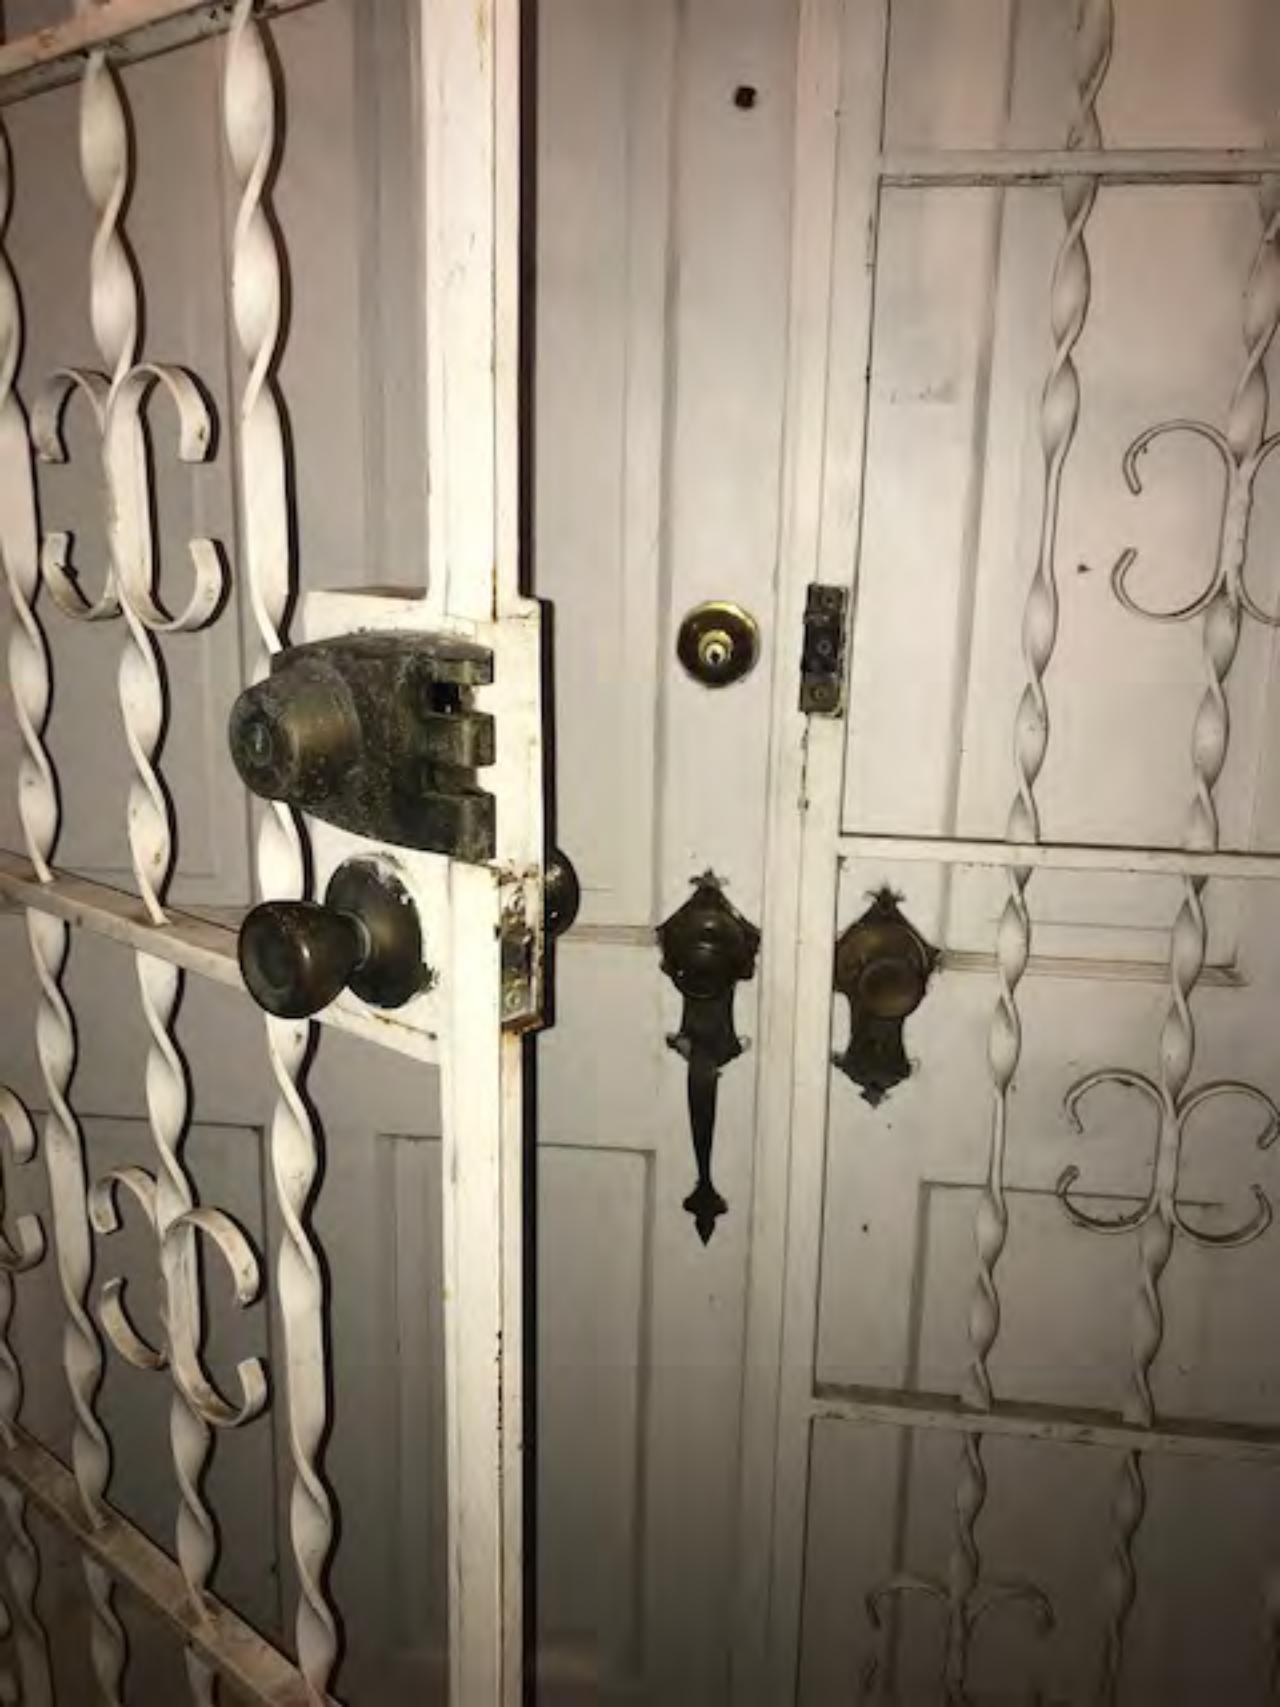
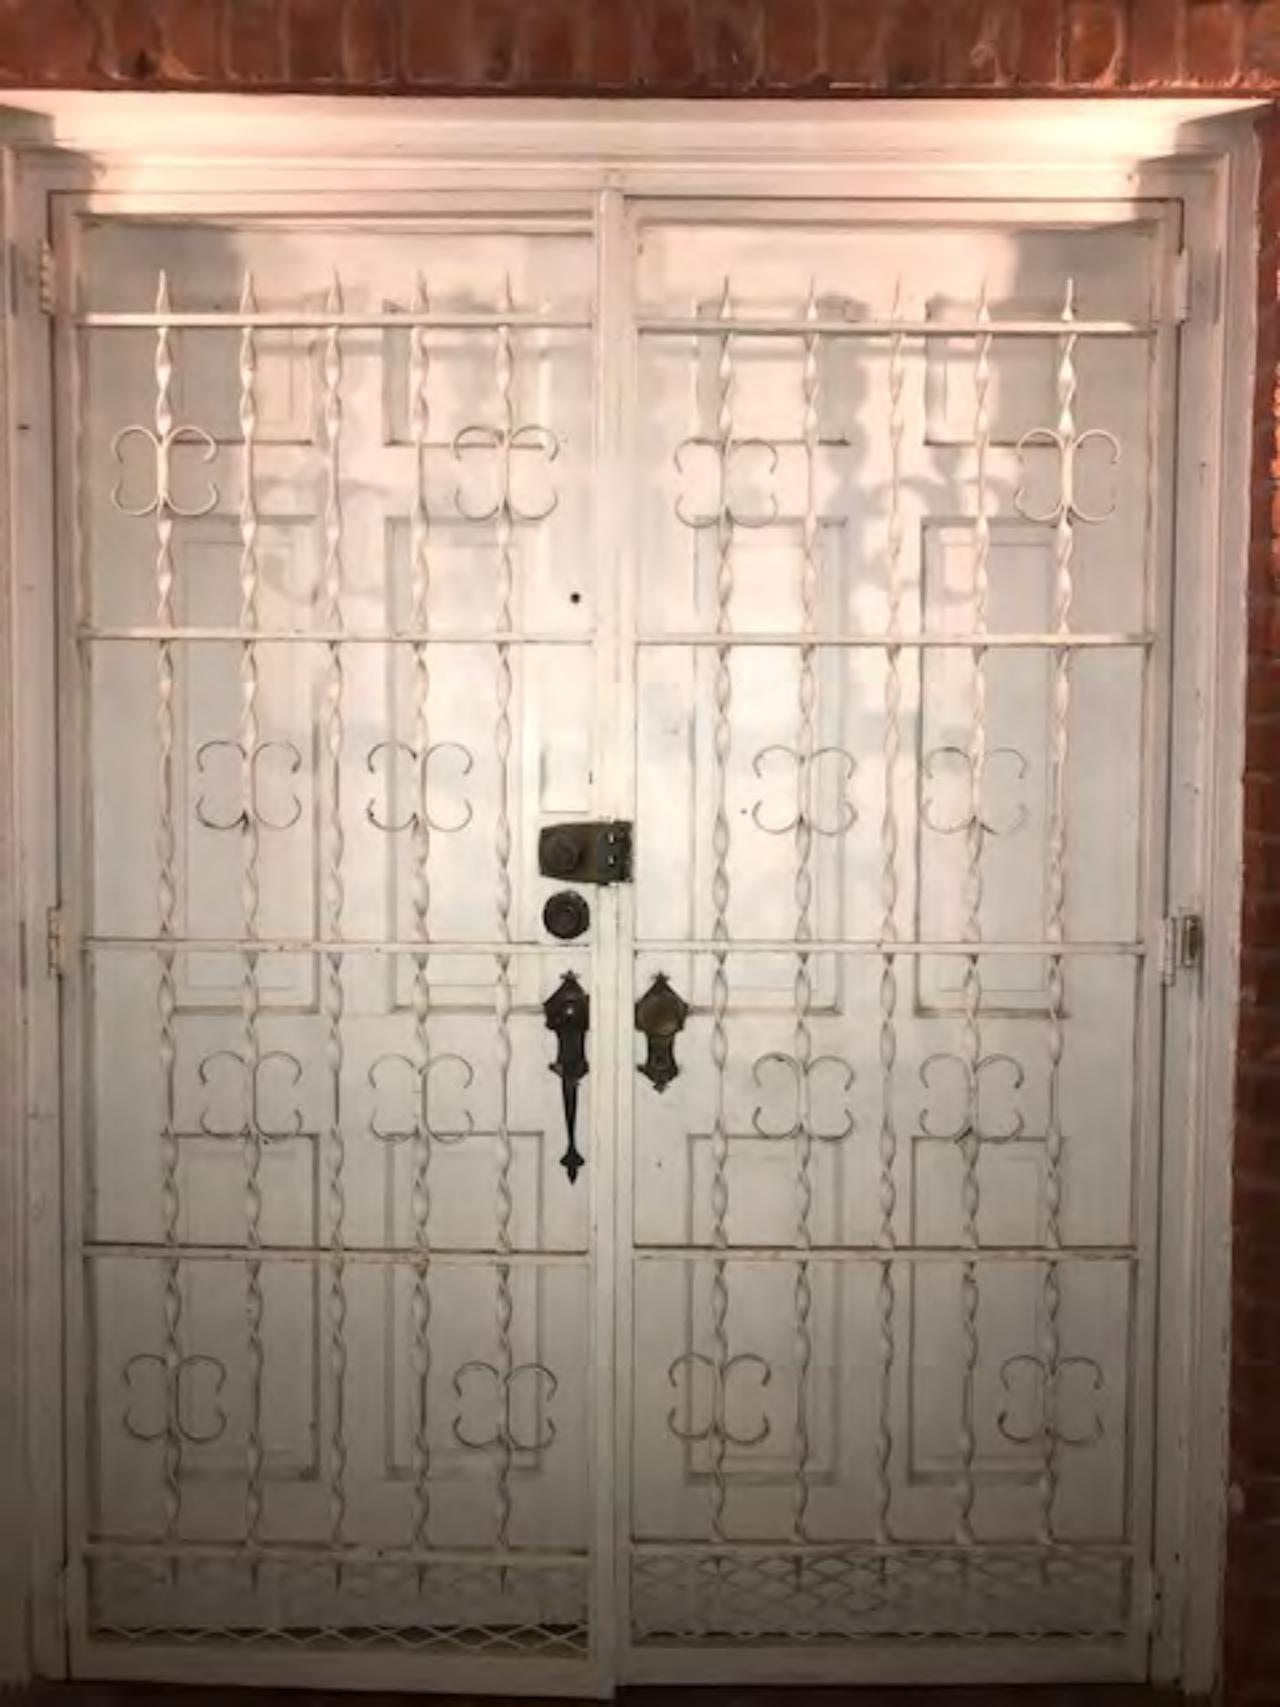
Existing unit to be removed:

- b. DOOR REPLACEMENT – The applicant has proposed to replace the existing pair of simple 6-panel white wood doors and white wrought iron security bars with a pair of new black steel and glass door with a woven design. Per the Guideline for Exterior Modifications and Alterations 6.B.i., applicants should replace doors, hardware, fanlight, sidelights, pilasters, and entablatures in-kind when possible and when deteriorated beyond repair; when in-kind replacement is not feasible, applicants should ensure features match the size, material, and profile of the historic element. Staff finds that the existing door is original to the structure and should be repaired. If the applicant provides additional supporting evidence that the doors are beyond repair, then a similar style door or one that is compatible to the style of the house is used.

Staff does not recommend approval based on finding b. The existing door is original to the structure and should be repaired. If the applicant provides additional information that the doors are beyond repair, then a similar style door or one that is compatible to the style of the house may be appropriate.

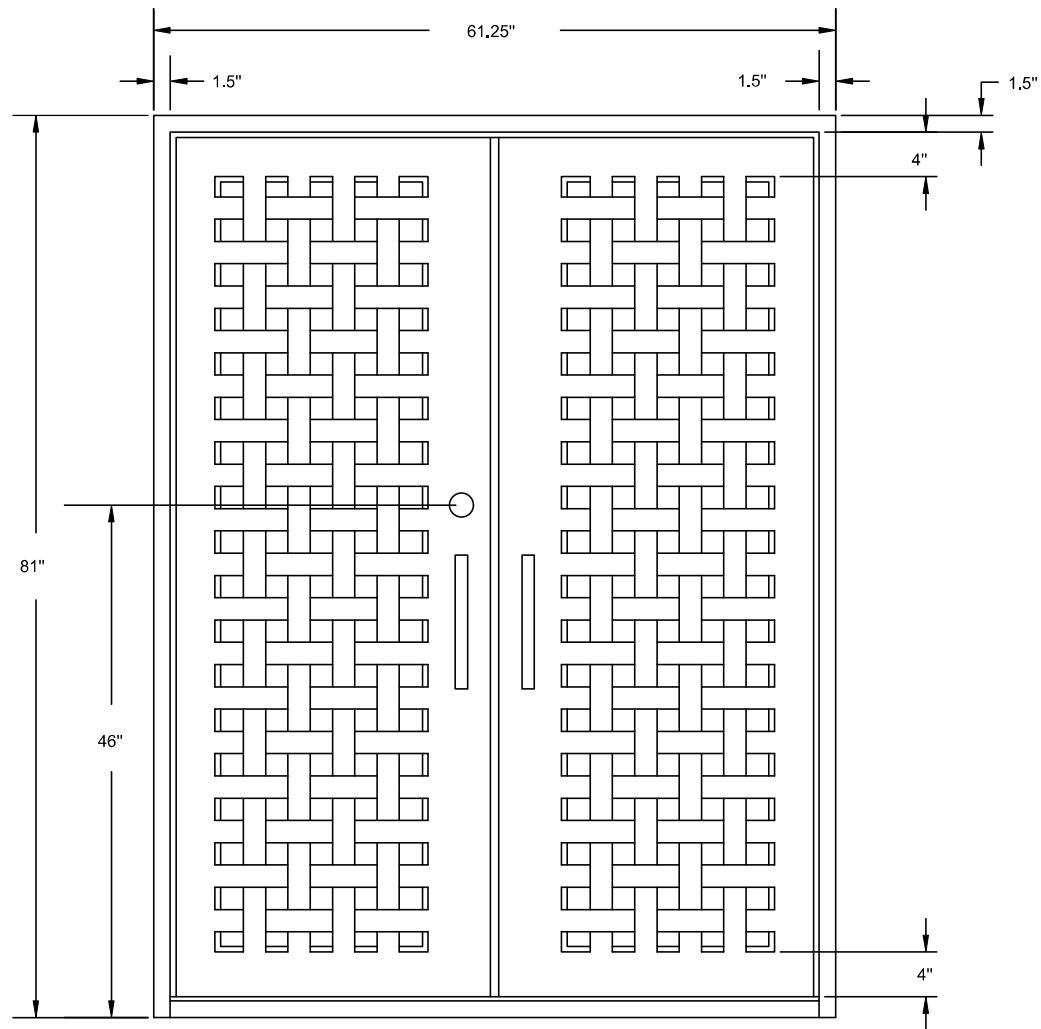
GLASS QTY: 2 W:19.125" : H:70.00"

Order: S03477		Description: FRONT DOOR		
Dimensions Height:	81"	Glass Type:	Clear	Glass Frame: Yes, operable
Dimensions Width:	61 1/4"	Handle Type:	#15	Trim Needed: Yes
Jamb:	6 1/2"	Handle L.F.O.	N/A	Type of Trim: Metal
Open:	In	Metal Threshold:	Yes, ADA	Extra Deadbolt: No
Active Door:	LEFT	Style:	4" and 6"	Deadbolt: Yes, single cylinder
Color:	Black	Style Thickness:	2"	Line: N/A
Glass Size:	5/8"	Scrollwork:	As per drawing	Construction: N/A

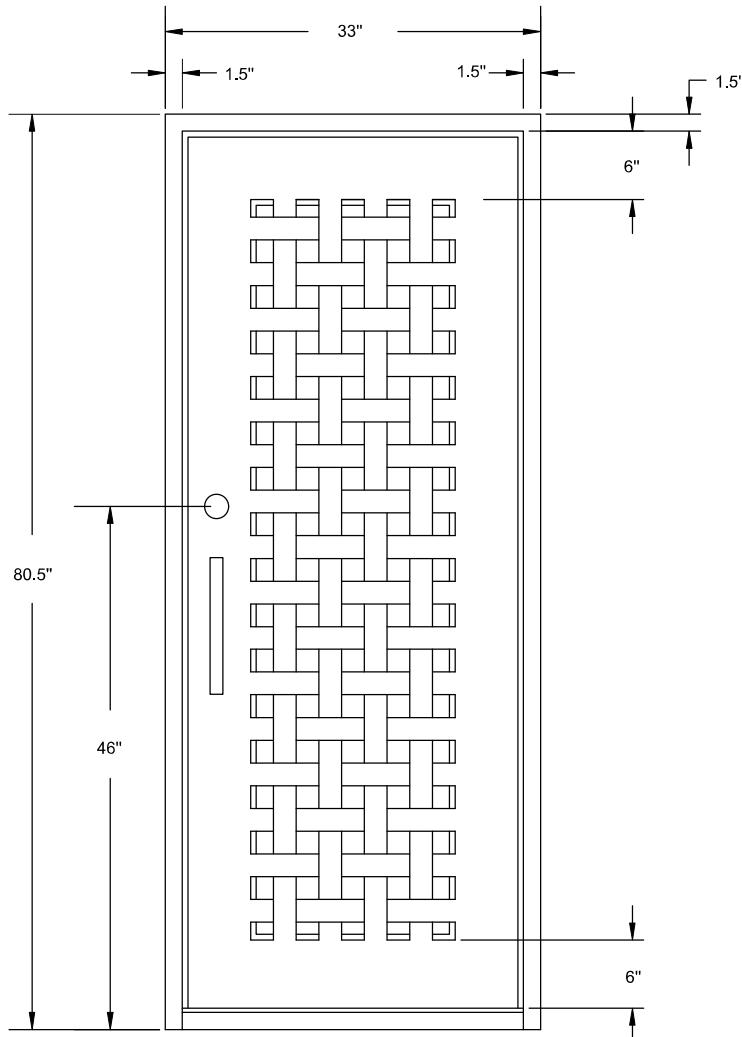
GLASS QTY: 1 W:18.00" : H:65.5"

Order: S03477		Description: OLIVARRI JEFF		
Dimensions Height:	80 1/2"	Glass Type:	Clear	Glass Frame: Yes, operable
Dimensions Width:	33"	Handle Type:	#15	Trim Needed: Yes
Jamb:	5"	Handle L.F.O.	Left	Type of Trim: Metal
Open:	In	Metal Threshold:	Yes	Extra Deadbolt: No
Active Door:	N/A	Style:	6"	Deadbolt: Yes, single Cylinder
Color:	Black	Style Thickness:	2"	Line: N/A
Glass Size:	5/8"	Scrollwork:	As per drawing	Construction: N/A

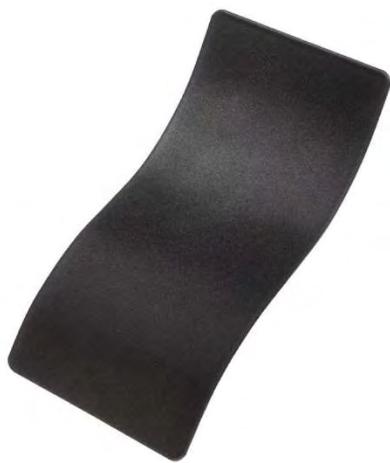
Color: Satin Black

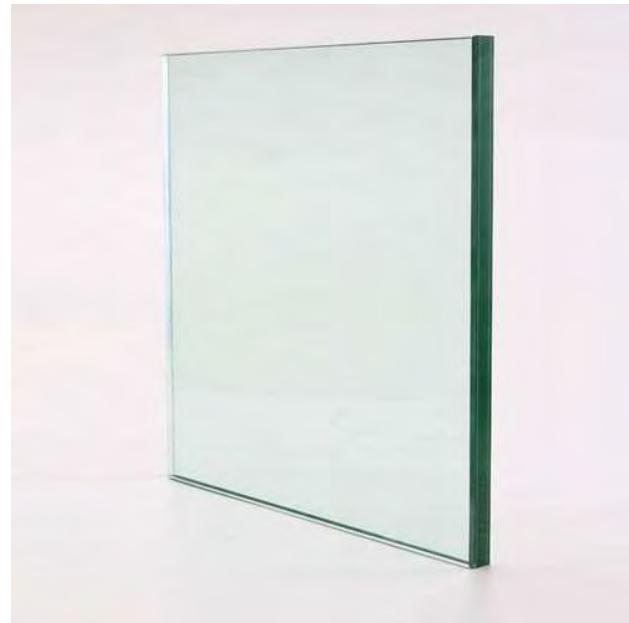
Glass: CLEAR

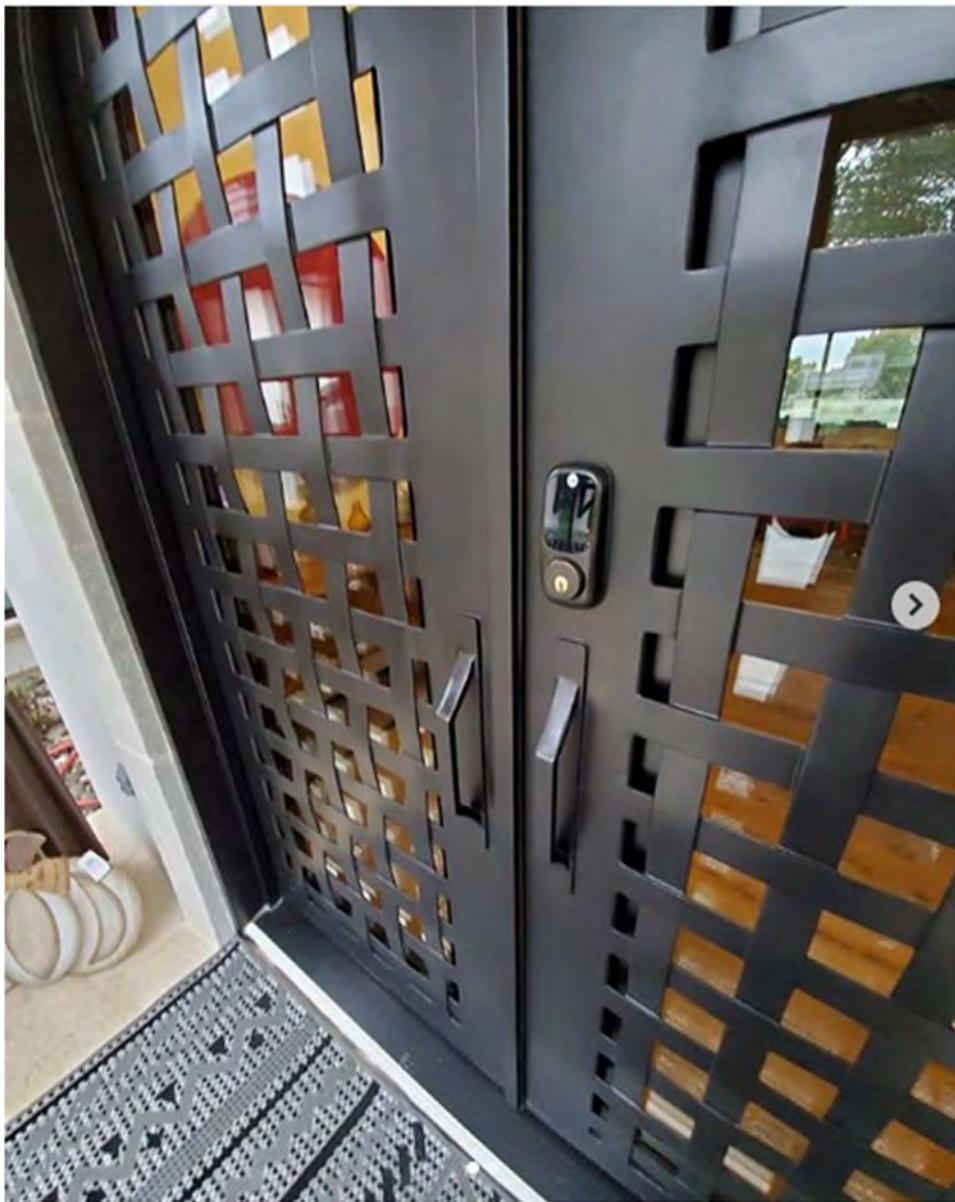
Close up of door design built in the past:
