HISTORIC AND DESIGN REVIEW COMMISSION

2020-112

602 KAMPMANN BLVD

Front door replacement

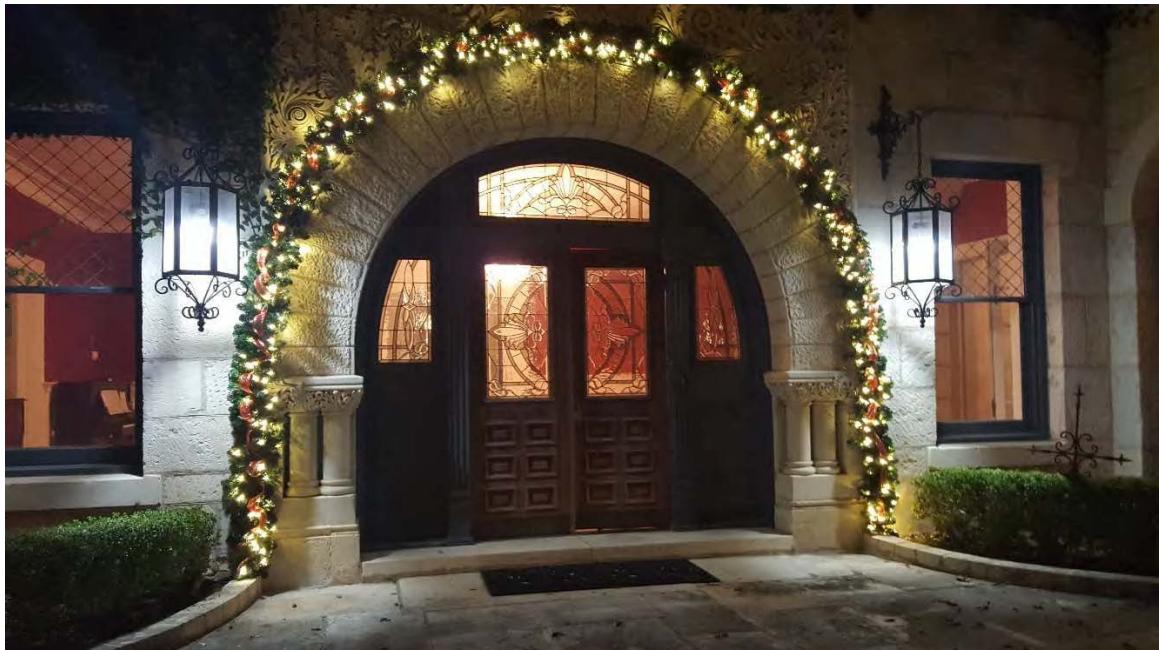
Previous Door:

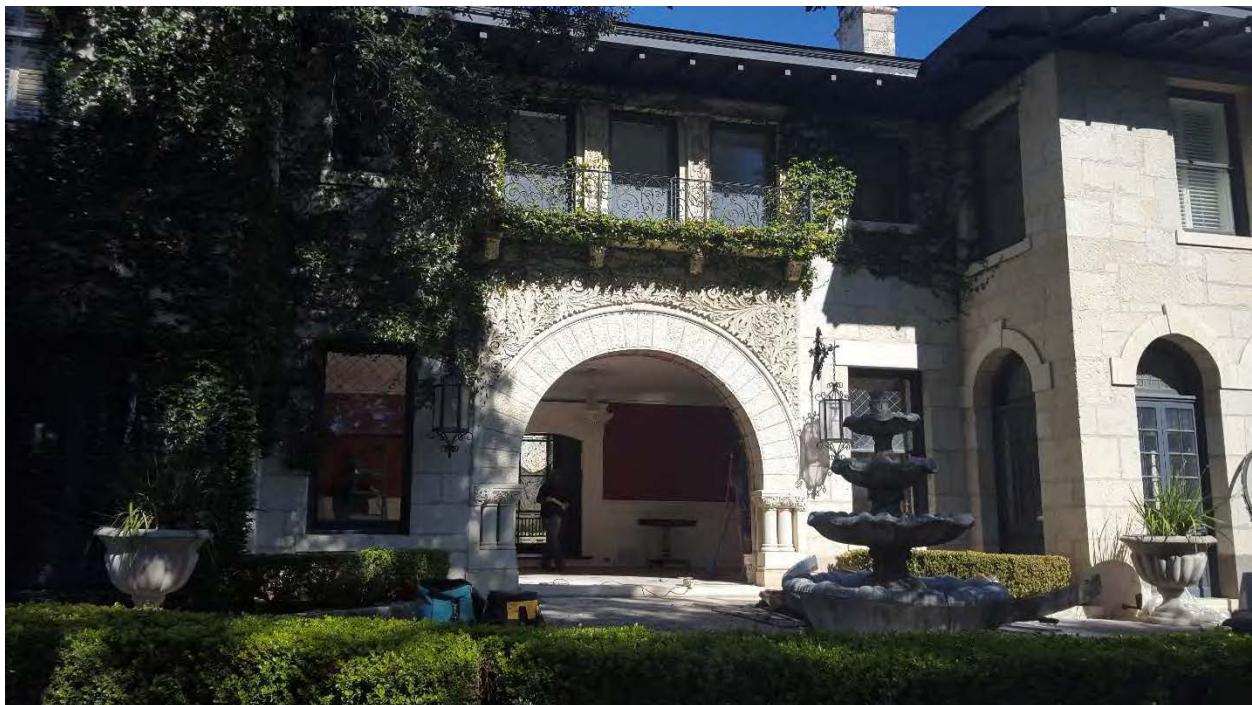
Mid remodel image:

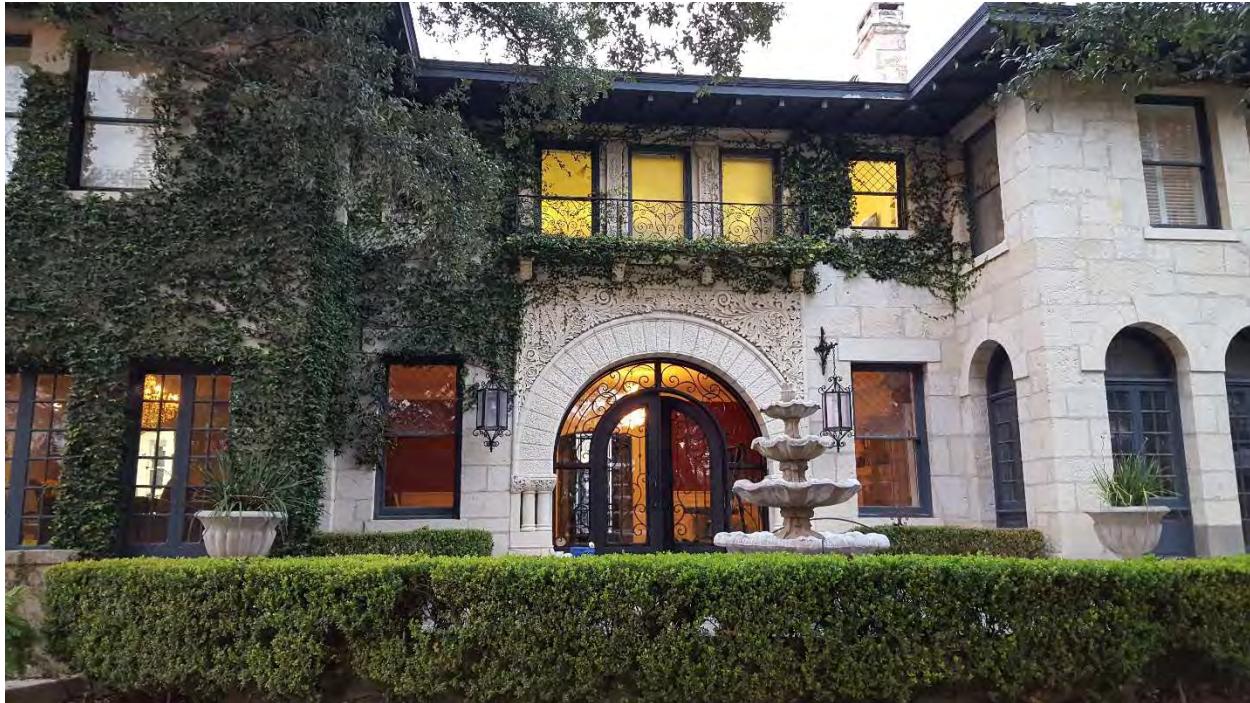
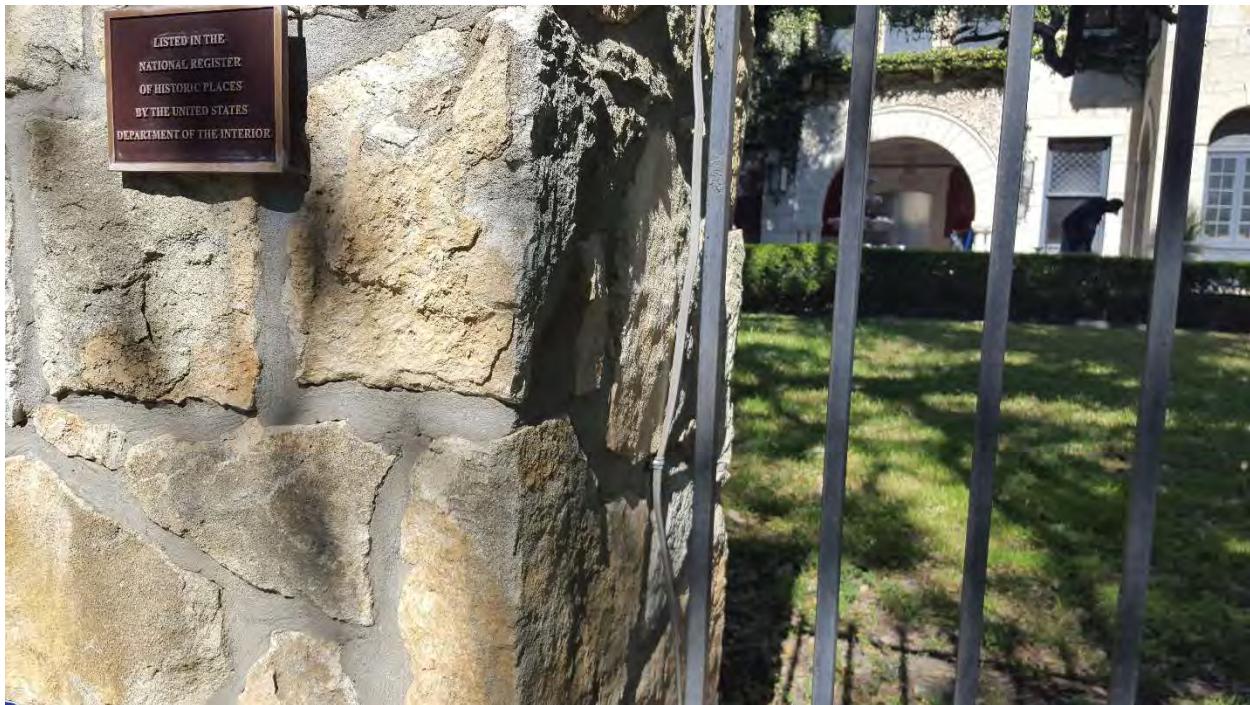
Finished project:
