# HISTORIC AND DESIGN REVIEW COMMISSION

**HDRC CASE NO:** 2018-263  
**ADDRESS:** 415 DONALDSON AVE  
**LEGAL DESCRIPTION:** NCB 6695 BLK 4 LOT 4  
**ZONING:** R-6 H  
**CITY COUNCIL DIST.:** 7  
**DISTRICT:** Monticello Park Historic District  
**APPLICANT:** Tiffany Dumond/Nook Rehab  
**OWNER:** Tiffany Dumond/Nook Rehab  
**TYPE OF WORK:** Limewashing of brick  
**APPLICATION RECEIVED:** May 11, 2018  
**60-DAY REVIEW:** July 10, 2018  
**REQUEST:**

The applicant is requesting a Certificate of Appropriateness to limewash two brick arches on the front façade of the primary structure, totaling approximately 50 bricks.

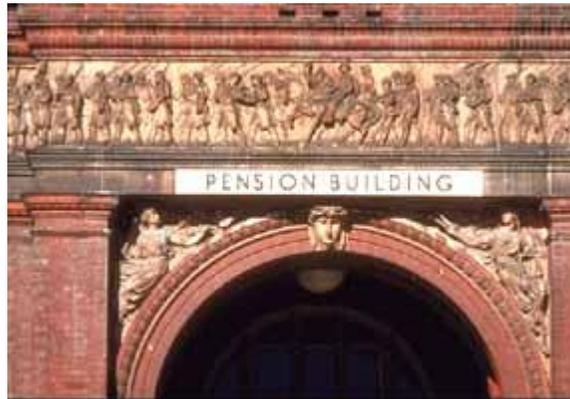
1880s brick building with terra-cotta trim.

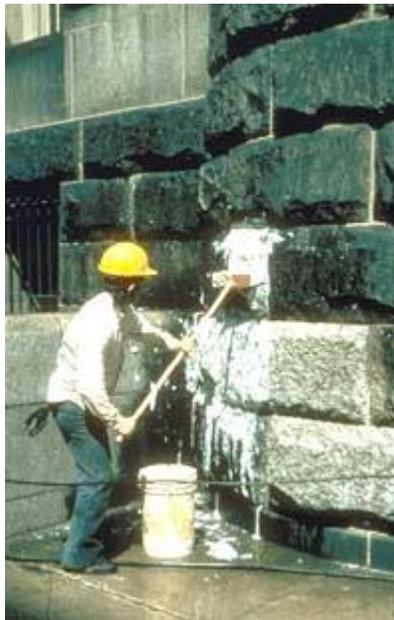
Chemical cleaning to remove dirt from granite.

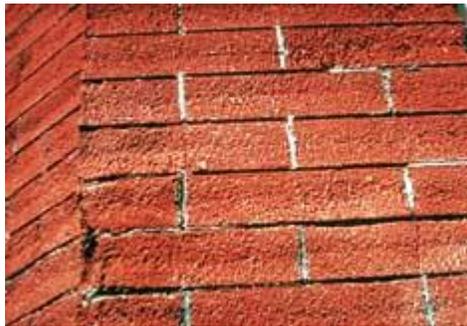
**Historic brick damaged by sandblasting.**

Sandblasting brick or stone surfaces using dry or wet grit or other abrasives. These methods of cleaning permanently erode the surface of the material and accelerate deterioration.

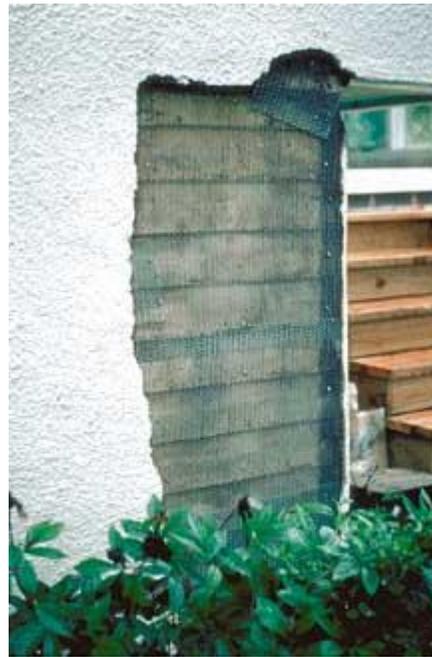
Preparation for stucco repair.

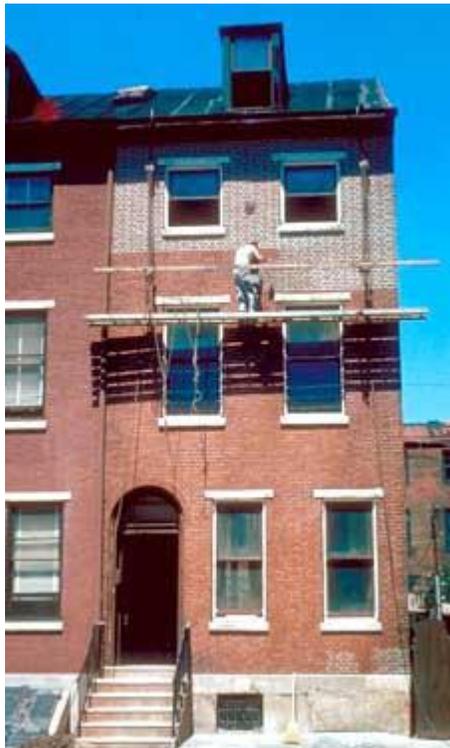
Loss of the historic character due to insensitive repointing.
