Limited Subsurface Investigation

**Sterling – Commerce Street
1432 – 1434 E. Commerce Street
&
323 Idaho Street
San Antonio, Texas 78205**

Drash Consultants, LLC
San Antonio, Texas
January 5, 2017
Drash Project No. 116E1164.00

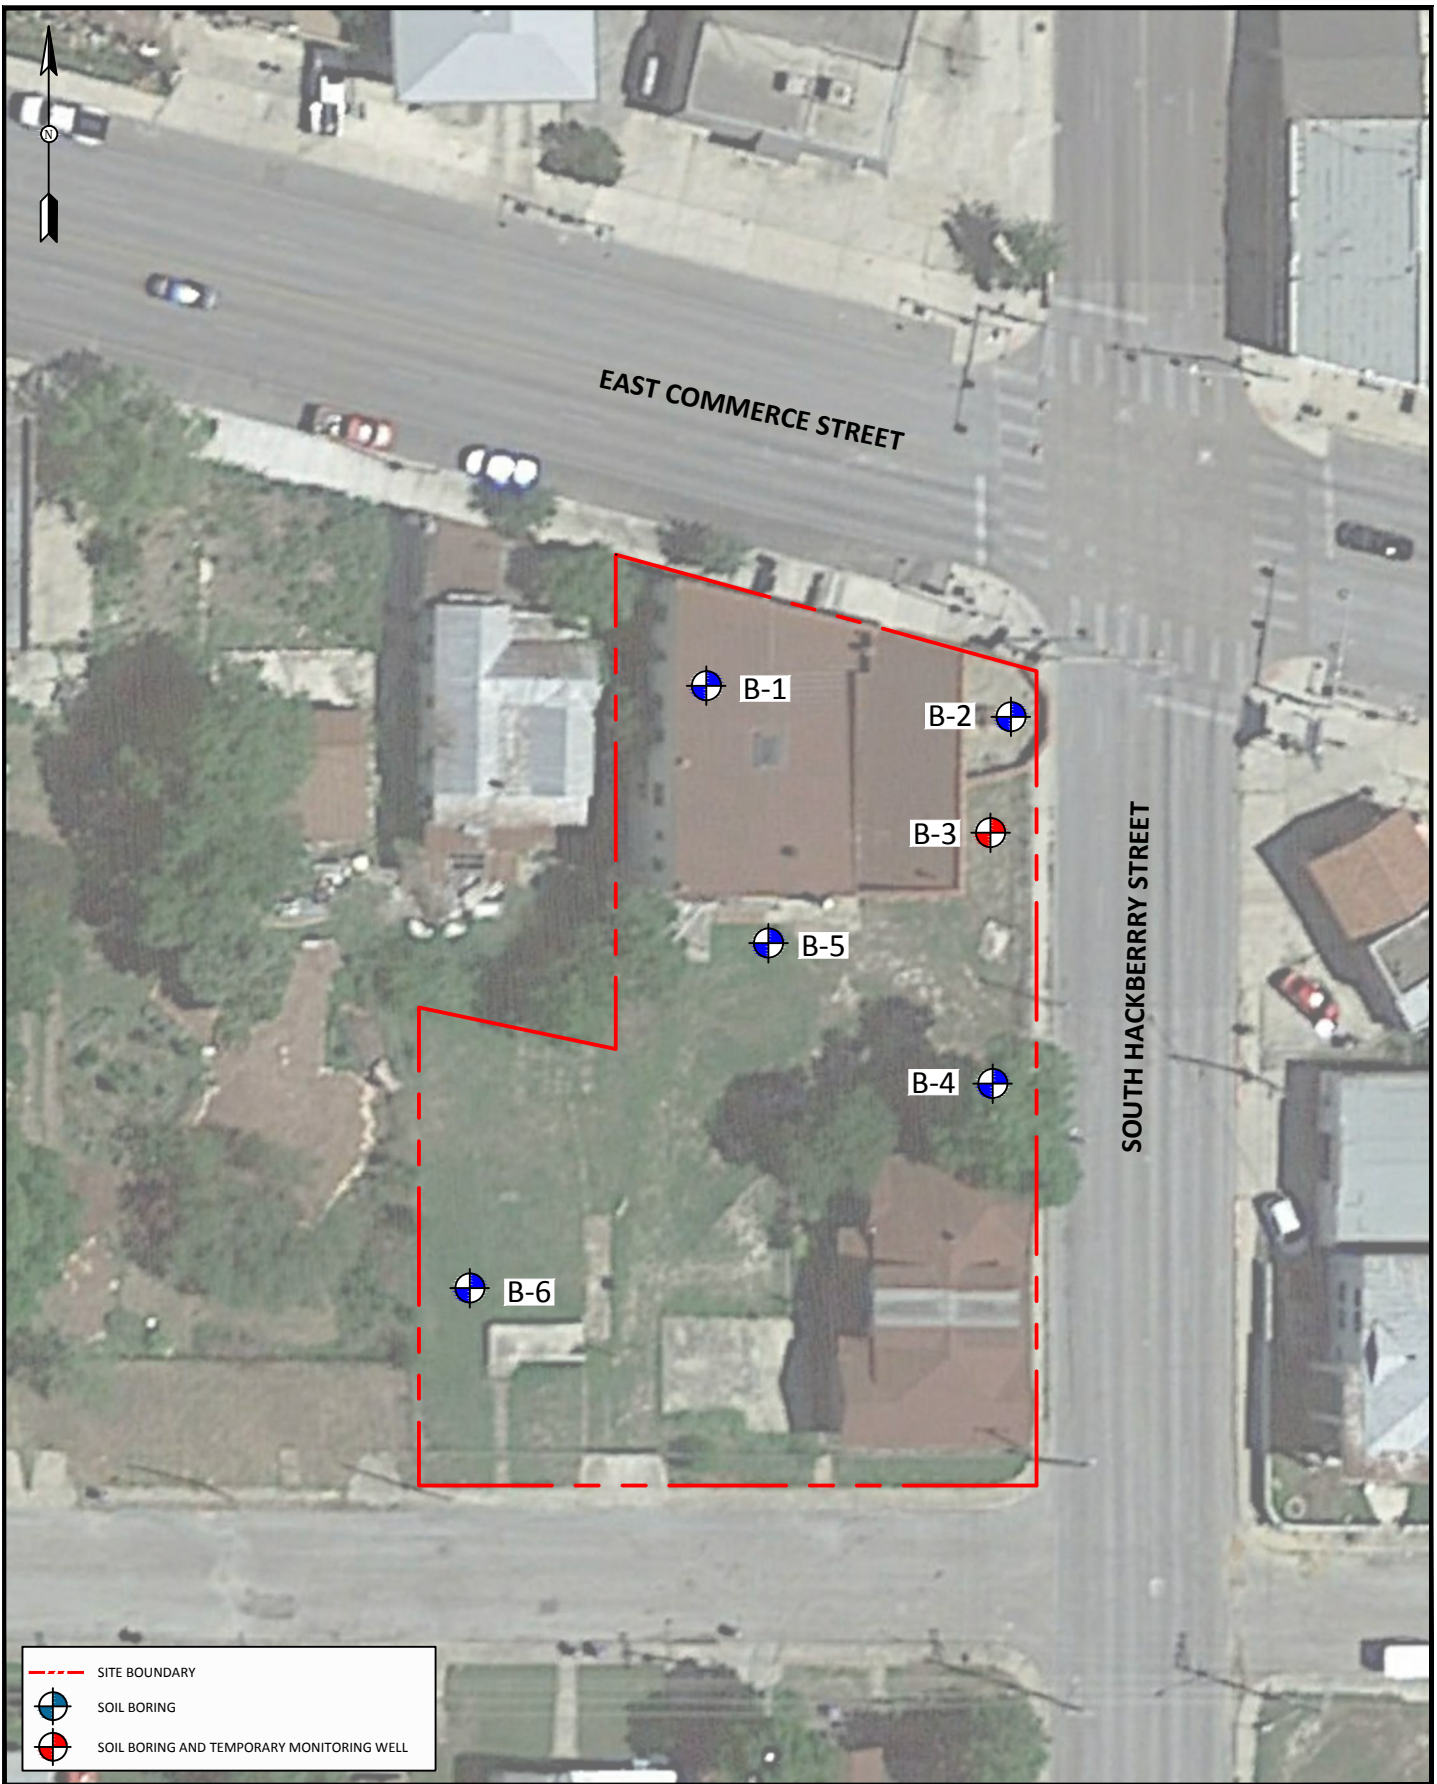
EXHIBIT

Soil Boring	Total Depth (Feet)	Location
B-1	8.0	Interior soil boring located within the northwest central portion of the 1434 E. Commerce Street structure.
B-2	10.0	Interior soil boring located within the far north-eastern portion of the 1432 E. Commerce Street structure.
B-3	15.0	Exterior soil boring located east adjacent to the 1432 E. Commerce Street structure.
B-4	10.0	Exterior soil boring located north-northeast adjacent to the 323 Idaho Street former residential structure.
B-5	15.0	Exterior soil boring located south adjacent to the 1434 E. Commerce Street structure.
B-6	15.0	Exterior soil boring located on the southwest portion of the Site near Idaho Street.

- - - - SITE BOUNDARY

SOIL BORING

SOIL BORING AND TEMPORARY MONITORING WELL

SITE BORING LOCATION PLAN
