# HISTORIC AND DESIGN REVIEW COMMISSION

**HDRC CASE NO:** 2018-026  
**ADDRESS:** 1830 N PINE ST  
**LEGAL DESCRIPTION:** NCB 992 BLK 1 LOT 21  
**ZONING:** R-6, H  
**CITY COUNCIL DIST.:** 2  
**DISTRICT:** Government Hill Historic District  
**APPLICANT:** Christopher Gill/CGRE LTD CO  
**OWNER:** Christopher Gill/CGRE LTD CO  
**TYPE OF WORK:** Installation of windows, amendments to previously approved rear addition, door installation  
**APPLICATION RECEIVED:** January 04, 2018  
**60-DAY REVIEW:** March 05, 2018  
**REQUEST:**

The applicant is requesting a Certificate of Appropriateness for approval to:

1. Amend the previously approved rear addition's fenestration pattern and massing to include roof form and the construction of a hot water heater closer.
2. Install two, architecturally inappropriate windows.
3. Install a front door and address numbers.

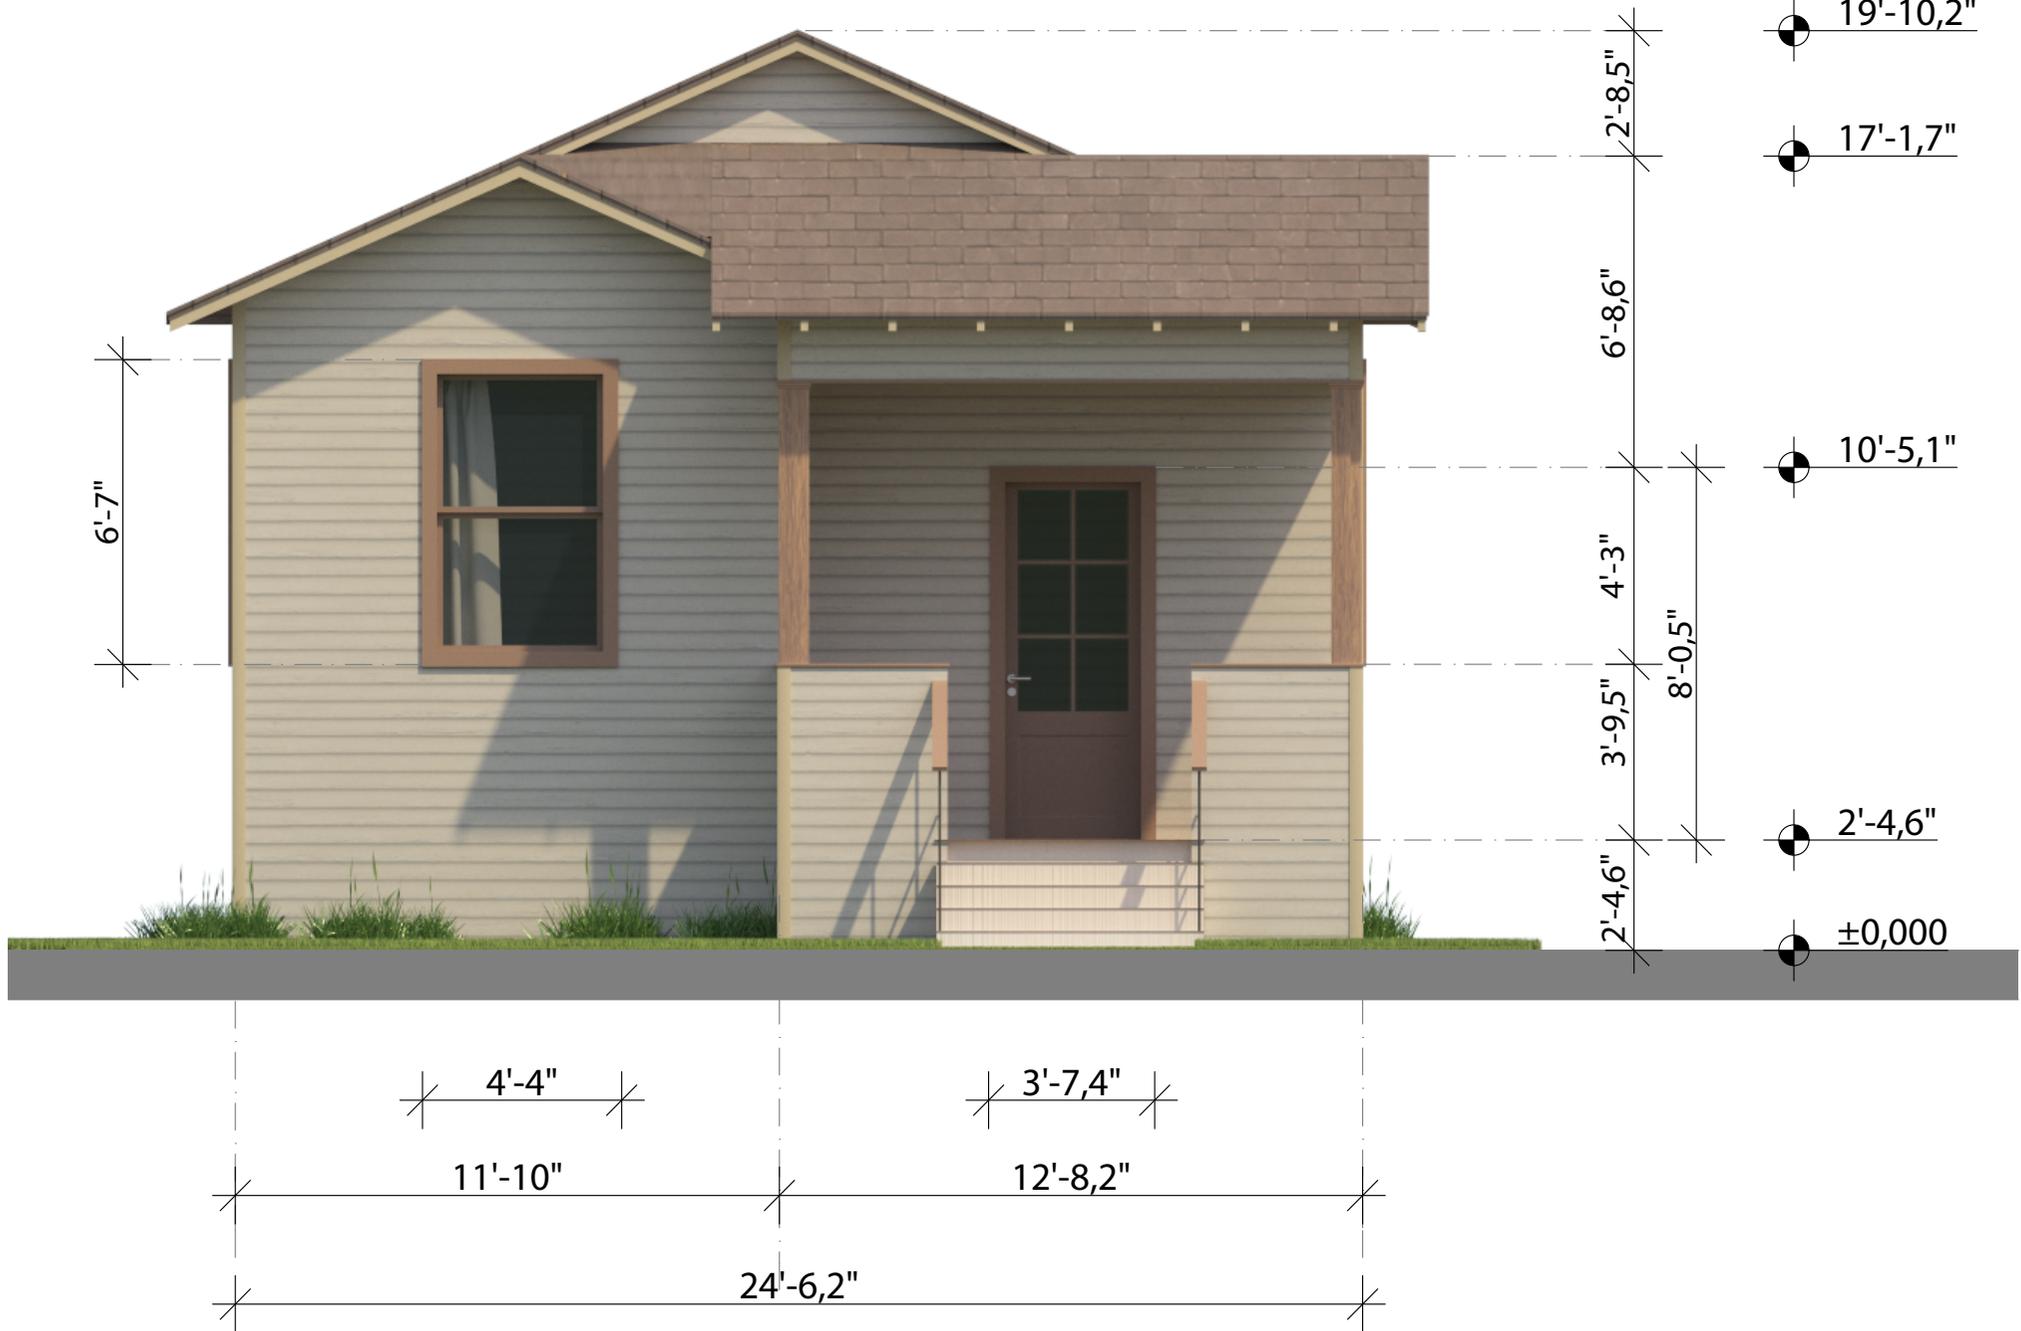
West Elevation (Front)

THE APPLICANT HAS PROPOSED TO REPAIR THE EXISTING PORCH COLUMNS, RETAIN BOTH FRONT DOORS, RETIAN THE FLARED SKIRTING, REPAIR THE ORIGINAL WOOD WINDOWS AND REPAIR ORIGINAL WOOD SIDING.

**APPROVED AT THE DECEMBER 21, 2016, HDRC HEARING**

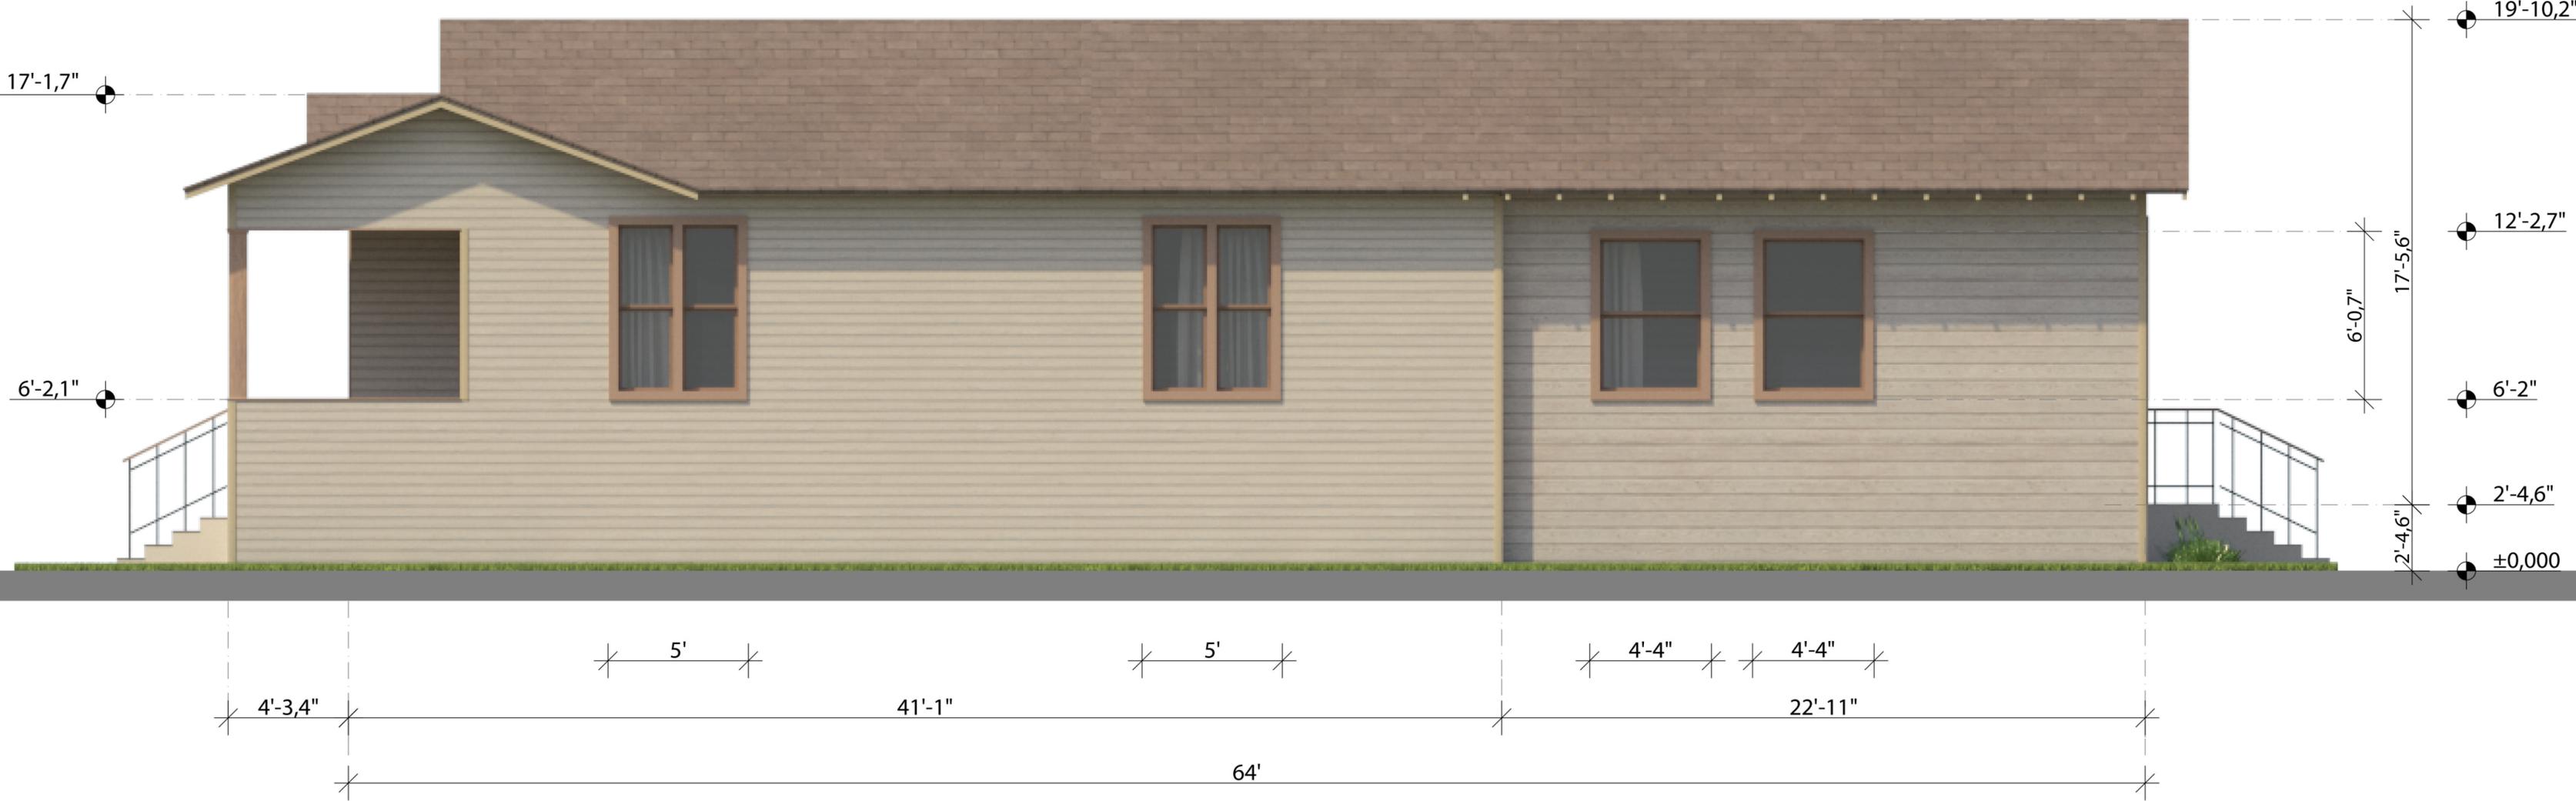
South Elevation (Right)

THE APPLICANT HAS PROPOSED TO REPAIR THE EXISTING PORCH COLUMNS, RETAIN BOTH FRONT DOORS, RETIAN THE FLARED SKIRTING, REPAIR THE ORIGINAL WOOD WINDOWS AND REPAIR ORIGINAL WOOD SIDING.

**APPROVED AT THE DECEMBER 21, 2016, HDRC HEARING**

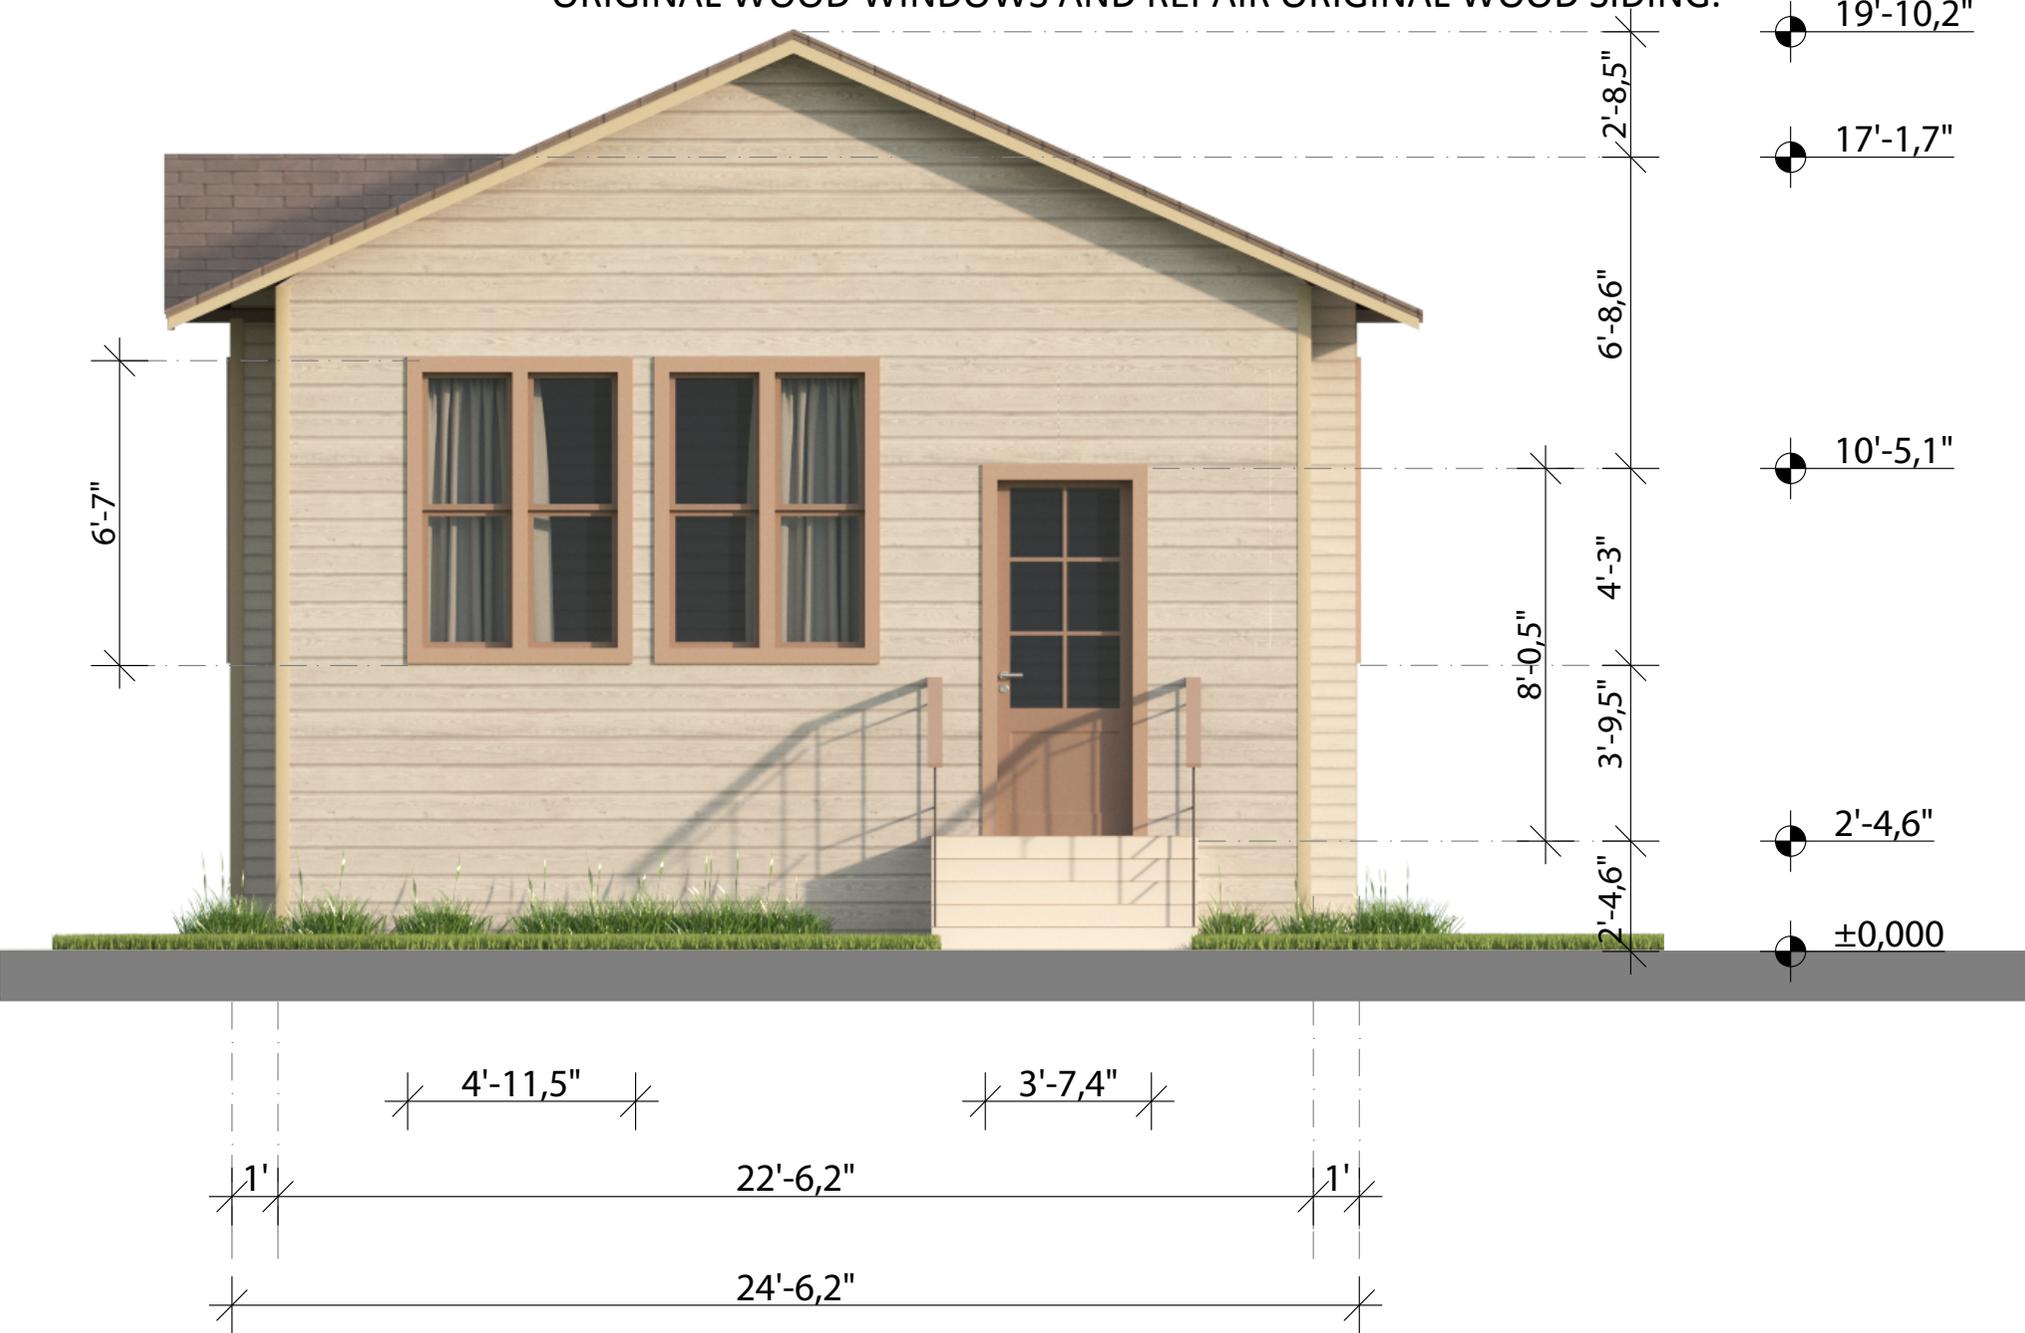
East Elevation (Back)

THE APPLICANT HAS PROPOSED TO REPAIR THE EXISTING PORCH COLUMNS,  
 RETAIN BOTH FRONT DOORS, RETIAN THE FLARED SKIRTING, REPAIR THE  
 ORIGINAL WOOD WINDOWS AND REPAIR ORIGINAL WOOD SIDING.

**APPROVED AT THE DECEMBER 21, 2016, HDRC HEARING**

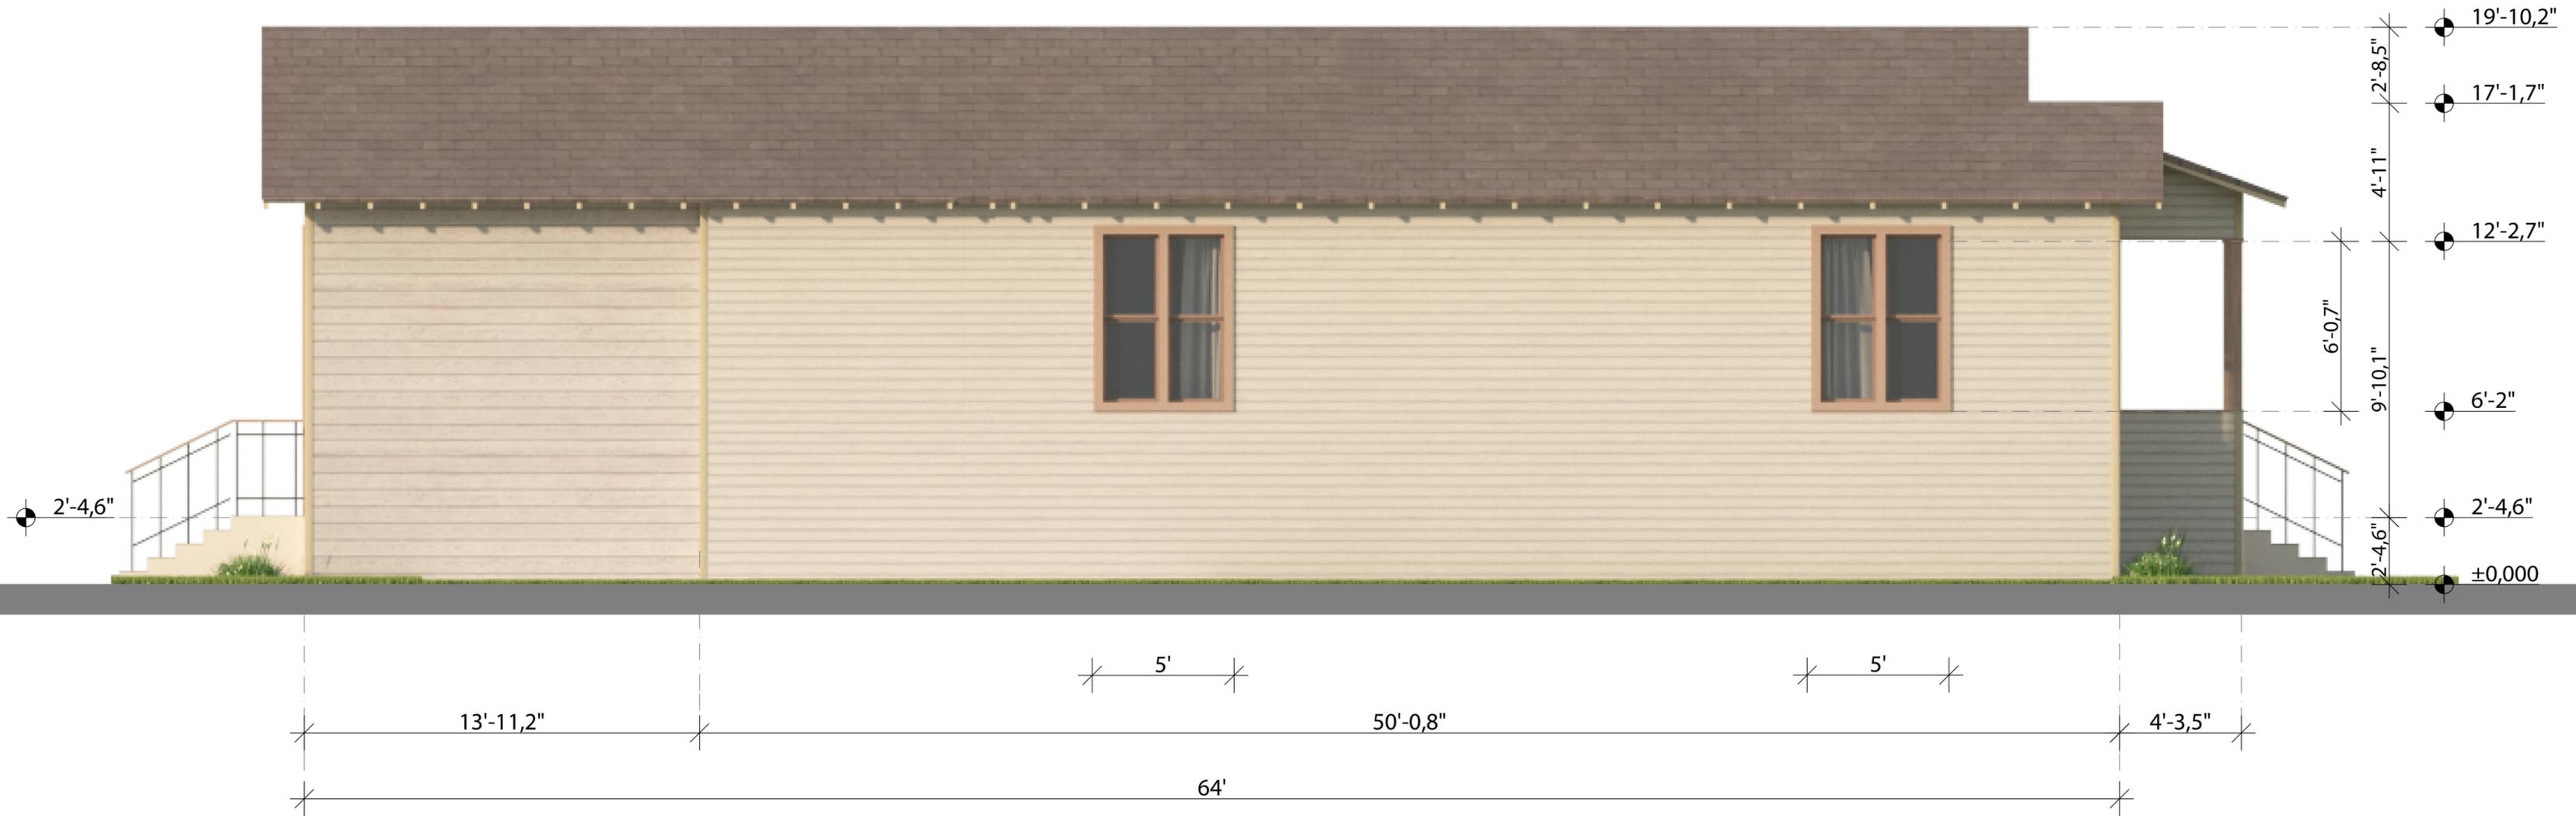
North Elevation (Left)

THE APPLICANT HAS PROPOSED TO REPAIR THE EXISTING PORCH COLUMNS, RETAIN BOTH FRONT DOORS, RETIAN THE FLARED SKIRTING, REPAIR THE ORIGINAL WOOD WINDOWS AND REPAIR ORIGINAL WOOD SIDING.

**APPROVED AT THE DECEMBER 21, 2016, HDRC HEARING**
