HISTORIC AND DESIGN REVIEW COMMISSION

HDRC CASE NO: 2018-270
ADDRESS: 802 N PINE ST
LEGAL DESCRIPTION: NCB 1656 BLK D LOT W 152.4 FT OF S 23.87 OF 7 & W 152.4 FT OF 8
ZONING: R-5 H
CITY COUNCIL DIST.: 2
DISTRICT: Dignowity Hill Historic District
APPLICANT: Office of Historic Preservation
OWNER: Charles Hawkins
TYPE OF WORK: Recommendation to the Building Standards Board (BSB)
APPLICATION RECEIVED: May 29, 2018
60-DAY REVIEW:
REQUEST:

The applicant is requesting a recommendation to the Building Standards Board (BSB) for the repair of the rear accessory structure at 801 Lamar.

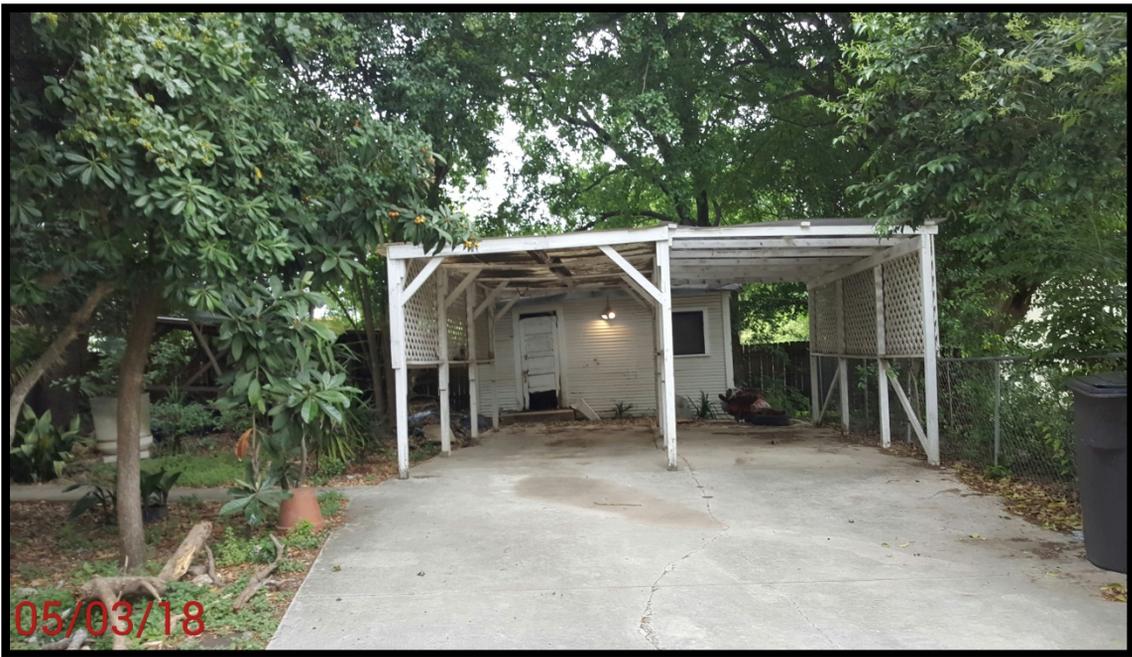
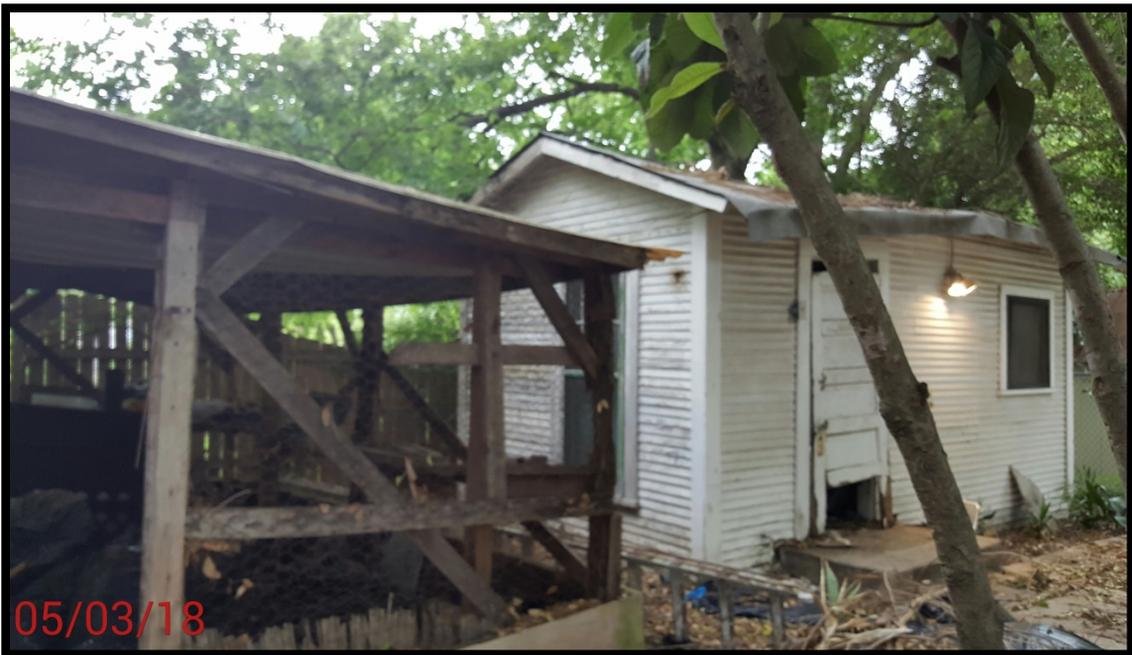
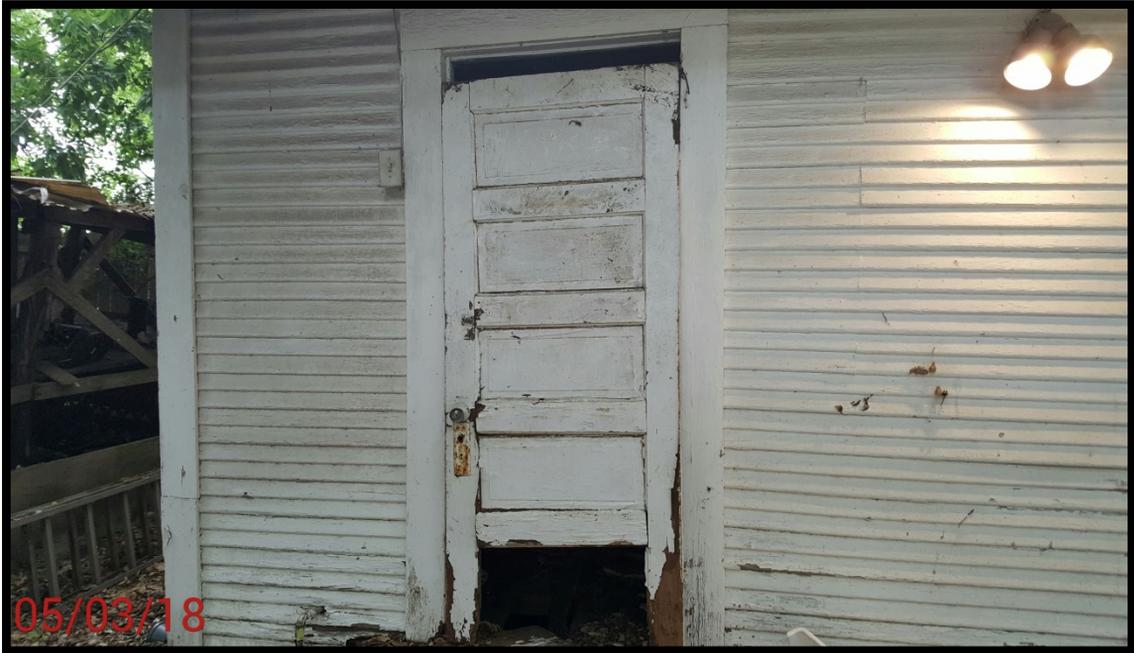
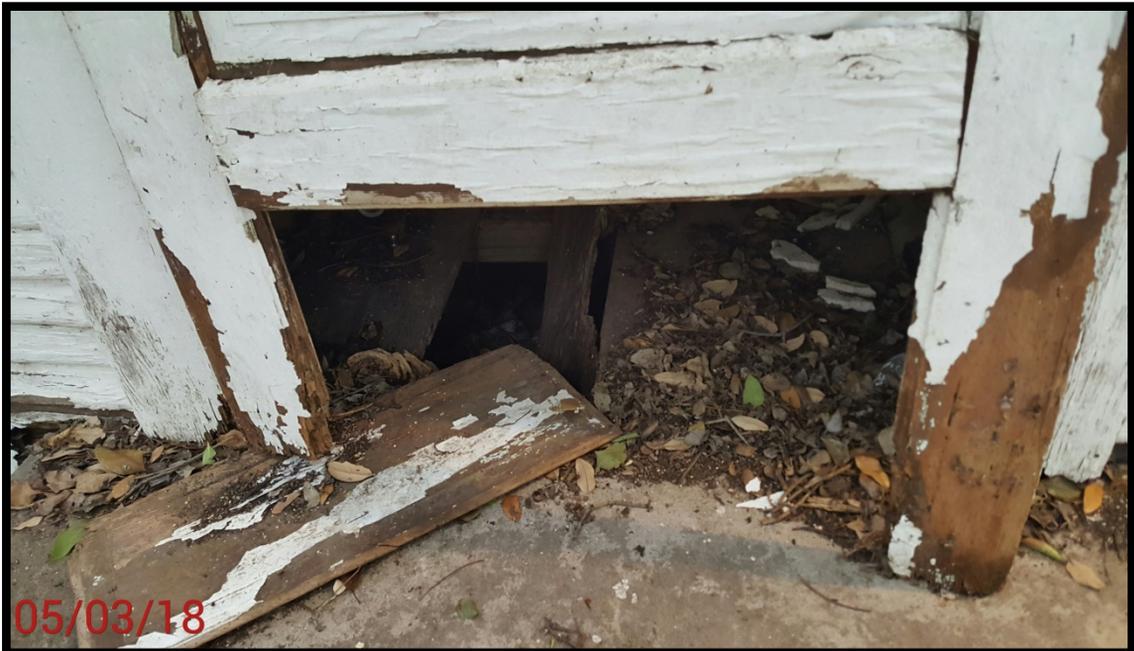
802 Pine Street N. Z94 Complaint#22980226

The City's Code Enforcement Division has determined that the rear accessory structure at this address has deteriorated beyond repair and is recommending demolition of the structure per Chapter 6-156, subsections 1, 2, 12, 15, 17 and 18.

Staff recommends repair of the existing, contributing historic structure based on findings a and b. The repair of this

accessory structure is eligible for administrative approval.
