HISTORIC AND DESIGN REVIEW COMMISSION

HDRC CASE NO: 2020-525
ADDRESS: 831 LAMAR ST
LEGAL DESCRIPTION: NCB 1368 BLK 5 LOT 21
ZONING: R-6, H
CITY COUNCIL DIST.: 2
DISTRICT: Dignowity Hill Historic District
APPLICANT: Ron Hill
OWNER: Ron Hill
TYPE OF WORK: Front yard fence
APPLICATION RECEIVED: November 20, 2020
60-DAY REVIEW: Not applicable due to City Council Emergency Orders
CASE MANAGER: Huy Pham

The applicant is requesting a Certificate of Appropriateness for approval to install a metal cattle panel front yard fence and gate.

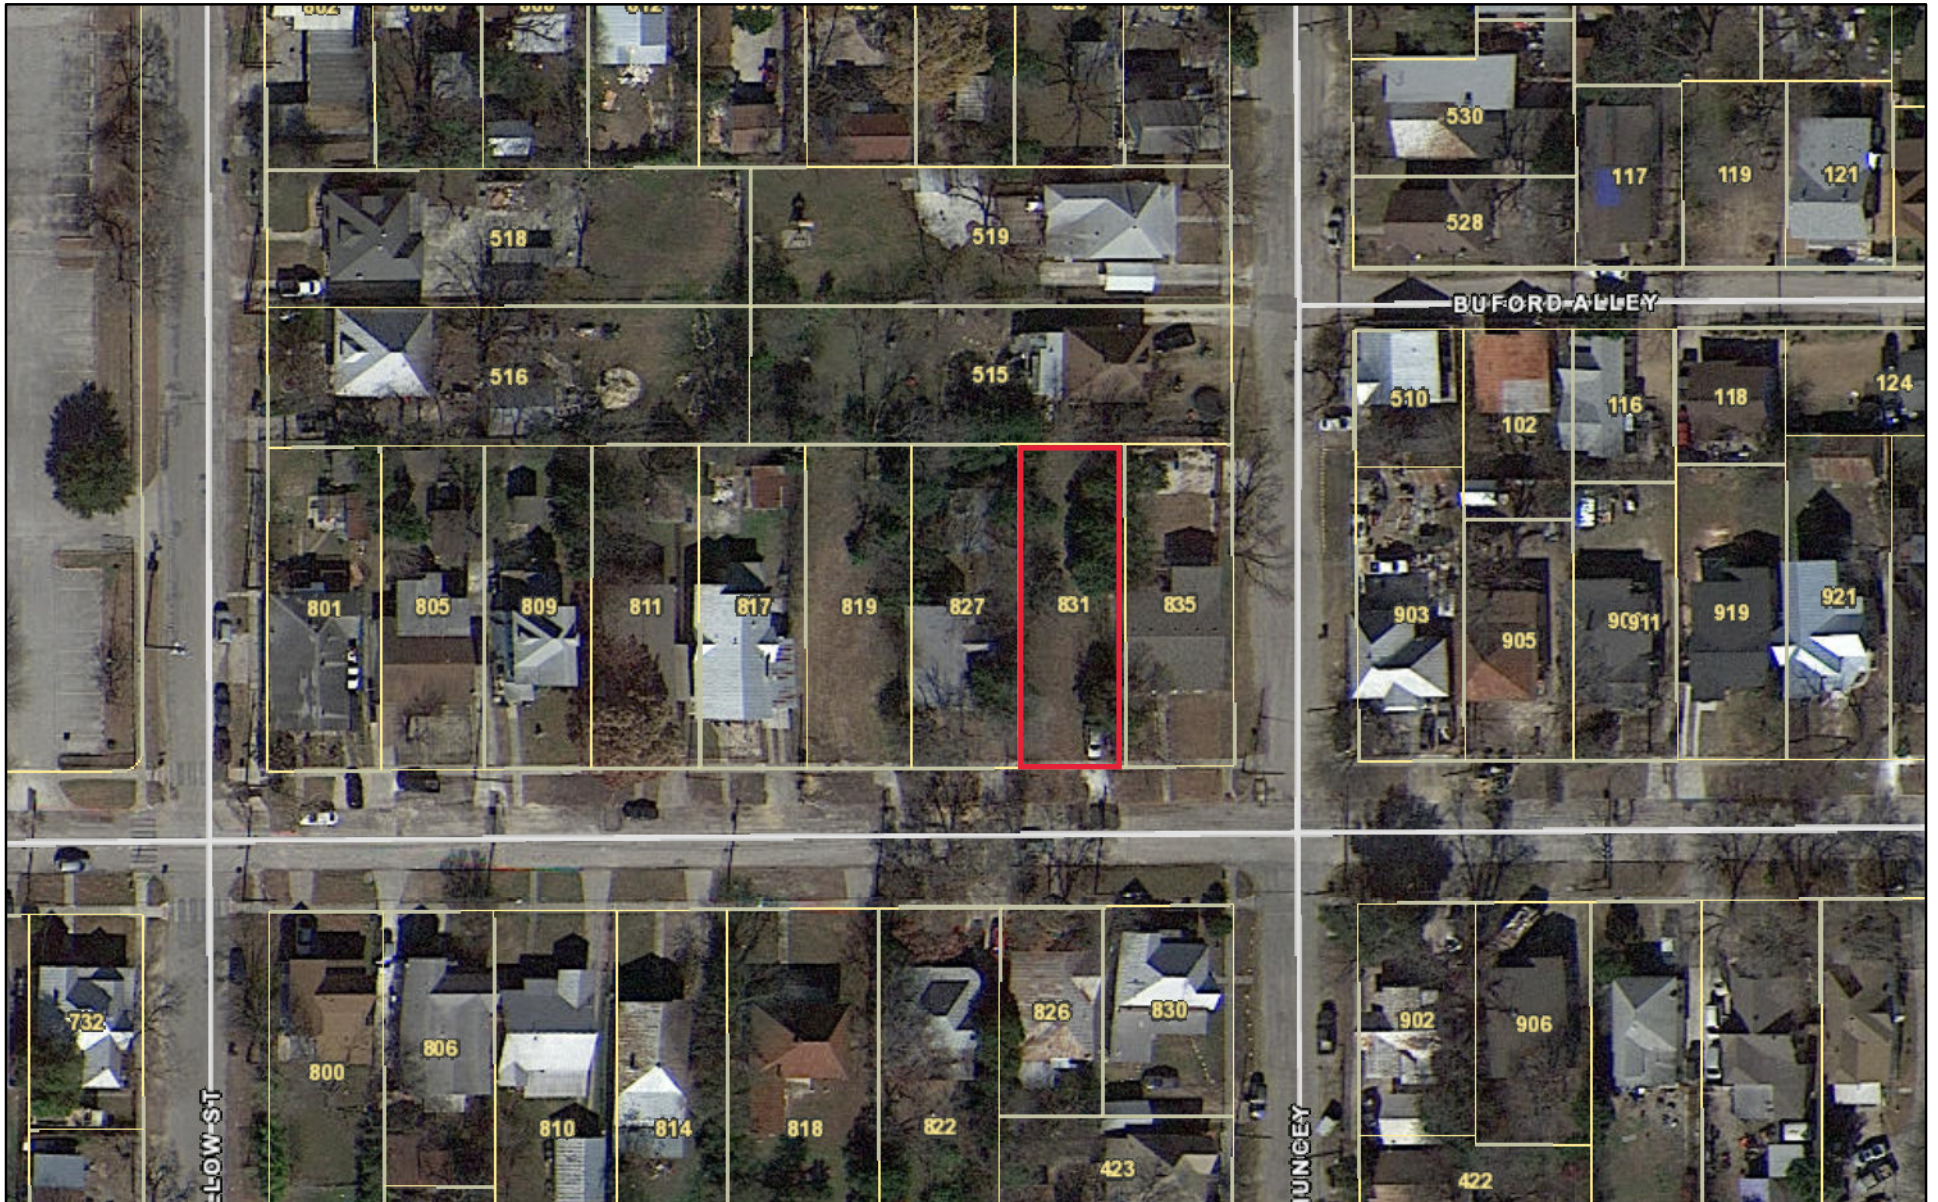
831 Lamar

- b. COMPLIANCE – On a site visit on November 16, 2020, staff found that a wood-framed cattle panel fence with a front driveway gate was installed prior to the issuance a Certificate of Appropriateness and permit. The property owner was cooperative and submitted an application of November 16, 2020, to be heard at the next available hearing.

- i. That the fence height is no taller than 4 feet at any portion in front of the front façade plane.
- ii. That any solar or mechanical gate equipment, if used, be concealed or minimally visible behind the fence from the public right of way.

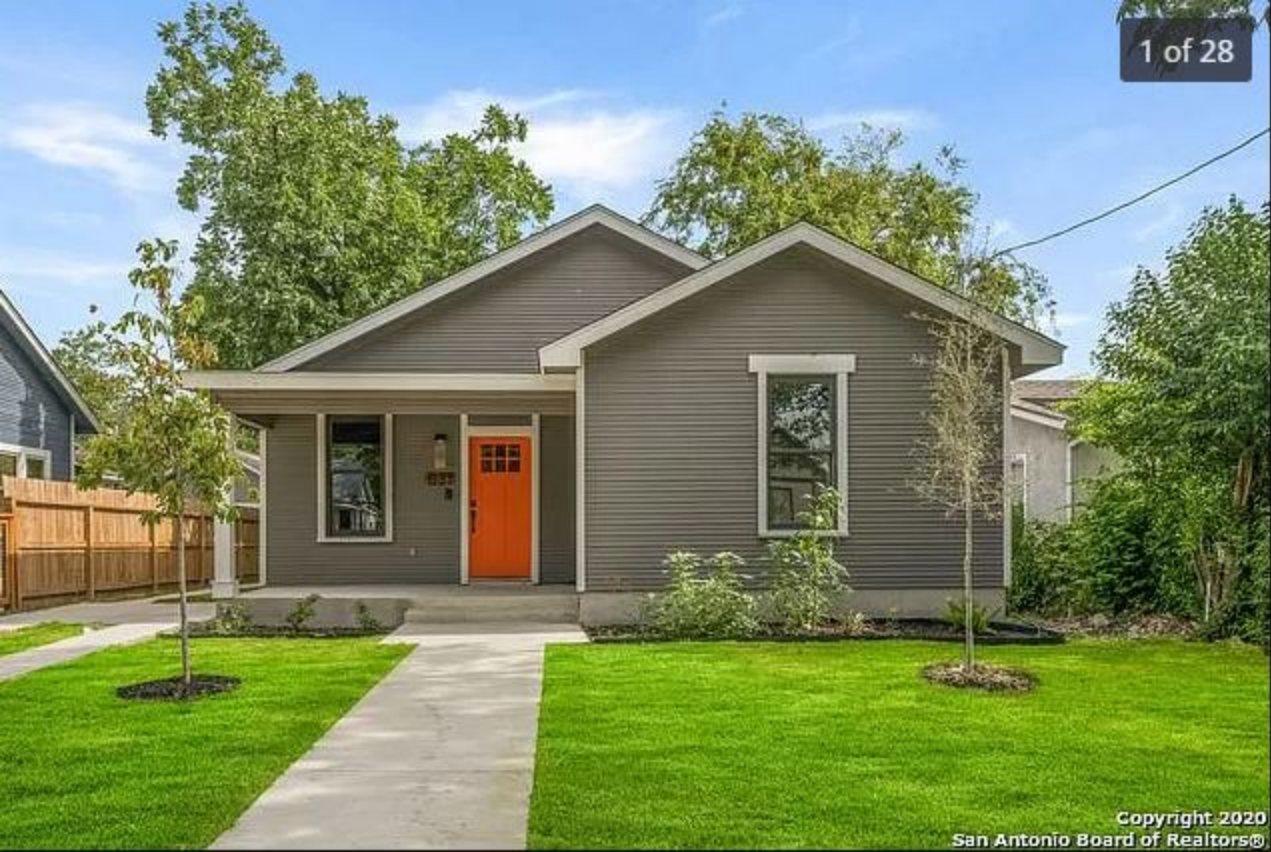
6' wood privacy

Future 6' wood privacy

Gate 4' metal

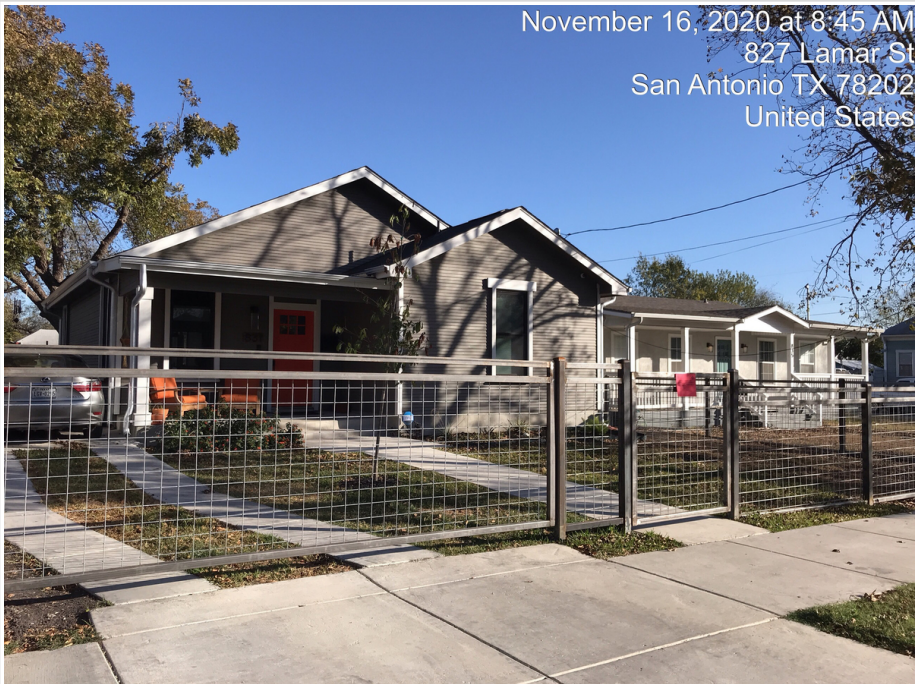
Photographs	<div>November 16, 2020 at 8:45 AM 827 Lamar St San Antonio TX 78202 United States</div>

Date	11/16/2020
Time	08:55 AM (-6 GMT)
Context	citizen report
Present Staff	Huy Pham
Present Individuals	Neighbor
Types of Work Observed	Site Elements
Amount of Work Completed	Completed
Description of work	Metal framed cattle panel fence with front driveway gate
Description of interaction	Staff spoke to owner who explained that the fence contractors said they revived permits and approval. Staff explained that no application has been submitted or approved. The owner was cooperative and committed to follow up.
