## HISTORIC AND DESIGN REVIEW COMMISSION

**HDRC CASE NO:** 2017-033  
**ADDRESS:** 293 W HERMOSA  
**LEGAL DESCRIPTION:** NCB 9016 BLK 8 LOT E 65.5 OF W 70 FT OF 7A THRU 10A & S 15 OF E 65.5 OF W 70 OF 6A  
**ZONING:** R-4  
**CITY COUNCIL DIST.:** 1  
**DISTRICT:** Olmos Park Terrace Historic District  
**APPLICANT:** Gene Gordon  
**OWNER:** Ironclad Bulls Com, LLC  
**TYPE OF WORK:** Historic Tax Certification, replace garage doors  
**REQUEST:**

The applicant is requesting a Certificate of Appropriateness for approval to install one double steel door at rear of the garage and receive the Historic Tax Certification.

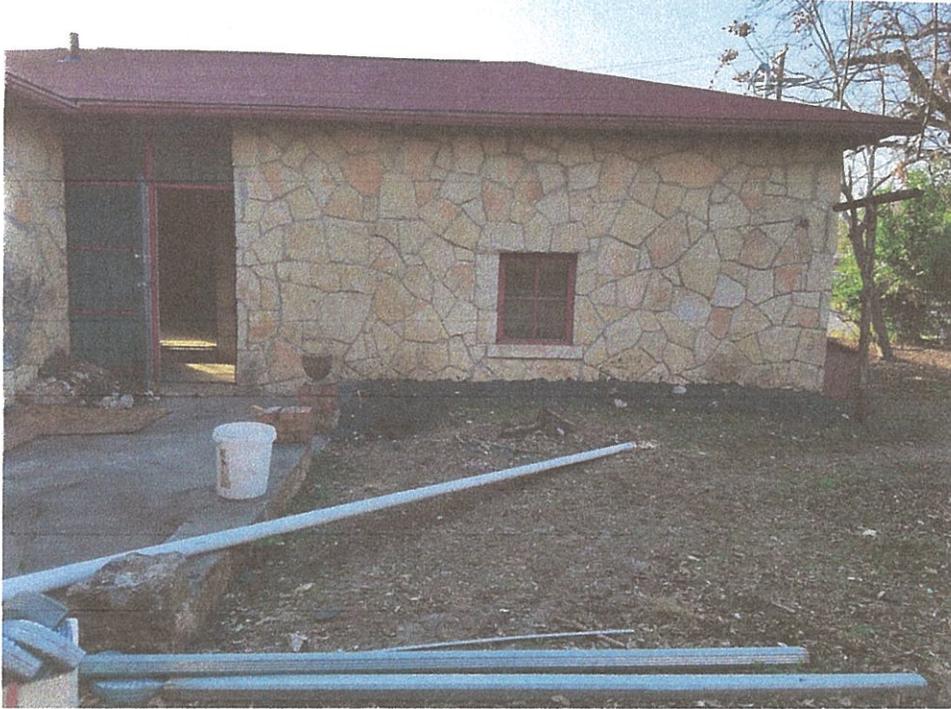
Rear wall of garage  
Dimensions: 20' x 9'

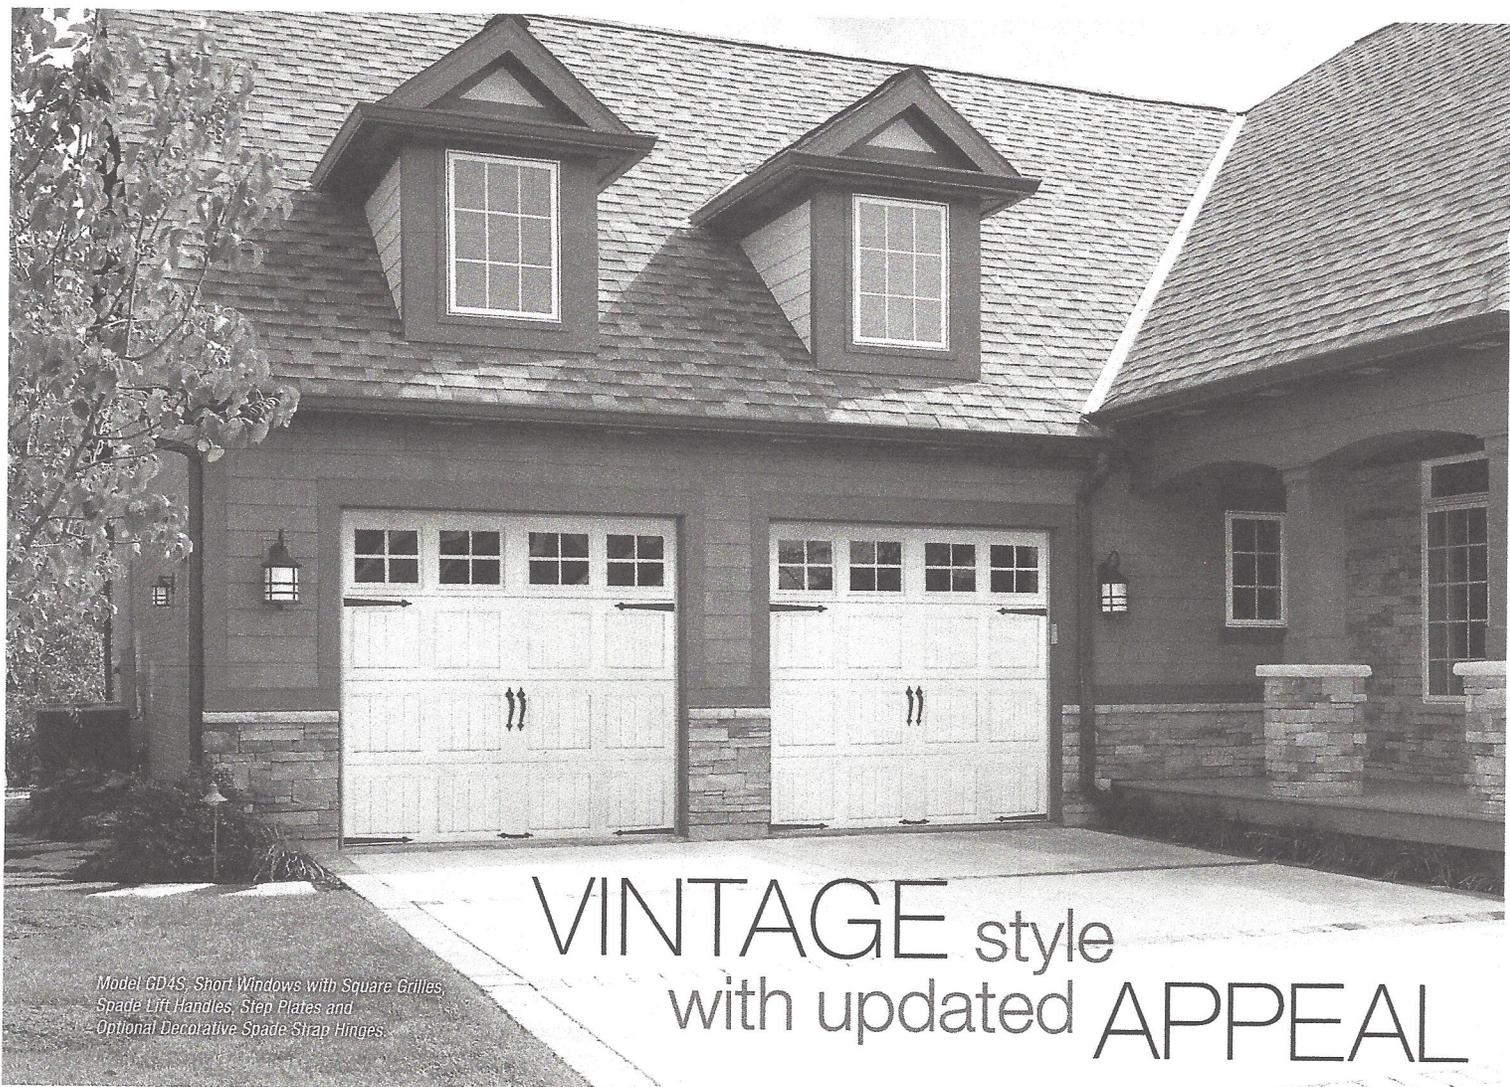
Model GD4S, Short Windows with Square Grilles, Spade Lift Handles, Step Plates and Optional Decorative Spade Strap Hinges.

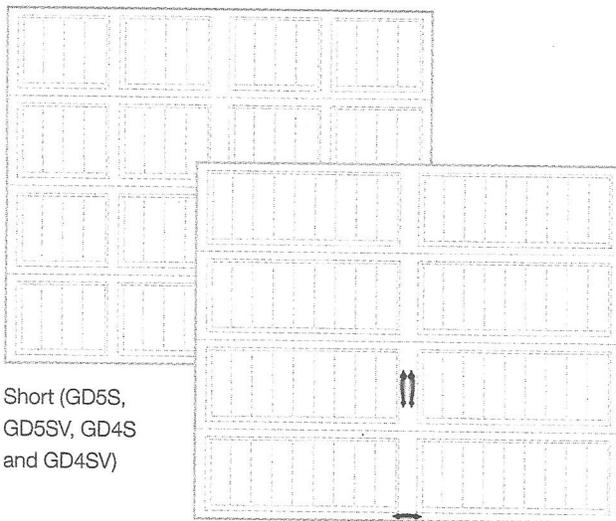
Short (GD5S, GD5SV, GD4S and GD4SV)

Long (GD4L and GD4LV)

GD5S/GD5SV available 5'0"–18'0" wide in 2" increments (excludes 10'2"–11'4" and 14'8").  
 GD4S/GD4SV available 5'0"–20'0" wide in 2" increments (excludes 10'2"–11'4" and 14'8").  
 GD4L/GD4LV available 7'8"–20'0" wide in 2" increments (excludes 10'2"–11'4" and 14'8").  
 All doors available 6'0"–16'0" high in 3" increments.  
 Standard hardware shown above.

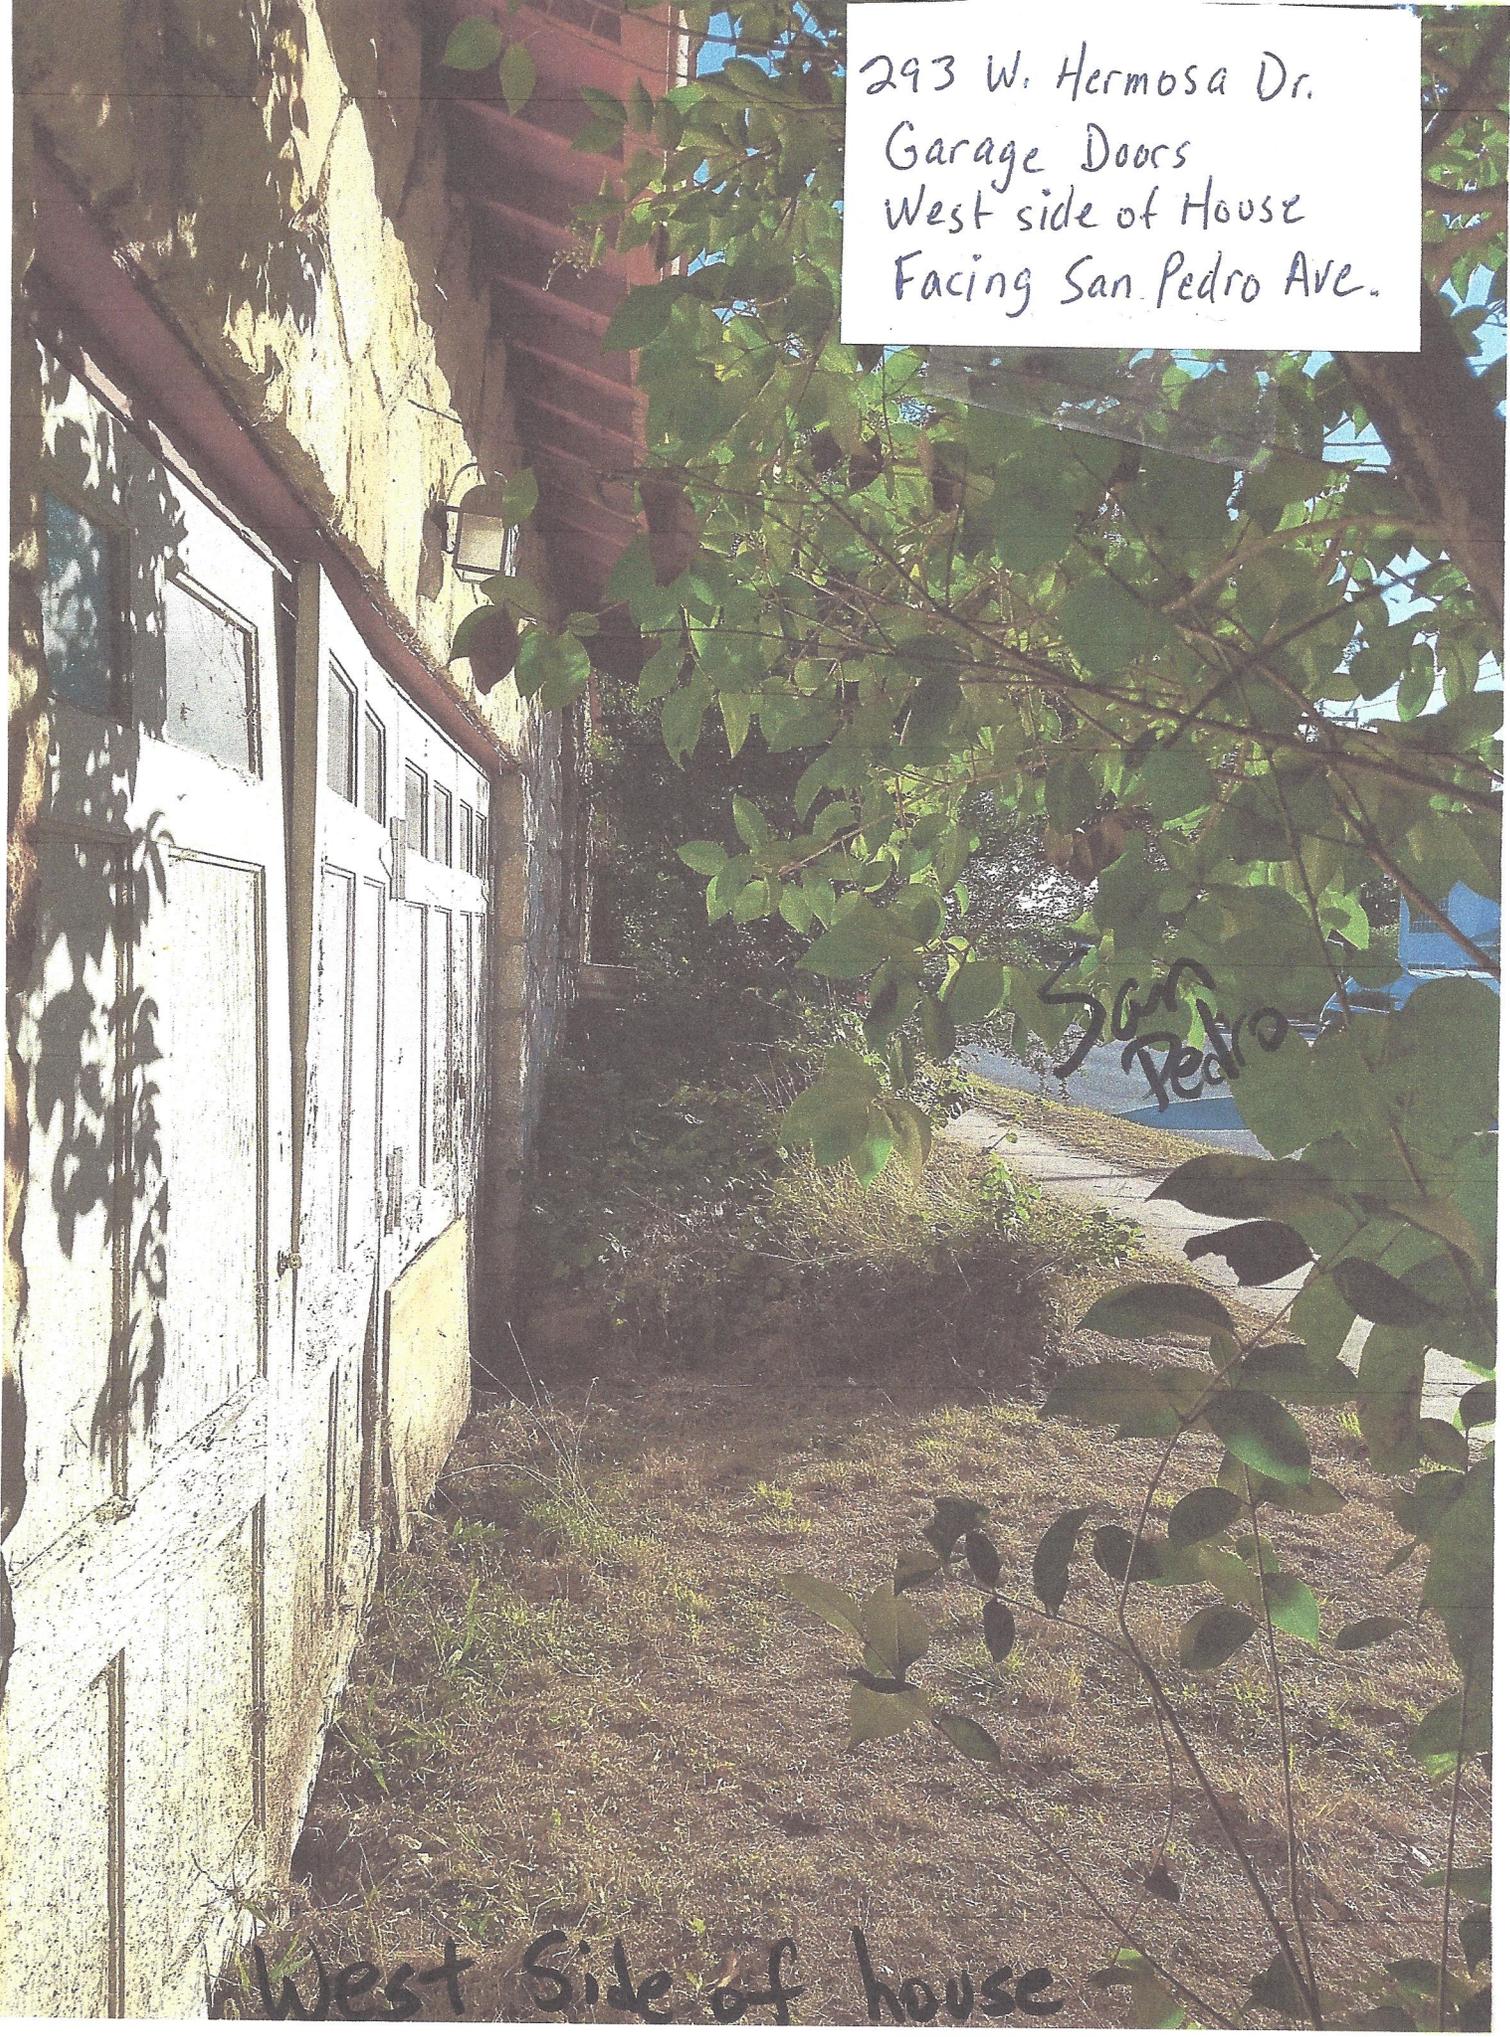
293 W. Hermosa Dr.  
Garage Doors  
West side of House  
Facing San Pedro Ave.
