# HISTORIC AND DESIGN REVIEW COMMISSION

**HDRC CASE NO:** 2015-160  
**ADDRESS:** 311 SHANNON LEE  
**LEGAL DESCRIPTION:** NCB 12011 BLK 3 LOT 19 & P-101 (ALLEY)  
**ZONING:** R5  
**CITY COUNCIL DIST.:** 1  
**APPLICANT:** David Pulido  
**OWNER:** City of San Antonio  
**TYPE OF WORK:** Barbara Dr. - Drainage Project  
**REQUEST:**

# BARBARA DRAINAGE

HISTORIC RESOURCES SURVEY REPORT,  
BARBARA DRIVE DRAINAGE PROJECT  
SAN ANTONIO, BEXAR COUNTY, TEXAS

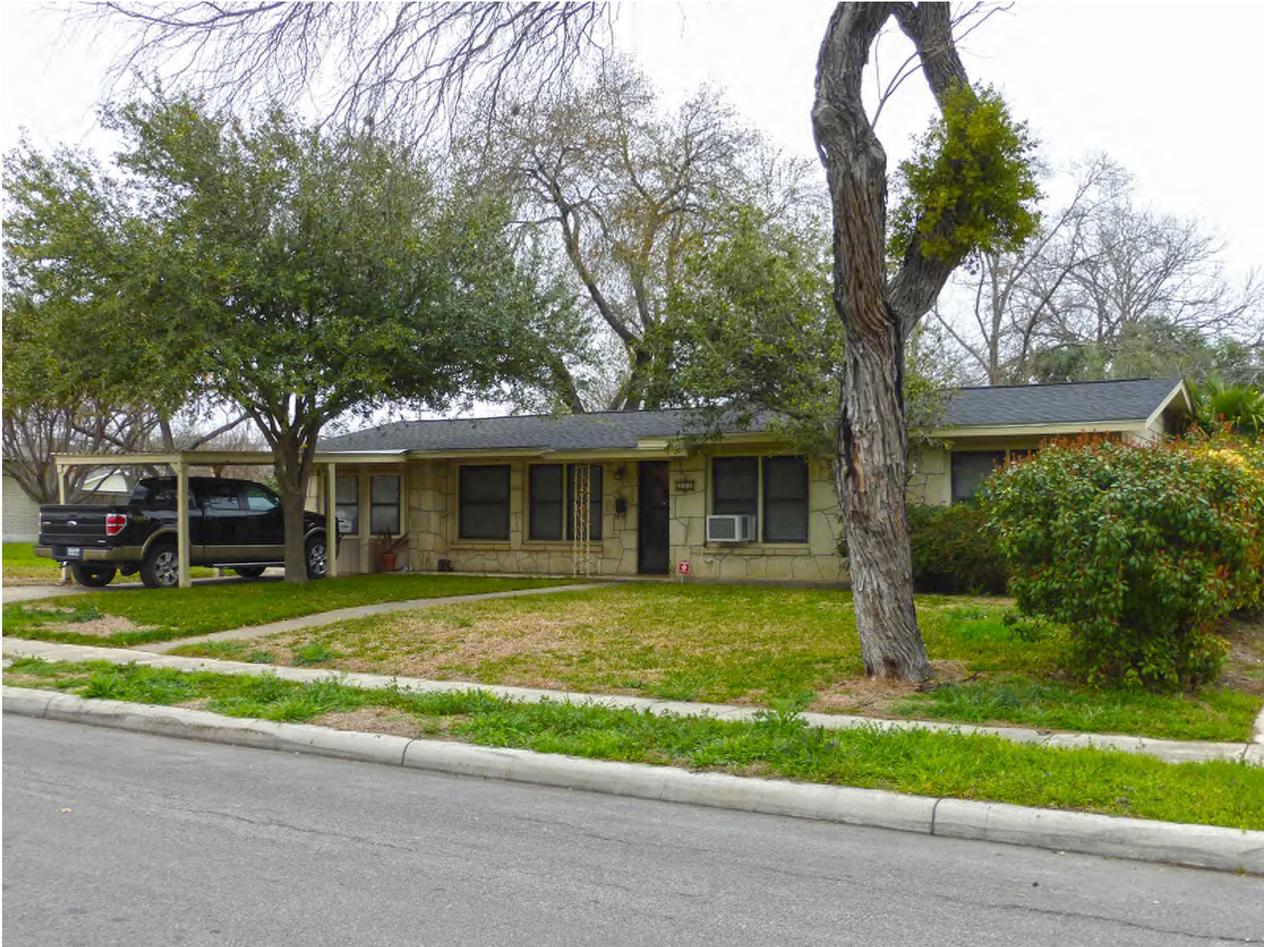
View of front facade of Resource 1, facing northwest.

**Description:** Resource 1 is a side-gable Ranch-style house with stone siding on the front facade. The porch features a decorative metal support. The garage has been enclosed and a carport has been added in front of the former garage. The house also has replacement vinyl siding on the east and west facades and a replacement front door.

**NRHP Justification:** Due to loss of historic materials and workmanship through non-historic age modifications, this house no longer retains the integrity to convey its significance. As a result, it is recommended Not Eligible for the NRHP.

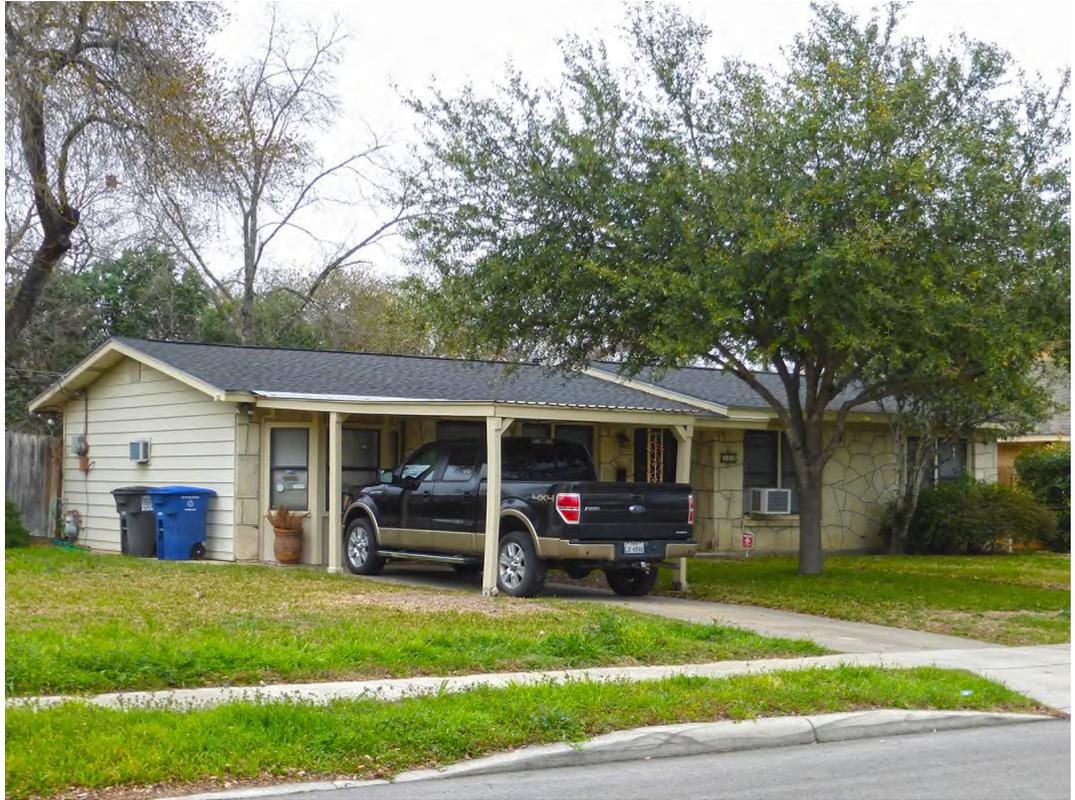
Photo 2 date taken:  
02-16-15

Oblique view of Resource 1,  
facing northeast.

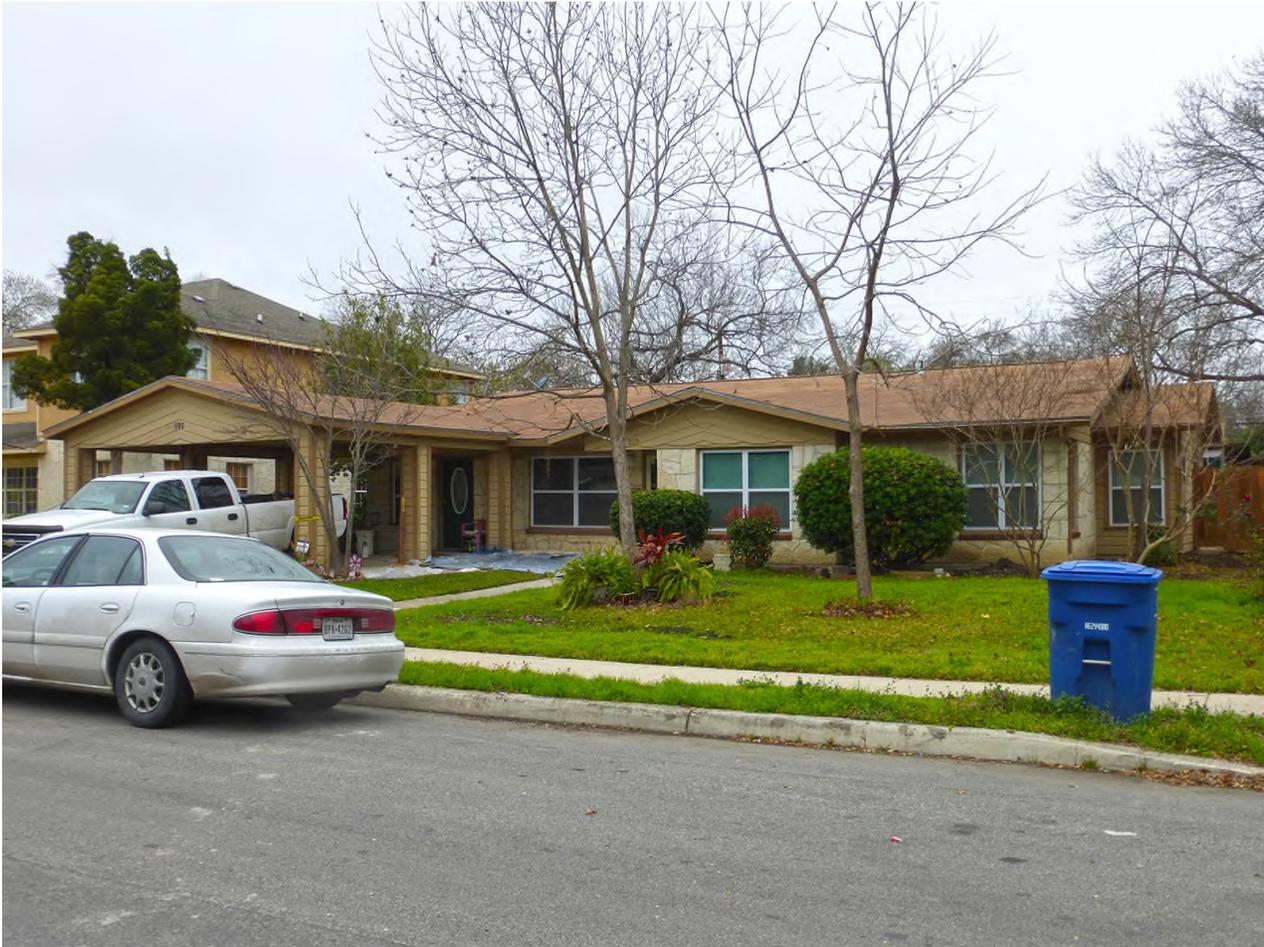
View of front facade of Resource 2. Camera facing northwest.

**Description:** Resource 2 is a cross-gable Ranch-style house with stone siding on the front facade. The house has an inset entrance. The garage has been enclosed and a non-historic-age carport has been added in front of the former garage. The house also has a replacement front door and non-historic age storm windows have been added.

**NRHP Justification:** Due to loss of historic materials and workmanship through non-historic age modifications, this house no longer retains the integrity necessary to convey its significance. As a result, it is recommended Not Eligible for the NRHP.

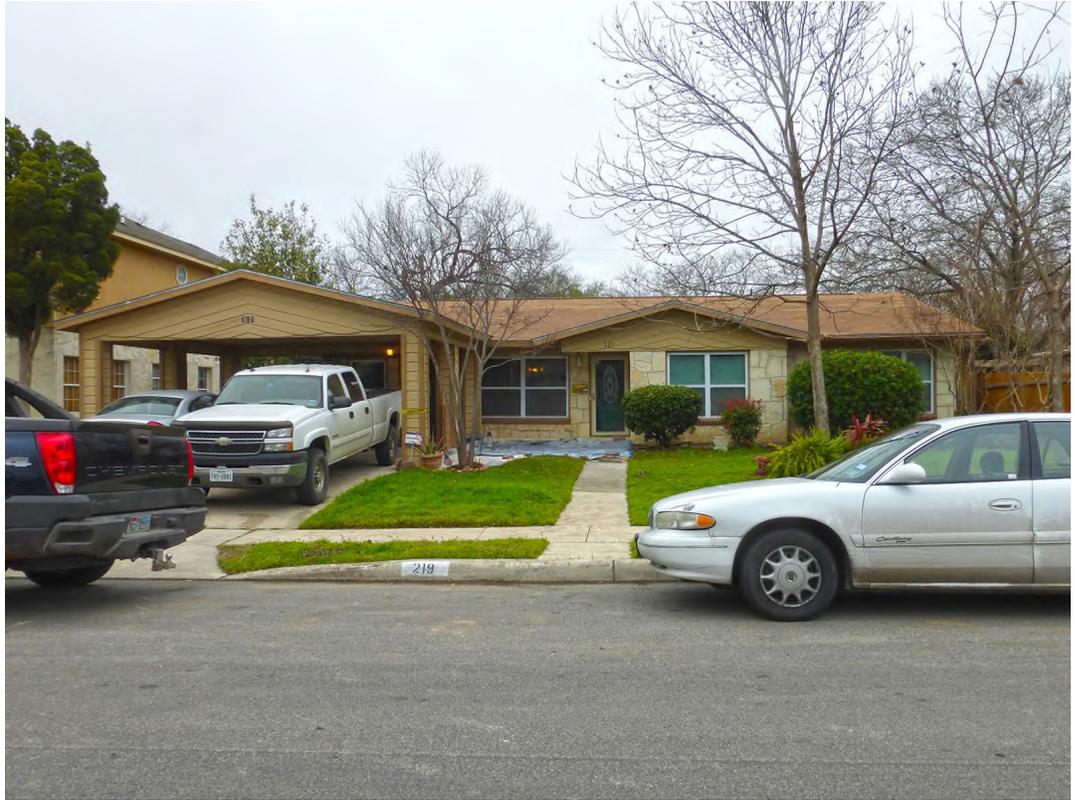
Photo 2 date taken:  
02-16-15

View of front facade of Resource 2. Camera facing north.

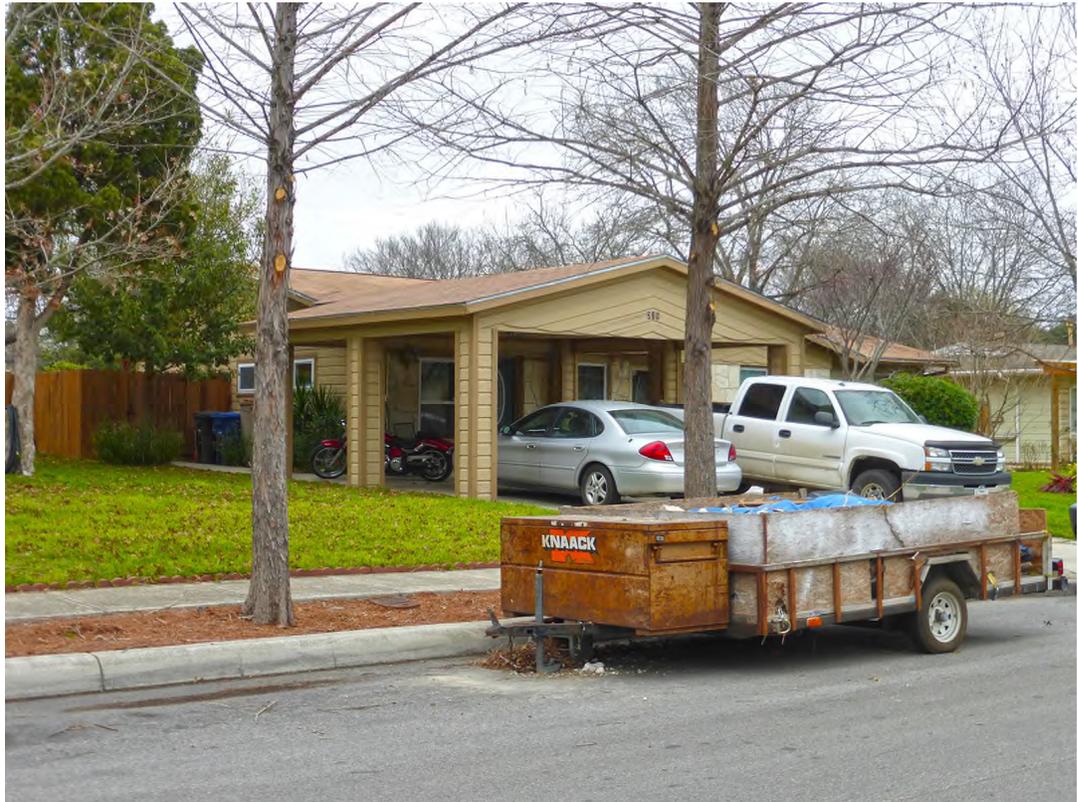
Photo 3 date taken:  
02-16-15

View of front and side facade of Resource 2. Camera facing northeast.

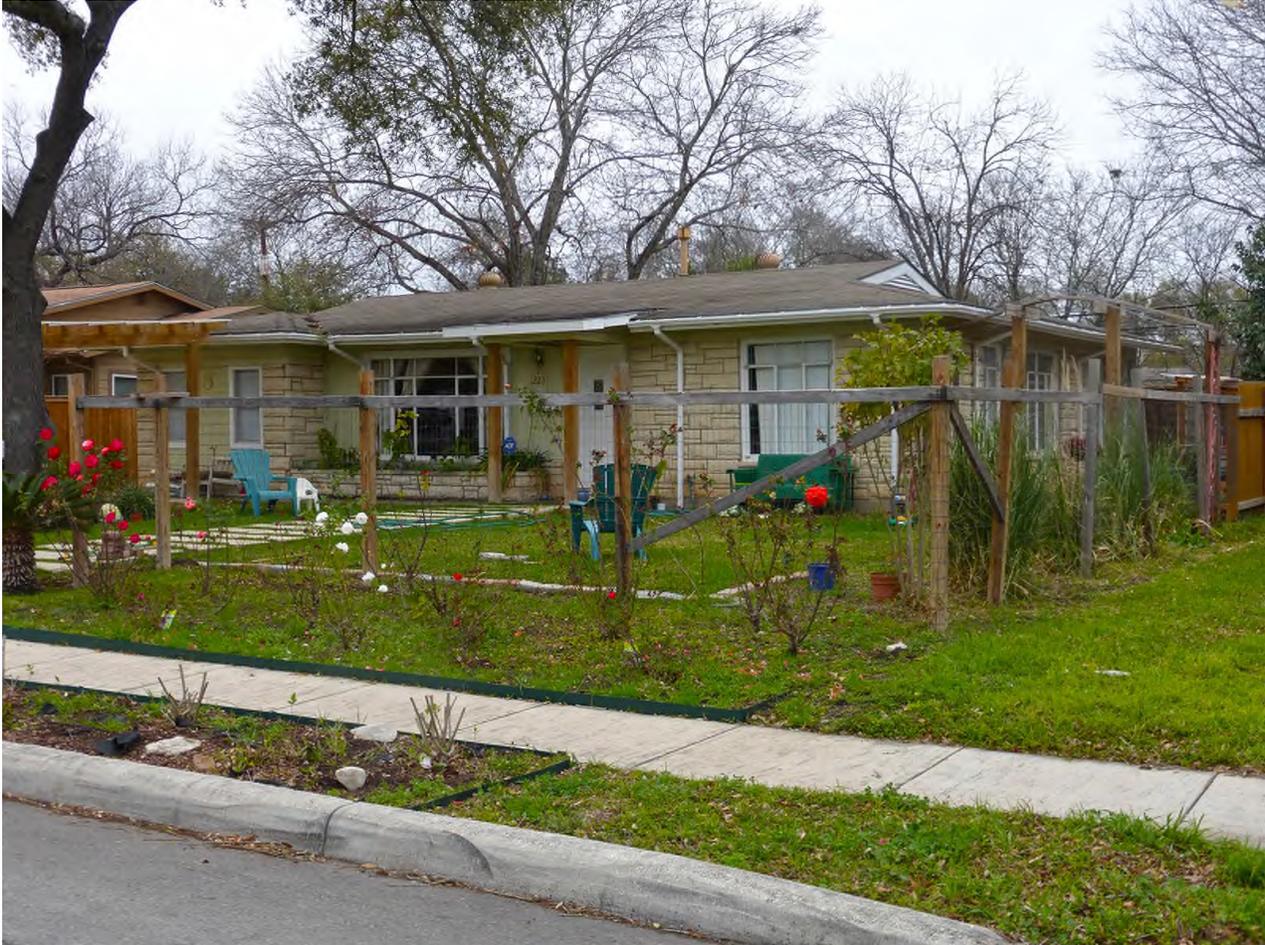
View of Resource 3 facing northwest.

**Description:** Resource 3 is a Ranch-style house with a gable-on-hip roof, ashlar siding, and metal casement windows. The entry porch has a shed roof and is supported by simple wood posts. The garage has been enclosed and the original front door has been replaced. A non-historic-age pergola has been constructed in lieu of a carport.

**NRHP Justification:** Due to loss of historic materials and workmanship through non-historic age modifications, this house no longer retains the integrity necessary to convey its significance. As a result, it is recommended Not Eligible for the NRHP.

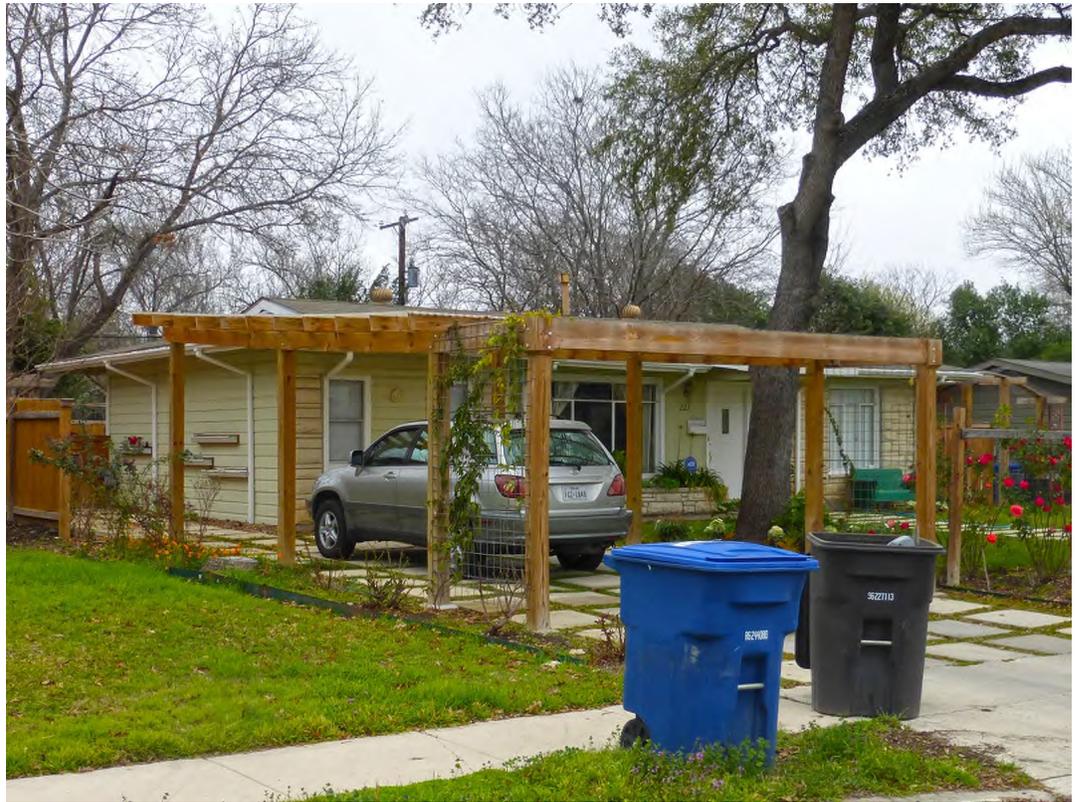
Photo 2 date taken:  
02-16-15

Oblique view of Resource 3,  
facing northeast.

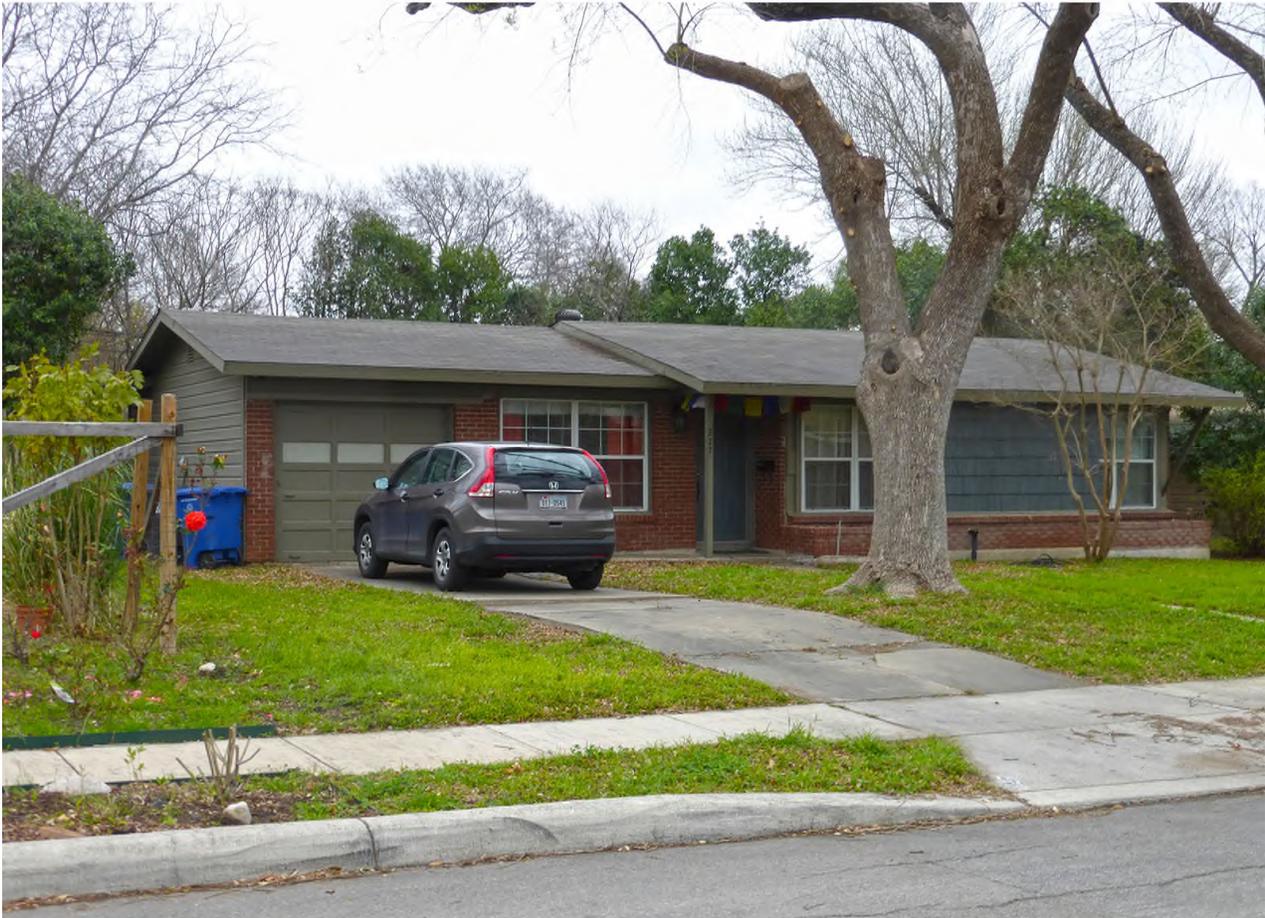
Oblique view of Resource 4, facing northeast.

**Description:** Resource 4 is a side-gable Ranch-style house with a combination of brick, wood, and asbestos siding materials. The inset entry features a simple wood post porch support. The house has an integrated brick planter across the front facade and non-historic age replacement windows.

**NRHP Justification:** The replacement windows significantly diminish the appearance and integrity of the house; it no longer retains the integrity necessary to convey its significance. As a result, it is recommended Not Eligible for the NRHP.

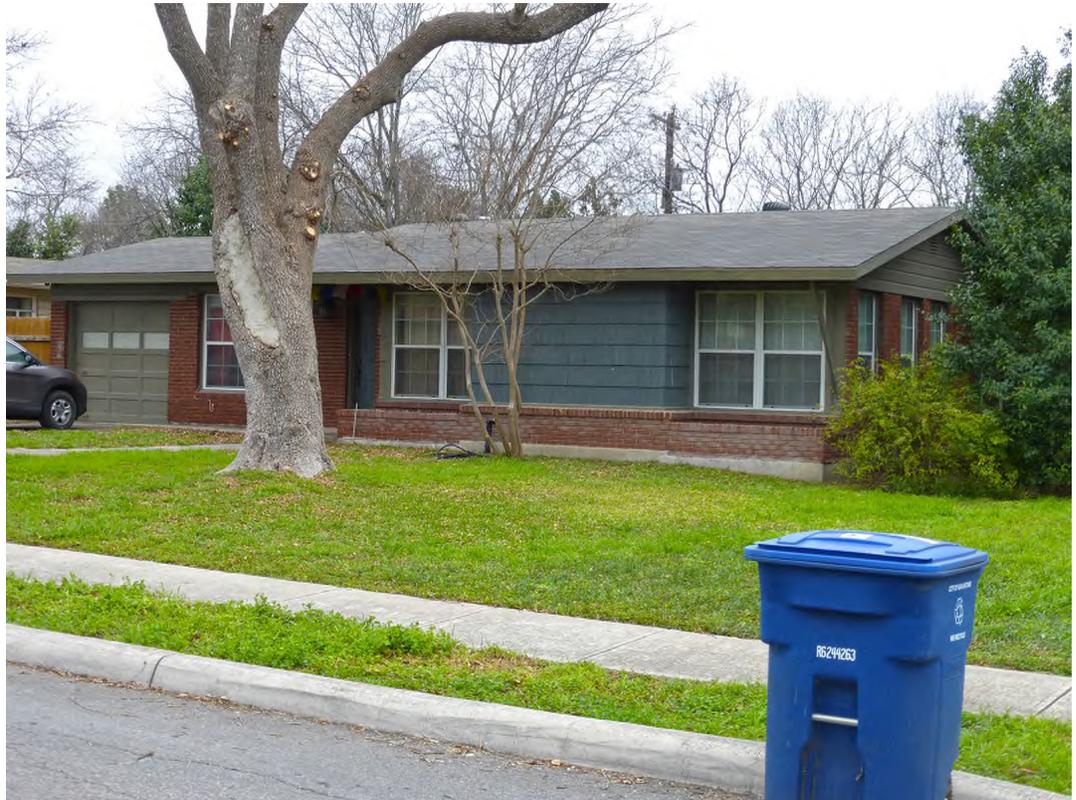
Photo 2 date taken:  
02-16-15

Oblique view of Resource 4,  
facing northwest.

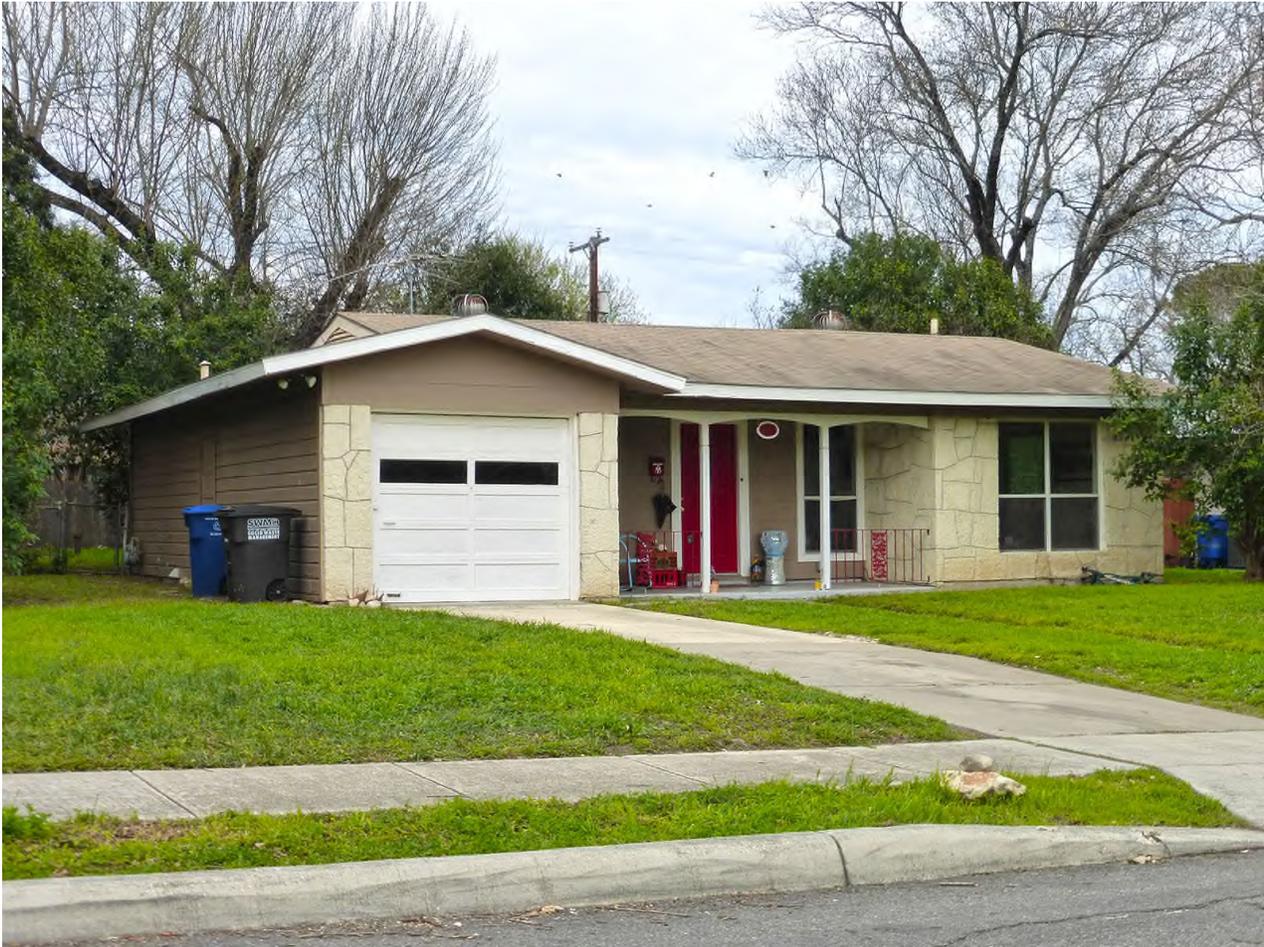
Oblique view of Resource 5, facing northeast.

**Description:** Resource 5 is a cross-gabled Ranch-style house clad in a combination of wood, stone, and asbestos siding. The house has an inset partial-width front porch supported by plain wood posts and has an integrated one-car garage. The original windows and front door have been replaced.

**NRHP Justification:** Due to loss of historic materials and workmanship through non-historic age modifications, this house no longer retains the integrity necessary to convey its significance. As a result, it is recommended Not Eligible for the NRHP.

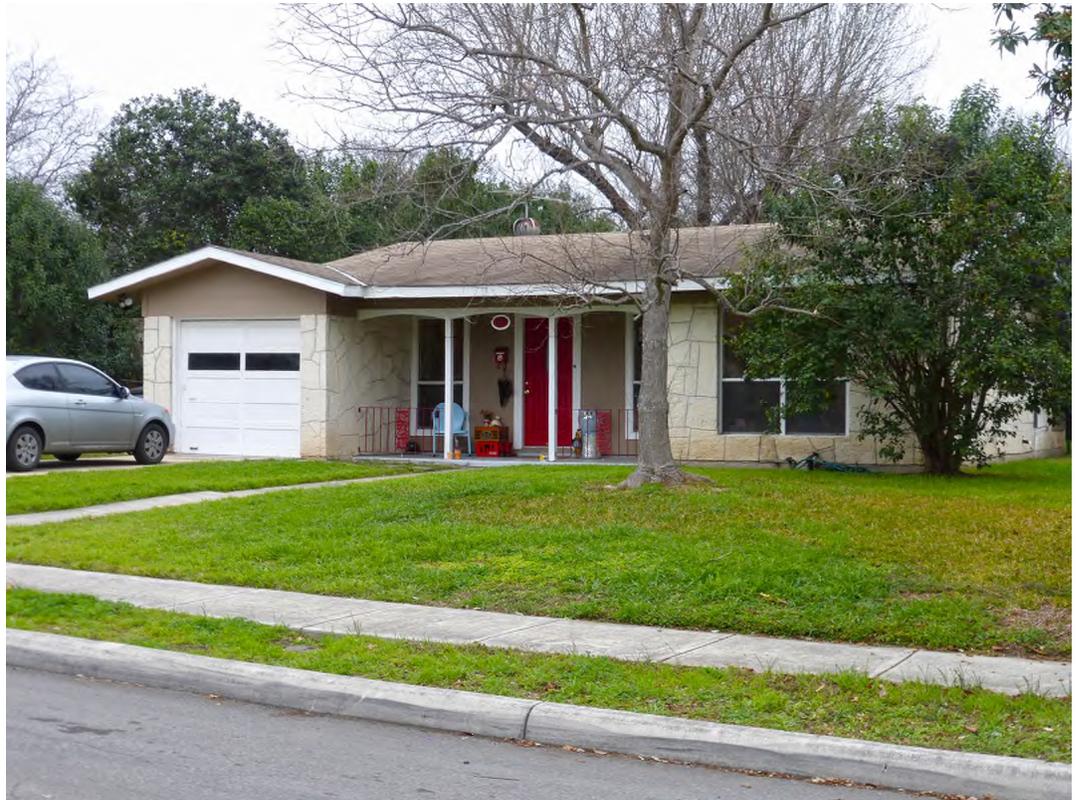
Photo 2 date taken:  
02-16-15

View of Resource 5 facing  
northwest.

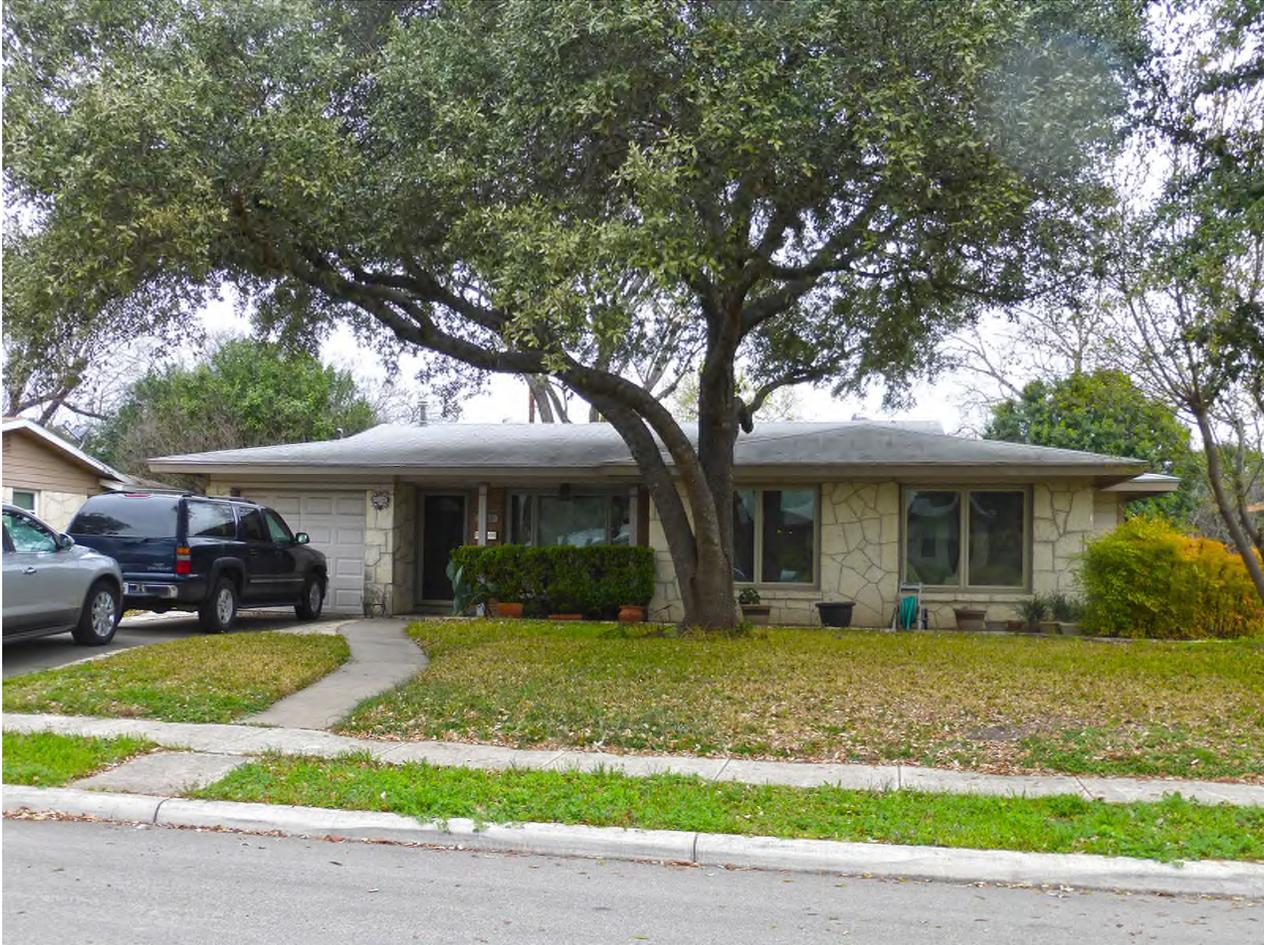
View of Resource 6 facing north.

**NRHP Justification:** Due to loss of historic materials and workmanship through non-historic age modifications, this house no longer retains the integrity necessary to convey its significance. As a result, it is recommended Not Eligible for the NRHP.

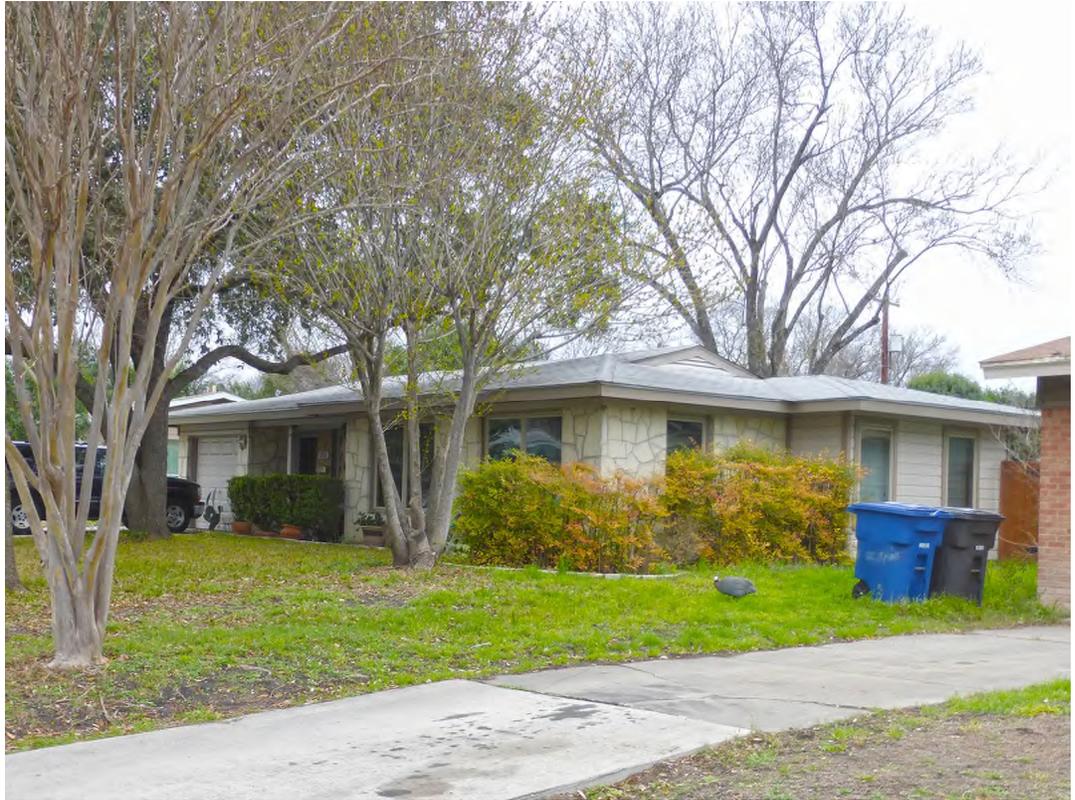
Photo 2 date taken:  
02-16-15

**Description:** Resource 6 is a Ranch-style house with a gable-on-hip roof. It is clad in a combination of wood, stone, and asbestos siding. The house has an inset partial-width front porch supported by plain wood posts and an integrated one-car garage. The original windows and front door have been replaced; the new windows significantly detract from its historic appearance.

Oblique view of Resource 6,  
facing northwest.

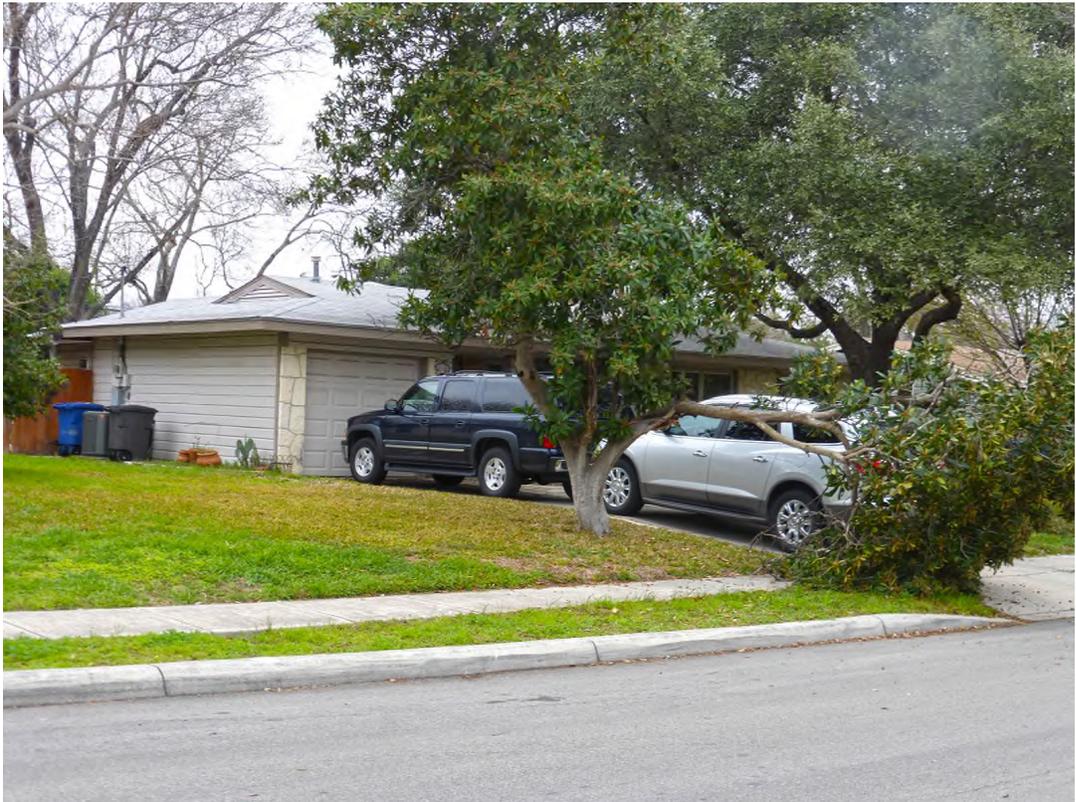
Photo 3 date taken:  
02-16-15

Oblique view of Resource 6,  
facing northeast.

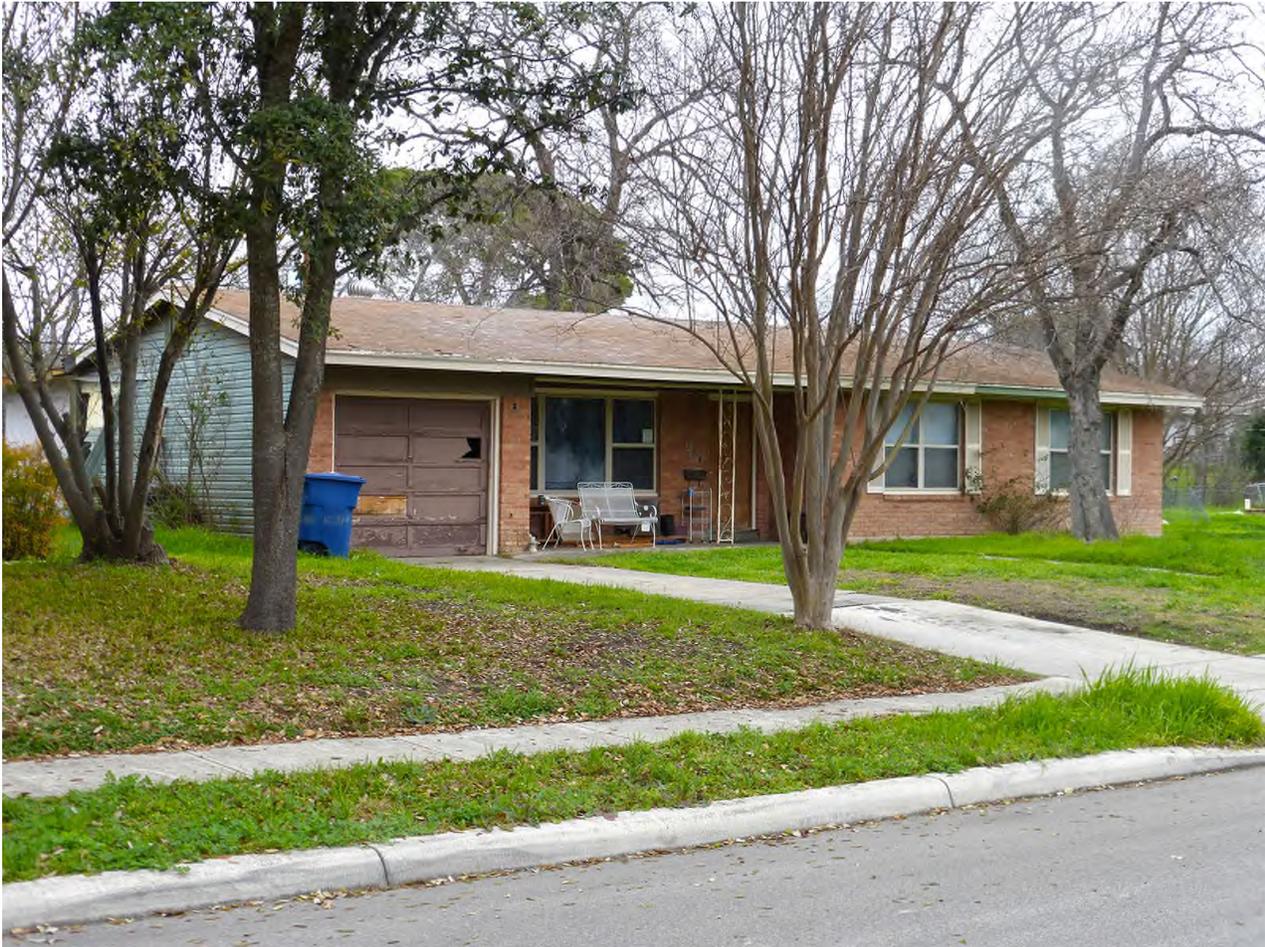
Photo 1 date taken: 02-16-15

View of Resource 7 facing northeast.

**Description:** Resource 7 is a side-gable Ranch-style house clad in brick and wood. The house has an inset partial-width front porch with a decorative metal support and features an integrated one-car garage. The original windows have been replaced.

**NRHP Justification:** Due to loss of historic materials and workmanship through non-historic age modifications, this house no longer retains the integrity to convey its significance. As a result, it is recommended Not Eligible for the NRHP.

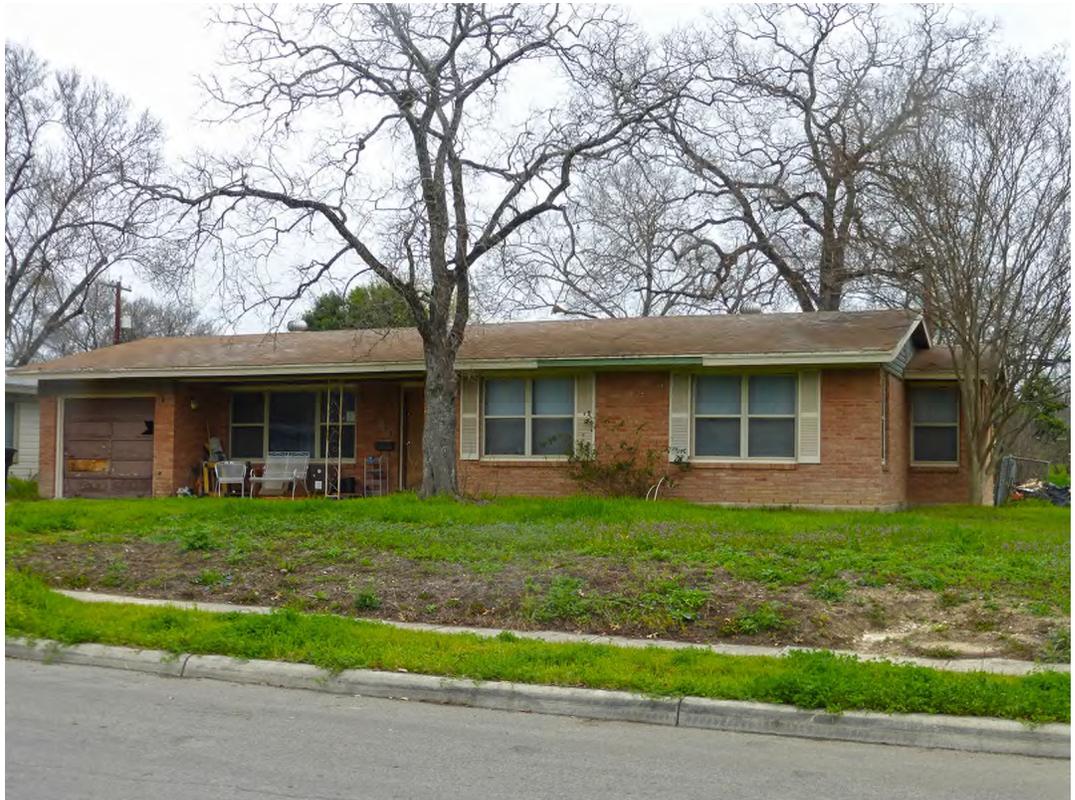
Photo 2 date taken:  
02-16-15

View of Resource 7 facing  
northwest.

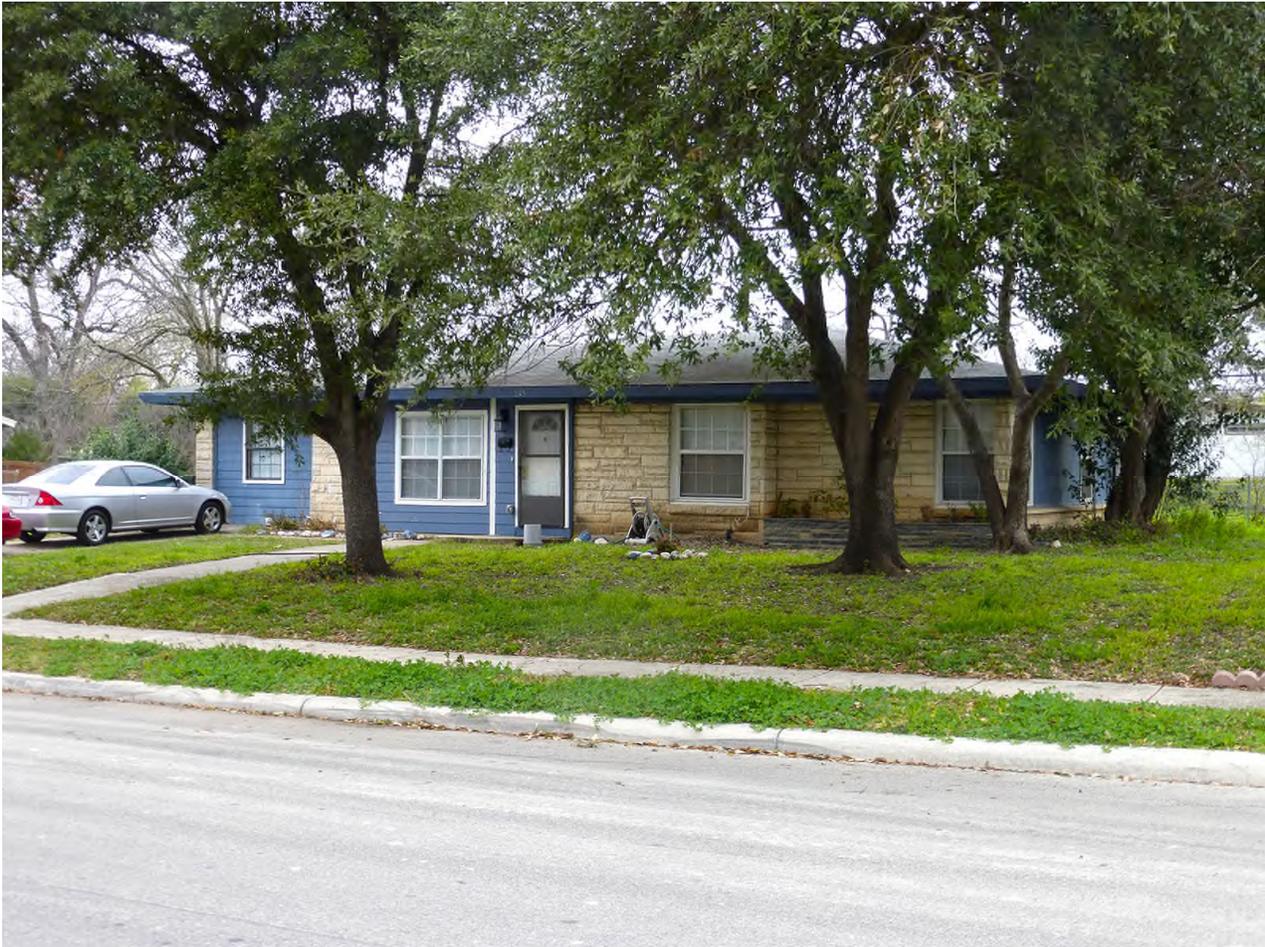
Photo 1 date taken: 02-16-15

View of Resource 8 facing northwest.

**Description:** Resource 8 is a Ranch-style house with hipped roof. It is clad in a combination of wood, asbestos and stone siding materials. The one-car garage has been enclosed, and the original entry has been enclosed to provide more living space. The windows and front door have been replaced.

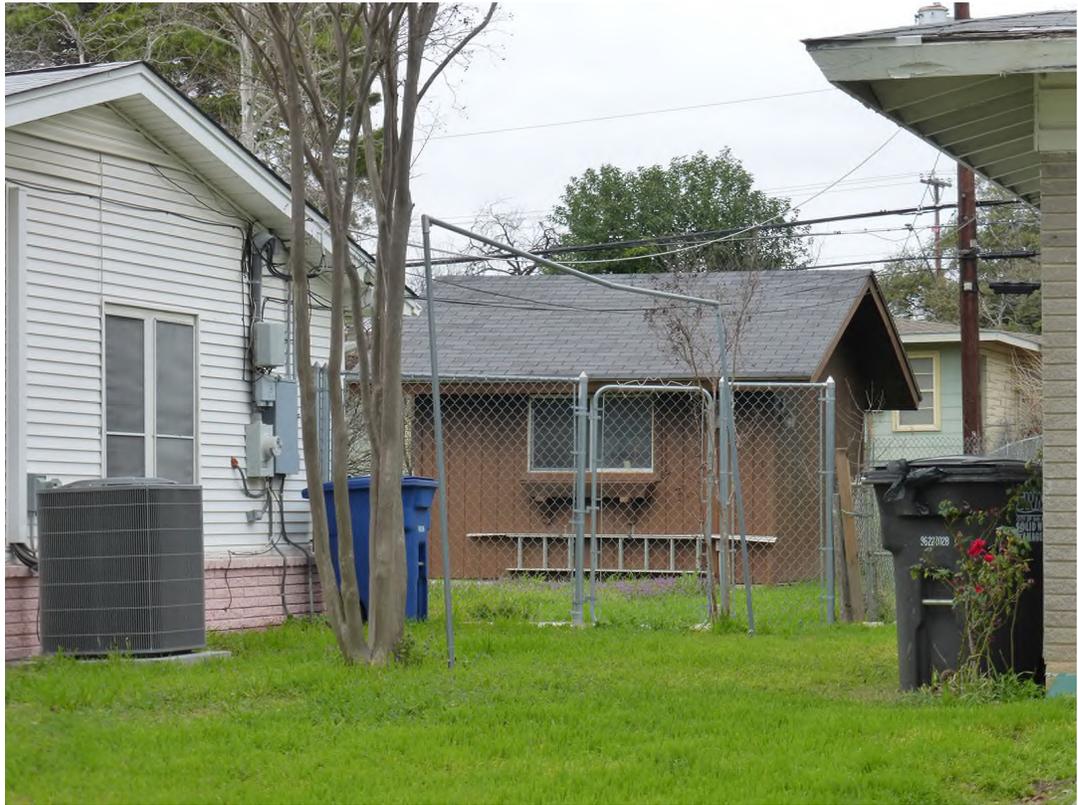
Photo 3 date taken:  
02-16-15

Non-historic-age shed at rear of Resource 9, facing northwest.

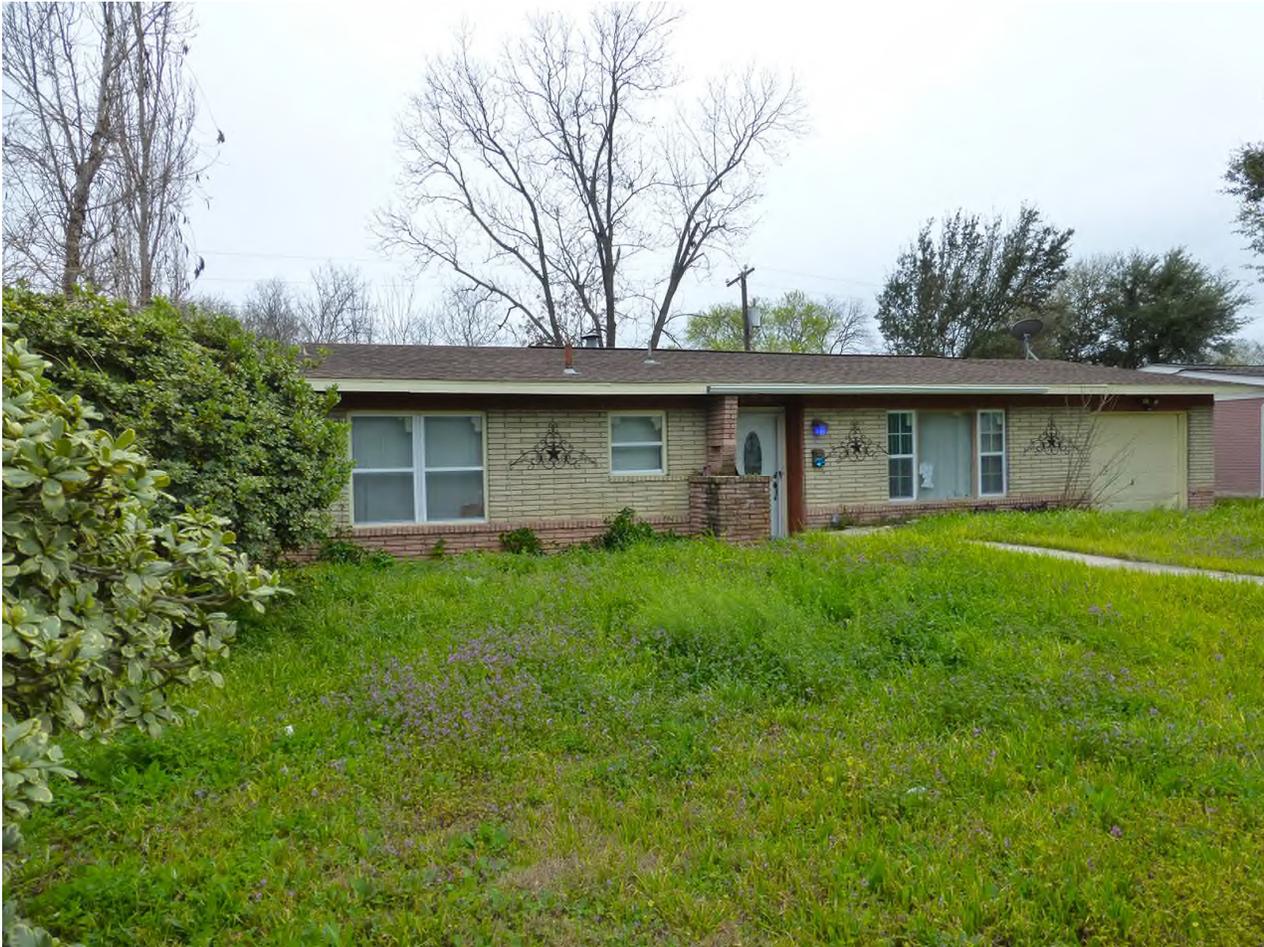
Photo 1 date taken: 02-16-15

View of Resource 19 facing southwest.

**Description:** Resource 19 is a side-gable Ranch-style house clad in brick and asbestos siding. The entry is slightly inset with a decorative brick support and the house has an integrated one-car garage. The original front door and windows have been replaced.

**NRHP Justification:** Due to loss of historic materials and workmanship through non-historic age modifications, this house no longer retains the integrity necessary to convey its significance. As a result, it is recommended Not Eligible for the NRHP.

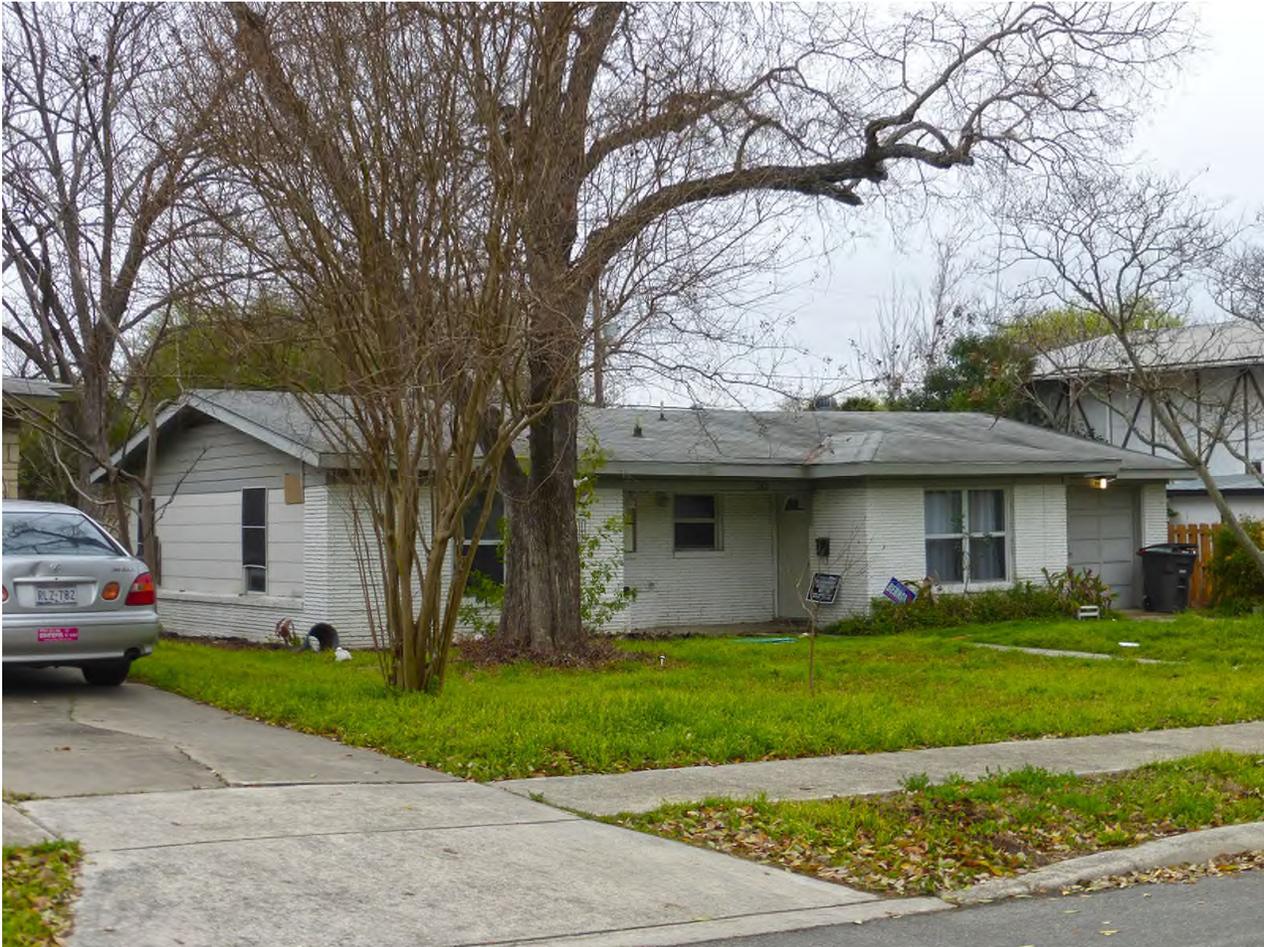
Photo 1 date taken: 02-16-15

View of Resource 20 facing southwest.

**Description:** Resource 20 is a cross-gable Ranch-style house clad in a combination of brick and asbestos siding. The house has an inset front porch and entrance set into the L formed by the cross-gabled roof and an integrated one-car garage. The original front door and windows have been replaced, and one window is covered with plywood.

**NRHP Justification:** Due to loss of historic materials and workmanship through non-historic age modifications, this house no longer retains the integrity necessary to convey its significance. As a result, it is recommended Not Eligible for the NRHP.
