# HISTORIC AND DESIGN REVIEW COMMISSION

**HDRC CASE NO:** 2015-160  
**ADDRESS:** 311 SHANNON LEE  
**LEGAL DESCRIPTION:** NCB 12011 BLK 3 LOT 19 & P-101 (ALLEY)  
**ZONING:** R5  
**CITY COUNCIL DIST.:** 1  
**APPLICANT:** David Pulido  
**OWNER:** City of San Antonio  
**TYPE OF WORK:** Barbara Dr. - Drainage Project  
**REQUEST:**

# BARBARA DRAINAGE

HISTORIC RESOURCES SURVEY REPORT,  
BARBARA DRIVE DRAINAGE PROJECT  
SAN ANTONIO, BEXAR COUNTY, TEXAS

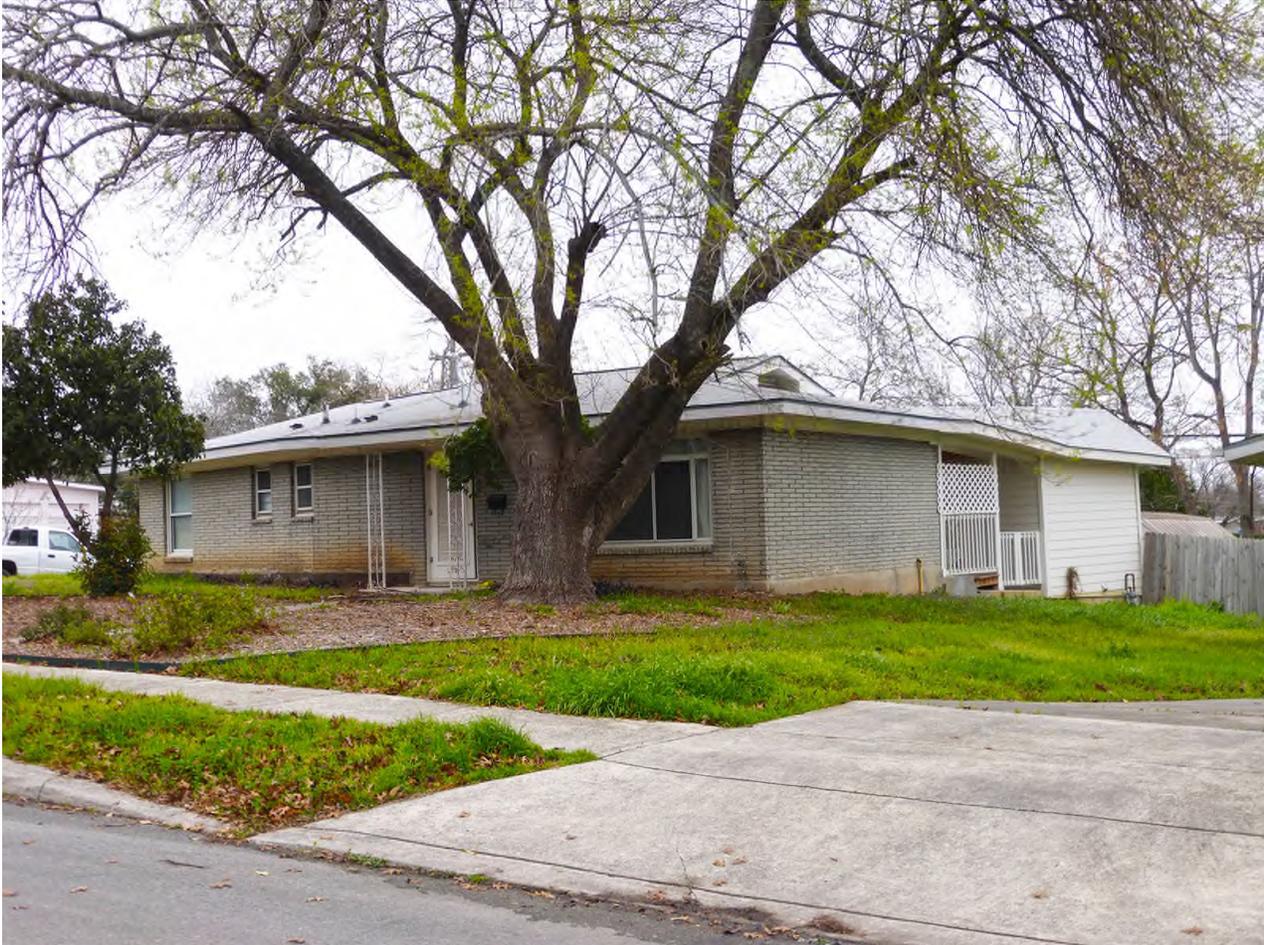
Photo 1 date taken: 02-16-15

View of Resource 23 facing southeast.

**Description:** Resource 23 is a Ranch-style house with gable-on-hip roof and wings that extend at a slight angle. The shed-roof entry porch features decorative metal supports and the entrance has a louvered storm door. The original windows have been replaced, and a large addition has been constructed at the rear of the house.

**NRHP Justification:** Due to loss of historic materials and workmanship through non-historic age modifications, this house no longer retains the integrity necessary to convey its significance. As a result, it is recommended Not Eligible for the NRHP.

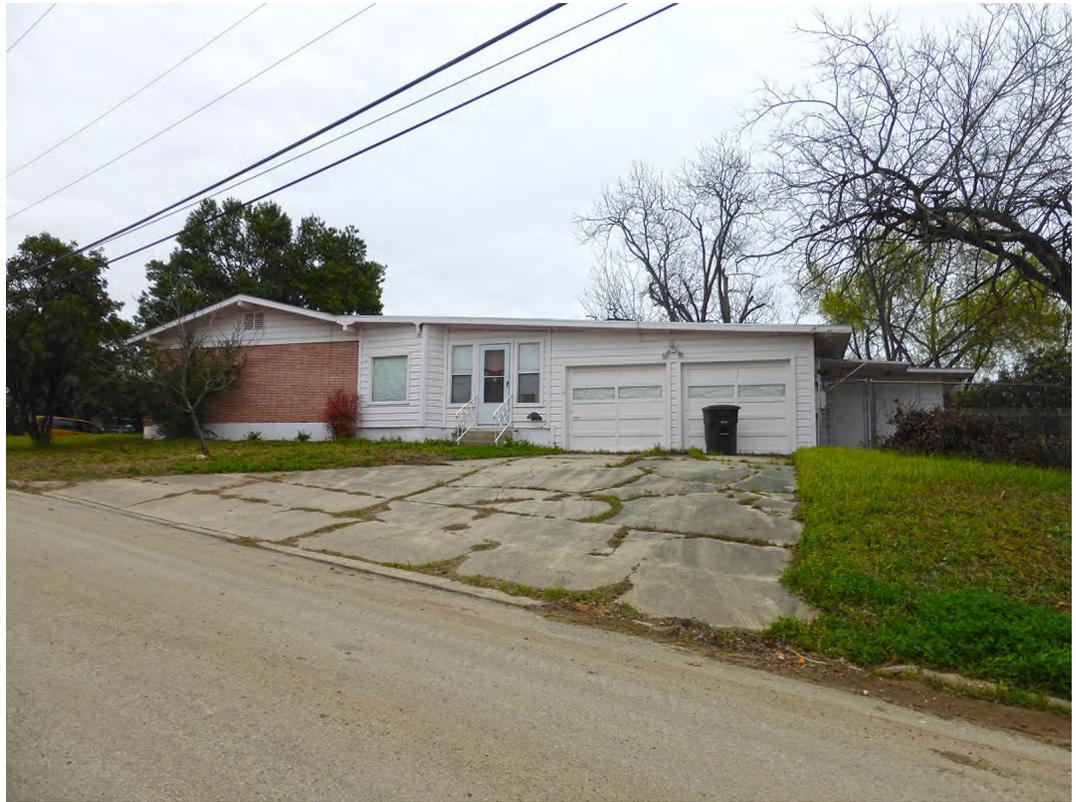
Photo 2 date taken:  
02-16-15

View of Resource 24 facing northeast, showing large rear addition.

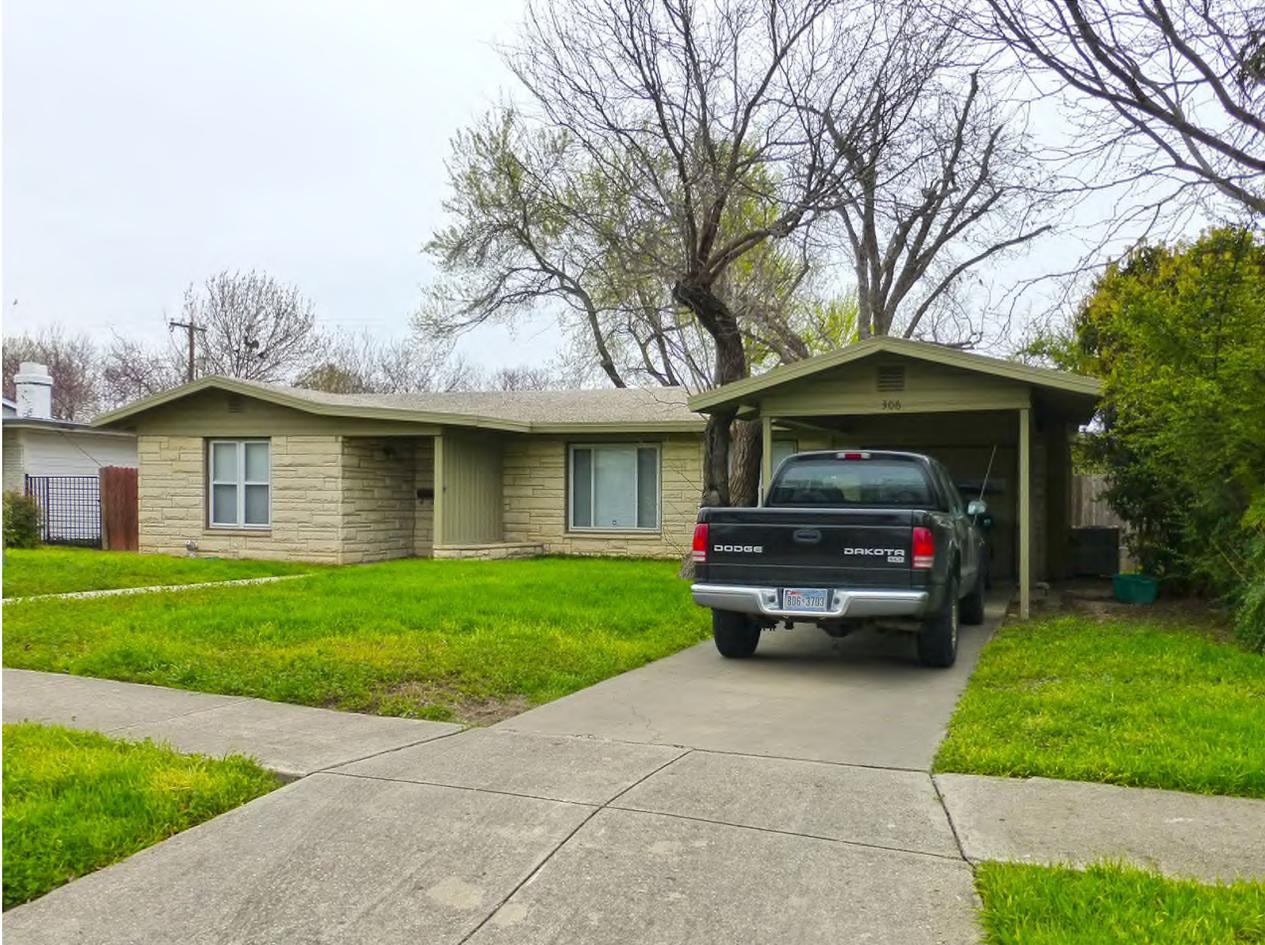
Photo 1 date taken: 02-16-15

View of Resource 25 facing southeast.

**Description:** Resource 25 is a cross-gable Ranch-style house clad in stone. The entry porch is supported by a row of angled boards, creating a screening effect. The original windows have been replaced, and a large carport has been constructed in front of the one-car garage.

**NRHP Justification:** Due to loss of historic materials and workmanship through non-historic age modifications, this house no longer retains the integrity necessary to convey its significance. As a result, it is recommended Not Eligible for the NRHP.

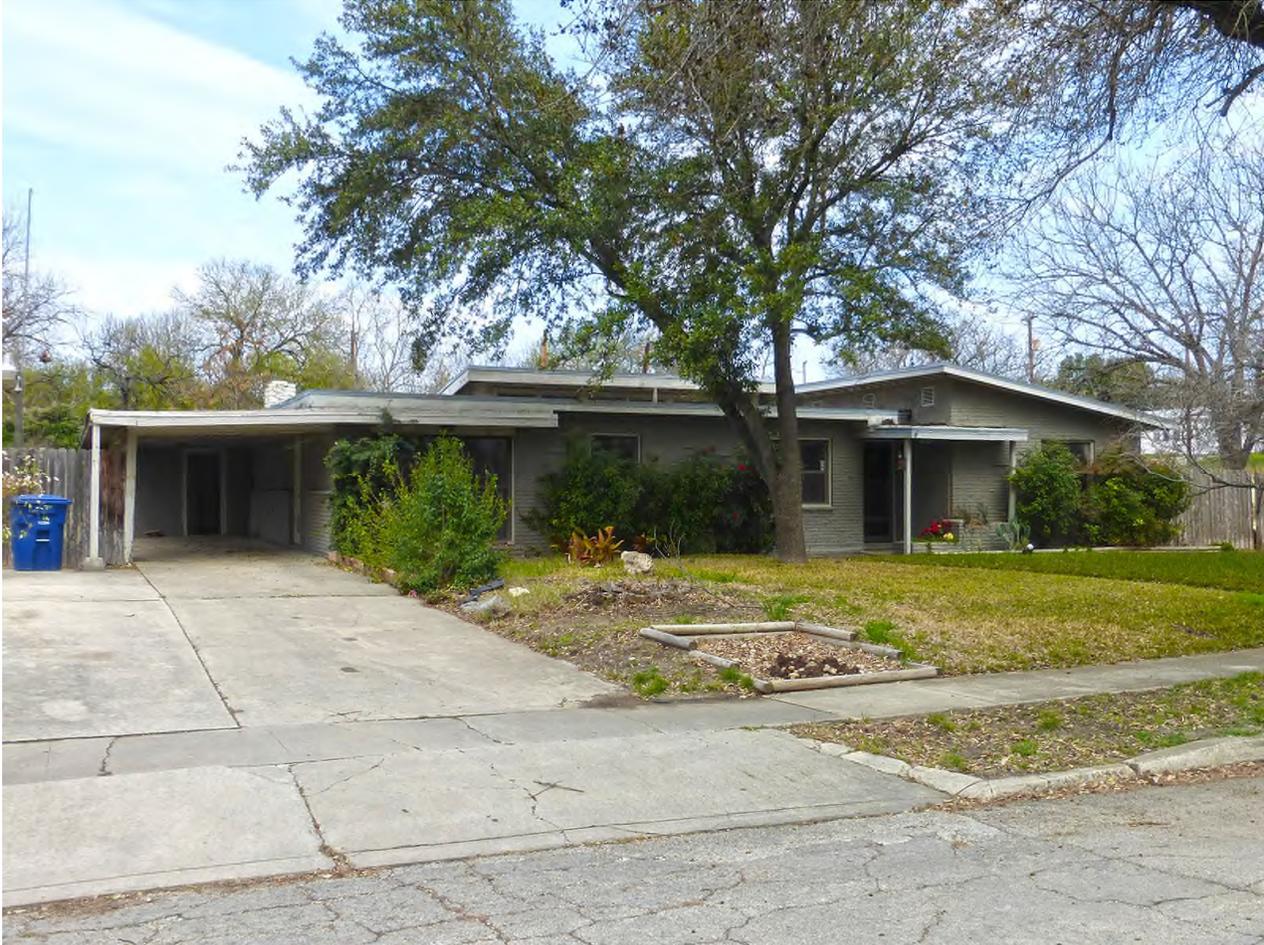
Photo 1 date taken: 02-16-15

View of Resource 30 facing northeast.

**Description:** Resource 30 is a Contemporary-style house clad in a combination of brick, stucco, and stone. The house has multi-directional shed roof forms and a large incompatible addition to the northeast (see Photo 3). The entry is recessed and the flat-roofed front porch has plain wood supports. The original windows have been replaced.

**NRHP Justification:** Due to loss of historic materials and workmanship through non-historic age modifications, this house no longer retains the integrity necessary to convey its significance. As a result, it is recommended Not Eligible for the NRHP.

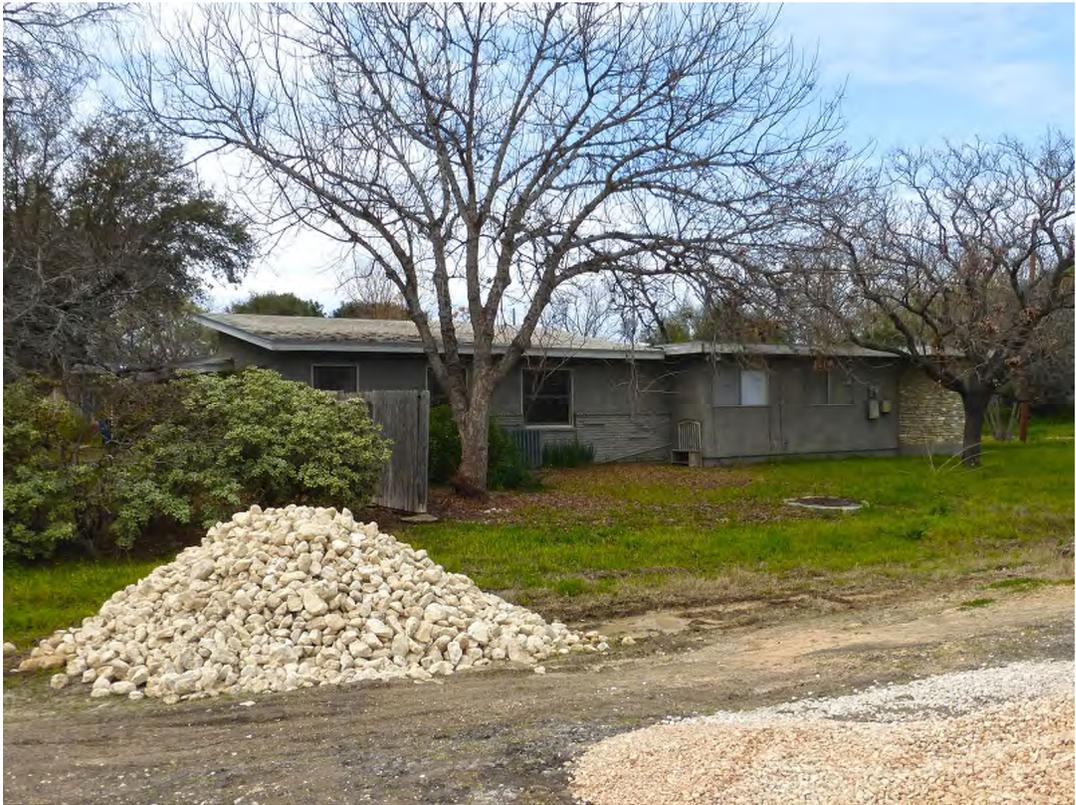
Photo 3 date taken:  
02-16-15

View of Resource 30 facing west.

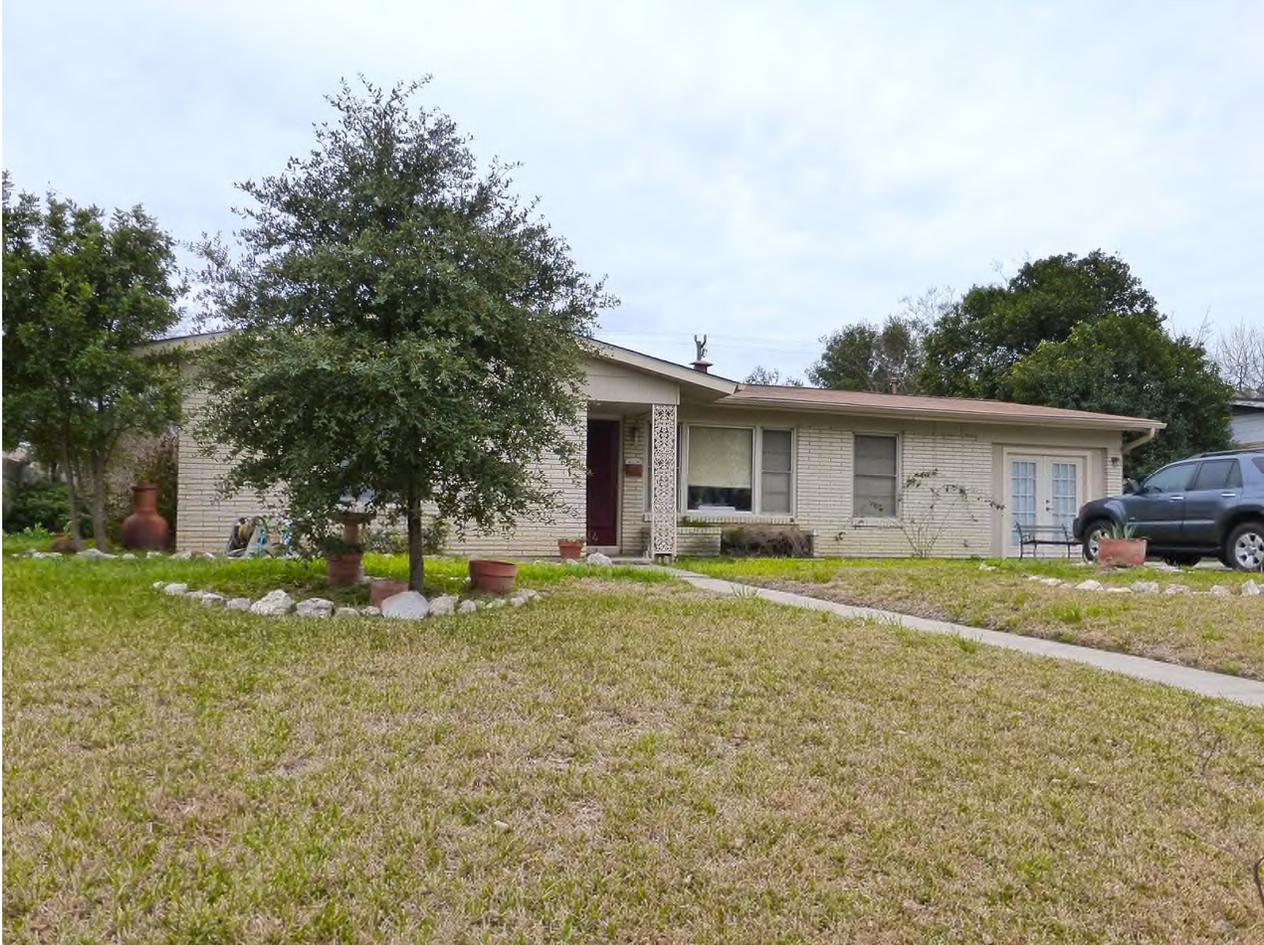
Photo 1 date taken: 02-16-15

View of Resource 33 facing south.

**Description:** Resource 33 is a cross-gable Ranch-style house clad in brick with aluminum windows. The entry of the house is inset into the front gable and has a decorative metal support. The garage has been enclosed; incompatible non-historic-age French doors have replaced the original garage door.

**NRHP Justification:** Due to loss of historic materials and workmanship through non-historic age modifications, this house no longer retains the integrity necessary to convey its significance. As a result, it is recommended Not Eligible for the NRHP.

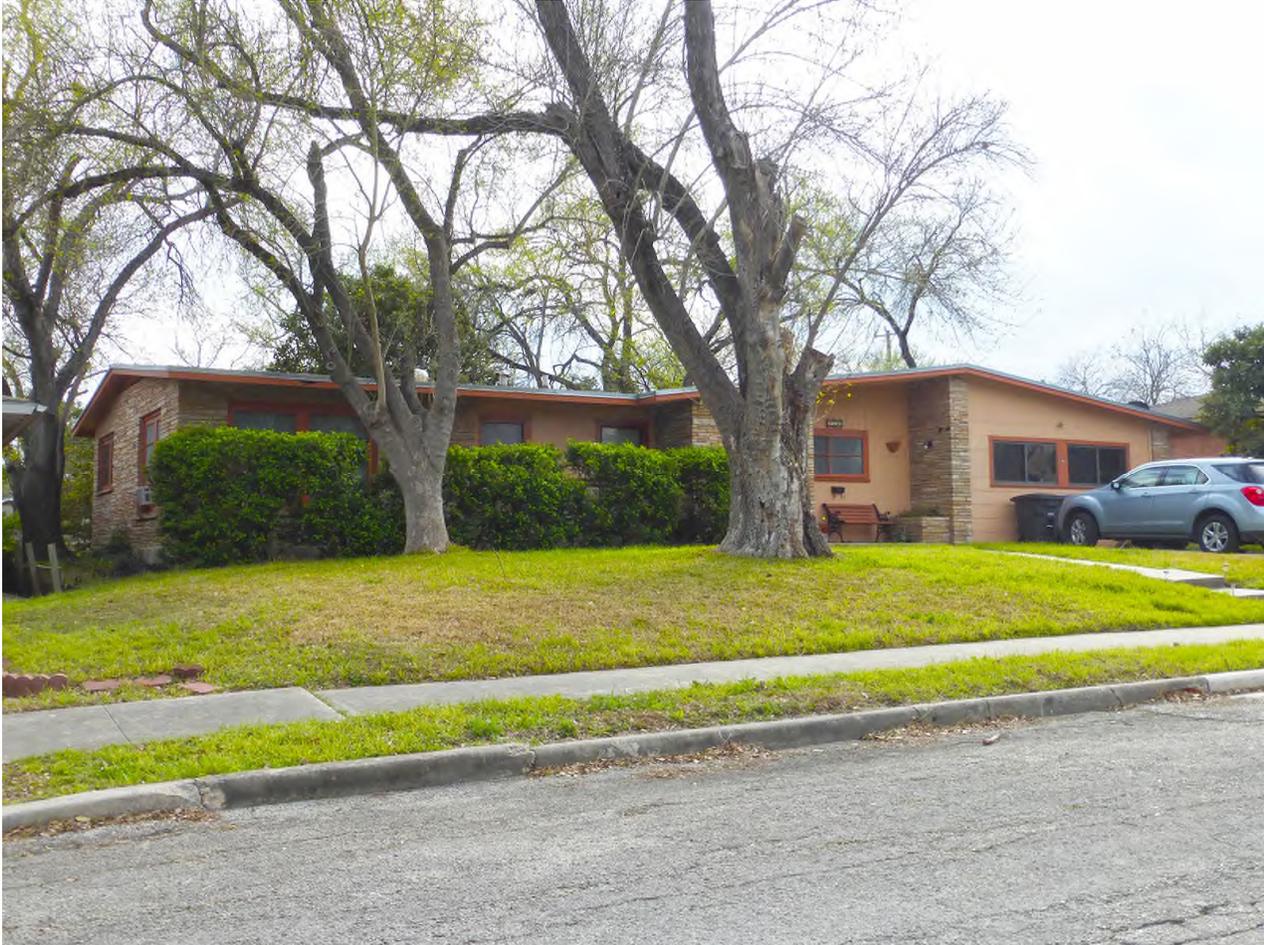
Photo 1 date taken: 02-16-15

View of Resource 36 facing southwest.

**Description:** Resource 36 is a cross-gable Ranch-style house clad in stone and asbestos siding. The entry is recessed and tucked in to the front gable. The original garage or carport has been enclosed, and the original windows have been replaced.

**NRHP Justification:** Due to loss of historic materials and workmanship through non-historic age modifications, this house no longer retains the integrity necessary to convey its significance. As a result, it is recommended Not Eligible for the NRHP.

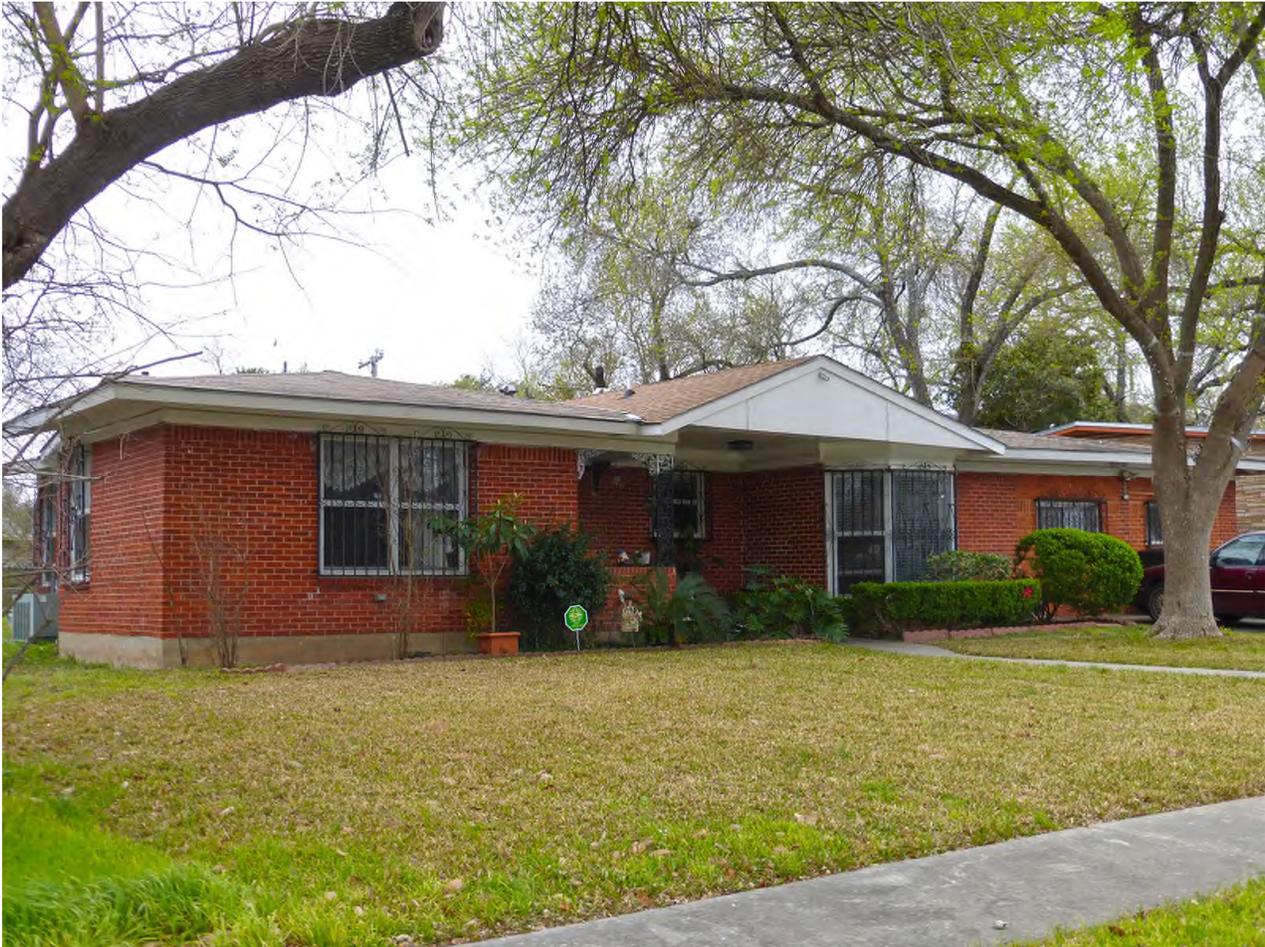
Photo 1 date taken: 02-16-15

View of Resource 37 facing southwest.

**Description:** Resource 37 is a cross-gable Ranch-style house clad in brick. The entry is recessed and features a decorative metal support. Iron bars have been installed over the non-historic-age replacement windows. The garage has been enclosed, and the front-gable may have been a later modification as well.

**NRHP Justification:** Due to loss of historic materials and workmanship through non-historic age modifications, this house no longer retains the integrity necessary to convey its significance. As a result, it is recommended Not Eligible for the NRHP.

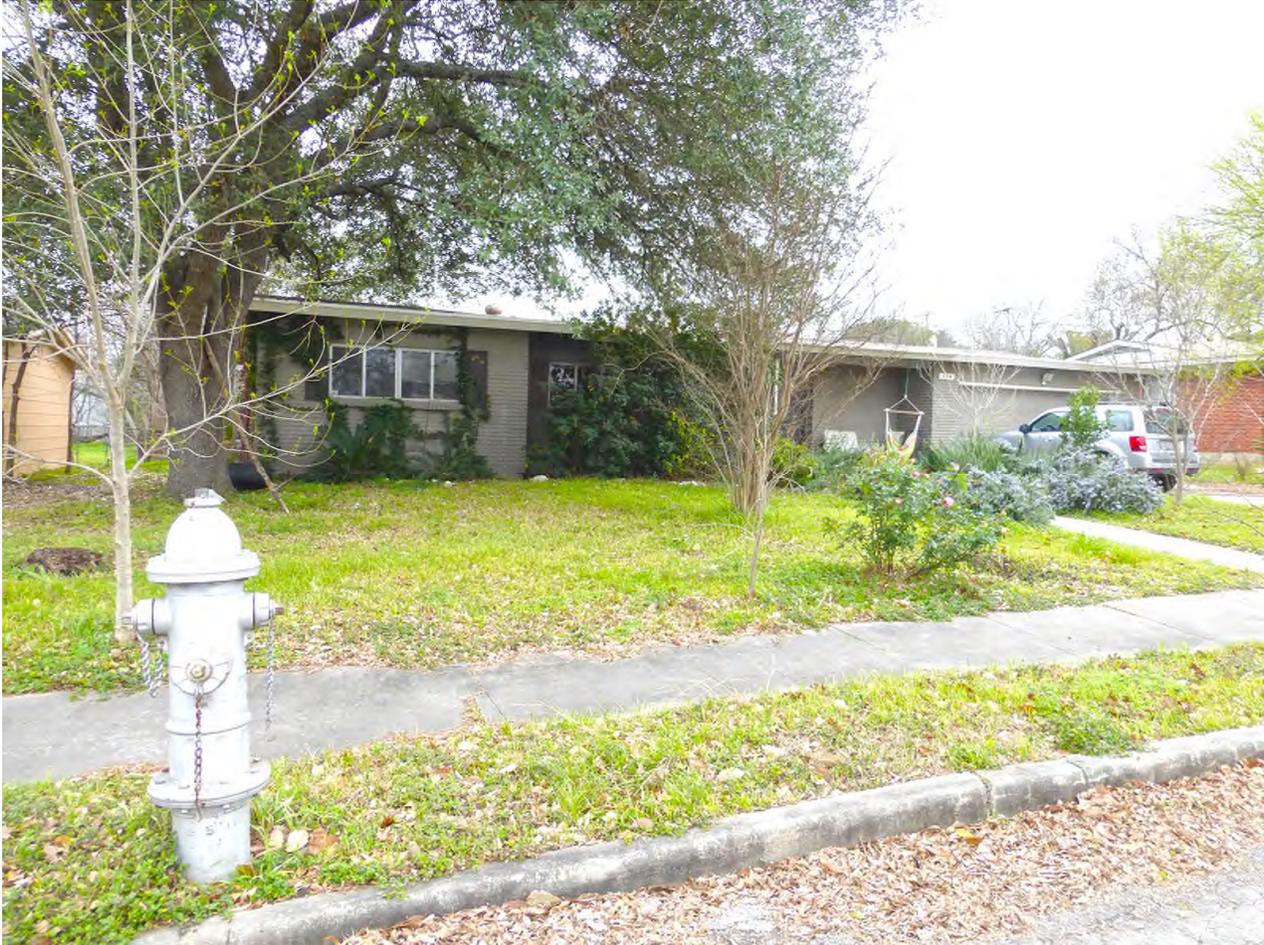
Photo 1 date taken: 02-16-15

View of Resource 38 facing southwest.

**Description:** Resource 38 is a side-gable Ranch-style house clad in brick with an integrated one-car garage. The partial-width front porch is inset and features non-original turned wood supports. The house retains its original casement windows on the east facade, but the windows on the front of the house have been replaced.

**NRHP Justification:** Due to loss of historic materials and workmanship through non-historic age modifications, this house no longer retains the integrity necessary to convey its significance. As a result, it is recommended Not Eligible for the NRHP.

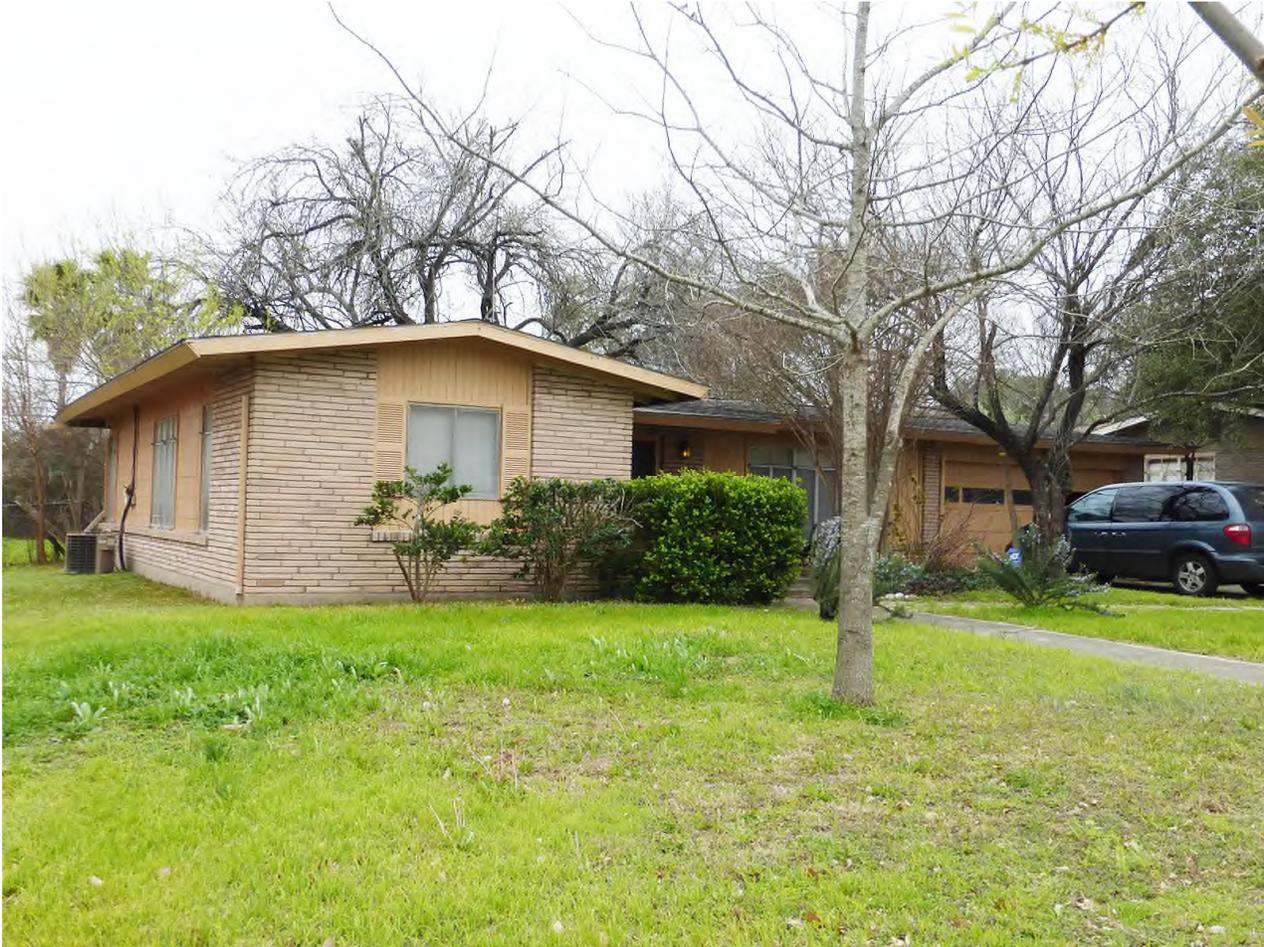
Photo 1 date taken: 02-16-15

View of Resource 39 facing southwest.

**Description:** Resource 39 is a cross-gable Ranch style house clad in brick and asbestos siding. The house has an integrated one-car garage and shed-roof entry porch. The house appears to retain some of its original metal casement windows, though the original front door has been replaced.

**NRHP Justification:** It is a common example of a modest Ranch house. During the historic context development, no associations were identified linking it to persons or events of historic importance. As a result, it is recommended Not Eligible for the NRHP under Criterion A, B, or C.

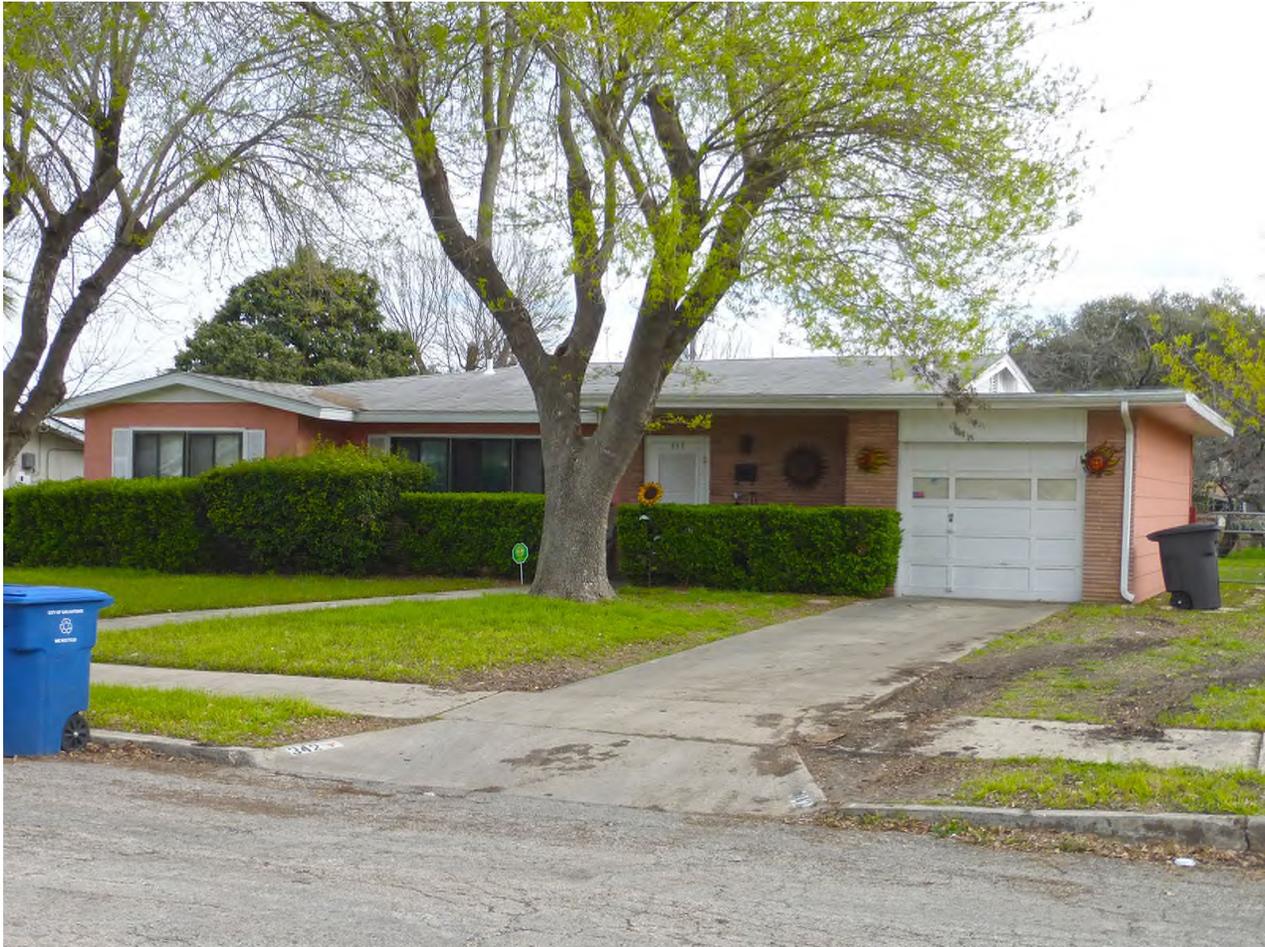
Photo 1 date taken: 02-16-15

View of Resource 40 facing southeast.

**Description:** Resource 40 is a cross-gabled Ranch-style house clad in brick and asbestos siding. The house features a partial-width front porch with simple wood support. The windows have been replaced with non-historic age, non-compatible dark-colored vinyl windows.

**NRHP Justification:** Due to loss of historic materials and workmanship through non-historic age modifications, this house no longer retains the integrity necessary to convey its significance. As a result, it is recommended Not Eligible for the NRHP.

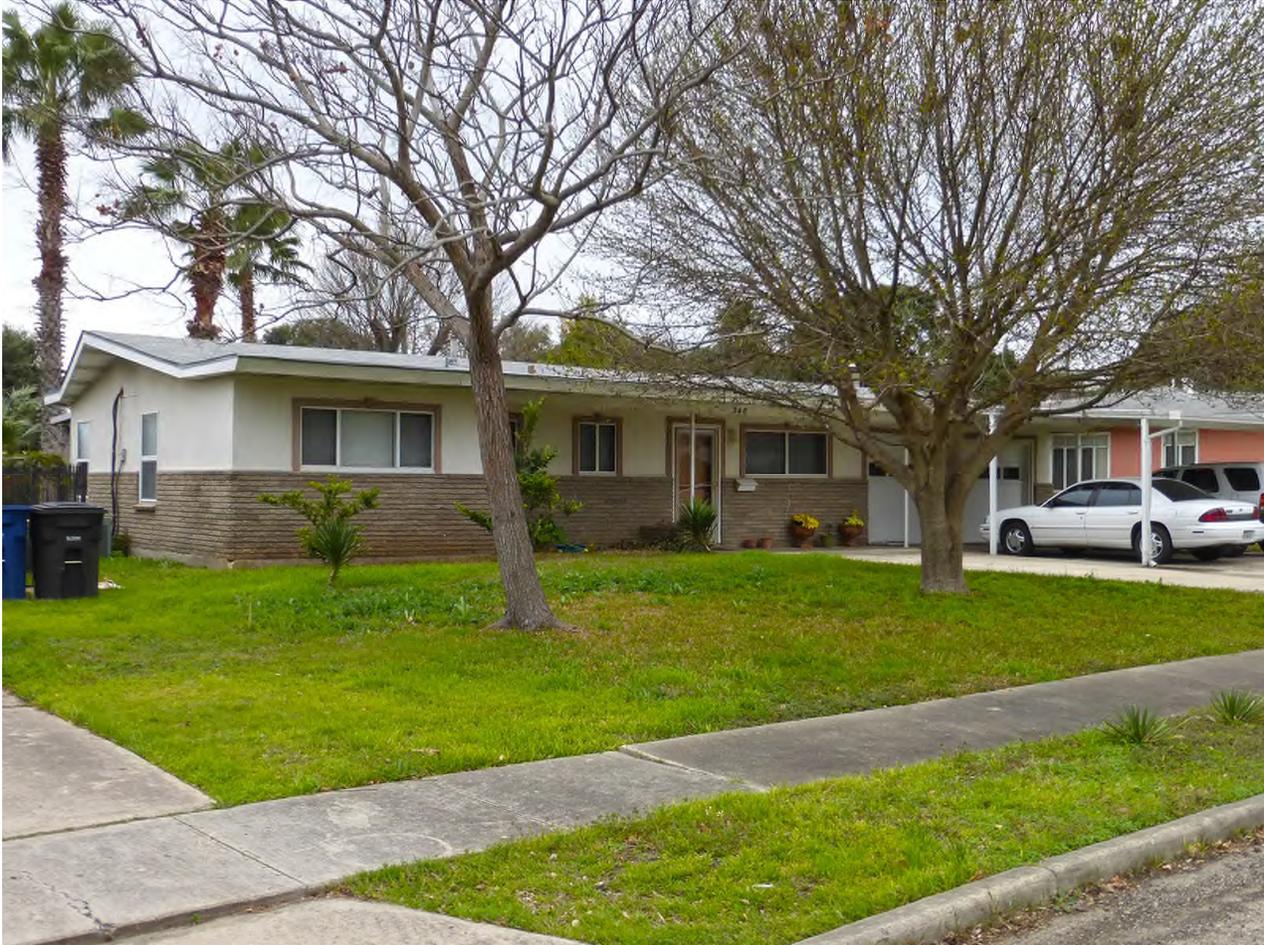
Photo 1 date taken: 02-16-15

View of Resource 41 facing southwest.

**Description:** Resource 41 is a Ranch-style house with a very low pitched roof with angled side gables. The house is clad in stucco and brick and the entry porch features a simple metal support. The windows and front door have been replaced and a non-historic-age carport has been constructed in front of the garage.

**NRHP Justification:** Due to loss of historic materials and workmanship through non-historic age modifications, this house no longer retains the integrity necessary to convey its significance. As a result, it is recommended Not Eligible for the NRHP.

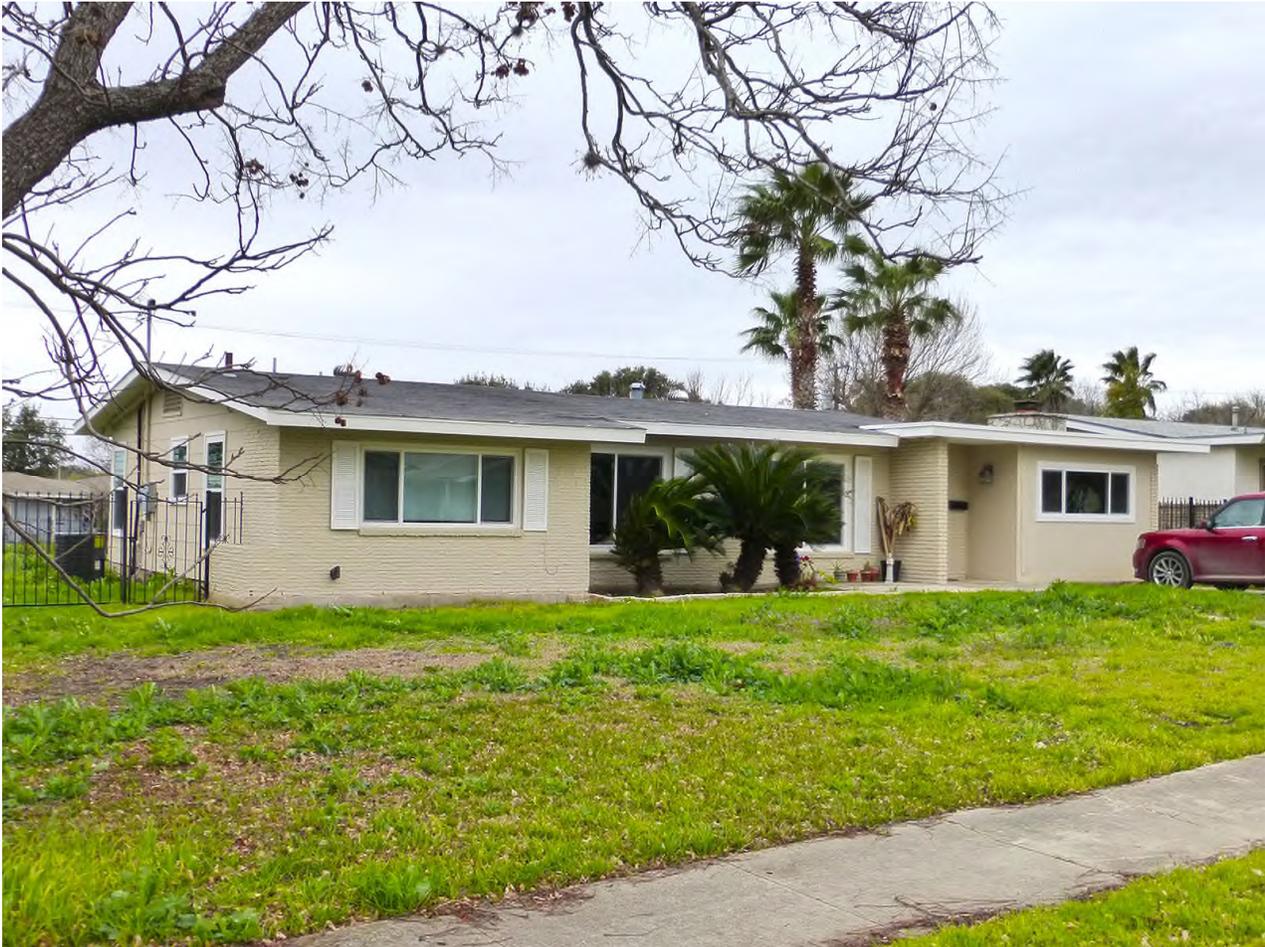
Photo 1 date taken: 02-16-15

View of Resource 42 facing southwest.

**Description:** Resource 42 is a side-gable Ranch-style house. The entry is inset with a brick screening wall. The original windows and front door have been replaced and the garage has been enclosed.

**NRHP Justification:** Due to loss of historic materials and workmanship through non-historic age modifications, this house no longer retains the integrity necessary to convey its significance. As a result, it is recommended Not Eligible for the NRHP.

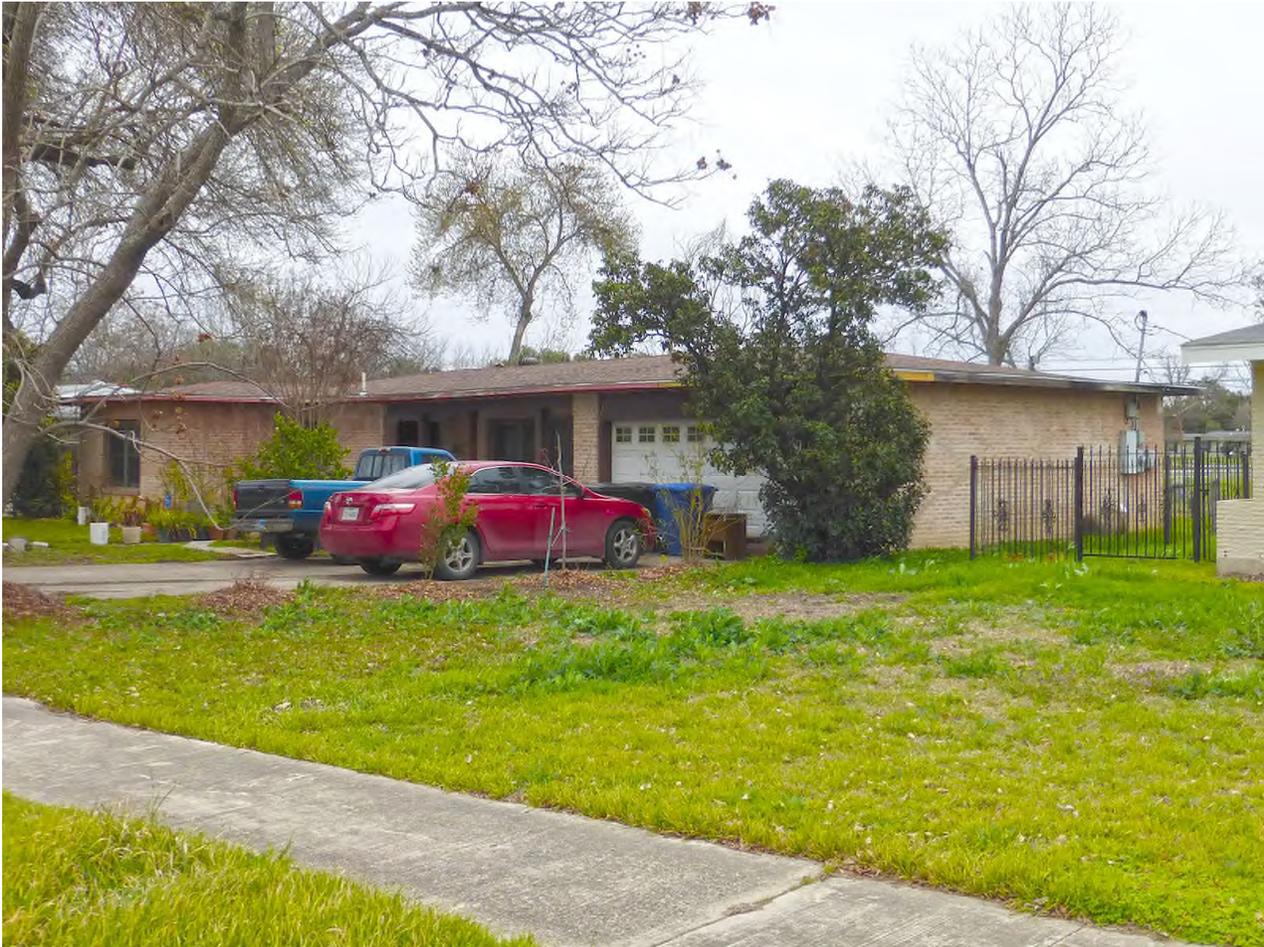
Photo 1 date taken: 02-16-15

View of Resource 43 facing southeast.

**Description:** Resource 43 is a cross-hipped Ranch-style house clad in brick. The house has an inset front porch with plain wood posts and an integrated garage. The original windows and original garage door appear to have been replaced.

**NRHP Justification:** The replacement windows and garage door do not significantly detract from the appearance, but this resource is a common example of a modest Ranch house. During the historic context development, no associations were identified linking it to persons or events of historic importance. As a result, it is recommended Not Eligible for the NRHP under Criterion A, B, or C.

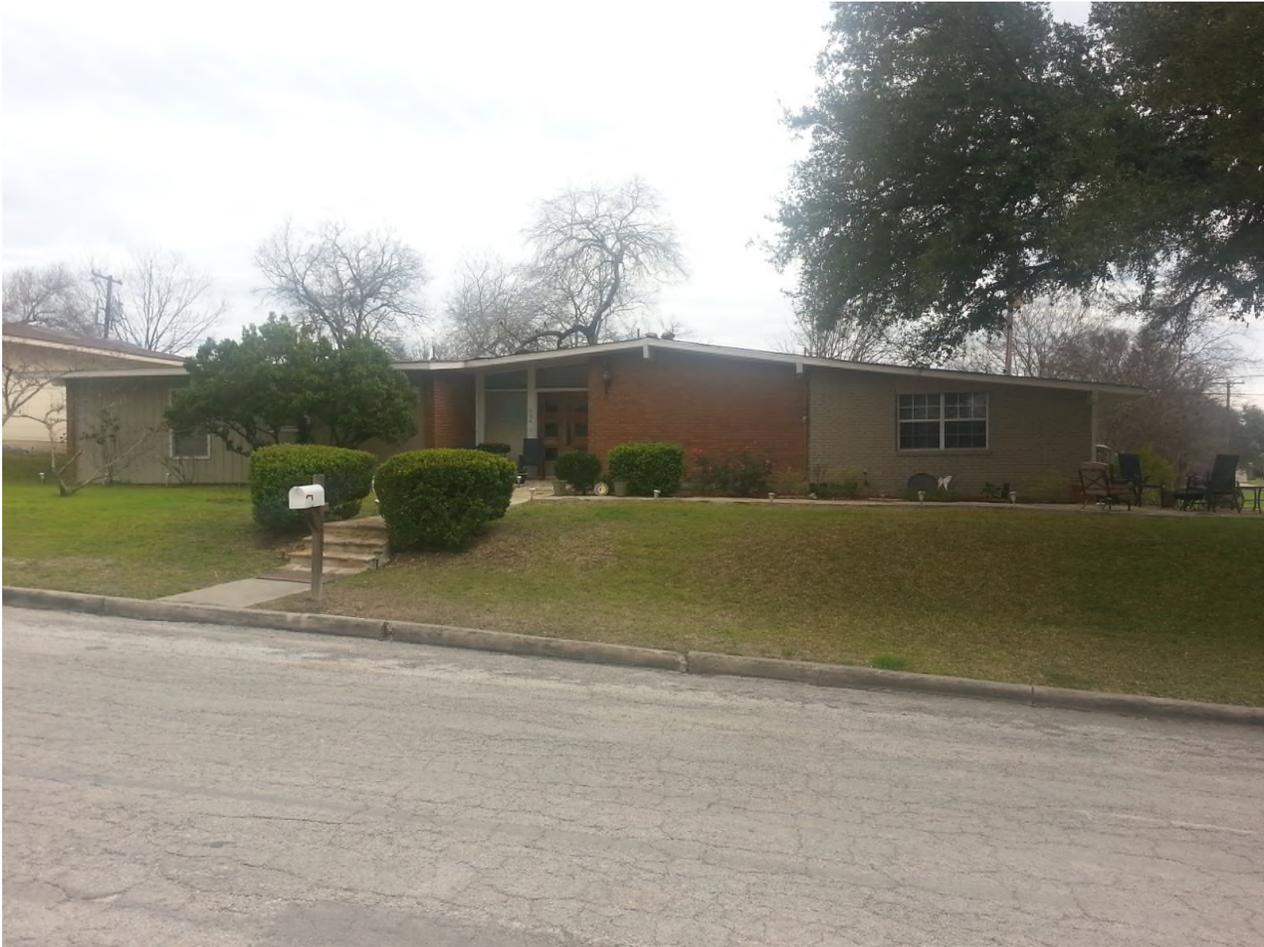
View of Resource 46 facing southeast. Enclosed carport at right.

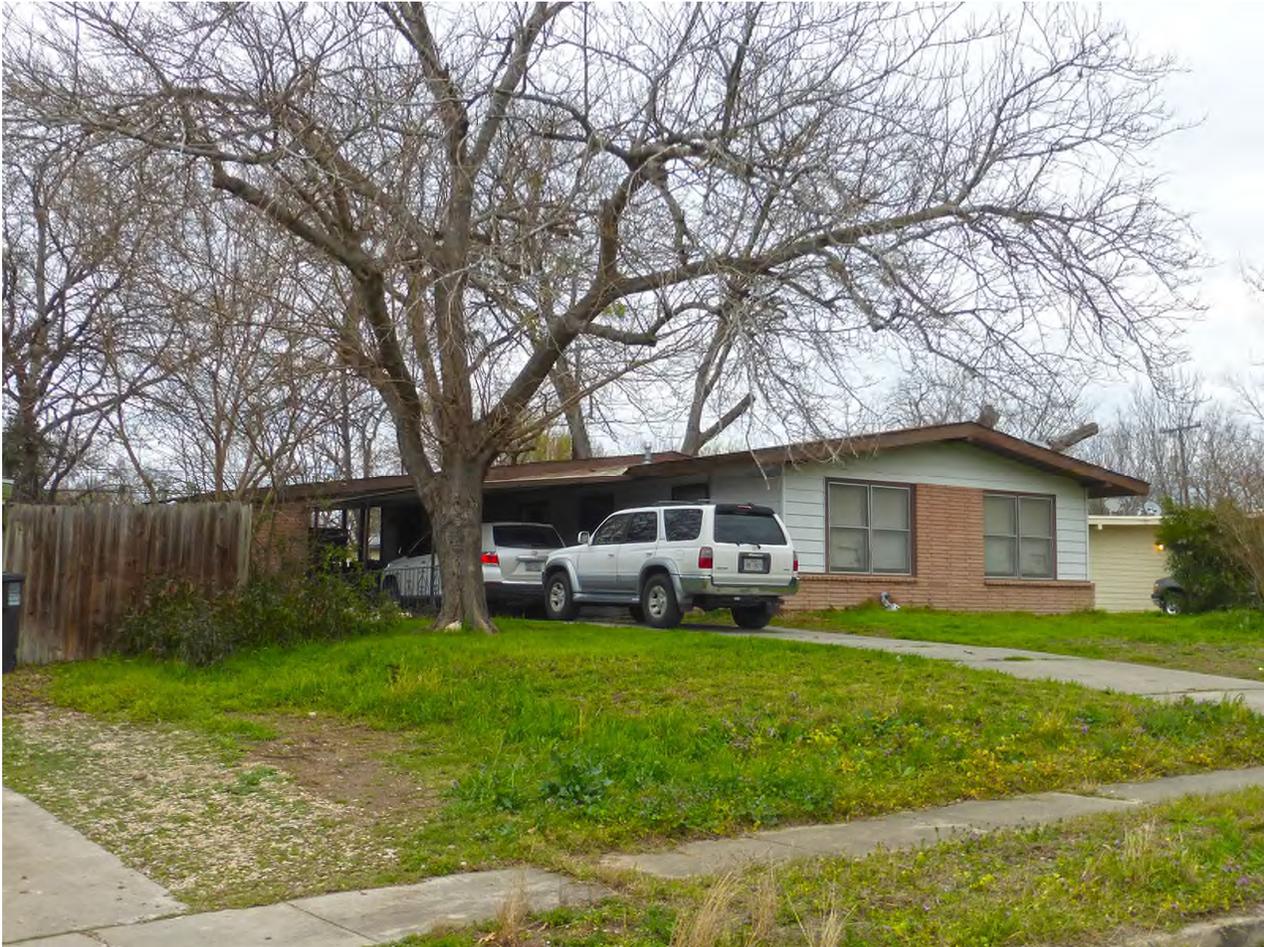
Photo 1 date taken: 02-16-15

View of Resource 48 facing northeast.

**Description:** Resource 48 is a side-gable Contemporary house with its short edge oriented towards the street. The house is clad in brick and replacement vinyl siding. The original car port has been extended south towards the street, and the front entry is currently sheltered by this roofline. Metal bars have been installed on the windows on the east side of the house.

**NRHP Justification:** Due to loss of historic materials and workmanship through non-historic age modifications, this house no longer retains the integrity necessary to convey its significance. As a result, it is recommended Not Eligible for the NRHP.

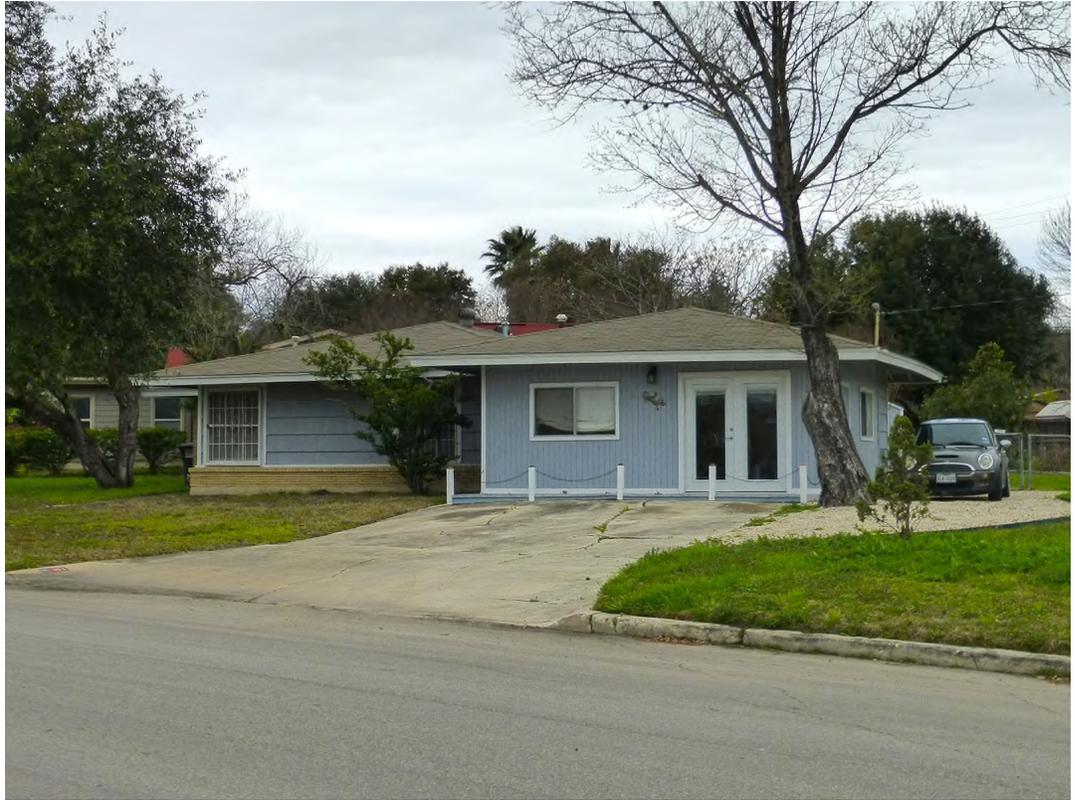
Photo 2 date taken:  
02-16-15

View of Resource 49 facing west.
