# HISTORIC AND DESIGN REVIEW COMMISSION

**HDRC CASE NO:** 2015-160  
**ADDRESS:** 311 SHANNON LEE  
**LEGAL DESCRIPTION:** NCB 12011 BLK 3 LOT 19 & P-101 (ALLEY)  
**ZONING:** R5  
**CITY COUNCIL DIST.:** 1  
**APPLICANT:** David Pulido  
**OWNER:** City of San Antonio  
**TYPE OF WORK:** Barbara Dr. - Drainage Project  
**REQUEST:**

# BARBARA DRAINAGE

HISTORIC RESOURCES SURVEY REPORT,  
BARBARA DRIVE DRAINAGE PROJECT  
SAN ANTONIO, BEXAR COUNTY, TEXAS

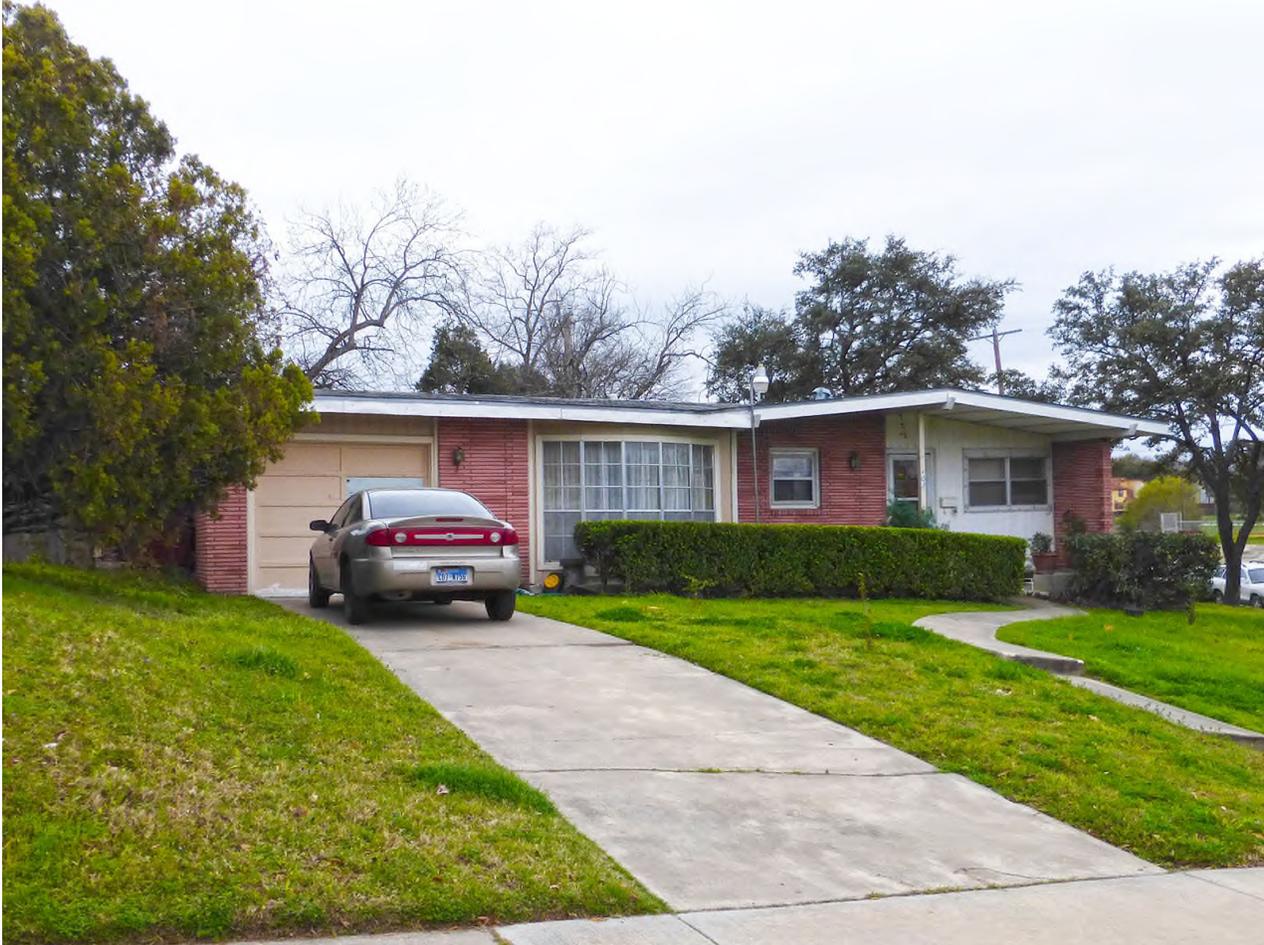
Photo 1 date taken: 02-16-15

View of Resource 50 facing southwest.

**Description:** Resource 50 is a Ranch-style house with some Contemporary influences. It is clad in brick and vinyl siding and features an integrated one-car garage and bowed picture window. The porch has plain wood supports. Several of the original windows have been replaced and the vinyl siding is not compatible.

**NRHP Justification:** Due to loss of historic materials and workmanship through non-historic age modifications, this house no longer retains the integrity necessary to convey its significance. As a result, it is recommended Not Eligible for the NRHP.

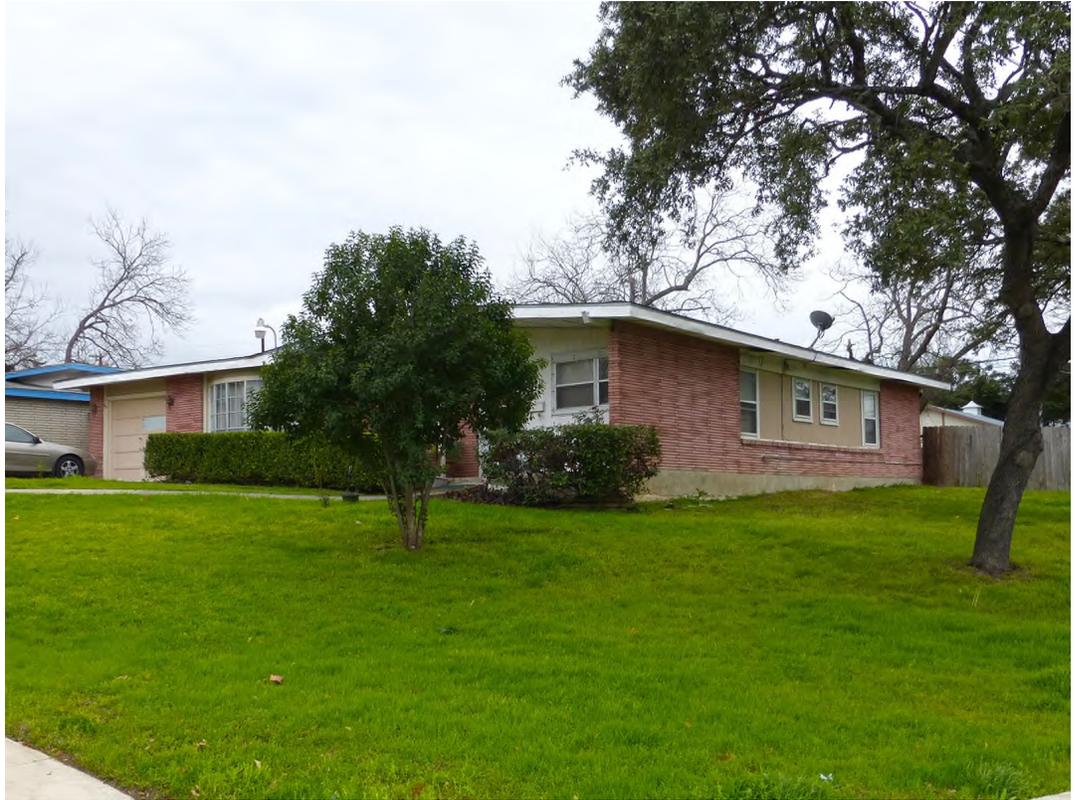
Photo 2 date taken:  
02-16-15

View of Resource 50 facing  
southeast.

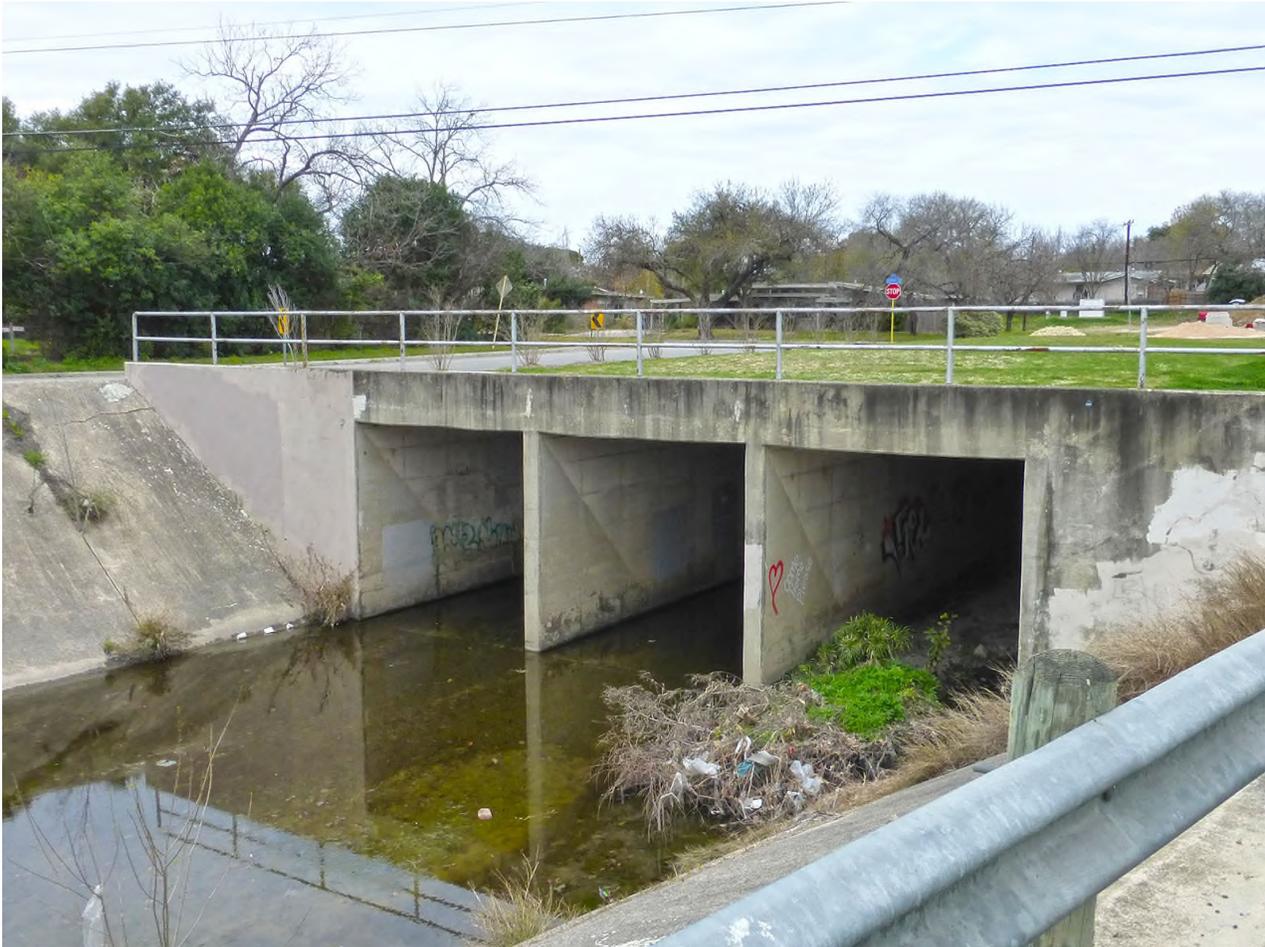
Photo 1 date taken: 02-16-15

View of Resource 51 facing northeast.

**NRHP Justification:** Due to loss of historic materials and workmanship through non-historic age modifications, this utilitarian drainage feature no longer retains the integrity necessary to convey its significance. As a result, it is recommended Not Eligible for the NRHP.

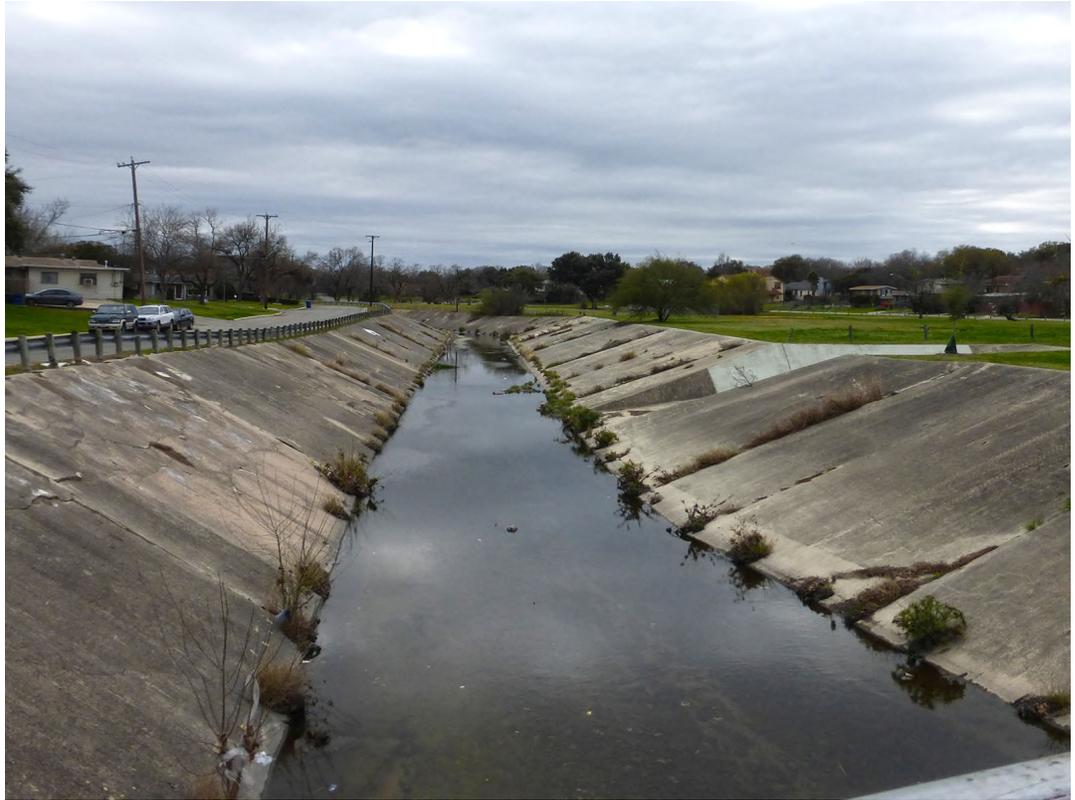
Photo 2 date taken:  
02-16-15

View of drainage channel looking south.

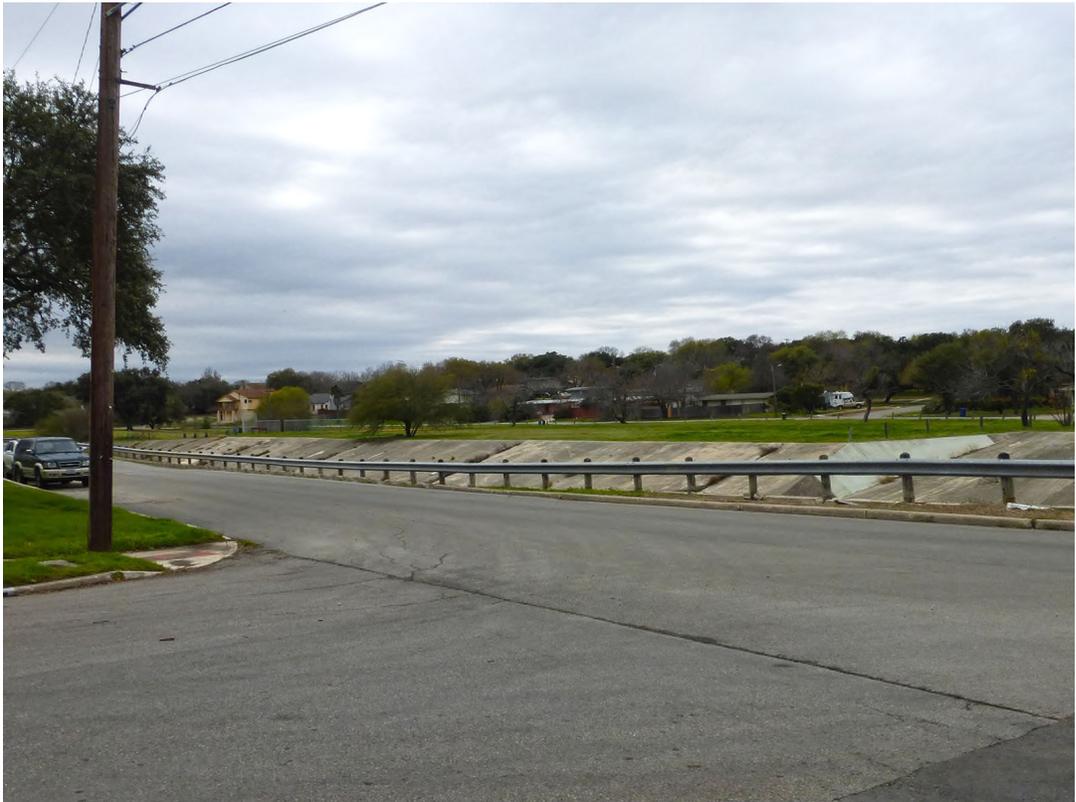
Photo 3 date taken:  
02-16-15

View of drainage channel looking west.
