# HISTORIC AND DESIGN REVIEW COMMISSION

**HDRC CASE NO:** 2017-656  
**ADDRESS:** 511 MISSION ST  
**LEGAL DESCRIPTION:** NCB 2879 BLK 4 LOT 5  
**ZONING:** RM-4, H  
**CITY COUNCIL DIST.:** 1  
**DISTRICT:** King William Historic District  
**APPLICANT:** Suzan Lambillotte  
**OWNER:** Suzan Lambillotte  
**TYPE OF WORK:** Replace concrete walkway with pavers  
**APPLICATION RECEIVED:** December 14, 2017  
**60-DAY REVIEW:** February 12, 2018

1. Remove the existing front concrete walkway and install brick pavers.

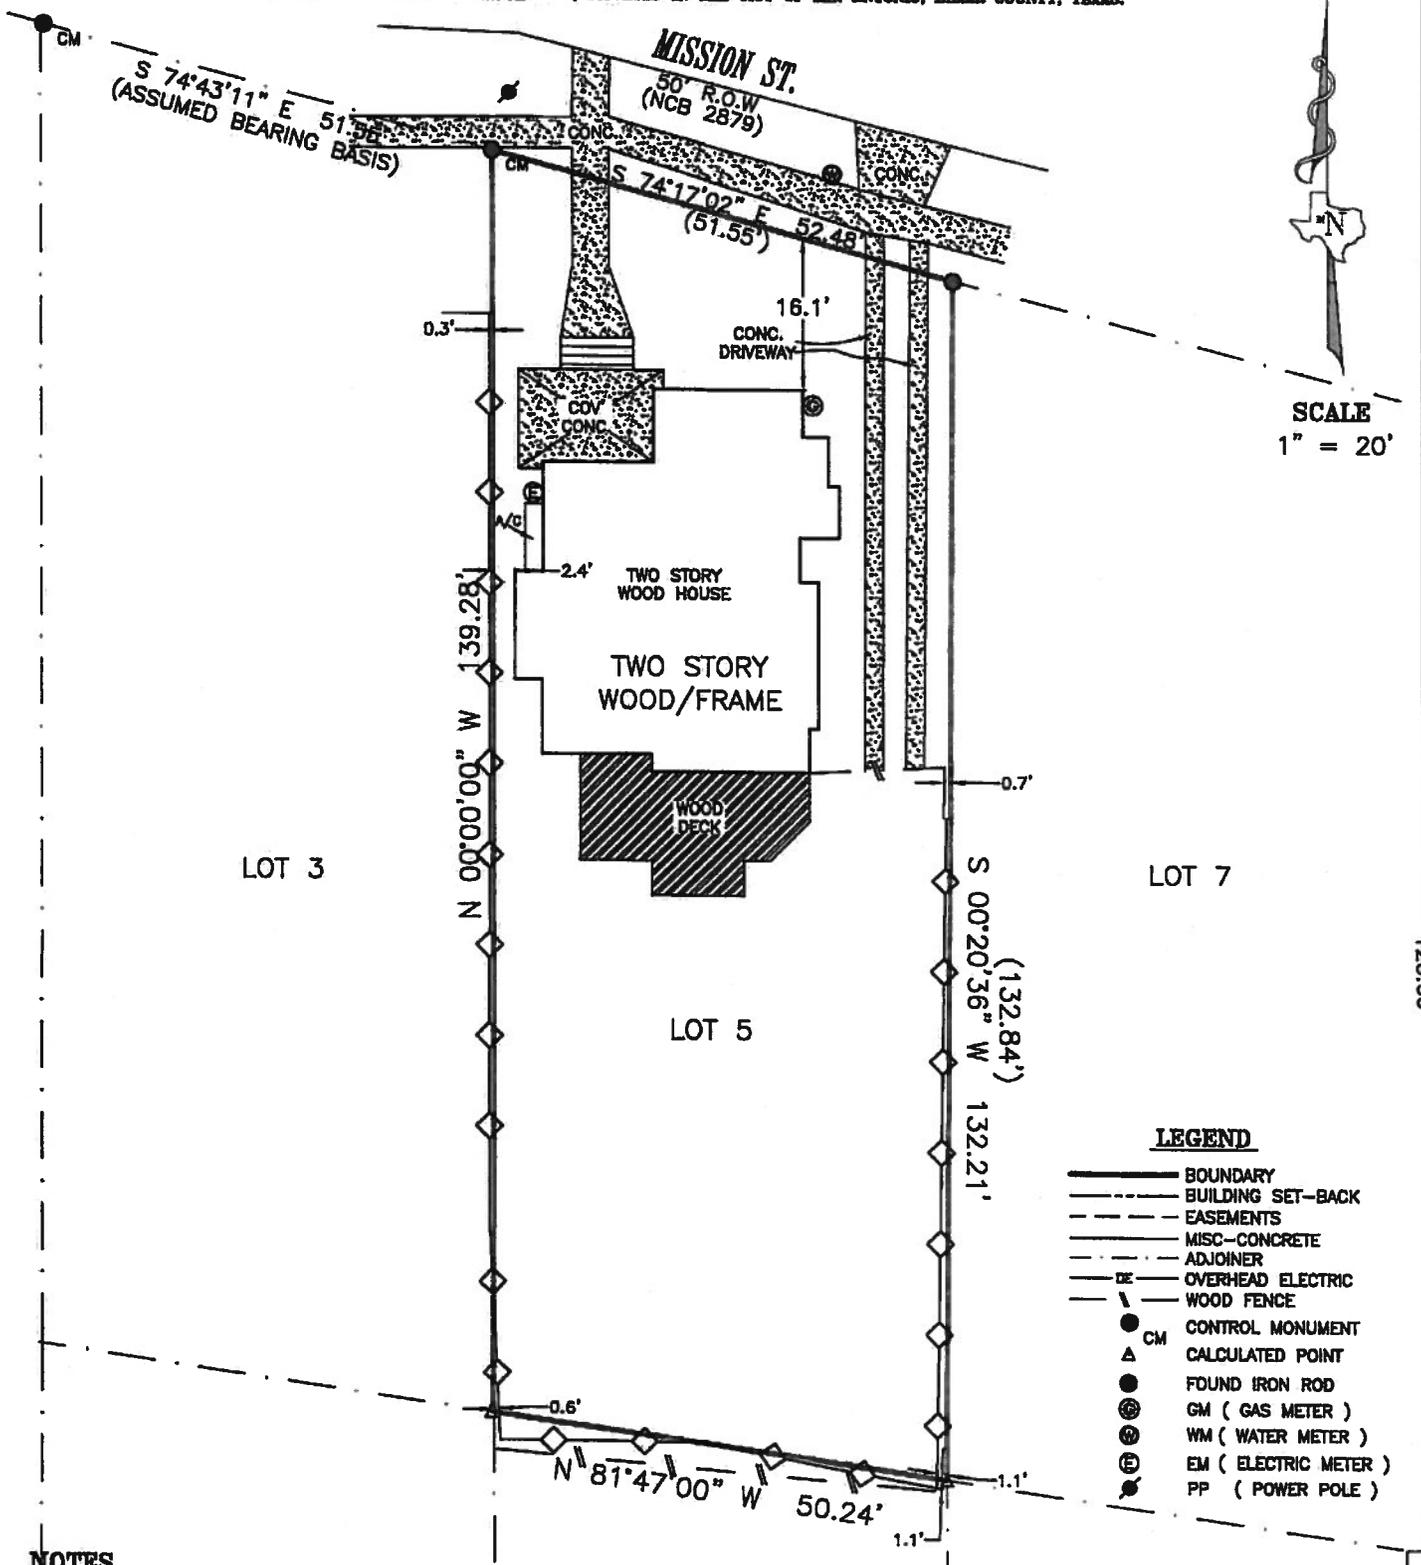
I David Newton Deibel, a Registered Professional Land Surveyor do hereby certify that the above plat represents an actual on the ground survey performed under my direct supervision and is true and correct to the best of my knowledge and belief and that there are no visible encroachments, overlapping of improvements and no discrepancies, shortages of area and conflicts in the boundary lines except as shown. I further certify that this survey meets the minimum standards established by the Texas Board of Professional Land Surveying.

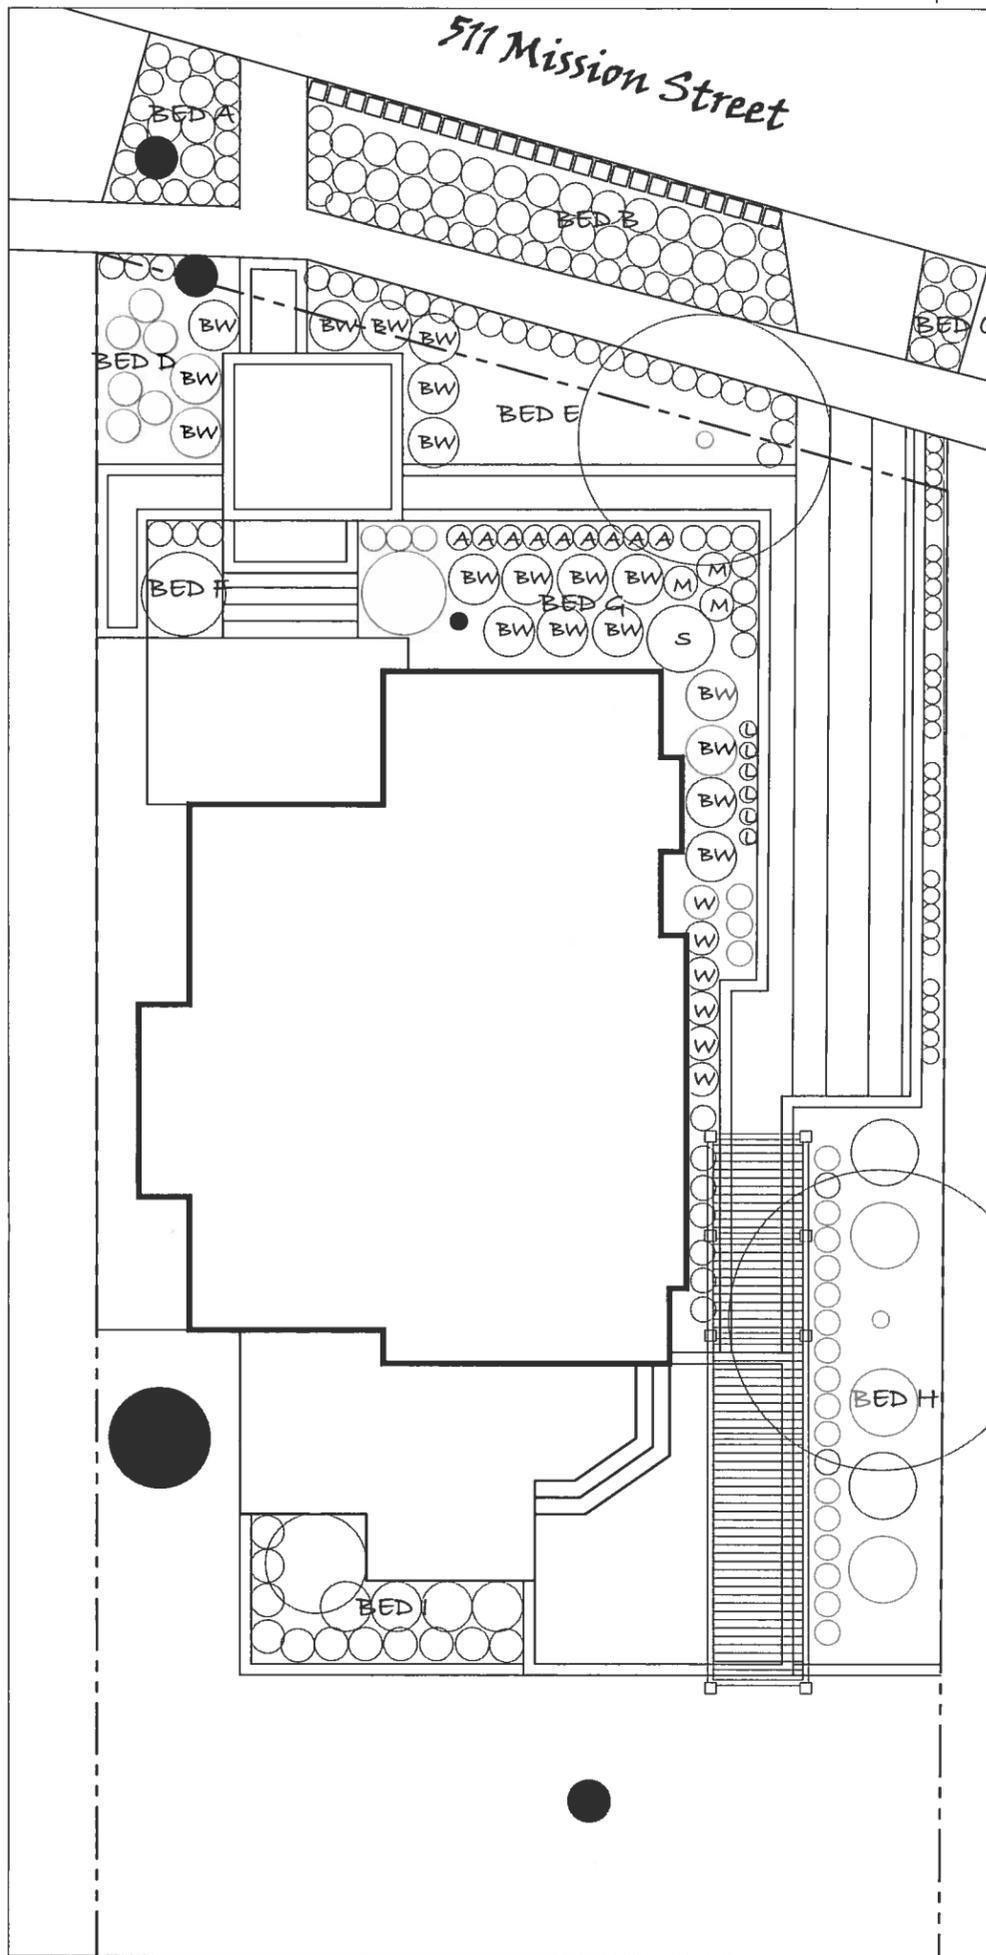
# PLAN

## PLANT KEY

### BED A - 66sq ft

### BED B - 215 sq ft

### BED G - 352 sq ft
